D. Beach Dump

Resolution Island Beach Dump Excavation Protocol

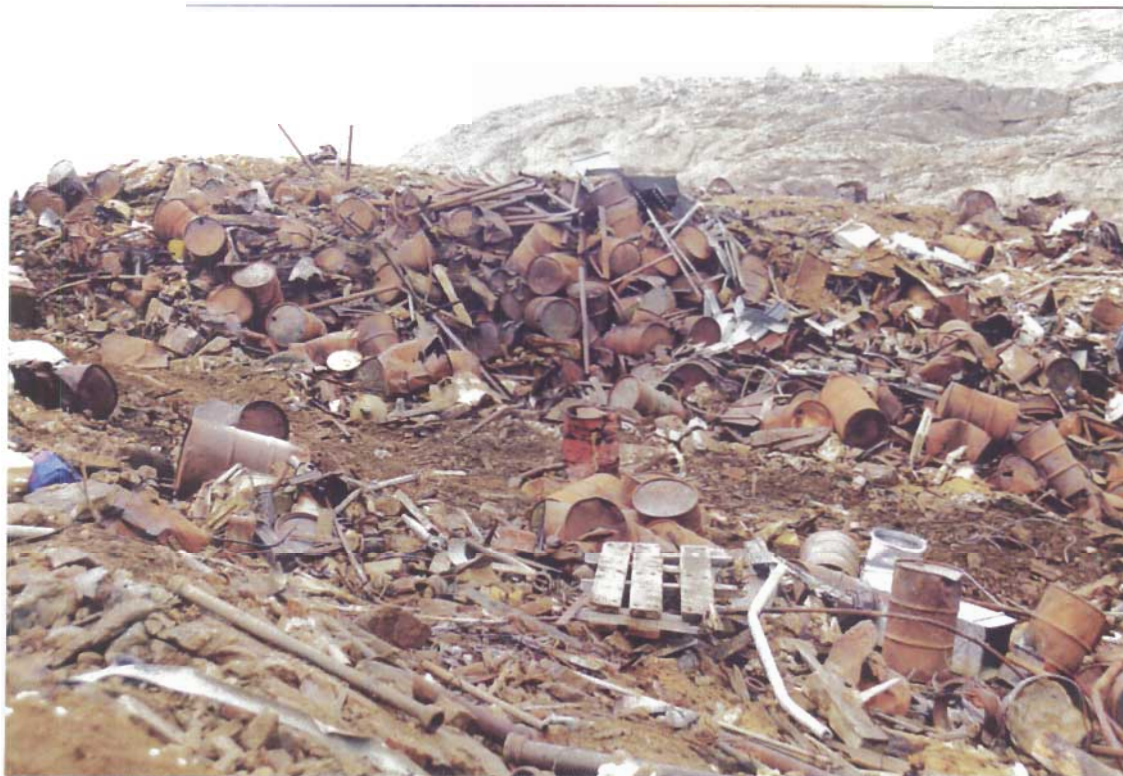
Photograph II-11: The Beach Dump at the Start of the Year.

A new protocol for the excavation work at this location was written and is reproduced at the end of this chapter as Annex B. All the visible debris was removed from the dump this year. All non-hazardous material was taken to the new beach landfill. Photograph II-11 shows the face of the dump at the start of the season and Photograph II-12 towards the end of the excavation. Barrels in various states of decay were again found in the dump and many contained oily liquids. These were treated as in 1999 by first testing to ensure that the material in the barrel contained < 50 ppm PCBs by the use of Clor-n-Oil test kits. None were found exceeding the limit. In some cases the test kits indicated 0 to 50 ppm and the contents of these barrels were checked on site by GC/ECD. The spill trays were also analyzed periodically. The contents of the barrels were then either pumped directly into sound barrels or emptied into containment trays from which the oils/fuels were then pumped into the sound barrels (Photograph II-13).

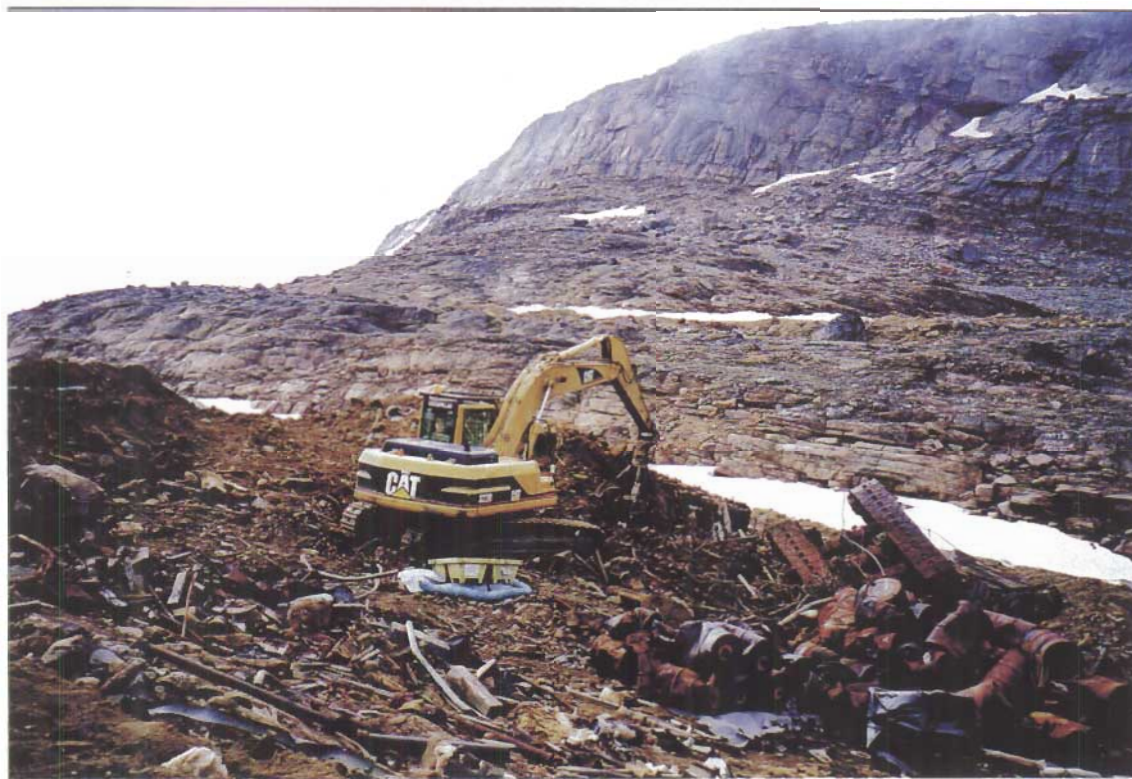
Photograph II-12: Near Completion of the Excavation of Debris From the Beach Dump.

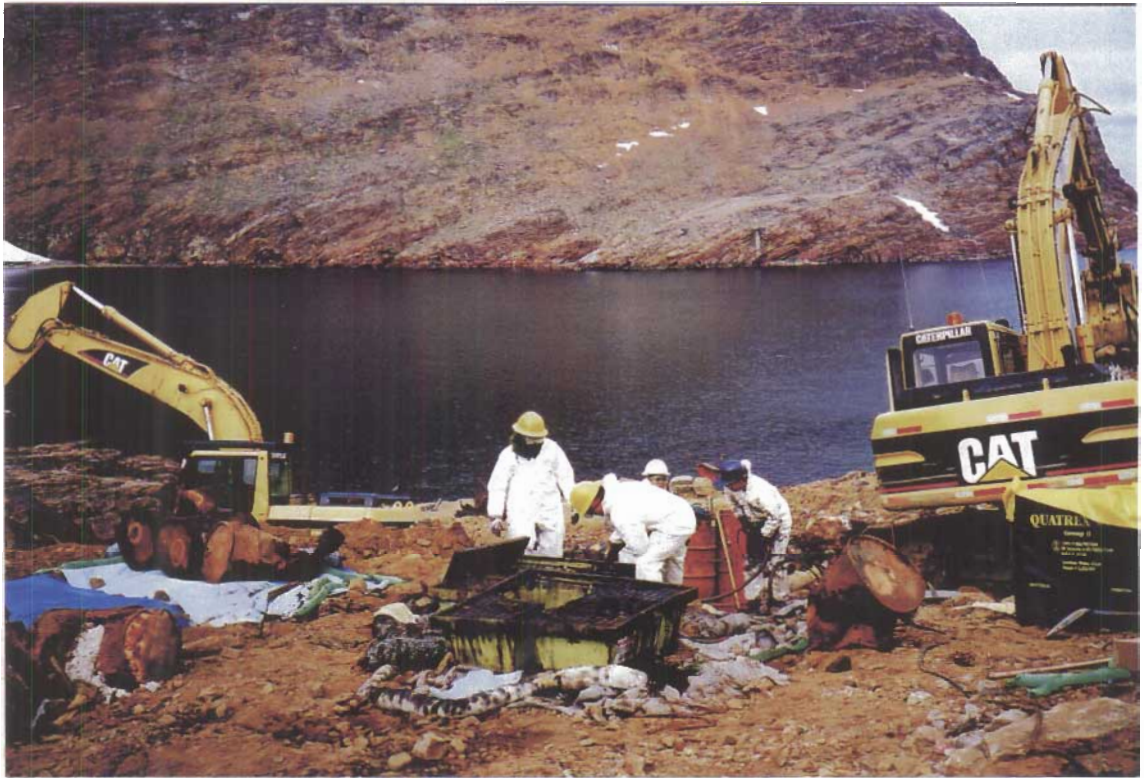
Photograph II-13: Pumping the Contents of Rusty Fragile Barrels into Sound Barrels at the Beach Dump.

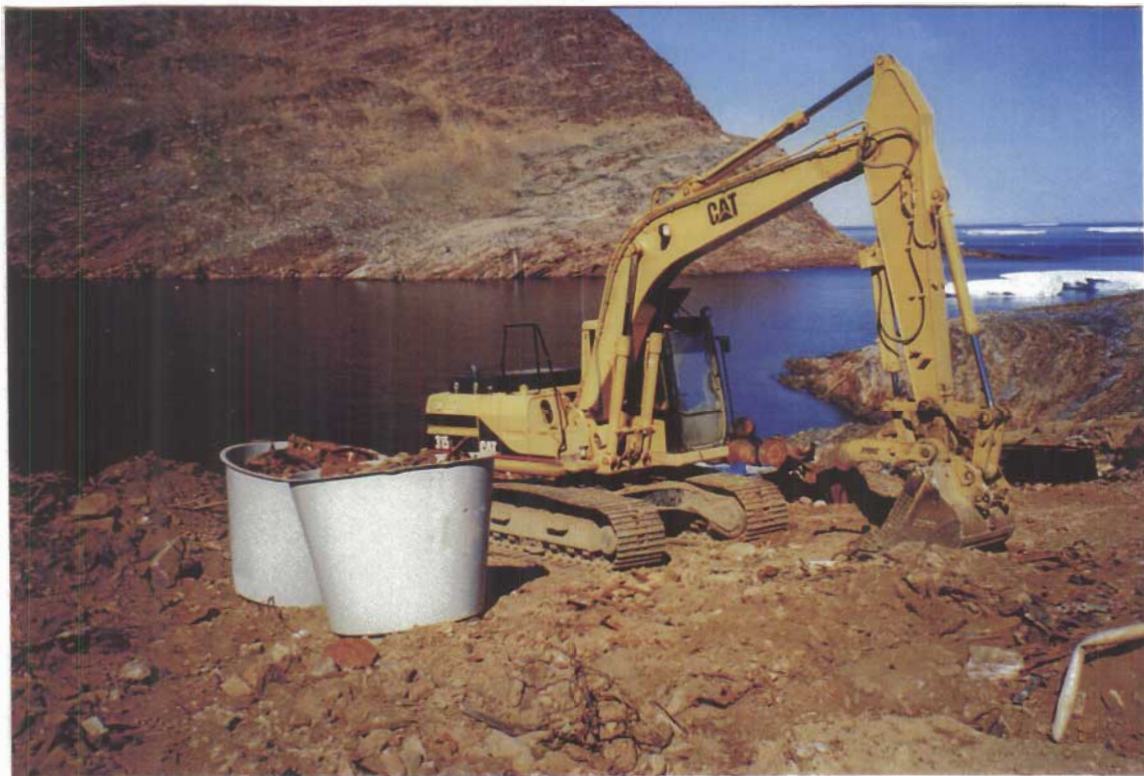
Photograph II-14: Placing Material Contaminated with a Formulation Containing Amyl Acetate into Steel Containers.

Amongst these, were several barrels of an amyl acetate based off-white coating product. These were placed in 2 steel flowerpot containers (Photograph II-14) and moved to the hazardous waste storage facility. One container was found to contain a yellow solid material identified as a mixture of calcium chloride and chromium chloride, and a barrel was found containing pink egg shaped objects, found to be a mixture of sodium phosphate, sodium sulfate and sodium sulfite (for use as a boiler additive). The “eggs” were placed in a barrel labeled RI01-EGGS1, and this was transported to the hazardous waste storage facility. During the excavation, several electrical components were also unearthed (Photograph IV-4). A hole was drilled into the center of each of these and the residue was analyzed. No PCBs were found in any of the components.

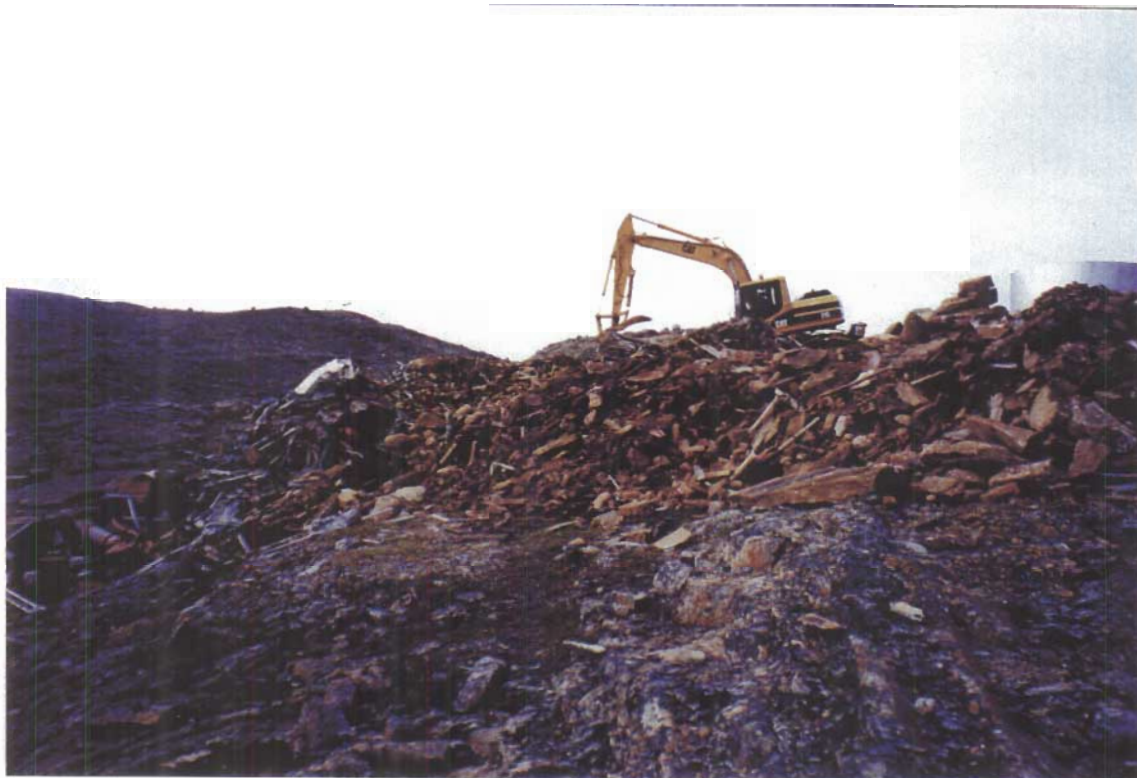
Photograph II-15: Excavation the Small Dump Adjacent to the Main Beach Dump.

Excavation was also carried out on a second smaller dump near to the beach dump (Photograph II-15). It is identified by reference to sample number L4118 in reports of the 1993 and 1994 work. Investigation at that time showed concentrations of PCBs at 1.4 ppm and lead of 221 ppm, both values slightly greater than DCC I criteria. A second sample (L1117) taken 6 m further down the drainage pathway, gave values much lower than the DCC criteria for either analyte. Contamination of the soil around L1118 was therefore concluded to be localized. A large quantity of debris from this area was excavated and piled besides the road leading to the main beach dump area (Photograph II-15). In the excavation process soil and rock was accumulated. Five composite samples were taken near the end of the field season from the excavated area and the results displayed in Table II-3. All samples tested as less than DCC I criteria for both metals and PCBs. QA/QC data is compiled in Chapter III, Section K.

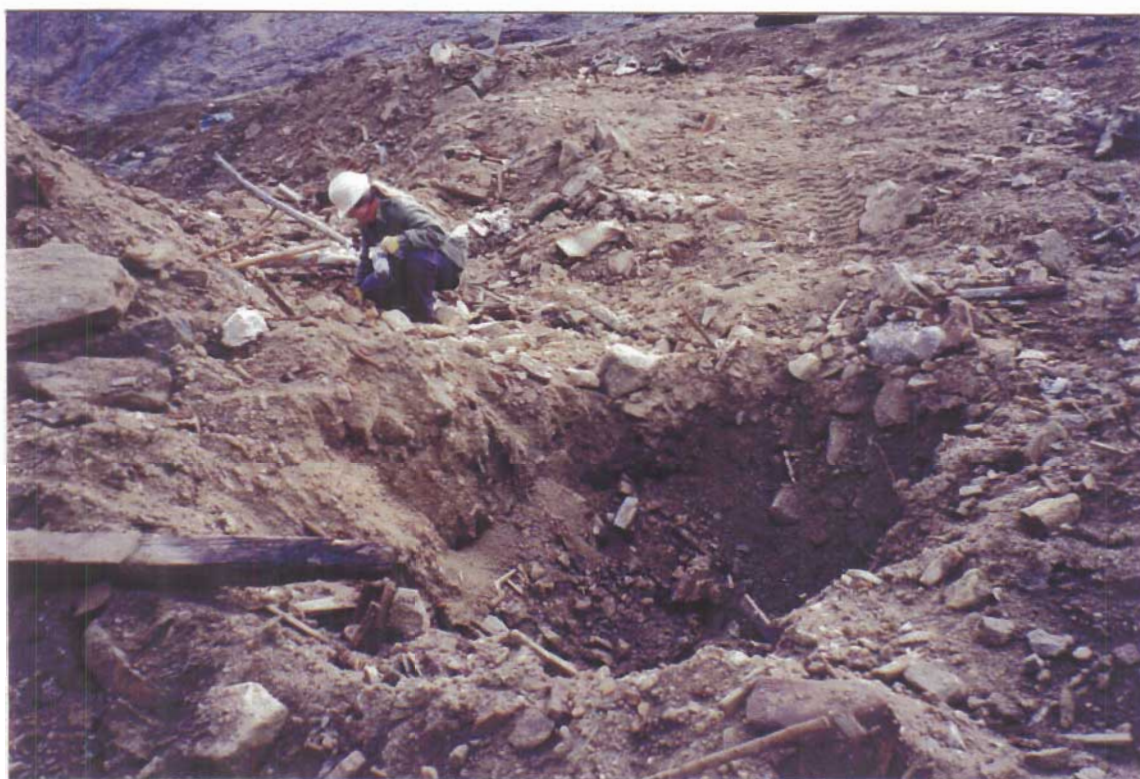
Photograph II-16: Taking Delineation Composite Soil Samples To Determine the Extent of Lead and PCB Contamination at the Beach Dump; The Hole was Excavated to Obtain Depth Samples.

The main beach dump area was delineated and tested for copper, lead and zinc. The footprint-shaped area was bisected into two parts by a row of tags, which were placed along the center of the dump. Sample markers were placed at equal intervals to form 27 grids within the perimeter of the dump. The area was subsequently mapped by GPS and the sampling locations are shown on Map II-4. Twenty-seven composite samples and four depth samples of the area were taken during a break in the excavation work, when the permafrost layer was first reached. The composite samples were taken between 0 - 20 cm and the depth samples ranged from 0.5 to 2 m from the surface of the dump. Each sample was tested for PCBs and metals (Table II-4). These results gave the contamination levels for individual quadrants. Those quadrants which contained metals above the DCC criteria were subdivided, re-sampled and analyzed. The second part of the excavation work, resulted in a re-distribution of some soil. Quadrants where soil had been disturbed were re-sampled. The results are shown in Table II-4 and displayed on Map II-5. QA/QC data is compiled in Chapter III, Section K. Based on the results of both surface and depth samples, the volume of Tier I metal contaminated soil is estimated as 300 m³ and the volume of Tier II metal contaminated soil as 500 m³.
