I. PCB Storage Facilities

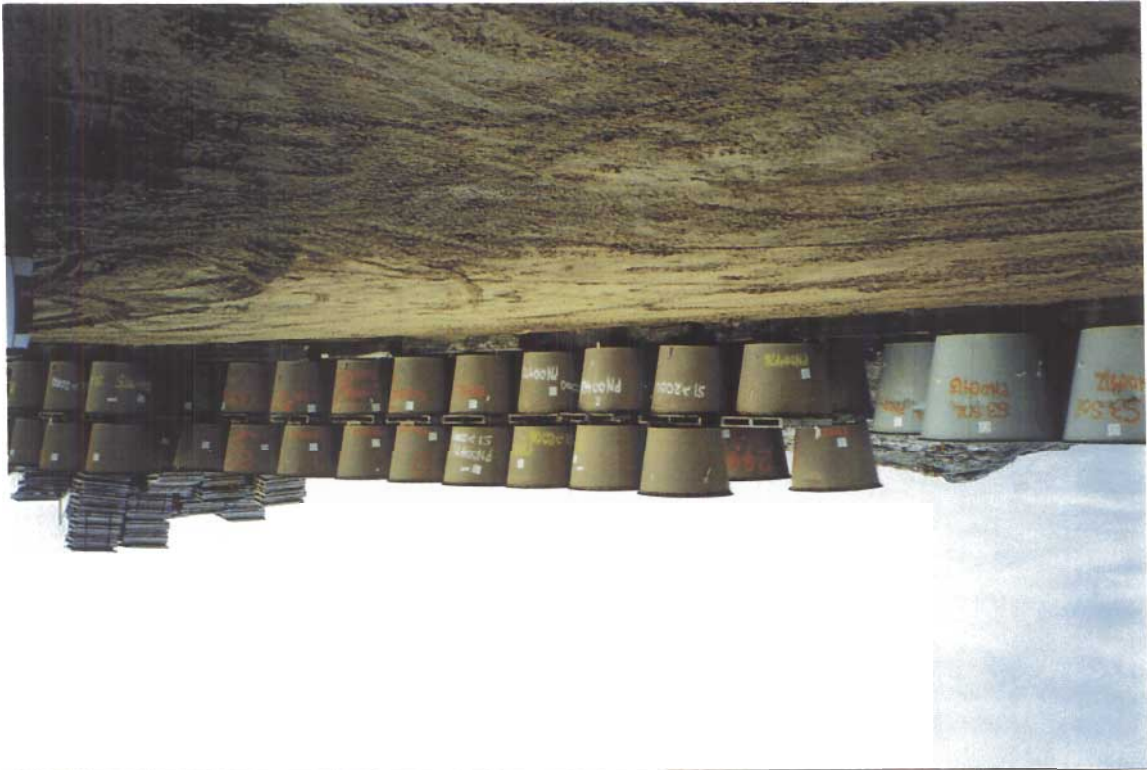
Photograph III-3: Steel Containers of Soil Contaminated with PCBs Above the 2000 ppm Level at the Main PCB Storage Facility

In 2001, an estimated 985 m³ of CEPA soil was excavated from the S1/S4 Buildings Area. Of this, 115 m³ was of material containing >2000 ppm PCBs and this was placed directly into steel containers. Problems were encountered with the new large (3.1 m³) steel containers as some were found to leak. Nine of these were filled with > 2000 ppm material so they were placed inside the facility (Photograph III-2). Sixty-one smaller steel containers (1.3 m³) were also filled with >2000 ppm material and these were stored outside the Main PCB Storage Facility (Photograph III-3). The remaining 835 m³ of soil was screened to two inches. Most of this (835 m³) was placed in the Main PCB Storage Facility along with the 630 m³ positioned there last year (Photographs III-4 to III-6); eleven large steel containers were mistakenly filled with screened material and these were placed outside the facility. The blue barrels containing CEPA soil and concrete which were brought to the site from Iqaluit in 1997, were removed from the building to make room for the screened soil and placed outside, adjacent to the building (Photograph III-7).

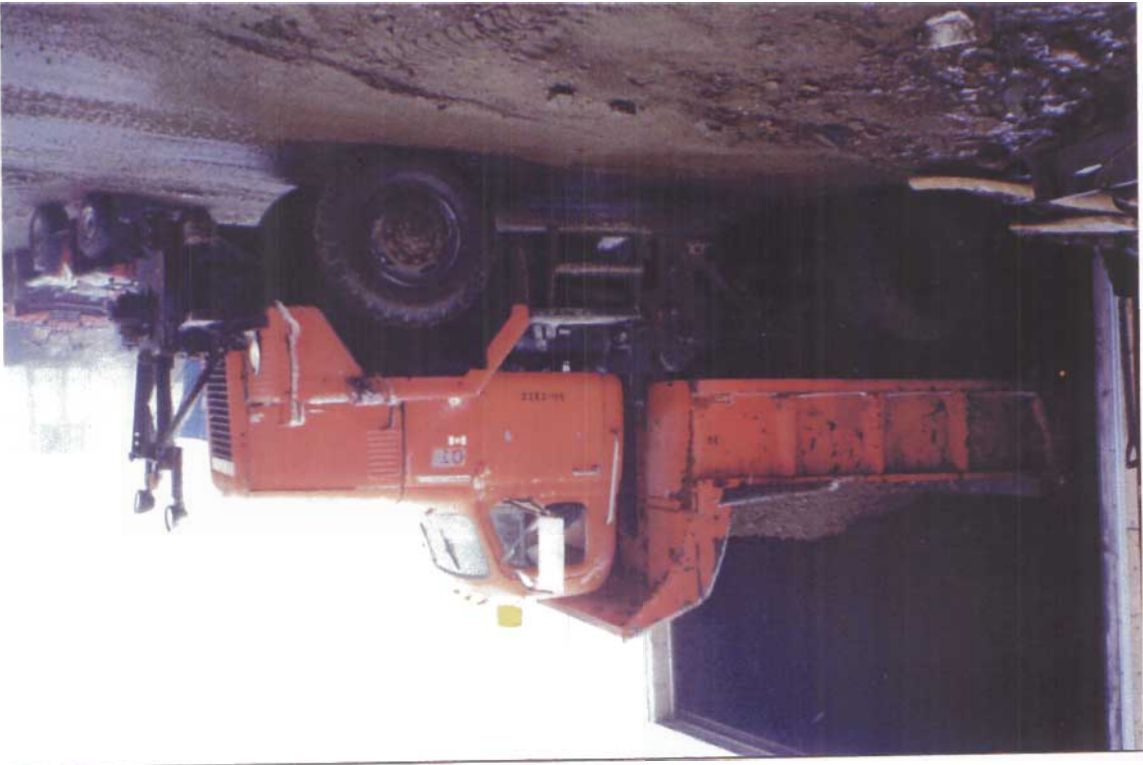
Photograph III-4: One of the Old International Trucks Delivering a Load of Screened CEPA Soil to the Main PCB Storage Facility

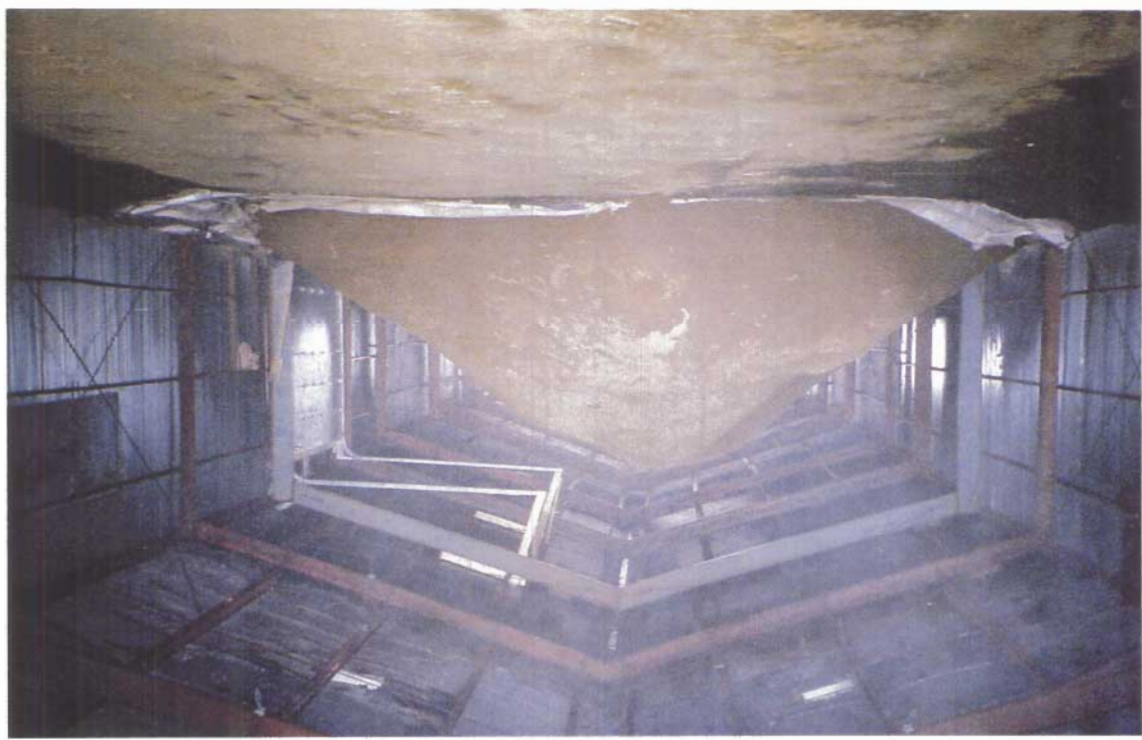
Photograph III-6: Soil Stored Within the Old Maintenance Buildings at the Main PCB Storage Facility

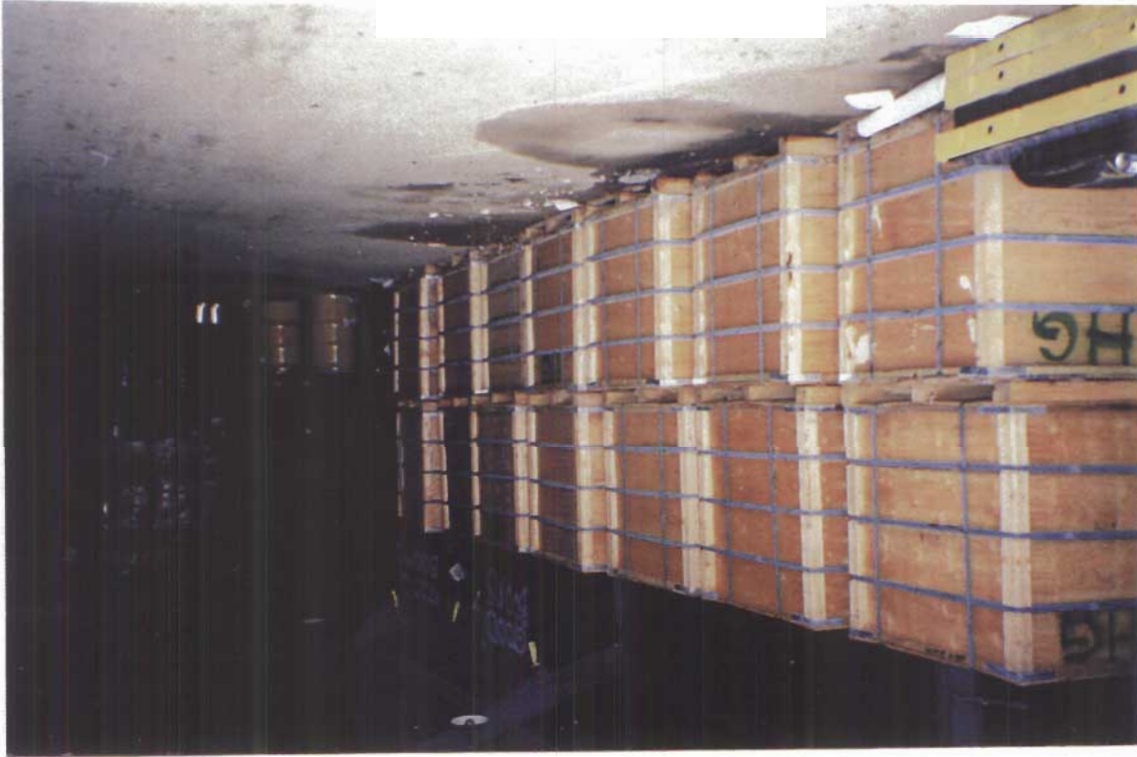
Photograph III-9: A View of the Inside of the Hazardous Waste Storage Facility.

Map III-9 and Table III-14 show the contents of the hazardous waste storage facility (Photograph III-9).
