4- PCB CONTAINERIZATION AND STORAGE

5- OTHER CLEAN UP ACTIVITIES

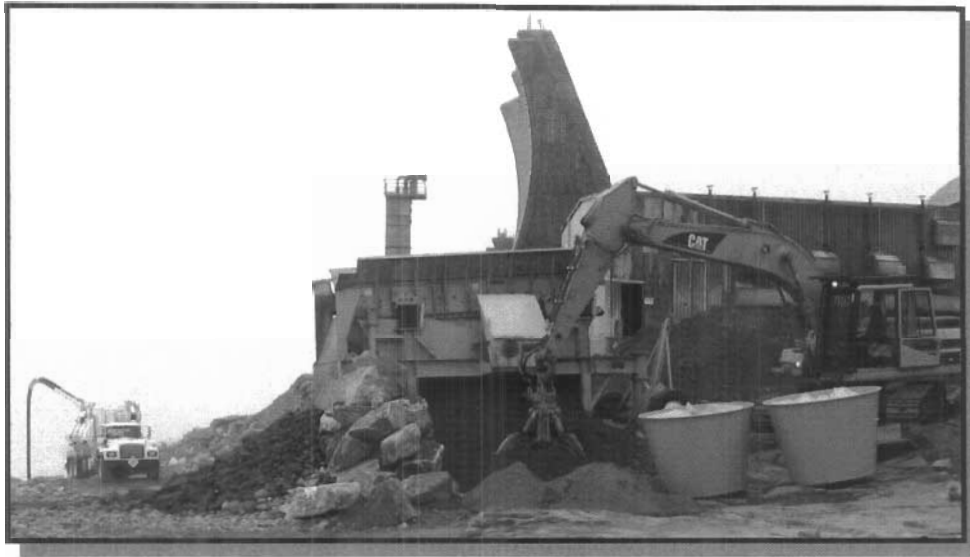
Most of the CEPA soil excavated and vacuumed this season was containerized immediately after being processed through the screening plant in the S1/S4 valley. A total of 89 containers were filled at that location from July 11 to 17.

Photograph 4.1 Containerization of CEPA soil from S1/S4 screener

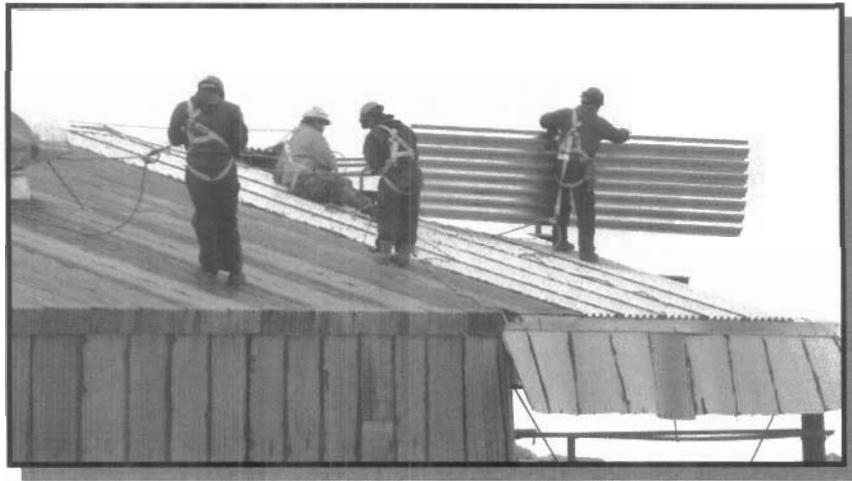
remaining steel cladding (*i.e.*, walls and roof) was manually removed by workers. Special safety precautions were taken during the removal of the roofing in order to prevent falls. A safety line was attached to the roof, and all workers were equipped with harnesses which were tied to that safety line. The annex on the southwest corner of the building was then removed. Finally, the steel frame structure was taken down using an excavator. Some of the steel beams had to be cut into smaller pieces using a gas torch. The waste steel was then moved aside using loaders.

Photograph 5.1: Removal of steel cladding from PCB building roof

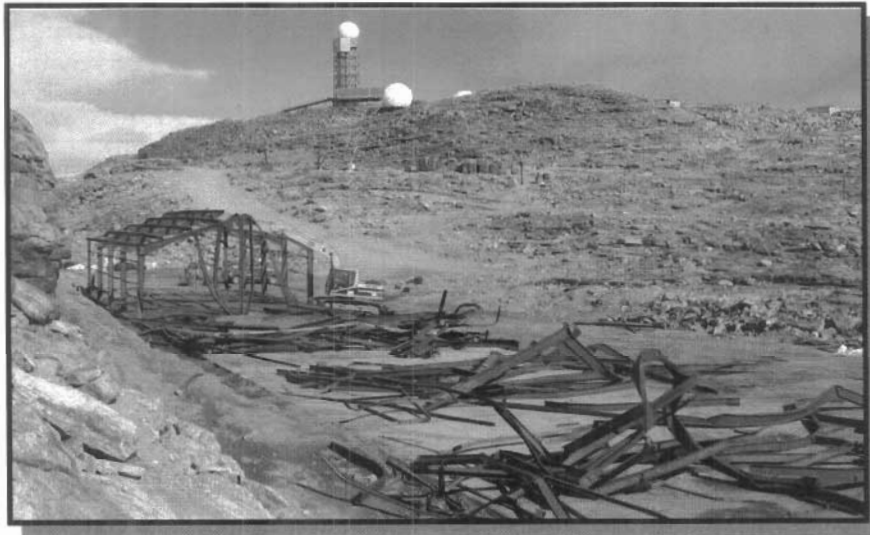
Photograph 5.2: Demolition of building structural steel frame

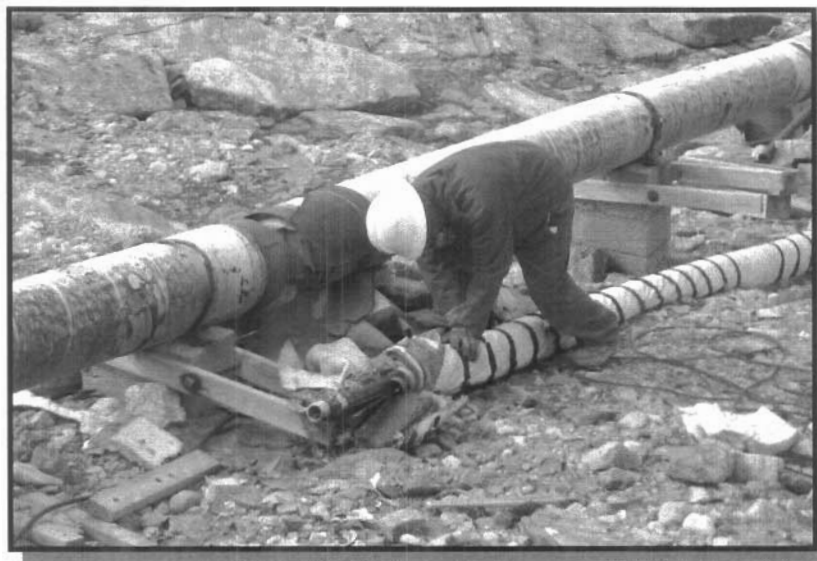
Part of the water line and other piping were lined with asbestos insulation. The removal, handling and disposal of this asbestos material required special procedures. Three (3) types of asbestos material were present on the two (2) different pipes. The water line was covered by a 12-inch (30-cm) diameter culvert which was lined with an asbestos fibreboard / tar paper. In this type of material the asbestos fibres are pressed and trapped within a resin matrix, which presents a very low risk of generating airborne fibres. This type of material resembles the asbestos fibreboard presently on the market.

Photograph 5.3: Removal of asbestos insulation from old fuel line

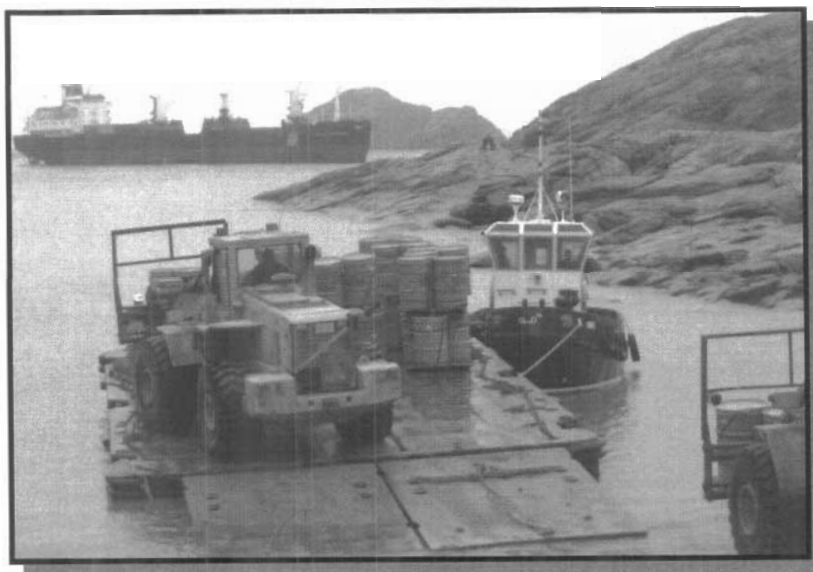
Photograph 6.2 Loading of waste drums on barge for south-bound shipment

On September 12, 2003, a total of 168 drums of hazardous waste were loaded onto the *M.V. Cécilia Desgagnés* for south-bound transport to a disposal facility. Most drums contained waste petroleum products (*i.e.* grease, fuel, gasoline, and oil), while others contained various other solid and liquid waste products (*e.g.*, solvent, charcoal, batteries, etc.).

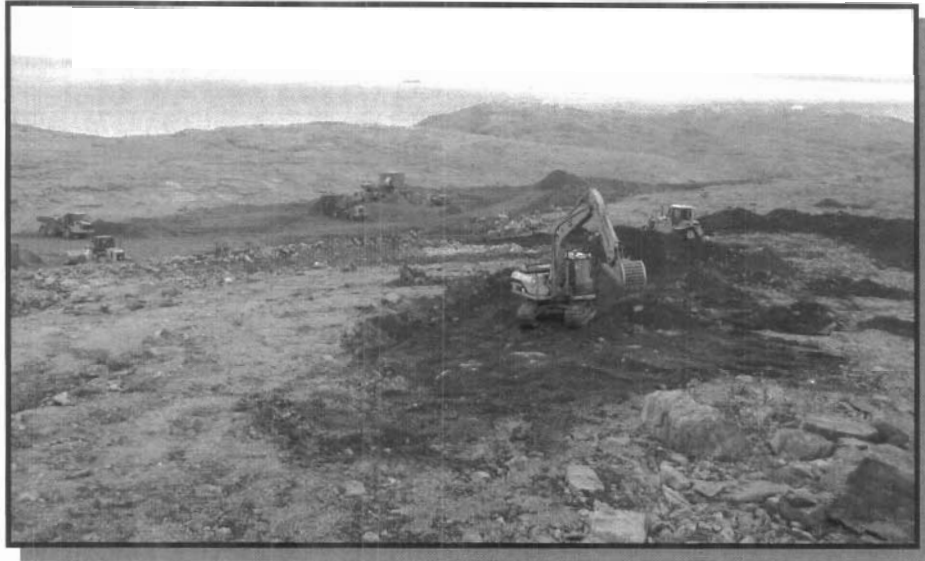
Before actual quarrying could begin, the borrow pit had to be drained of its excess moisture. Drainage ditches were dug in a grid pattern to maximize efficiency. After a few days of soil draining, stockpiling of unscreened pit run was initiated by pushing material into several piles using bulldozers. Once sufficient material was stockpiled, the material was screened through grizzlies to remove large boulders. Since the pre-screened material still contained a fair amount of large

rocks, the material was then processed through a screener with four-inch (4") diameter openings. In certain areas, pit run was also hauled to the screening plant using a rock truck.

Photograph 7.1: Quarrying operations at the Airstrip borrow pit
