### **3.2- S1/S4 Valley**

### **3.3- S4 Building**

## 4- PCB CONTAINERIZATION AND STORAGE

## 5- TIER II LANDFILL

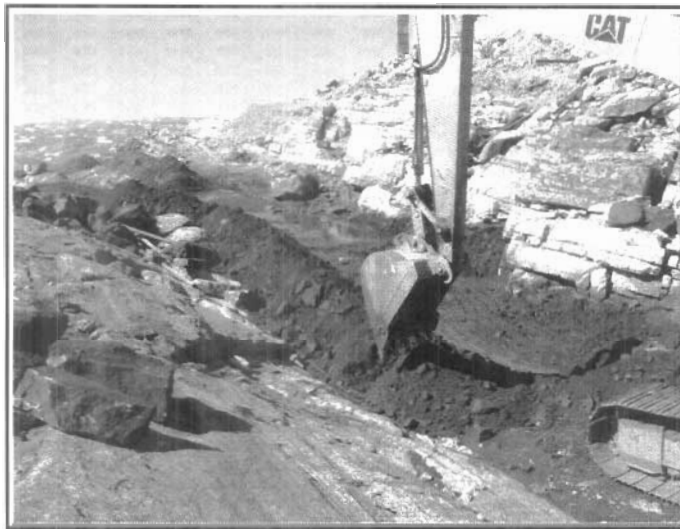
**Photograph 3.2: Excavation of PCB Tier II soil - S1/S4 Valley**

Excavation of PCB Tier II contaminated soils in the S1/S4 valley was initiated on July 24. The excavator worked its way up from the bottom of the valley leaving soil stockpiles along the way. Approximately 3,300 m<sup>3</sup> of the estimated 6,000 m<sup>3</sup> Tier II soil in the S1/S4 valley was excavated and stockpiled on site. The soil stockpiles are ready to be loaded into trucks and hauled to the Tier II landfill. Disposal of these soils in the Tier II landfill, initially scheduled for the 2004 season, was postponed to the 2005 season, due to delays related to bad weather.

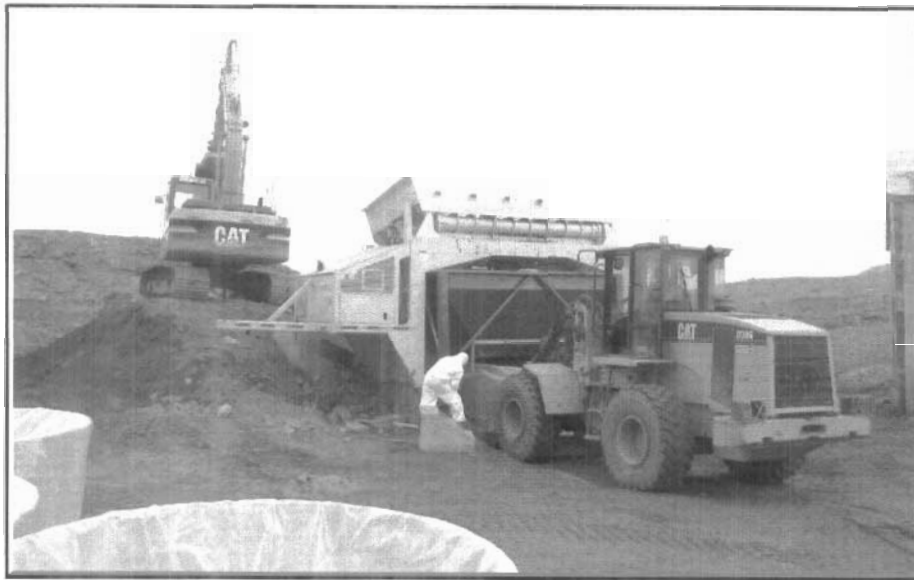
**Photograph 4.1: CEPA soil screening and containerization behind B2 building**

A soil processing pad was setup behind the B2 building in order to receive and screen the excavated CEPA soil from the S1/S4 beach area. At first, the clean soil in the area was excavated down to bedrock. A protective berm was then built along one side of the pad, using clean soil and a geomembrane liner, to prevent potential migration of contamination away from the pad. The natural bedrock outcrop along the back end of the area served the same purpose.

The first few loads of CEPA soil excavated from the S1/S4 beach area were hauled to the processing pad for temporary storage. When the supply ship arrived on site, the new soil screener was set up beside the B2 stockpile. Soil screening and containerization operations were conducted simultaneously by placing the empty flower pot containers underneath the screener. Once filled, the containers were brought to the lid and bolting platform. The efficiency of the containerization operations were thereby greatly improved. The screening rejects, consisting of rocks larger than 2 inches (5 cm) in diameter, fell off the screener and onto a pile located beside the screening unit. When a sufficient volume of rejects had accumulated, they were loaded into a dump truck and hauled nearby to the D8 pile, located approximately 100 m away.

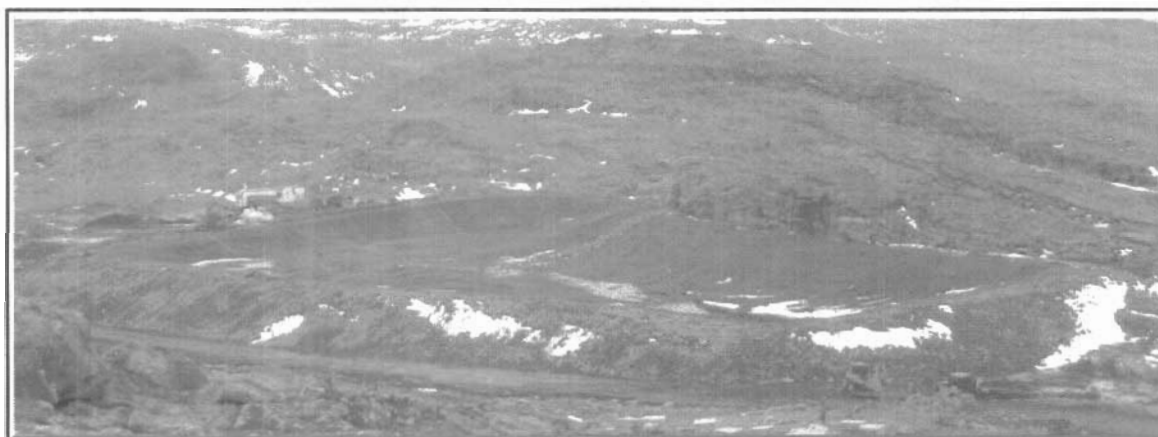
**Photograph 5.2: Completed landfill at the end of the season**

The wet weather conditions not only delayed the completion of the north and west berm cores but also caused erosion damage to the 1:1 outside slope of the south berm core. In order to protect

the outside south berm from further damage, Type 2 material was immediately placed and compacted dry along the outer south berm core as per Tier II Landfill Construction Specifications. Eventually, the Type 2 material was also placed along the outer east and west berm cores. As time permitted, a one metre thick layer of Type 1 material (screener reject) was placed on top of the Type 2 material along the outer west, south and east berms, as per Specifications. These activities, scheduled for the 2005 season, were completed by the end of the 2004 season.

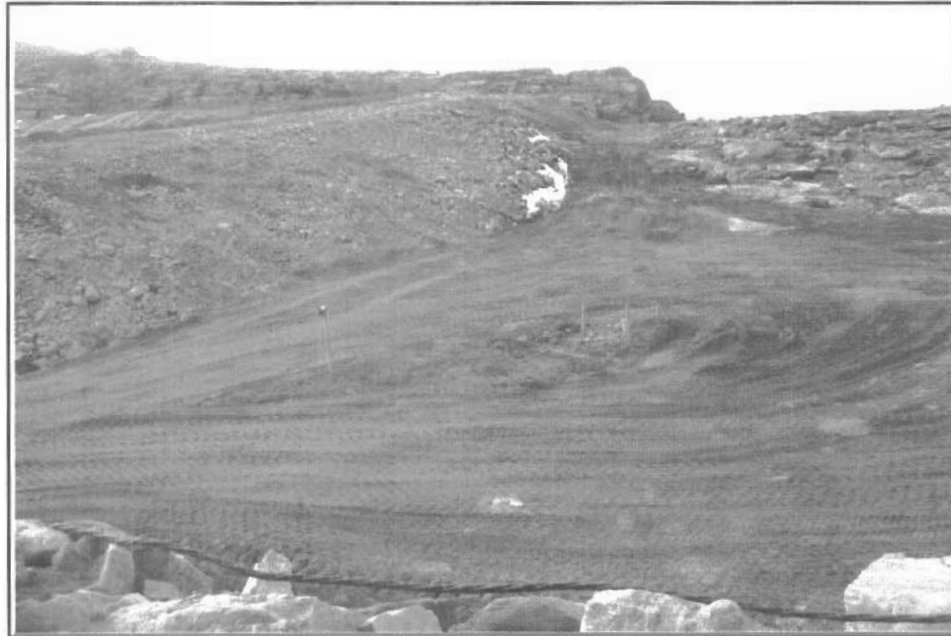
**Photograph 5.3:** Area east of East berm backfilled and sloped towards the southwest; monitoring well MW-1 approximately 10 m from the toe of berm

In 2003, construction of the east berm core blocked off the natural drainage path of the area east of the berm. Runoff water from the area used to flow towards the road and into a drainage ditch along the north side of the road. Since the construction, water from precipitation and snow melt accumulates in the depression formed by the two (2) bedrock outcrops and forms a deep pond.

At the end of the 2003 season, a trench was dug across the road and a culvert was installed in order to drain the area temporarily. During the 2004 spring thaw, the culvert was obstructed by sediment. At the end of the season, the whole area was backfilled with approximately 980 m<sup>3</sup> of pit run and sloped towards the road in order to prevent any accumulation of surface water. Furthermore, the obstructed 6" OD (outside diameter) culvert was replaced with a 24" OD culvert.

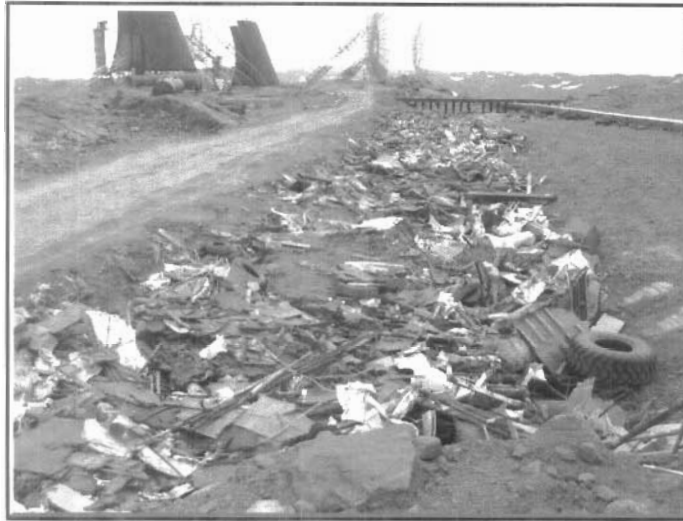
**Photograph 6.2: Demolition debris in the camp NH waste landfill**

Demolition debris were hauled to the nearby camp non-hazardous landfill located between the access road and the sewage line. The landfilled debris were compacted with the bulldozer and then covered with gravel. After demolishing the building, approximately 0.2 m<sup>3</sup> of PCB CEPA contaminated concrete was removed from the floor (see Section 3.3). The remaining building foundation will be covered with clean gravel once the contaminated soil surrounding the foundation is removed.

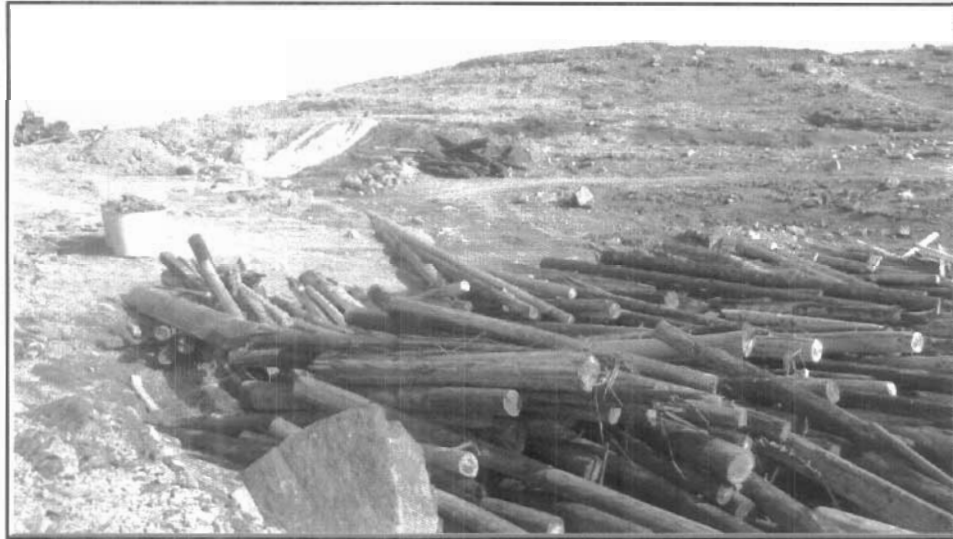
**Photograph 6.3: Creosote poles and timbers stockpiled near Beach NH Landfill; lined cell in landfill (background)**

various areas. These poles, along with creosote timbers from various locations on site, were collected and hauled down to the beach NH waste landfill. A polyethylene lined cell was setup in the landfill. The stockpiled poles and timbers were placed in the cell. The cell was covered with a polyethylene liner and gravel fill. Remaining poles at Radio Hill and timbers used for operations will eventually be placed in an adjacent cell at project completion.
