4- PCB CONTAINERIZATION AND STORAGE

5- TIER II LANDFILL

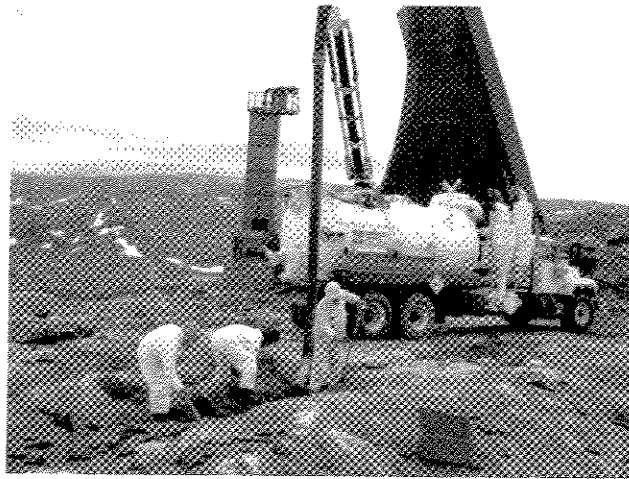
Photograph 3.3: Excavation of CEPA soil - S1/S4 Valley

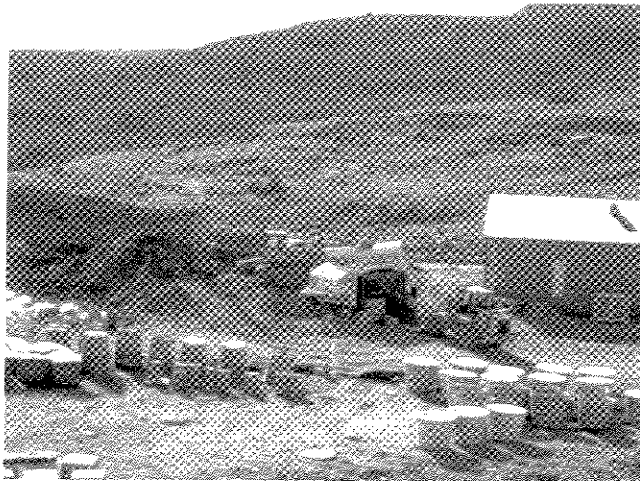
A soil processing pad was setup behind the B2 building in order to receive and screen the excavated CEPA soil from the S1/S4 Beach and S1/S4 Valley areas.

The soil was screened into a lined container, sitting on a containment pad made of HDPE membrane. A loader was used to move the containers (empty and full). Once filled, the containers were brought to the lid and bolting platform.

The screening rejects, consisting of rocks larger than 2 inches (5 cm) in diameter, fell off the screener and onto a pile located beside the screening unit. When a sufficient volume of rejects had accumulated, they were loaded into a dump truck and hauled to the Tier II Landfill (approximately 70 m³).

Photograph 4.1: CEPA soil screening and containerization behind B2 building

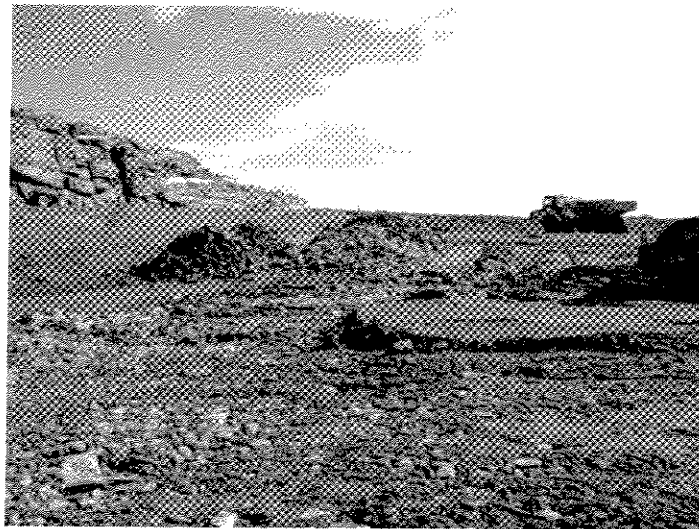
Approximately 475 m³ of debris was also landfilled: assorted metal cabinets and furniture that was stockpiled in the S1/S4 Valley after excavation from the Furniture Dump, assorted metal and wooden debris (from building demolition in the S1/S4 Valley), Tier II shredded wood, wooden boxes containing lead and mercury contaminated soil and insulation from the maintenance building demolition. These were systematically mixed with soil to reduce voids and minimize settlement.

Photograph 5.3: Debris landfilling

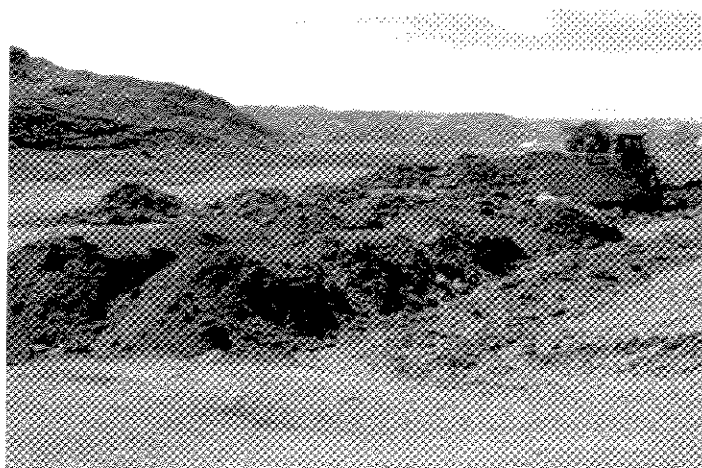
The hauling of Tier I soil excavated from S1/S4 Valley, S1/S4 Beach, and Lead dump was initiated on July 17th and completed on August 1st. Each lift of soil was compacted with the CAT CS-563D roller-compactor. Approximately 4,100 m³ Tier I soil was landfilled over of the Tier II layer to act as

Photograph 5.4: Tier I soil landfilling

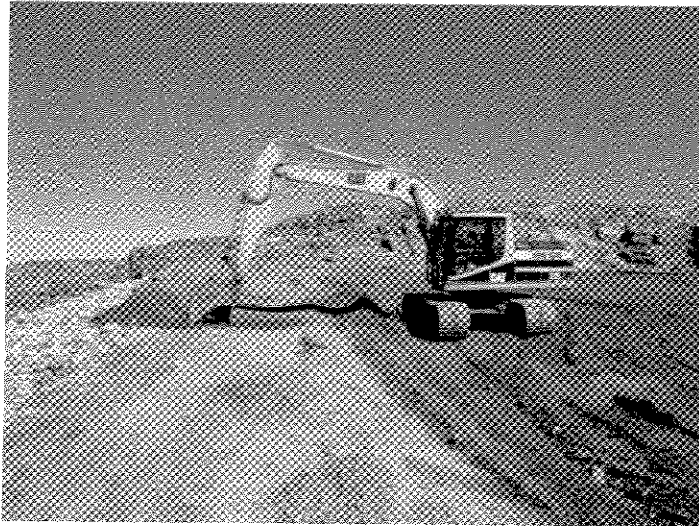
Prior to capping with the liner, the soil covering the geotextile on the berm was removed using the CAT excavator 315.

Photograph 5.5: Soil removing from the berms
