5.3- Other Related Activities

6- OTHER ACTIVITIES

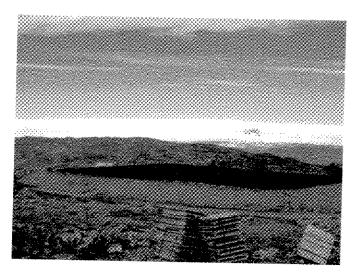
Photograph 5.6: Liner installation

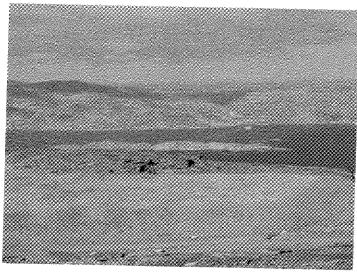
Photograph 5.7: Type 4, type 2 and type 1 layers

Three lifts of clean soil of different grades have been spread on the final membrane layer; Type 4, type 2 and then Type 1.

Approximately 2,400 m³ type 4 (from Radio Hill borrow pit) was placed and compacted over the membrane layer. The type 4 layer placement was initiated on August 16 and completed on August 18. A survey was then done.

An approximative type 2 volume of 5,700 m³ (from Airstrip borrow pit and Lake #2) was spread in two compacted lifts over the type 4 layer. The type 2 layer placement was initiated on August 18 and completed on August 22. Much attention was put on the compaction of the type 2 layer in order to avoid any deviancies from specifications.

Once the compaction was completed, approximately 3,800 m³ type 1 (from Radio Hill, Airstrip borrow pit) was placed over the type 2 layer. A survey was done. The on-site representative from EBA/UMA company gave his final approval on August 25: the Tier II Landfill construction complied with the specifications.

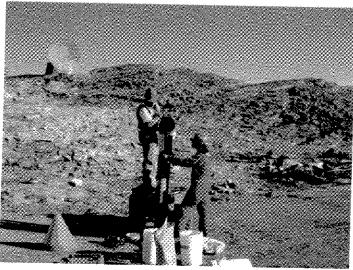
Photograph 5.8: Thermistor installation and filling

Initially, four (4) thermistors had to be installed inside the landfill; according to the EBA on-site engineer, only two (2) in addition to those mentioned above were finally required. The drilling was scheduled once the type 4 layer was completed (underneath the final membrane layer). One (1) technician from the specialized drilling contractor Sonic Soils drilled the boreholes as per Specifications using the grapple and Sonic augers. Due to the concrete-like characteristics of the soil, the drilling (August 6) was unsuccessful despite nine (9) different drilling locations attempts. The day after, with the approval of EBA/UMA, the airtrack was used successfully to drill the two (2) boreholes. The east borehole was 2,5 m depth and the west borehole was 2 m depth from the top of the type 4 layer.

The PVC pipes were installed and the top of the pipe was covered with a cap. The ground temperature cables and the waterproof housing for the dataloggers were installed on August 20; the filling with silica sand and cement grout was completed on August 23. The same day, the dataloggers were set up.

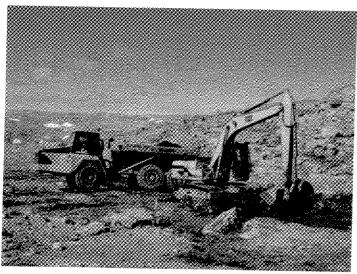
Photograph 6.2: Cobalt dump excavation

The excavation of Tier II soils contaminated with cobalt was initiated and completed on July 24. Approximately 180 m³ of Tier II soil was removed from the cobalt dump and hauled to the Tier II Landfill.

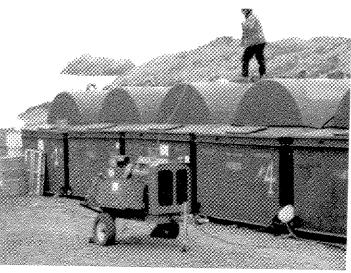
Photograph 6.4: Fuel filtration

Prior of the transfer of 50,000 L of clean fuel from NWS tanks, the project's fuel tanks located at the beach area have been emptied and cleaned. Some water had contaminated the fuel during the winter time and the fuel also needed to be filtered. Two (2) technicians from the company SANEXEN were involved in the decontamination process.

- The tanks 2, 6, 7 and 8 were almost emptied; their content has been transferred in the tank
 1 to allow their cleaning.
- The tanks 3, 4 and 5 were contaminated with water; after a first filtration, the fuel was transferred in the tanks 6, 7 and 8. The tanks 3, 4 and 5 were then cleaned. The fuel underwent a second filtration and was transferred to the tanks 3, 4 and 5.
- The fuel contained in the tank 1 (almost 6,000 L) was transferred in a wheel tank to allow its incineration (POL incineration area).

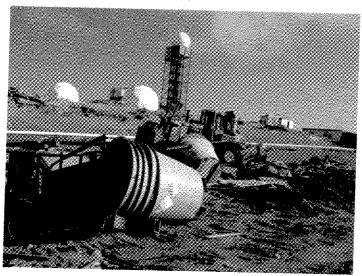
Photograph 6.5: Debris landfilling

Lighter metal debris such as empty drums were shredded, and disposed of in the non-hazardous waste landfill, while bulkier metal debris were dumped directly into the landfill. Regularly, the landfill debris were compacted by driving the D7 bulldozer on top of the debris pile.

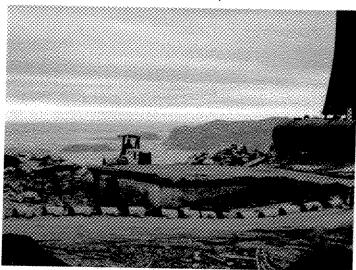
Photograph 6.6: S4 building slab covering

Once all Tier I and Tier II PCB contaminated soil were excavated in the close vicinity, the slab of the S4 building, demolished during the 2004 season, was covered with approximately 280 m³ of clean soil (pit run) excavated from the Airstrip borrow pit.

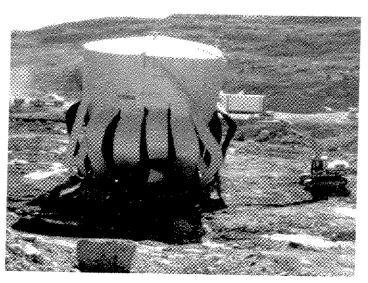
Photograph 6.7: POL tanks dismantling

The two (2) POL tanks located at the beach area were demolished on August 20 and 21 using the ripper. All metal pieces were cut and hauled to the beach non-hazardous landfill. ASU was requested to do analysis (refer to ASU report for results).
