Resolution Island 2007

Monitoring and Research

Resolution Island 2007 Monitoring and Research

Analytical Services Unit
Queen's University
Kingston, Ontario

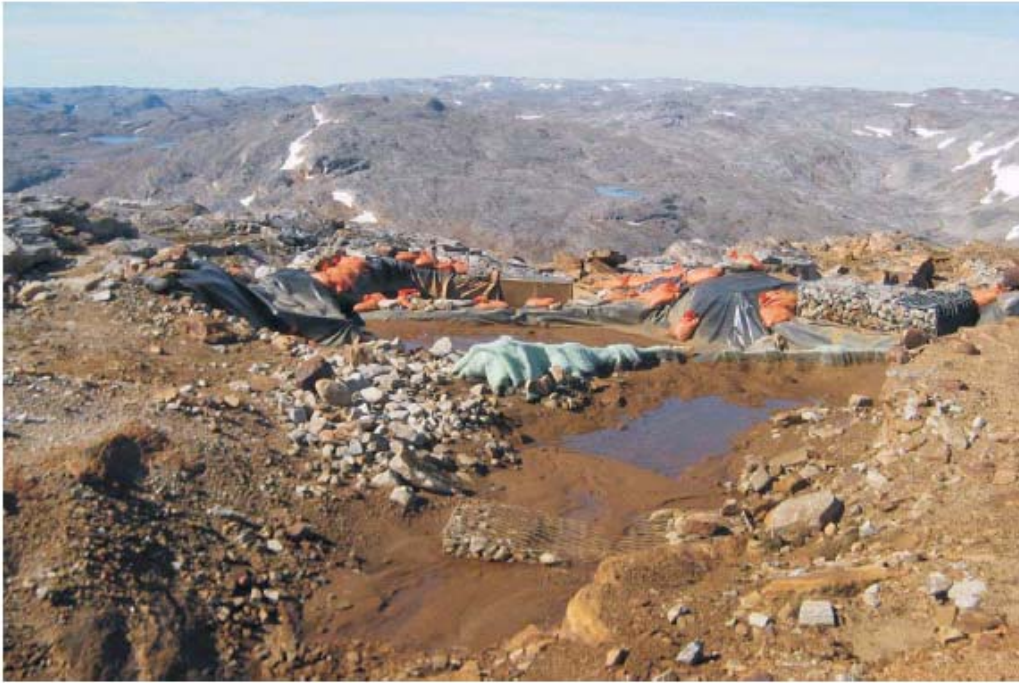
Upon preliminary inspection of the valley barrier it was noted that the sediment loading was about half that of 2006 and much less than 2005 (Photograph 3). A decrease was expected since the soil excavation in the valley had been completed in 2005 and this made the task of maintaining the barrier system less arduous this year. Moss has started to grow along the bottom side of the chevrons (Photograph 4). The chevrons are constructed of a geosynthetic that is primarily used for hydroseeding so this was quite interesting to see. Water was flowing through the filter gates, but no leakage was visible around the filters. The uncontaminated sediment in the first clean cell had been washed away but the second cell was in good condition. No repairs were necessary at the barrier. The material in the first clean cell was not replaced as it would likely be washed out as in previous years.

Photograph 3: The Barrier at the S1/S4 Valley at the Start of Field Work

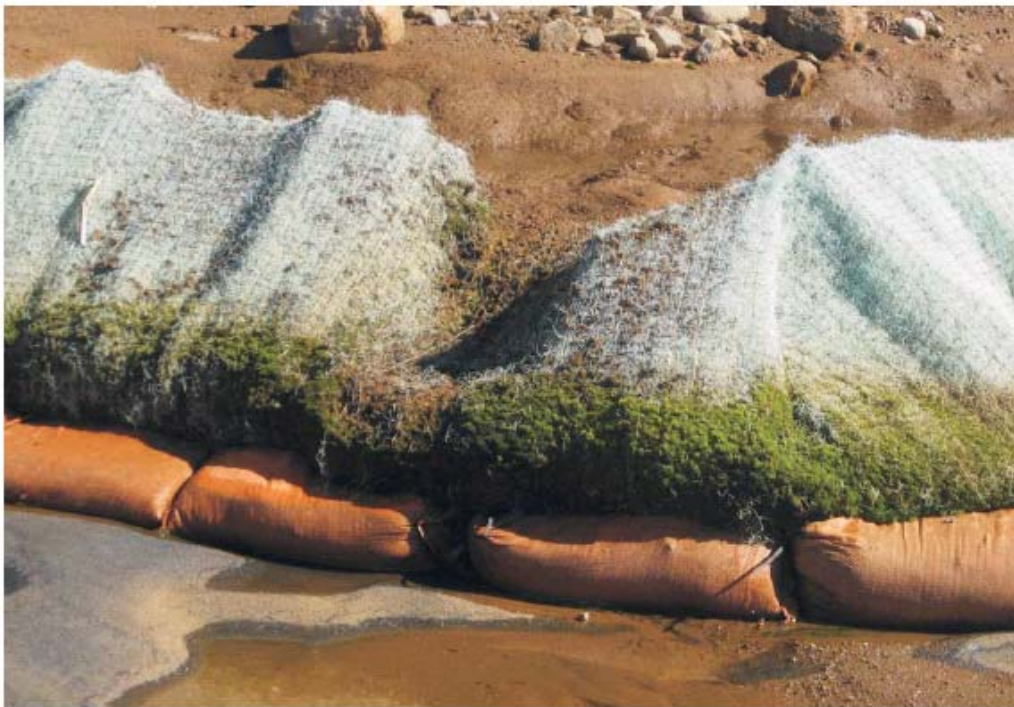
Photograph 4: The Curlex Trap

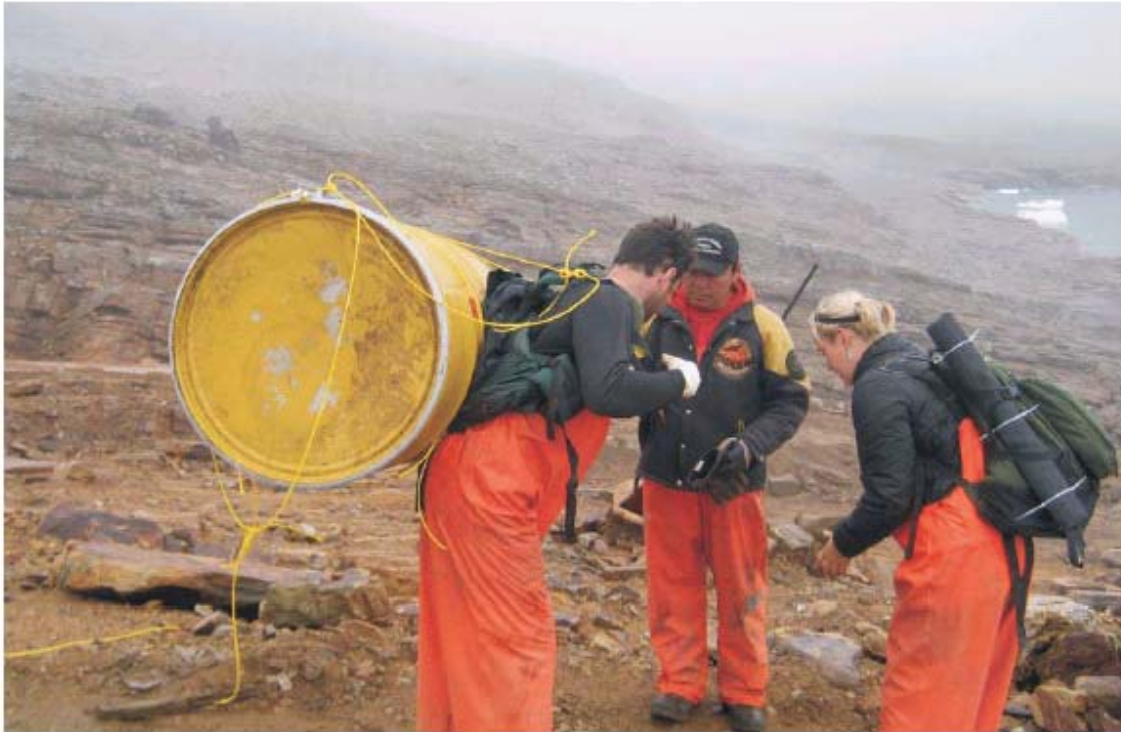
Photograph 5: Transporting Supplies to the S1/S4 Beach Barrier

The area was reached by walking from the beach landing area adjacent to building B2 (Photograph 5). The S1/S4 beach barrier was found to be in good condition upon arrival (Photograph 6). Six sediment samples were taken from in and adjacent to the barrier. Five overpack drums labeled Beach 1 to 5 were completely filled with sediment shoveled out of the funnel area. The filter cassettes were then sampled and their contents placed in an overpack drum labeled Beach 6. The filters were then recharged and replaced within the filter box. These comprised one gravel and two GAC filters, for a total of 3 gravel and 6 GAC filters as shown in Figure 10. In the last filter slot in each box, four layers of a non-woven geotextile (1200R) were placed one after the other with about a 2 cm gap between each. The height of each decreased approximately 2 cm from front to back so that if the first were to clog it would not prevent the next from functioning properly. The top black wooden plate was replaced securely on top of the filters.

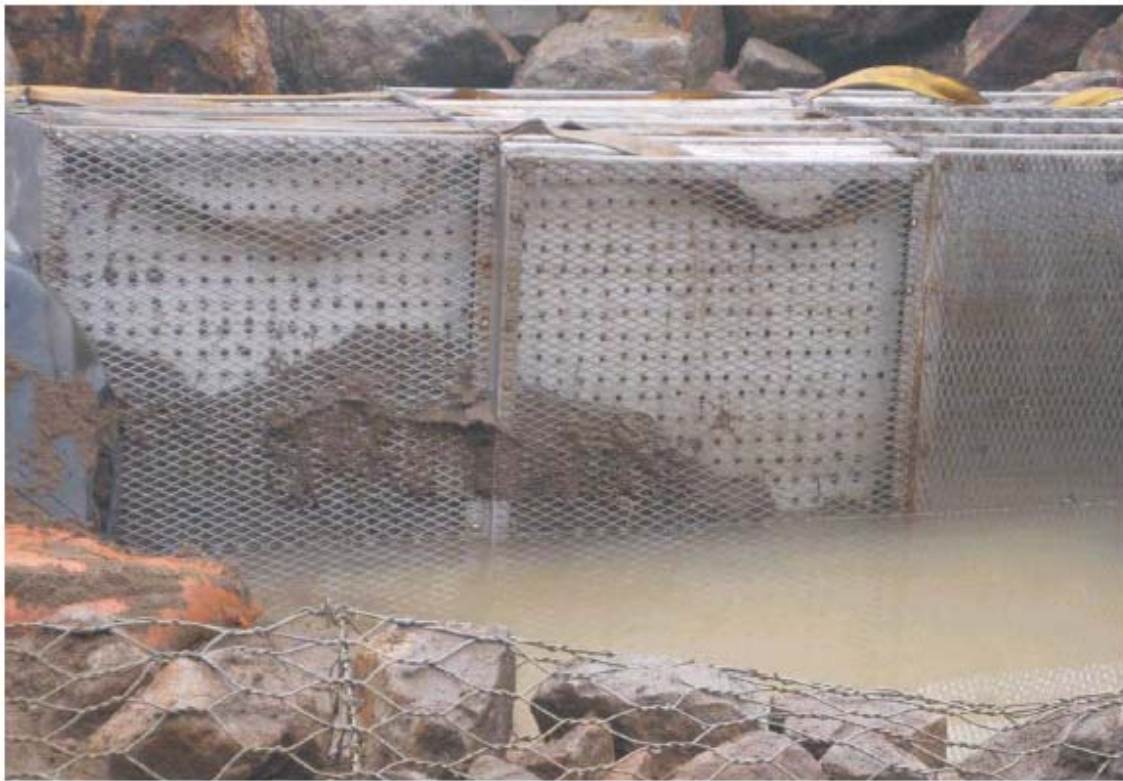
Photograph 6: The Three Cassettes of the S1/S4 Beach Barrier Before Their Removal

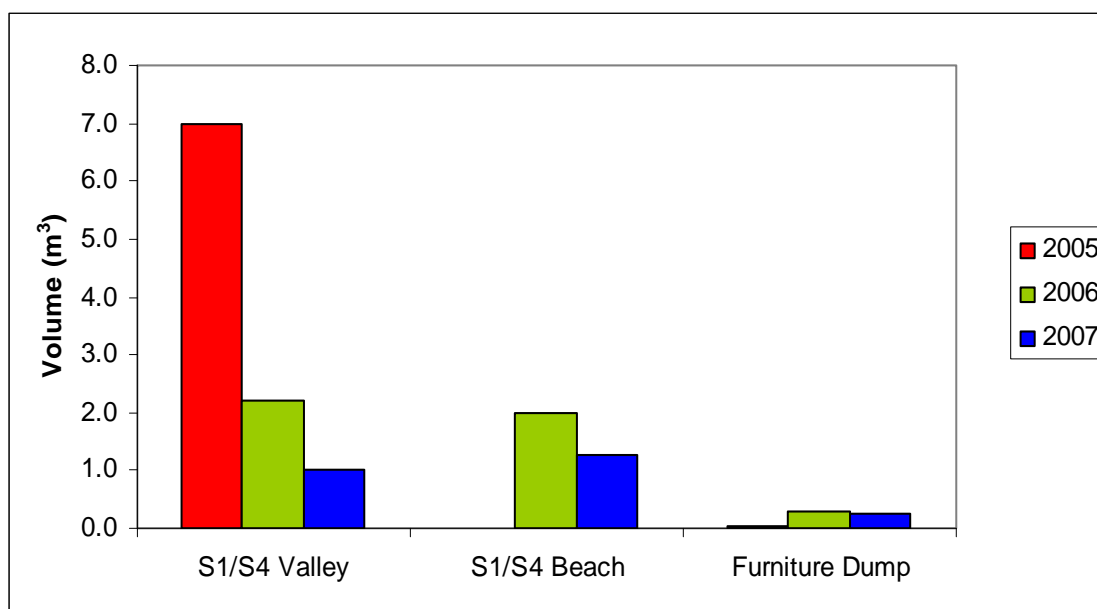
Figure 16: Change in Volume of Sediment Collected at the Three Barriers With Time

Similar quantities of sediment were collected in the two barriers in the S1/S4 drainage pathway in 2006 and 2007 but the PCB concentration in the valley sediment was higher in both years than the beach sediment. This year the volume of sediment and mass

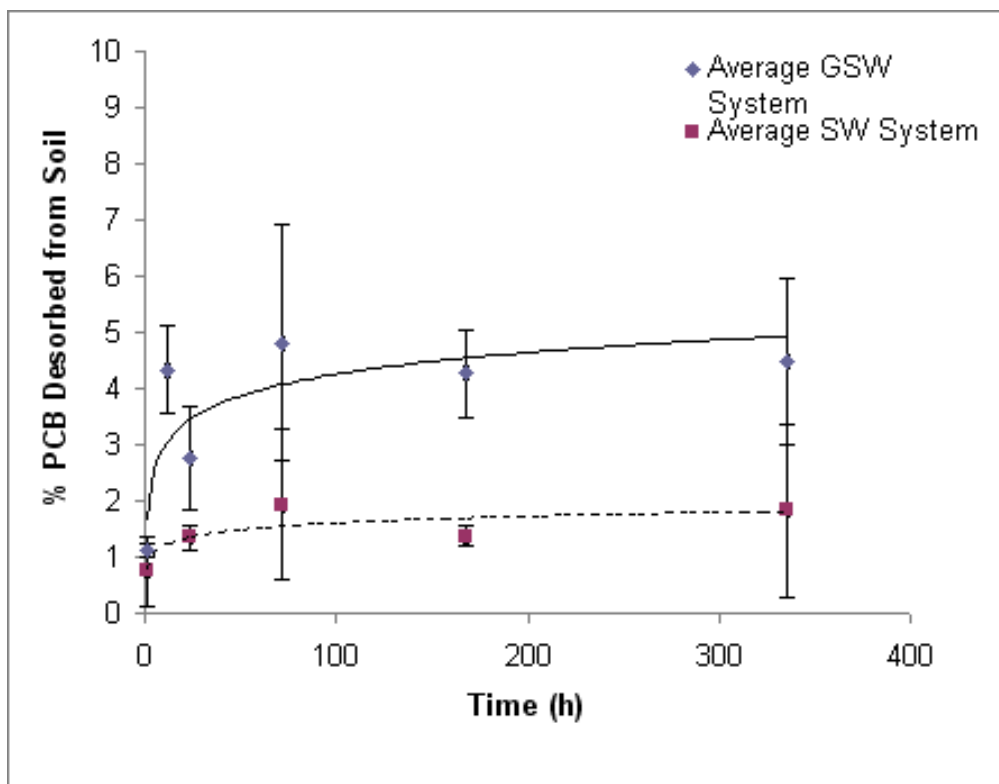
Figure 17: % Desorption of PCBs from Soil Over Time

It can also be concluded from the overall amount of PCB that is desorbed from the soil (only 4% of total PCB has desorbed by one week), that the first desorption reaction ($\text{PCB}_{(\text{soil})} \rightarrow \text{PCB}_{(\text{water})}$) is the rate-limiting step. Previous laboratory studies have shown that GAC has the potential to adsorb within an hour, $92 \pm 6\%$ of PCBs (initial concentrations ranging from 25 to 1000 ppb in water) within an aqueous system (ASU, 2004). This data also agrees with previous soil/water desorption/partitioning studies with PCBs in sediments that show slow and very slow desorption (ASU, 2006). This very slow desorption begins around 72 hours and can be seen by the shape of the curves in Figure 17

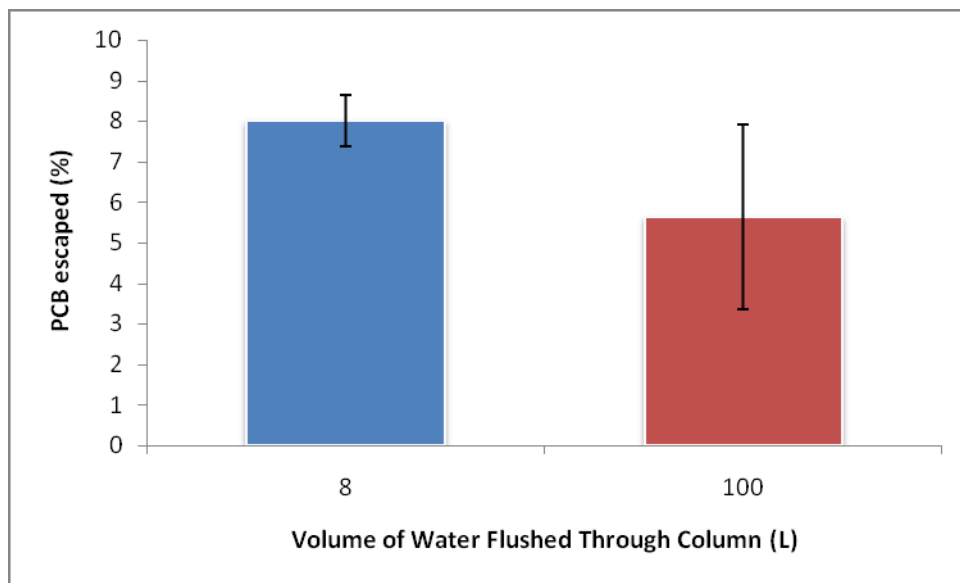
Figure 19. Loss of PCBs From the Column System: Long-Term versus Short-Term

Over time, granular filter materials can be washed out (Locke et al., 2001). In the field, one of the key questions was whether PCBs may be rinsed off/out of the filter materials. A longer-term column study conducted that flushed 100 L over 25 minutes and showed that further PCBs were not lost by increasing the volume of water flushing through the system. Results are shown below in Figure 19.

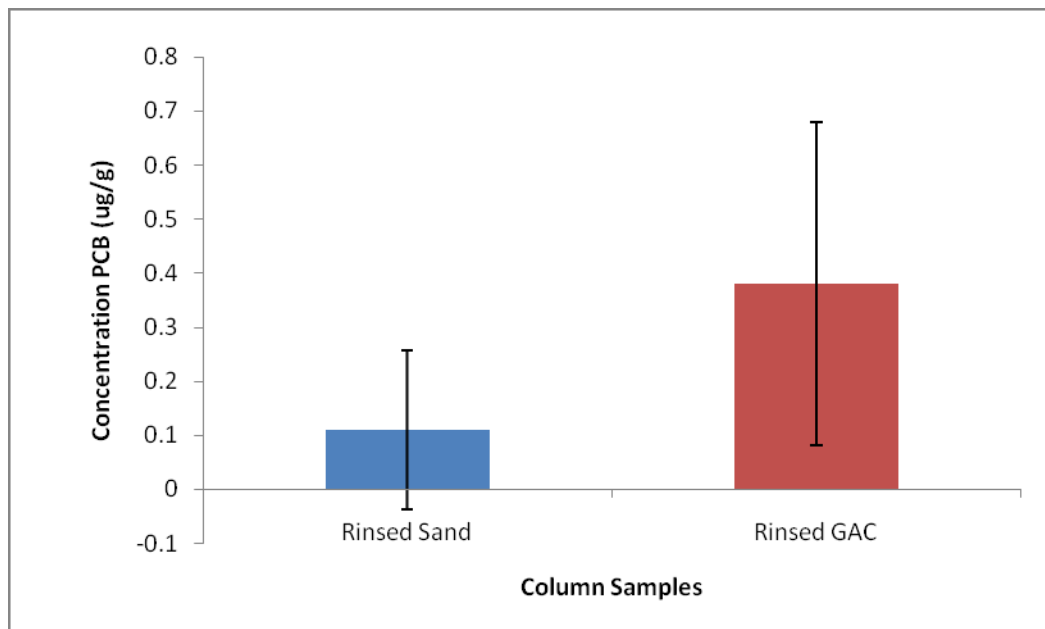
Figure 20: PCB Results of Rinsed Materials in Column Testing

Results of this wet-sieved GAC were compared to wet-sieved sand and are shown below in Figure 20. Non-sieved GAC column runs were also completed for comparison, to evaluate the extent of PCBs trapped through particle retention versus adsorption. Wet-sieved GAC retained 0.37 ± 0.29 % whereas non wet-sieved GAC retained $18 \pm 8.2\%$. This clearly indicated that although some adsorption was occurring, particle retention was the most important factor in terms of capturing PCBs. There was no statistical difference between the sand and GAC materials for adsorption. These tests demonstrate that sand could be used instead of GAC for a filter material in the barrier system. However, these results are different than those from the partitioning experiment in section 2 using sand. In the partitioning study the sand/soil/water system showed no adsorption of PCBs to sand whereas the GAC did show adsorption of PCBs. In this case the batch test studies are more consistent with the field samples described in the next section.

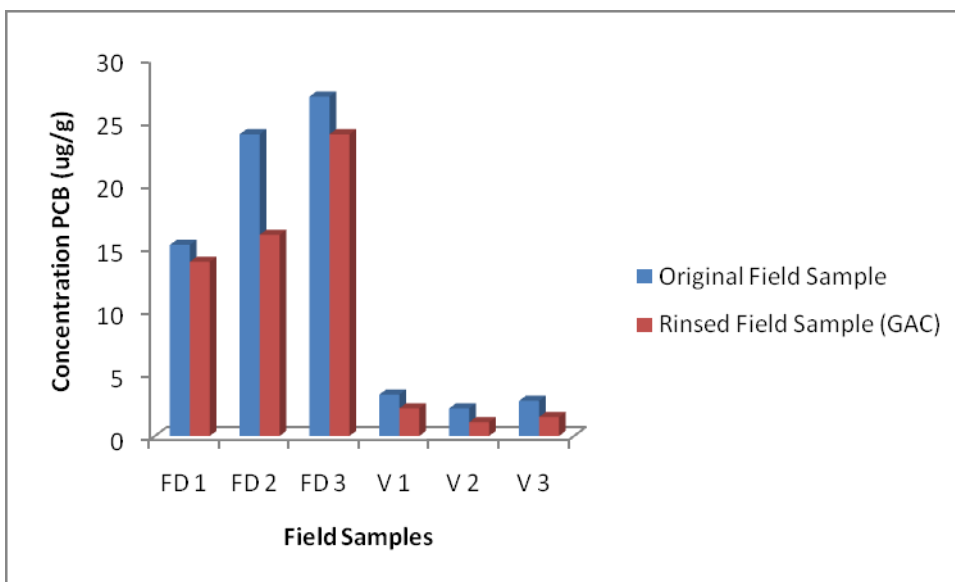
Figure 21: PCB Concentrations of Rinsed Field Samples.

These samples were rinsed with distilled water to remove all soil particles from the GAC and left to dry prior to soxhlet extraction and GC/ECD analysis. Results of initial and final partitioned concentrations are shown below in Figure 21:

These results show that there seems to be a significant difference in how the GAC is behaving in the field versus what is being seen in the laboratory column tests. Rinsed field samples showed that adsorption plays a much larger role than previously thought. GAC field samples showed an adsorption of $35 \pm 2\%$ (valley) and $62 \pm 11\%$ (furniture dump) of the total amount of PCBs, whereas experimental column data in the laboratory shows an adsorption of $0.4 \pm 0.3\%$. There is also a noted difference between how the different areas are behaving; adsorption clearly plays a much more integral role in the furniture dump barrier.
