# **Resolute Bay, Nunavut Land Farm Operation and Maintenance Plan**

**Prepared by  
Transport Canada**

**January 2012**

**FINAL REPORT**  
**Resolute Bay FTA Remedial Work**  
**Resolute Bay, Nunavut, Canada**

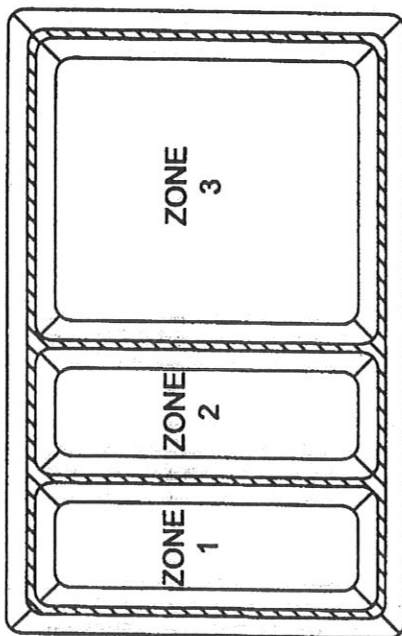
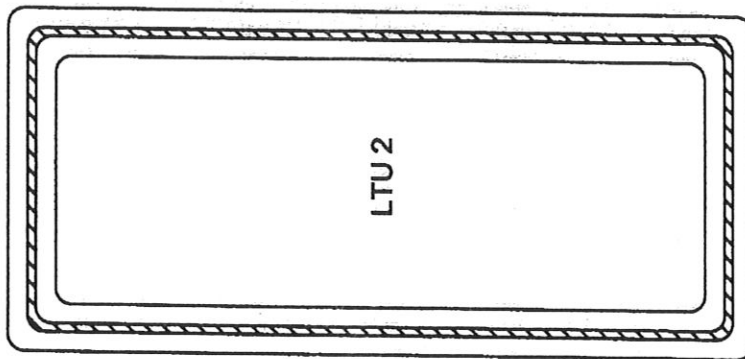
| DWG DESCRIPTION: LTU LOCATIONS | | | |

LTU 1

LTU 2

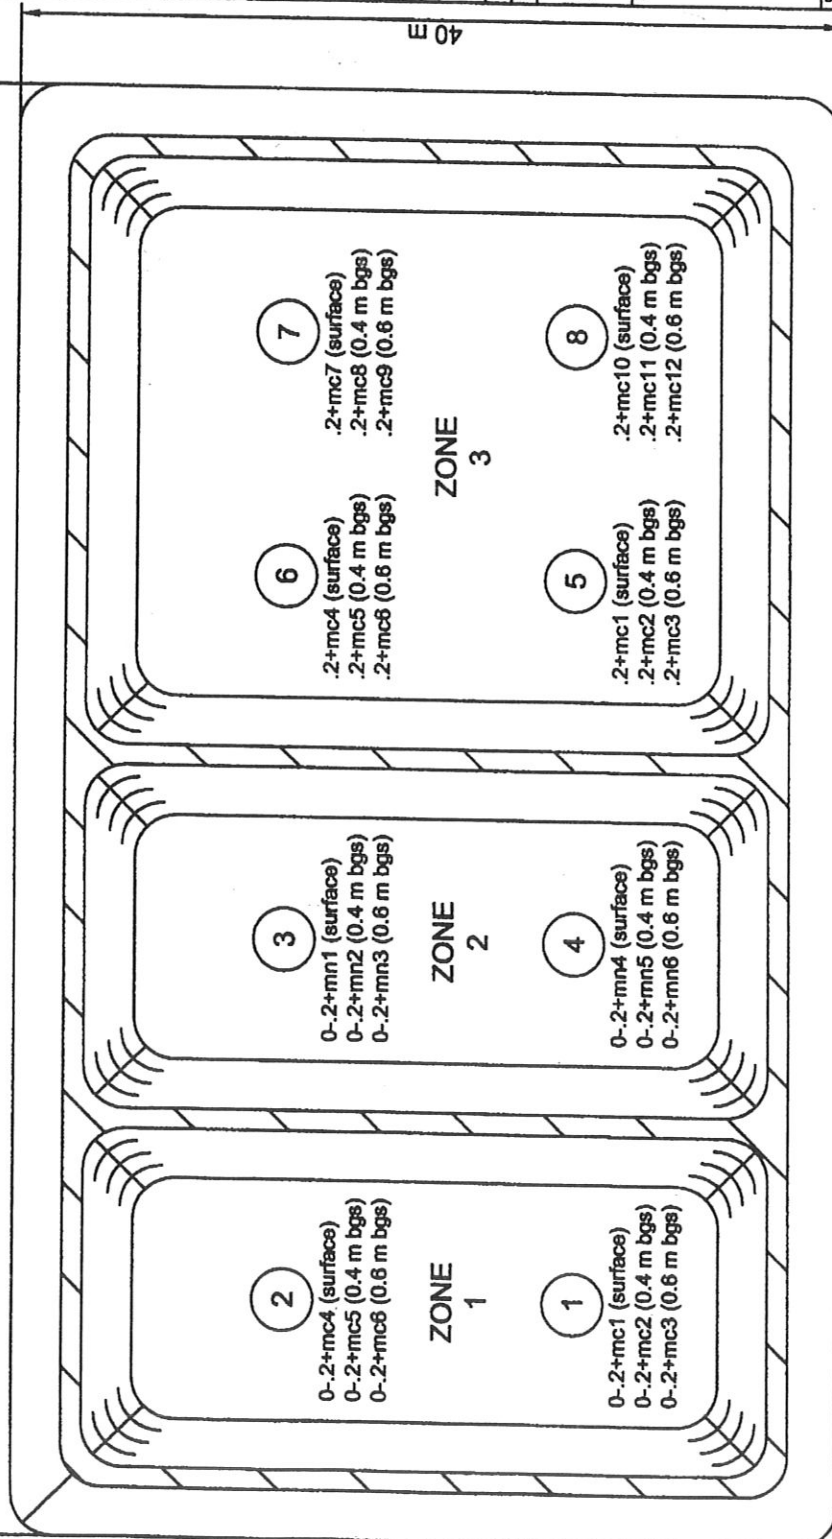
| DWG DESCRIPTION: | LTU 1 SAMPLING LOCATIONS |

1 Sample Location

0-2+mc1 (surface) = Sample identification (depth of sample)
