2017 ENVIRONMENTAL MONITORING PROGRAM

Resolute Bay Airport Land Treatment Units

November 21, 2017

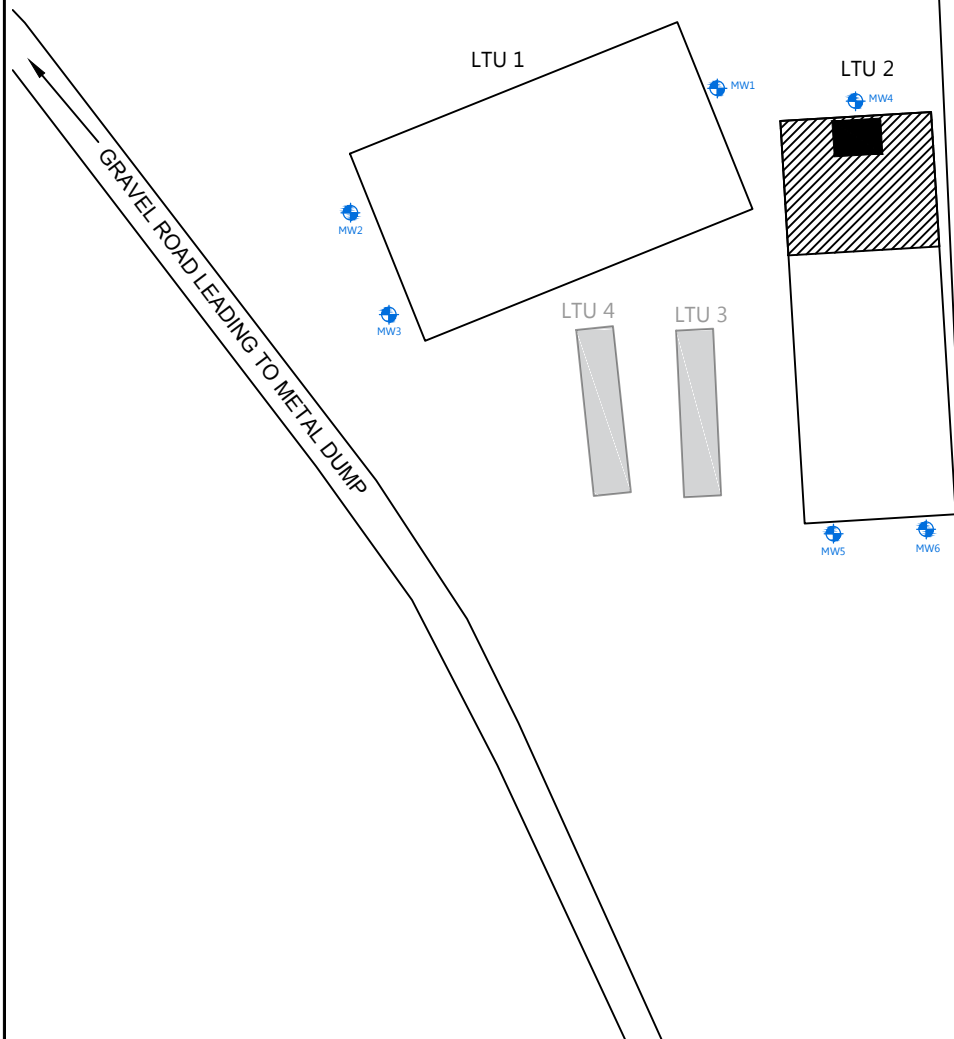
Figure 2

All six groundwater monitoring wells were inspected prior to conducting the groundwater monitoring and sampling program and their condition recorded. The locations of all six groundwater monitoring wells are shown on **Figure 2**.

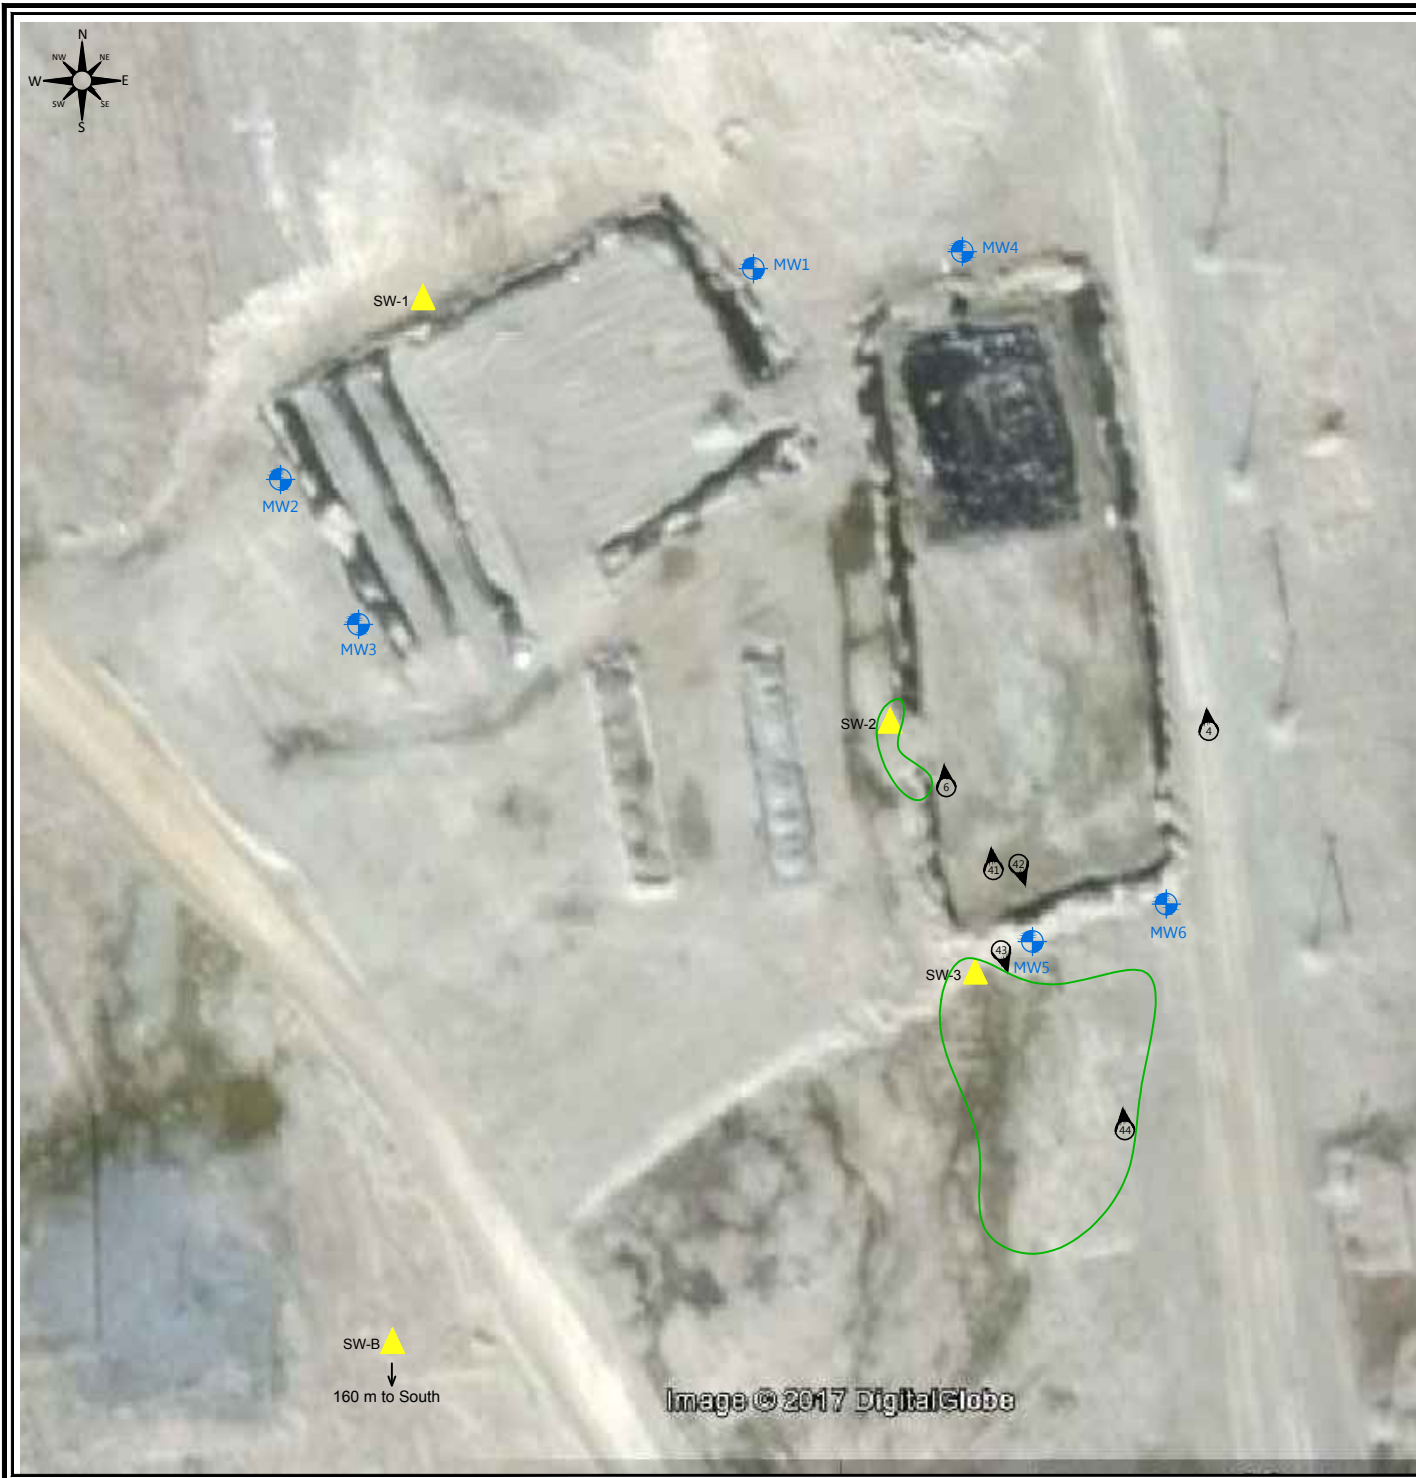
Title: Groundwater Exceedances	
ARCADIS	Project: Resolute Bay Airport Land Treatment Units Resolute Bay, Nunavut
Date: November 2017	Client: PWGSC/TC
Figure 6

As stated above, only one monitoring well contained groundwater during the 2017 field program. One objective of this Environmental Monitoring Program was to fulfill the requirements of the NWB License and, in their current condition, monitoring wells MW-2, MW-2, MW-4, MW-5 and MW-6 did not allow the collection of groundwater to satisfy this objective. Therefore, while on-site, after discussion with PSPC/TC, the only other similar media that could be collected to partly fulfill the NWB License requirements was the ponded water observed in areas around the LTUs. Consequently, surface water samples were collected from the small ponded area north of LTU 1 (SW-1); west of LTU 2 (SW-2); and south of LTU 2 (SW-3) to attempt to measure the presence of contaminants from the LTUs in the local environment. Background Sample (SW-B) was also collected from a ponded area located approximately 160 metres south of the LTUs. These locations are shown on **Figure 6**.

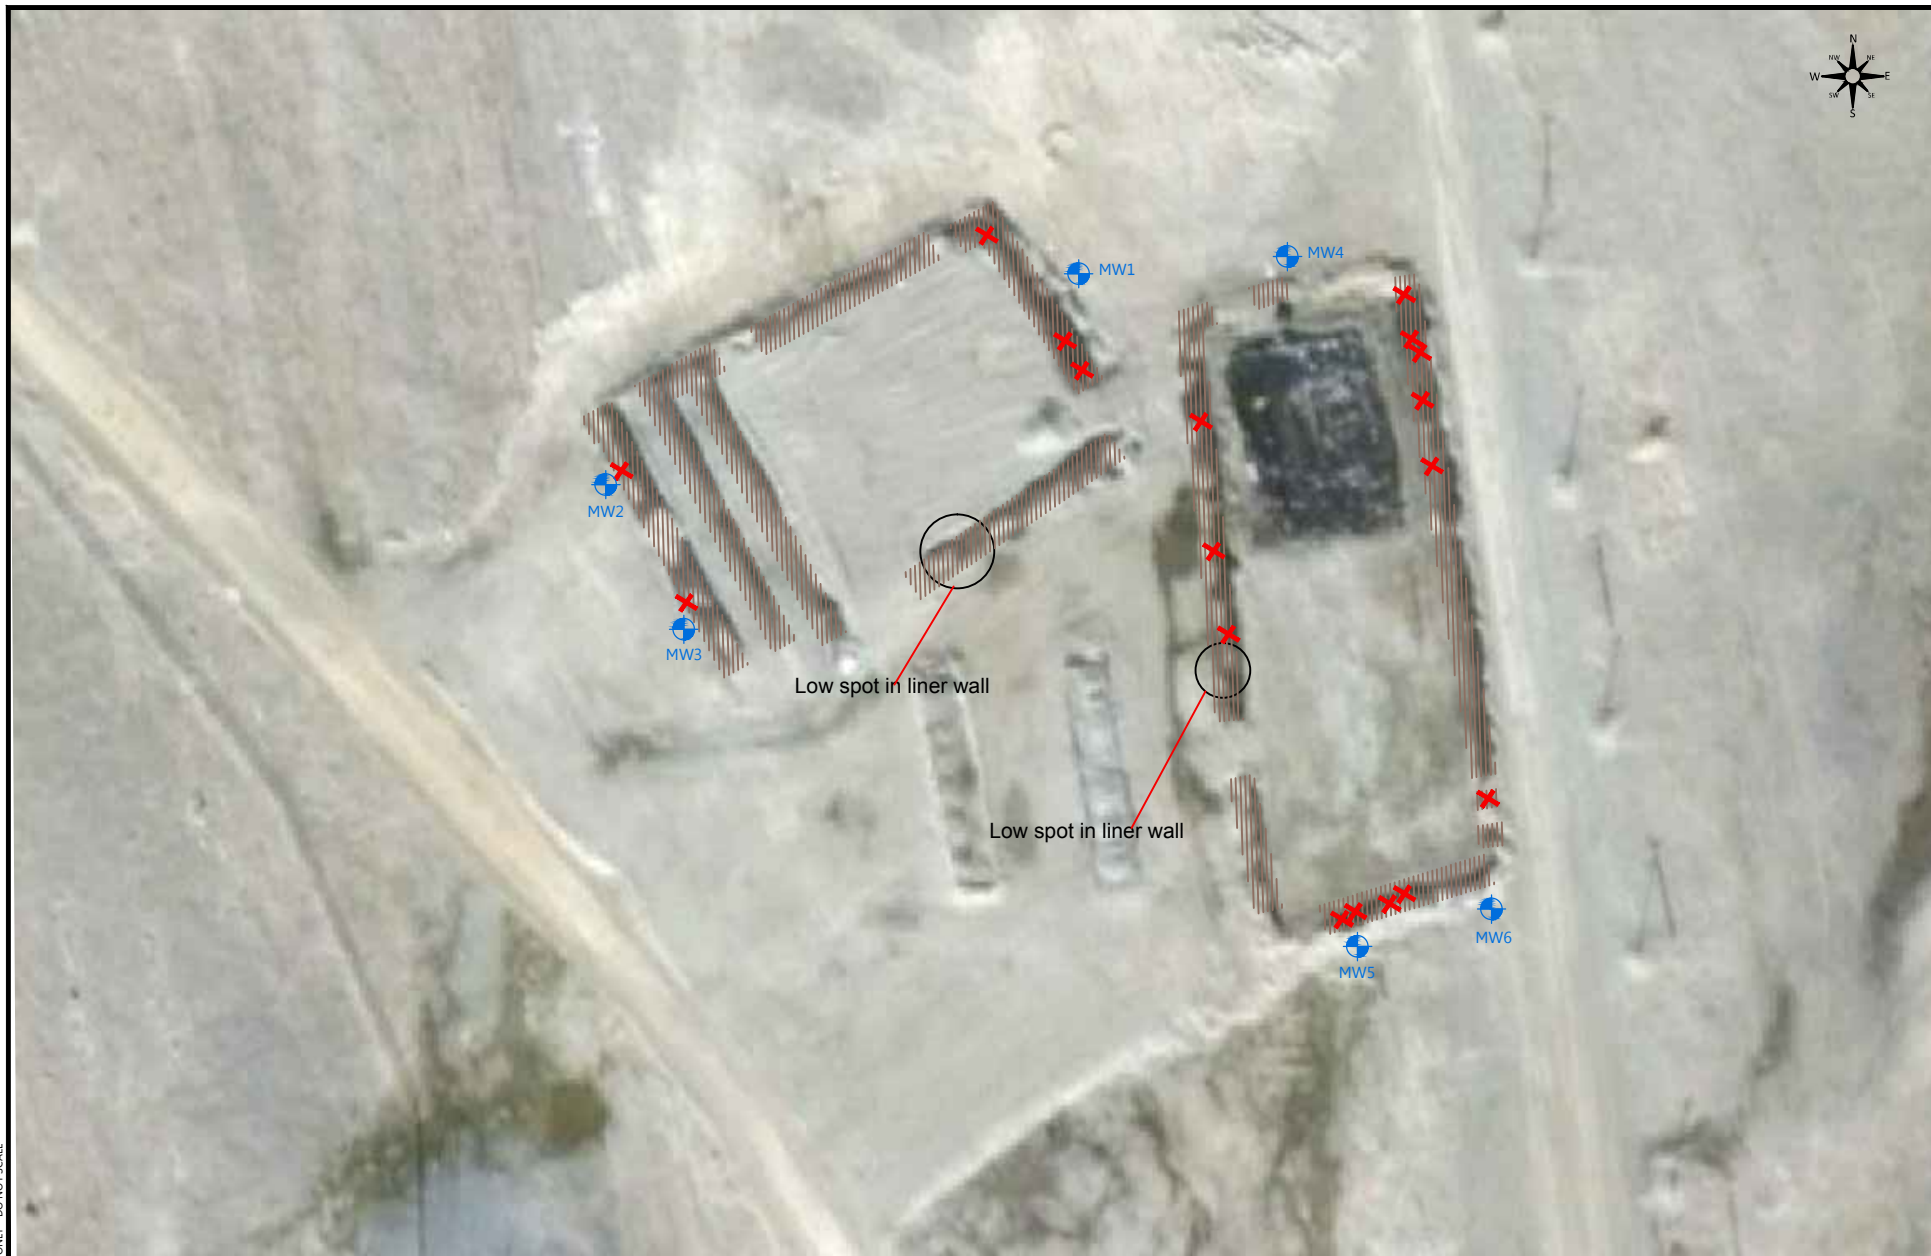
Figure 7

During the site visit, Arcadis observed the condition of the berms constructed around each LTU. The berms varied in width from one to two metres. It was observed that the liner granular cover on LTU 1 was very thin or non-existent along the majority of the berm walls, which resulted in exposure of the liner to atmospheric conditions and sunlight. The exposed areas of the liners are shown on **Figure 7**.

Rips and tears in the liner covering the bermed areas were also observed at numerous locations. In particular, the liner on the southern berm of LTU 2 (downgradient side of the LTU) showed several tears/rips that ranged from 1 to 10 centimetres in length. As well, there is a low spot in the liner wall along the south-western berm of LTU 2, suggesting that the secondary containment for the LTU may have been breached and the runoff water from the impacted soils may be discharging to the environment, potentially resulting in the green vegetation discussed in Section 6.6.

The areas where tears/rips were observed are shown on **Figure 7**.

5. The southwest portion of the berm of LTU 2 should be built up where it has eroded.
6. All tears and rips located in the liners should be repaired and the berms covered by overburden.

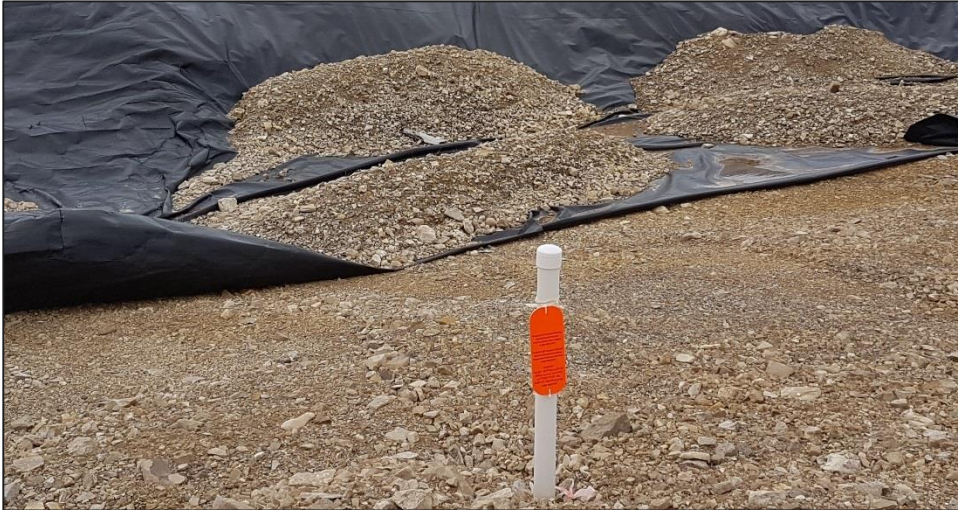
Photo: 7

Description:
MW-1

Location:
Near east side of LTU 1,
looking west

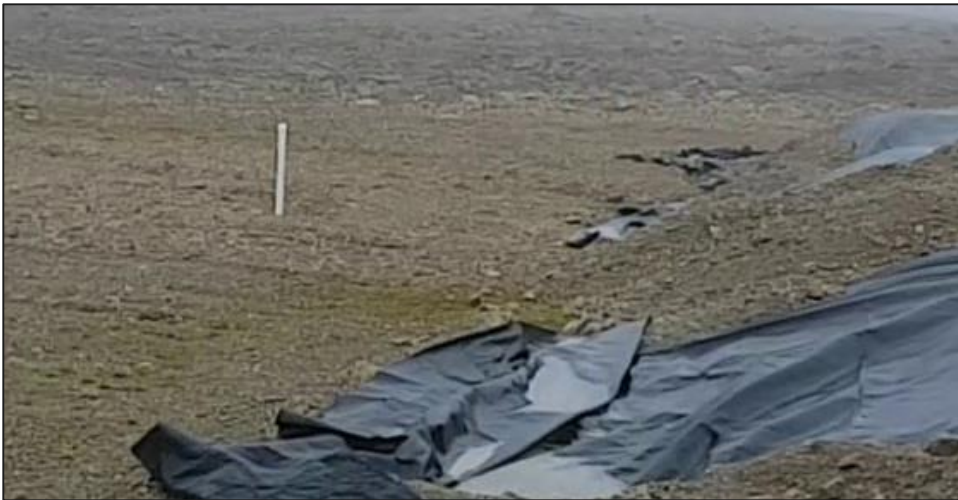
Photo: 8

Frost heaving is suspected of having occurred at the locations of monitoring wells MW-2, MW-3, MW04, MW-5 and MW-6. The casing of monitoring wells MW-3 and MW-6 was observed to be at a steep angle.

Description:
MW-2

Location:
Adjacent west of LTU2,
looking north

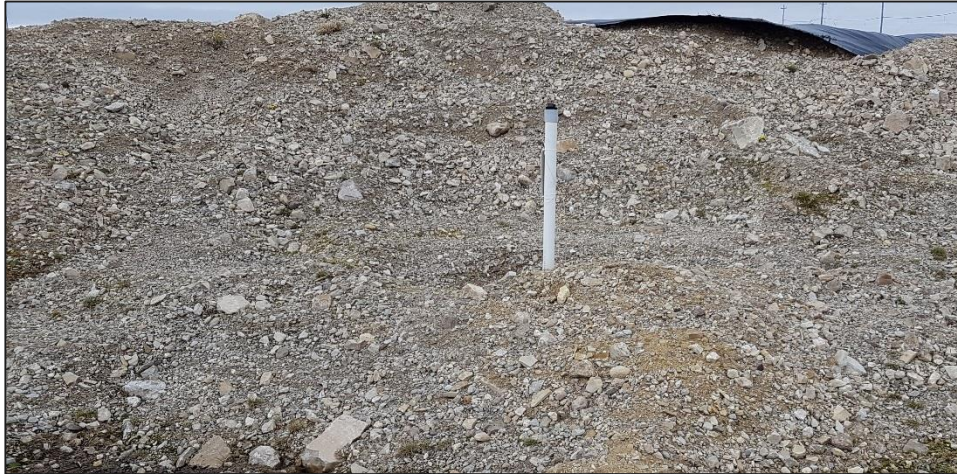
Photo: 13

Description:
MW-5

Location:
South of southwest corner of
LTU 2, view looking north

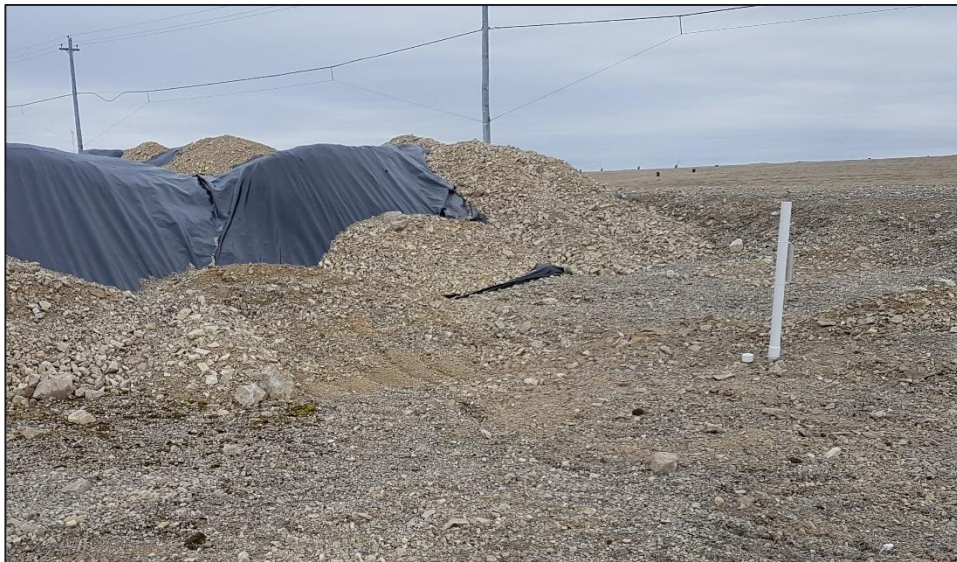
Photo: 14

Description:
MW-6

Location:
South of southeast corner of
LTU 2

3. Monitoring wells MW-4 and MW-6 were observed to be screened above the ground surface. Therefore, any analytical results from groundwater collected from these wells would be considered unreliable due to potential surface water infiltration. It is recommended that these two wells be properly decommissioned.

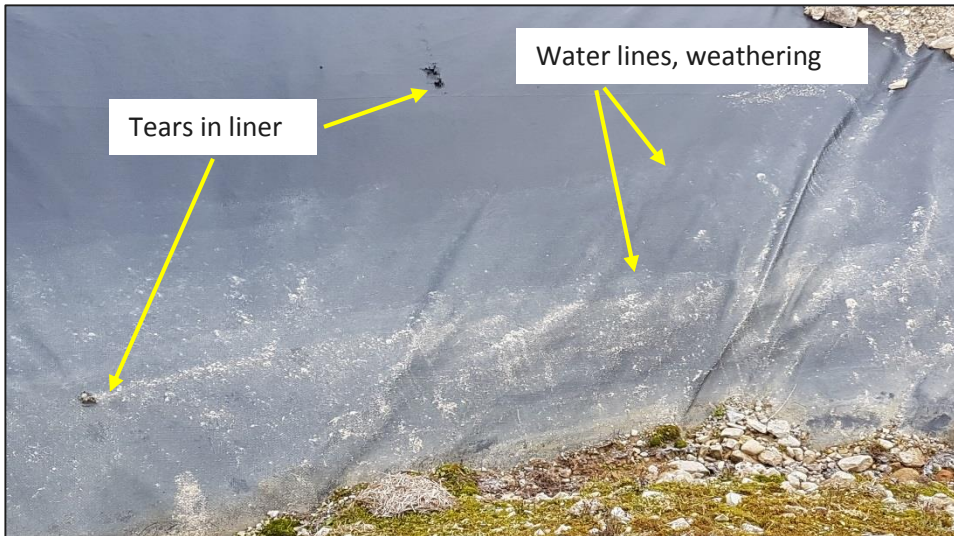
Photo: 16

LTU 2 southwest wall – Inset 1 view looking south

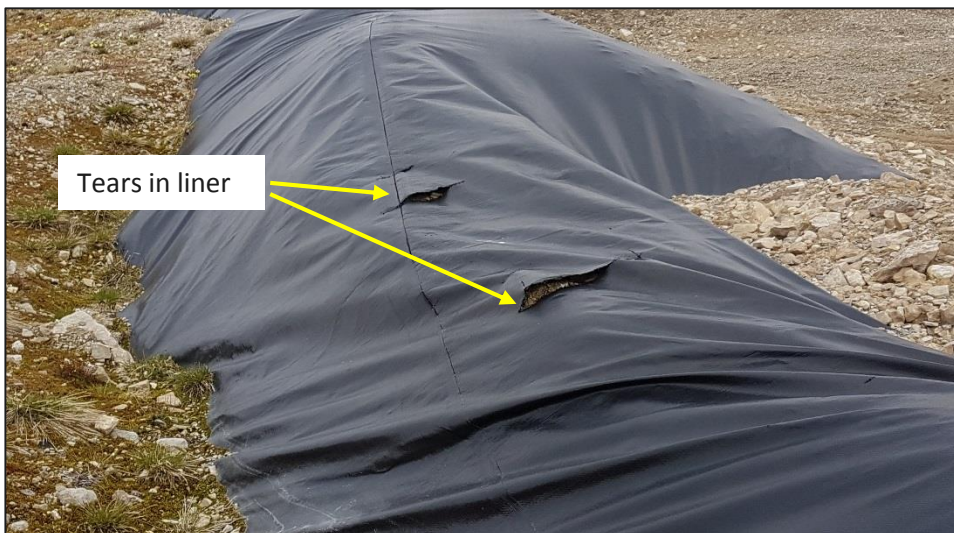
Photo: 17

LTU 2 south wall, center portion - Inset 2, view looking east
