Roberts Bay and Ida Bay Abandoned Mine Sites Geotechnical and Geophysical Assessment Final Report

April 2006

Re: Roberts and Ida Bay Abandoned Mine Sites - Geotechnical and Geophysical

Assessment Final Report

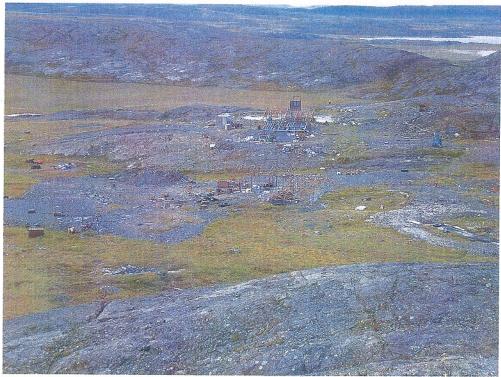
Photo 2: Potential Landfill Location B, Center Left, on Waste Rock Pad

The waste rock pad thickness varies from approximately 0.3 m at the north edge to more than 2 m at the south edge of the designated area. Some debris, barrels, the remains of the garage frame, and miscellaneous equipment would have to be cleared out of the vicinity to allow placement of waste. As Adit No. 1 is immediately north of the area, any closure or remedial plans for the adit would have to be considered in the layout of a landfill cell at this location. The site is centrally located and would require limited hauling of waste materials. In addition, the waste rock foundation is frost stable and would not require clearing of organics.

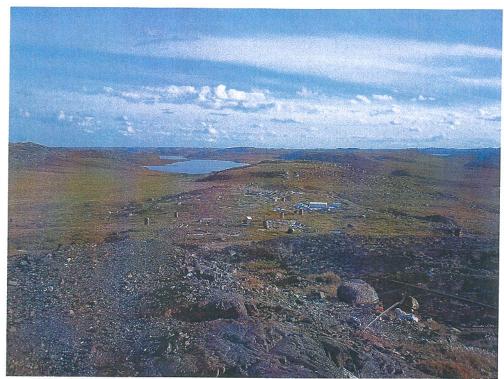
Photo 3: Potential Landfill Location C, Old Campsite in Center of Photo

Potential Landfill Location C is located on a relatively level rock outcrop area where the mine site camp was formerly located. This site is in close proximity to the waste source areas, thereby minimizing haul distances. It is well drained with a stable foundation free of frost susceptible materials. It is also located in close proximity to Borrow Area 3 immediately to the south. The total estimated potential surface area available for the construction of the landfill is approximately at 1,500 m². This area is illustrated in Figures 2 and 5 as well as in Photo 3.

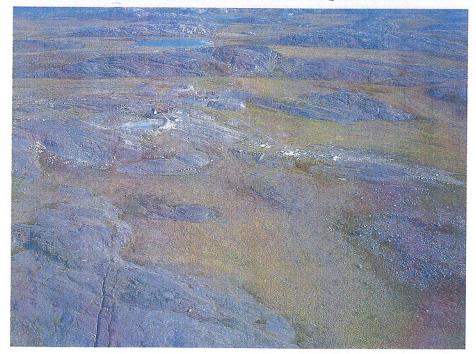
Photo 4: Potential Landfill Location D, looking East

Location D is immediately south of the waste rock pile as illustrated in Figure 5 and Photo 4. The water table was found to be approximately 0.5 m below the surface of this well graded gravelly sand deposit. Bedrock was noted at a depth of 0.75 m. This area is centrally located, implying minimal haul distances. Waste and fill could be placed against the waste rock face to the north and the rock outcrop to the east, thereby reducing the volume of granular material required for containment berms.

Site is south of waste rock pile and east of old campsite. Note tailings pond at center-left and camp dumpsite just below old campsite.

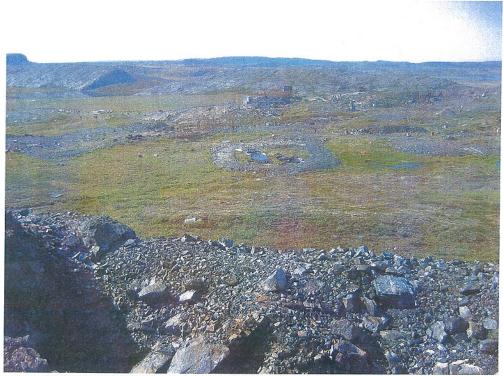
Photo 9: Borrow Area 4, looking West

This area was also identified as a borrow area (Borrow Area 4) and is very close to the source waste areas at the site. The water table is approximately 0.7 m below grade in this area and if the granular material was removed, suitable foundation material would have to be placed.

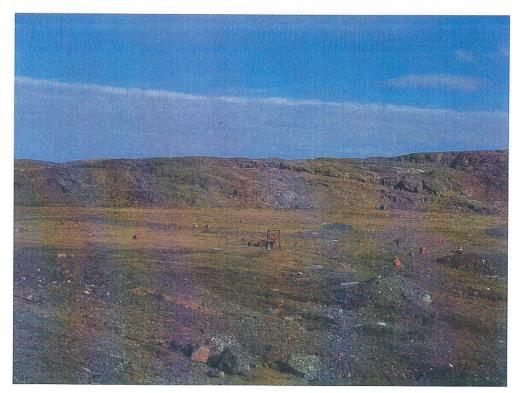
Photo 10: Borrow Area 5, Center, immediately West of hopper, looking East

Borrow Area 5 is located approximately 100 m north of the former mill building. It is a small deposit consisting of silty sand, trace gravel and is approximately 265 m² with an estimated available volume of 215 m³ above the frost line at 0.76 m. Due to the silt content of the material it is frost susceptible and is not free draining, however, it could be used as general fill. This area is illustrated in Figure 6.

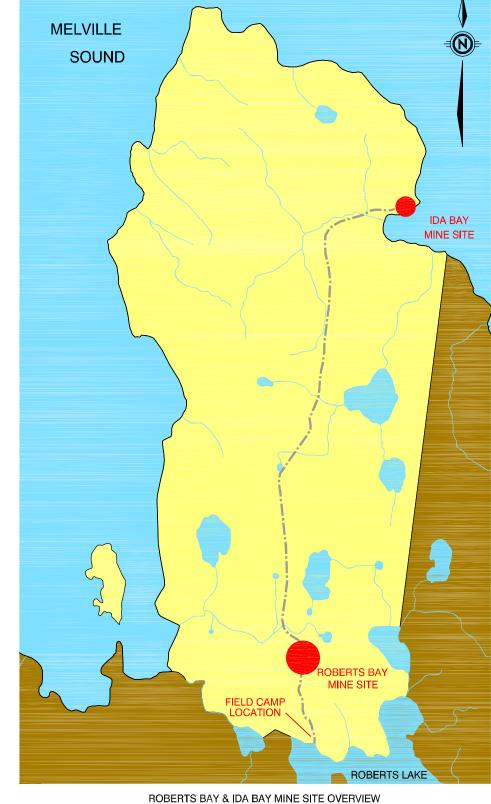
Figure 1
Site Location Plan

ROBERTS BAY & IDA BAY MINE SITE OVERVIEW

The Roberts Bay and Ida Bay Silver Mines are approximately 125 km southwest of Cambridge Bay at 68°10'45" latitude and 106°33'29" longitude. A location map is provided in Figure 1. The geophysical investigation at Roberts Bay was carried out between August 17 and August 18, 2005, by Mr. Brad Anshelm of EBA's Edmonton office. On August 19, Mr. Anshelm assisted the Earth Tech environmental sampling program. It was decided on site by Earth Tech and PWGSC that the geophysical investigation was not needed at the Ida Bay site. The rationale for this was that remediation work was already planned for the waste rock at the Ida Bay site. Therefore, any metallic debris would be identified and removed as part of the process.

A total of six locations were investigated at Roberts Bay Site. The overall plan map showing the relative location of all surveyed sites is shown in Figure 1. Within each area, anomalous lobes are identified where gradiometer readings were significant. The larger lobes are indicative of either larger objects, or several objects situated in the same area. Smaller anomalies are the result of individual, compact ferrous surface debris and are not labeled.

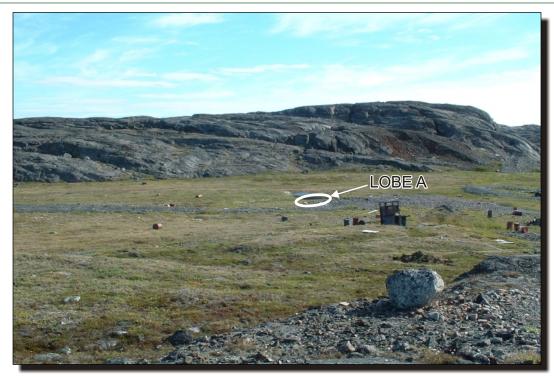
Photo 1
Ida Access Road - West of survey area facing East.

This area is located on the northern section of the mine site and is the start of the trail to the Ida Bay Mine site (Photo 1). The area has the highest surface elevation of all six survey areas. In Figures 3 (a,b,c), Lobe A is located at the storage pad on the southern portion of the surveyed area. Lobe A consists of a large iron beam and two fuel drums.

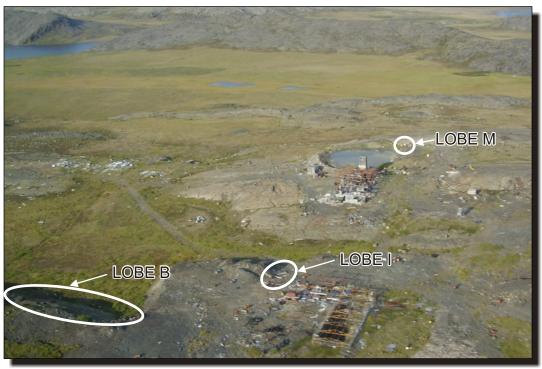
Photo 2

Machine Shop Area - East of survey area, facing West.

The Machine Shop area is located south of the Mine vestibule and Machine Shop (Photos 2 and 3). The surveyed area and geophysical results are presented in Figures 4 (a,b,c). The area is scattered with ferrous surface debris, concentrated near the machine shop on the

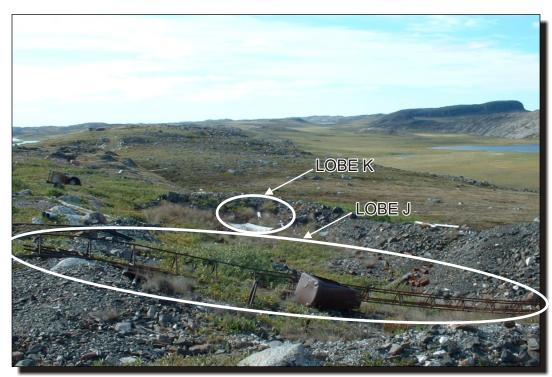
Photo 4
Old Camp Area - North of survey area, facing South.

The Old Camp is located approximately 70 m south of the tailings pond (Photos 4,5,6). This area was used for housing during summer mining operations, and later used as a collection point for refuse. The surface debris covering the Old Camp area consists of metal cans, metal frames and beams, two antenna shafts, furniture, and kitchen appliances. Over ten fuel drums were counted in the area. The geophysical survey results are shown in Figures 6 (a,b,c) and cover an area southwest of the main surface debris area. The survey detected a low vertical gradient which has been attributed to geological features throughout except for areas Lobes J and K.

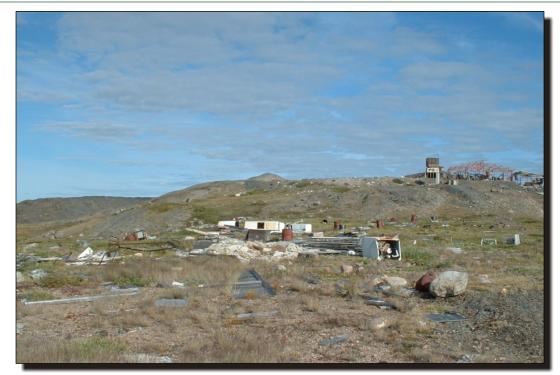
Photo 5
Old Camp Area - Northeast of survey area, facing North.

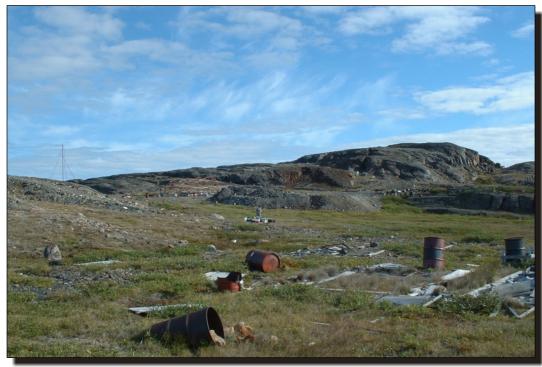
Photo 6
Old Camp Area - East of survey area, facing Northeast.

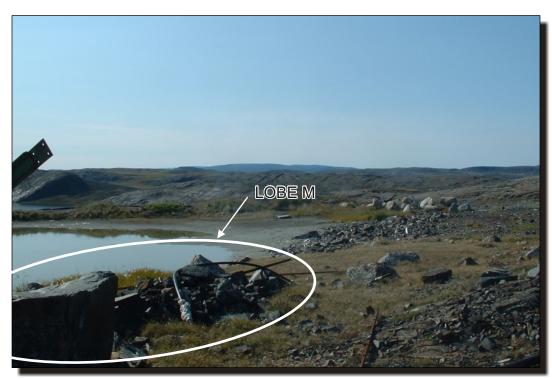
Photo 8
Mill Area - South edge of survey area, facing southeast corner.

The Mill Area surveyed is located west of the Mill building, and north of the Tailings Pond (Photos 7, 8). The geophysical results are presented in Figures 8 (a,b,c). A vertical gradient of between 70-130 nT/m is found throughout the area and is attributed to be the result of magnetic rock. A pile of large ferrous surface debris at the southeast corner is indicated as Lobe M.

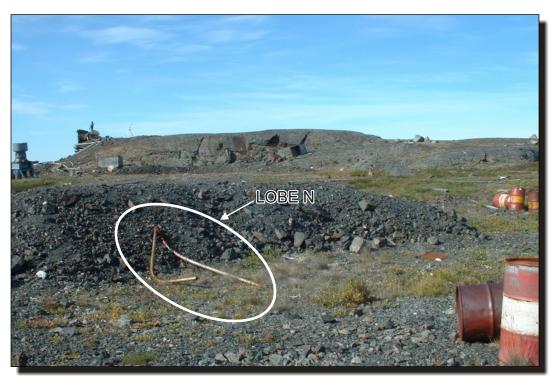
Photo 10
Waste Rock Pile 1 - East of rock pile, facing West.

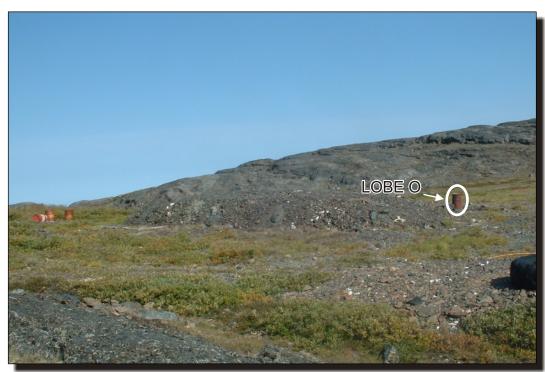
Photo 11
Waste Rock - West of rock pile, facing East.
