**PHASE I/II ENVIRONMENTAL SITE ASSESSMENT
ROBERTS BAY SILVER MINE
AND
IDA BAY SILVER DEPOSIT
NUNAVUT**

**Indian and Northern Affairs Canada
Iqaluit, Nunavut**

**Environmental Services, Western Region
Public Works and Government Services Canada
Edmonton, Alberta**

February 2004

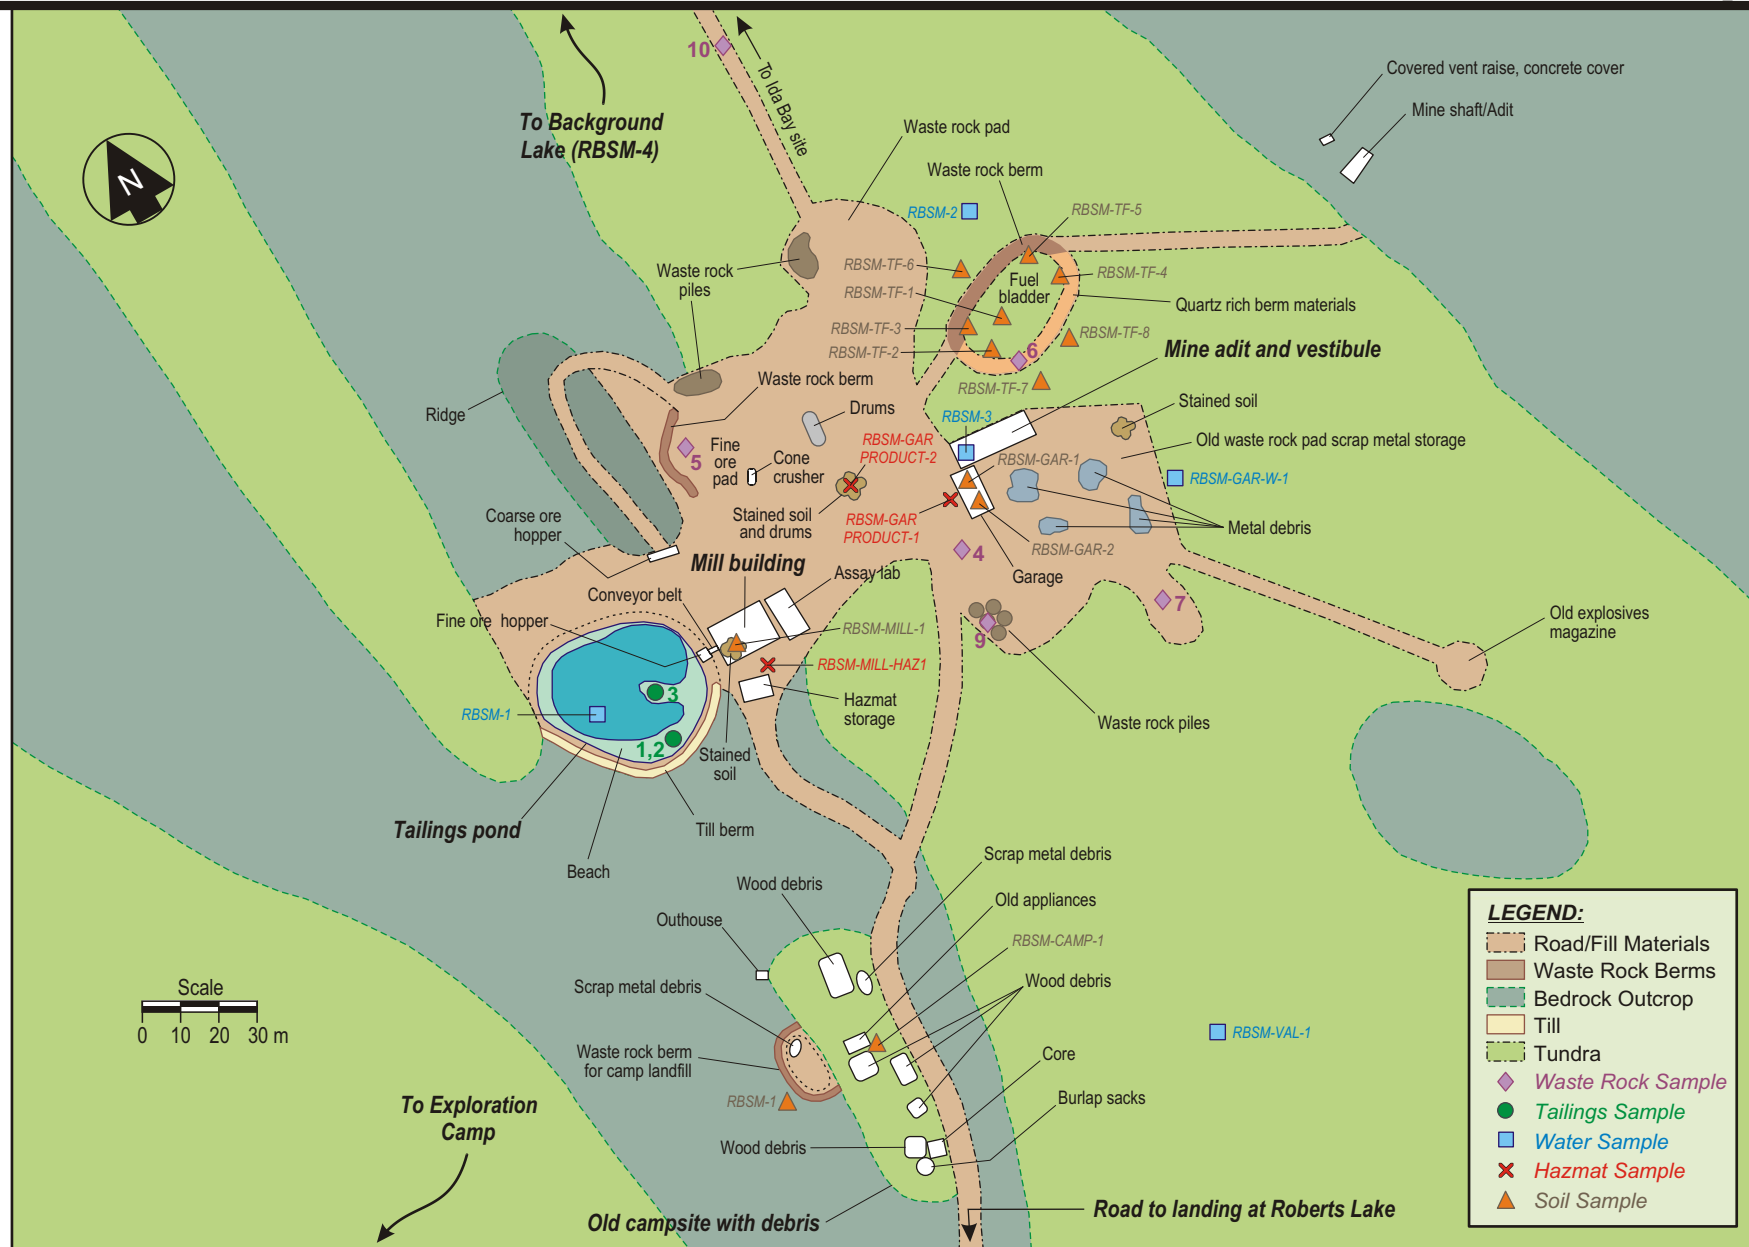
FIGURE 4

Roberts Bay Abandoned Mine Site Sample Locations

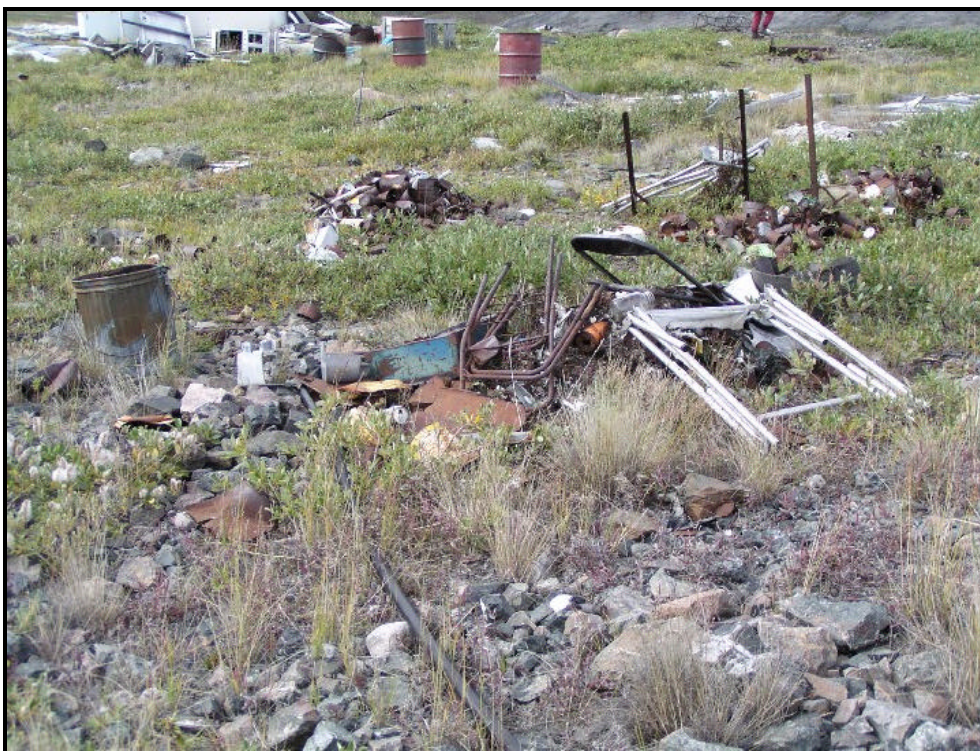
Mine Camp Area. There are no structures remaining at the camp area. However there is a significant volume of non-hazardous debris strewn throughout this area. The debris consisted of wood, metal, burlap bags, and drill core. The only hazardous debris noted at the site were a few batteries. To the west of the camp buildings is a waste rock bermed area, which was the former land fill. Small amounts of metal debris were noted in the landfill. Soil samples were collected from the vicinity of the former kitchen and the landfill. A hydrocarbon sheen was noted in the swamp located in the valley east of the camp and south of the mill and garage. A water sample was collected from this area.

Photo 3. Typical debris at Roberts Bay Mine Camp Area

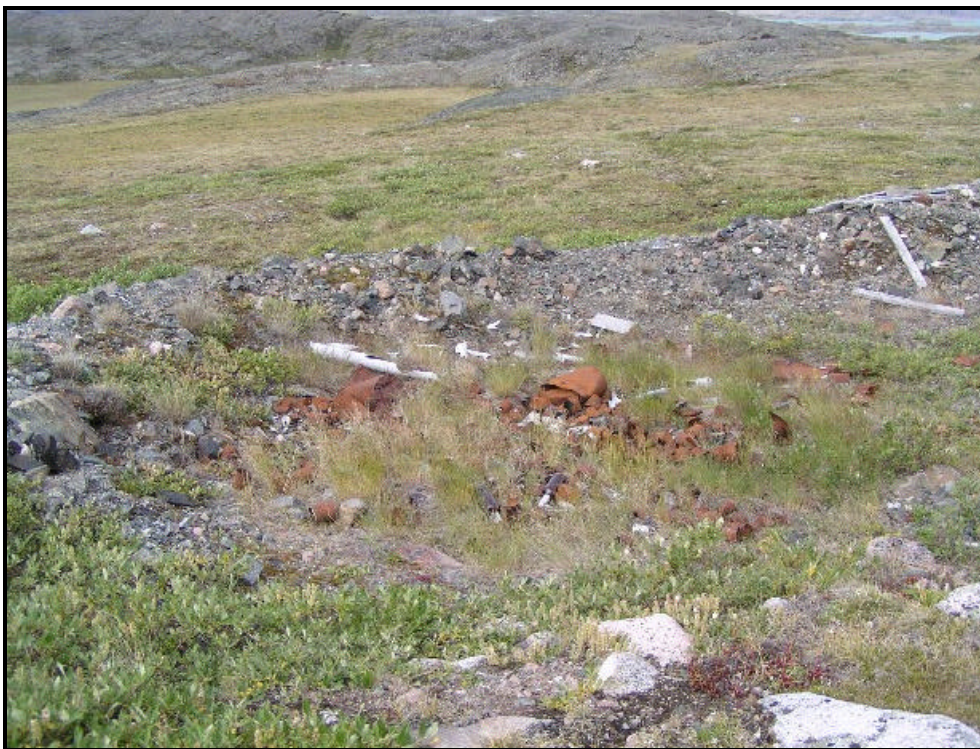
Photo 4. Landfill at Roberts Bay Mine Camp Area

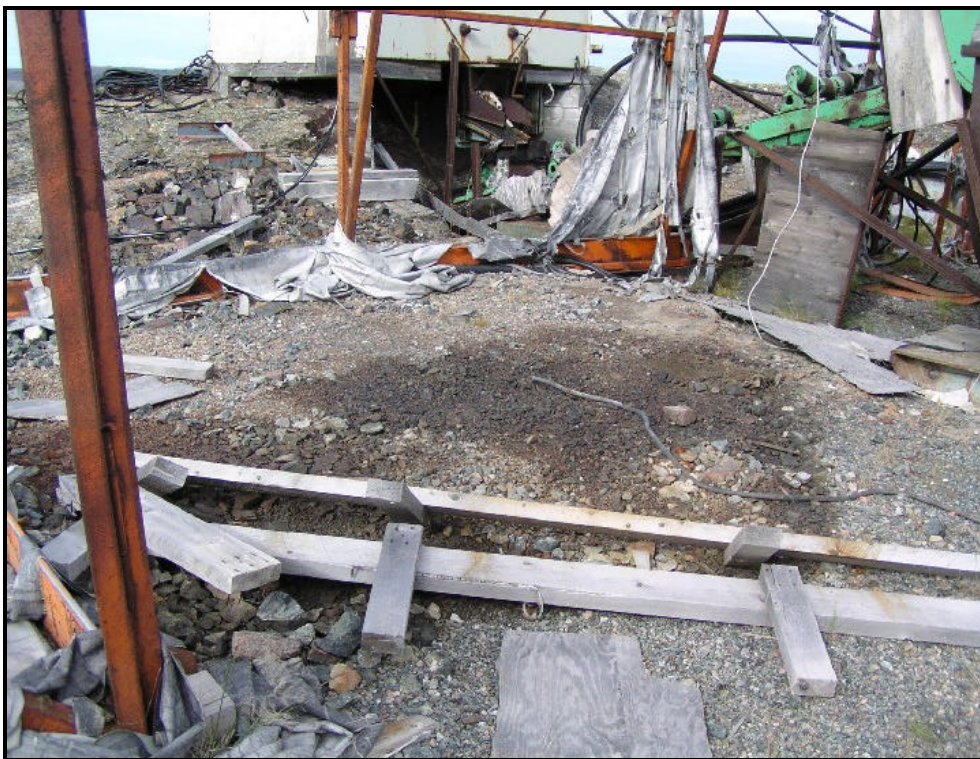
Soil samples were also collected from localized stained areas within the garage and mill. The analyses indicate that the stained soils had F2 and F3 hydrocarbons concentrations,

Photo 7. Localized soil staining in Mill building

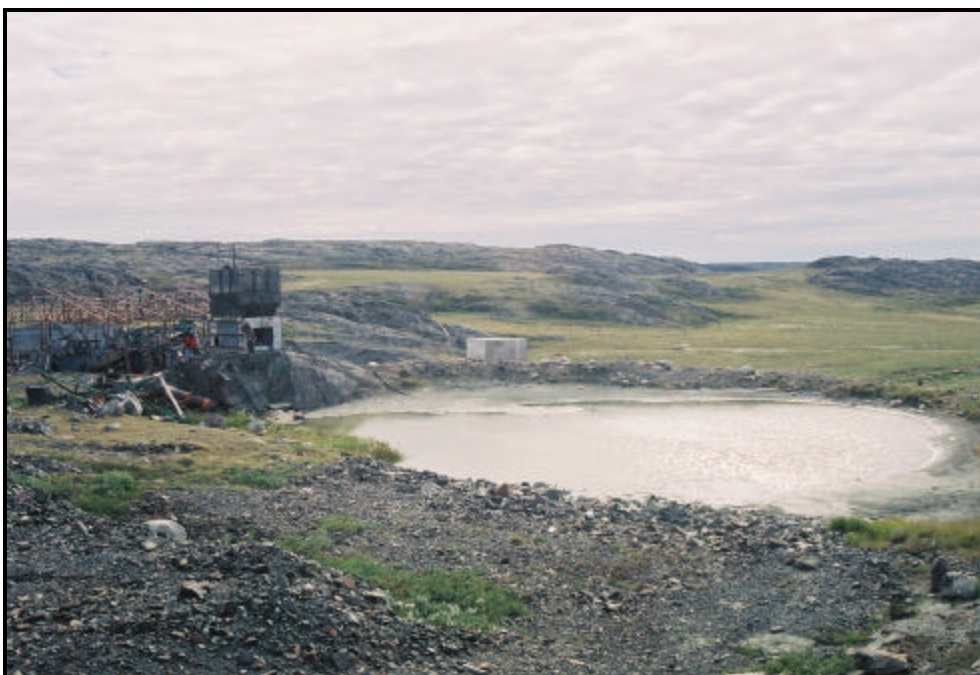
There is one tailings pond located west of the mill building at the Roberts Bay site. The tailings pond is estimated to be 30 m in diameter with approximately 60% of the tailings solids submerged below the surface of the water line at the time of the site inspection. Algae and grasses were observed to be growing at the northeast margin of the tailings.

Judging from the tailings deposition pattern observed within the impoundment, it would appear that the tailings were discharged into the pond at several locations around the perimeter of the impoundment thereby limiting infiltration of tailings porewater into the upstream side of the impoundment berm. The tailings impoundment berm is constructed of glacial till but is not sufficiently armoured with crushed rock to limit long-term erosion. There were no design documents available for the tailings containment berm and it is unclear what level of quality control procedures were implemented during construction.

The tailings themselves are greenish grey in colour and comprised of silt and sand sized particles. The exposed tailings are on a 2 to 5% slope and fairly evenly distributed with no desiccation cracks or erosional features noted. No rusty oxidation staining was observed on the surface of the tailings however, approximately 10 to 15% of the exposed tailings is covered with a brittle white precipitate (possibly gypsum) creating a speckled appearance in these areas.

Photo 8. Fine ore hopper and tailings pond.

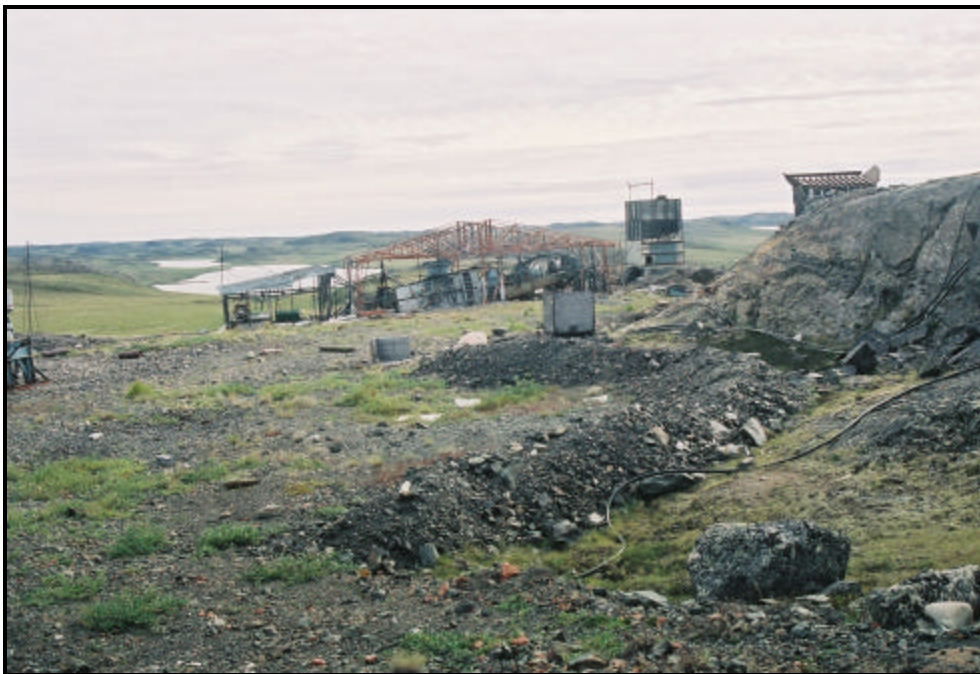
- **Waste Rock Piles and Berms.** The seven waste rock piles identified at the site had uniform side slopes consolidated and stable enough that the piles could be climbed without material being significantly displaced. They did not display evidence of instability. The rock berms at the site were all generally long, low-lying structures. No instability issues associated with the berms were noted.

Photo 10. Waste rock berm at fine ore pad.

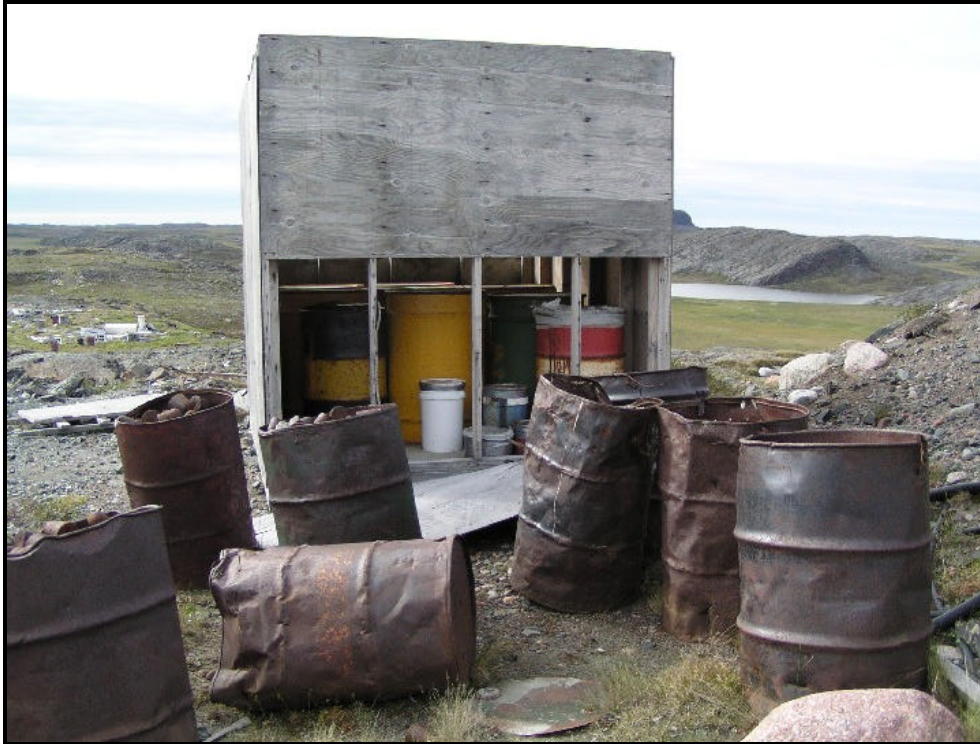
A sample of a clear odourless liquid stored at the hazardous materials storage area, south of the Mill (RBSM-Mill-Haz-1) was characterized as a light hydraulic oil, free of PCBs.

Photo 11. Hazardous material storage area south of Mill

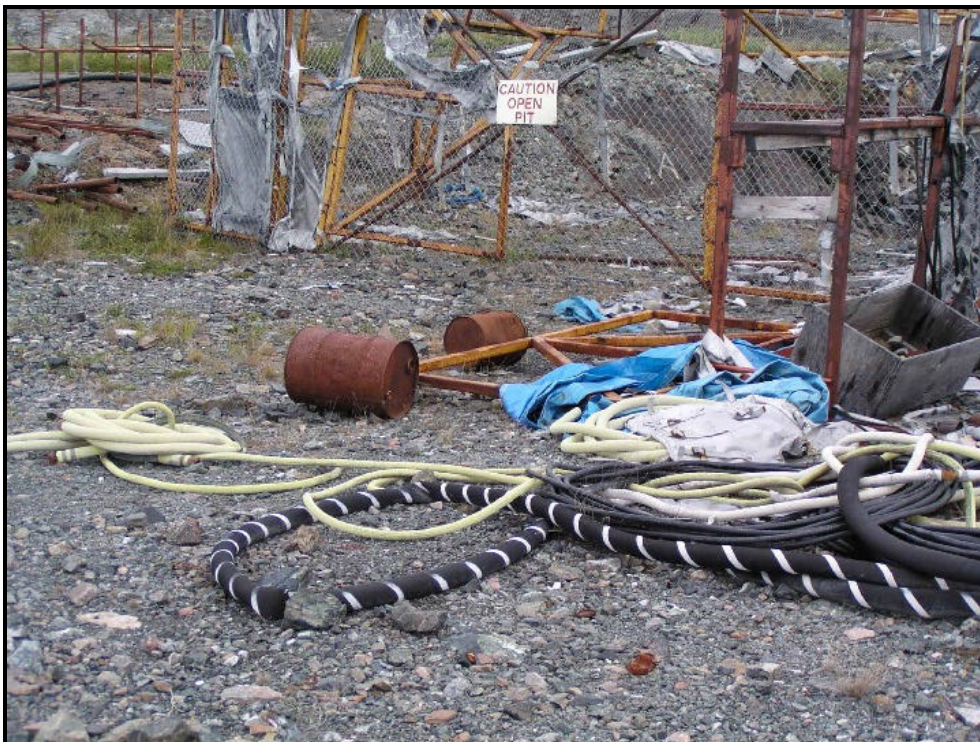
- **Site Debris.** Non-hazardous debris was identified throughout the site. Concentrations of debris were noted in the mine camp area, the mill area and the adit/garage area. This debris is a physical hazard, which could injure humans or wildlife utilizing the site.

Photo 14. Debris west of Garage. Adit in background

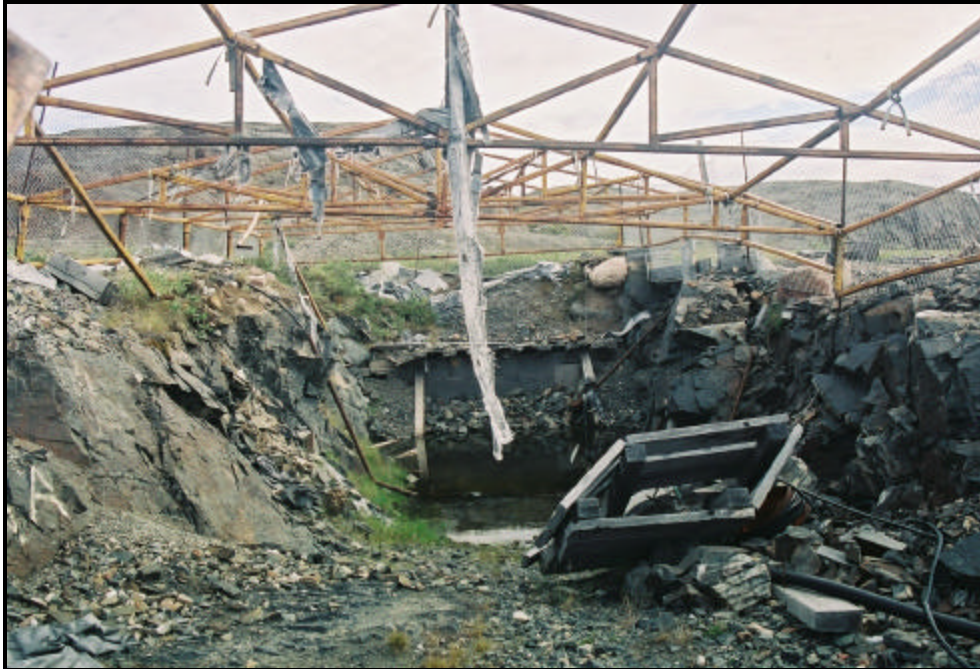
- **Adit.** The main adit has been covered over with a wooden framework and plywood against which a layer of waste rock has been placed. The adit itself is surrounded by a chain-link fence that has been installed over a pre-existing framework. The fence is in relatively good condition preventing accidental access to the portal area. At the time of the site reconnaissance visit, there was a body of standing water observed at the entrance to the adit indicating that the adit itself is fully flooded.

Photo 15. Boarded up adit.

The adit has been boarded over and has a chain link fence around it, however the measures implemented to date are not sufficient for the long-term. The shaft has also been partially closed off but is still fully accessible from the upstream side by persons or wildlife. The shaft itself is structurally unsound as evidenced by the collapse of the collar onto the wooded support beams. There were no concerns noted as a result of inspection

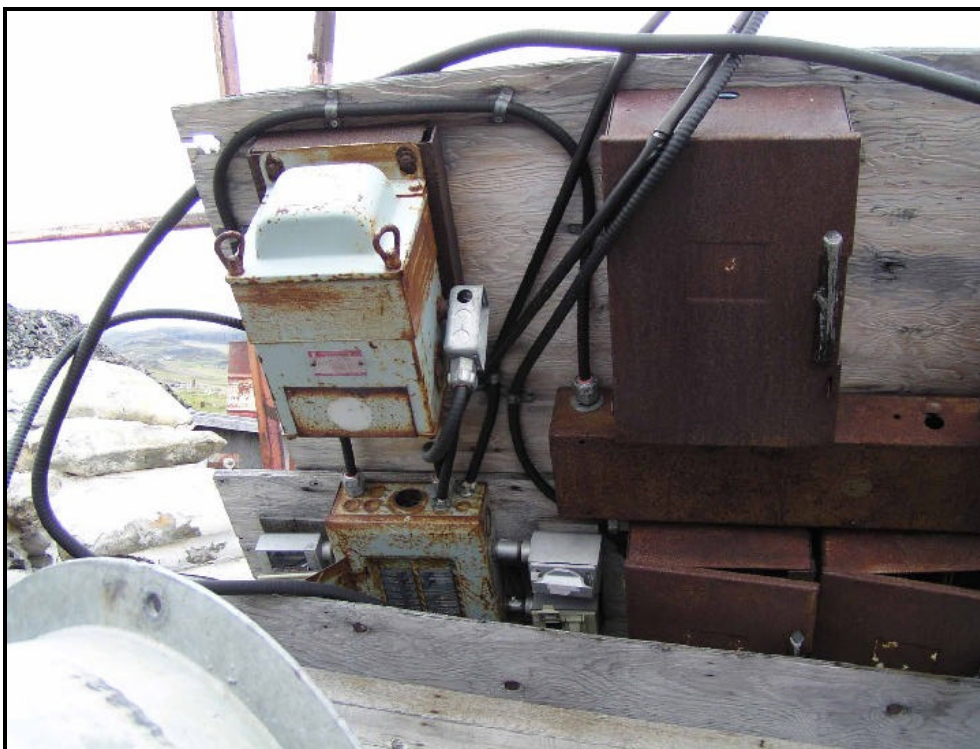
Hazardous materials identified at the Roberts Bay site included hydrocarbon products, batteries and a transformer. Samples of waste oil/grease (RBSM-Gar-Product-1) and the contents of a partially filled barrel (RBSM-Gar-Product-2) were collected from the Garage Area. Analyses confirmed that these materials did not contain PCB. RBSM-Gar-Product-1 was characterized as a heavy oil / grease which did not contain PCBs. RBSM-Gar-Product-2 was characterized as a oily water mixture. Although it was observed during collection to be yellow in colour, it had no detectable hydrocarbons or PCBs.

Hazardous materials identified at the site include propane cylinders, lead acid batteries, unknown chemicals and one possible PCB containing transformer. These materials pose an environmental risk to humans and animals visiting the site.

Photo 17. Transformer in Garage

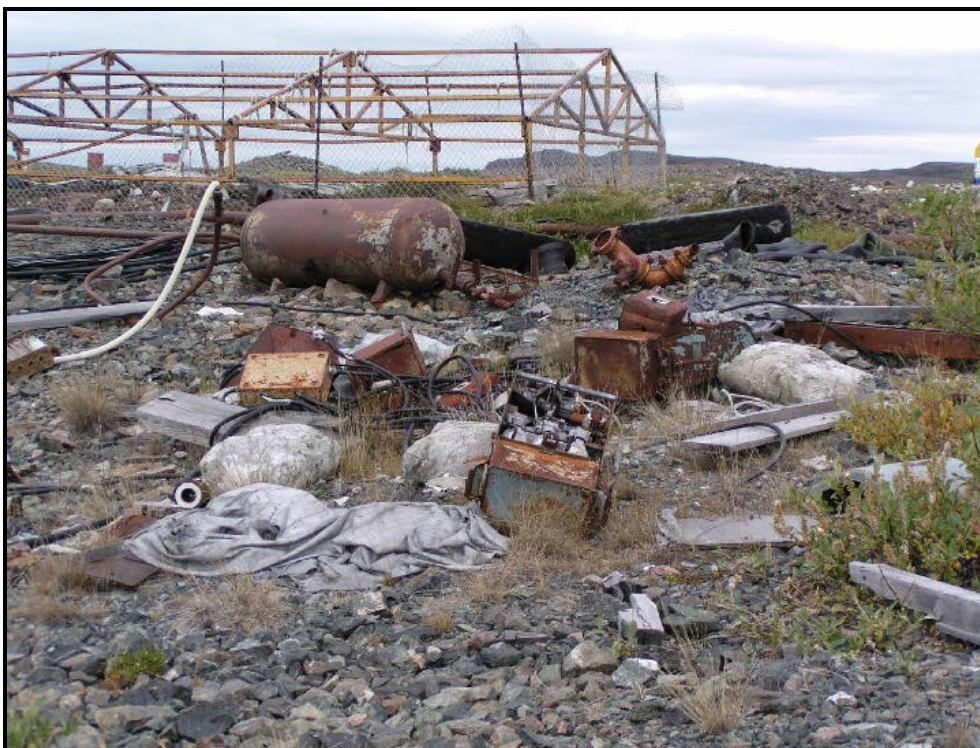
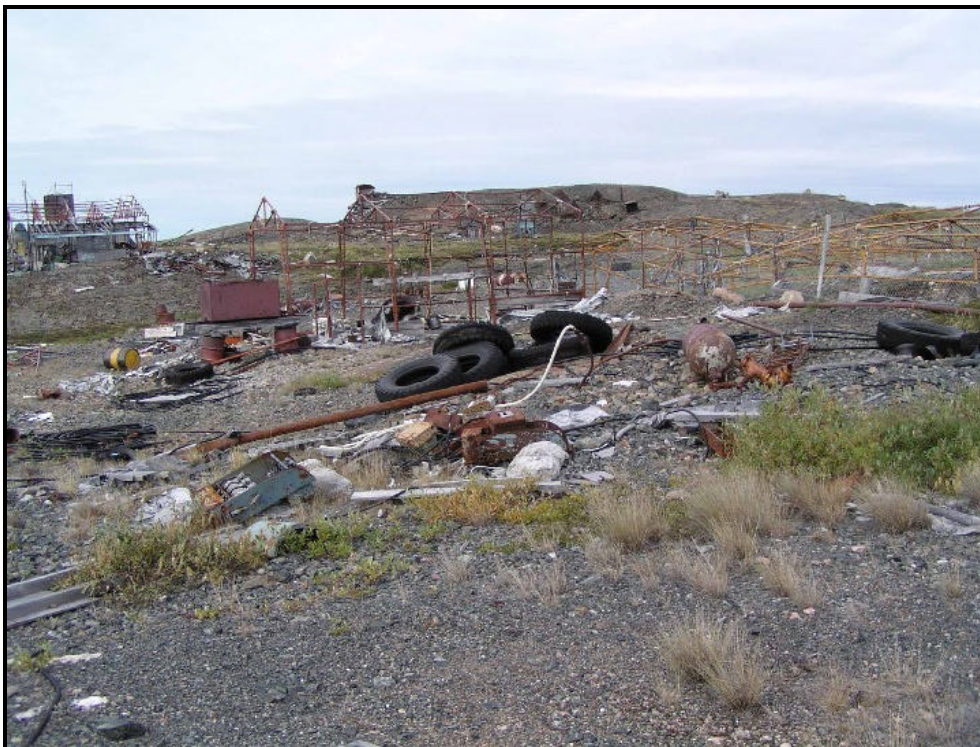
Photo 18. Debris east of Garage

Photo 19. Debris east of Garage

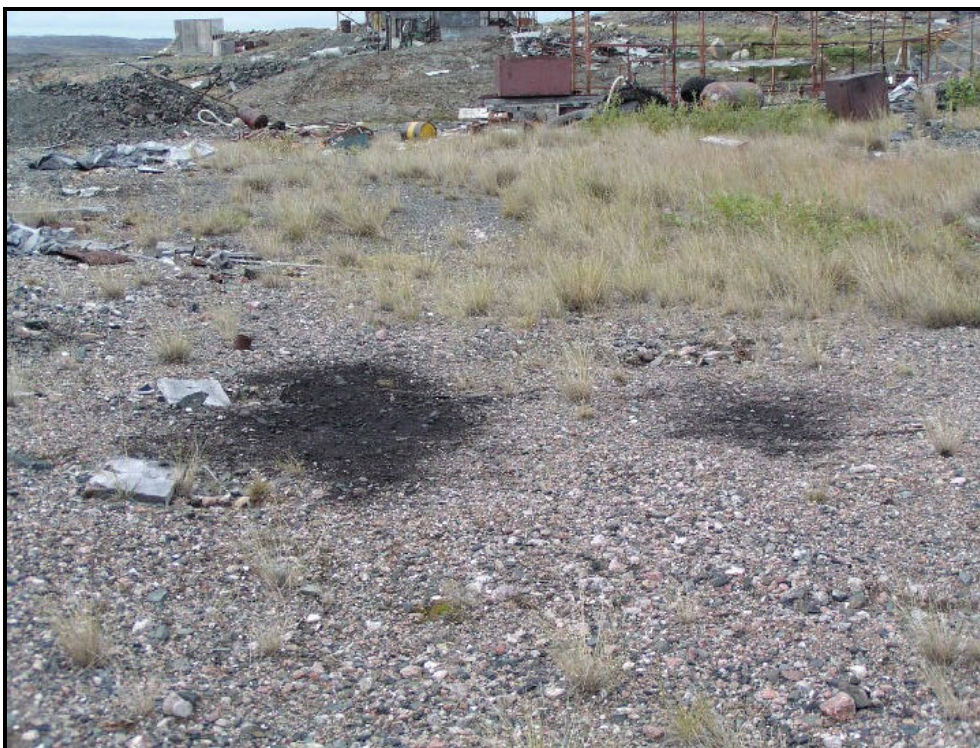
Photo 20. Localized stained soils east of Garage

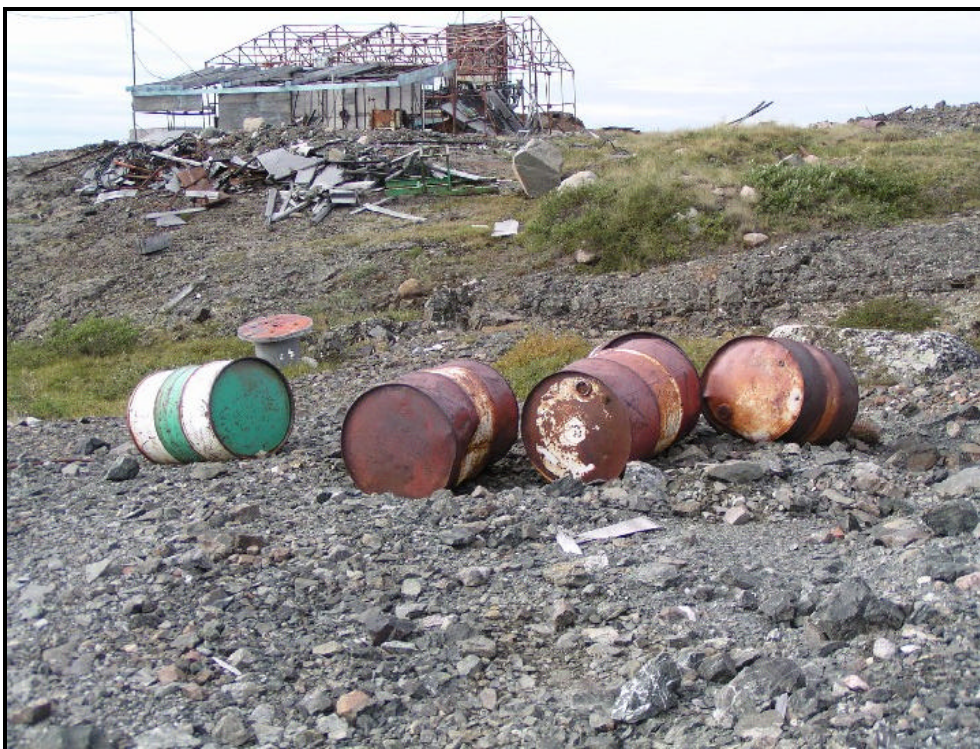
The storage of petroleum hydrocarbons at the site poses a significant environmental risk. Fifteen 205L drums of Jet “B”, motor oil, and gasoline, one 8L pail of grease and one 20L pail of waste oil were identified at the site. The drums and pails were in fair to poor condition.

Photo 21. Drums between Garage and Mill Area

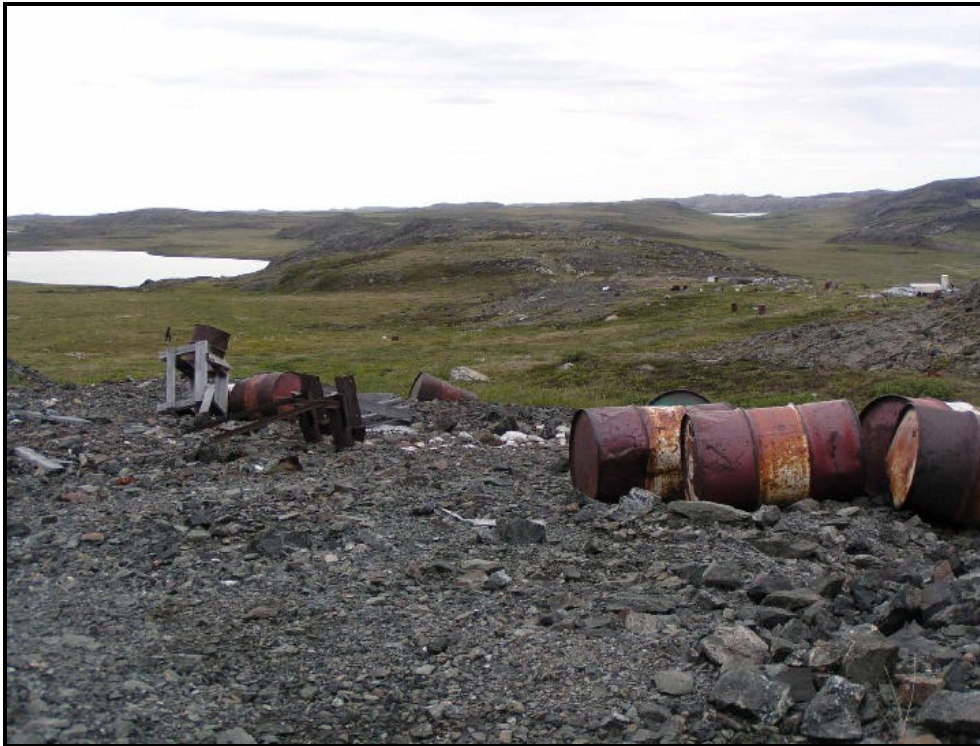
Approximately 225m³ of hydrocarbon contaminated soils were identified at the site. The contamination appears to be localized and not migrating. A hydrocarbon sheen was also identified on standing water in a muskeg area east of the mine camp. Water samples collected from this area had no detectable hydrocarbon concentrations.

Photo 22. Drums in Garage Area overlooking muskeg valley where hydrocarbon sheen observed

- Additional investigation of the muskeg area where hydrocarbon sheens had been noted.
- Additional assessment of the acid rock drainage potential of the waste rock at the site
- Confirmation of contents of drums identified at the site and their disposal requirements

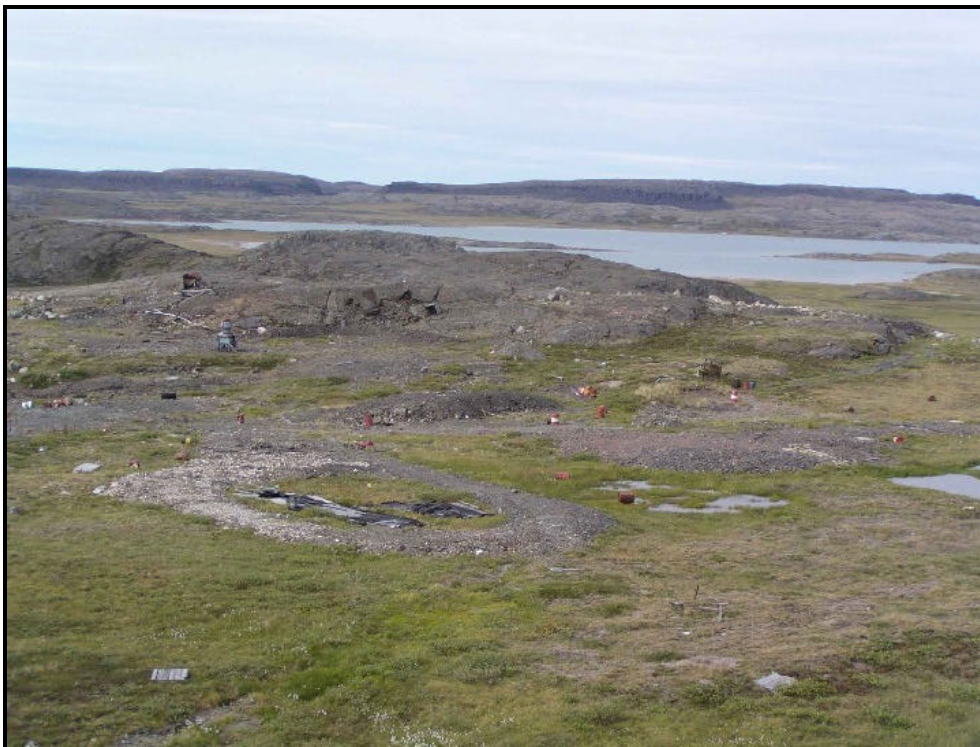
Soil samples RBSM-TF-1 to RBSM-TF-8 were collected from the vicinity of the Fuel Area. The analytical results indicate that the soils from within the fuel berm area have F2 and F3 hydrocarbons concentrations which exceed the CCME Canada Wide Standards for Petroleum Hydrocarbons – fine grained surface soils. Testpitting in this area identified that permafrost is located at approximately 0.6m and that the hydrocarbon impacted soils do not extend past the berms. Therefore, it is estimated that 195 m³ of soils have been impacted.

The materials which make up the berm around the fuel bladder are also a mixture of basalt, gabbro and granites with the addition of 40 to 50% quartz and 3 to 5% visible sulphides with rust and oxidation staining occurring in greater frequency .

Photo 23. Fuel bladder bermed area

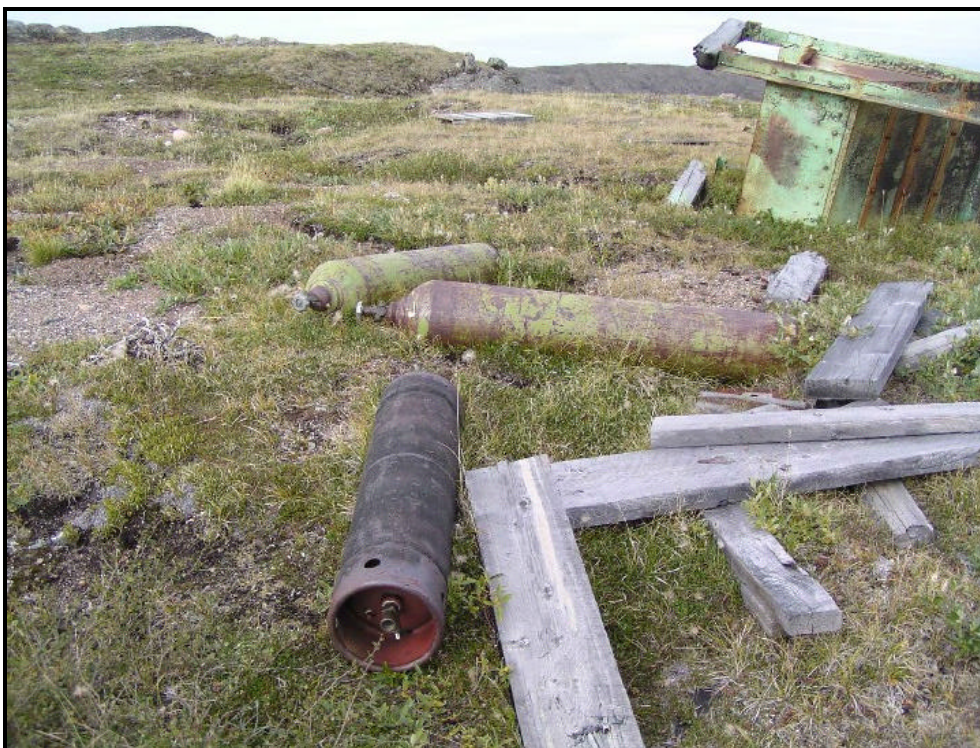
Photo 24. Compressed gas cylinders north of Mill Area

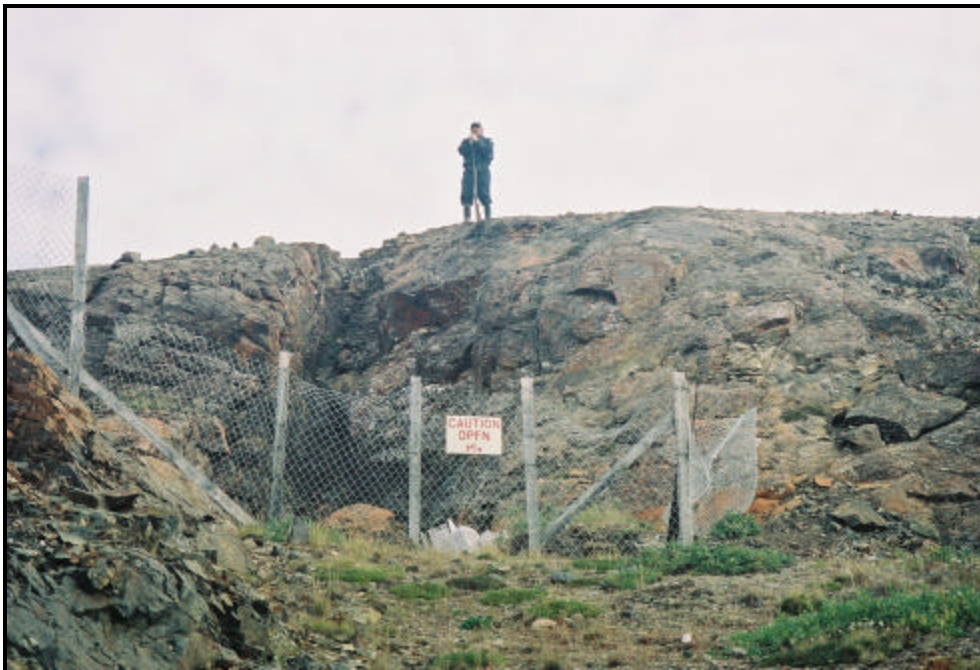
- **Vertical Shaft.** The shaft is located on the side of a basaltic ridge and is accessible by climbing up the ridge. The shaft is still open although it appears as though the walls have partially caved-in. A chain-link fence has been installed on the collar of the shaft but only surrounds 2/3 of the perimeter. The uphill side remains open allowing access to the shaft opening at any time. There are serious stability problems with the collar surrounding the shaft as evidenced by the open fractures and caving of bedrock.

Photo 26. Mine shaft on east side.

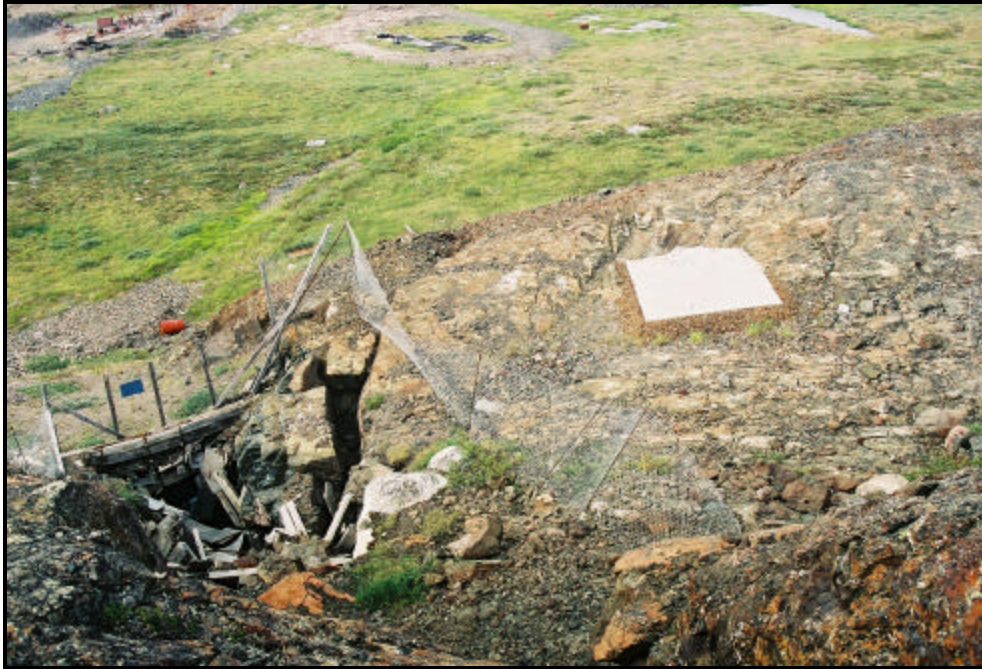
- **Vent Raise.** A vent raise is located 10 metres north of the shaft. It has been sealed with concrete and there were no signs of subsidence noted during inspection.

Photo 27. Mine shaft and concrete covered ventilation raise.

of the capped vent raise as the area appeared to be stable with no signs of subsidence or cracking of the concrete cap.

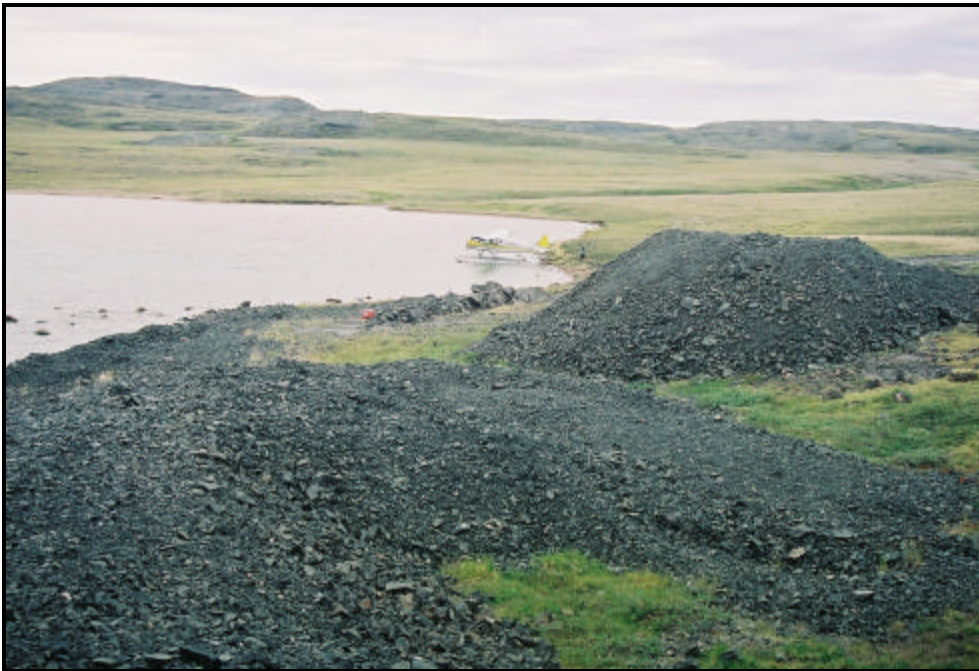
A total of three waste rock piles were identified at Ida Bay each located in close proximity to the adit. The smallest of the three piles is located immediately north of the adit and extends from land into the ocean. The second pile is located west of the adit while a third large elongated pile is located to the west of the second pile. A description of the waste rock sample collected at the site can be found in Appendix D.

The composition of the waste rock from all of the piles was essentially the same; black fine-grained basalt with trace to an estimated 1% pyrite coating on fracture surfaces and rare quartz veinettes and stringers with sulphides on their selvages. Within the basalt are 5% inclusions of pink syenitic granite as pods and stringers less than 10 cm wide. There was no visible oxidation staining.

Photo 30. Waste rock piles.

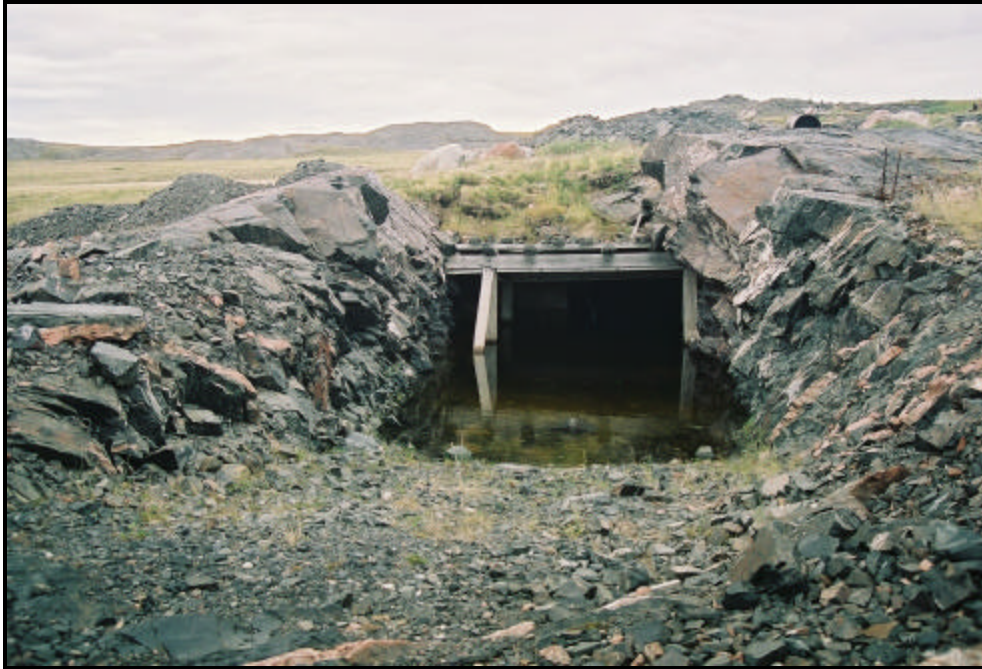
The Ida Bay site is located approximately 7km north of the Roberts Bay Silver Mine. The site consists of one adit, three exploration trenches and a vent raise. The adit is in poor condition and flooded. The vent raise has been covered with plywood, which is in poor condition, and the exploration trenches are open. A small amount of non-hazardous debris (scrap wood and metal) was identified at the site.

Photo 31. Flooded adit.

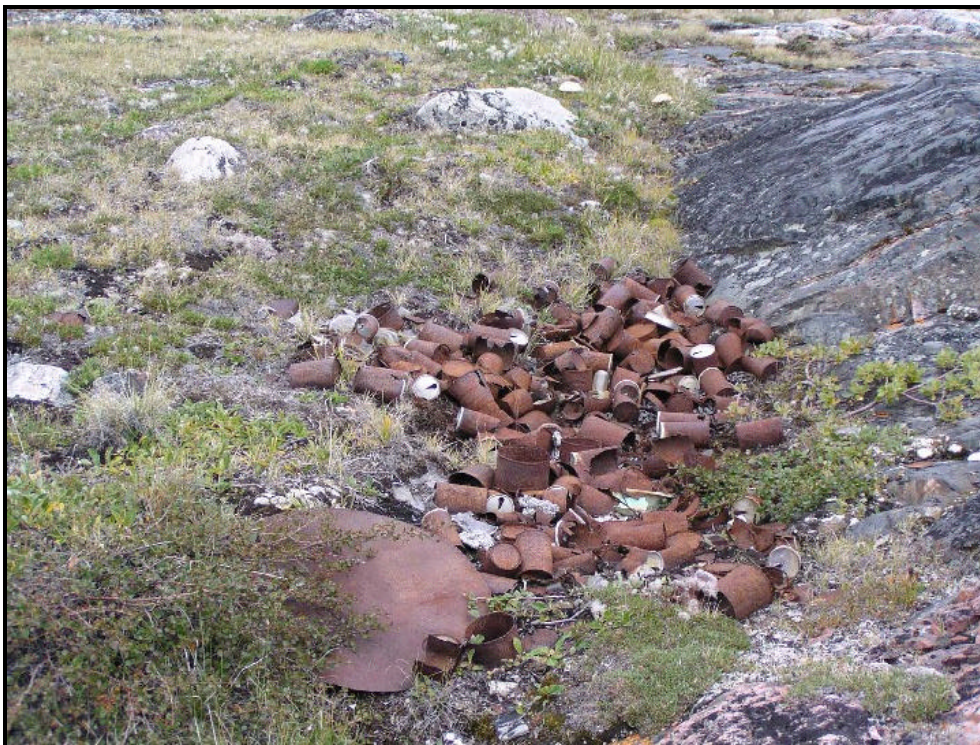
Photo 33. Debris around former Camp Area

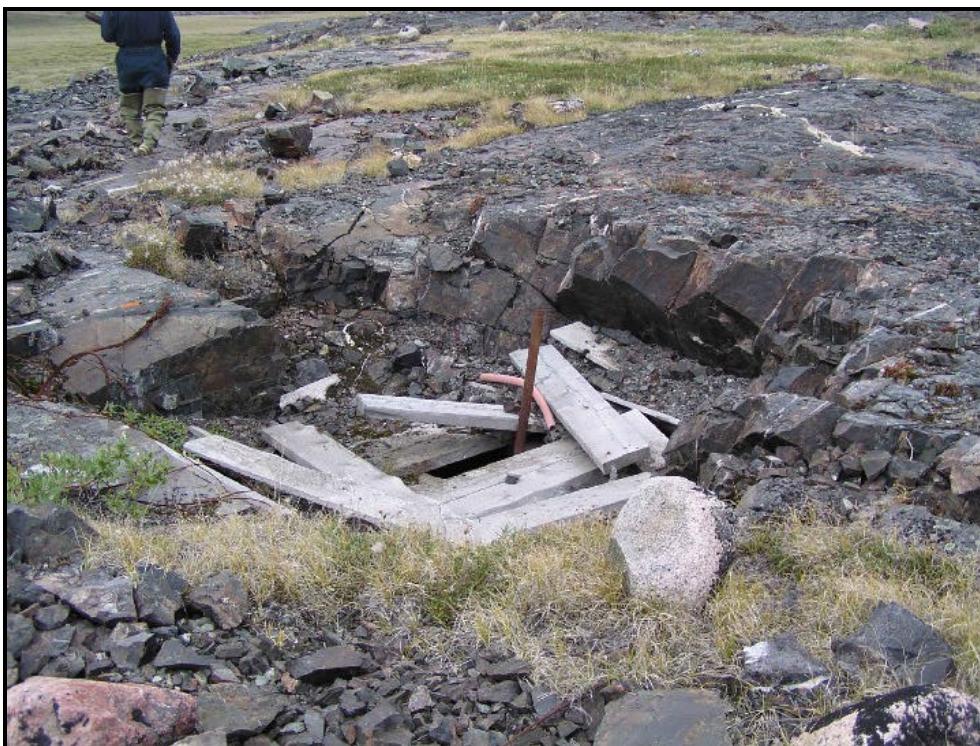
Photo 34. Partially covered vent raise

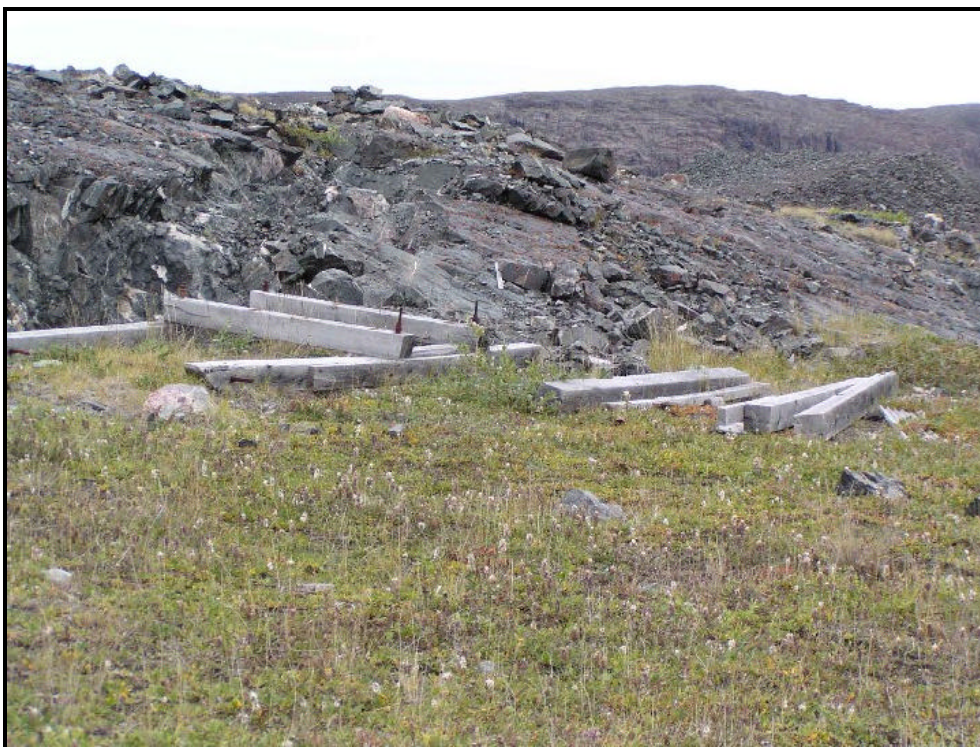
Photo 35. Debris south of adit

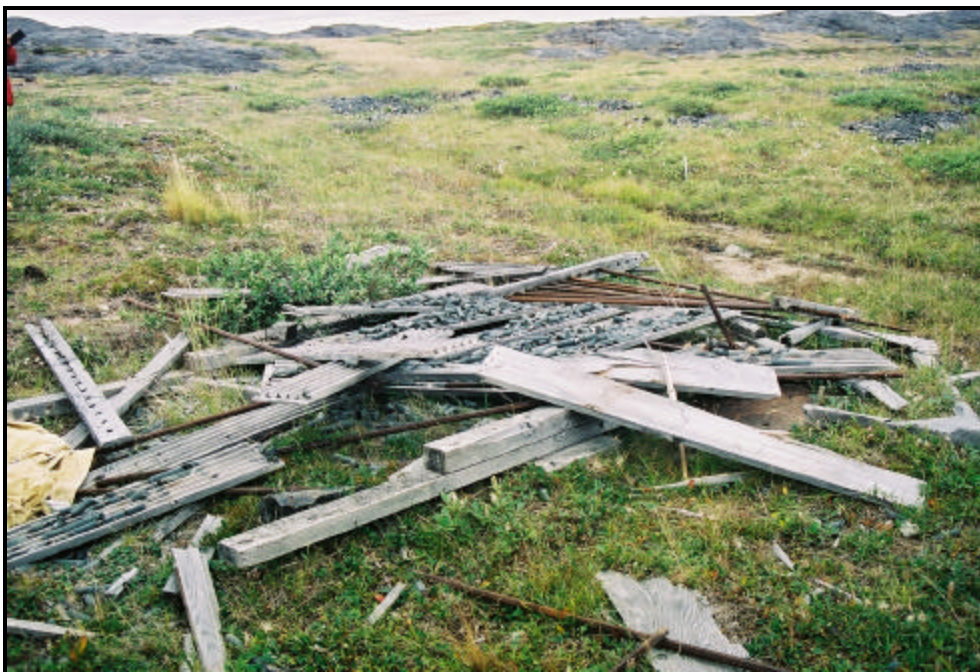
Photo 36. Spilled drill core on site.
