Completion Report for Roberts Bay and Ida Bay Mine Sites Site Remediation Program, Nunavut

FEBRUARY 2011

SENES Consultants Limited

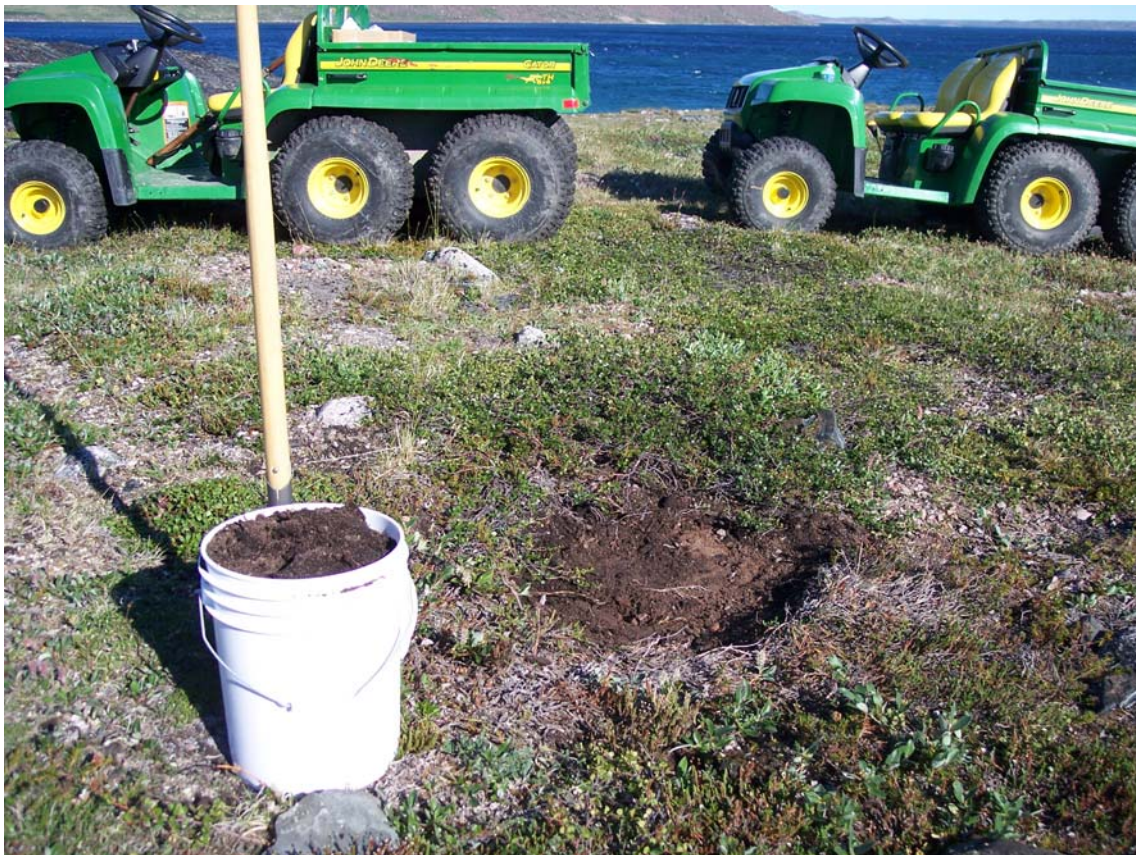
Excavation of additional soils at former location of batteries, looking north, north-east

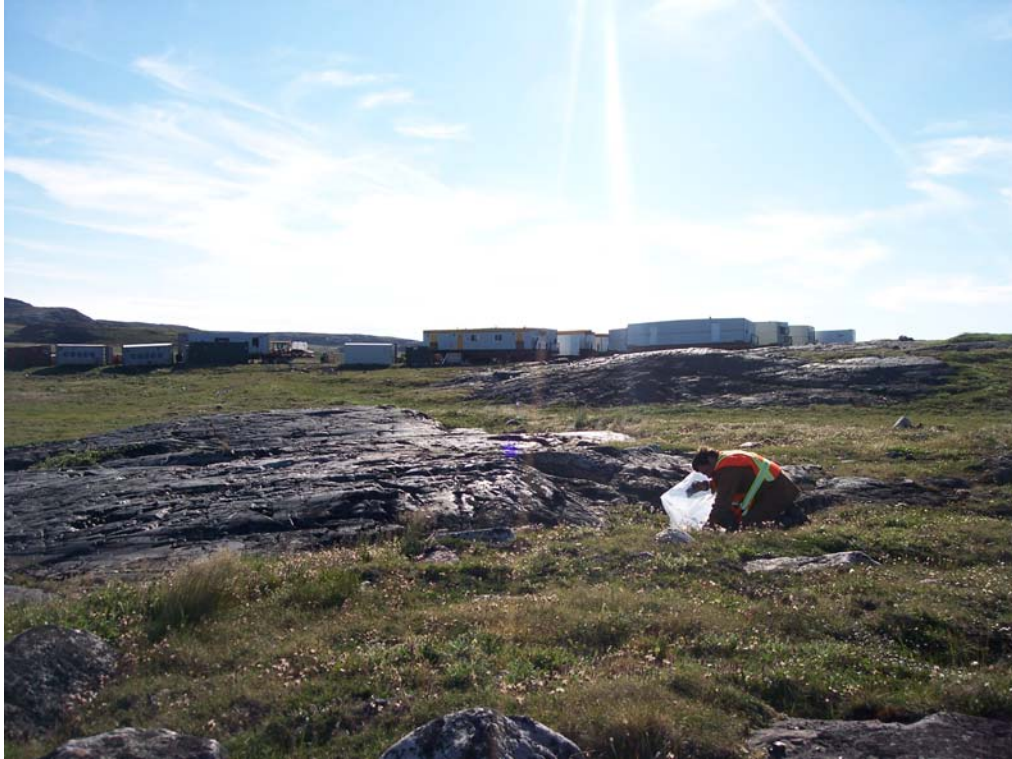
Gathering of all non-hazardous debris observed at Ida Bay former camp facilities, looking south-west

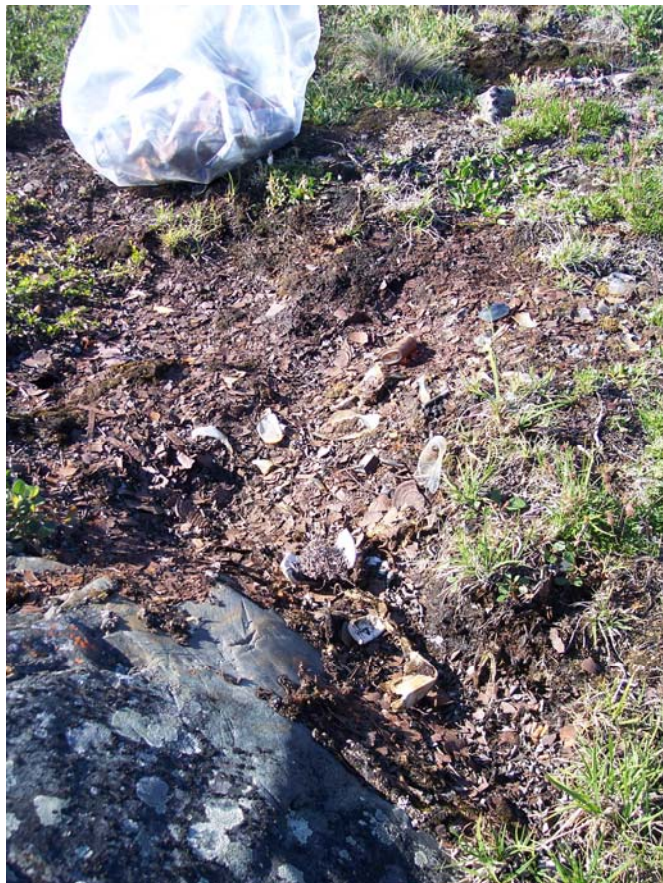
Scattered debris (mostly glass and rusted metal tins) found during the site clean-up

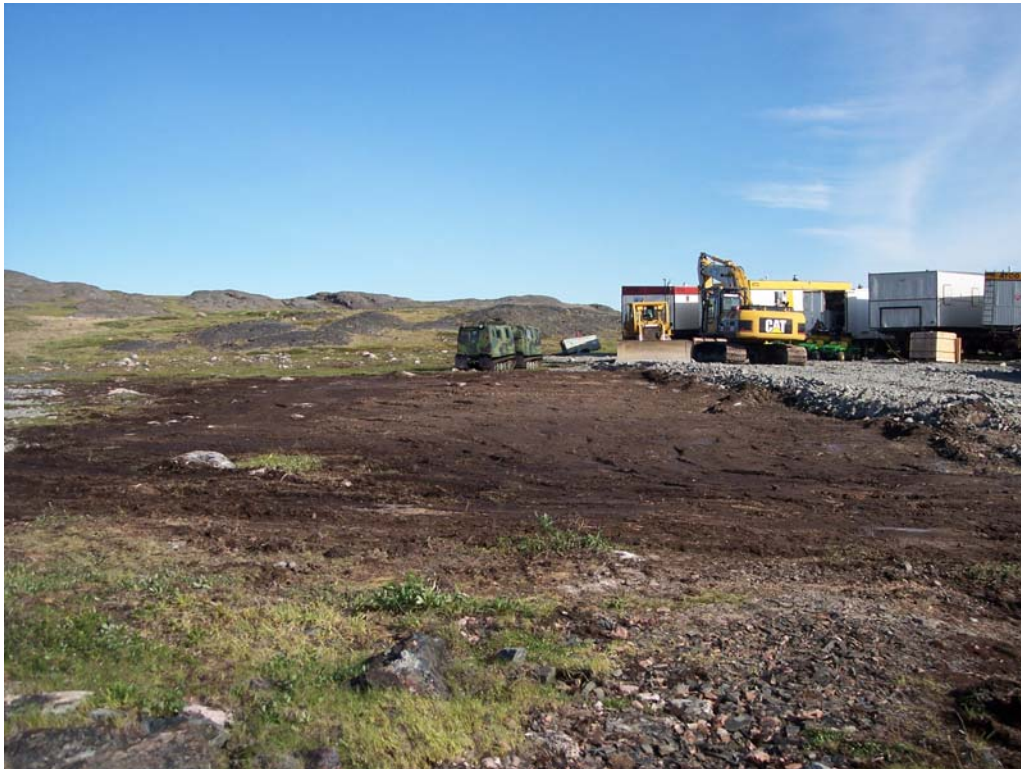
Former boxed crates lay down area re-graded after their relocation and grading of waste rock for ease of travel with machinery and equipment during loading, looking west

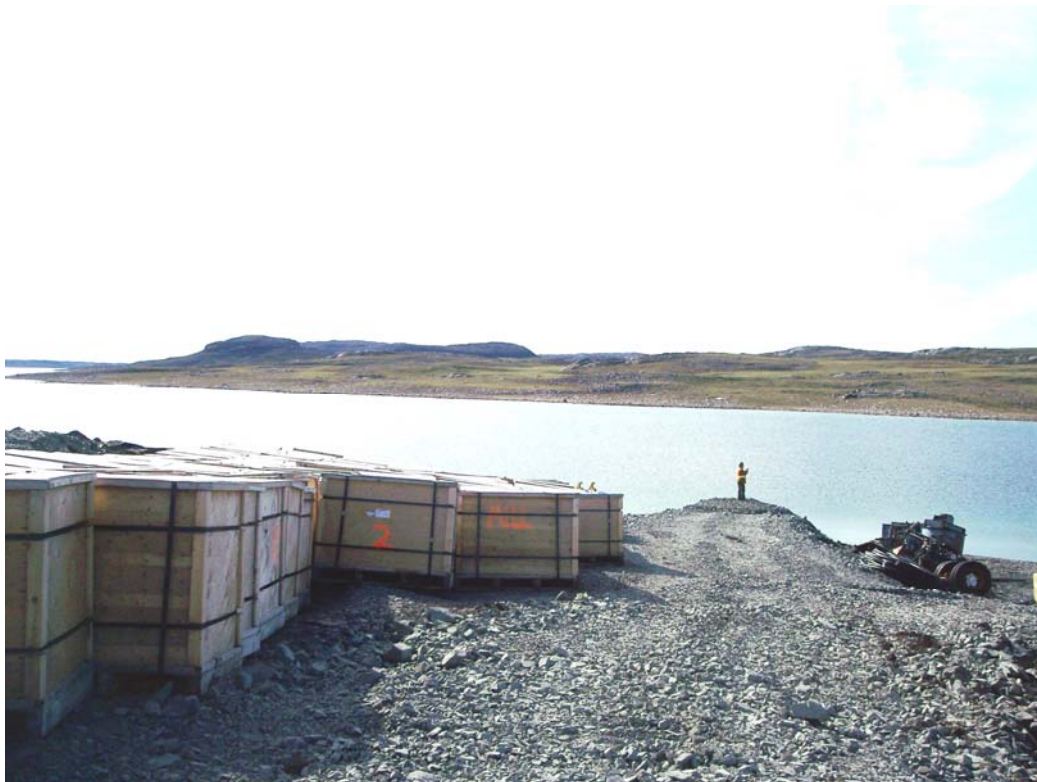
Loading ramp with new lay down area for boxed crates (left) and Mill equipment (far right), looking east, south-east

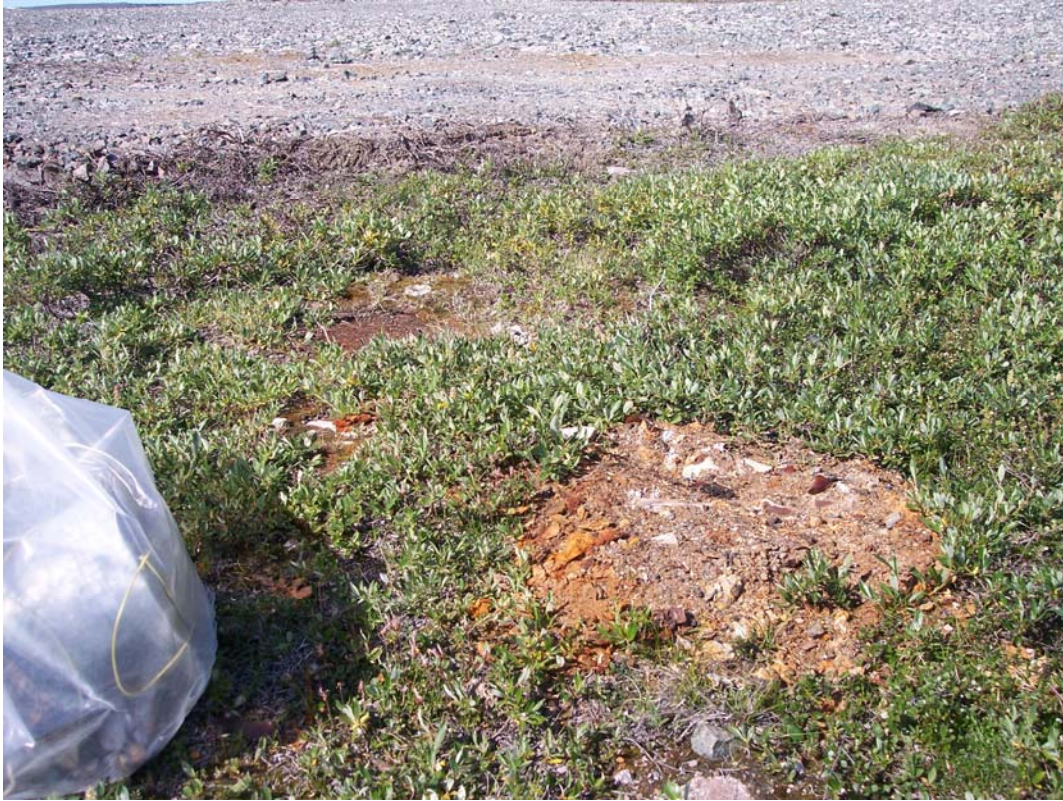
Small pile of burnt debris recovered during final clean-up at Roberts Bay

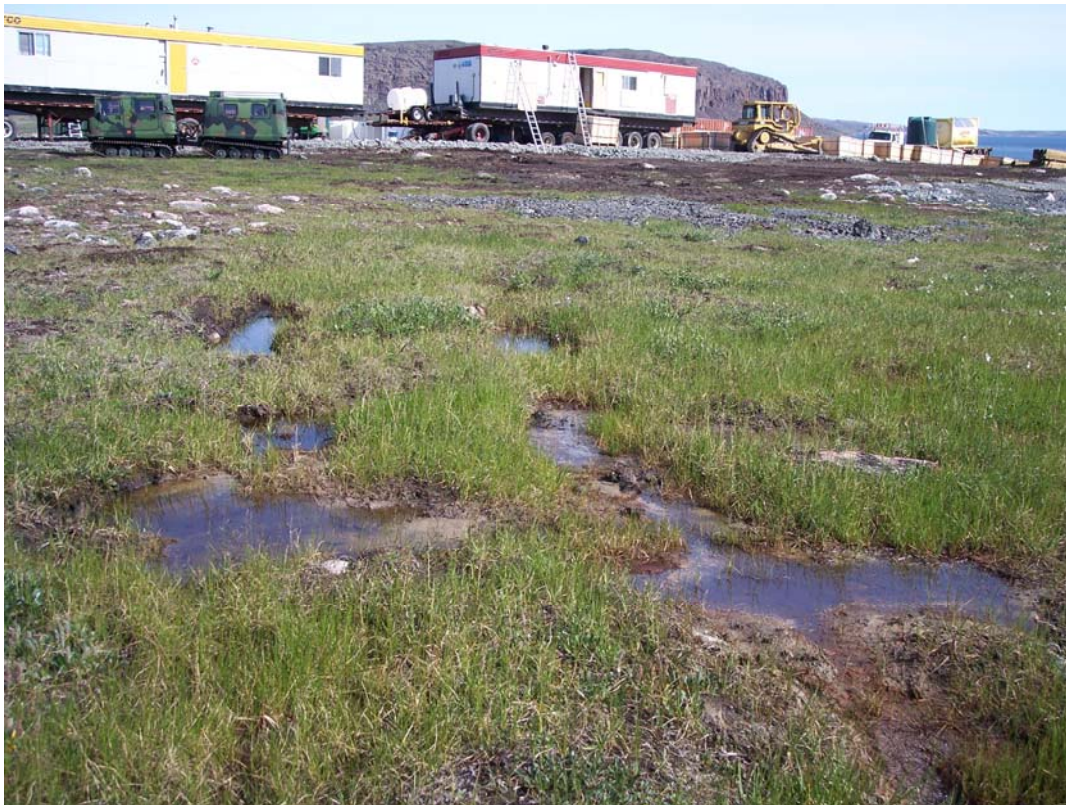
Old tracks left from former operations in the vicinity of present work, looking north-east
