## Completion Report for Roberts Bay and Ida Bay Mine Sites Site Remediation Program, Nunavut

FEBRUARY 2011

**SENES Consultants Limited**

This Completion Report presents a summary of the remediation works completed at the Roberts Bay and Ida Bay Mine sites during the 2009 and 2010 field seasons. The Remediation Project consisted of the installation of mine seals at the respective openings, re-grading of waste rock to fill in low lying areas and other depressions, placement of a waste rock cap over the former domestic landfill, removal of waste rock from below the high water mark along the shoreline to Melville Sound, demolition of abandoned structures, consolidation and containerization of hazardous waste, relocation and containment of non-hazardous debris and waste within a solid waste management facility, mitigation of chemical impacts in the subsurface at discrete locations on-site, and construction of a solid waste management facility within the limits of the former tailings containment area to provide suitable cover over the tailings.

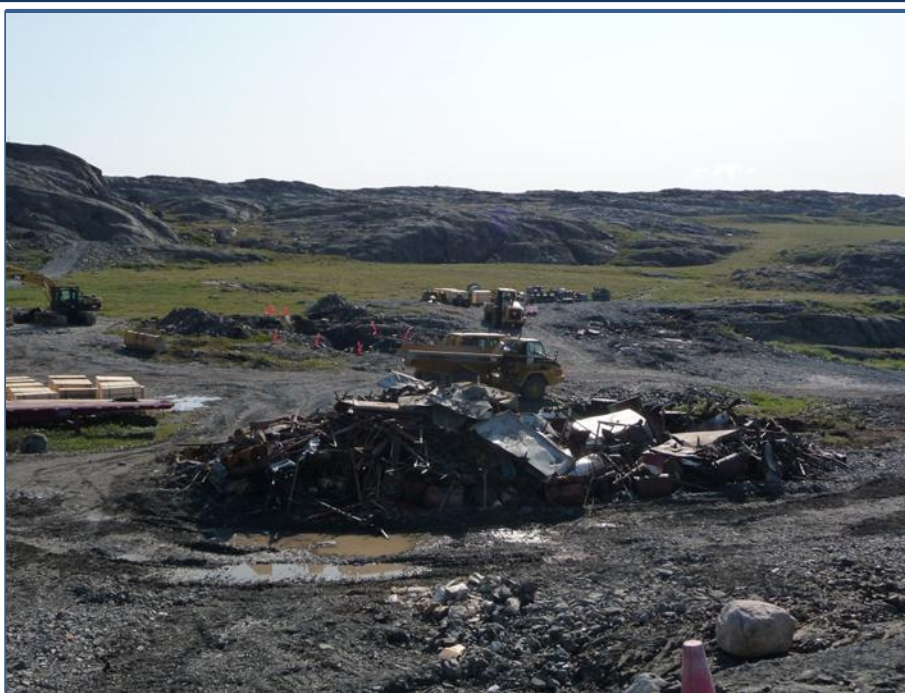
Debris Pile from West - Before

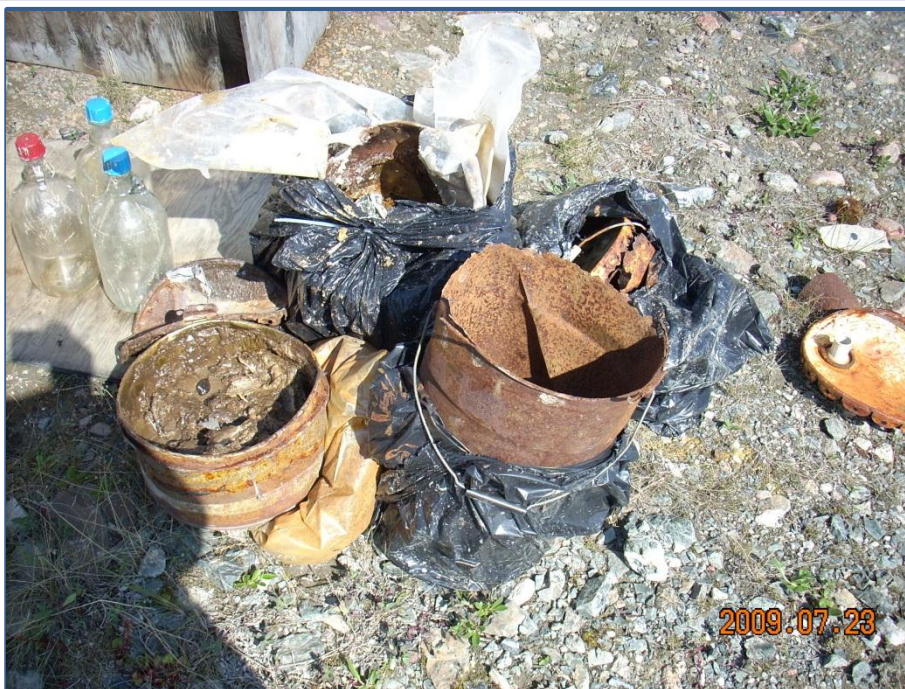
Various Hazardous Waste Before

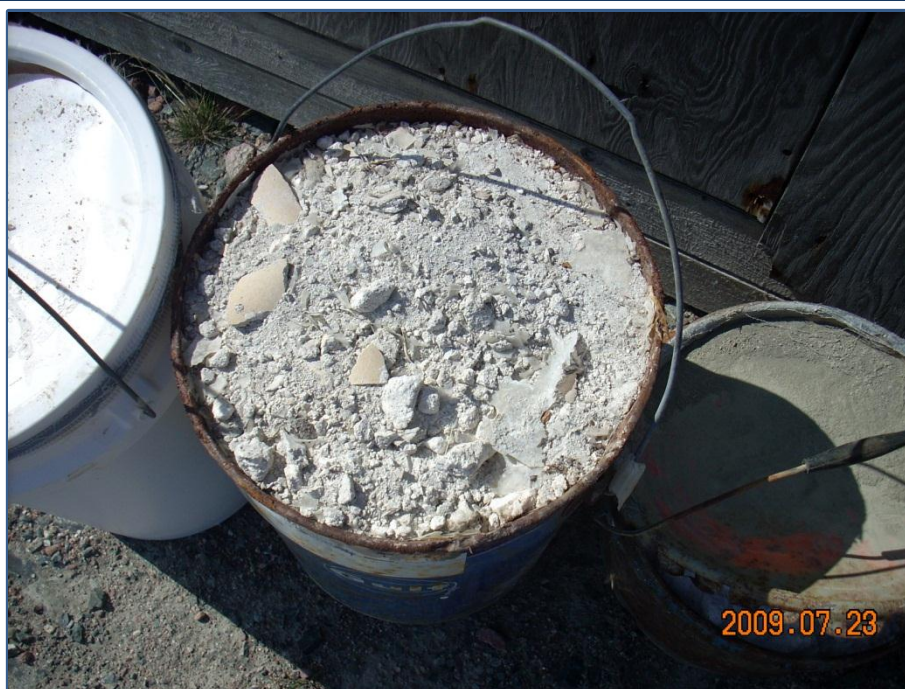
Various Hazardous Waste Before

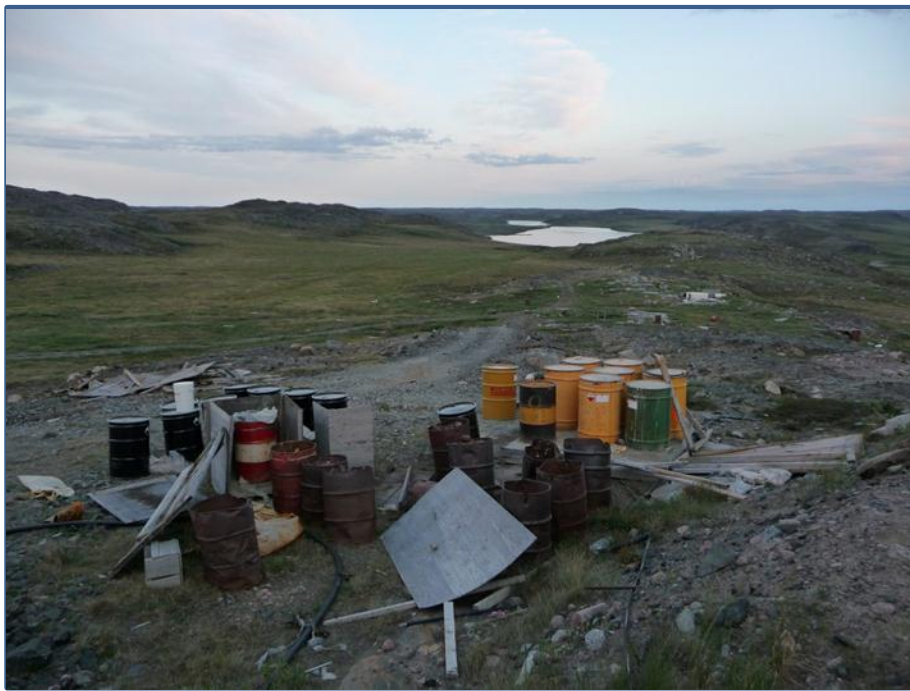
Various Hazardous Waste from North - Before

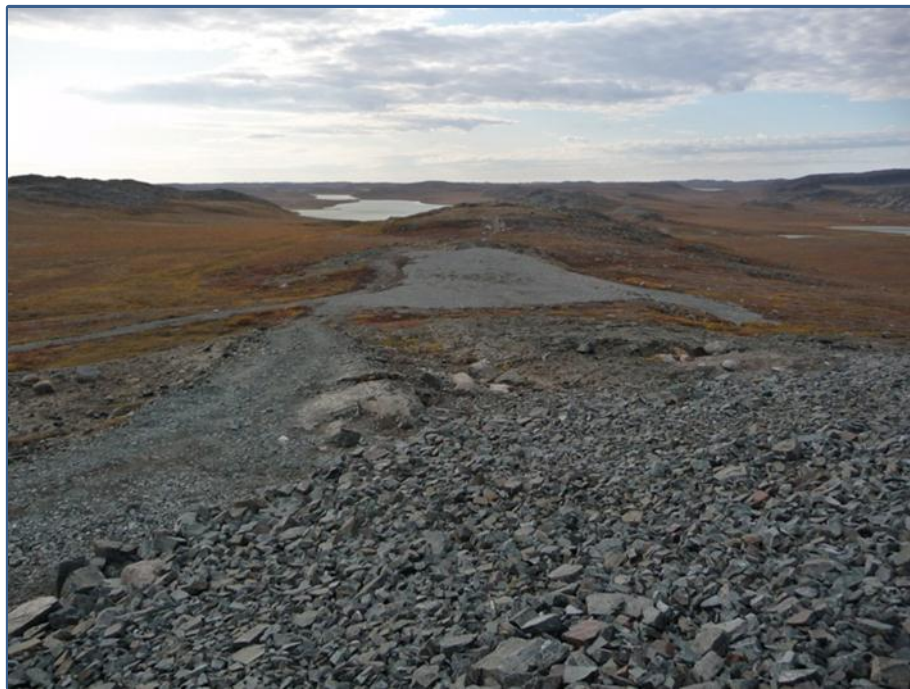
Various Hazardous Waste from North - After

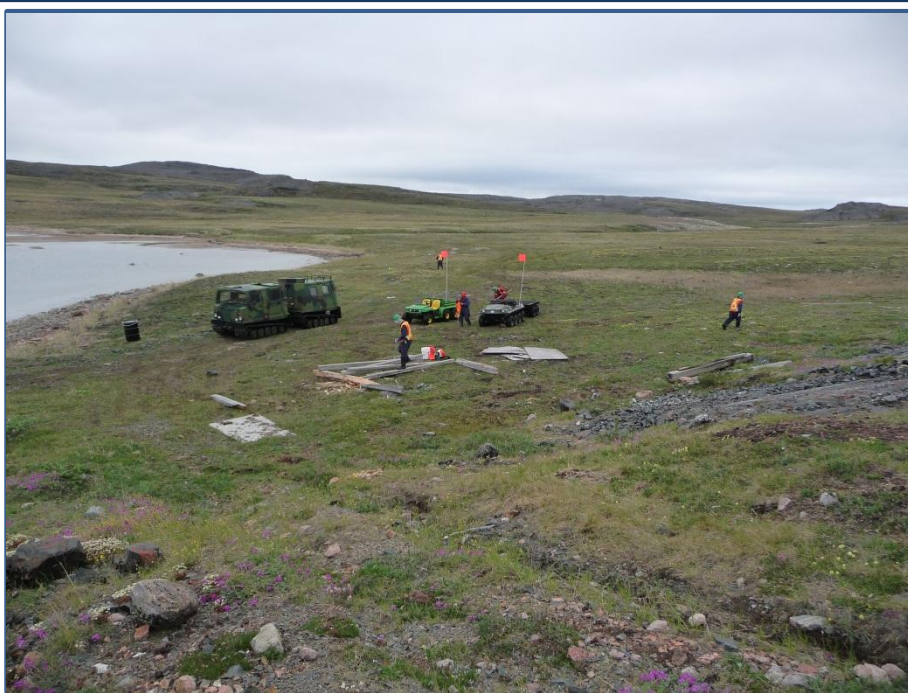
Debris Area from North - Before

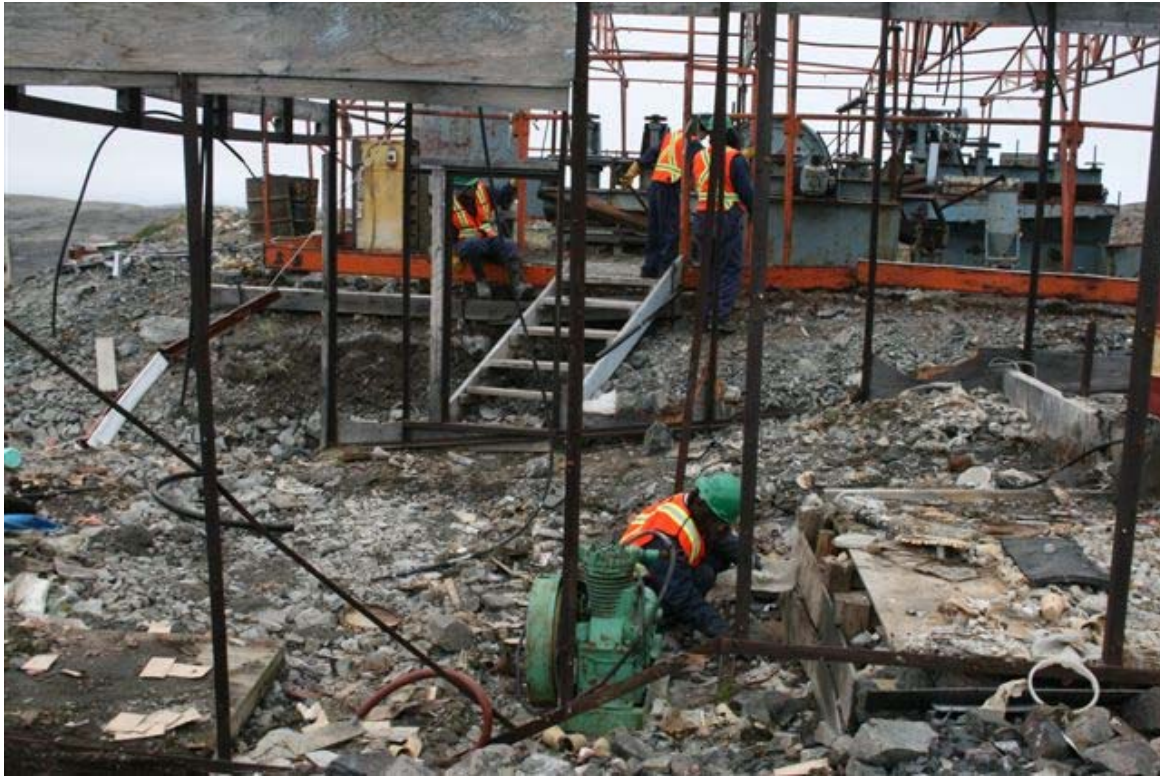
Debris cleanup crew working in mill building

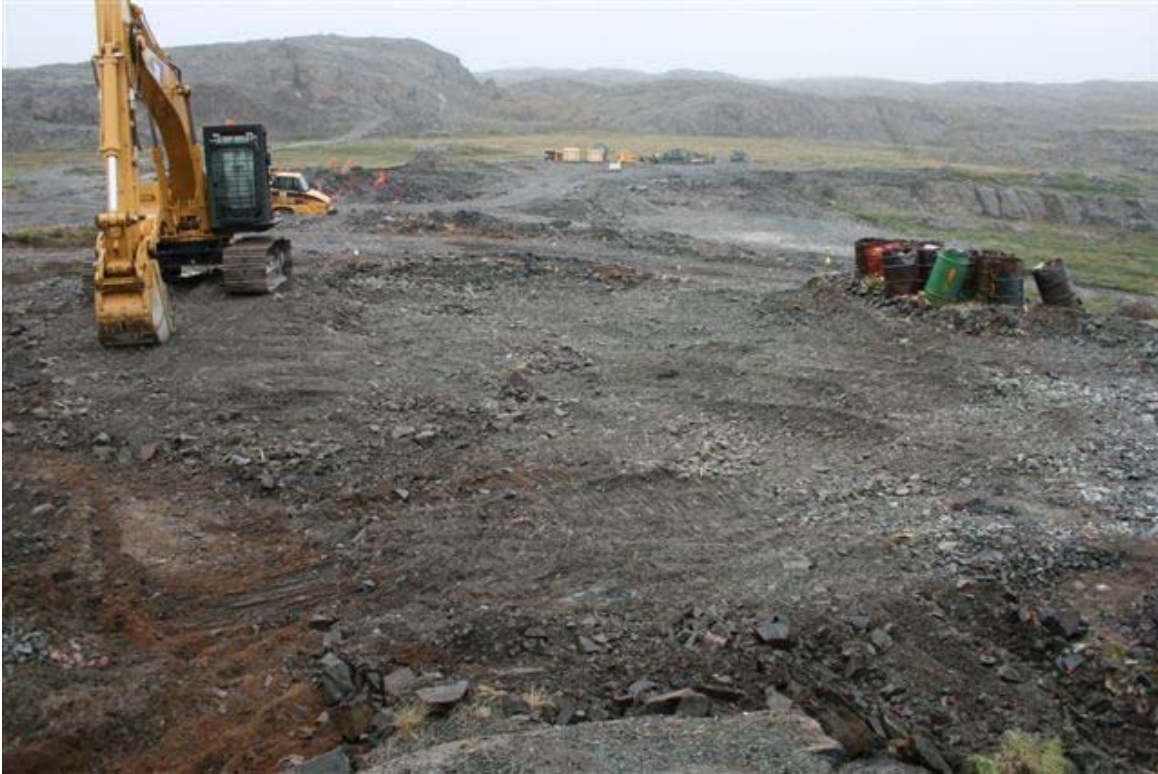
Mill area after contaminated soils removed.

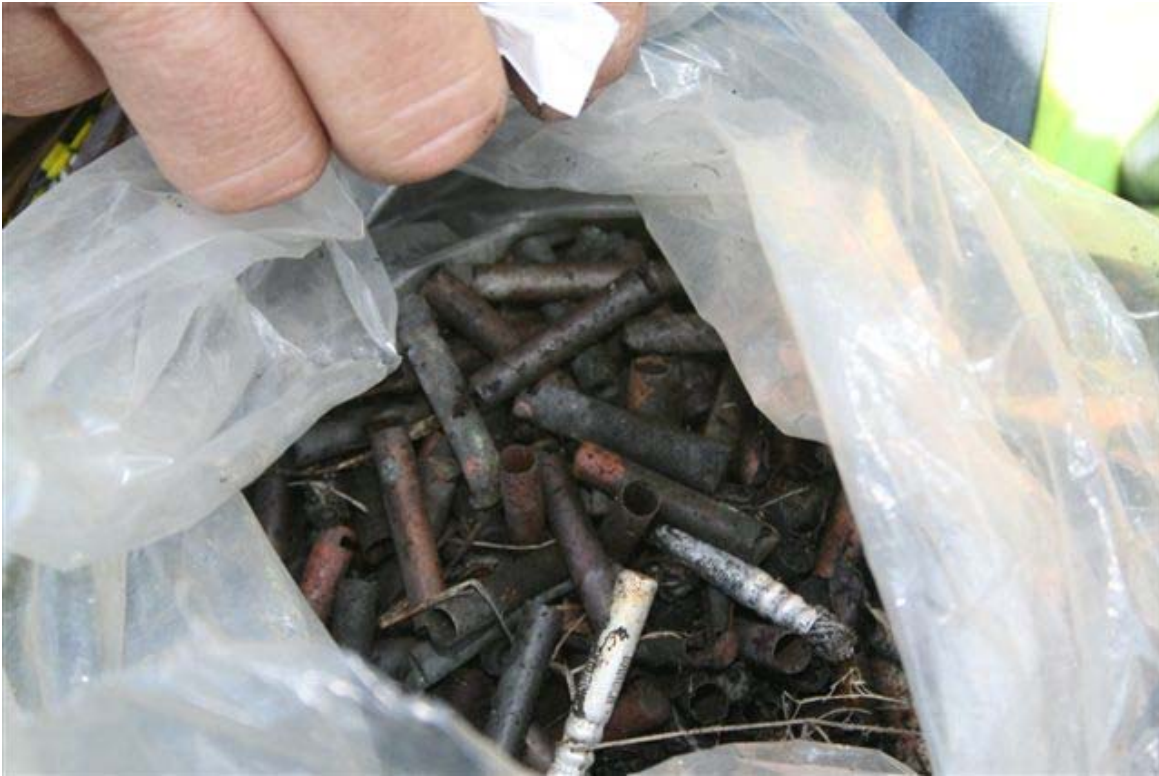
Blasting caps collected. Silver blasting caps are live.

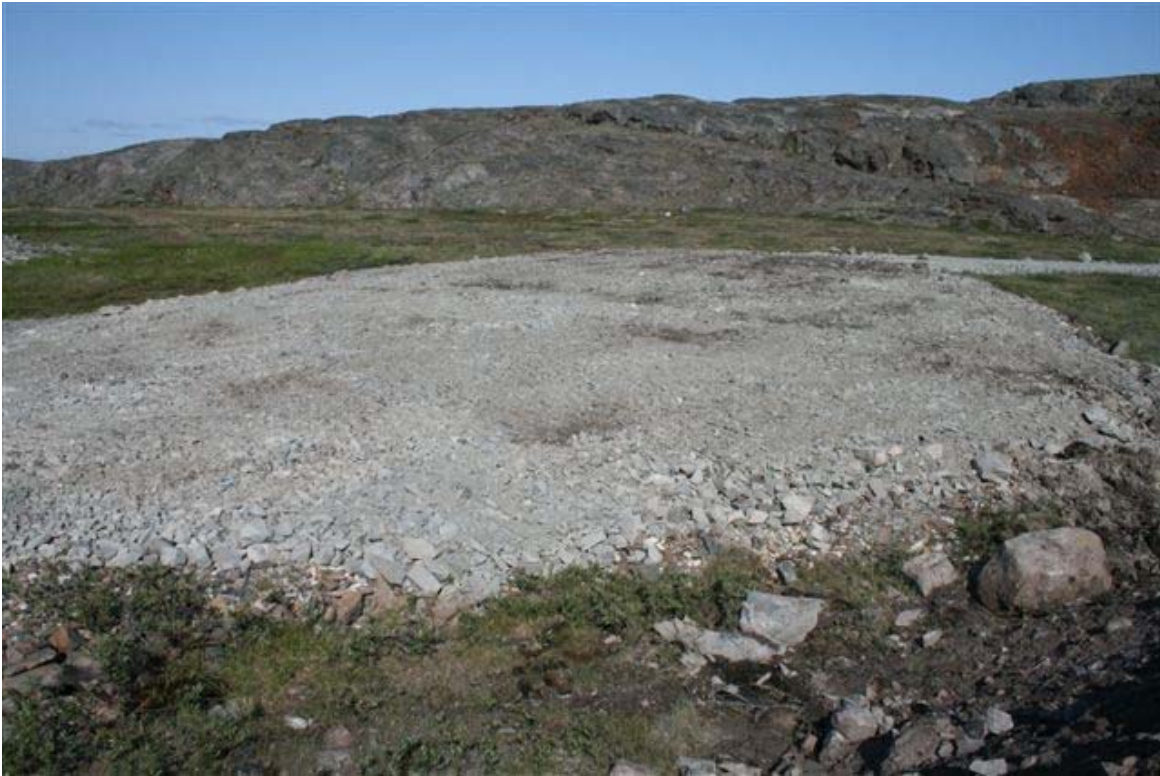
Pad constructed overlapping the fuel bladder area. Pad will be used to stage contaminated soil boxes.

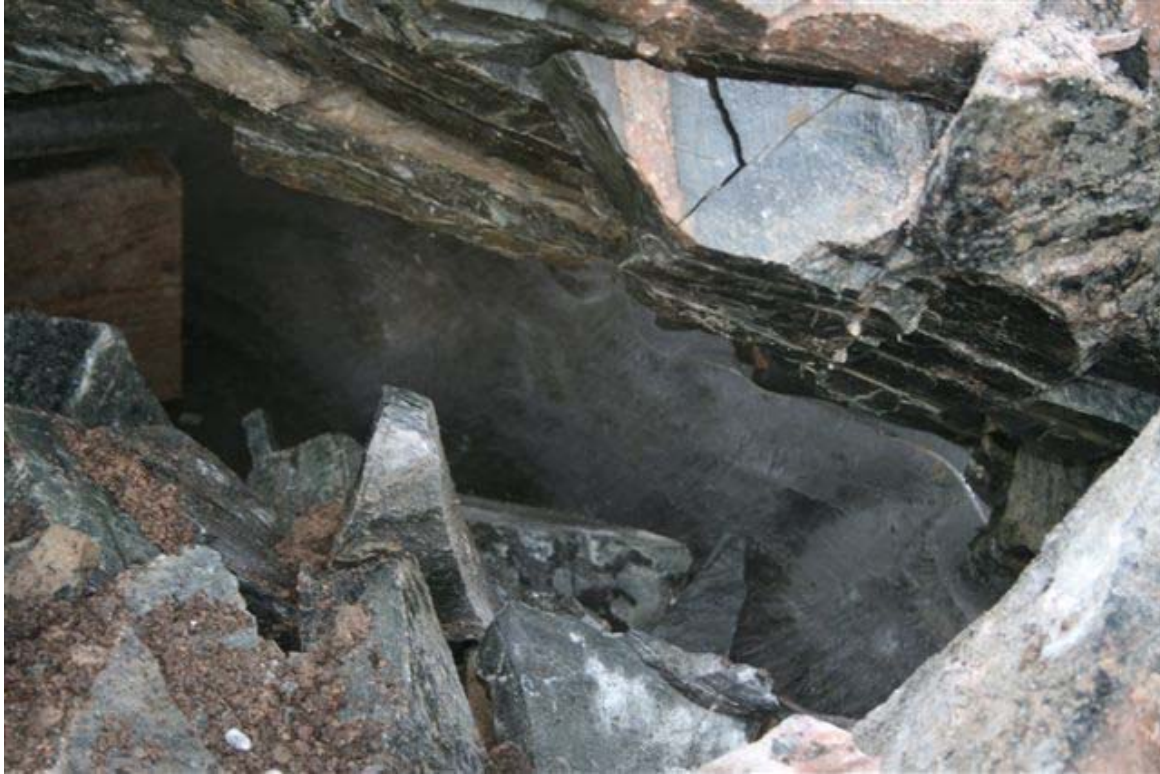
Ice in adit 1. This is at ceiling level.

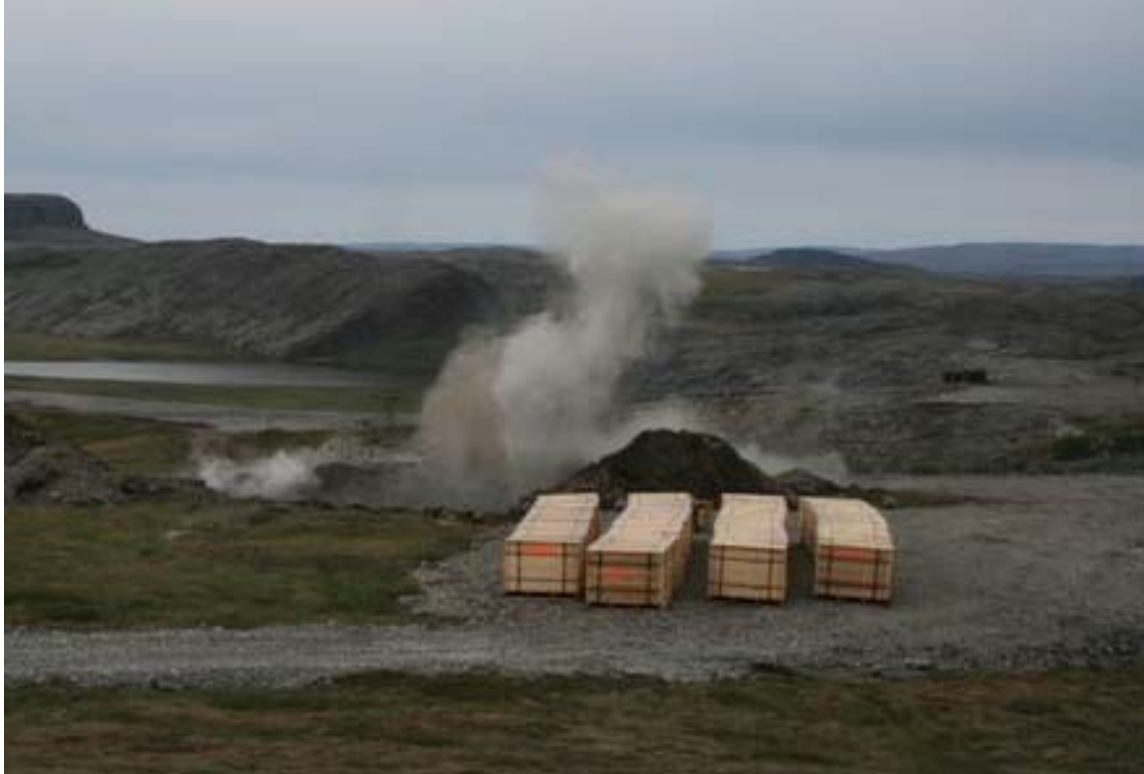
Blast at Adit 1

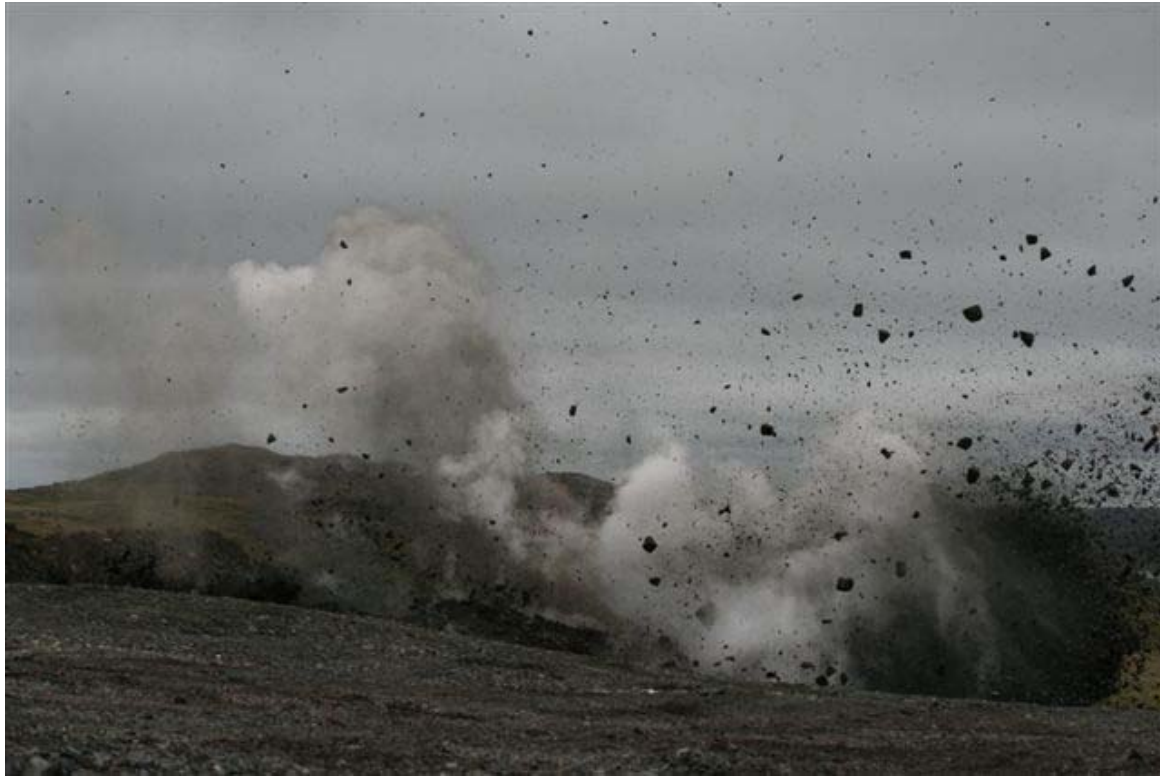
Blast south of adit 1

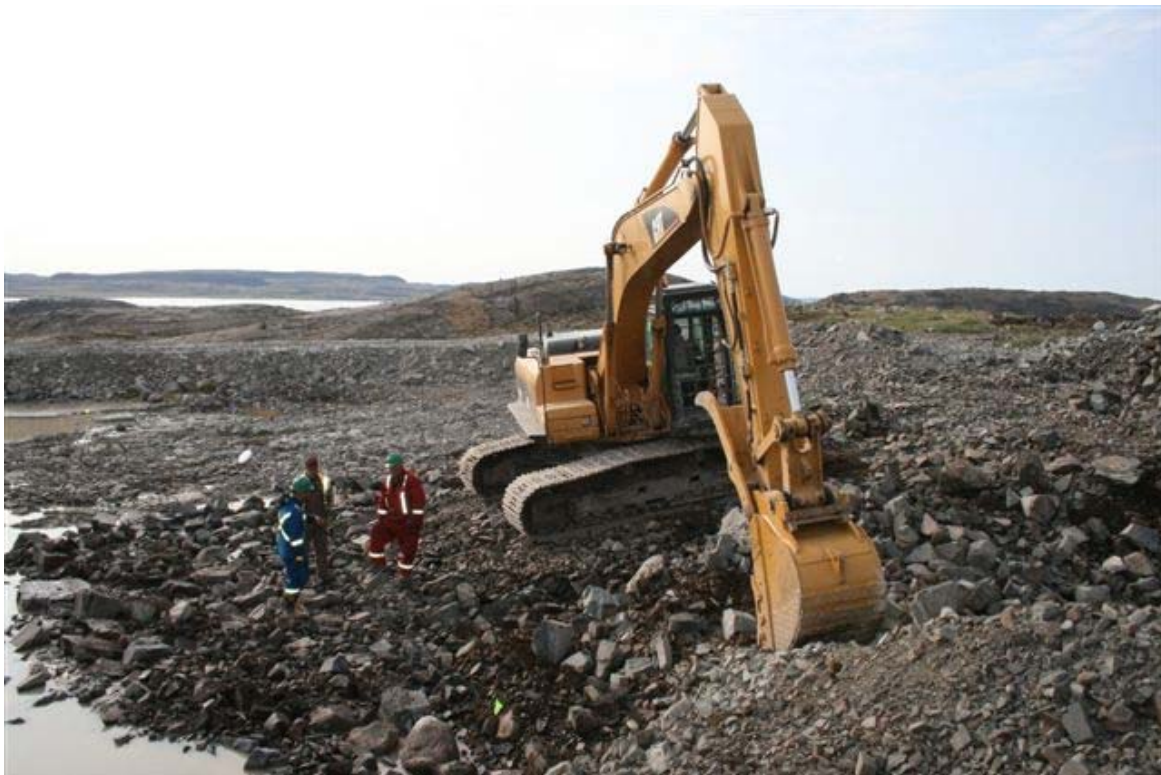
Test section at the tailings pond....considered a failure

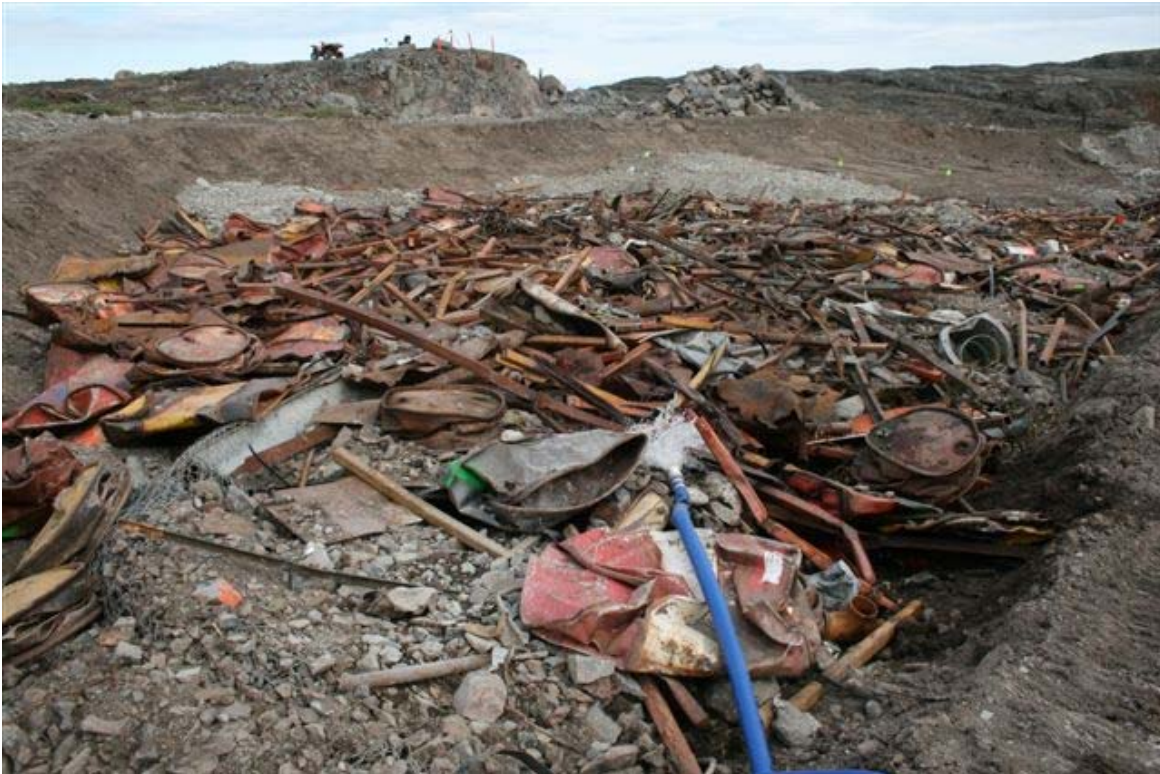
Dry pond with all steel placed

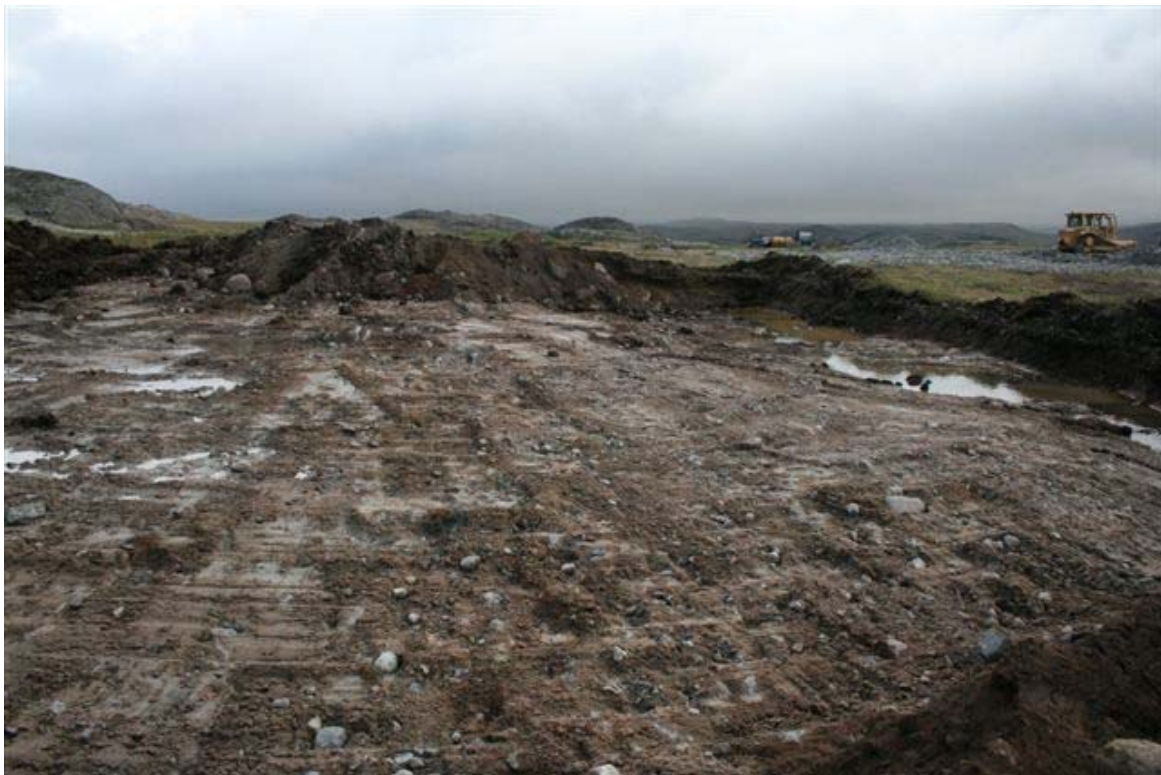
Borrow source 4. Permafrost a major issue

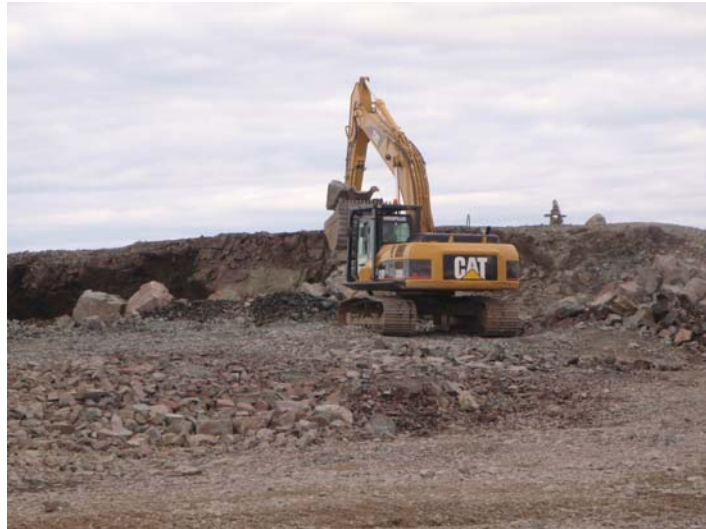
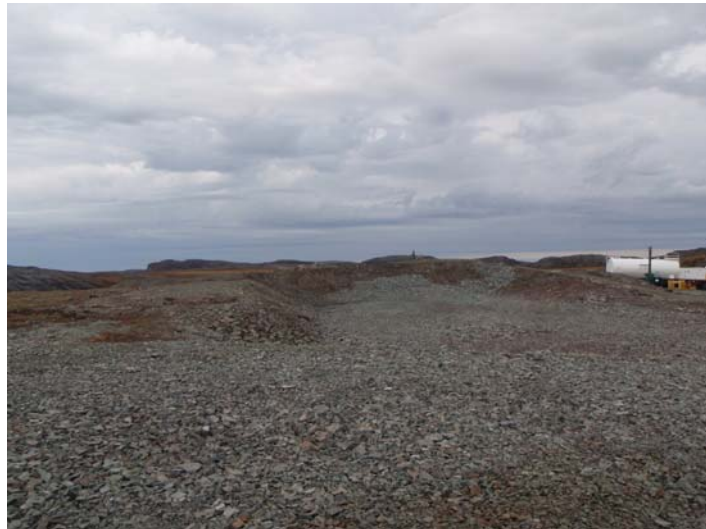
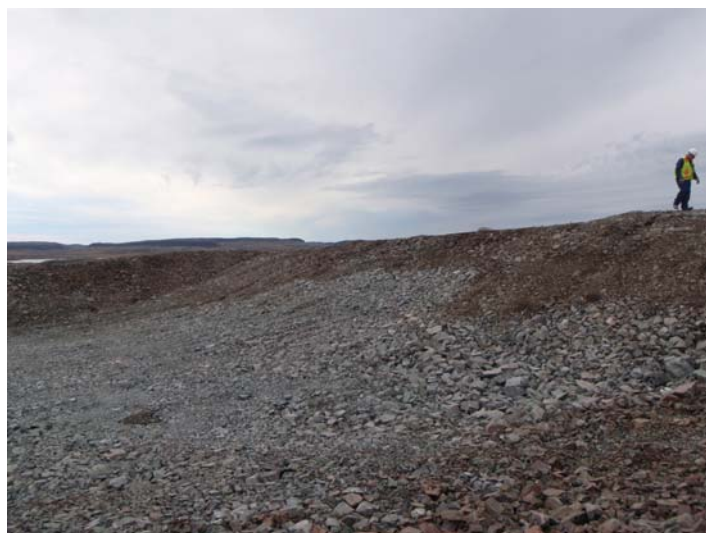
**Re-shaped Borrowed Area North of Landfill.**

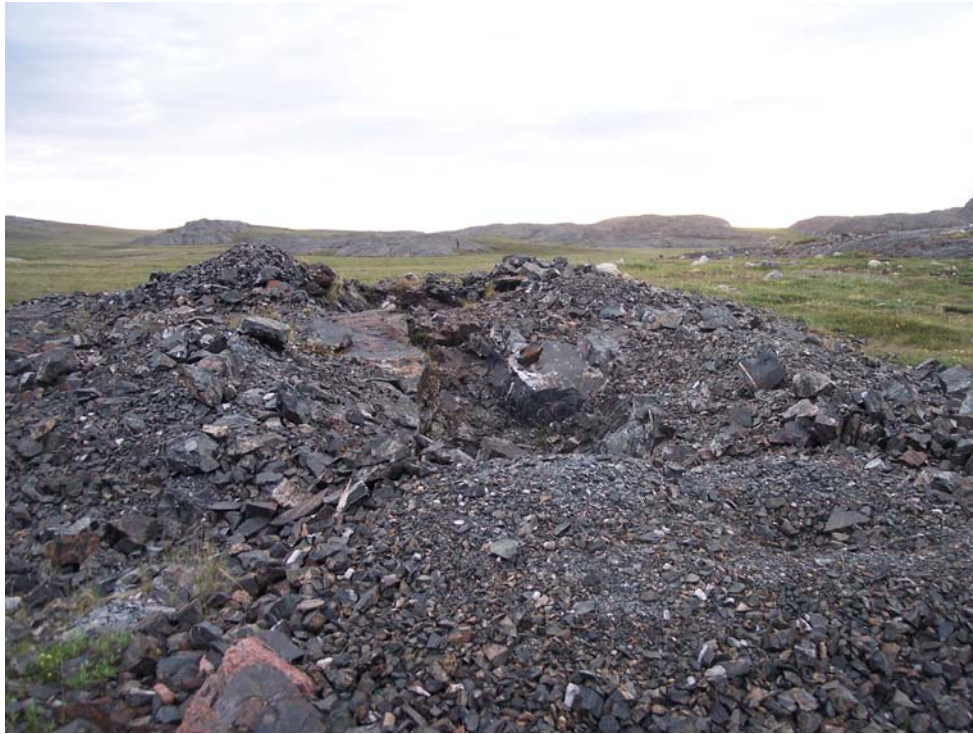
Exploration trench as of July 21<sup>st</sup> 2010, prior to final grading

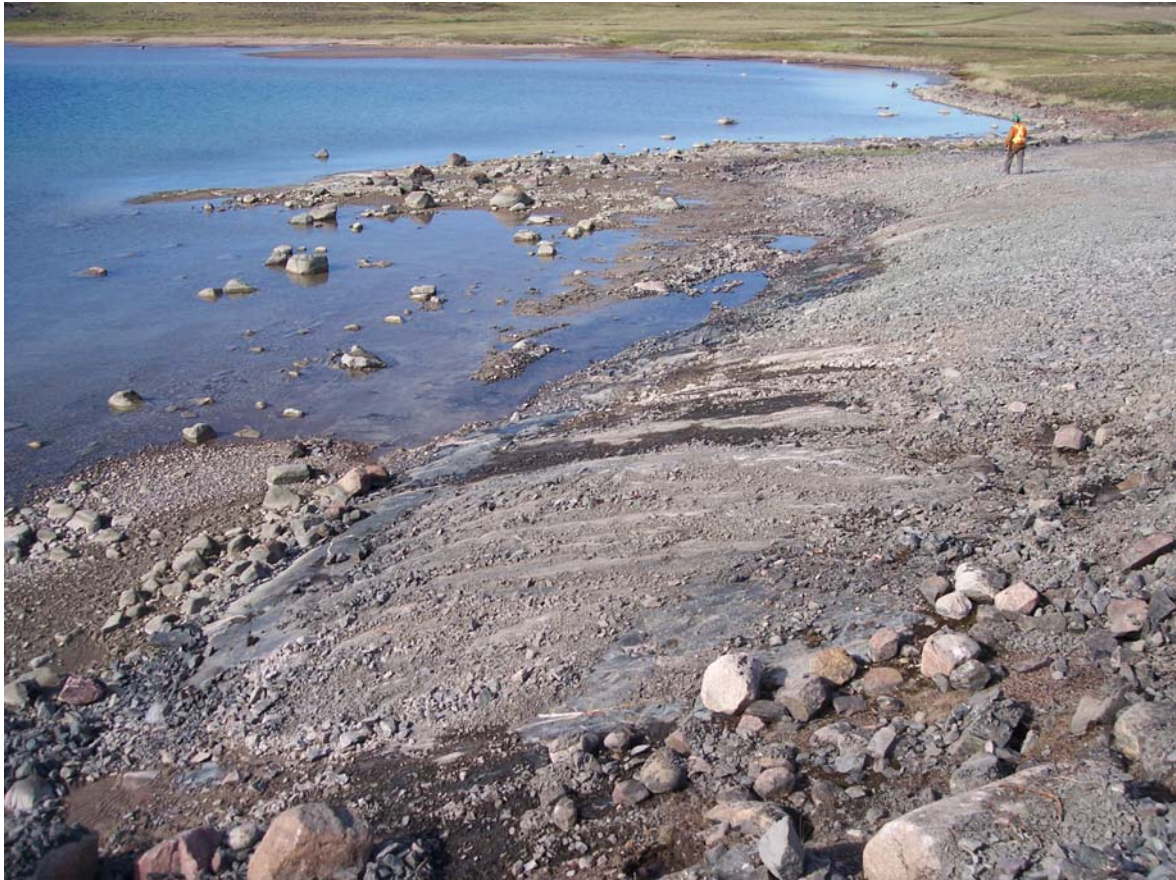
Final grading of shoreline excavation, looking south

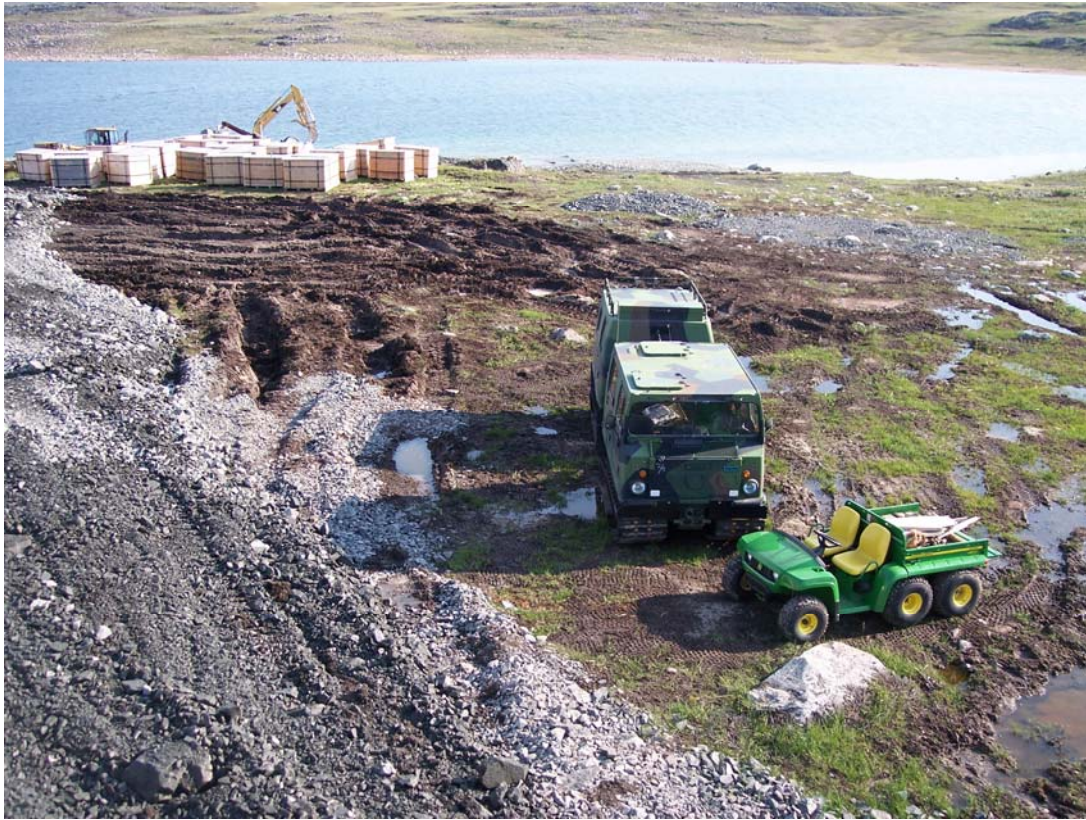
Overview of damaged tundra, looking south-east

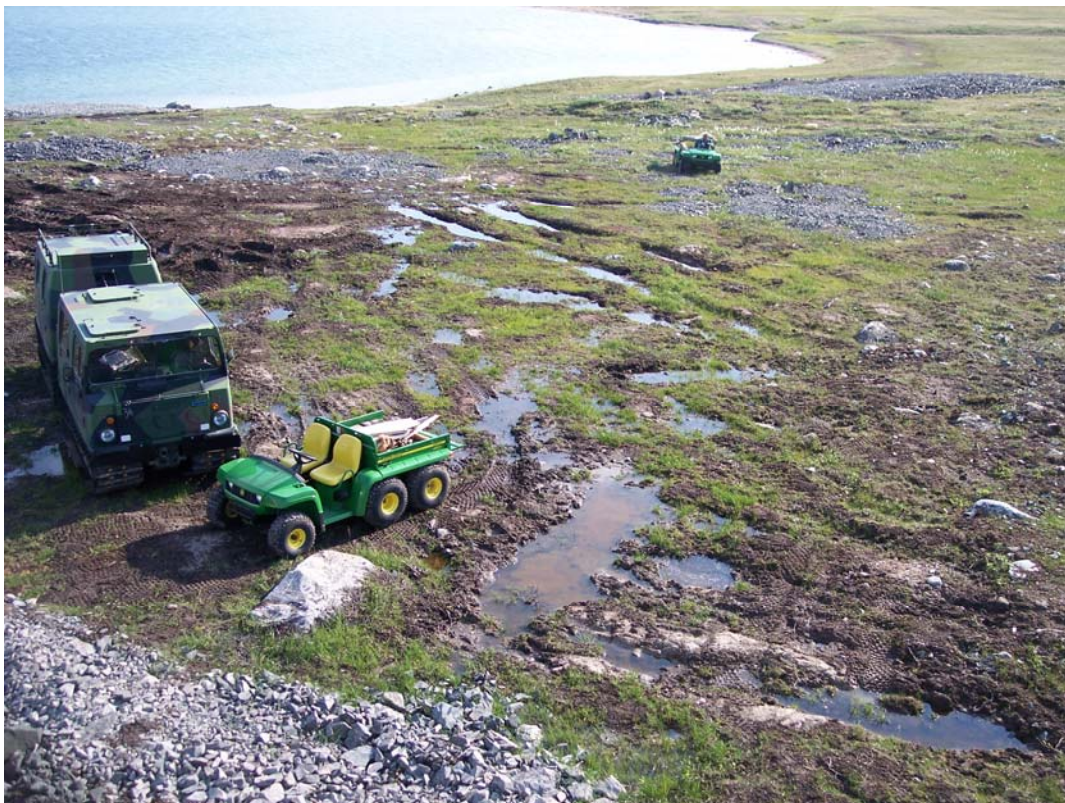
Overview of damaged tundra with backfilled exploration trench in top right corner, looking south-east

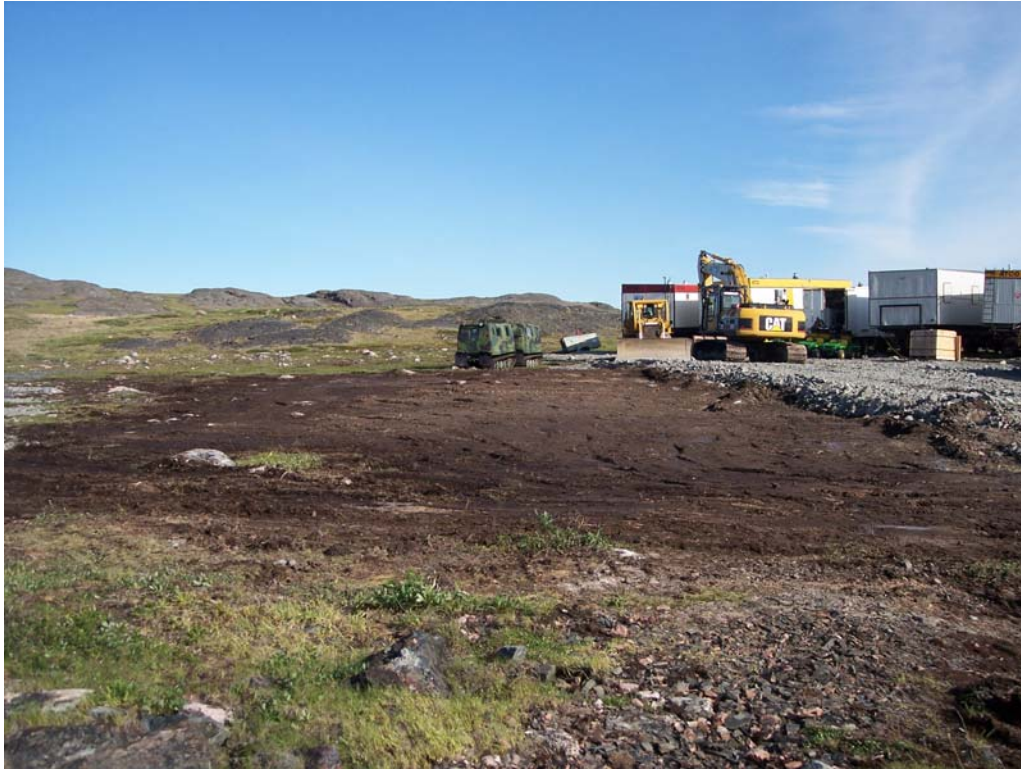
Former boxed crates lay down area re-graded after their relocation and grading of waste rock for ease of travel with machinery and equipment during loading, looking west

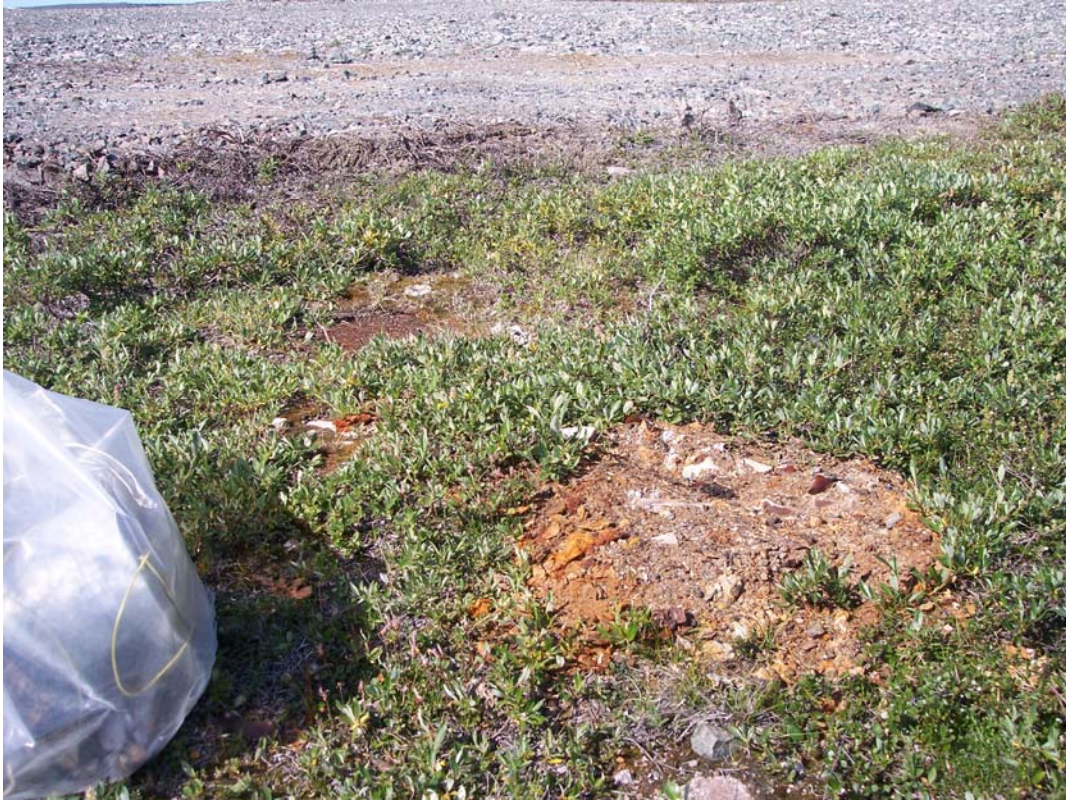
Small pile of burnt debris recovered during final clean-up at Roberts Bay

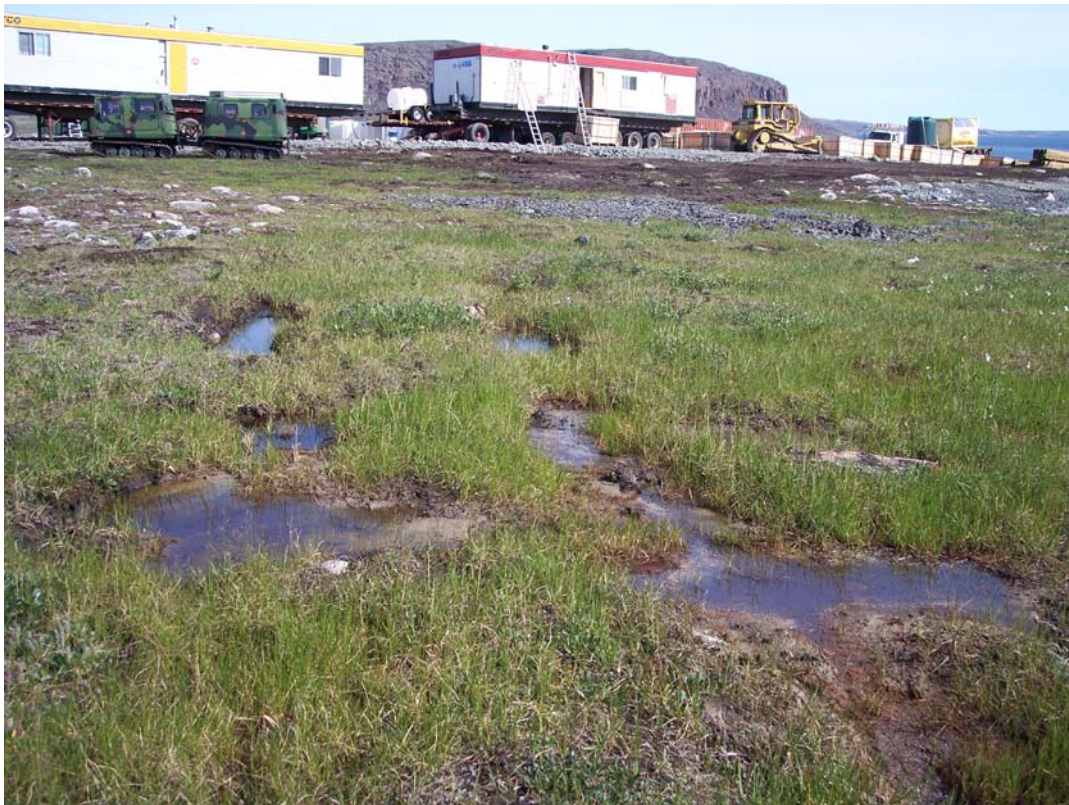
Old tracks left from former operations in the vicinity of present work, looking north-east

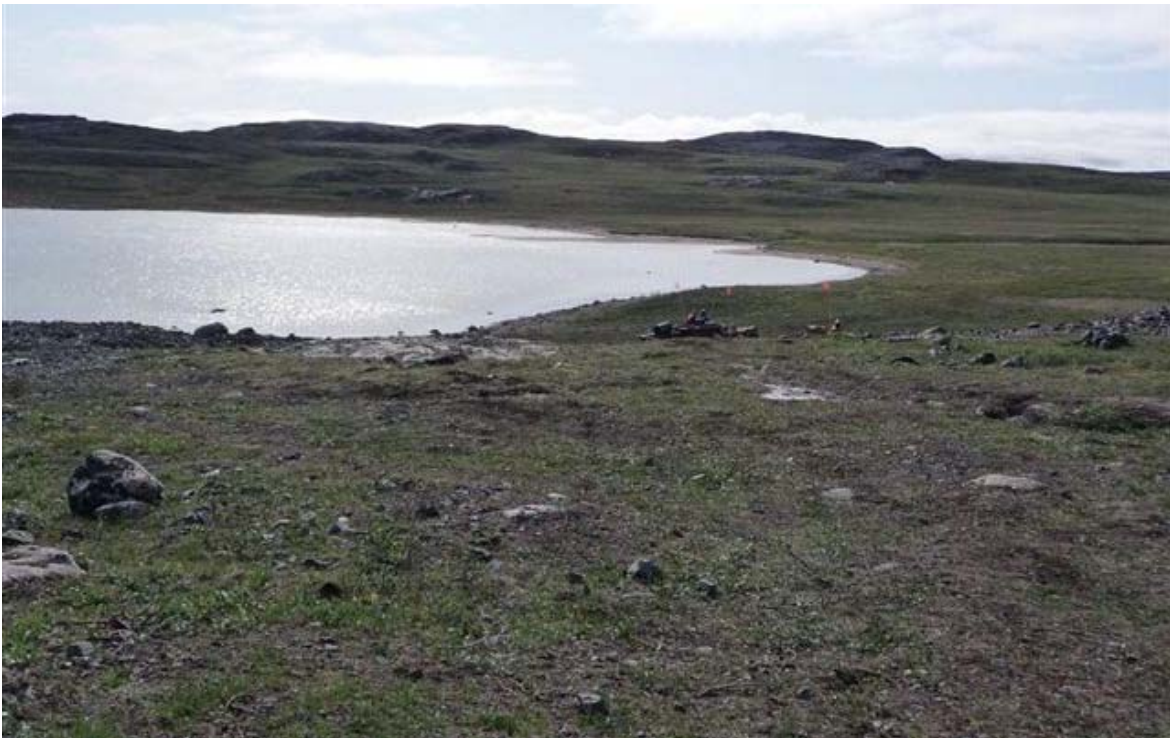
**Photograph No. 4: Ida Bay site conditions at end of 2009 Field Season**

The 2009 site work at Ida Bay (prior to the mobilization to the Roberts Bay site), entailed the blasting and collapsing of the Ida Bay adit roof. This work was undertaken on April 23, 2009. Final grading of the area was done in 2010. Photograph No. 4 shows the site conditions at the end of 2009 field season.

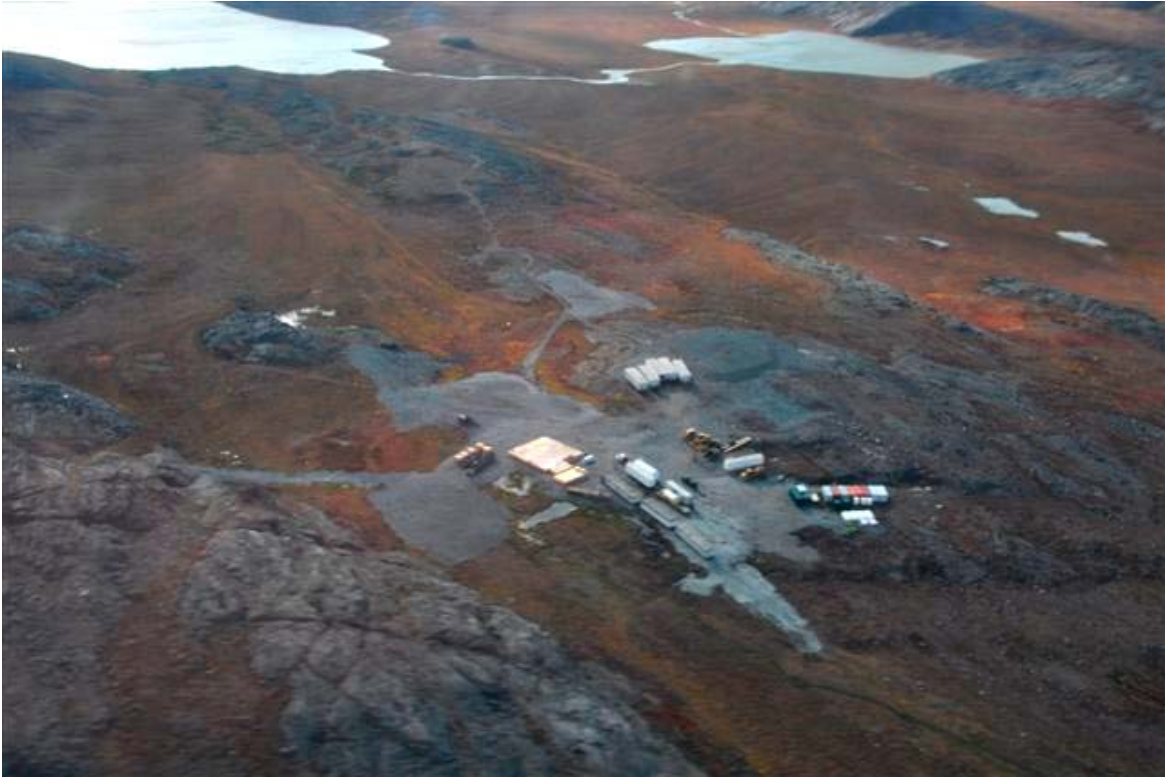
**Photograph 5: Roberts Bay site conditions at end of 2009 Field Season**

Site work for the 2009 field season at the Roberts Bay site started July 23 and ended on August 31, followed by camp shut down. The camp was vacated on September 6, 2009. During this period debris clean up work was also completed at the Ida Bay mine site. At the end of the 2009 field season the equipment, materials and supplies at the Roberts Bay site were winterized in anticipation of the 2010 demobilization work. Site conditions at Roberts Bay at the end of the 2009 field season are presented in Photograph No. 5 to 8.
