## Completion Report for Roberts Bay and Ida Bay Mine Sites Site Remediation Program, Nunavut

FEBRUARY 2011

**SENES Consultants Limited**

This Completion Report presents a summary of the remediation works completed at the Roberts Bay and Ida Bay Mine sites during the 2009 and 2010 field seasons. The Remediation Project consisted of the installation of mine seals at the respective openings, re-grading of waste rock to fill in low lying areas and other depressions, placement of a waste rock cap over the former domestic landfill, removal of waste rock from below the high water mark along the shoreline to Melville Sound, demolition of abandoned structures, consolidation and containerization of hazardous waste, relocation and containment of non-hazardous debris and waste within a solid waste management facility, mitigation of chemical impacts in the subsurface at discrete locations on-site, and construction of a solid waste management facility within the limits of the former tailings containment area to provide suitable cover over the tailings.

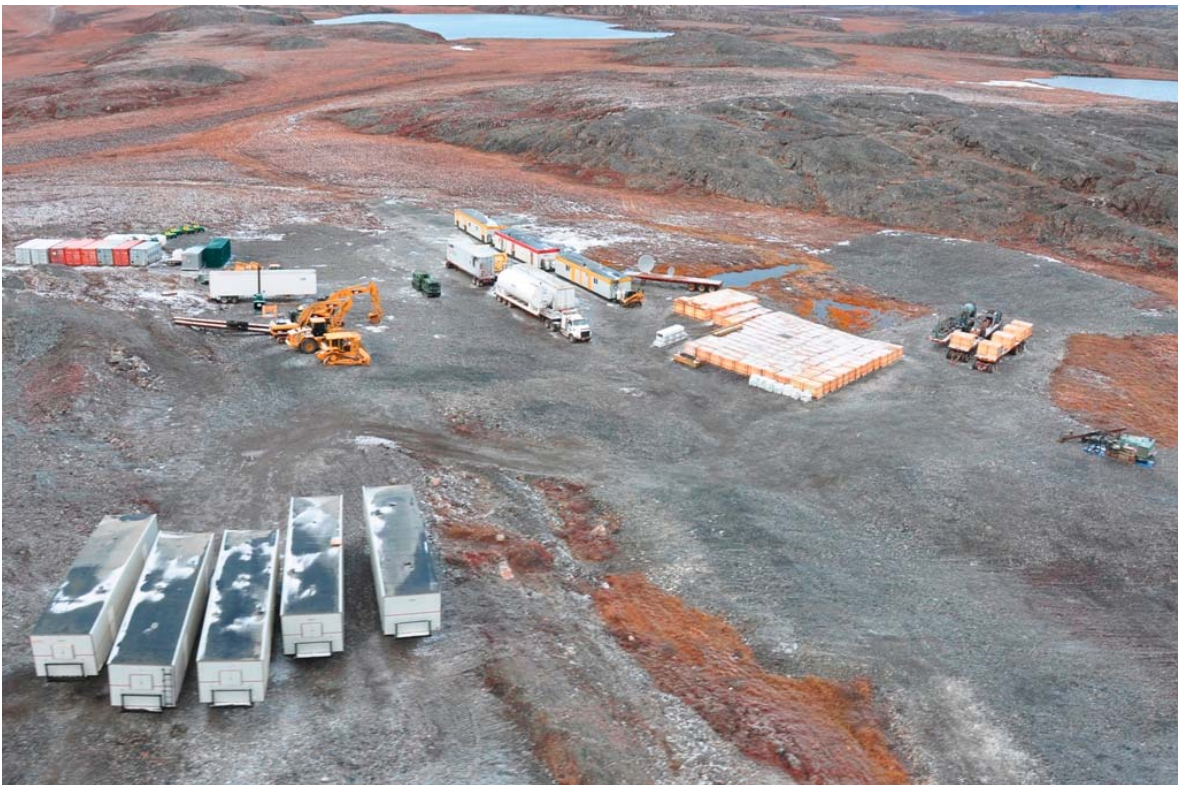
**Photograph 6: Roberts Bay site conditions at end of 2009 Field Season looking west**

Site work for the 2009 field season at the Roberts Bay site started July 23 and ended on August 31, followed by camp shut down. The camp was vacated on September 6, 2009. During this period debris clean up work was also completed at the Ida Bay mine site. At the end of the 2009 field season the equipment, materials and supplies at the Roberts Bay site were winterized in anticipation of the 2010 demobilization work. Site conditions at Roberts Bay at the end of the 2009 field season are presented in Photograph No. 5 to 8.

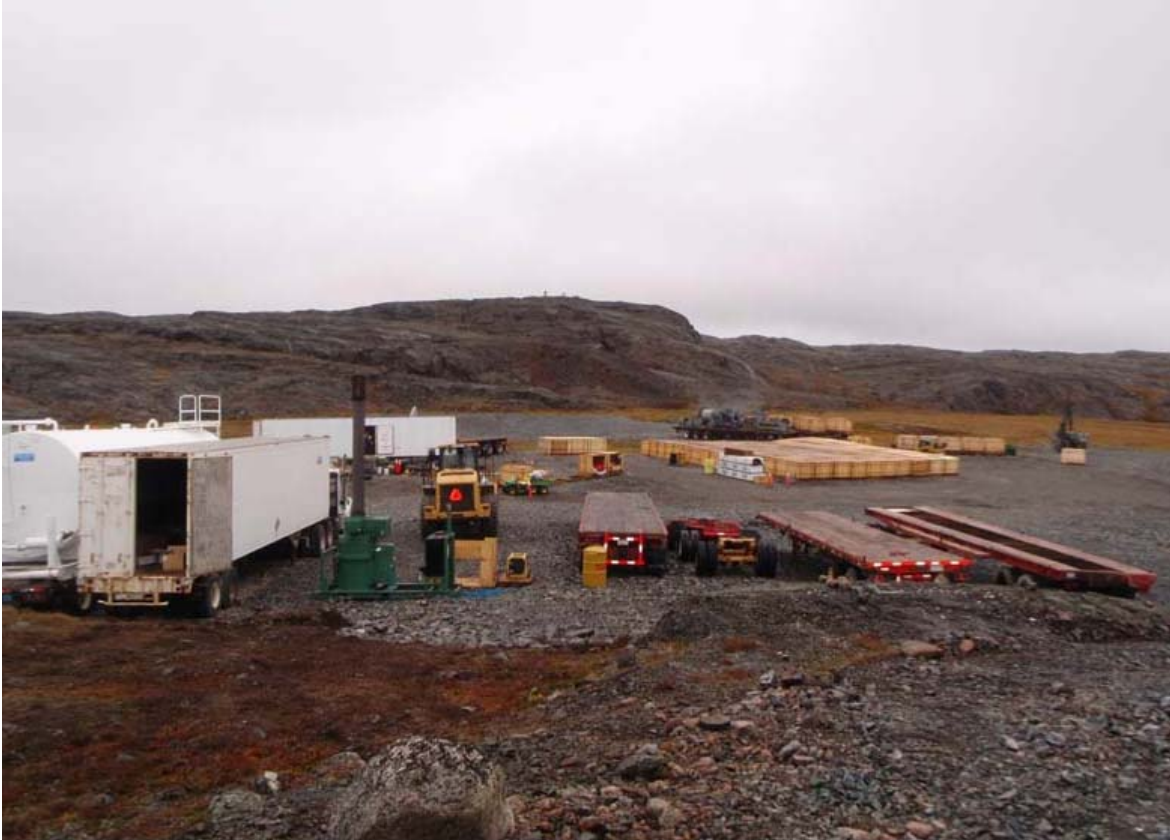
**Photograph 7: Roberts Bay site conditions at end of 2009 Field Season looking east**

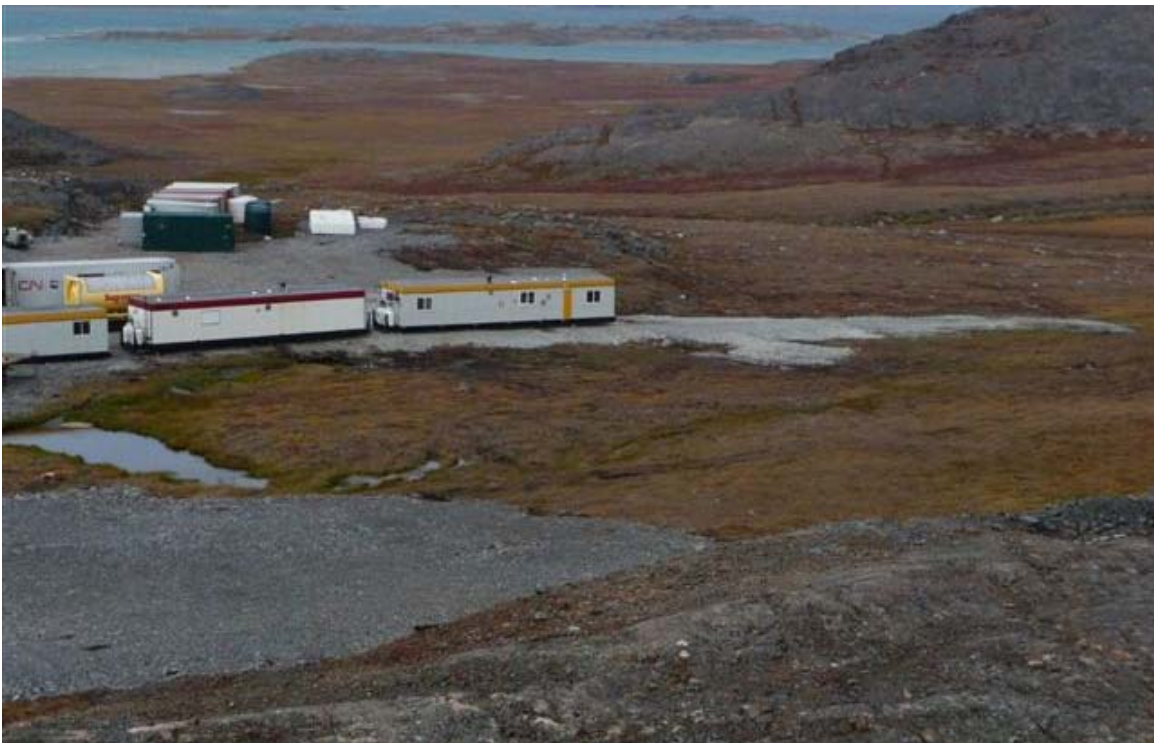
**Photograph 8: Roberts Bay site conditions at end of 2009 Field Season**

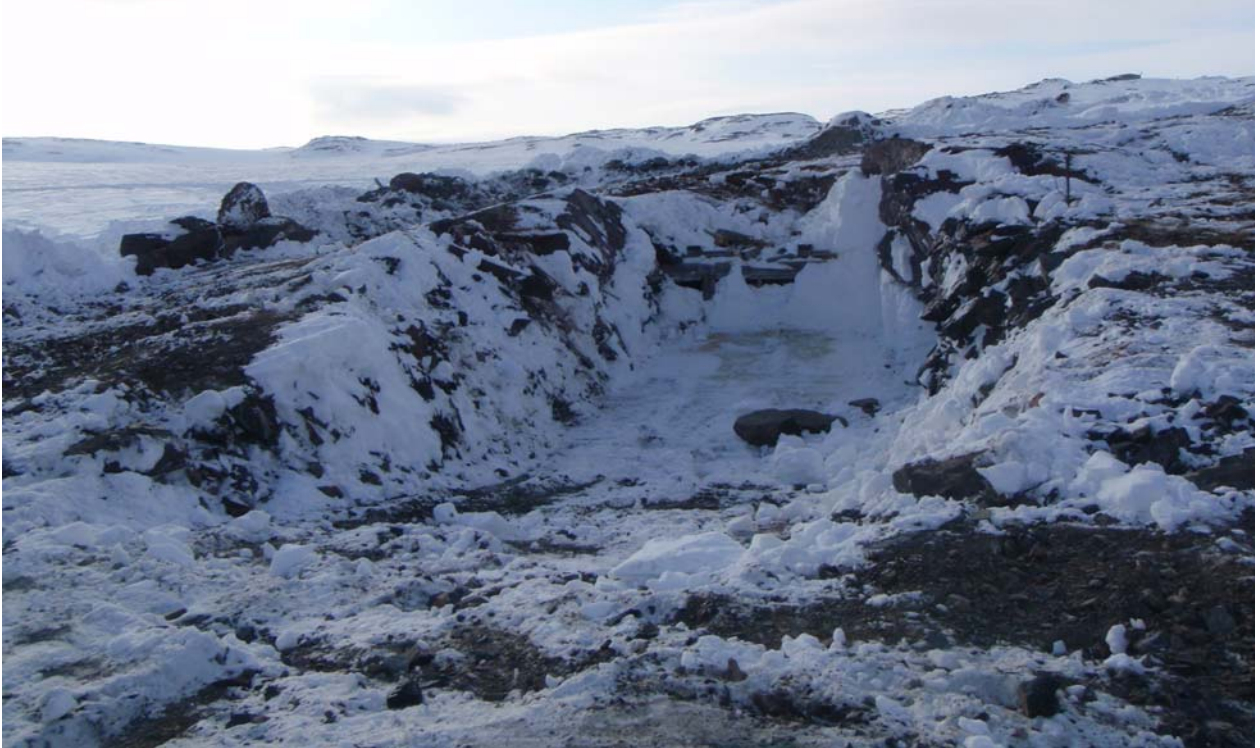
**Photograph No. 9: Adit at Ida Bay prior to blasting**

On 23 April 2009 the roof of the Ida Bay adit was blasted and waste rock from the area immediately adjacent the adit was used to partially fill the depression. Photograph No. 9 and 10 show the before and after condition of the adit prior to equipment being mobilized to the Roberts Bay Mine site.

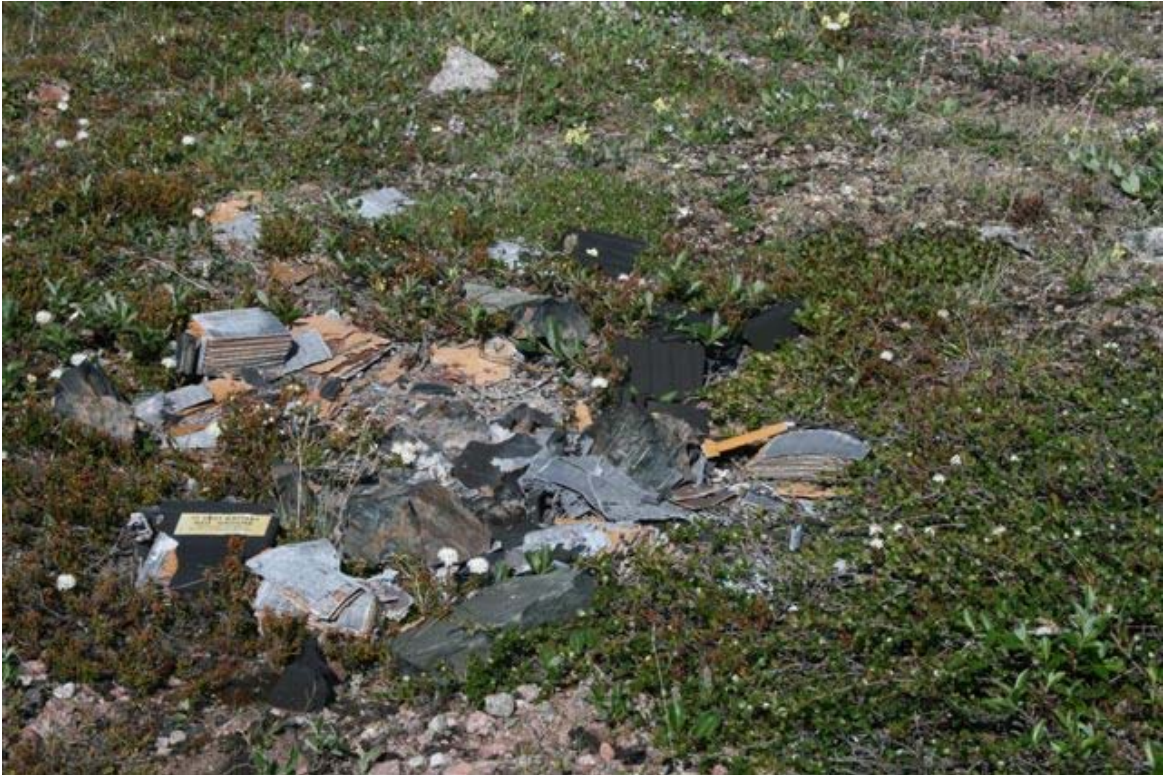
**Photograph No. 37: Hazardous Materials at Ida Bay Mine Site**

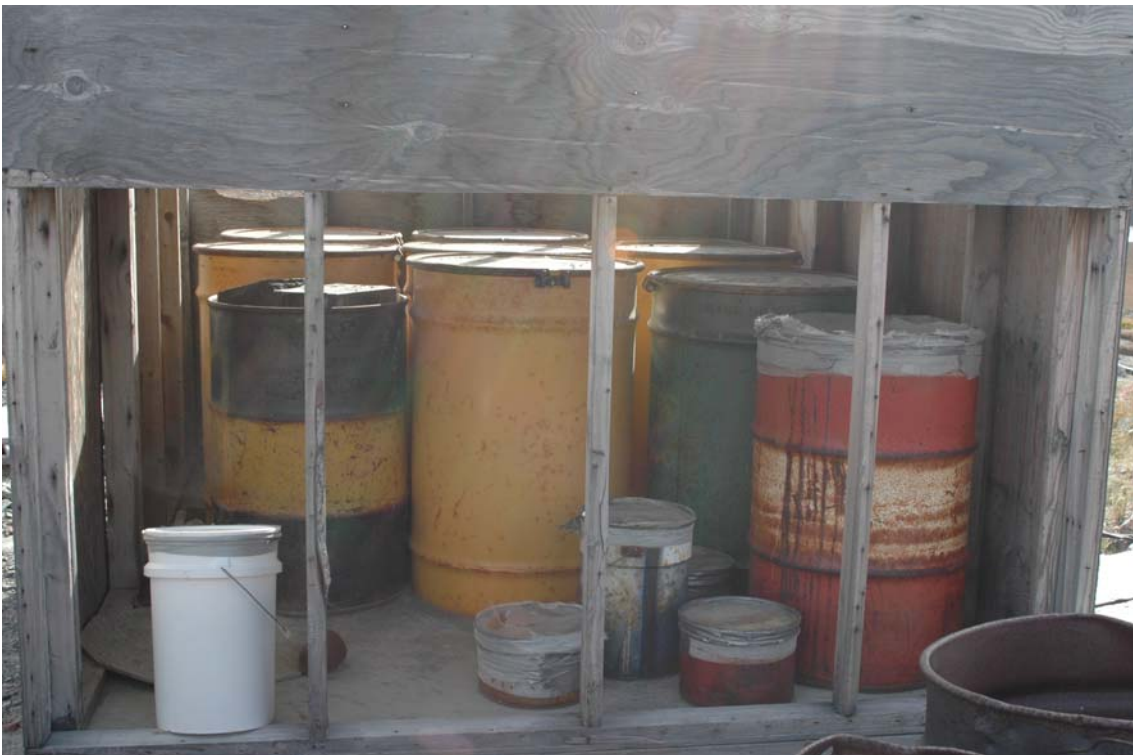
**Photograph No. 38: Hazardous Materials at Roberts Bay Mine Site**

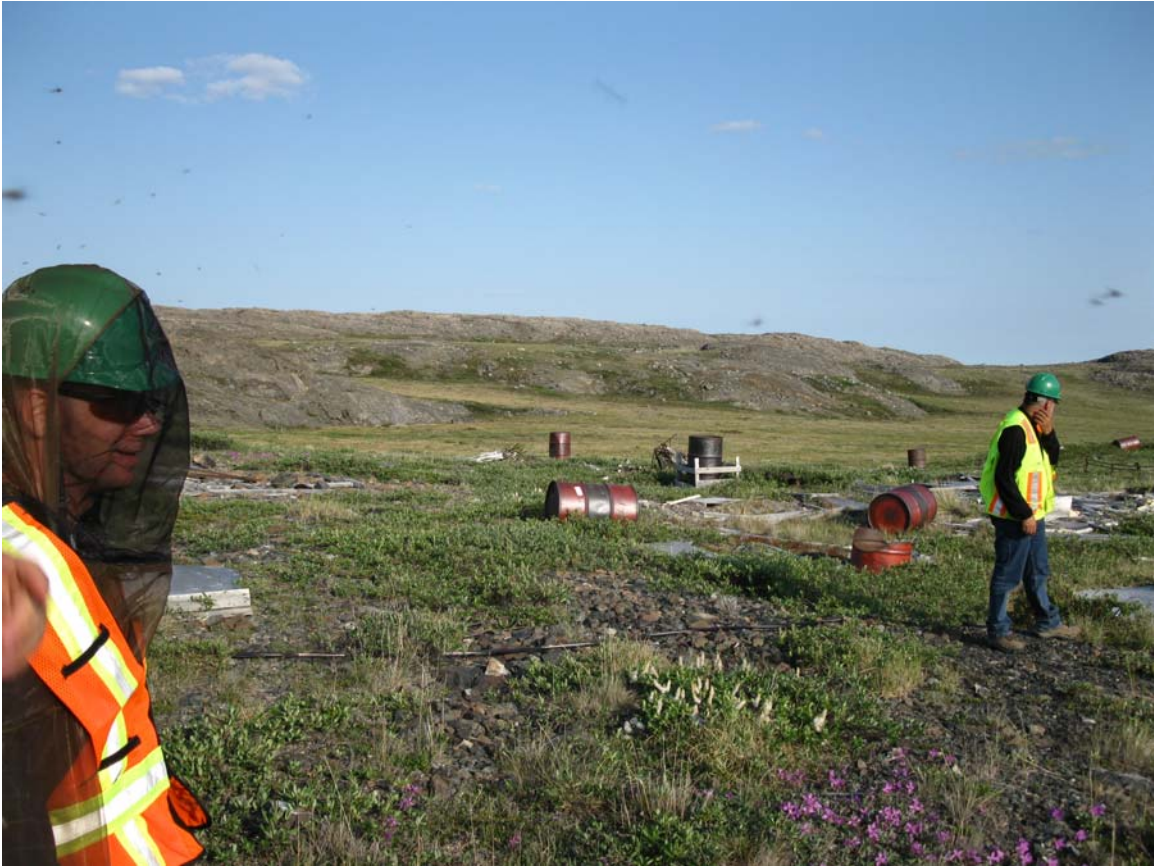
**Photograph No. 39: Hazardous Materials at Roberts Bay Mine Site**

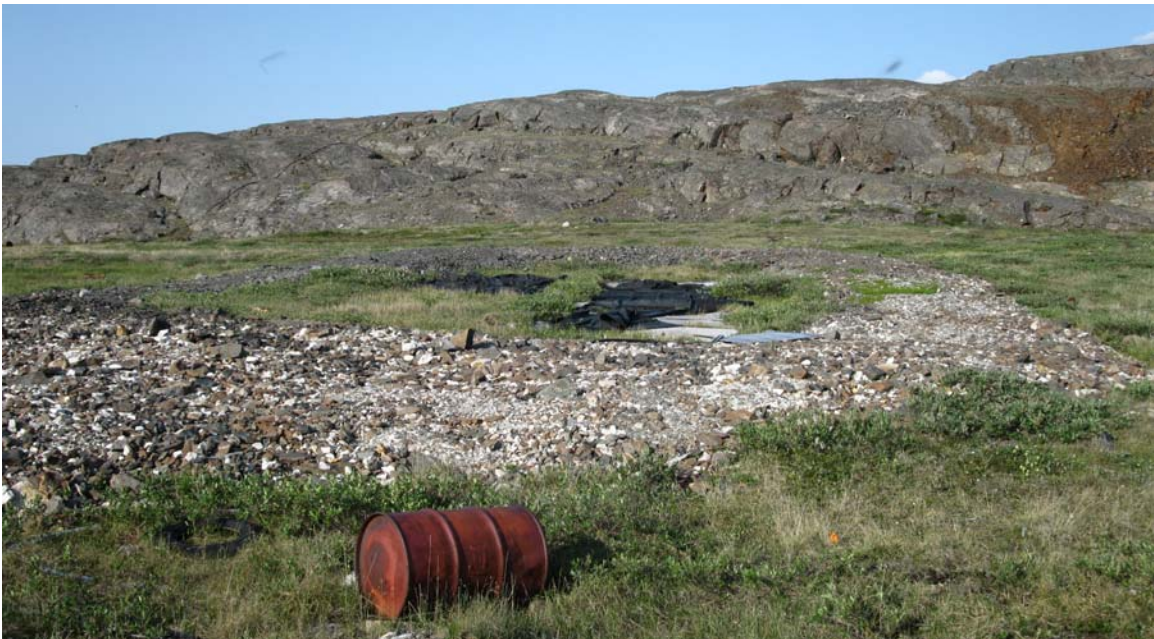
**Photograph No. 40: Hazardous Materials at Roberts Bay Mine Site**

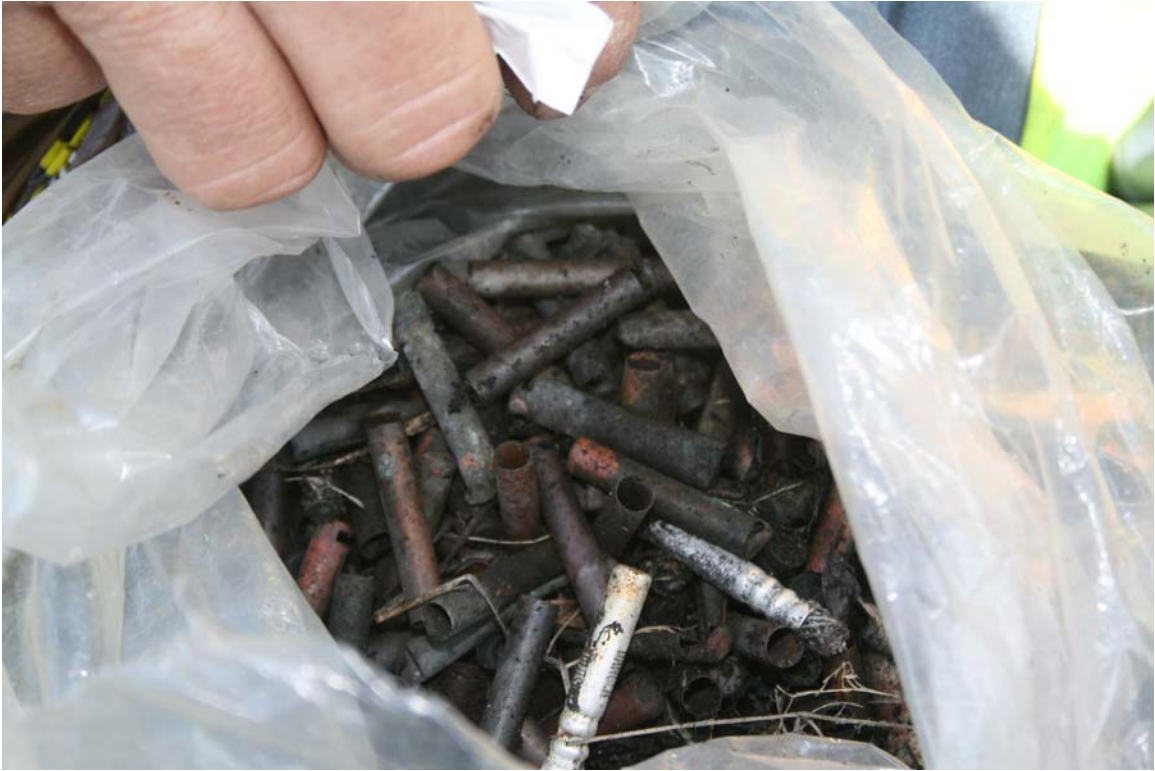
**Photograph No. 41: Hazardous Materials at Roberts Bay Mine Site**

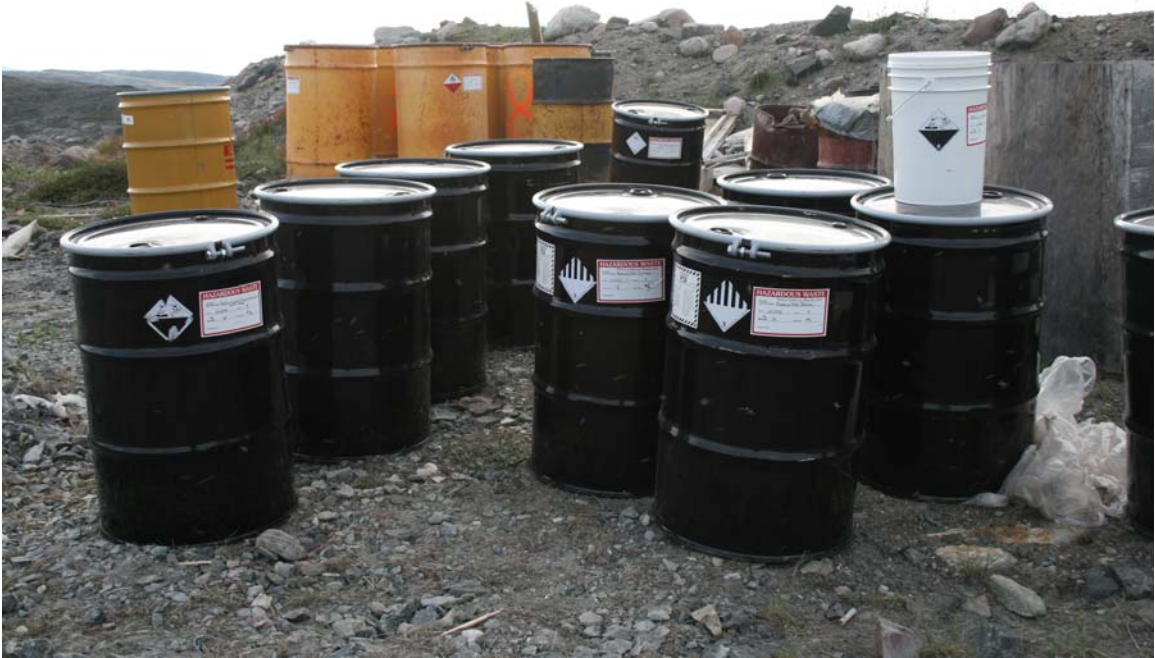
**Photograph No. 42: Hazardous Materials at Roberts Bay Mine Site**

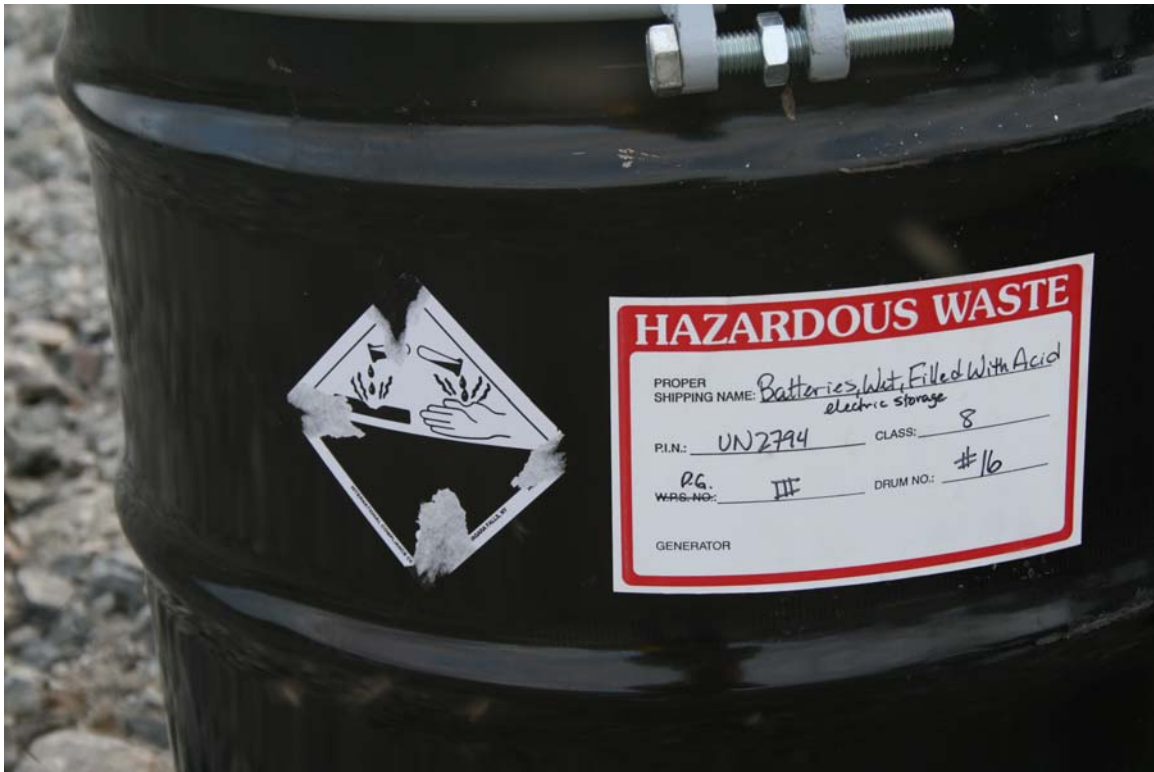
**Photograph No. 43: Hazardous Materials at Roberts Bay Mine Site**

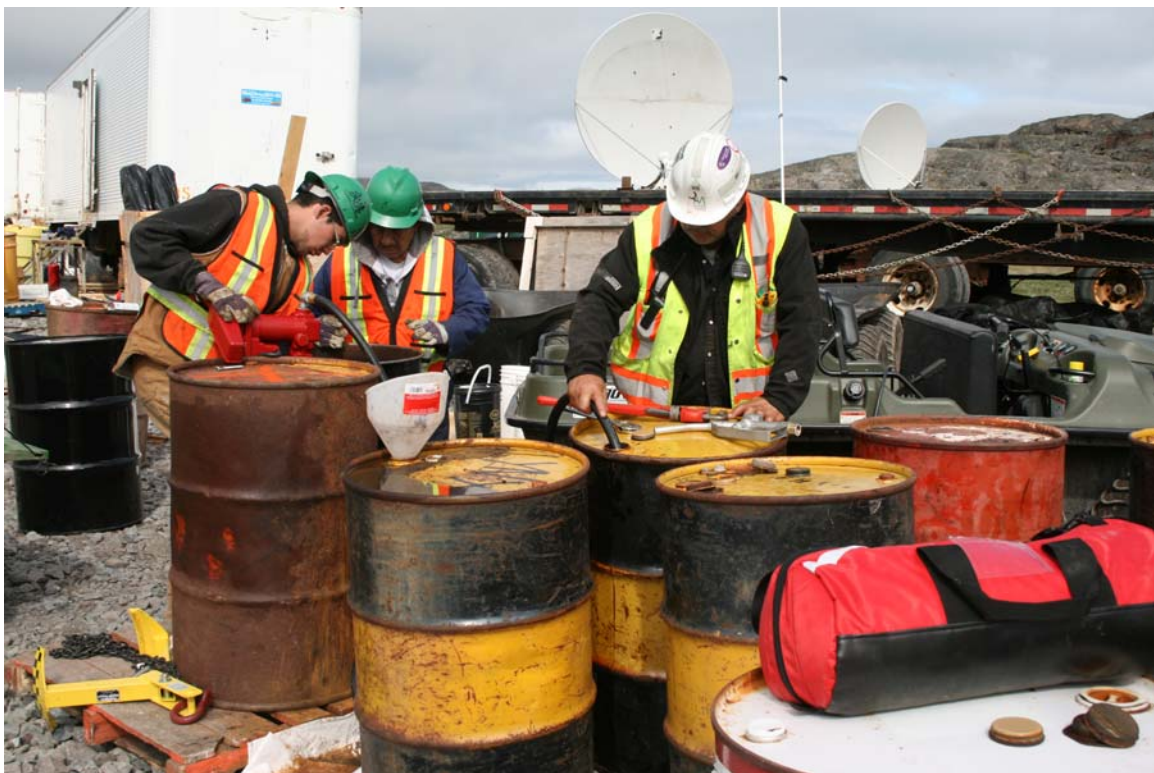
**Photograph No. 44: Hazardous Materials at Roberts Bay Mine Site**

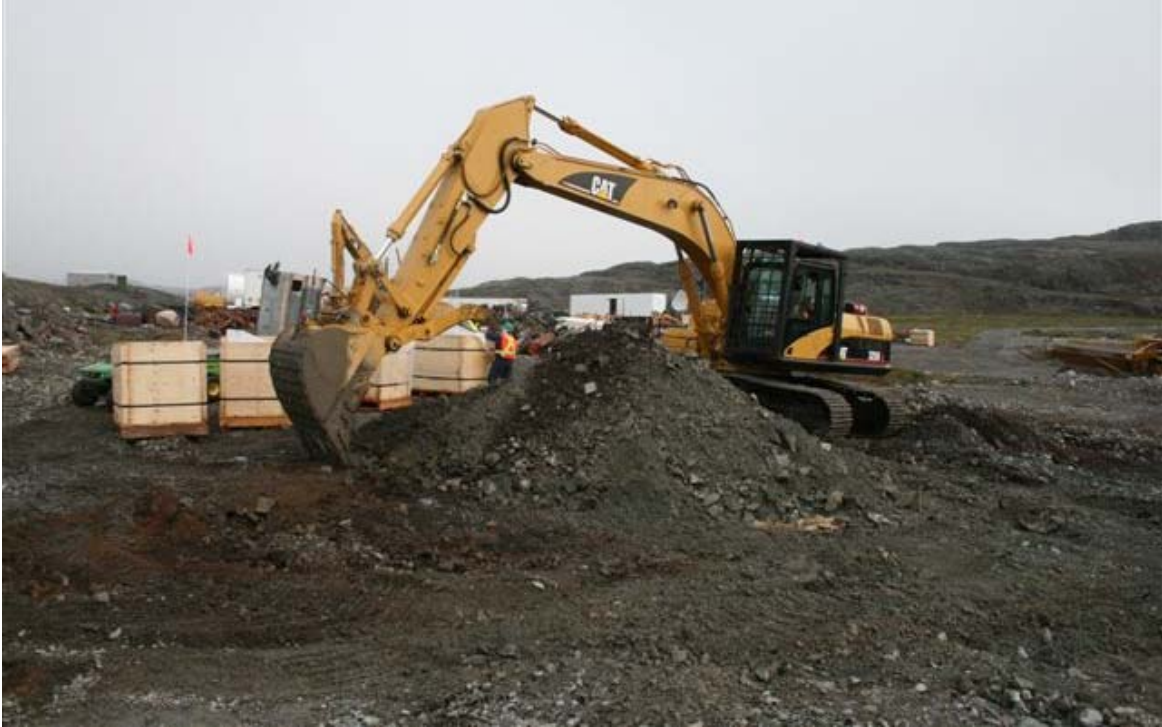
**Photograph No. 45: Metal Impacted soil remediation at the Mill Area of Roberts Bay**

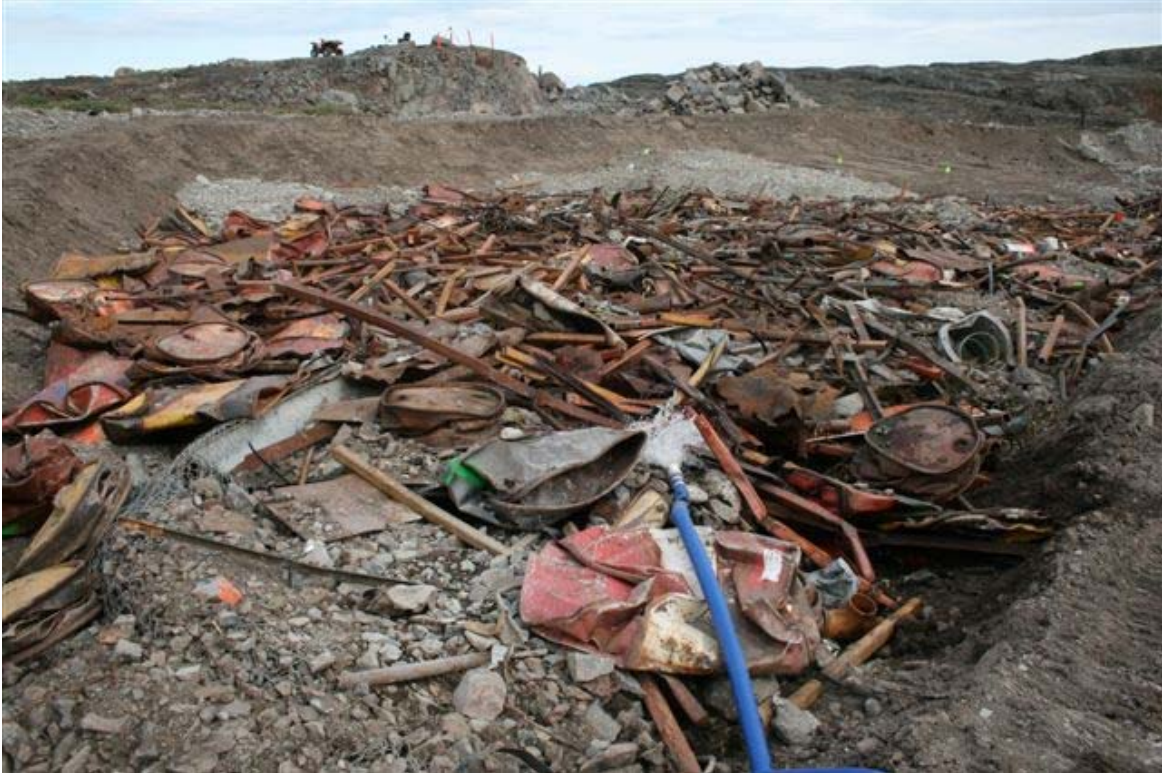
**Photograph No. 63: Placement of non-hazardous debris into SWMF**

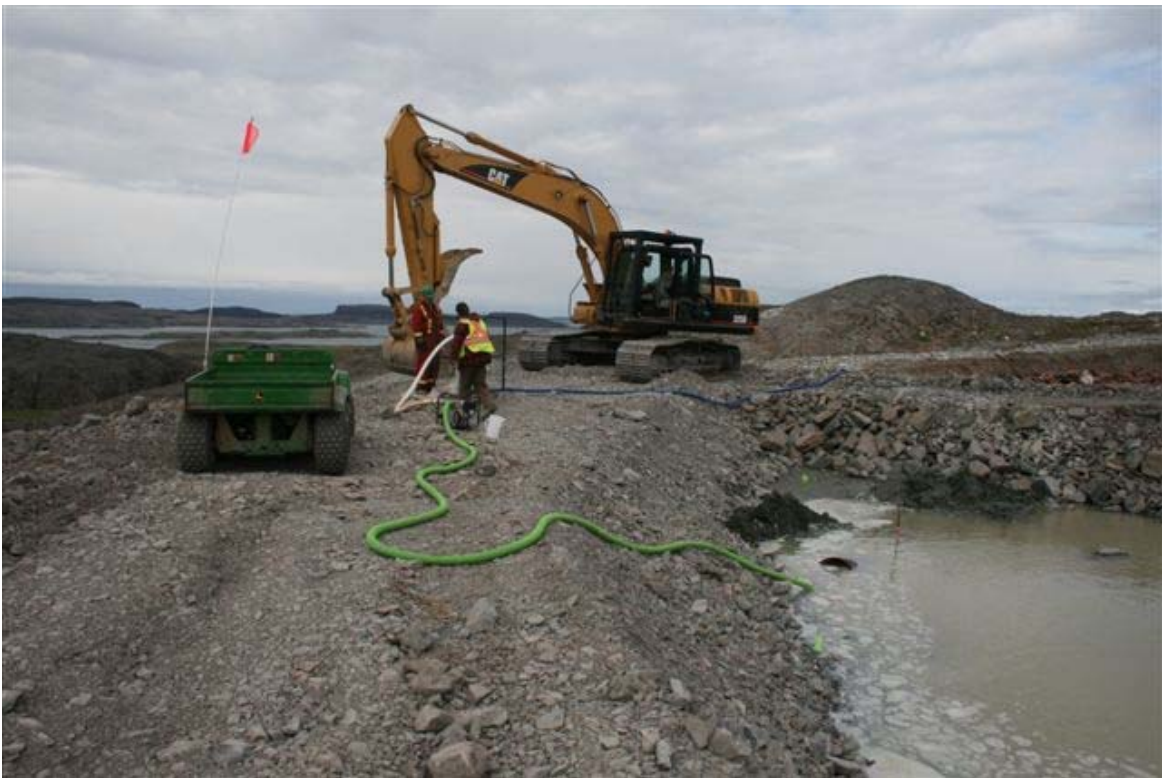
**Photograph No. 64: Decanting water above tailings to dry side of SWMF**
