## **Long Term Monitoring, 2012 SWMF Landfill, Roberts Bay, Nunavut**

### **FINAL REPORT**

Project No. 1697-1201  
January 2013

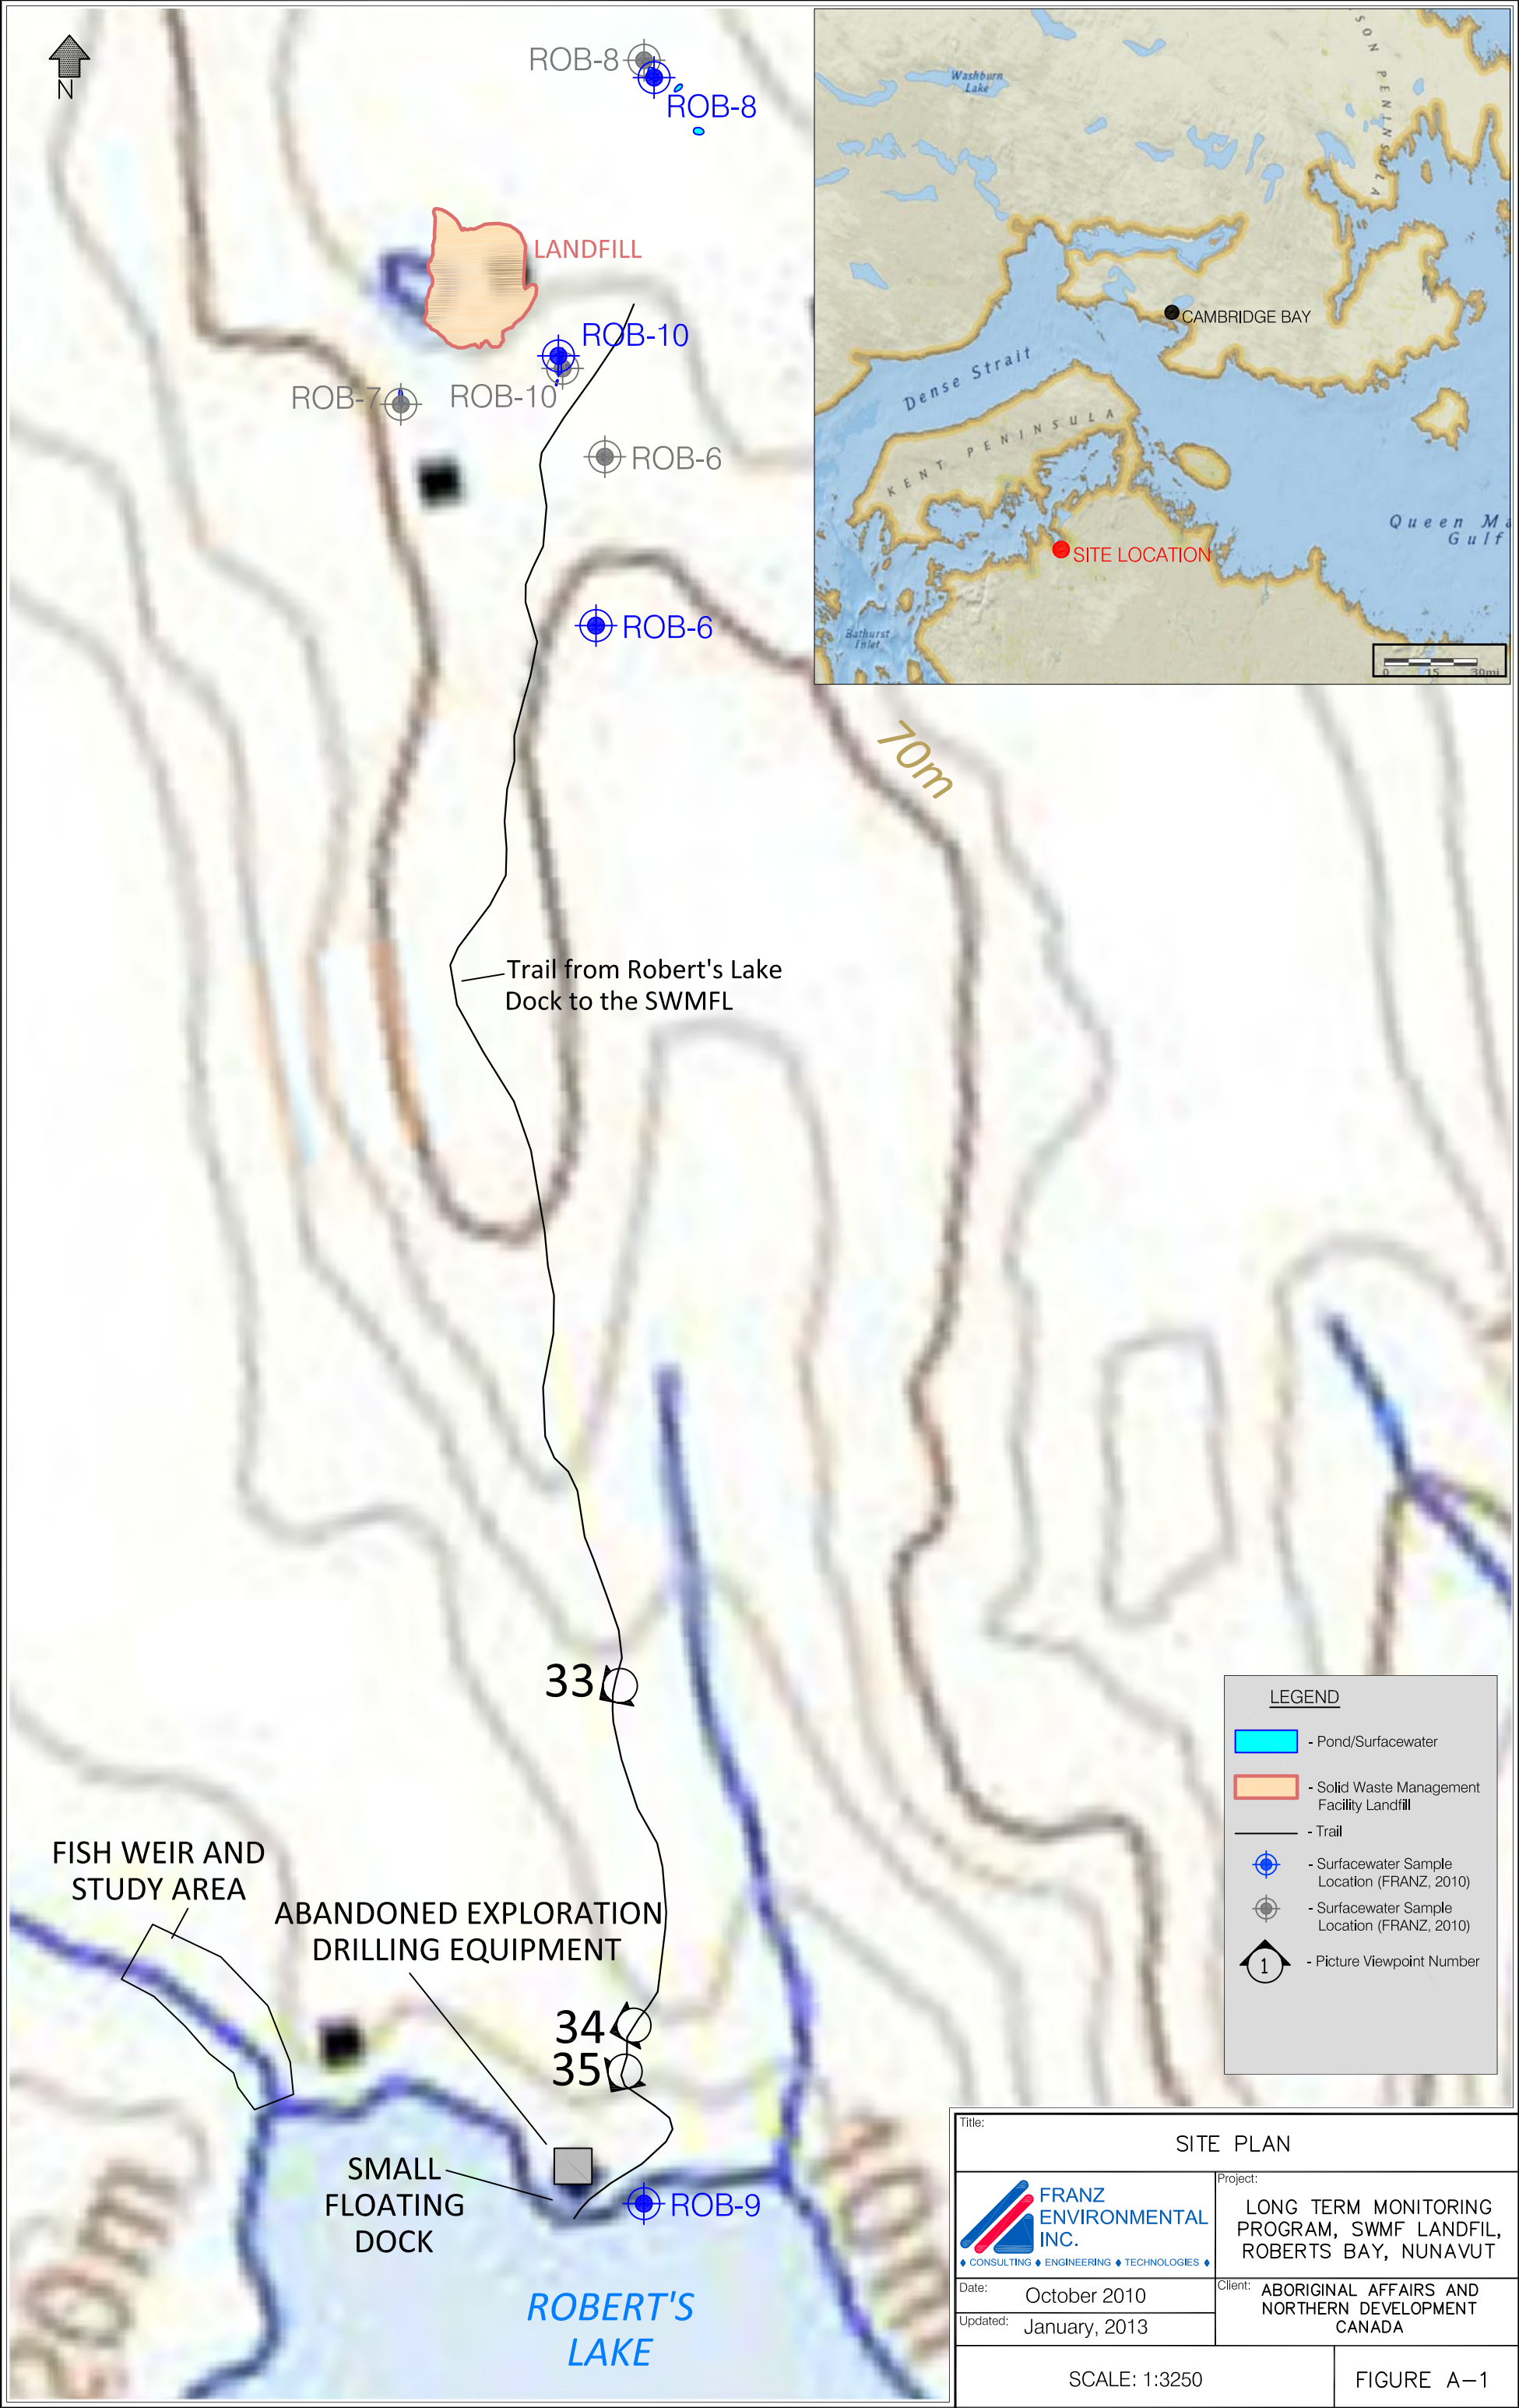
Title: SITE PLAN

Constructed during remediation in the summer of 2009, the SWMF is a non-hazardous waste landfill built over the former tailings pond, as seen on Figures A-1 and A-2, Appendix A (also refer to Photos 1 to 3, Appendix F). Monitoring procedures adopted by AANDC for this site are similar to those defined in the AANDC Abandoned Military Site Remediation Protocol, AMSRP, with some modifications as applicable to mine sites.

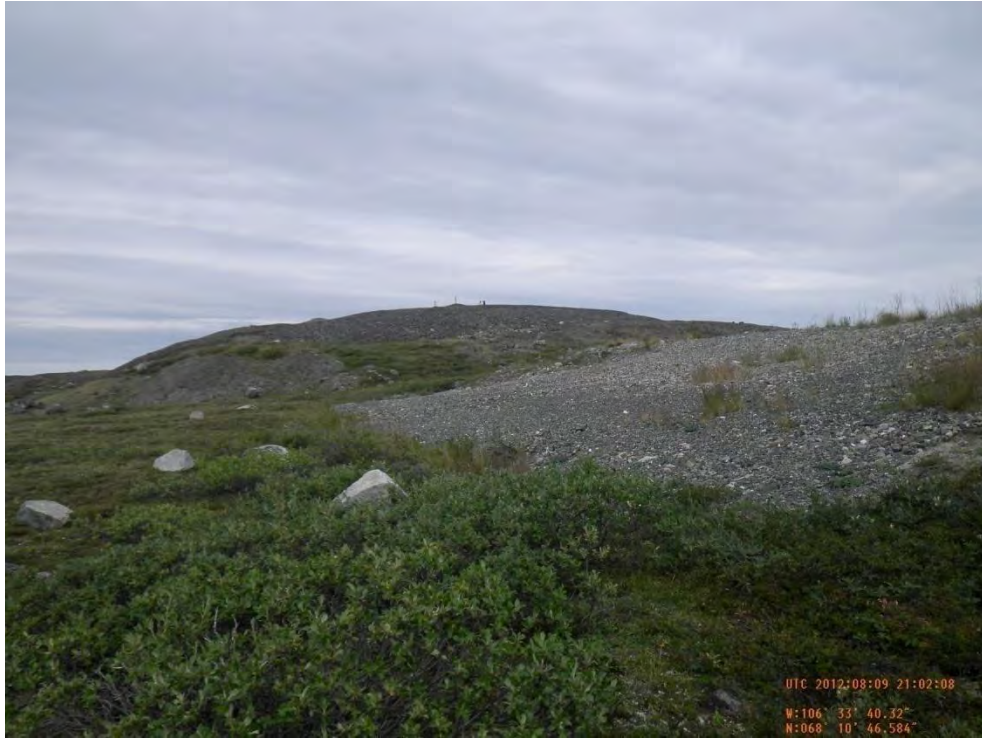
South side of Solid Waste Management Facility Landfill (SWMFL). Viewpoint 1 (Figure A-2; Appendix A). Photograph reference RIMG0001. Direction photo taken: N

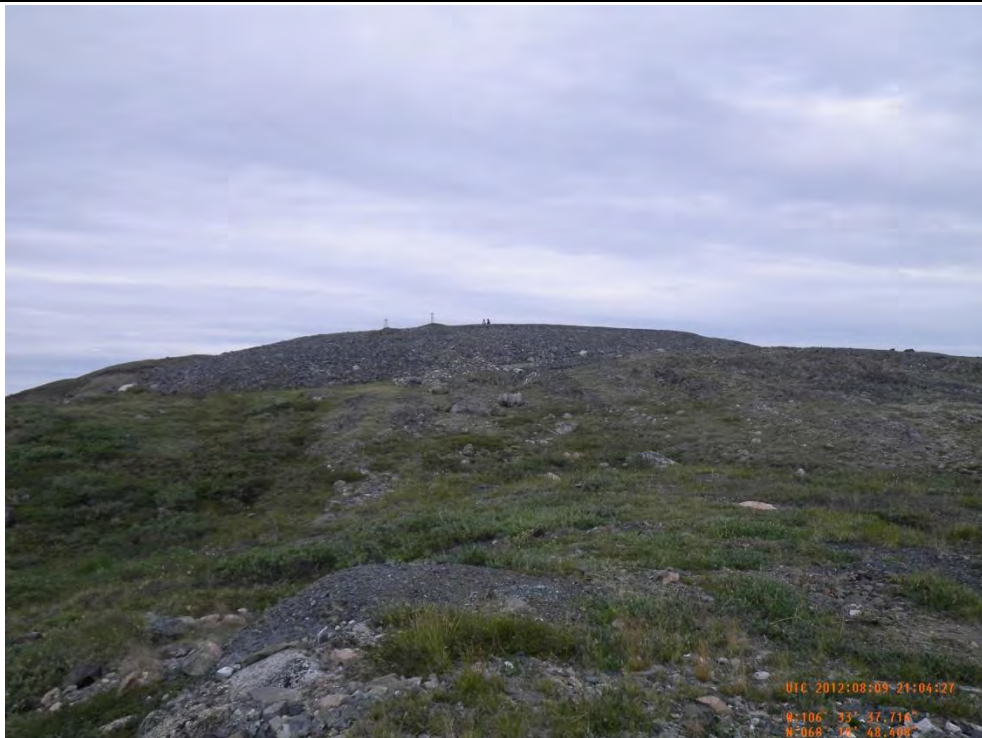
South side of SWMFL. Viewpoint 2 (Figure A-2; Appendix A). Photograph reference RIMG0002.  
Direction photo taken: N

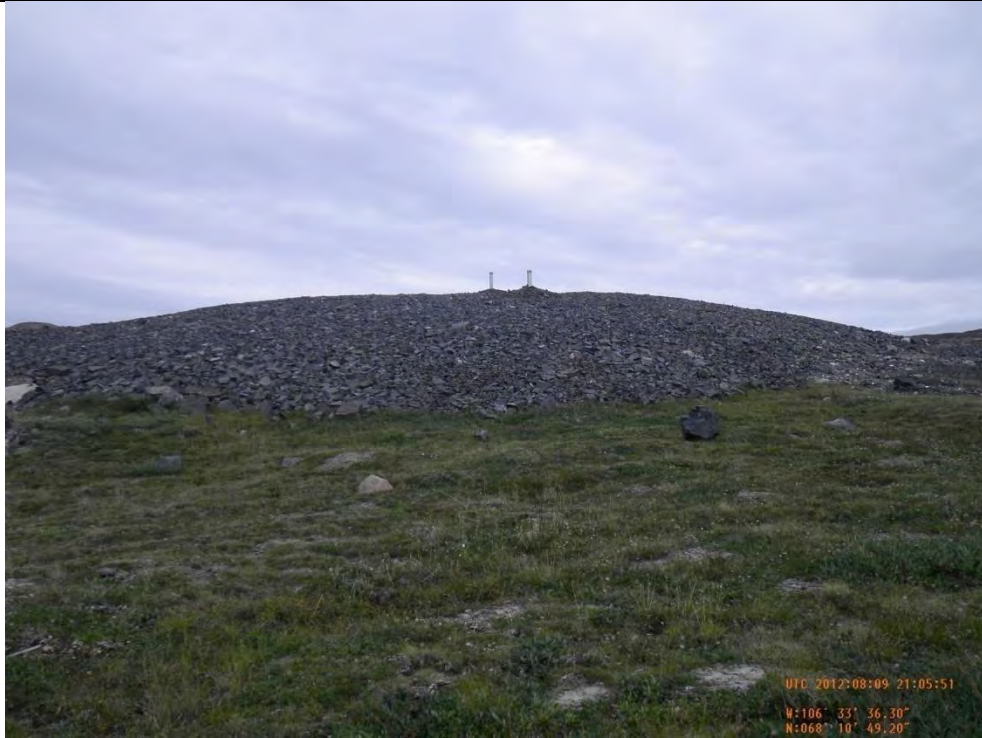
South side of SWMFL. Viewpoint 3 (Figure A-2; Appendix A). Photograph reference RIMG0003.  
Direction photo taken: N

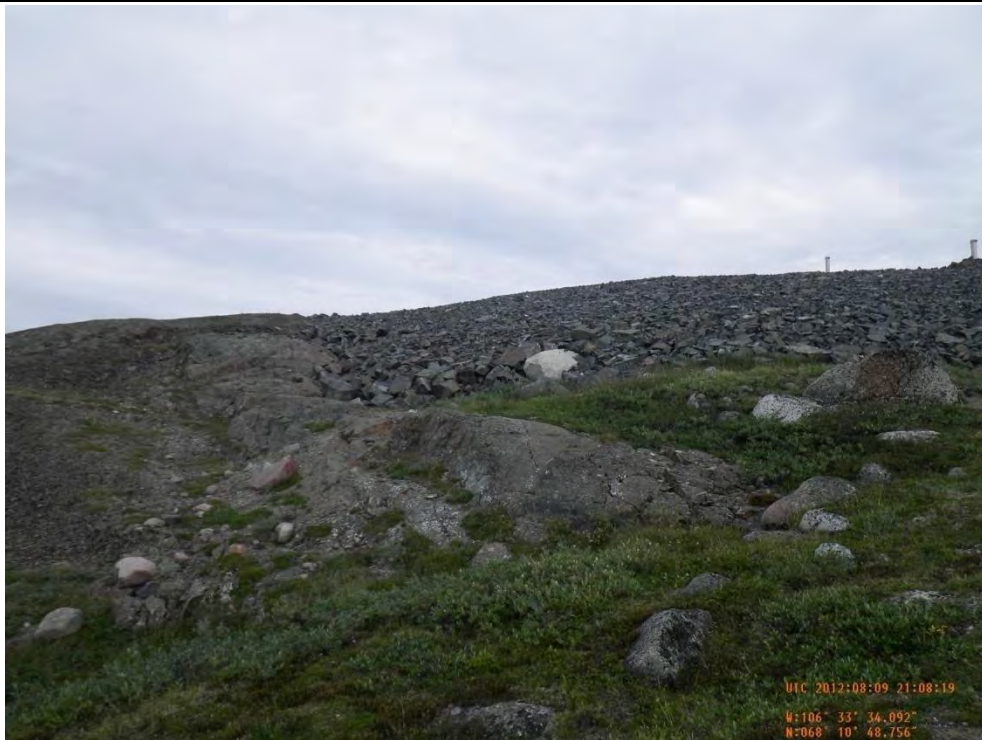
West edge of SWMFL. Viewpoint 4 (Figure A-2; Appendix A). Photograph reference RIMG0004.  
Direction photo taken: N

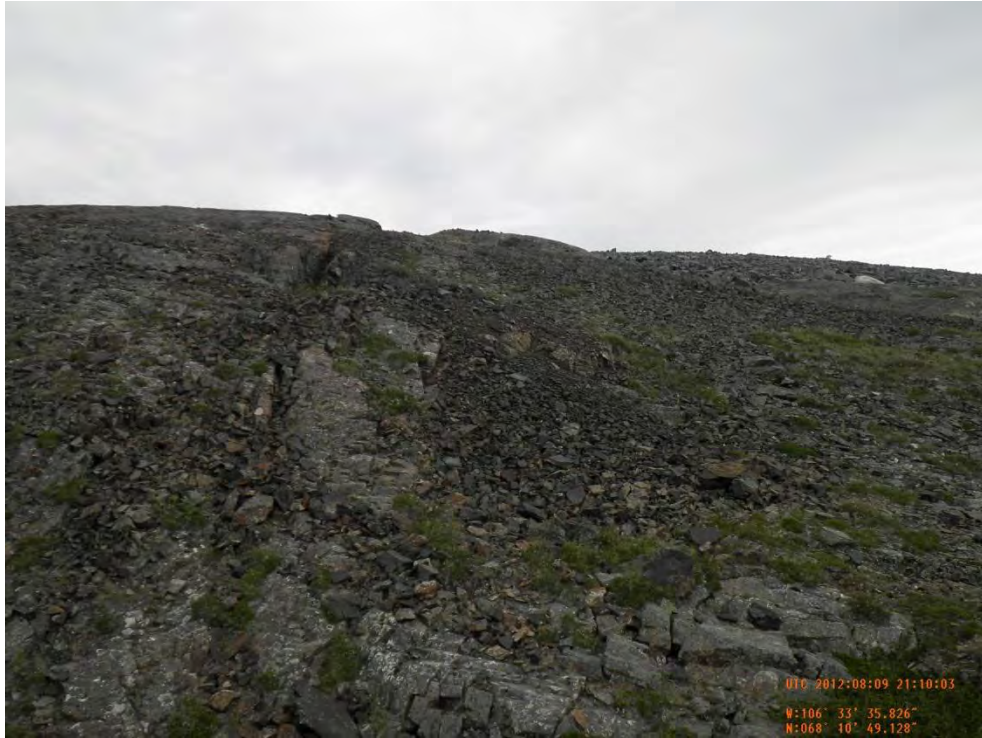
West side of SWMFL. Viewpoint 5 (Figure A-2; Appendix A). Photograph reference RIMG0005.  
Direction photo taken: E

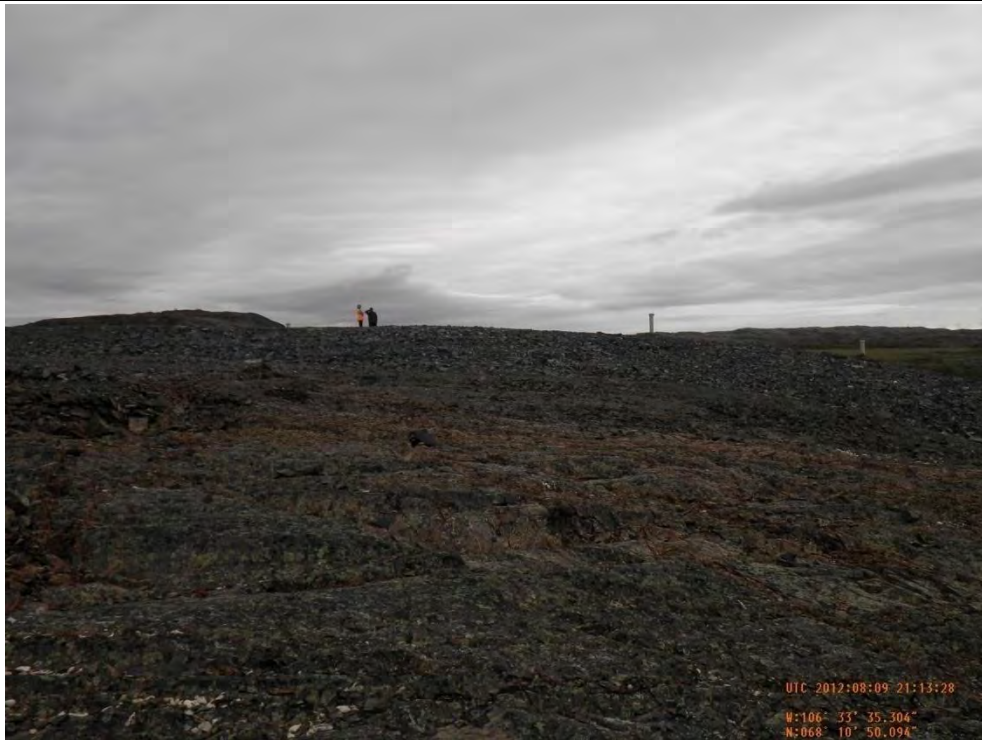
West side of SWMFL. Viewpoint 6 (Figure A-2; Appendix A). Photograph reference RIMG0006.  
Direction photo taken: E

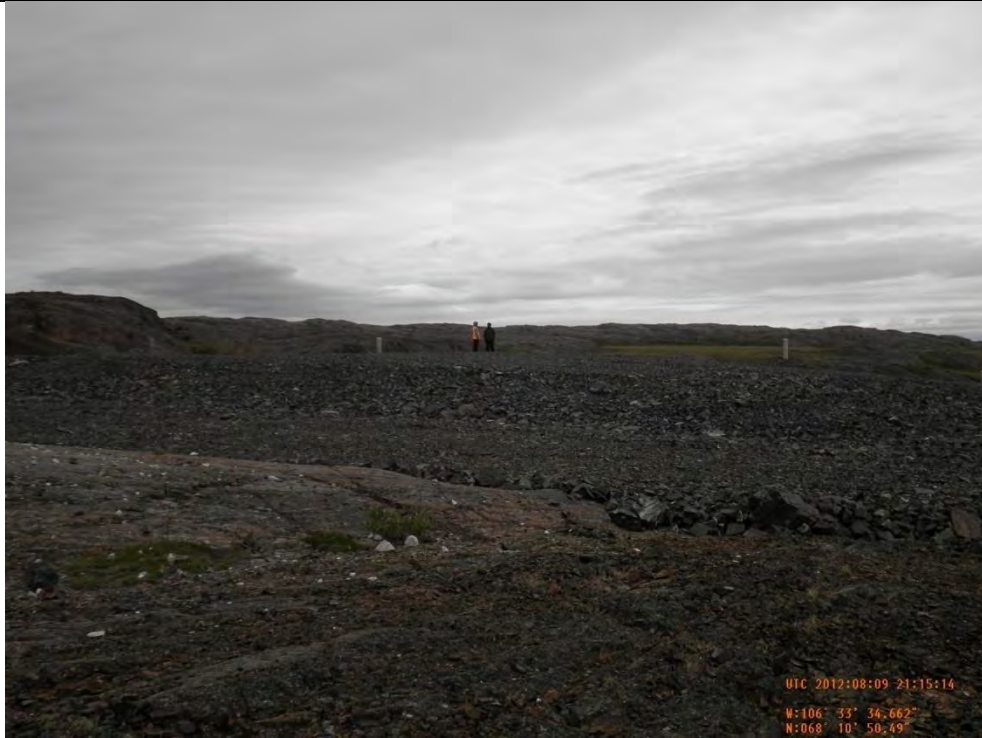
West side of SWMFL. Viewpoint 7 (Figure A-2; Appendix A). Photograph reference RIMG0007.  
Direction photo taken: E

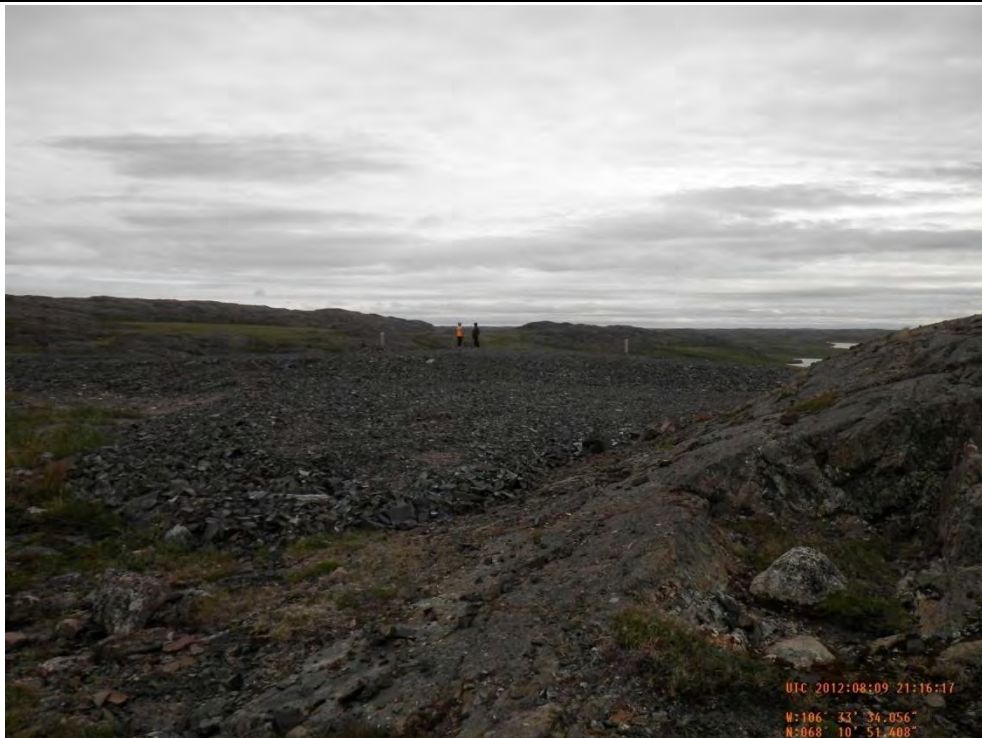
Northwest corner of SWMFL. Viewpoint 8 (Figure A-2; Appendix A). Photograph reference RIMG0008.  
Direction photo taken: E

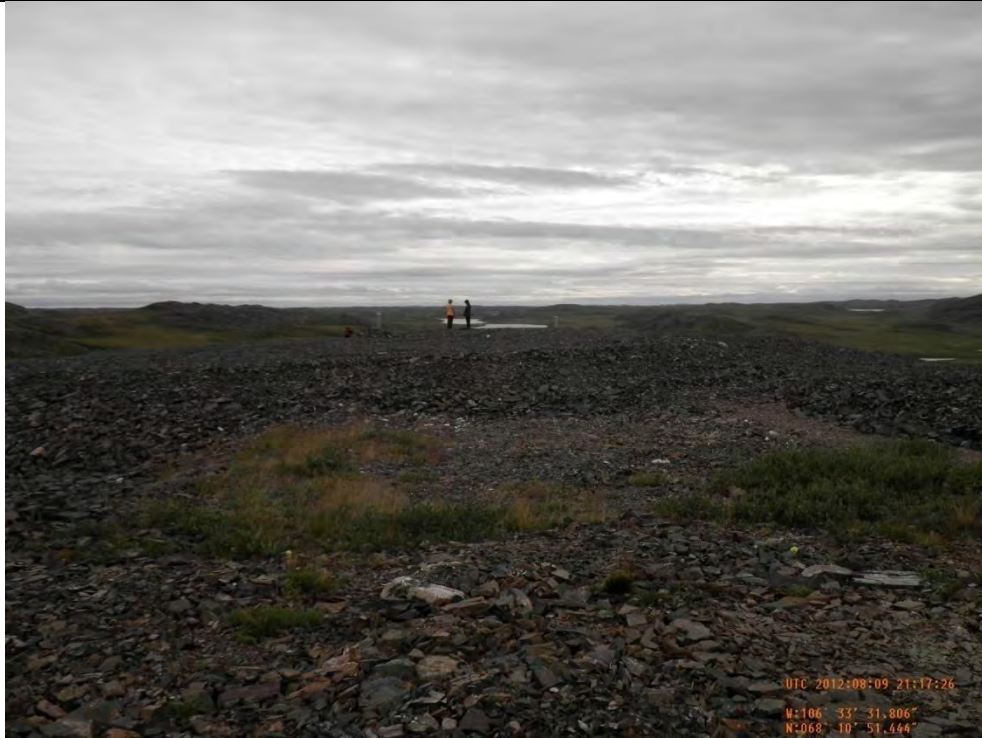
North side of SWMFL. Viewpoint 9 (Figure A-2; Appendix A). Photograph reference RIMG0009.  
Direction photo taken: S

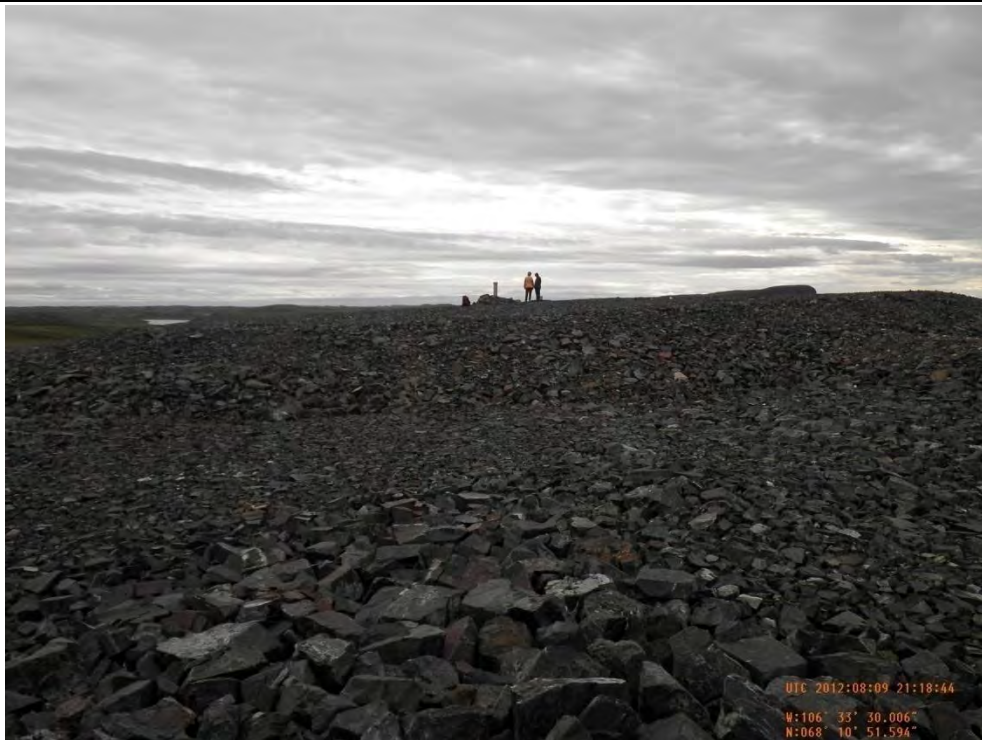
North side of SWMFL. Viewpoint 10 (Figure A-2; Appendix A). Photograph reference RIMG0010.  
Direction photo taken: S

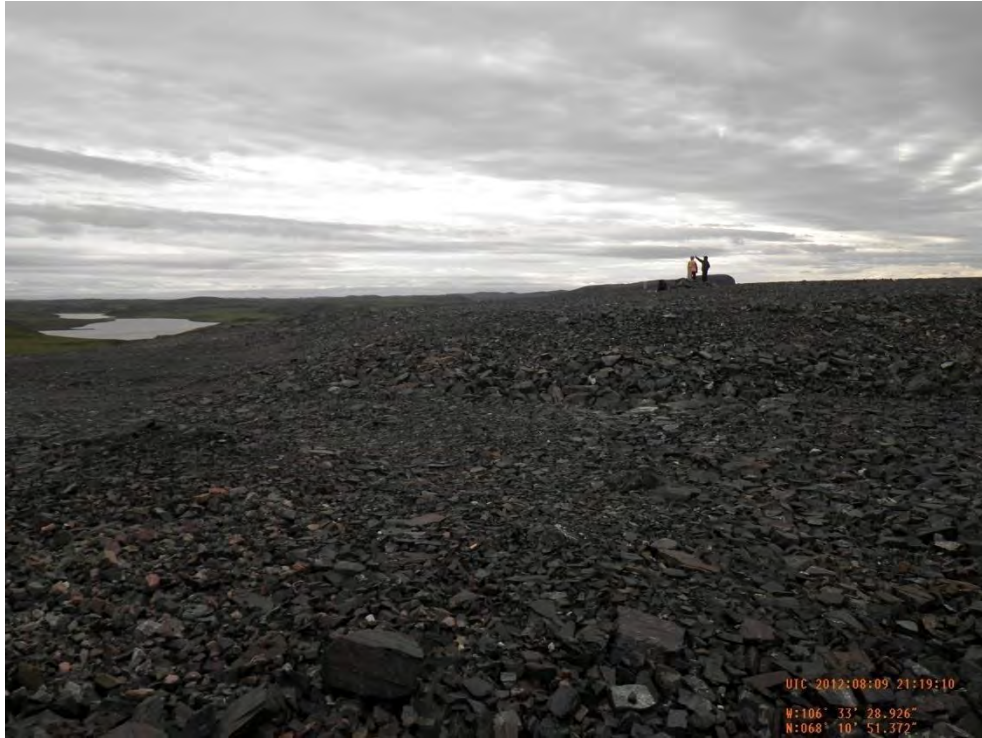
North side of SWMFL. Viewpoint 11 (Figure A-2; Appendix A). Photograph reference RIMG0011.  
Direction photo taken: S

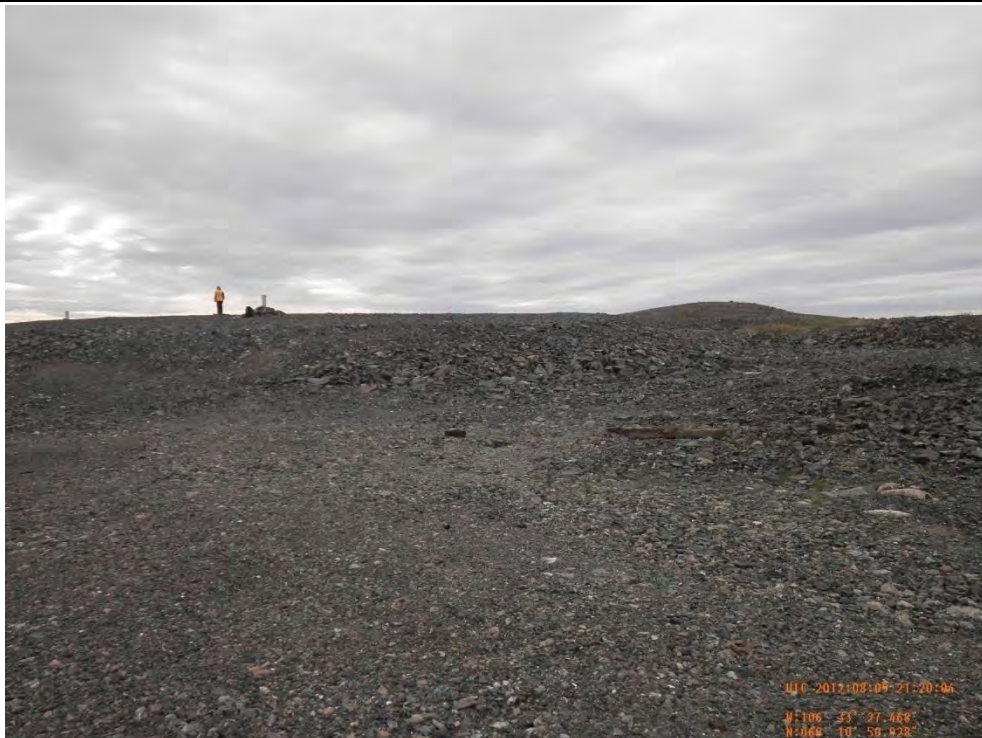
East side of SWMFL. Viewpoint 12 (Figure A-2; Appendix A). Photograph reference RIMG0012.  
Direction photo taken: W

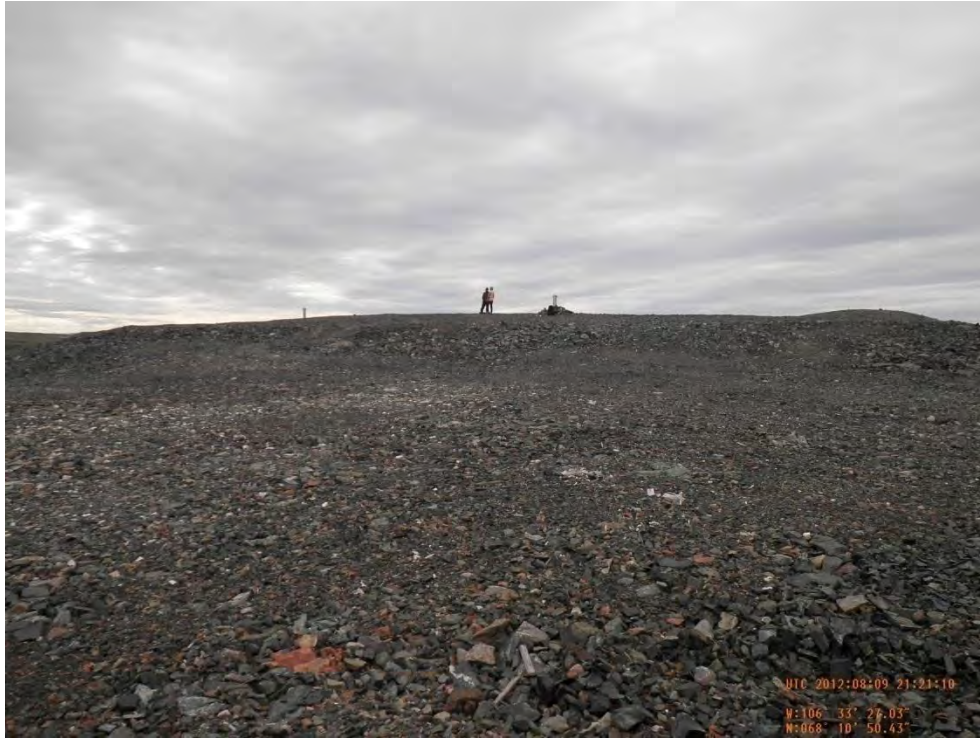
East side of SWMFL. Viewpoint 13 (Figure A-2; Appendix A). Photograph reference RIMG0013.  
Direction photo taken: W

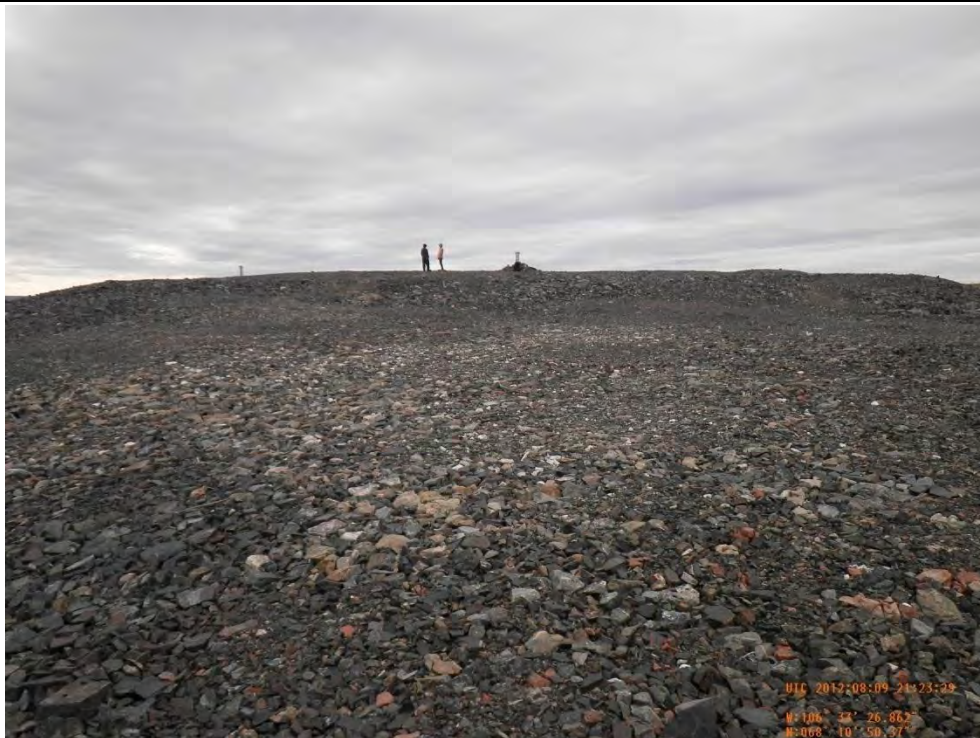
East side of SWMFL. Viewpoint 14 (Figure A-2; Appendix A). Photograph reference RIMG0014.  
Direction photo taken: W

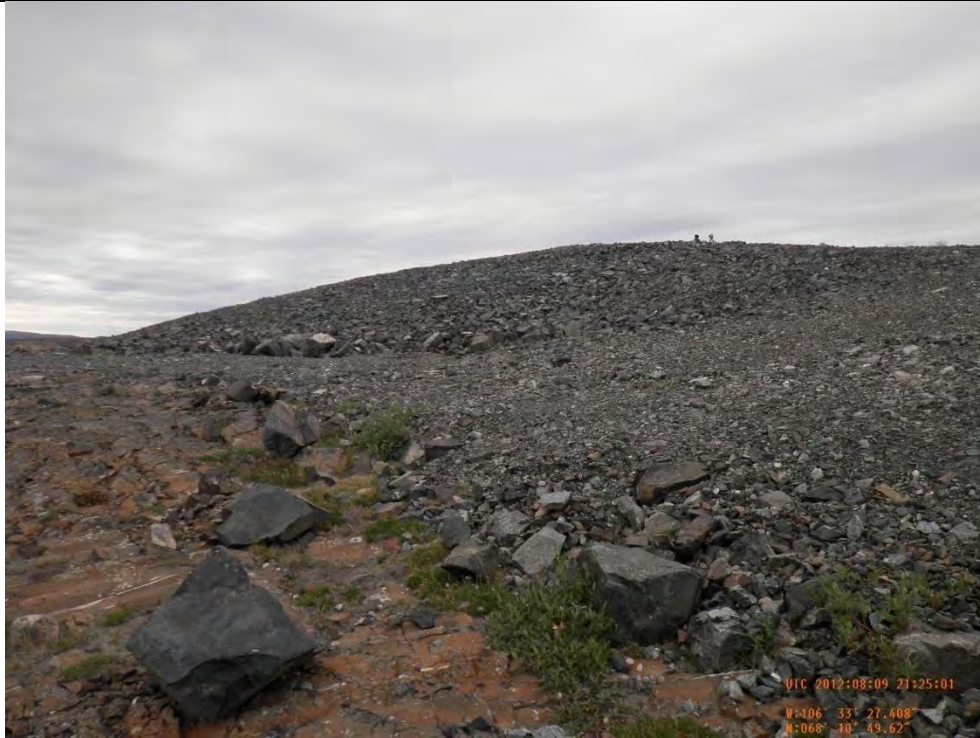
East side of SWMFL. Viewpoint 15 (Figure A-2; Appendix A). Photograph reference RIMG0015.  
Direction photo taken: W

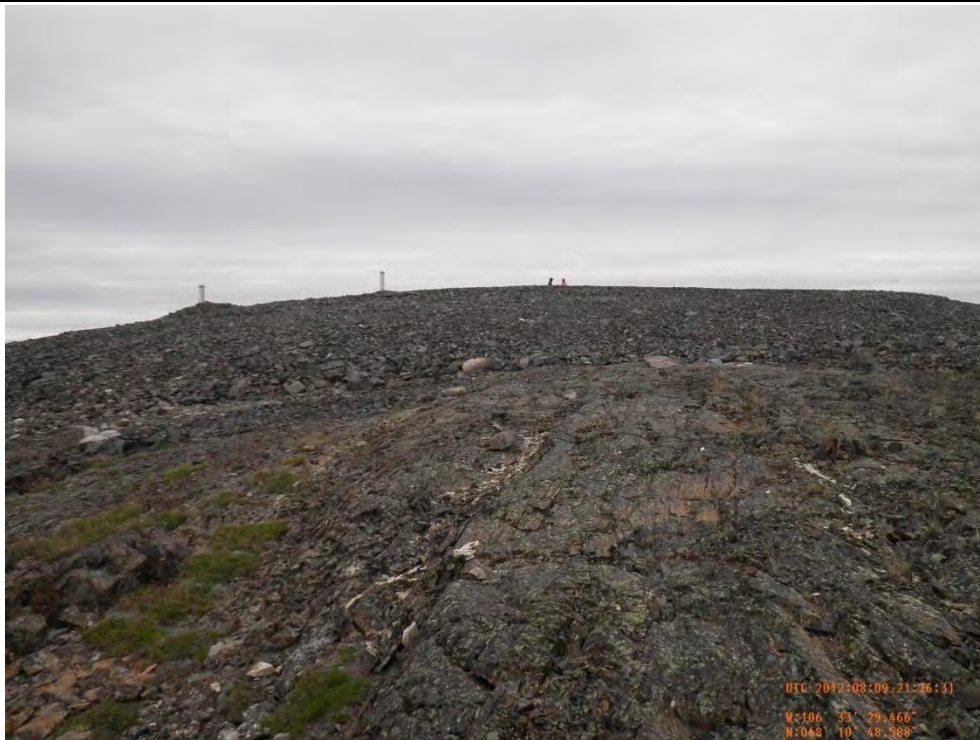
Southeast corner of SWMFL. Viewpoint 16 (Figure A-2; Appendix A). Photograph reference RIMG0016.  
Direction photo taken: NW

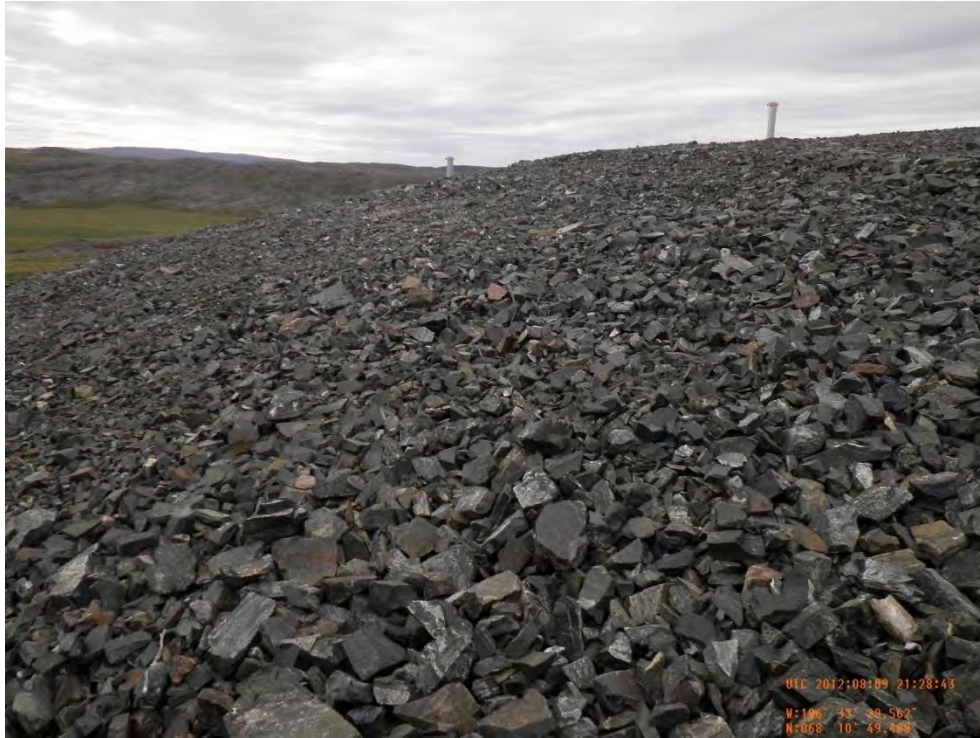
Top of the SWMFL from the Southeast corner. Viewpoint 17 (Figure A-2; Appendix A). Photograph reference RIMG0017. Direction photo taken: W

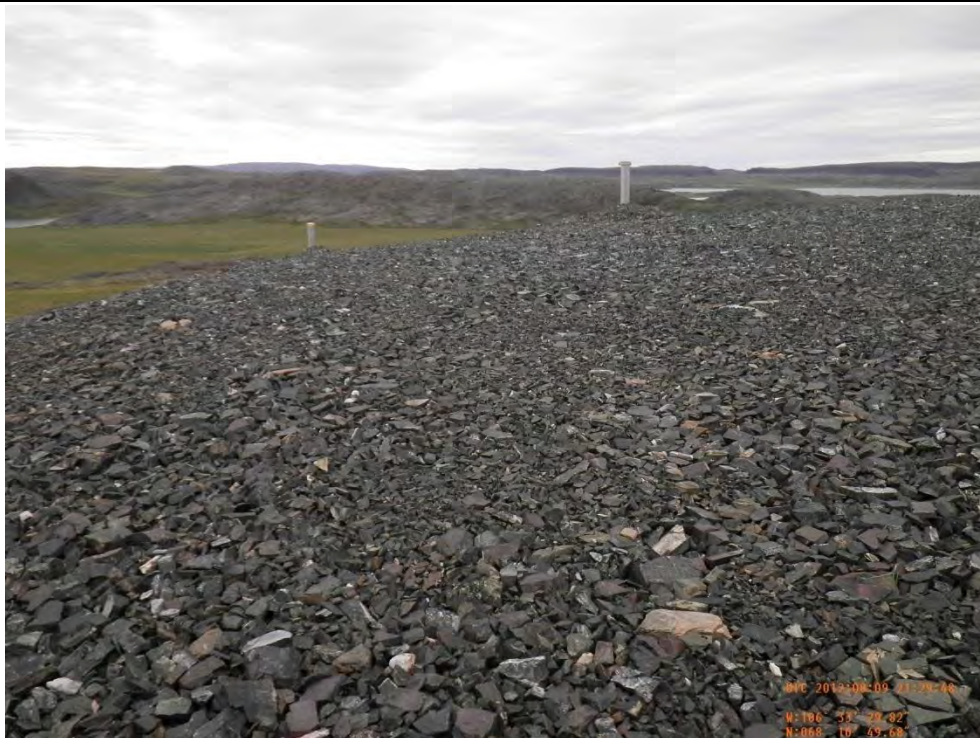
Top of the SWMFL from the Southeast corner. Viewpoint 18 (Figure A-2; Appendix A). Photograph reference RIMG0018. Direction photo taken: W

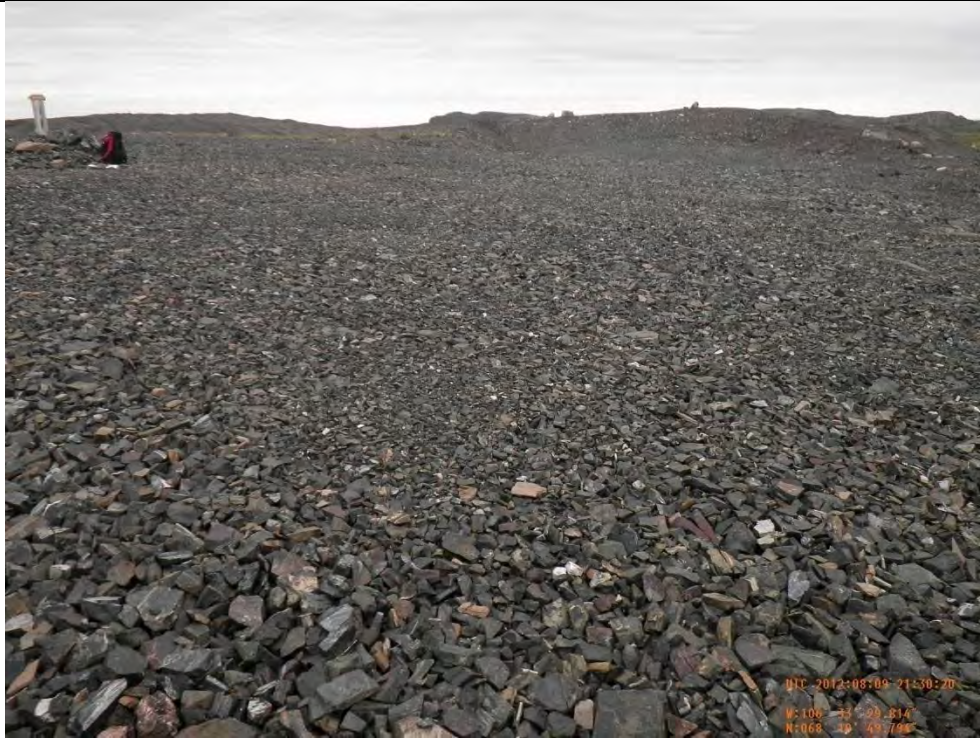
Top of the SWMFL from the Southeast corner. Viewpoint 19 (Figure A-2; Appendix A). Photograph reference RIMG0019. Direction photo taken: N

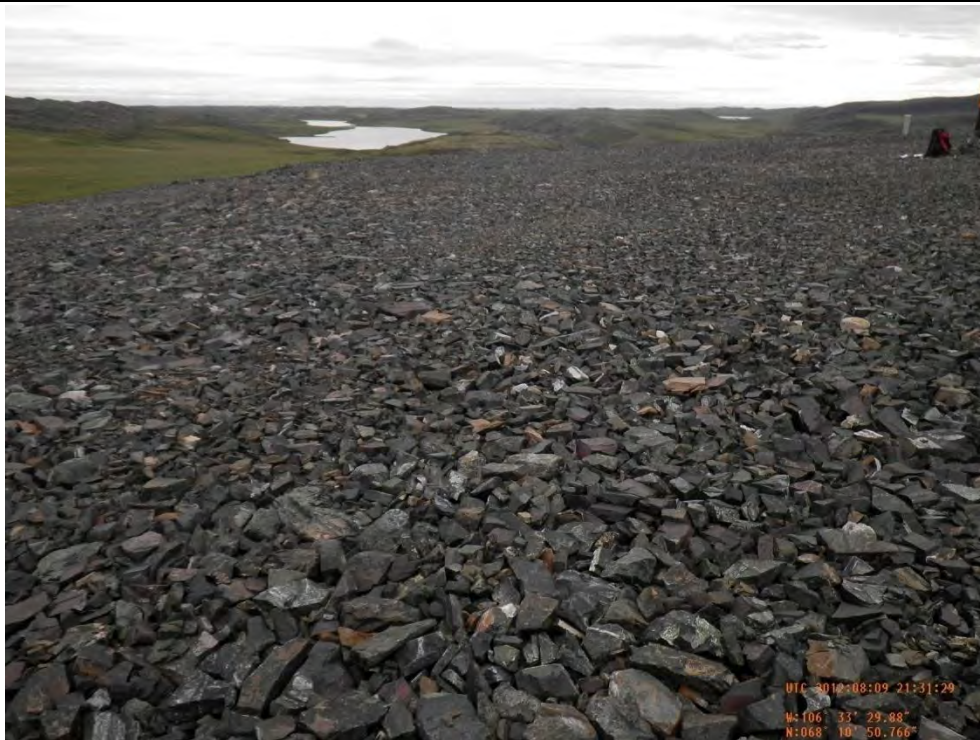
Top of the SWMFL from the Northeast corner. Viewpoint 20 (Figure A-2; Appendix A). Photograph reference RIMG0020. Direction photo taken: S

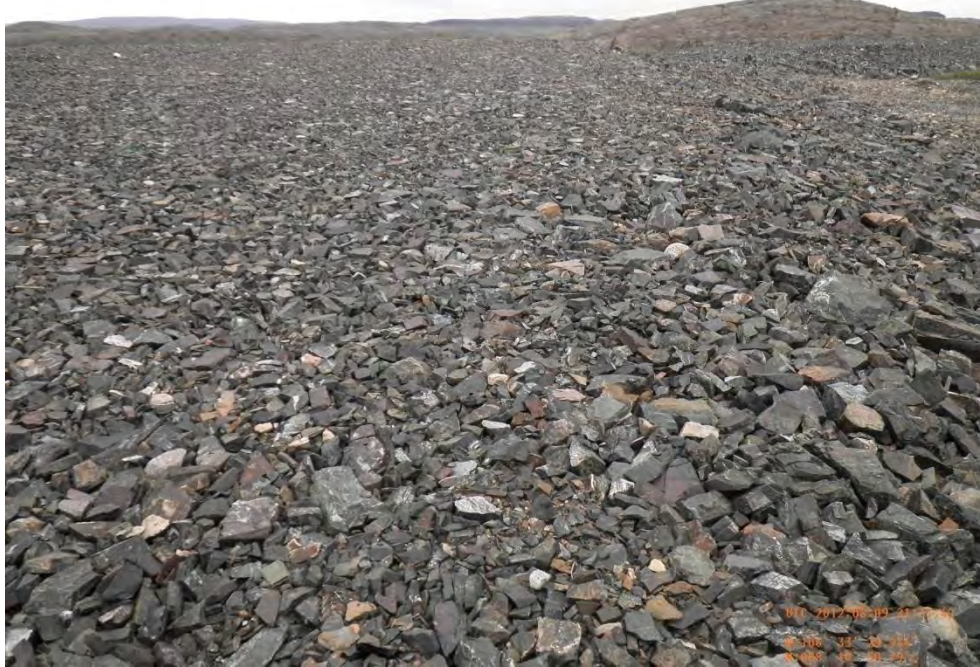
Top of the SWMFL from the Northeast corner. Viewpoint 21 (Figure A-2; Appendix A). Photograph reference RIMG0021. Direction photo taken: W

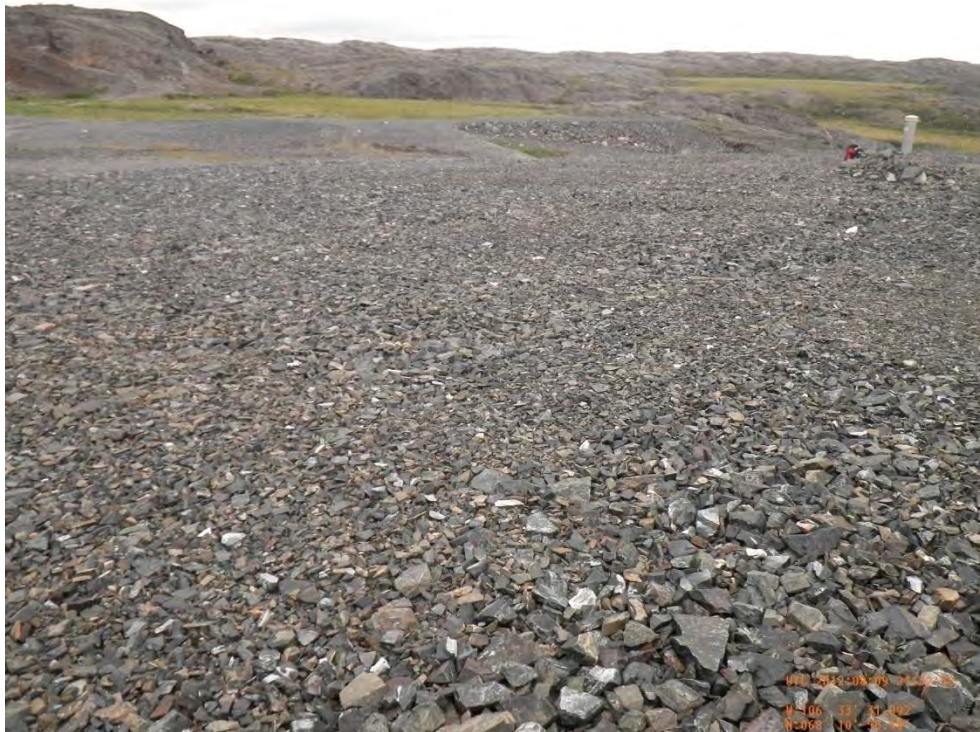
Top of the SWMFL from the Northwest corner. Viewpoint 22 (Figure A-2; Appendix A). Photograph reference RIMG0022. Direction photo taken: E

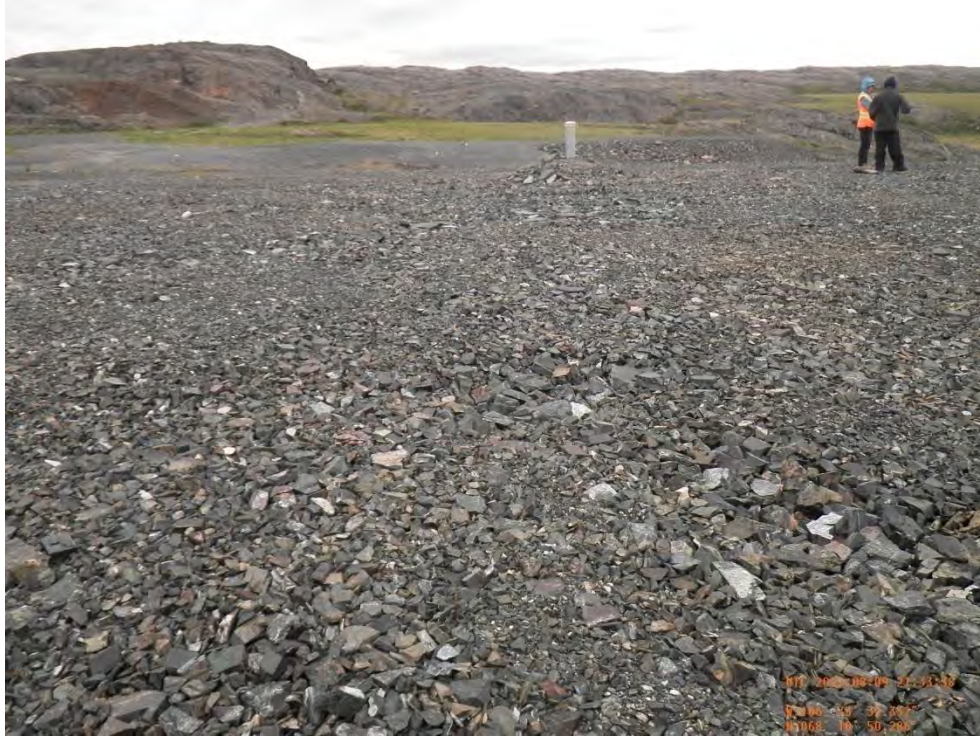
Top of the SWMFL from the Northwest side. Viewpoint 23 (Figure A-2; Appendix A). Photograph reference RIMG0023. Direction photo taken: E

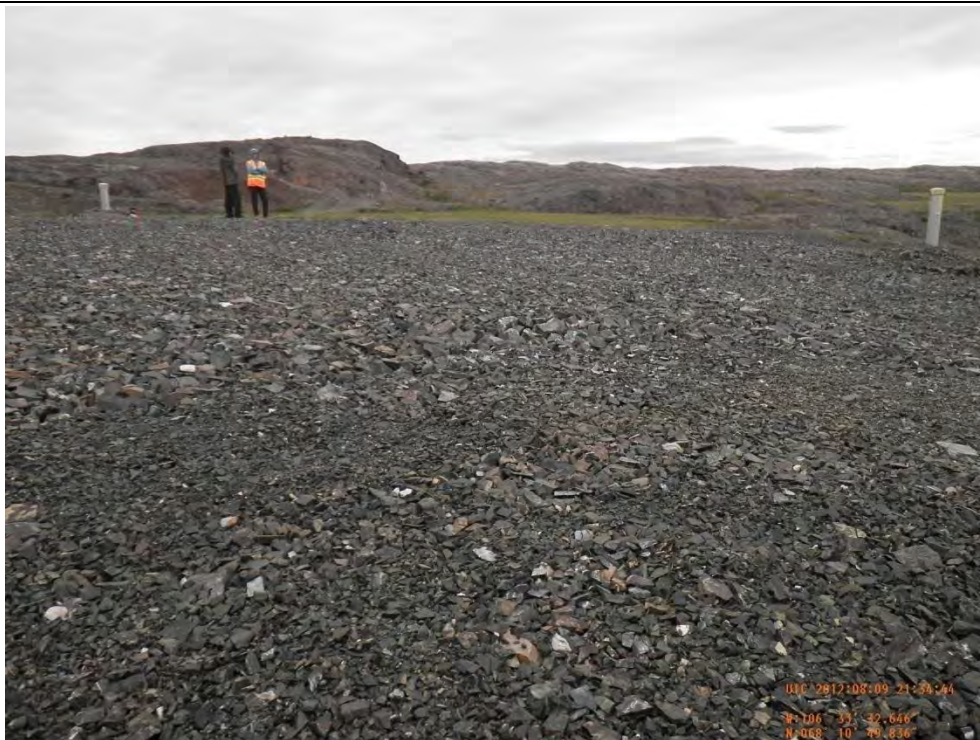
Top of the SWMFL from the West side. Viewpoint 24 (Figure A-2; Appendix A). Photograph reference RIMG0024. Direction photo taken: E

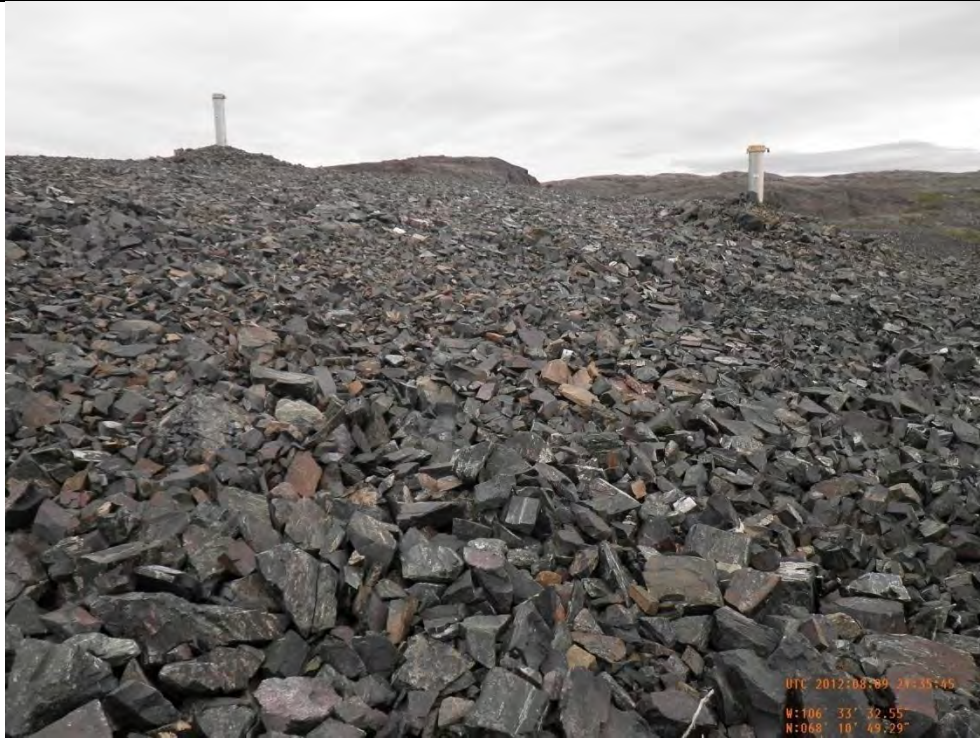
Top of the SWMFL from the Southwest side. Viewpoint 25 (Figure A-2; Appendix A). Photograph reference RIMG0025. Direction photo taken: E
