## **Long Term Monitoring, 2012 SWMF Landfill, Roberts Bay, Nunavut**

### **FINAL REPORT**

Project No. 1697-1201  
January 2013

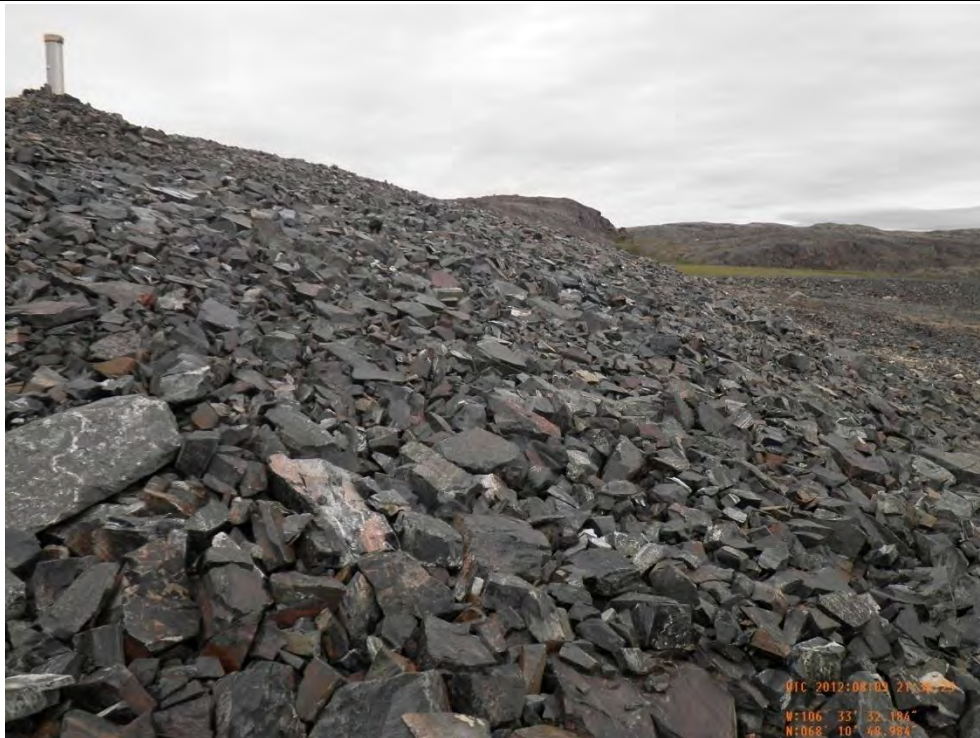
Top of the SWMFL from the Southwest corner. Viewpoint 26 (Figure A-2; Appendix A). Photograph reference RIMG0026. Direction photo taken: E

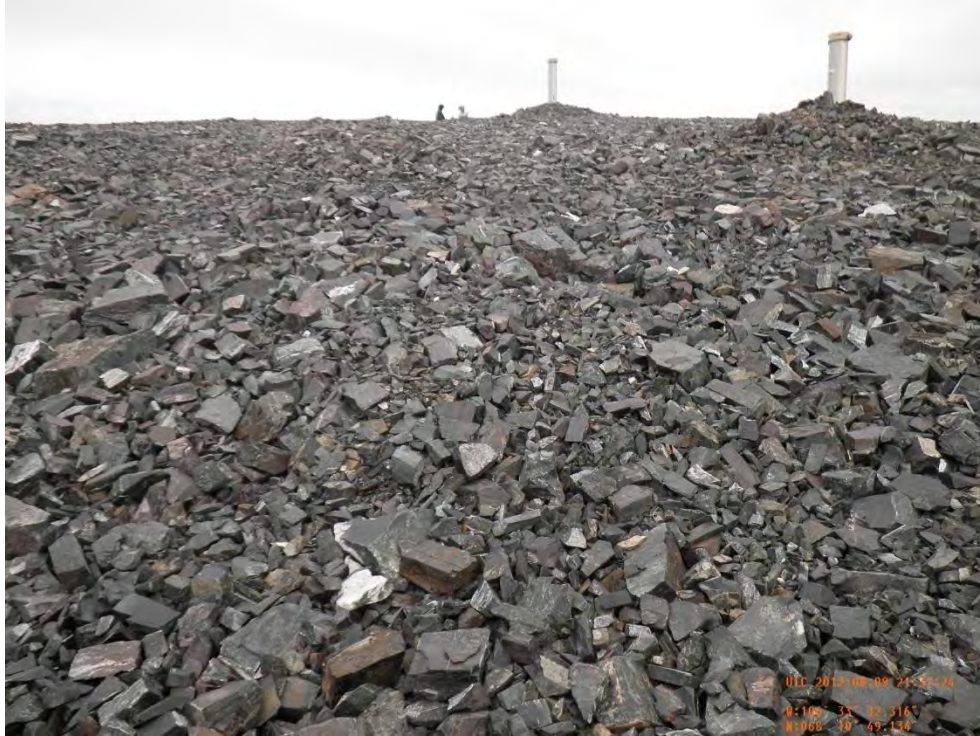
Top of the SWMFL from the Southwest corner. Viewpoint 27 (Figure A-2; Appendix A). Photograph reference RIMG0027. Direction photo taken: NE

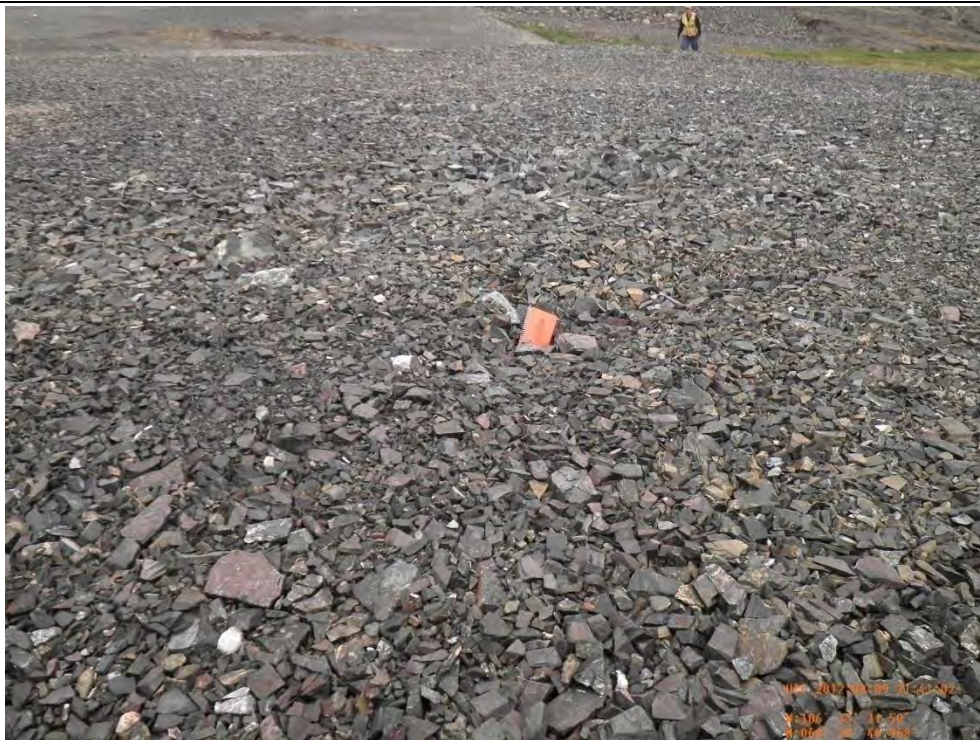
Top of the SWMFL from the center. Viewpoint 28 (Figure A-2; Appendix A). Photograph reference RIMG0028. Direction photo taken: E

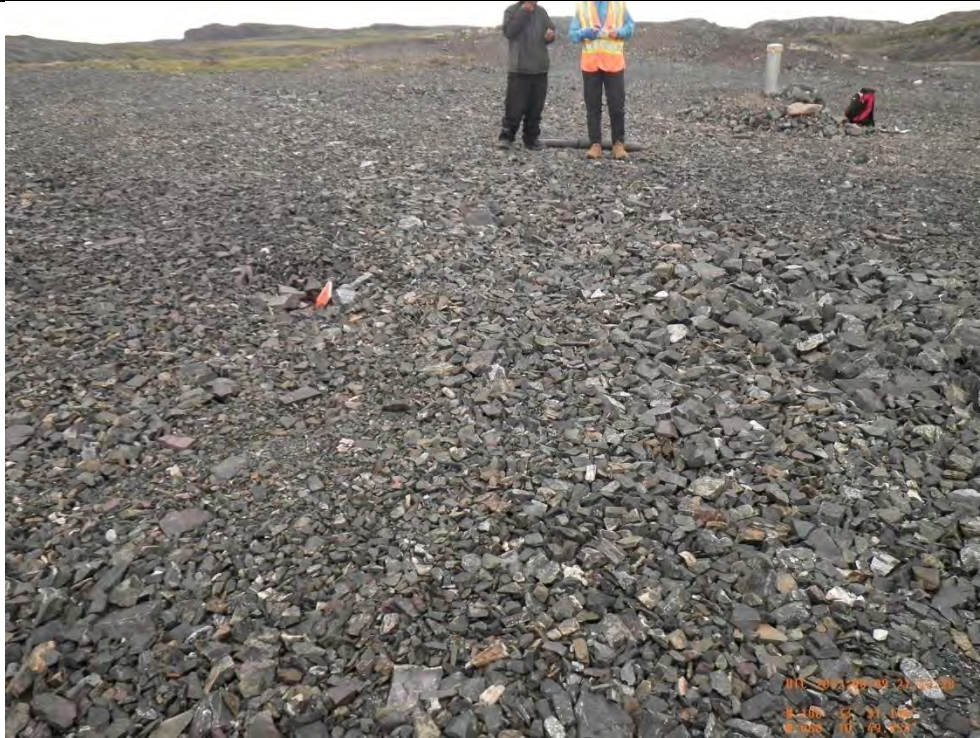
Top of the SWMFL from the center. Viewpoint 29 (Figure A-2; Appendix A). Photograph reference RIMG0029.  
Direction photo taken: NE

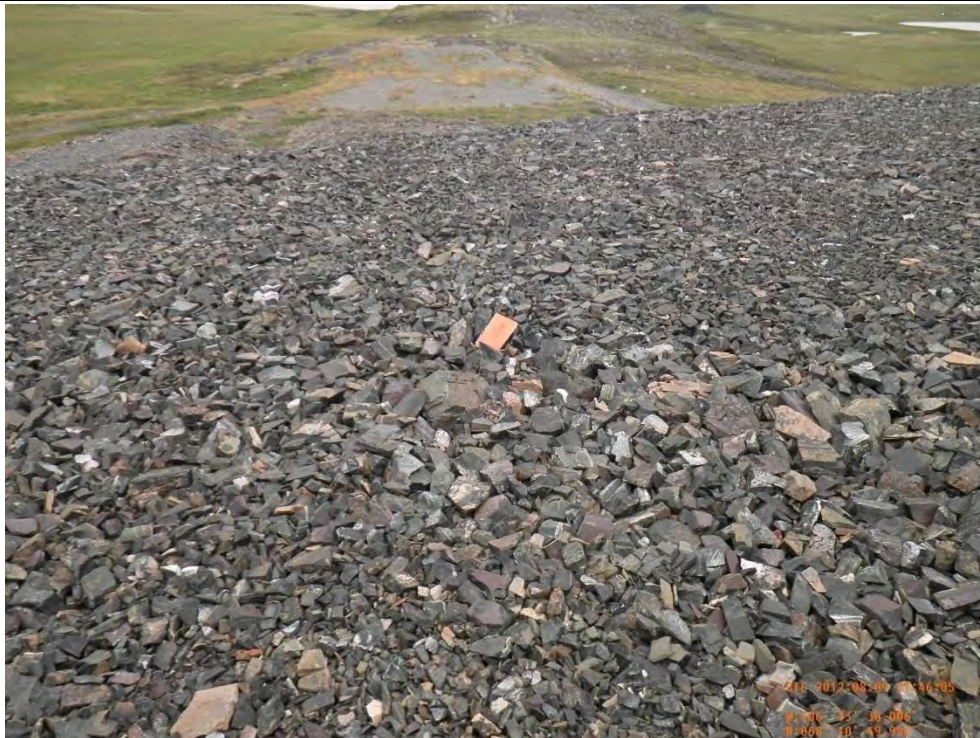
Top of the SWMFL from the Southeast corner. Viewpoint 31 (Figure A-2; Appendix A). Photograph reference RIMG0031. Direction photo taken: S

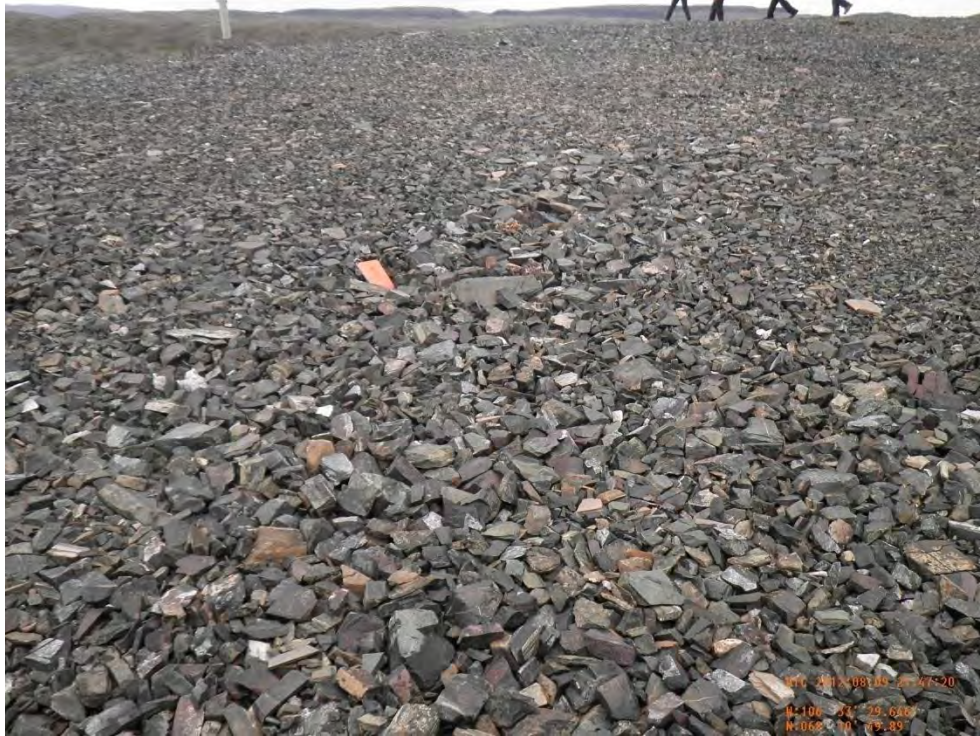
Top of the SWMFL from the Southeast corner. Viewpoint 32 (Figure A-2; Appendix A). Photograph reference RIMG0032. Direction photo taken: W

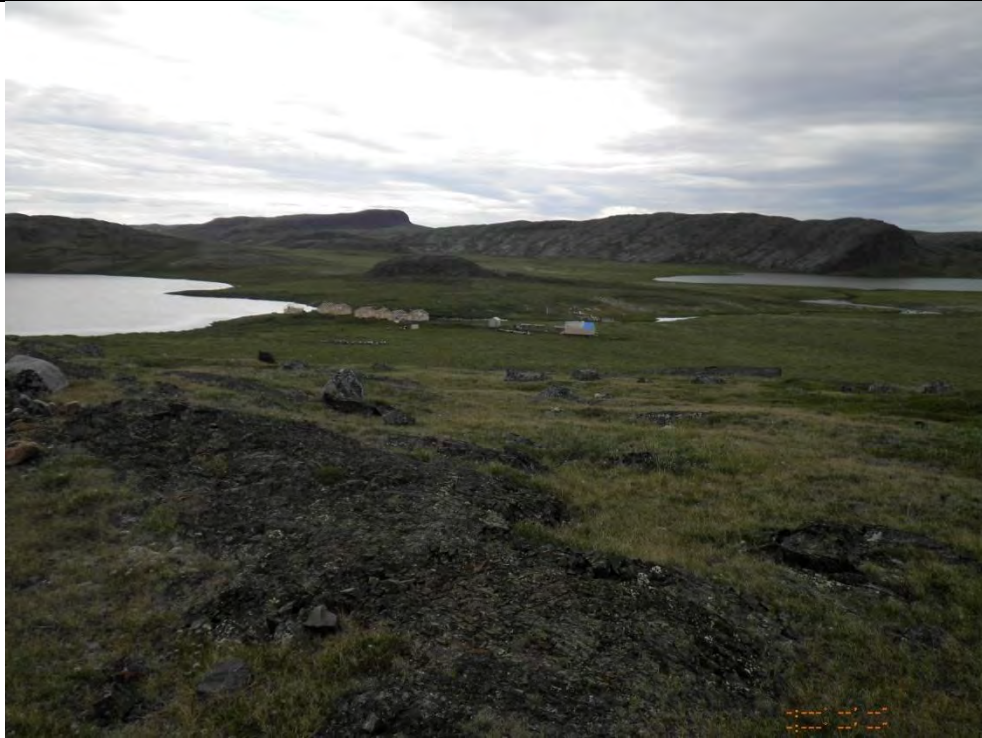
View of the river and fish survey infrastructure. Photograph reference RIMG0033. Direction photo taken: SW

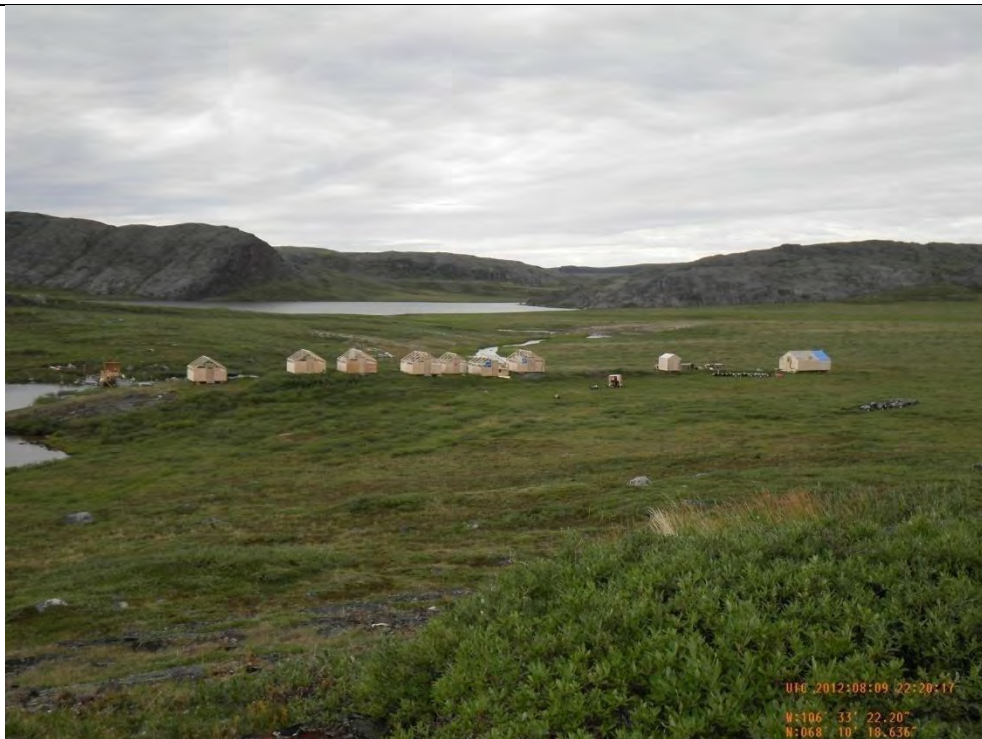
View of the river and fish survey infrastructure. Photograph reference RIMG0034. Direction photo taken: SW

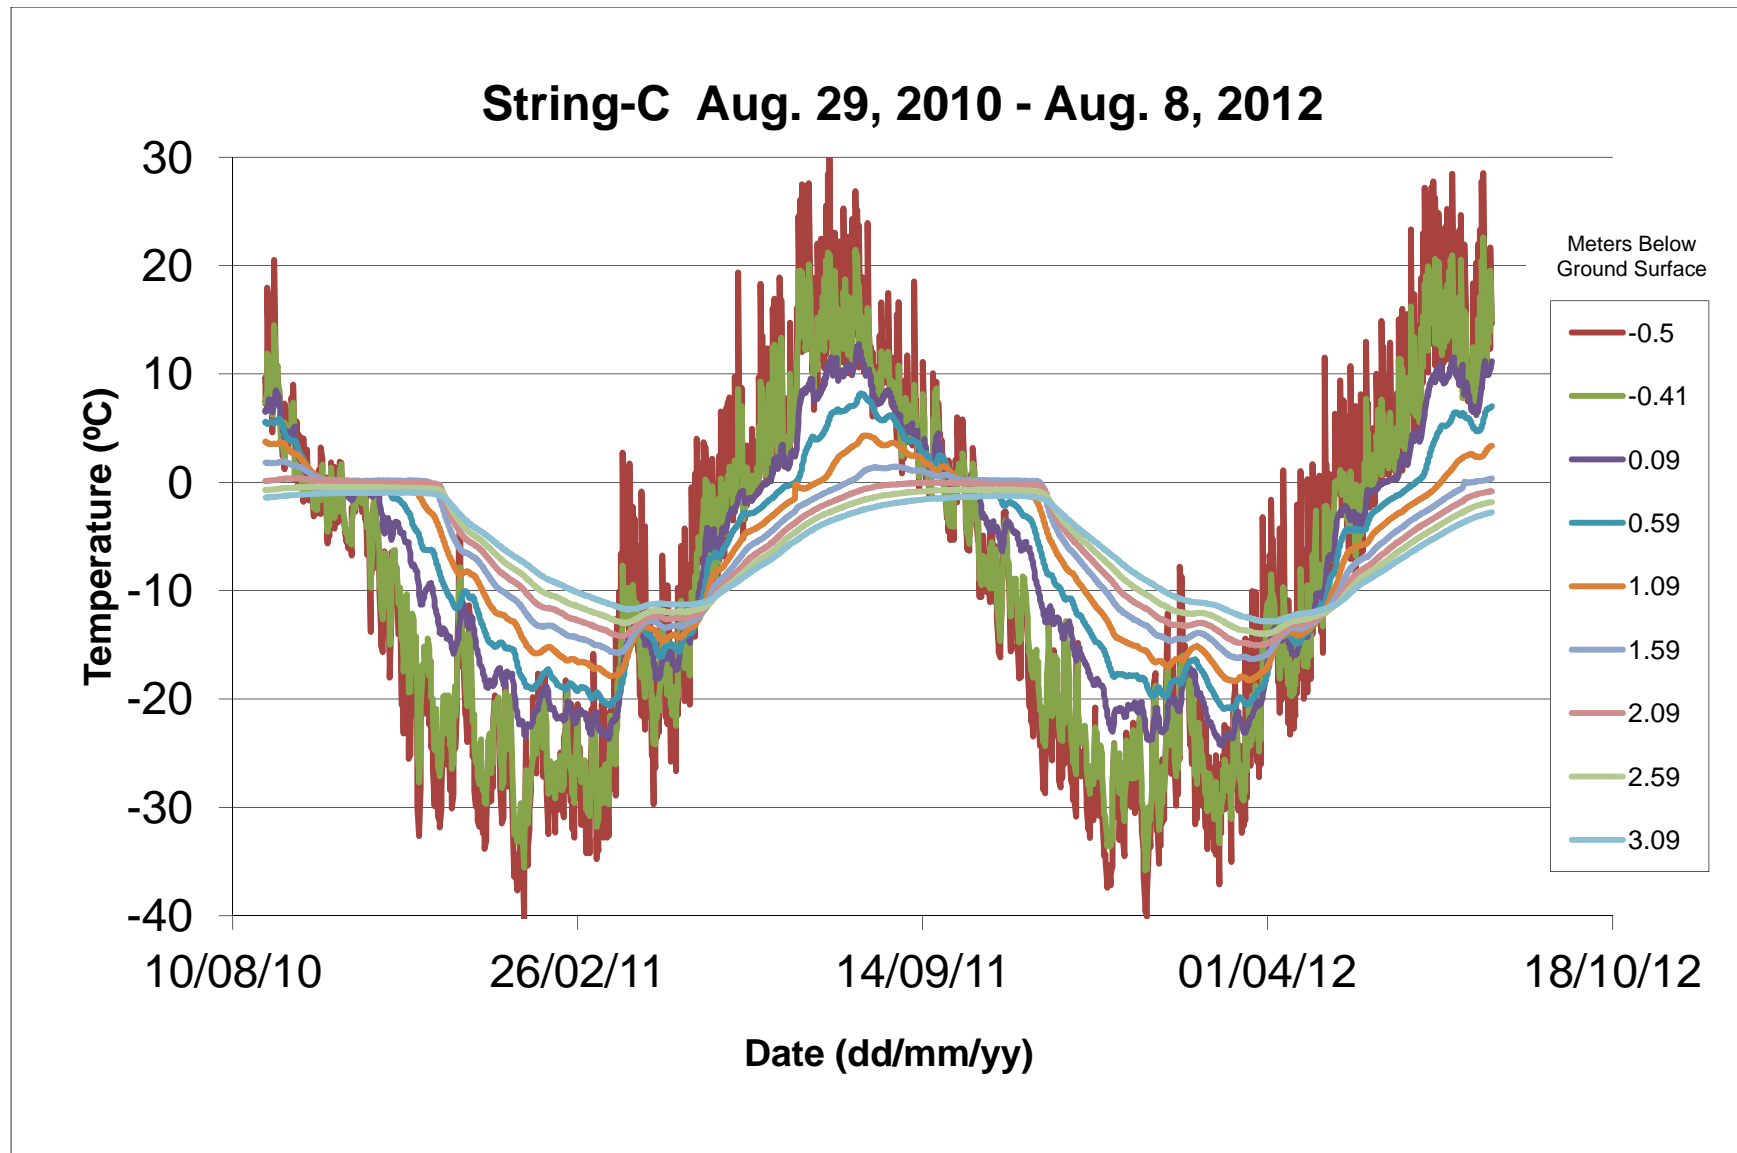
Figure H- 6: Temperature Vs. Time at Thermistor String C (August 2010-August 2012)
