Indigenous and Northern Affairs Canada – Nunavut
Regional Office

LONG TERM MONITORING - 2016

Roberts Bay, Nunavut

January 31, 2017

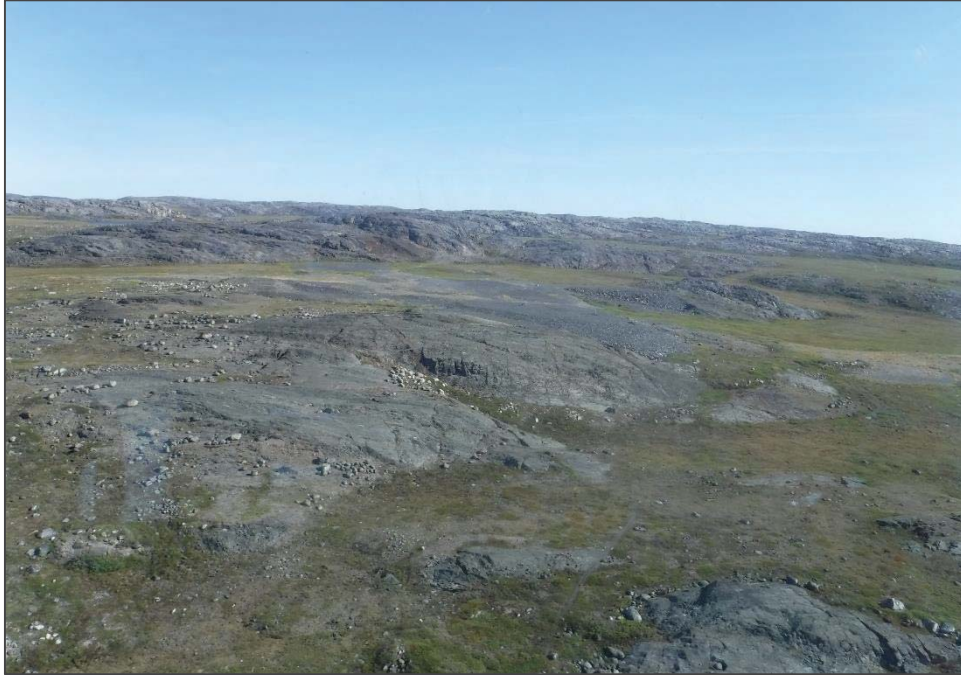
Photo: 1

Roberts Bay SWMF

Constructed during remediation in the summer of 2009, the SWMF is a non-hazardous waste landfill built over the former tailings pond, as seen on Figures 1 and 2 (also refer to Photos 1 to 3, Appendix A). Monitoring procedures adopted by INAC for this site are similar to those defined in the Abandoned Military Site Remediation Protocol (AMSRP), with some modifications as applicable to mine sites.

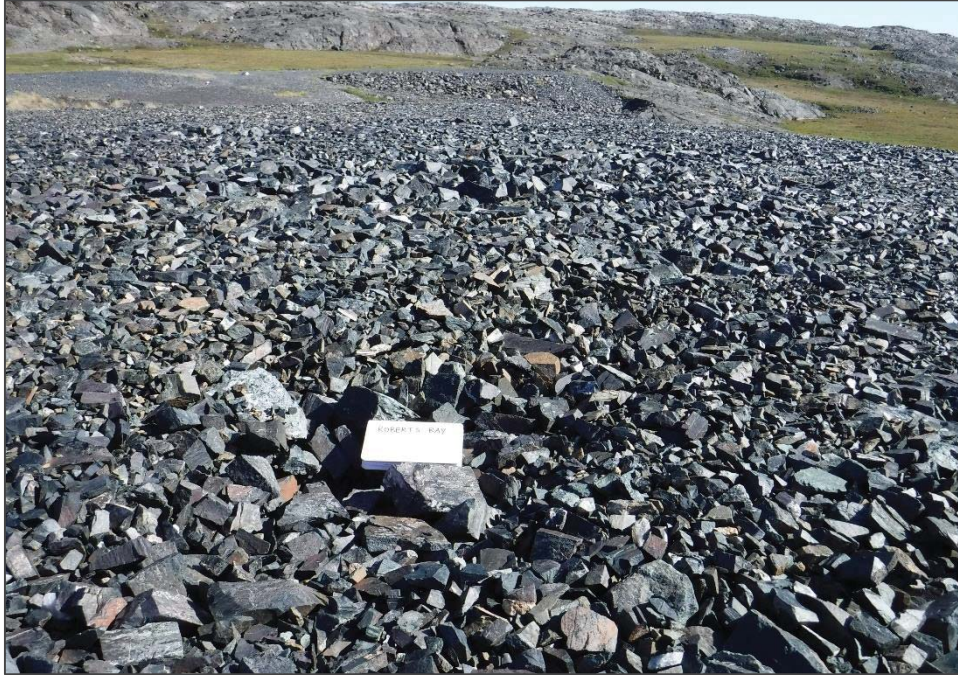
Photo: 7

| Checklist Item | Feature Letter | Relative Location | Length* (m) | Width* (m) | Depth* (m) | Extent | Description (Change) | Additional Comments | Viewpoint Reference |
|---|---|---|---|---|---|---|---|---|---|
| Settlement | A | Top of SWMF, between thermistors A and B | 0.2 | 0.3 | 0.4 | <1% | Minor area of settlement | Observed in 2014 | 28 and 29 |

Viewpoint 28

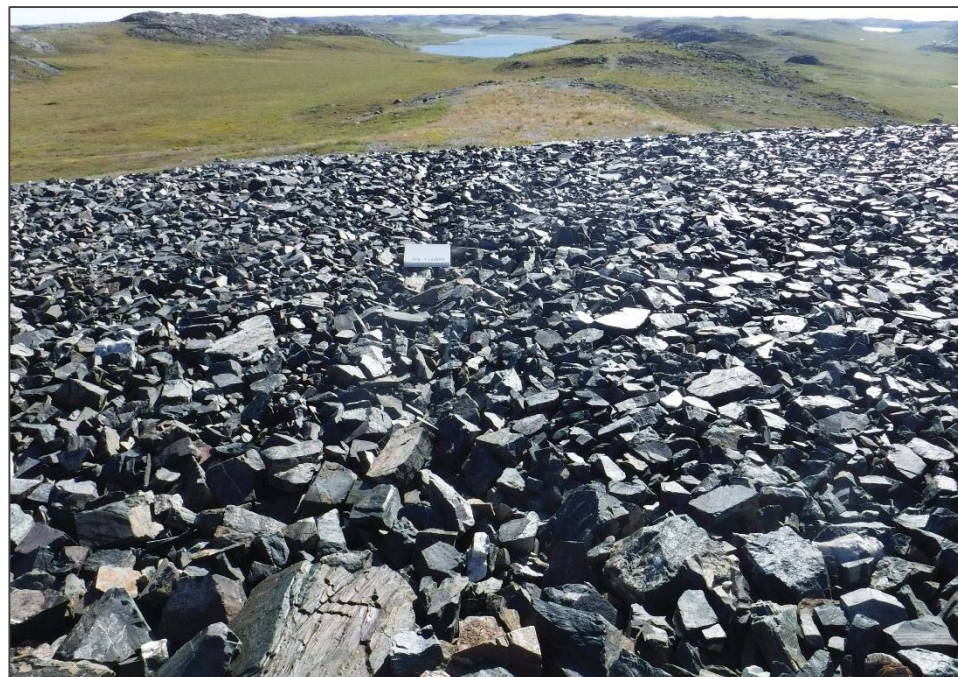
Photo: 8

New area of settlement
observed in 2016 (Feature D)

Viewpoint 37

Four areas of possible settlement were identified on the top of the SWMF during the 2016 site visit (refer to Figure 2). Three areas were observed in 2014, and one new area was observed in 2016. These four isolated areas were reported to be small (less than a few square metres) and shallow (less than 30 cm). Previous reports have indicated that these areas appear to be a result of mechanical processes and may

simply represent minor variation in the final grading and compaction of the surface of the landfill. These settlement areas have not previously been labelled. To facilitate consistency and accuracy, they have been designated Features A through D, as noted in Figure 2.

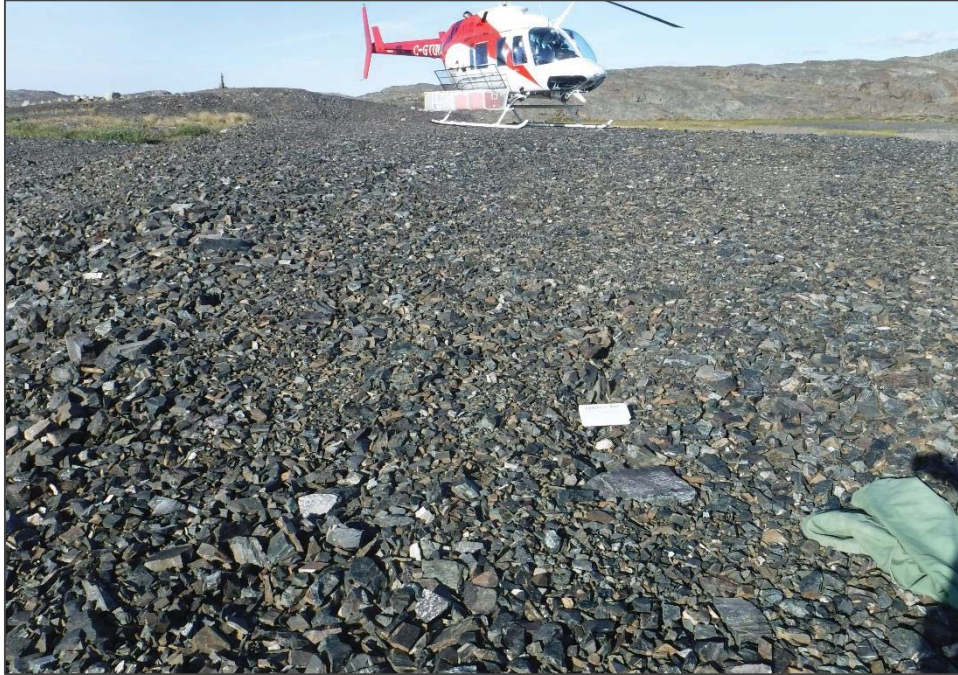
Photo: 9

| Checklist Item | Feature Letter | Relative Location | Length* (m) | Width* (m) | Depth* (m) | Extent | Description (Change) | Additional Comments | Viewpoint Reference |
|---|---|---|---|---|---|---|---|---|---|
| Settlement | D | Top of SWMF, 6 m west of Feature A | 0.03 | 0.05 | 1.5 | <1% | Minor area of settlement | First observed in 2016 | 37 |

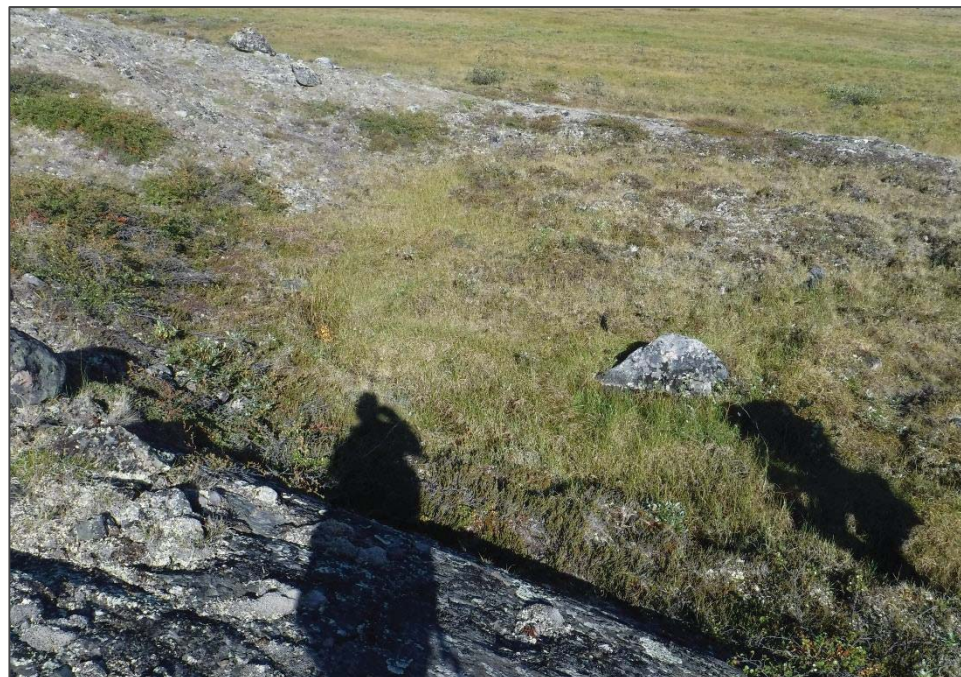
Photo: 10

- The sample collected from monitoring location ROB-6 reported colour results that exceeded the ULA of 118 PtCo units. The location where sample ROB-6 was collected was very shallow, with significant vegetation (see Photo 10). A high colour result is not unexpected for this type of water body;

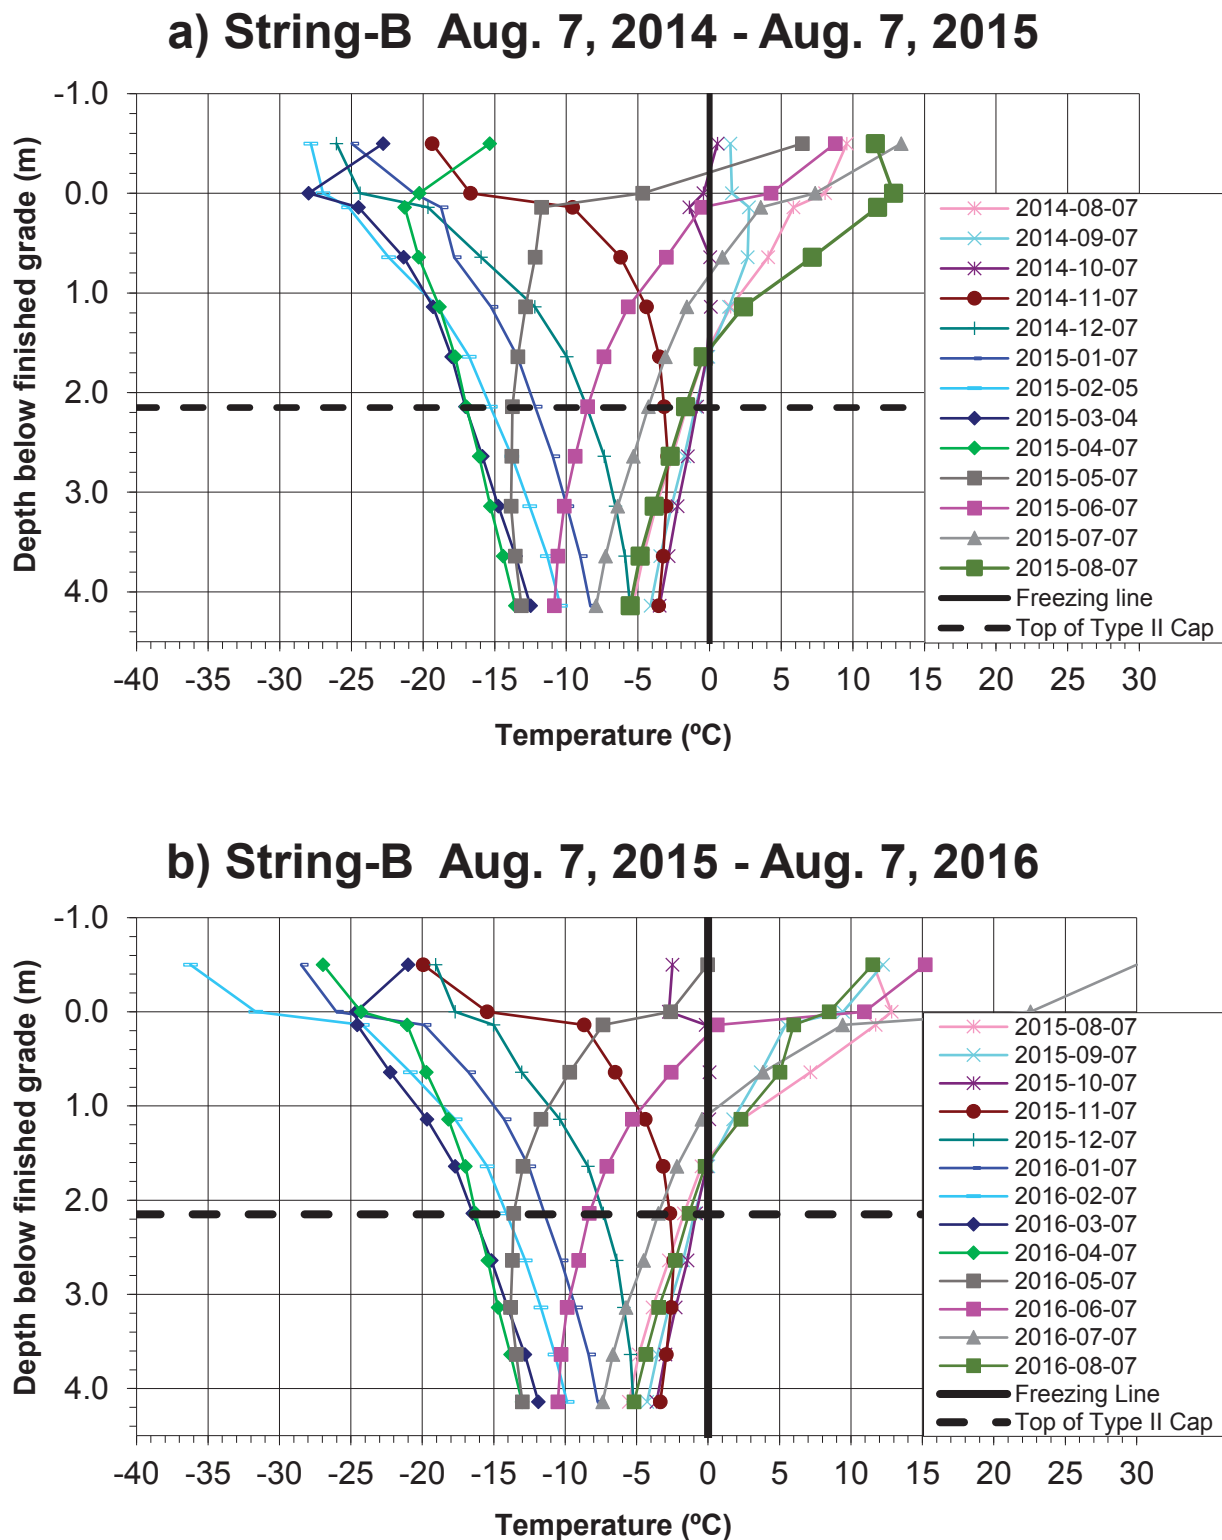
Arcadis assessed that the data stored on the datalogger installed at string B was corrupt and recorded faulty temperatures on multiple beads at seemingly random timeframes. Corrupted data from string B was also encountered during the previous monitoring event in 2014. Arcadis was able to extract and assess non-corrupted data from the 2014, 2015 and 2016 data sets. Replacement of the datalogger at string B is expected to prevent further issues with corrupt data at thermistor string B in the future.

Figure B-3: Monthly ground temperature profiles at thermistor string B: a) 2014-2015, b) 2015-2016

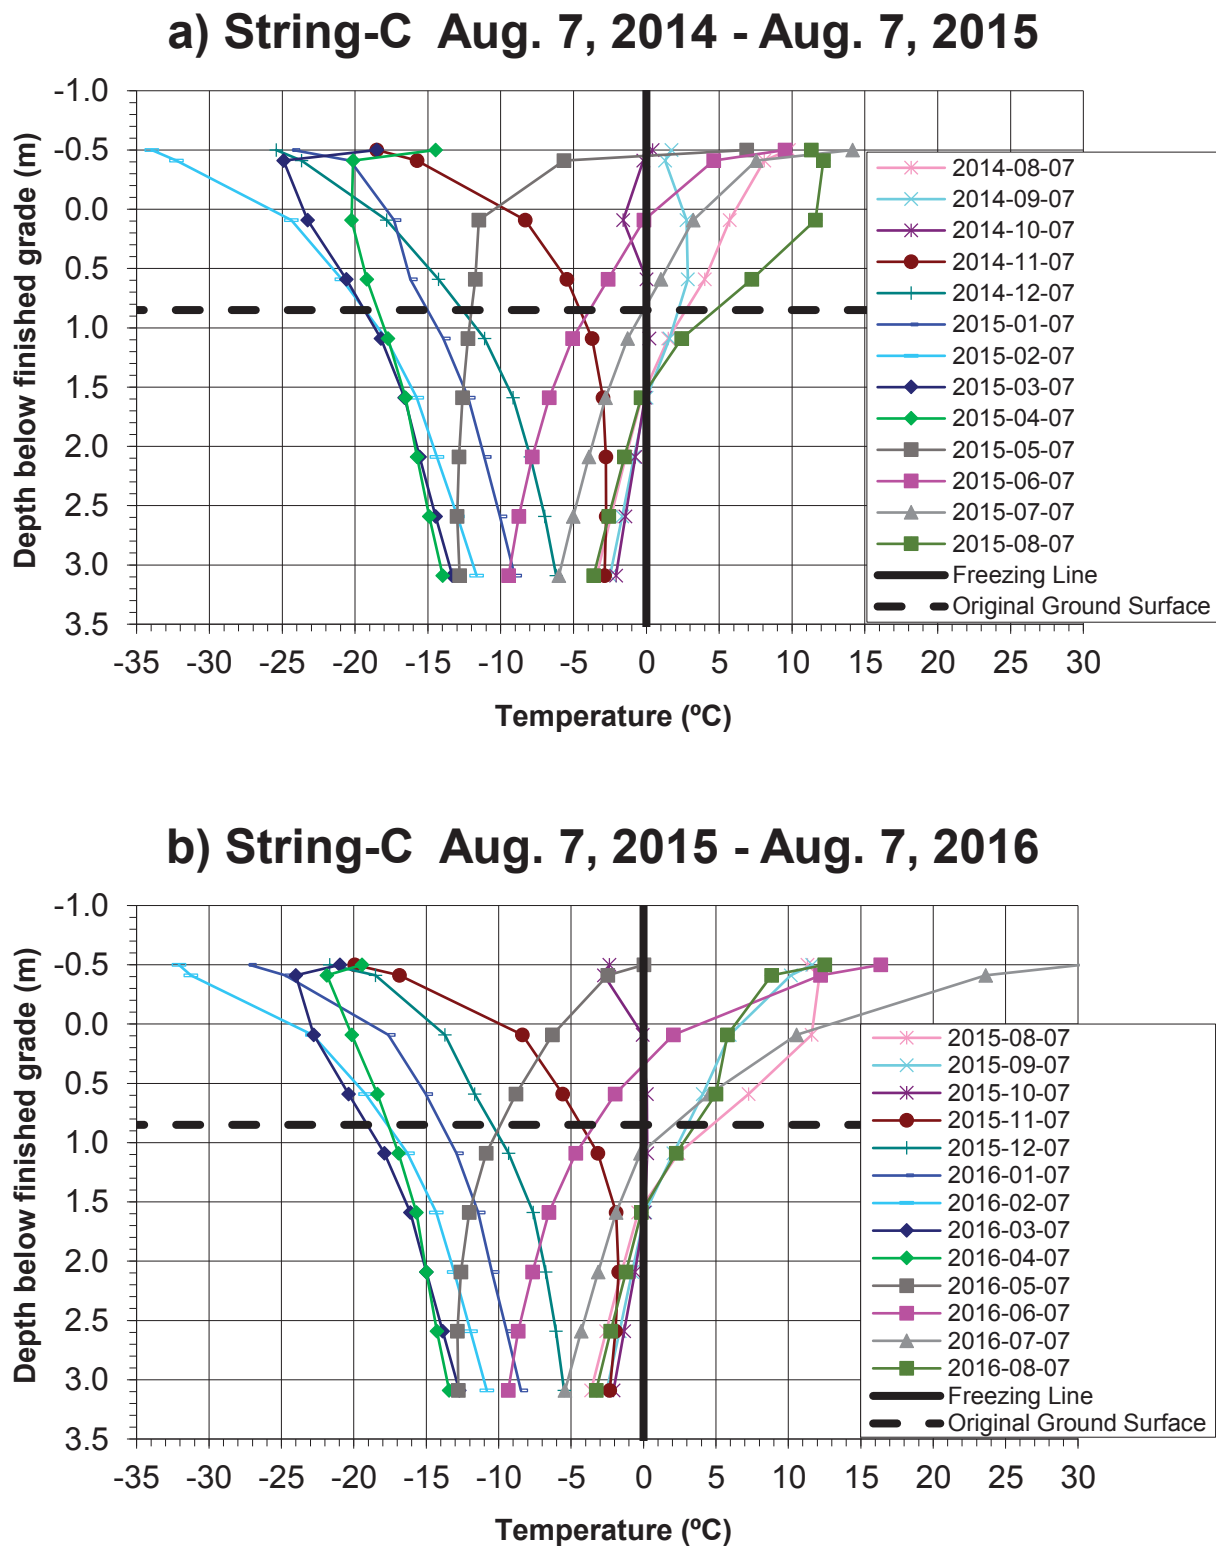
Figure B-5: Monthly ground temperature profiles at thermistor string C: a) 2014-2015, b) 2015-2016
