## LONG TERM MONITORING, 2015

PIN-D, Ross Point, Nunavut

January 20, 2016

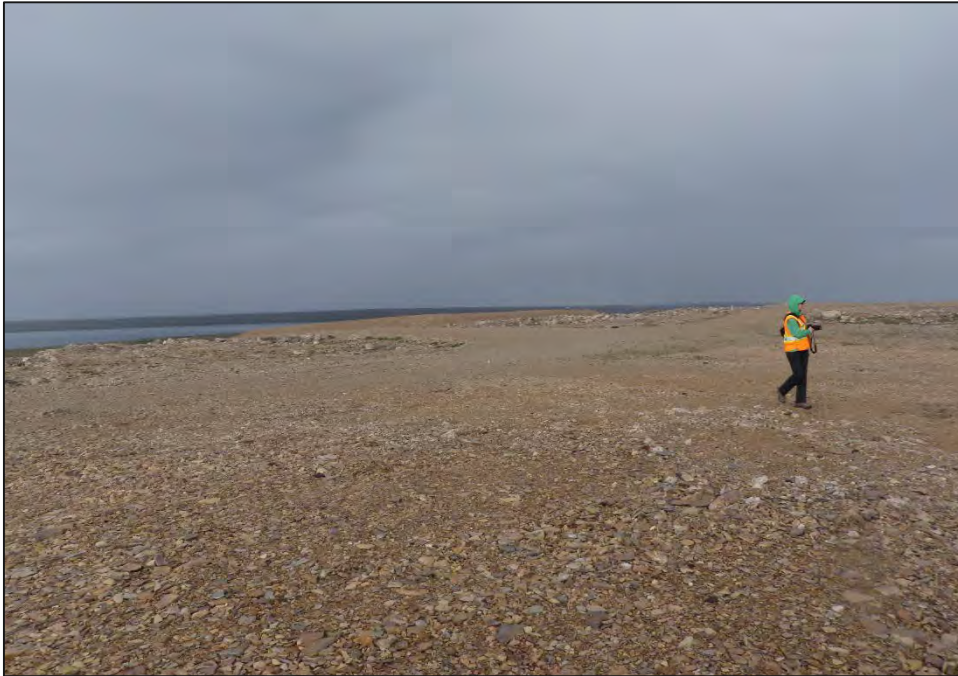
**Photo:** 15

The East Beach Area was inspected by aerial fly over. No apparent changes from 2013 were observed. This area is at a much lower elevation than the Main Station. Here there is an increase of vegetation growth including mosses and grasses. Remnants of a derelict camp remain. A partially standing plywood cabin, old camp equipment and caribou antlers were observed in 2013. The access road from this beach area connecting to the airstrip was observed in fair to good condition (Photo 15, Appendix A).
