LONG TERM MONITORING, 2017

PIN-D, Ross Point, Nunavut

January 18, 2018

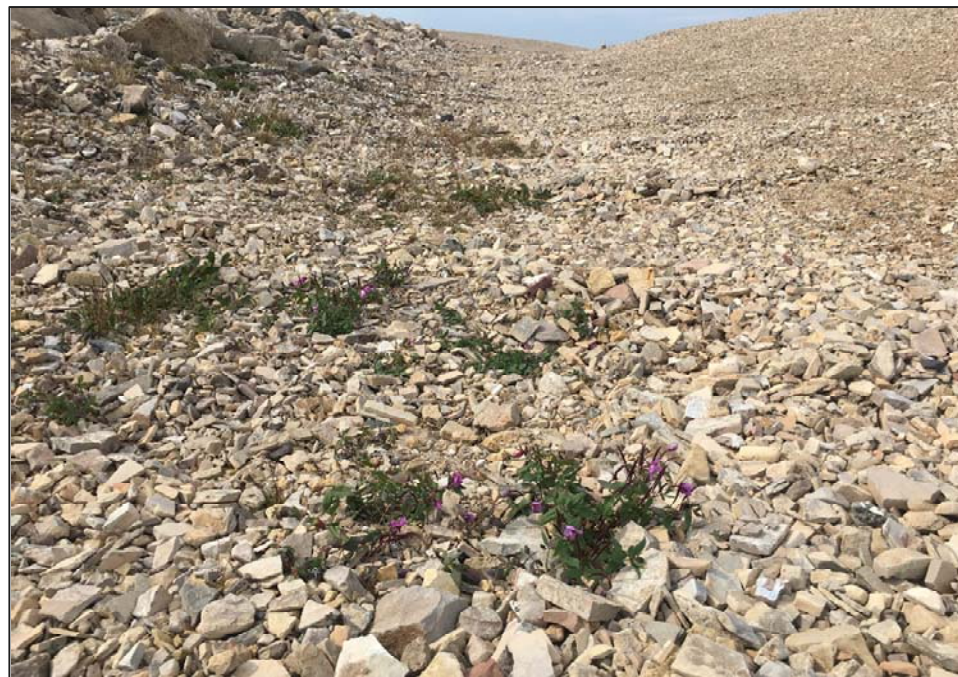
Photo: 2

Based on the regional setting of this site, re-establishment of vegetation is not likely in the near future. Minor growth was again observed on the south side of the NHL, at the toe of landfill (Photo 2, Appendix A), in a similar location to 2015 observations. No vegetation growth was observed on the surface or remaining berms of the landfill.
