## **Long Term Monitoring, 2013 PIN-D, Ross Point, Nunavut**

### **FINAL REPORT**

The 2013 monitoring program was carried out at the site on August 21, 2013. The monitoring program consisted of a visual inspection of the NHWL, active layer water monitoring and natural environment monitoring.

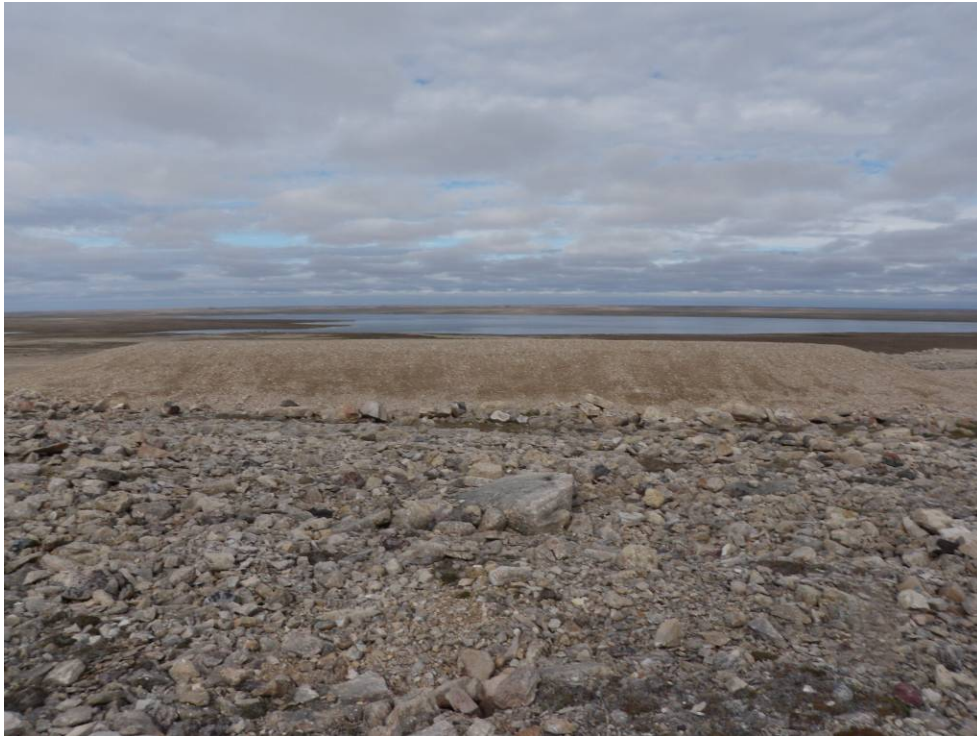
South side of the NHWL. Viewpoint 9 (Figure A-1; Appendix A). Photograph reference 9 (CD-ROM). Direction photo taken: N

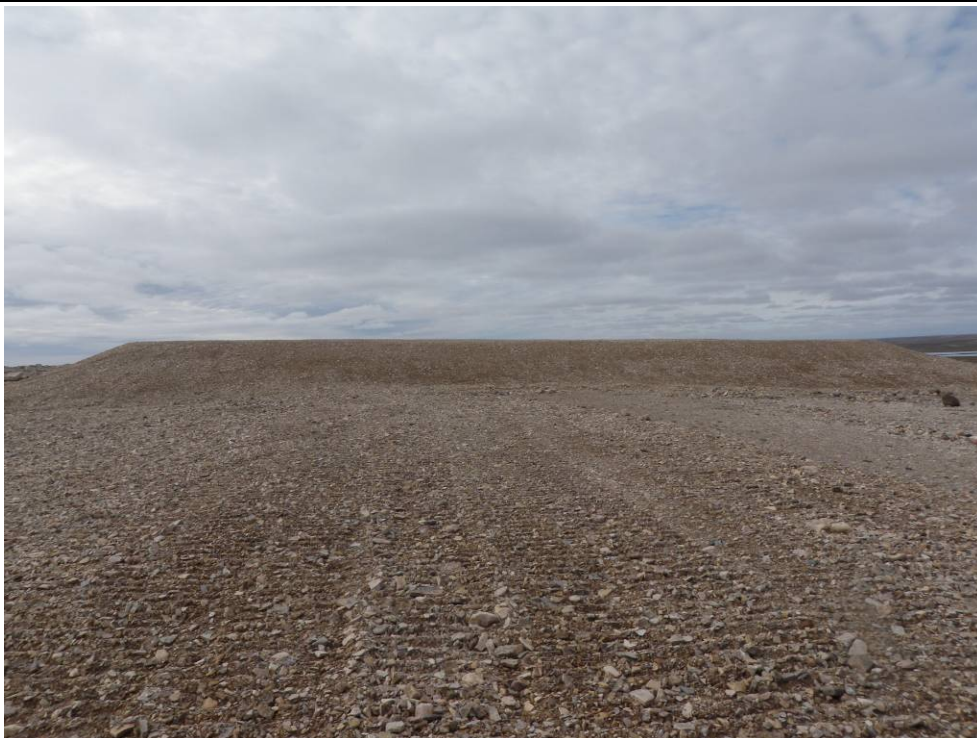
East side of the NHWL. Viewpoint 18 (Figure A-1; Appendix A). Photograph reference 18 (CD-ROM). Direction photo taken: W

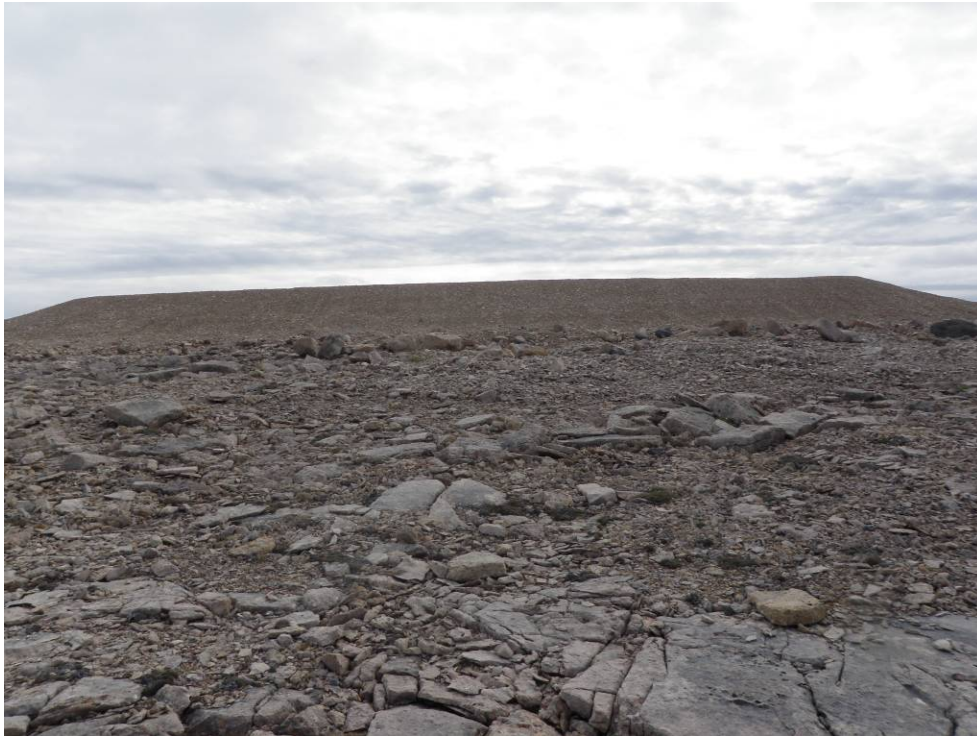
North side of the NHL. Viewpoint 27 (Figure A-1; Appendix A). Photograph reference 27 (CD-ROM). Direction photo taken: S

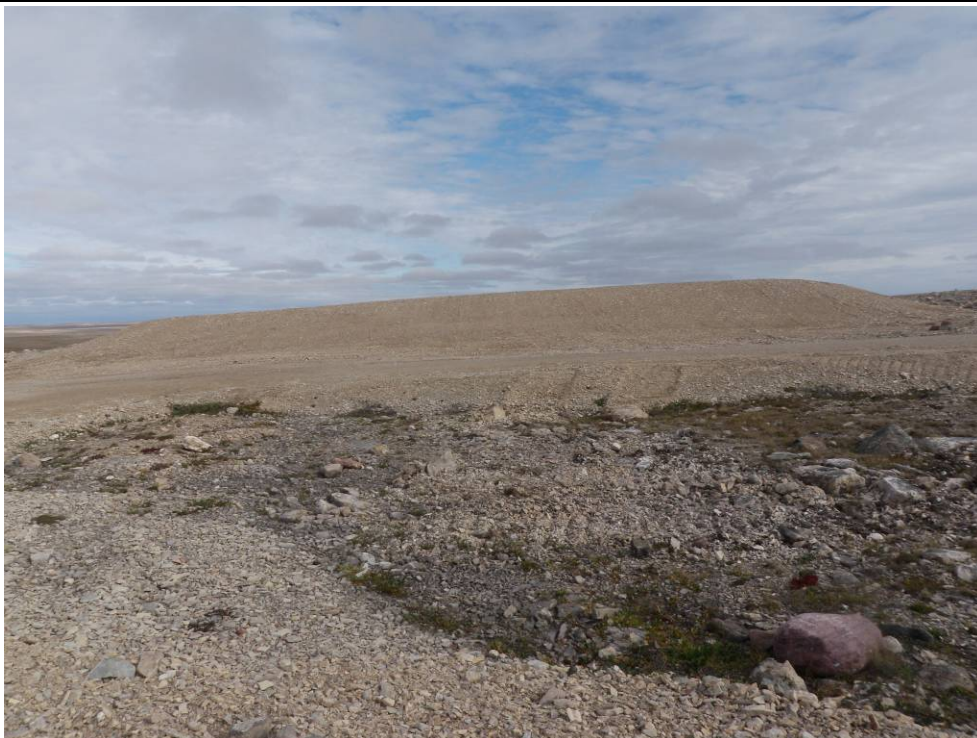
West side of the NHL. Viewpoint 36 (Figure A-1; Appendix A). Photograph reference 36 (CD-ROM). Direction photo taken: E

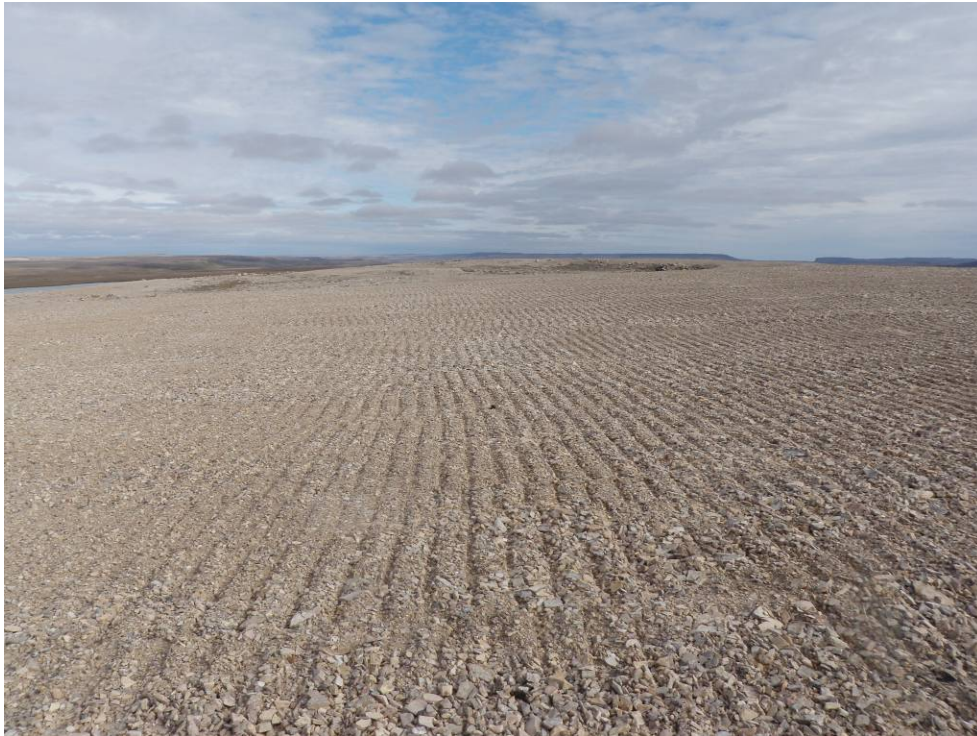
View of grading on surface of NHWL. Viewpoint 35 (Figure A-1; Appendix A).  
Photograph reference 35 (CD-ROM). Direction photo taken: E

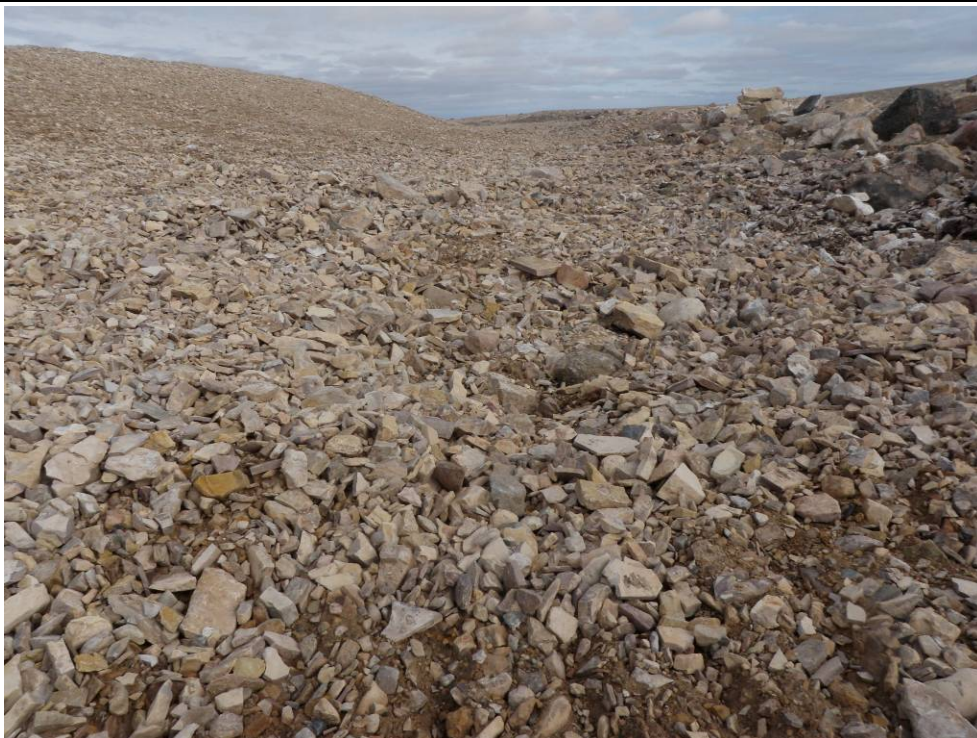
Three minor depressions were observed in the area of the NHWL. One small depression on the eastern side of the surface of the landfill was noted. This depression appeared to be the result of final grading. Another small depression was noted at the southwest corner of the landfill at the toe of the berm (Photo 38, Appendix C). The final minor depression was observed at the northwest corner of the landfill at the toe of the berm (Photo 42, Appendix C). Both of these appeared to be the result of poor final grading. All three features are considered minor in scale (<1 m diameter and 0.1 m deep) and are not considered to affect landfill integrity.

View of depression on southwest corner of NHWL (Feature D). Also poorly graded. Viewpoint 38 (Figure A-1; Appendix A). Photograph reference 38 (CD-ROM). Direction photo taken: E

All physical observations suggest that the NHWL is performing as designed and is containing the enclosed waste. During future monitoring events all depression areas noted at NHWL should be inspected for an increase in size and/or depth.

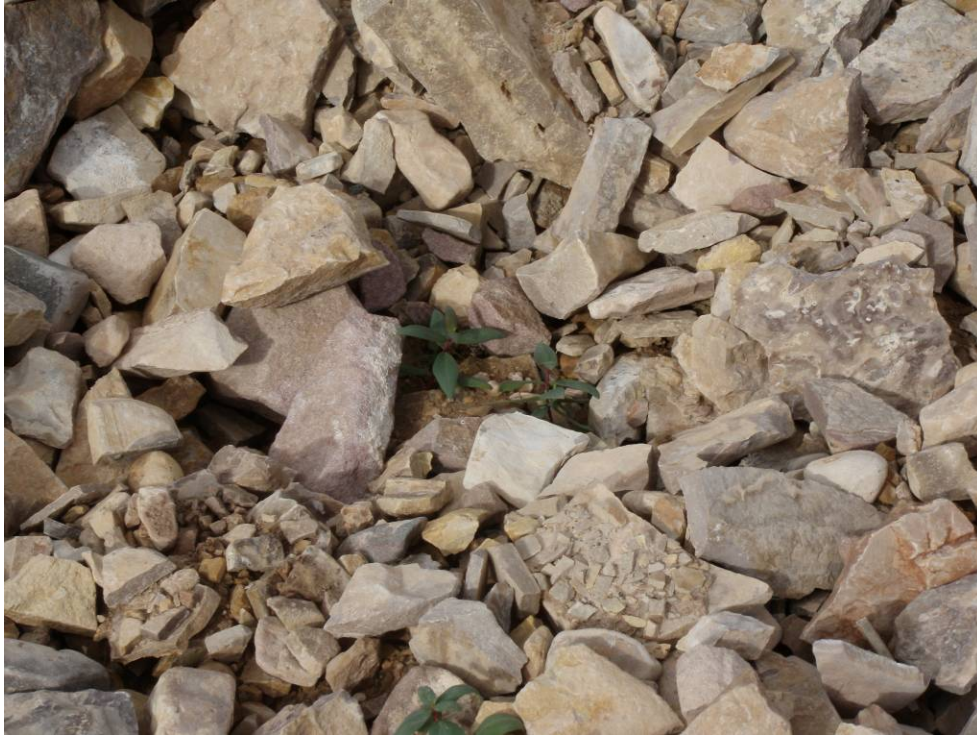
One pothole was observed at the southeast corner of the toe of the landfill berm. This pothole appears to be a result of grading (Photo 40, Appendix C).

Based on the regional setting of this landfill, full re-establishment of vegetation will likely not occur within the timeframe of the first phase of long term monitoring. Very minor vegetation growth was observed at southeast corner of the landfill at the observed pothole (Photo 40, Appendix C).

Based on the regional setting of this site, re-establishment of vegetation is not likely in the near future. Minor growth was observed on south side of the NHWL, at the toe of landfill, during the 2013 monitoring activity (Photo 40, Appendix C).

View of pothole at southeast corner of the NHWL, minor vegetation growth is evident. Viewpoint 40 (Figure A-1; Appendix A). Photograph reference 40 (CD-ROM). Direction photo taken: N/A

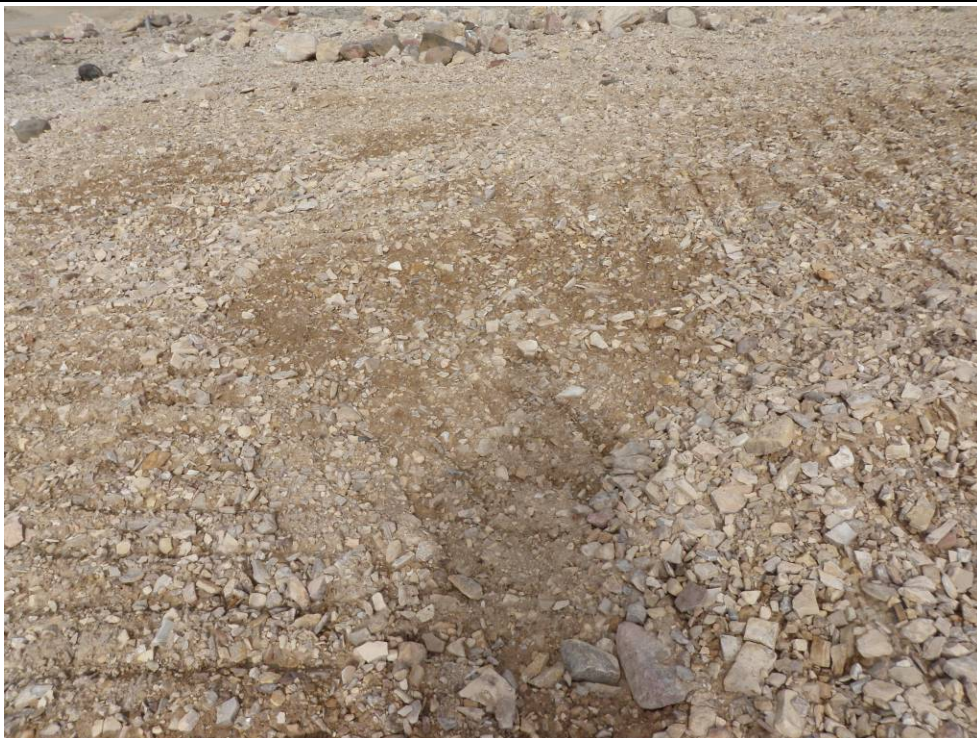
View of depression on northwest corner of NHWL (Feature C). Viewpoint 42 (Figure A-1; Appendix A). Photograph reference 42 (CD-ROM). Direction photo taken: SE

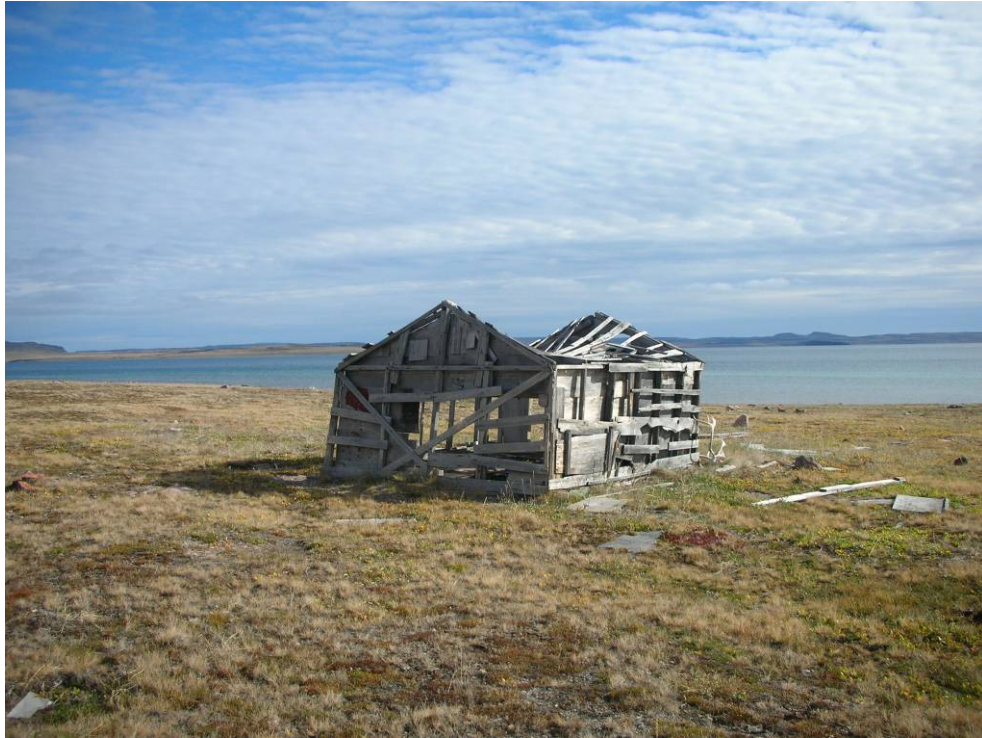
The East Beach Area was inspected by foot. This area is at a much lower elevation than the Main Station. Here there is an increase of vegetation growth including mosses and grasses. Remnants of a derelict camp remain. A partially standing ply wood cabin, old camp equipment and caribou antlers were observed (Photos 46 and 47, Appendix C). The access road from this beach area connecting to the airstrip was observed in fair to good condition (Photo 48, Appendix C).

View of derelict camp at East Beach Area. Photograph reference 46 (CD-ROM). Direction photo taken: N/A

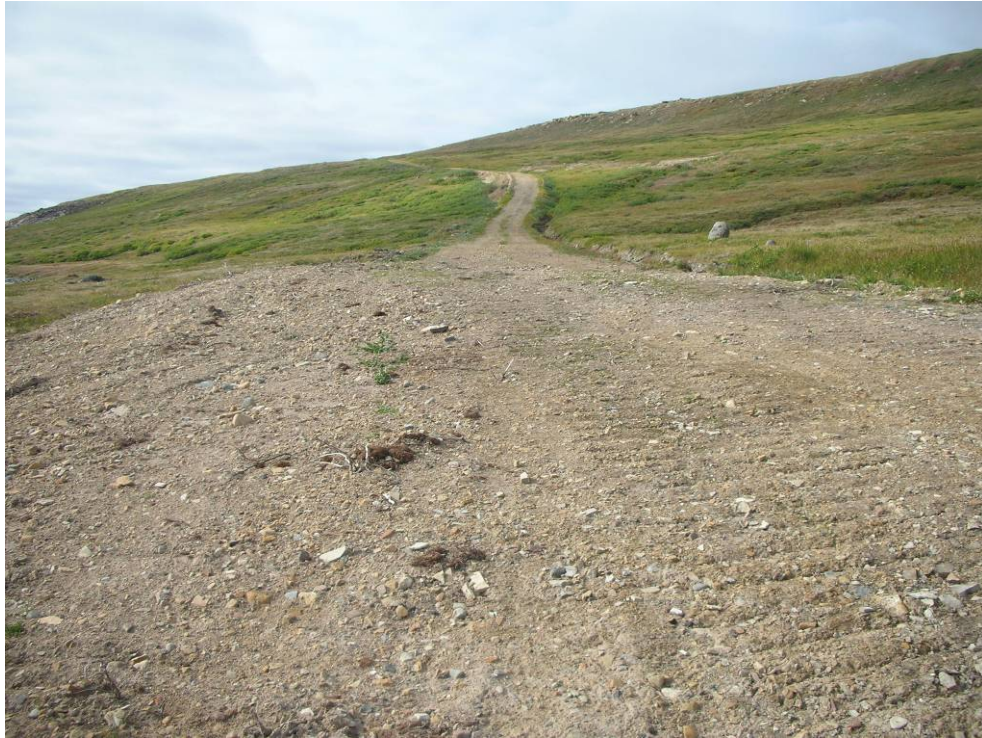
Access road from East Beach Area up to airstrip. Photograph reference 48 (CD-ROM). Direction photo taken: NW

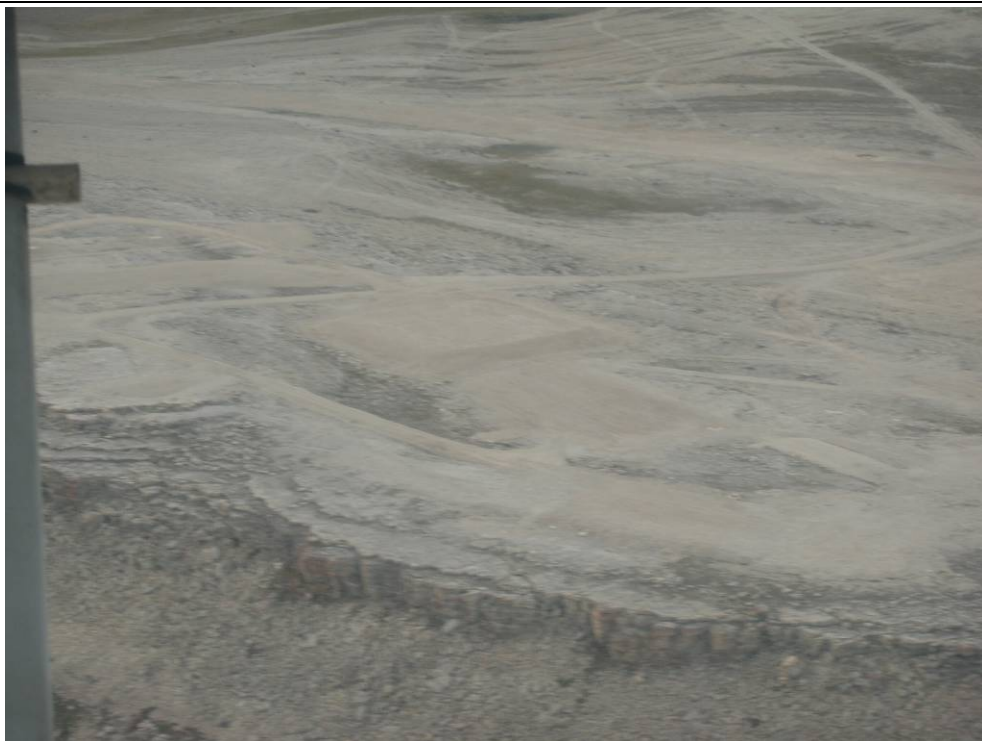
Aerial view of NHWL. Photograph reference 49 (CD-ROM). Direction photo taken: N/A
