## **LONG TERM MONITORING, 2015**

PIN-D, Ross Point, Nunavut

January 20, 2016

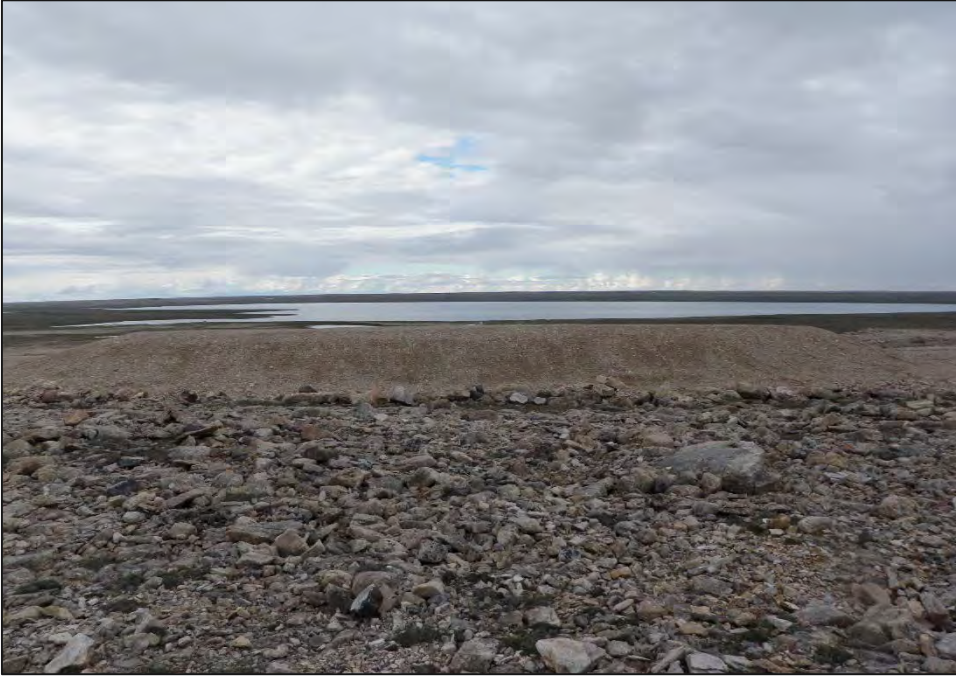
**Photo: 1**

**Location:**  
Viewpoint 9 (Figure 2)

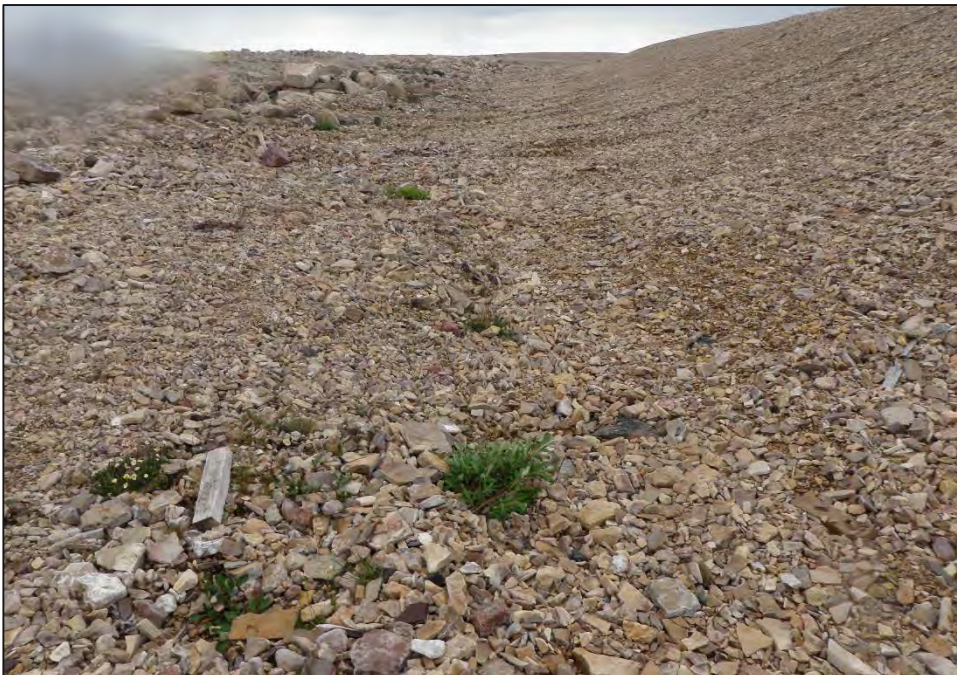
**Photo: 2**

One pothole was observed at the southeast corner of the toe of the landfill berm, as in 2013. This pothole appears to be a result of grading (Photo 2, Appendix A). A new pothole was observed in 2015, in the southwest corner of the landfill (Photo 11, Appendix A). It was approximately 0.75 m by 0.75 m, with an approximately depth of 0.10 m. It appears that this pothole was a result of a minor slump where the edge of the surface of the landfill and the slope meet.

Based on the regional setting of this landfill, full re-establishment of vegetation will likely not occur within the timeframe of the first phase of long term monitoring. Very minor vegetation growth was observed at southeast corner of the landfill at the observed pothole (Photo 2, Appendix A). No vegetation growth was observed on the surface of the landfill.

Based on the regional setting of this site, re-establishment of vegetation is not likely in the near future. Minor growth was again observed on the south side of the NHL, at the toe of landfill (Photo 2, Appendix A), in a similar location to 2013 observations. No vegetation growth was observed on the surface of the landfill.
