## **Long-Term Monitoring, 2010 CAM-F, Sarcpa Lake, Nunavut**

### **FINAL REPORT**

Project No. 1697-1001  
December 10, 2010

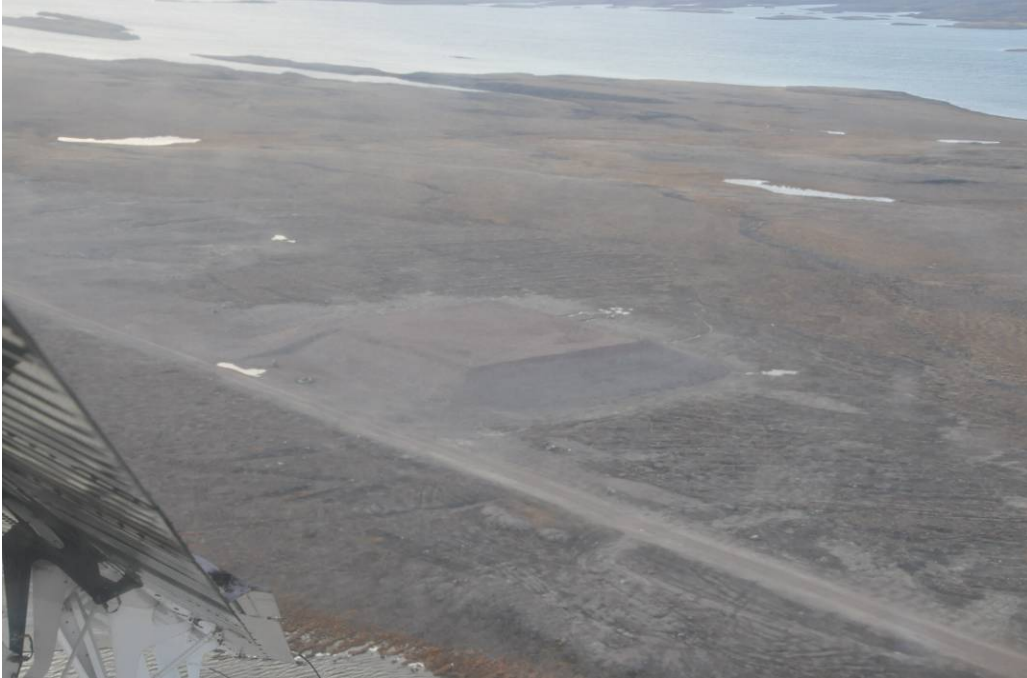
Ponding was observed in areas set back from the toe of the SSDF by several metres in multiple locations on all sides (refer to Figure A-2, Appendix A).

Photo 1. The CAM-F Secure Soil Disposal Facility (SSDF). Areas with ponded surface water can be seen at both the northern (left) and southern (right) toes of the SSDF. Direction photo taken: SSE (picture # DSC\_0264).

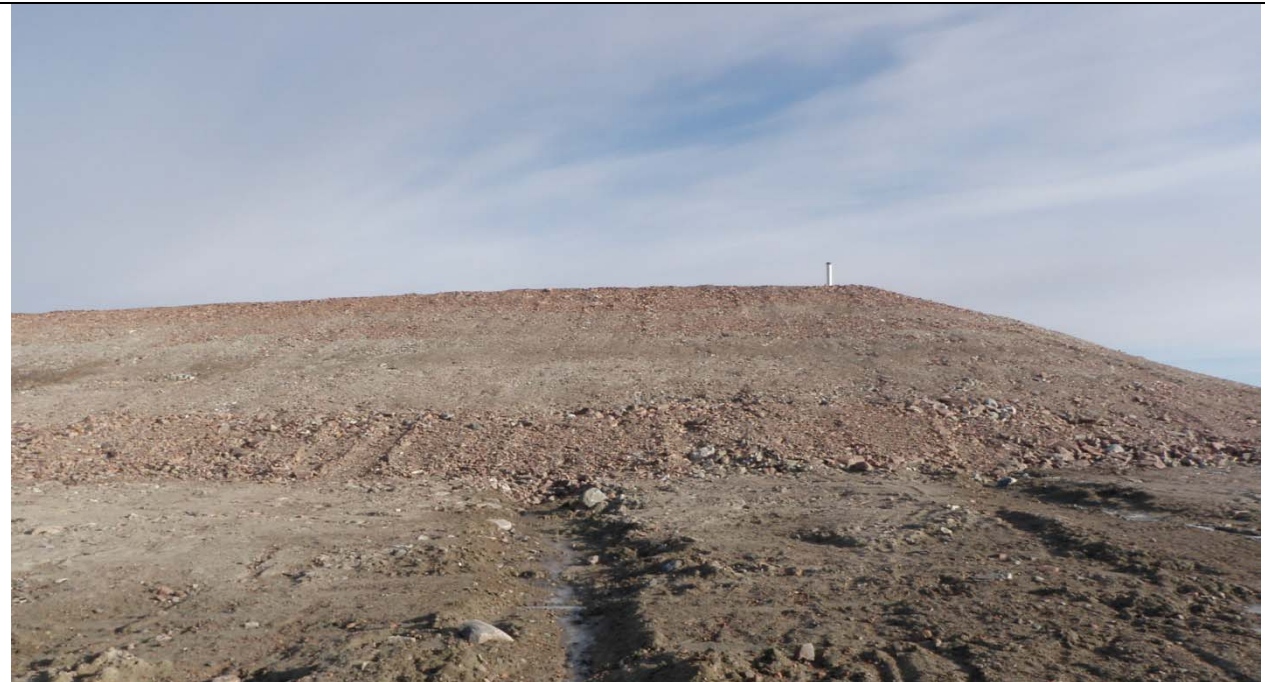
The small preferred-drainage channels observed in previous years at the toe on the southeast side of the SSDF are still apparent. Based on a comparison with photo documentation from 2008 and 2009, there does not appear to be an appreciable increase in the size of these channels.

Photo 2. Rivulet (erosion channel) on south side of SSDF; picture viewpoint number 24a (Figure A-1, Appendix A). Direction photo taken: N (picture # P9090571).

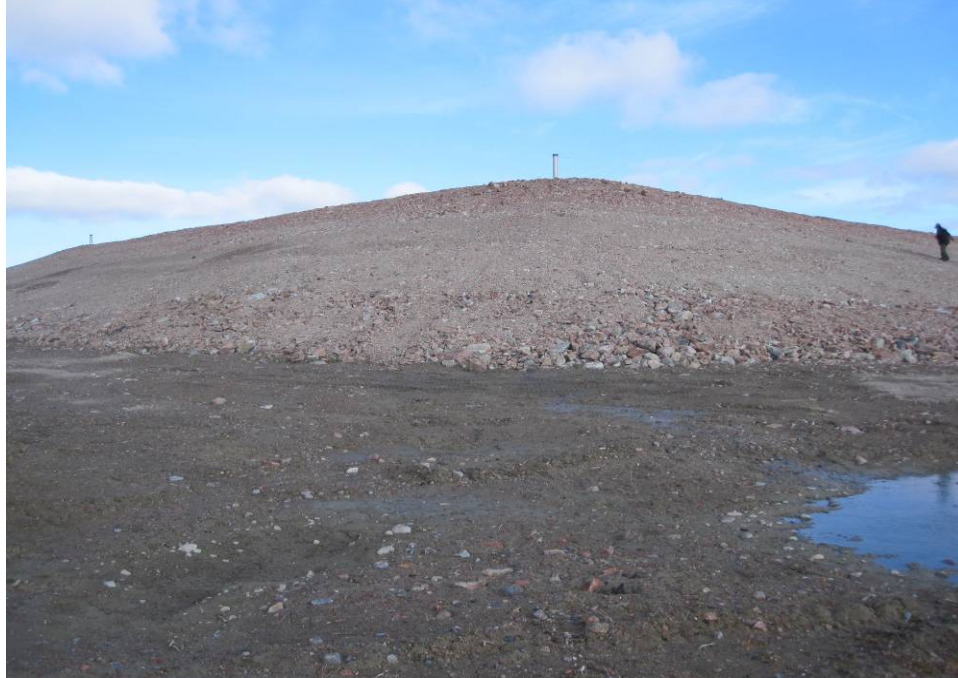
Photo 3. Picture viewpoint number 15 (Figure A-1, Appendix A) of the SW corner of the SSDF. Seepage points A, B and C can be seen on the far left; ponded surface appears in the lower right; and exposed riprap can be seen along the southern edge of the landfill toe. Direction photo taken: NE (picture # IMG\_2499).

1. a soil sample collection be added to the monitoring program for one of the seepage points on the SSDF should seepage persist or new signs of landfill deterioration appear near any of these points;
2. a new lock be brought for the monitoring well MW0601, near the NHWL; and
3. the desiccant cartridges inside the thermistor data loggers be replaced during the next site visit.

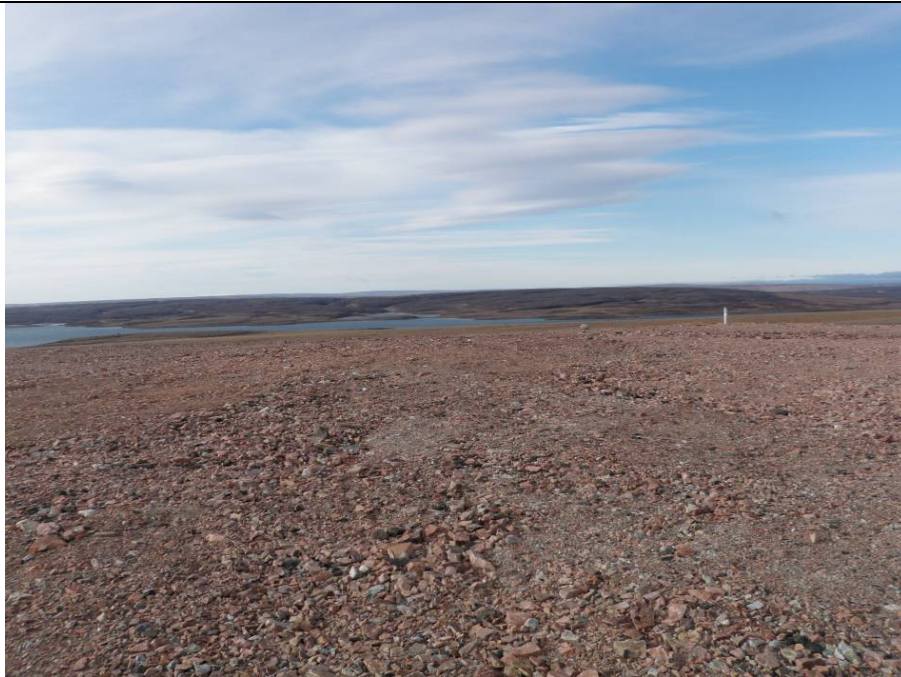
Photo 4. Top of the SSDF; picture viewpoint number 62 (Figure A-1, Appendix A). No significant change since previous inspection. Direction photo taken: SSW (picture # P9090620).

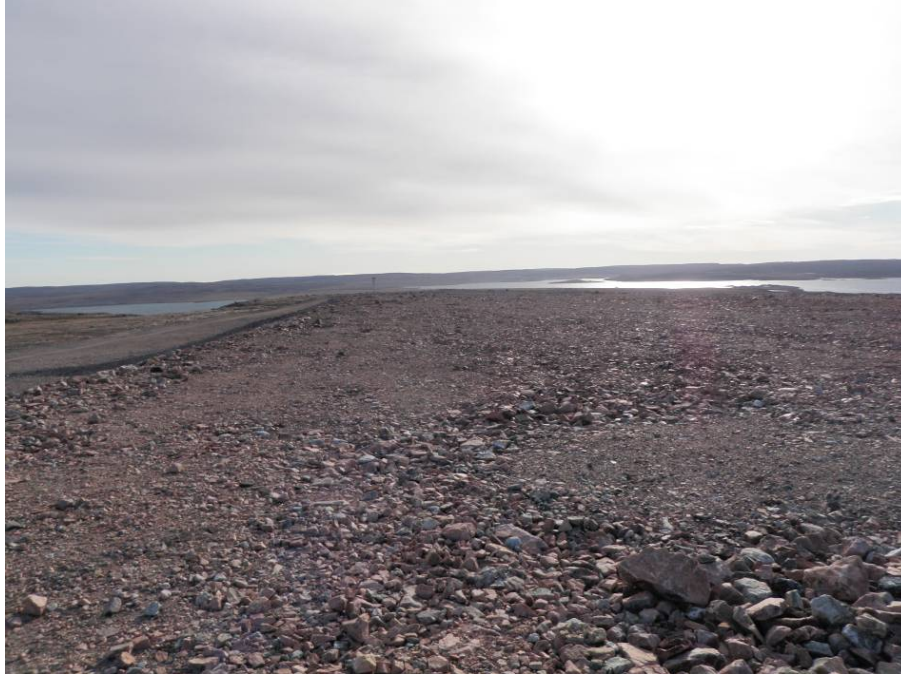
Rip rap has been exposed in small, localized amounts, where fine-grained fill has been washed out on some of the structure's slopes and top, although no significant change from previous years is apparent. A few new, small, scattered potholes have formed in one area on the eastern side of the SSDF. Potholes elsewhere over the structure were observed in 2008 and 2009, and it would appear that the top and sides of the SSDF have not appreciably worsened in this respect. The large section of exposed rip rap along the southern edge roughly coincides with the area where Type 1 Granular Fill was used to construct the SSDF; the presumably smaller diameter, Type 2 Granular Fill was used to cover the remainder of the SSDF surface. It is unlikely, therefore, that this exposed rip rap is due to erosion.

Photo 5. Minor erosion of fines and slight depression on the top of the SSDF; picture viewpoint number 56 (Figure A-1, Appendix A). No significant change since previous inspection. Direction photo taken: SE (picture # P9090677).

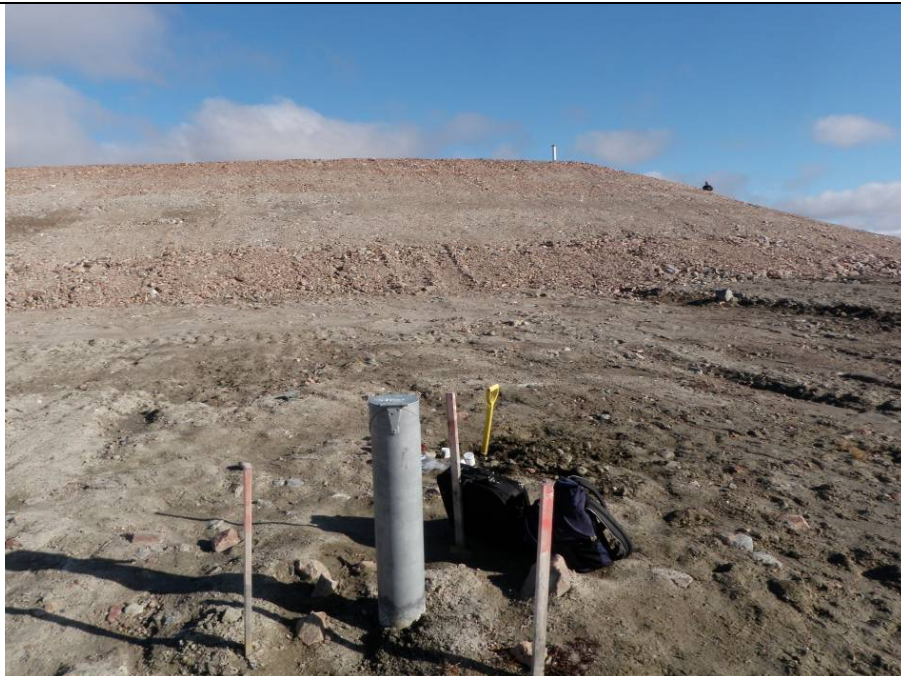
Photo 6. MW0605 on the wouth side of the SSDF (picture # P9080462).

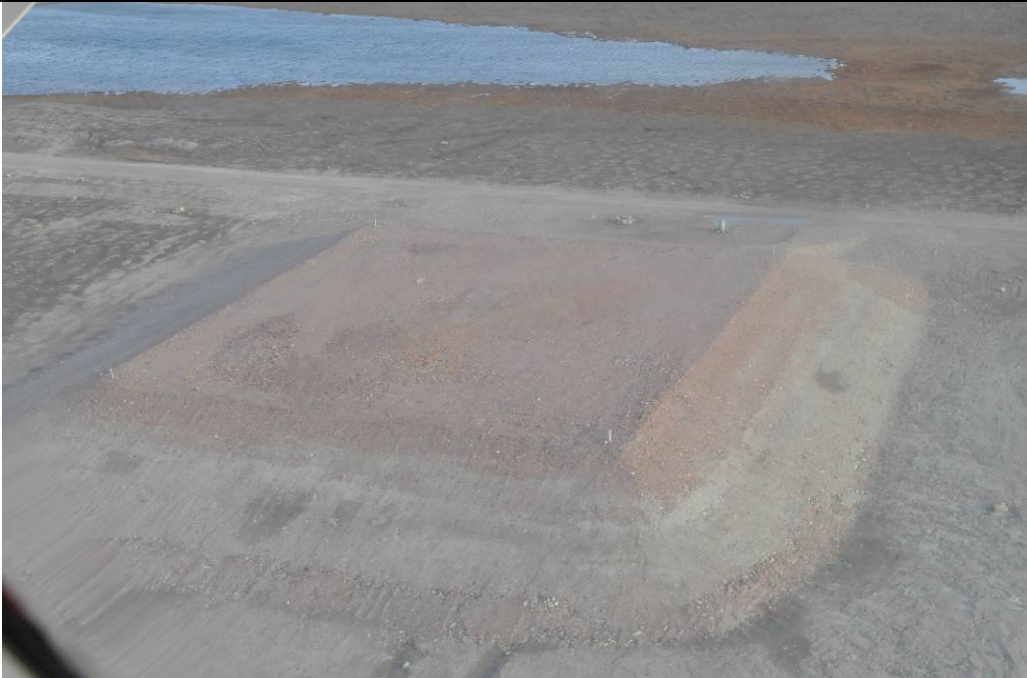
Photo 7. Seepage points on the eastern and southern sides of the SSDF. Direction photo taken: N (picture # DSC\_0259).

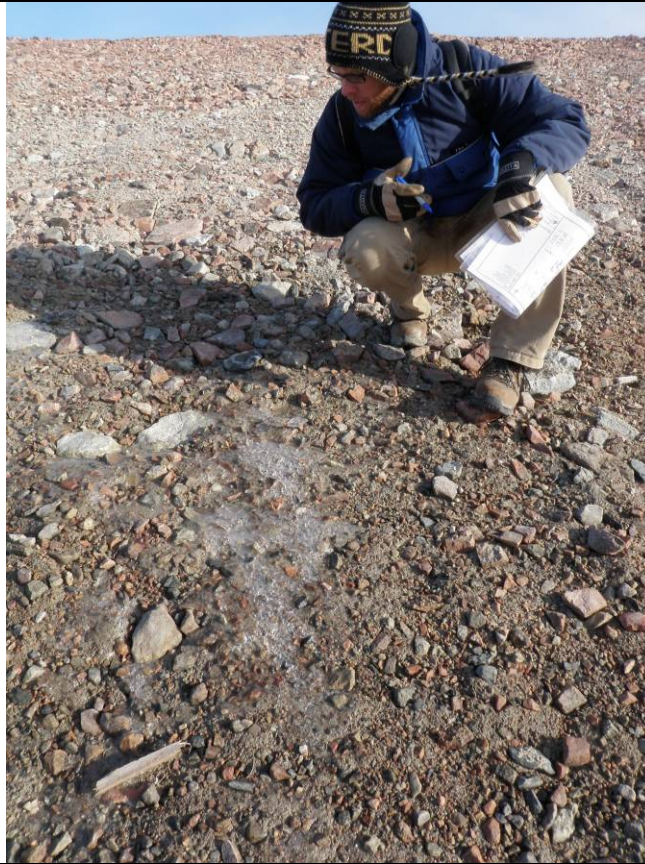
Photo 9. Close-up of active seepage point E showing frozen surface water (refer to Figure A-1, Appendix A).  
Picture # P9090682.

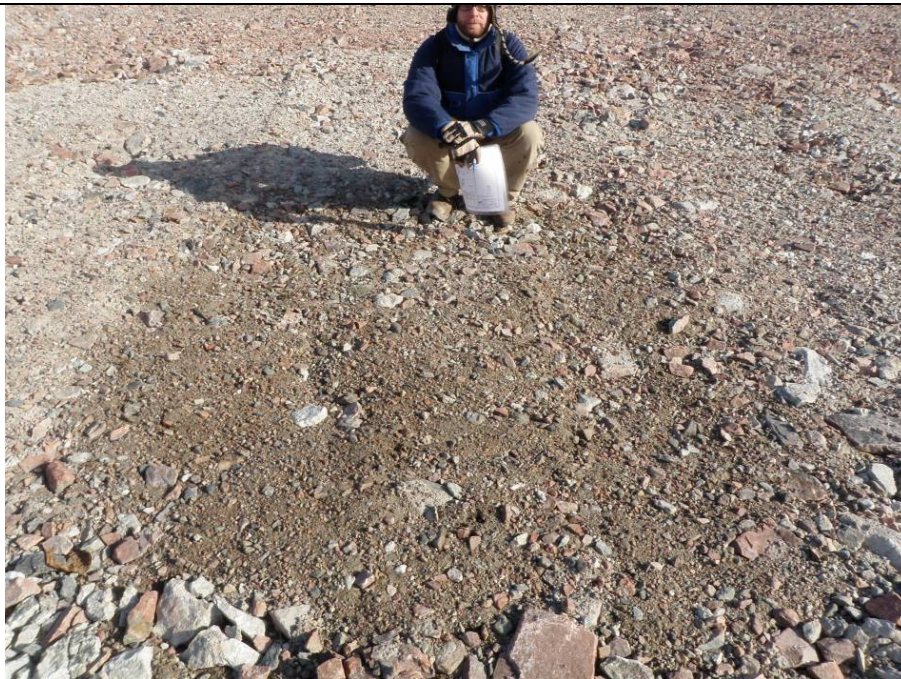
Photo 10. Active seepage point F on south side of SSDF (refer to Figure A-1, Appendix A) where small vegetation regrowing. Picture # P9090684.

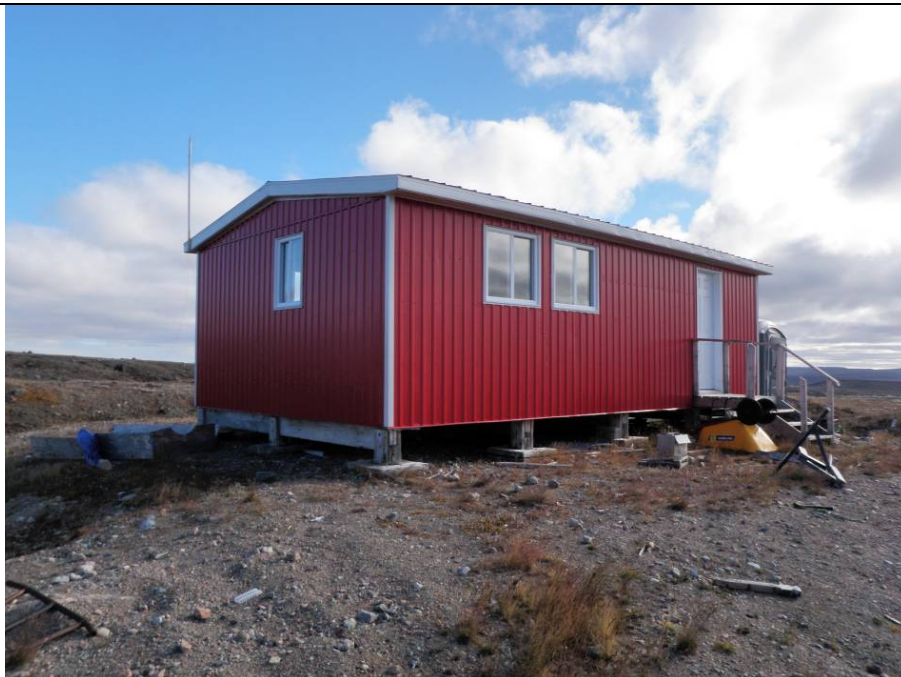
Photo 12. Cabin located between the SSDF and the NHL showing some of surrounding debris. Direction photo taken: NE (picture # P9080469).

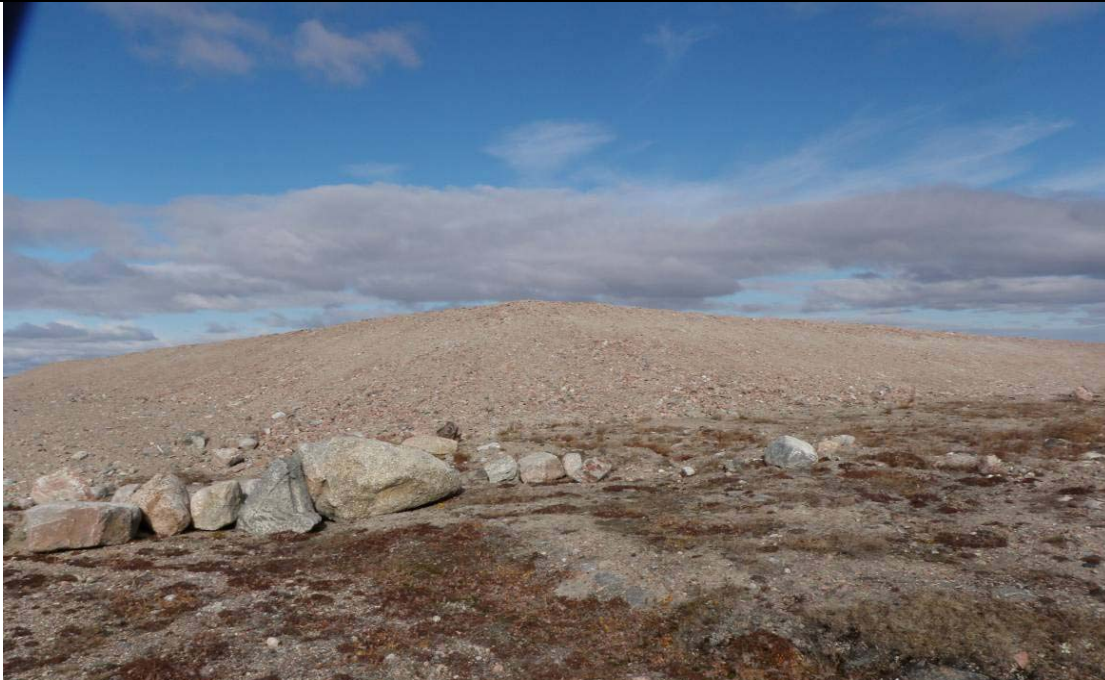
Photo 13. The south-eastern and south-western sides of the Non-Hazardous Waste Landfill (NHWL) shown from picture viewpoint number 23 (Figure A-2, Appendix A). Typical of all sides of the landfill, the NHWL shows little sign of erosion, seepage or settlement. Direction photo taken: N ( picture # P9080513).

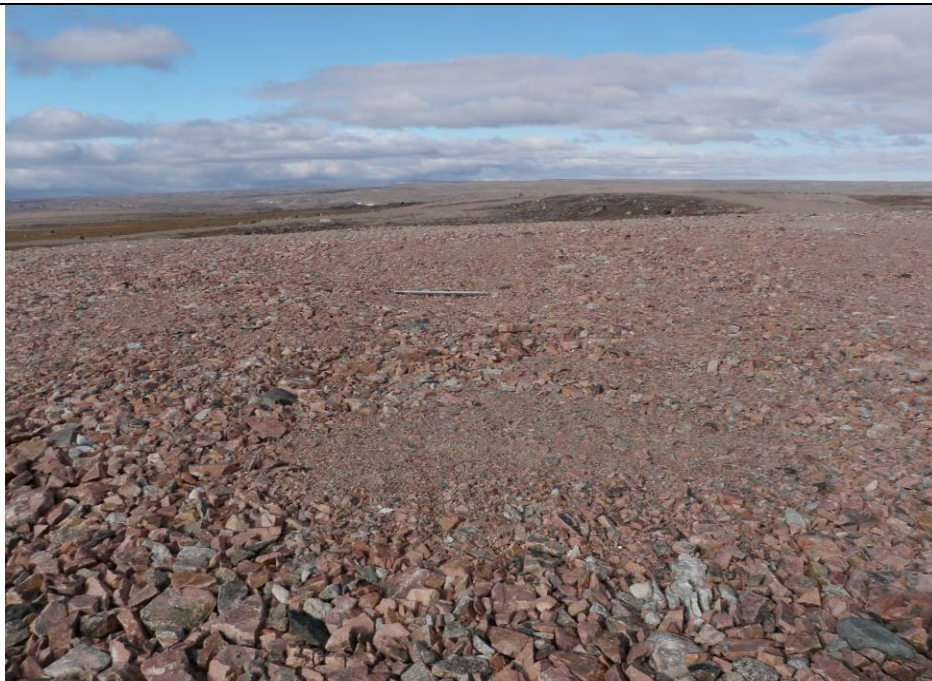
Photo 14. Top of NHWL showing minor depression and erosion of fines revealing gravel and cobbles; picture viewpoint number 35 (Figure A-2, Appendix A). Direction photo taken: NW (picture # P9080503).

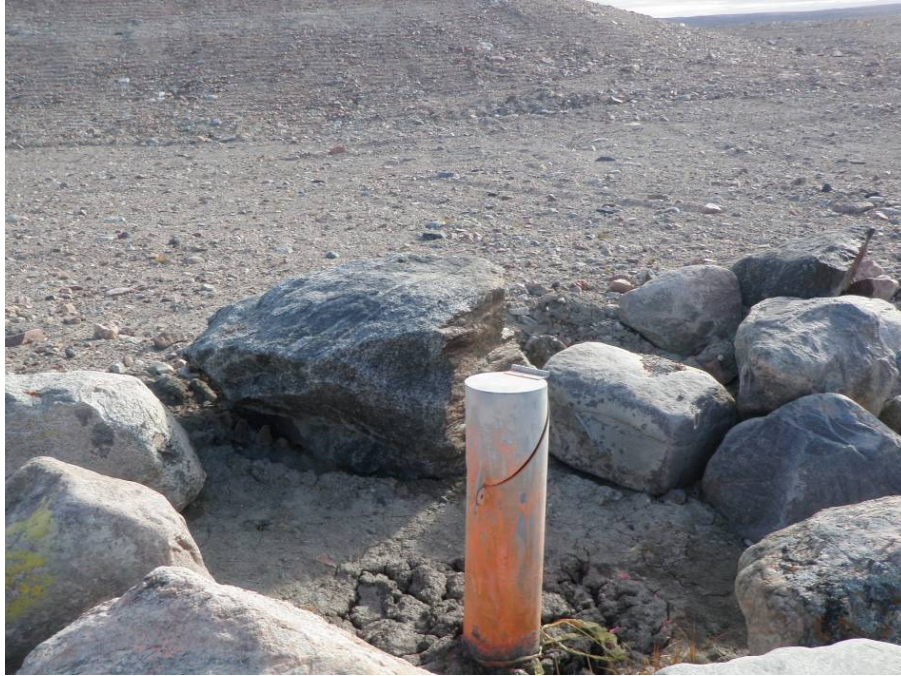
Photo 15. MW06-01 near the NHWL showing conditions similar to those observed during the previous year's monitoring event. Picture viewpoint number 15 (Figure A-2, Appendix A); picture # P9080483.
