Long-Term Monitoring, 2011 CAM-F, Sarcpa Lake, Nunavut

FINAL REPORT

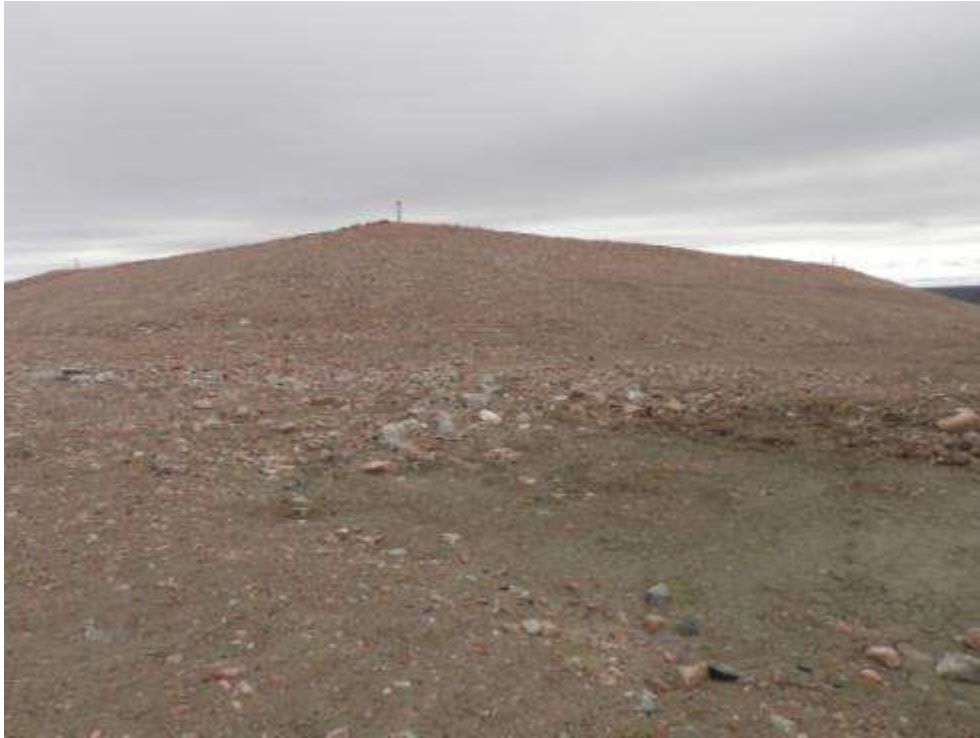
Northwest corner of the SSDF. Viewpoint 2 (Figure A-2; Appendix A). Photograph reference P8270099 (CD-ROM).
Direction photo taken: SE

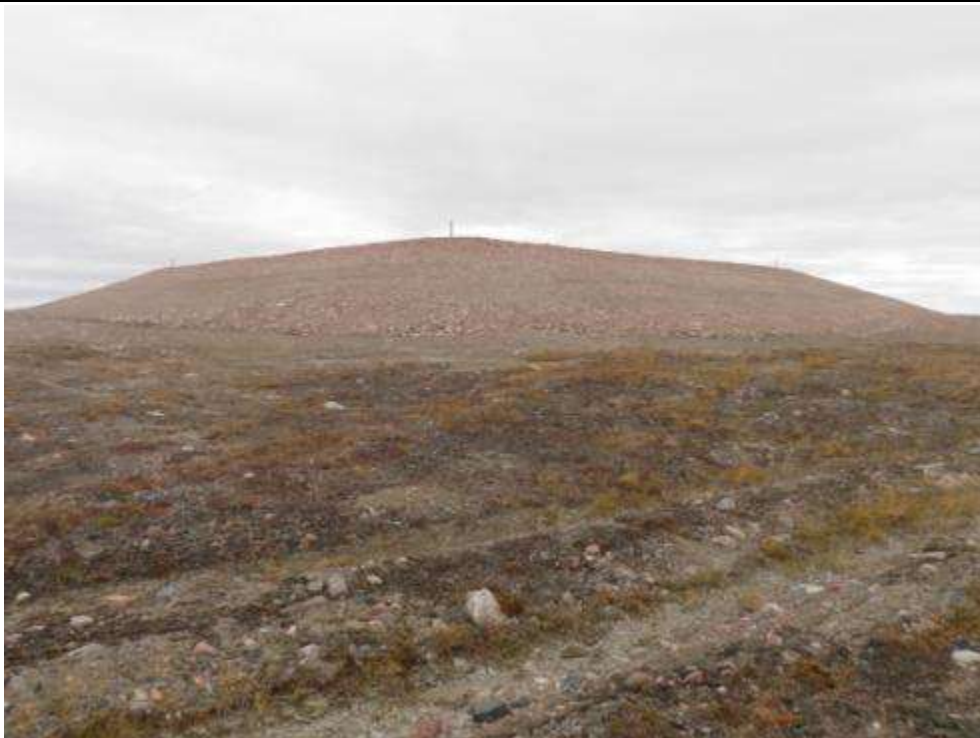
Southwest corner of the SSDF. Viewpoint 11 (Figure A-2; Appendix A). Photograph reference P8270108 (CD-ROM).
Direction photo taken: NE

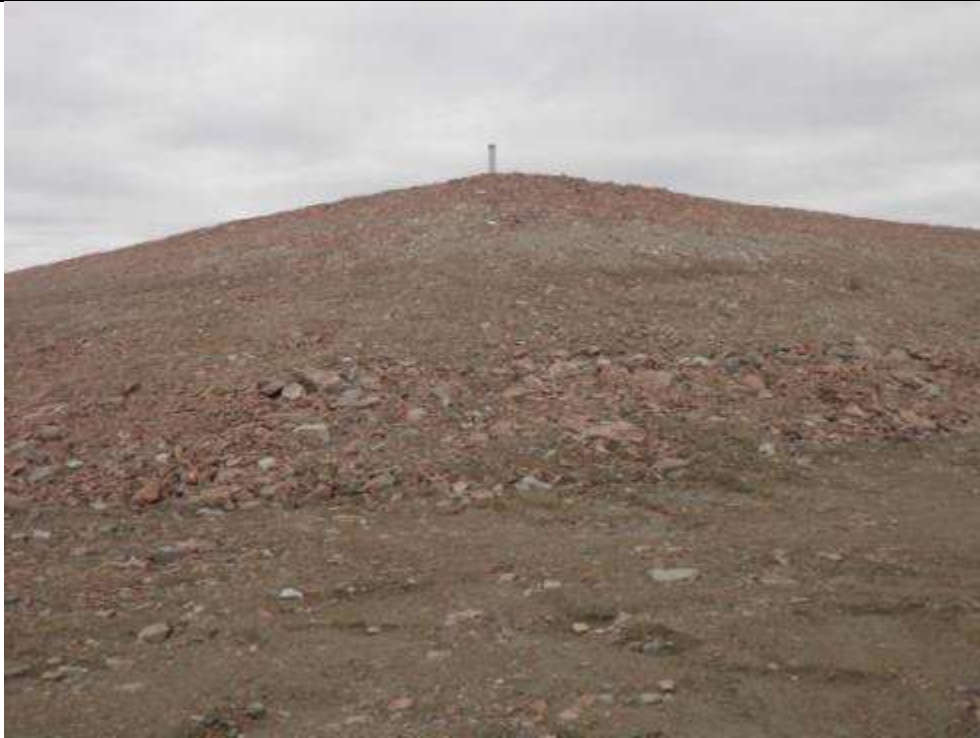
Southeast corner of the SSDF. Viewpoint 23 (Figure A-2; Appendix A). Photograph reference P8270120 (CD-ROM).
Direction photo taken: NW

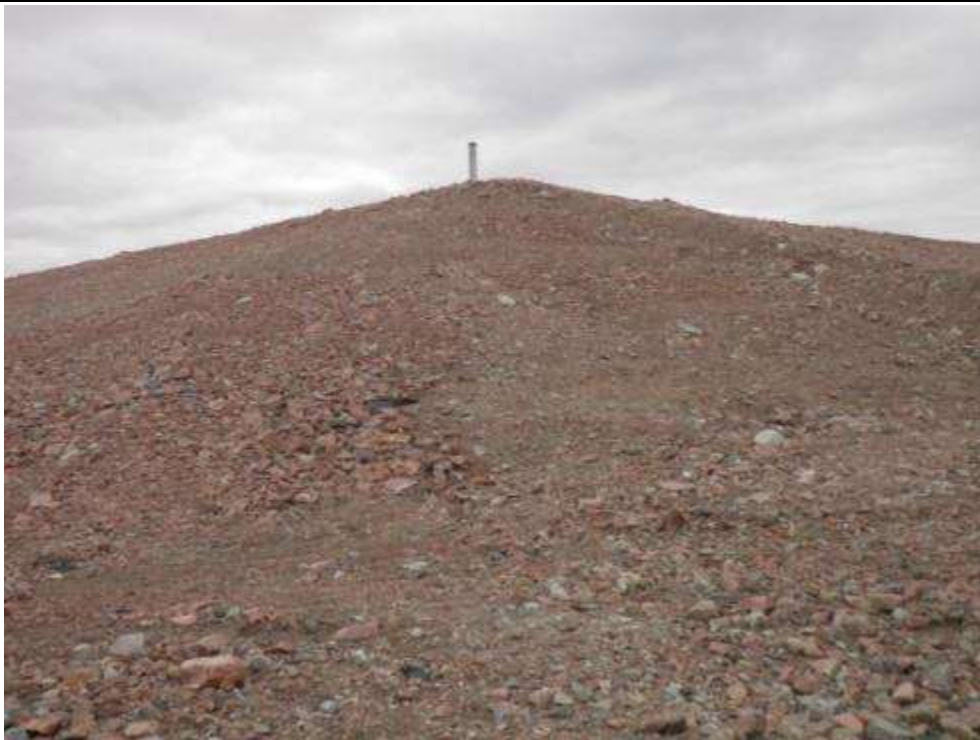
Northeast corner of the SSDF. Viewpoint 33 (Figure A-2; Appendix A). Photograph reference P8270130 (CD-ROM).
Direction photo taken: SW

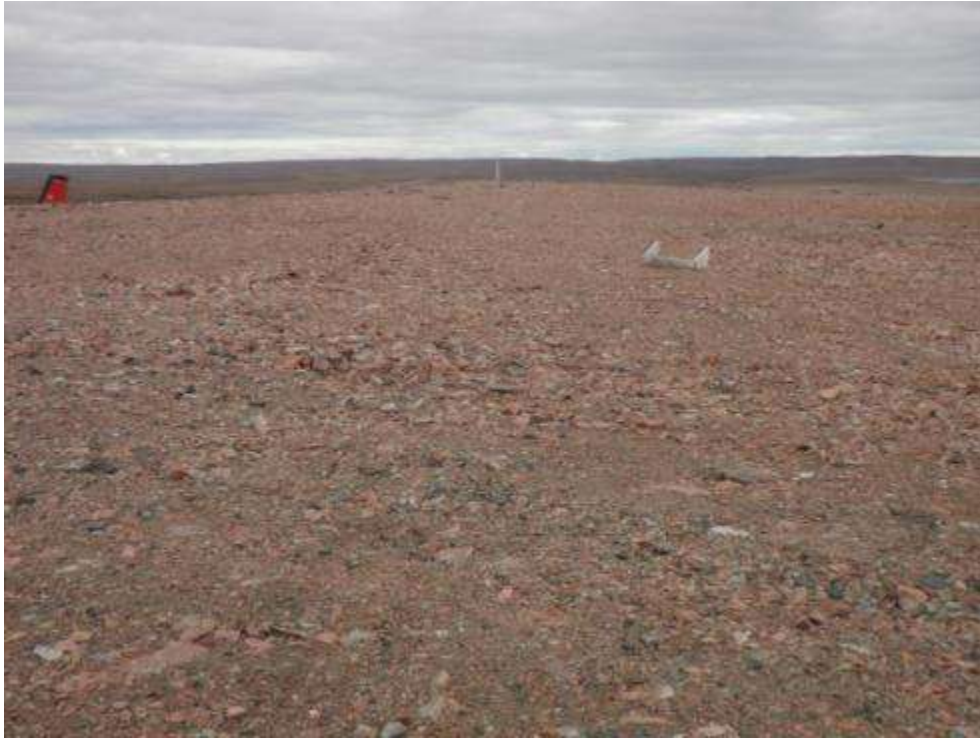
Top of the SSDF. Viewpoint 43 (Figure A-2; Appendix A). Photograph reference P8270140 (CD-ROM). Direction photo taken: E

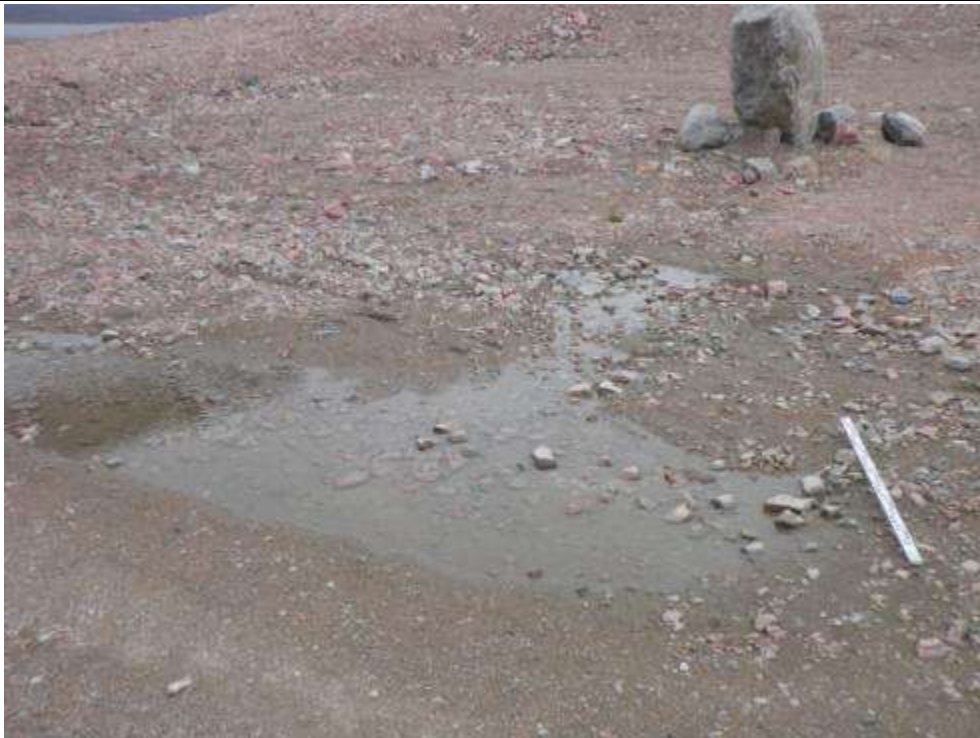
Ponded water near airstrip. Viewpoint 54 (Figure A-2; Appendix A). Photograph reference P8270151 (CD-ROM). Direction photo taken: S

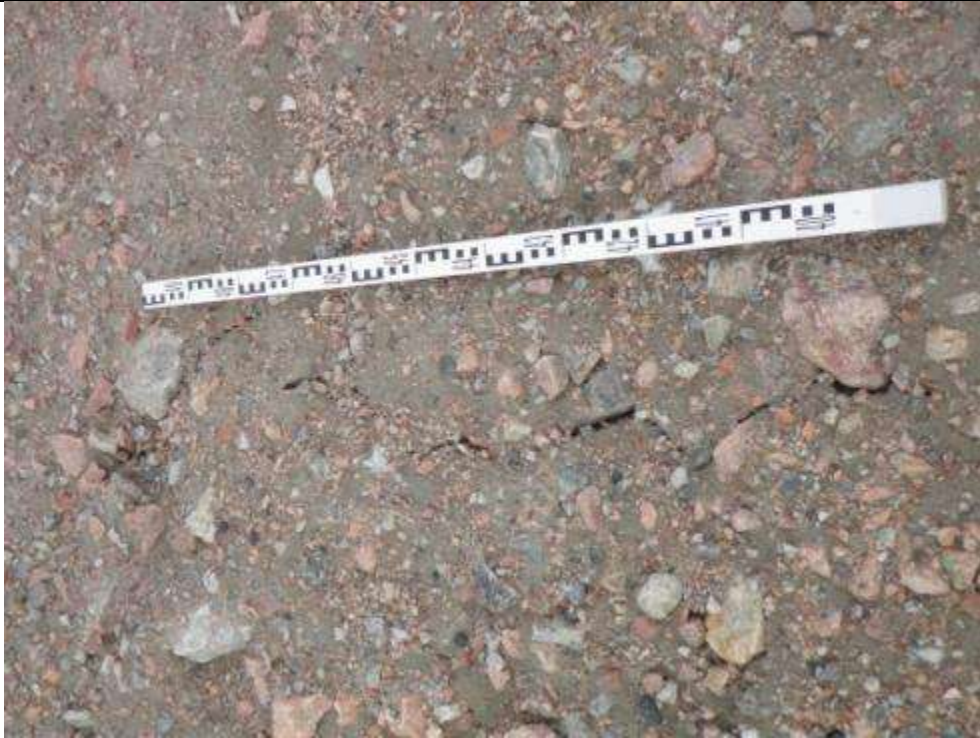
These features do not pose any risk to the landfills integrity. Minor settlement cracking was observed along the landfill's perimeter, generally located approximately 4 m up the face of the berm from the toe (see features C, D, F, K, M, O, and T; Figure A-2; Appendix A). Although the additional observed settlement cracking is minor, it does indicate that the toe of the landfill has settled slightly from the previous site visit in 2010.

Cracking on west slope of SSDF. Viewpoint 59 (Figure A-2; Appendix A). Photograph reference P8270156 (CD-ROM). Direction photo taken: E

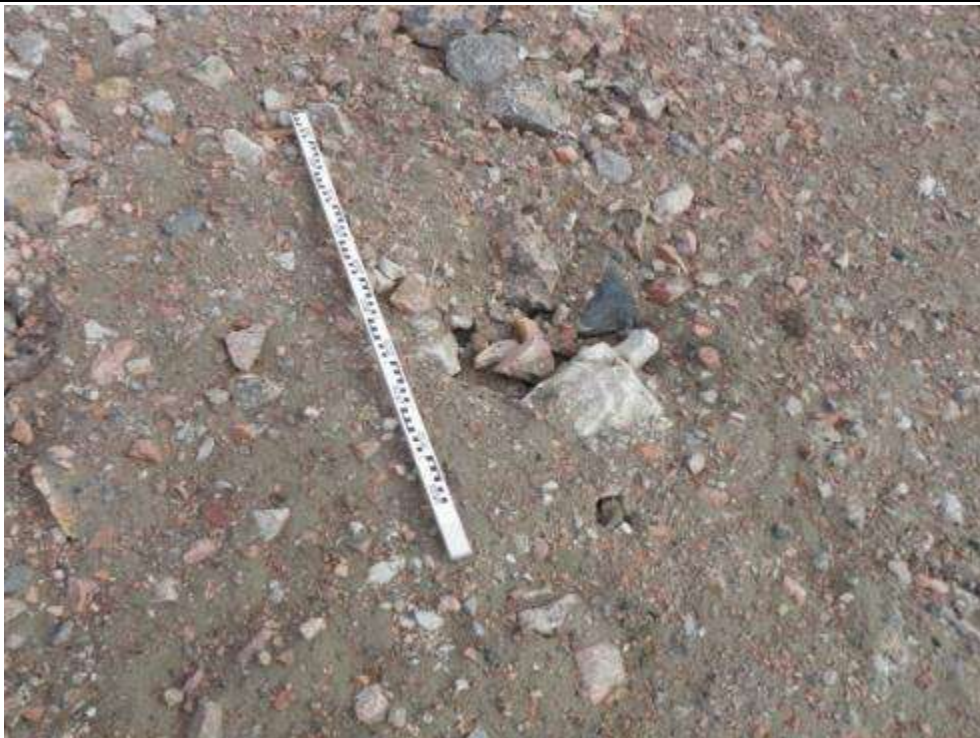
Rip rap has been exposed in a small, localized area, where fine-grained fill has been washed out on some of the structure's slopes and top, although no significant change from previous years is apparent. A few new, small, scattered potholes have formed in one area on the eastern side of the SSDF. Potholes elsewhere over the structure were observed in 2008, 2009, and 2010 and it would appear that the top and sides of the SSDF have not noticeably worsened in this respect. The large section of exposed rip rap along the southern edge roughly coincides with the area where Type 1 Granular Fill was used to construct the SSDF; the presumably smaller diameter, Type 2 Granular Fill was used to cover the remainder of the SSDF surface. It is unlikely, therefore, that this exposed rip rap is due to erosion.

Pothole on west slope of SSDF. Viewpoint 64 (Figure A-2; Appendix A). Photograph reference P8270161 (CD-ROM). Direction photo taken: E

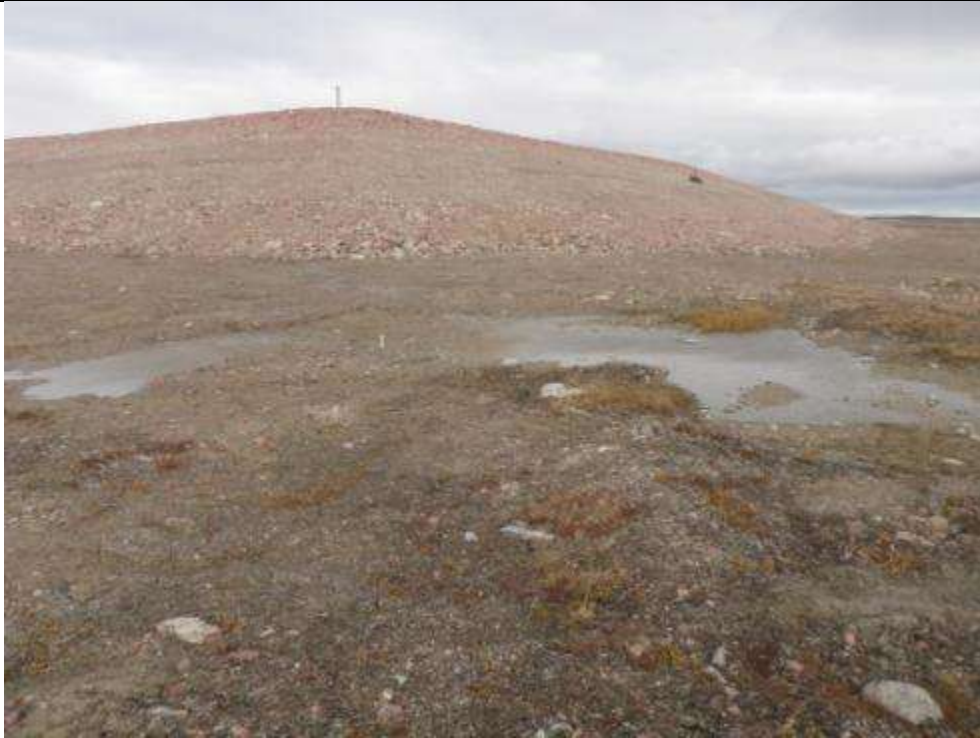
Ponding from active seepage at the southwest corner. Viewpoint 68 (Figure A-2; Appendix A). Photograph reference P8270165 (CD-ROM). Direction photo taken: NE

1. Should signs of seepage persist or new signs of landfill deterioration appear near any of the seepage points noted in 2011, collection of a soil sample from one of the seepage points on the SSDF should be added to the monitoring program.

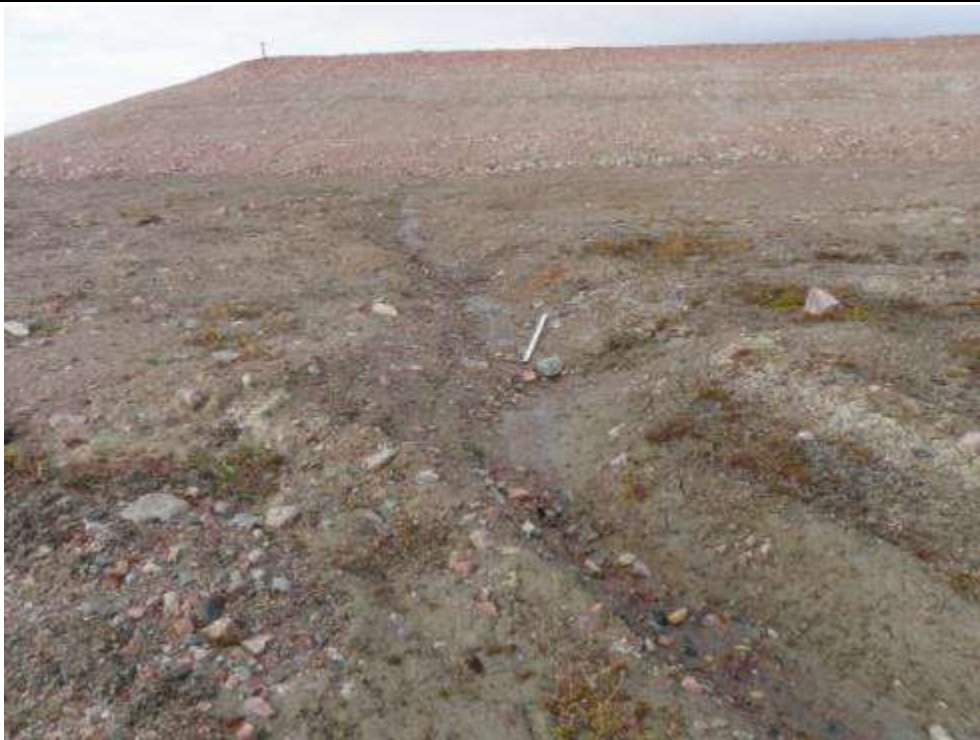
The small preferred-drainage channels observed in previous years at the toe on the southwest side of the SSDF are still apparent (see features I, J, N, and Q; Figure A-2; Appendix A). Based on a comparison with photo documentation from 2008, 2009, and 2010, there does not appear to be an appreciable increase in the size of these channels.

Active erosion from active seepage along the south toe of the SSDF. Viewpoint 74 (Figure A-2; Appendix A). Photograph reference P8270171 (CD-ROM). Direction photo taken: N

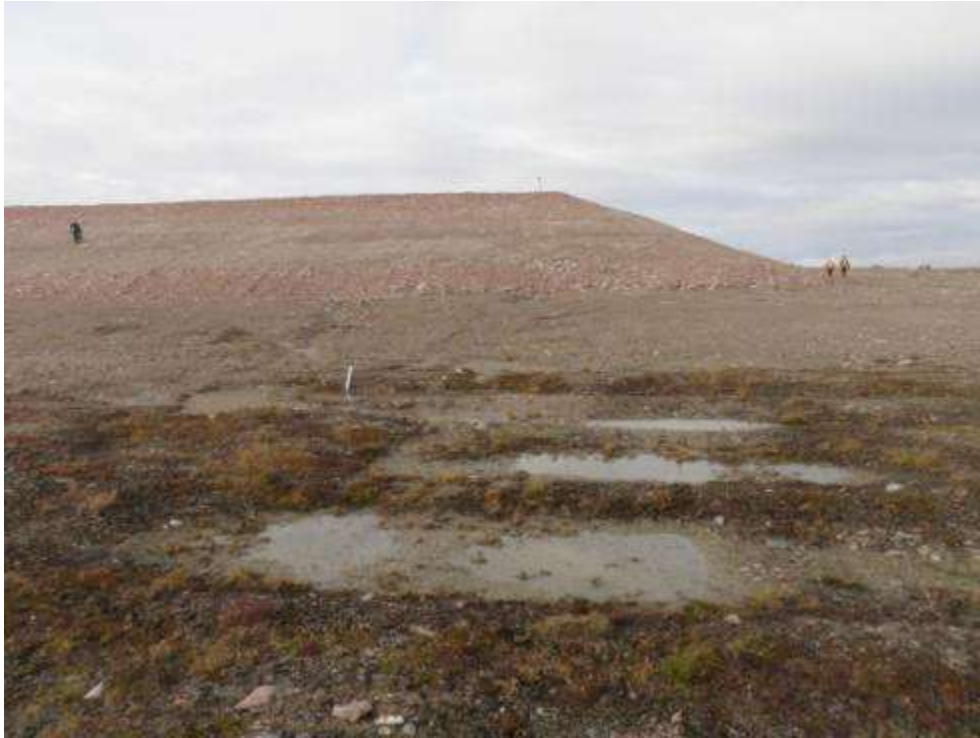
Ponded water from the active seep near the southeast corner of the SSDF. Viewpoint 78 (Figure A-2; Appendix A).
Photograph reference P8270175 (CD-ROM). Direction photo taken: SE

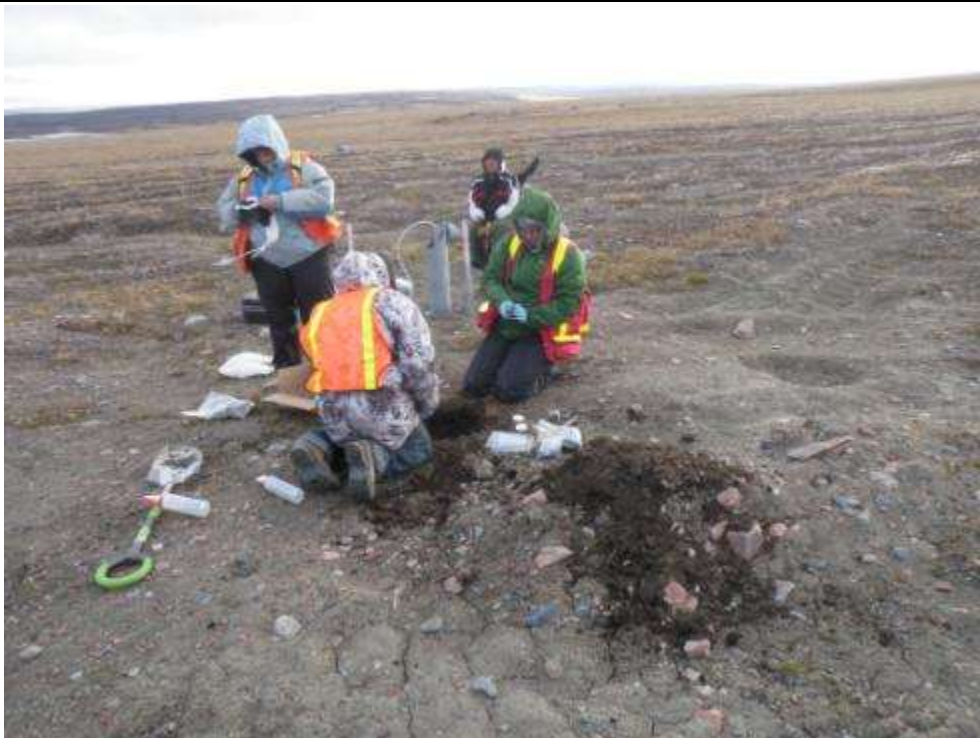
Soil sampling near MW0606. Viewpoint 83 (Figure A-2; Appendix A). Photograph reference P8270180 (CD-ROM).
Direction photo taken: SE

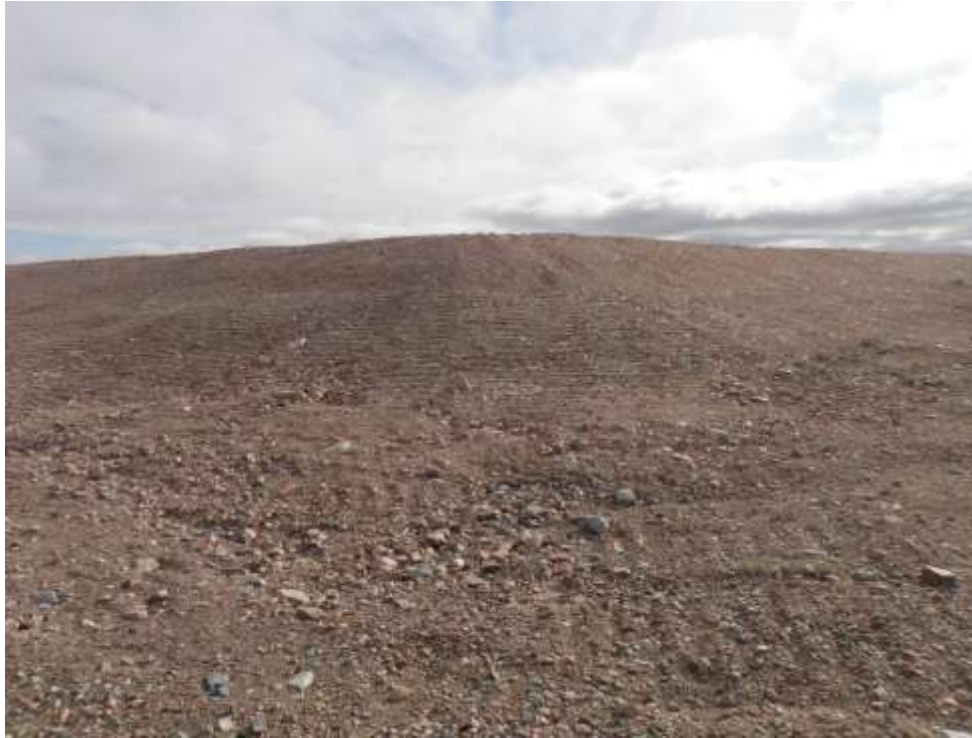
West corner of the NHL. Viewpoint 2 (Figure A-3; Appendix A). Photograph reference P8280002 (CD-ROM).
Direction photo taken: E

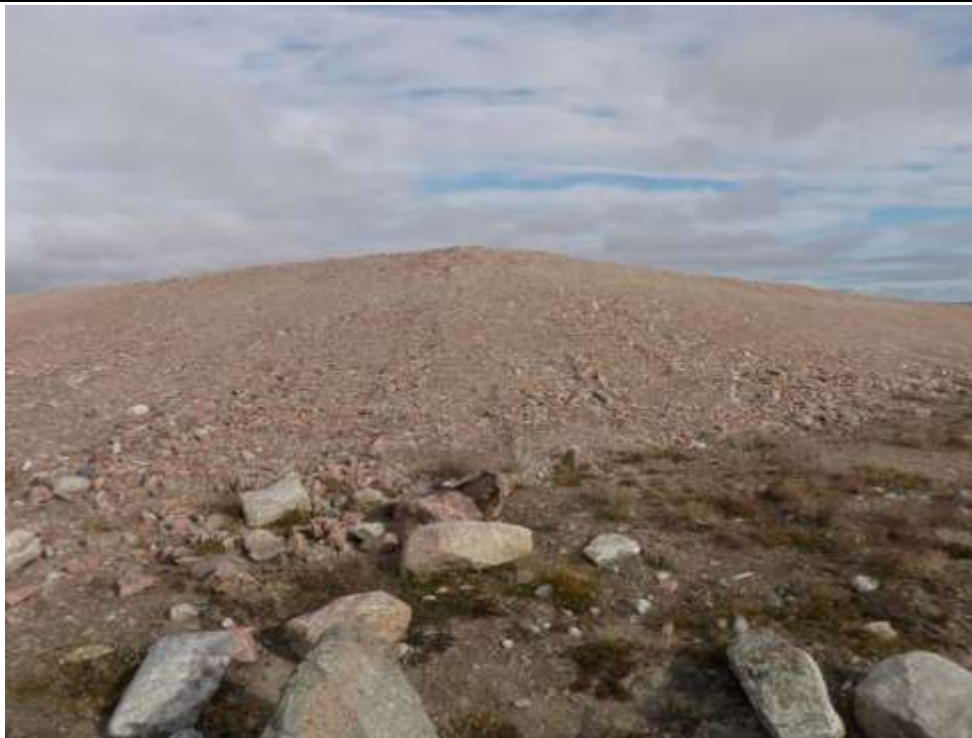
South corner of the NHL. Viewpoint 10 (Figure A-3; Appendix A). Photograph reference P8280010 (CD-ROM).
Direction photo taken: N

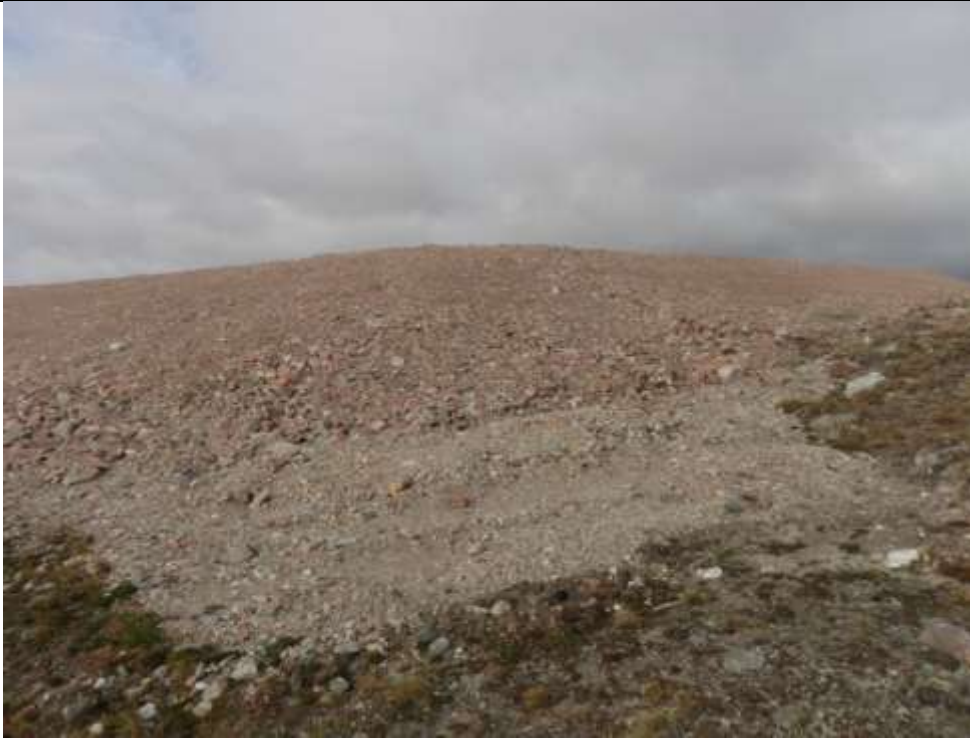
East corner of the NHWL. Viewpoint 20 (Figure A-3; Appendix A). Photograph reference P8280020 (CD-ROM).
Direction photo taken: W

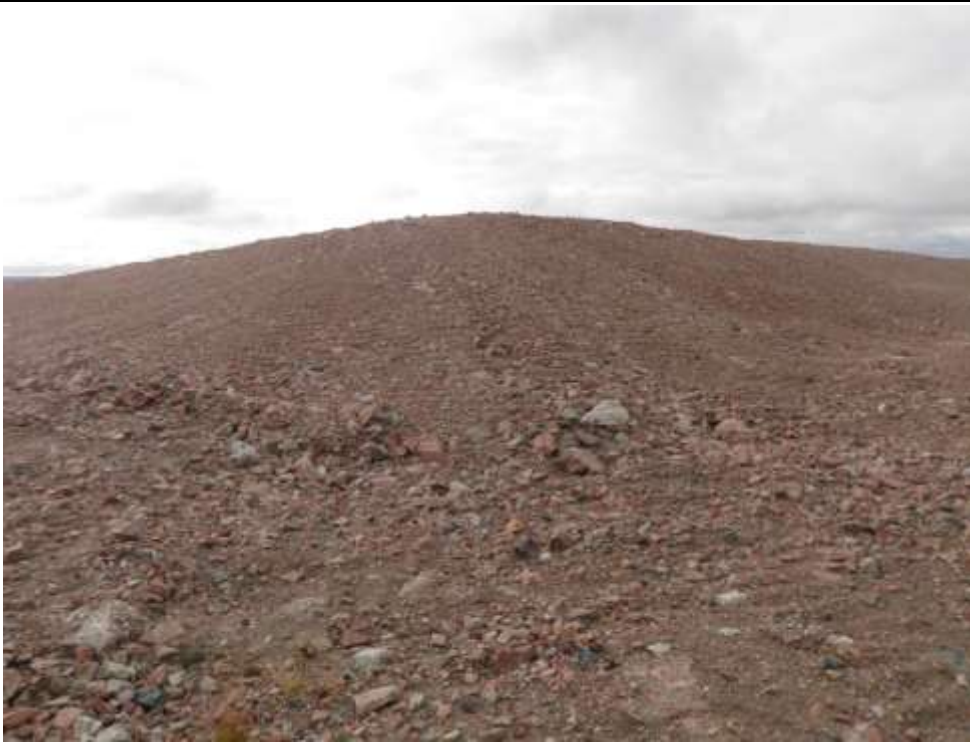
West corner of the NHWL. Viewpoint 28 (Figure A-3; Appendix A). Photograph reference P8280028 (CD-ROM).
Direction photo taken: S

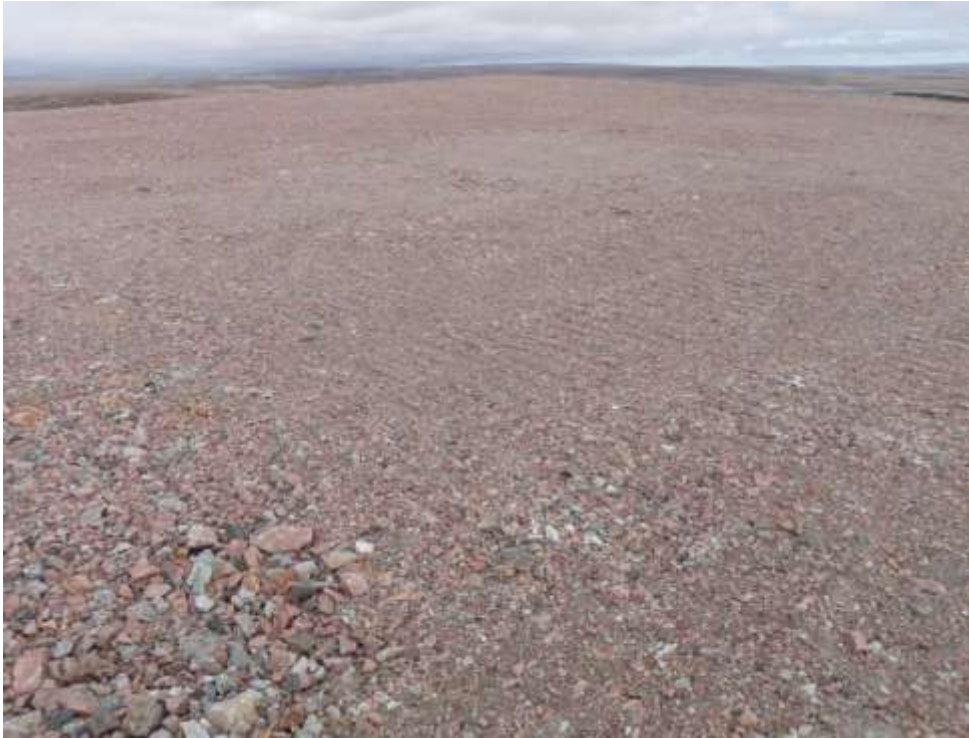
Top of the NHWL from west corner. Viewpoint 39 (Figure A-3; Appendix A). Photograph reference P8280039 (CD-ROM). Direction photo taken: N

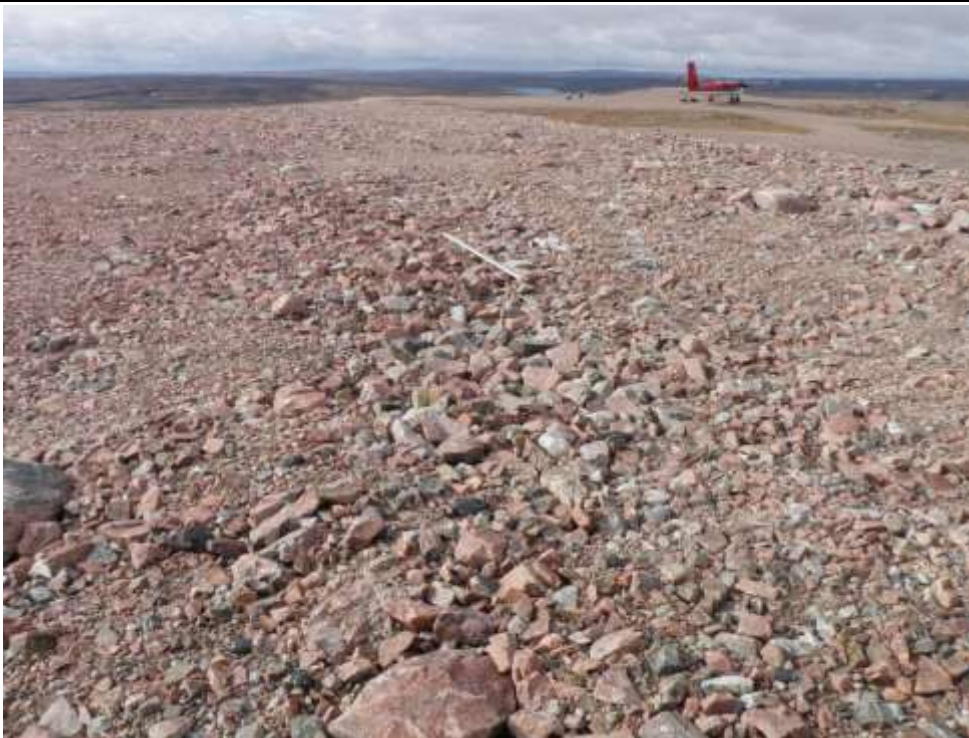
Feature A – small depression on top of the NHWL. Viewpoint 48 (Figure A-3; Appendix A). Photograph reference P8280048 (CD-ROM). Direction photo taken: SW

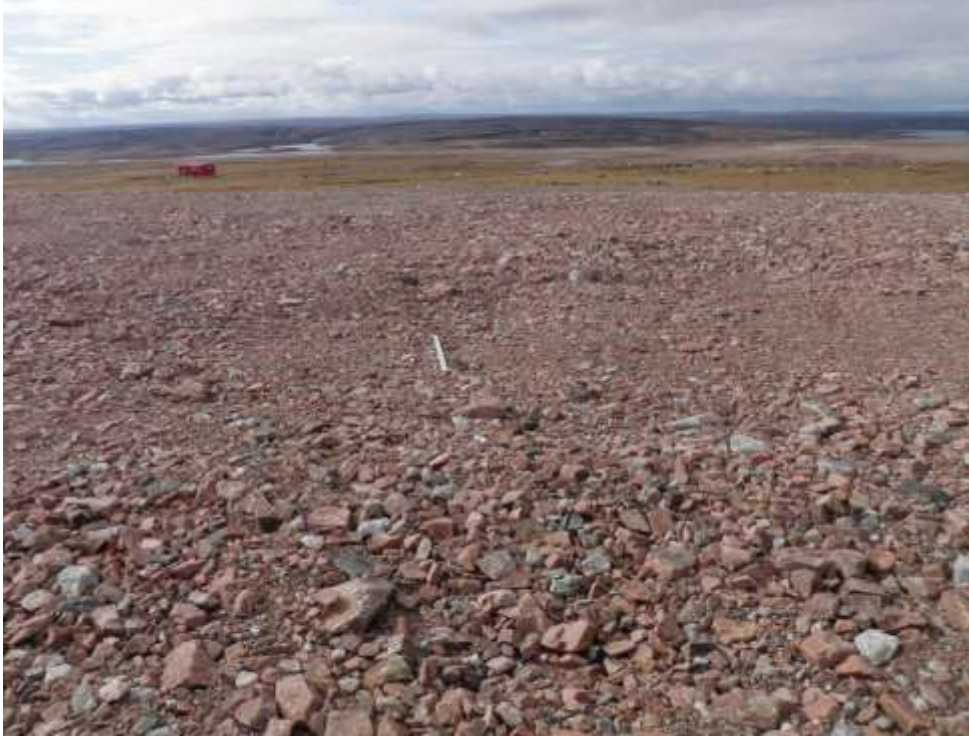
Feature B – large depression on top of the NHL. Viewpoint 49 (Figure A-3; Appendix A). Photograph reference P8280049 (CD-ROM). Direction photo taken: S

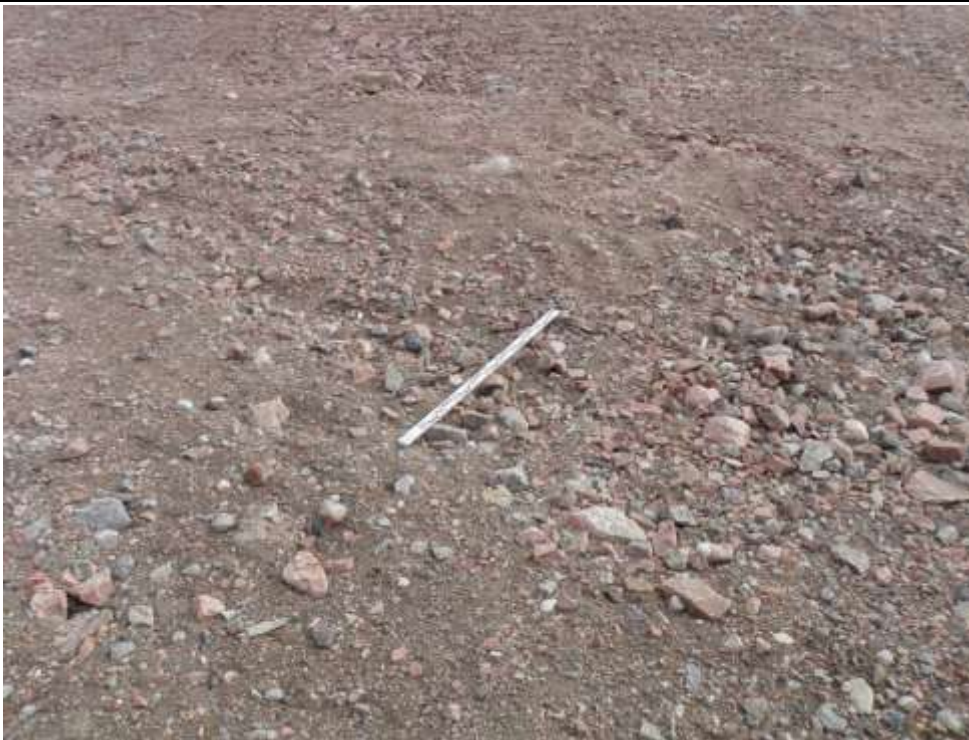
Feature C –Slight low area near the west corner of the NHL. Viewpoint 50 (Figure A-3; Appendix A). Photograph reference P8280050 (CD-ROM). Direction photo taken: W

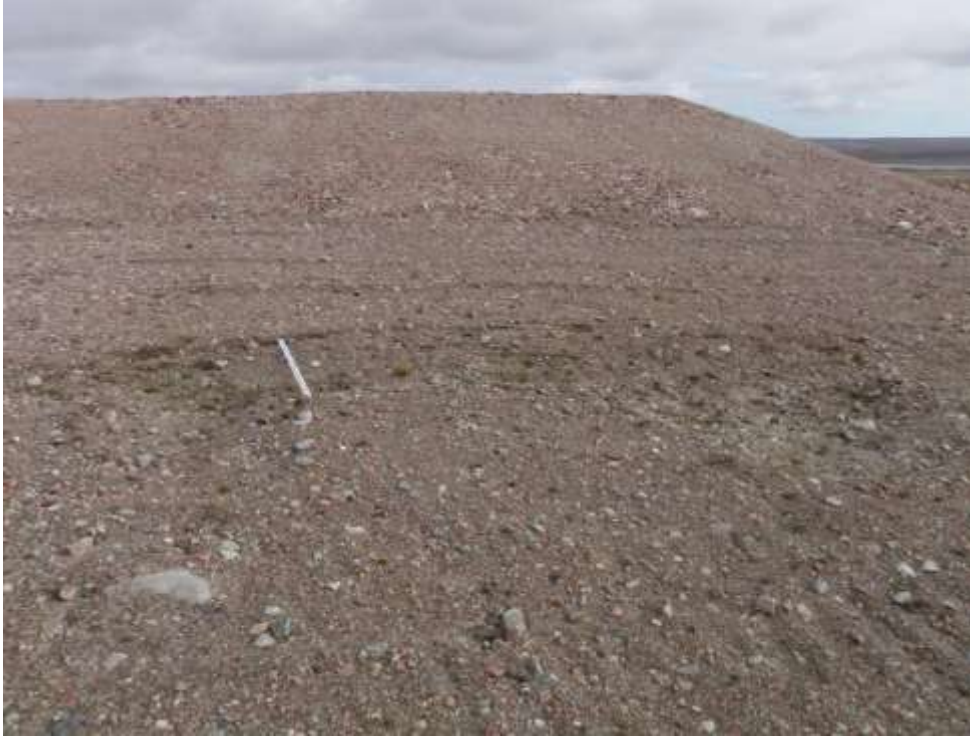
Feature D –Settlement near the south corner of the NWHL. Viewpoint 51 (Figure A-3; Appendix A). Photograph reference P8280051 (CD-ROM). Direction photo taken: W
