Long Term Monitoring, 2012 CAM-F, Sarcpa Lake, Nunavut

FINAL REPORT

EXECUTIVE SUMMARY

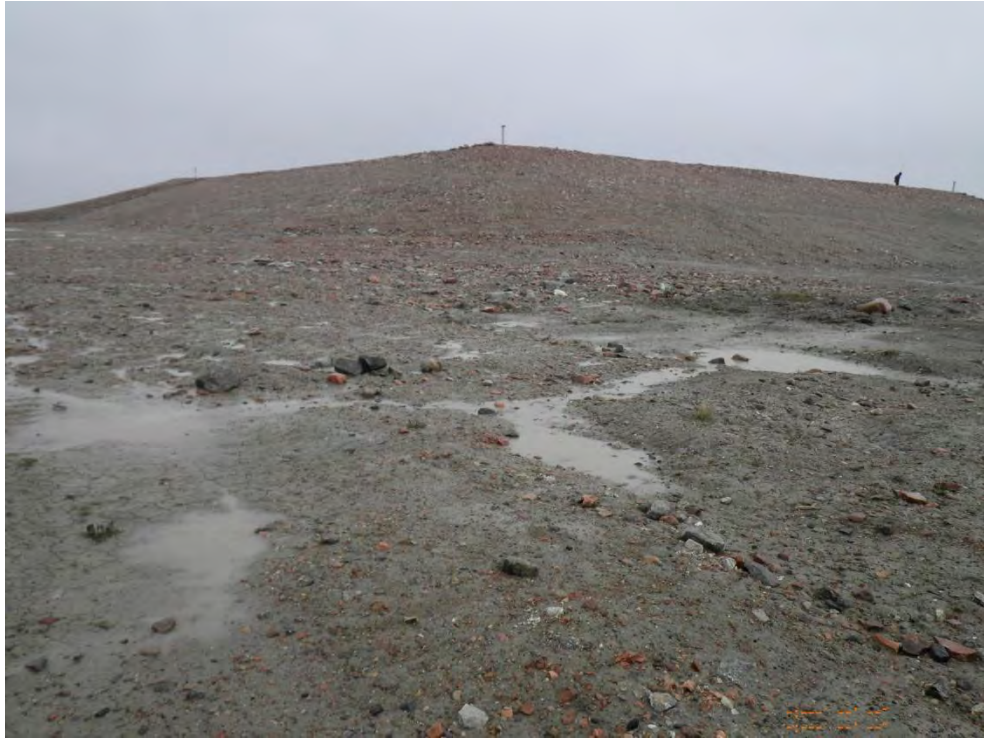
Northwest corner of the SSDF. Viewpoint 2 (Figure A-2; Appendix A). Photograph reference RIMG0002 (CD-ROM).
Direction photo taken: SE

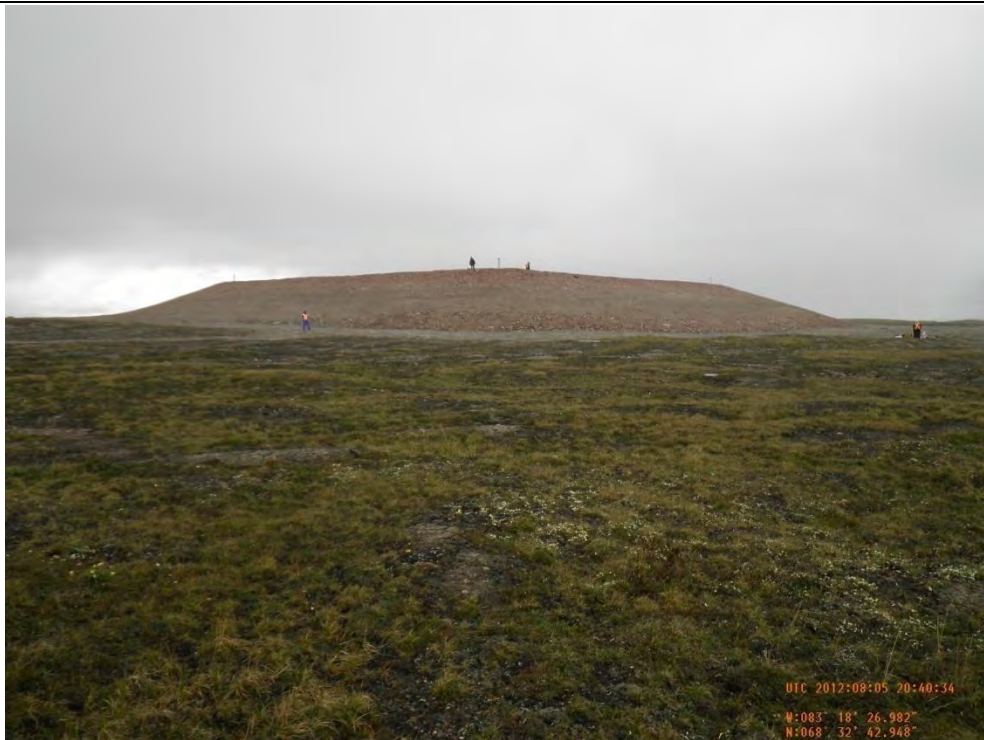
Southwest corner of the SSDF. Viewpoint 11 (Figure A-2; Appendix A). Photograph reference RIMG0011 (CD-ROM). Direction photo taken: NE

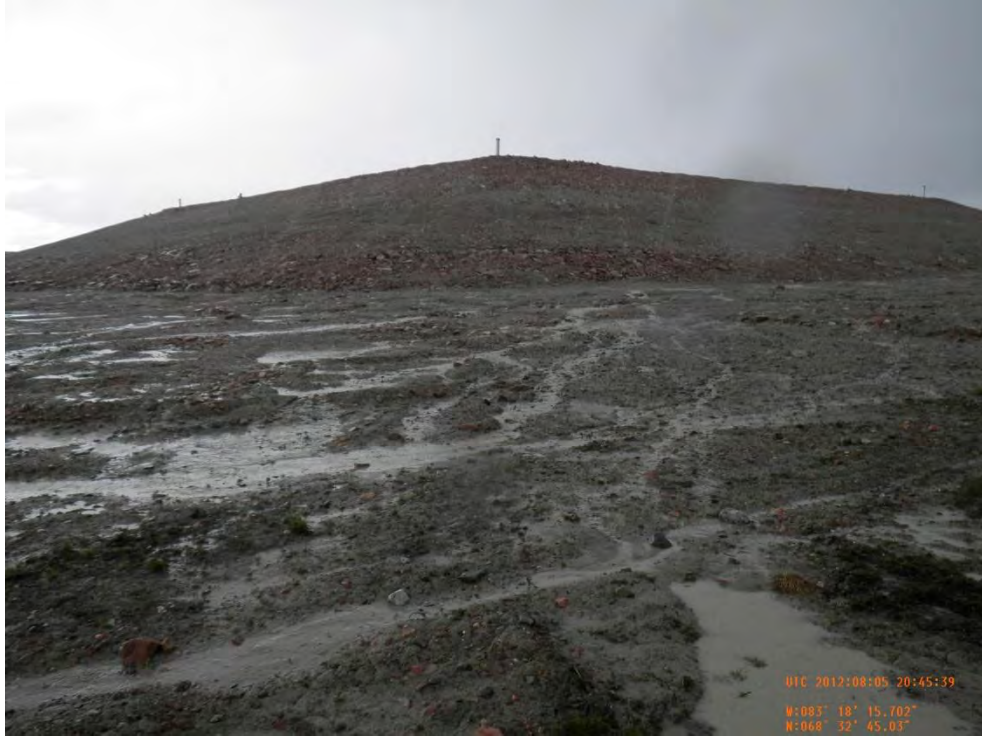
Southeast corner of the SSDF. Viewpoint 23 (Figure A-2; Appendix A). Photograph reference RIMG0023 (CD-ROM).
Direction photo taken: NW

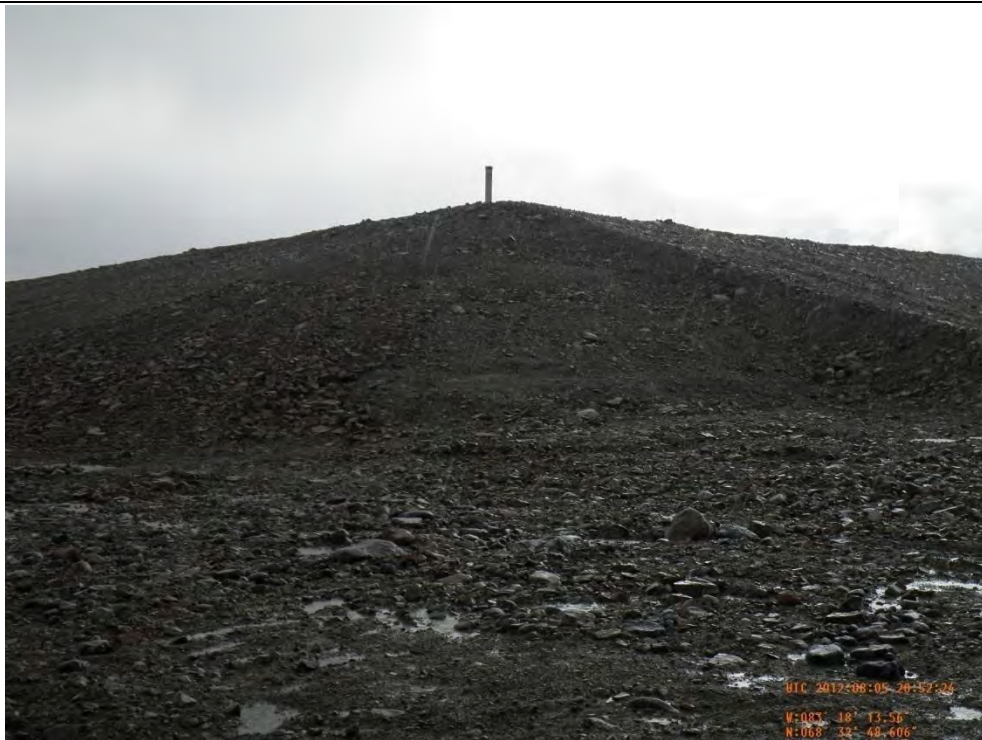
Northeast corner of the SSDF. Viewpoint 33 (Figure A-2; Appendix A). Photograph reference RIMG0033 (CD-ROM).
Direction photo taken: SW

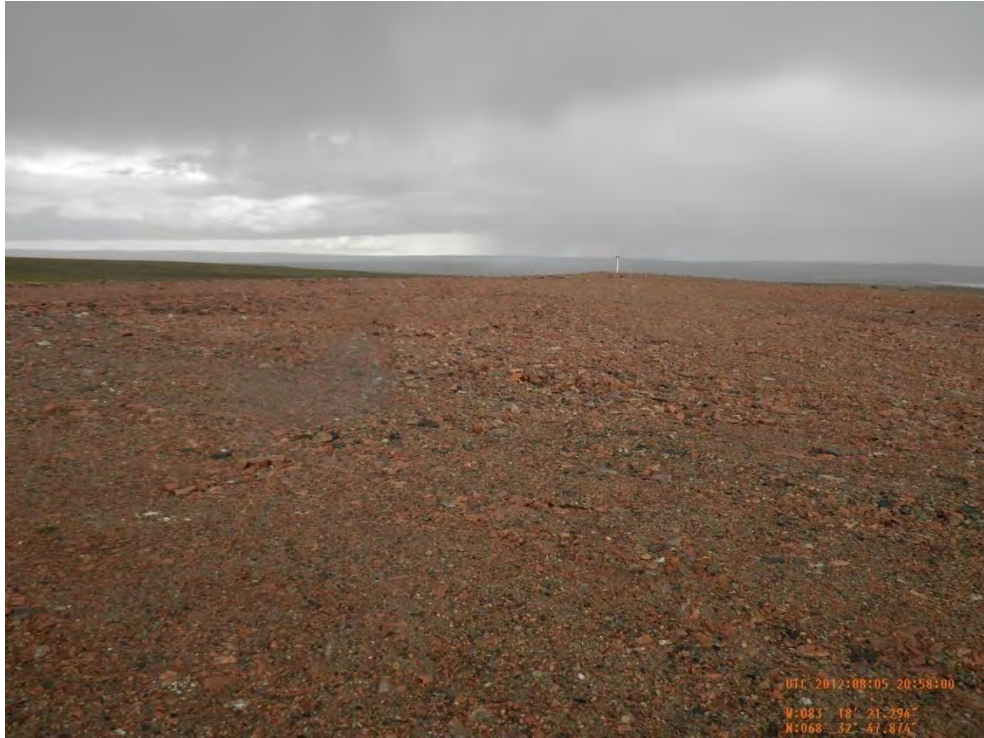
Top of the SSDF. Viewpoint 43 (Figure A-2; Appendix A). Photograph reference RIMG0043 (CD-ROM). Direction photo taken: E

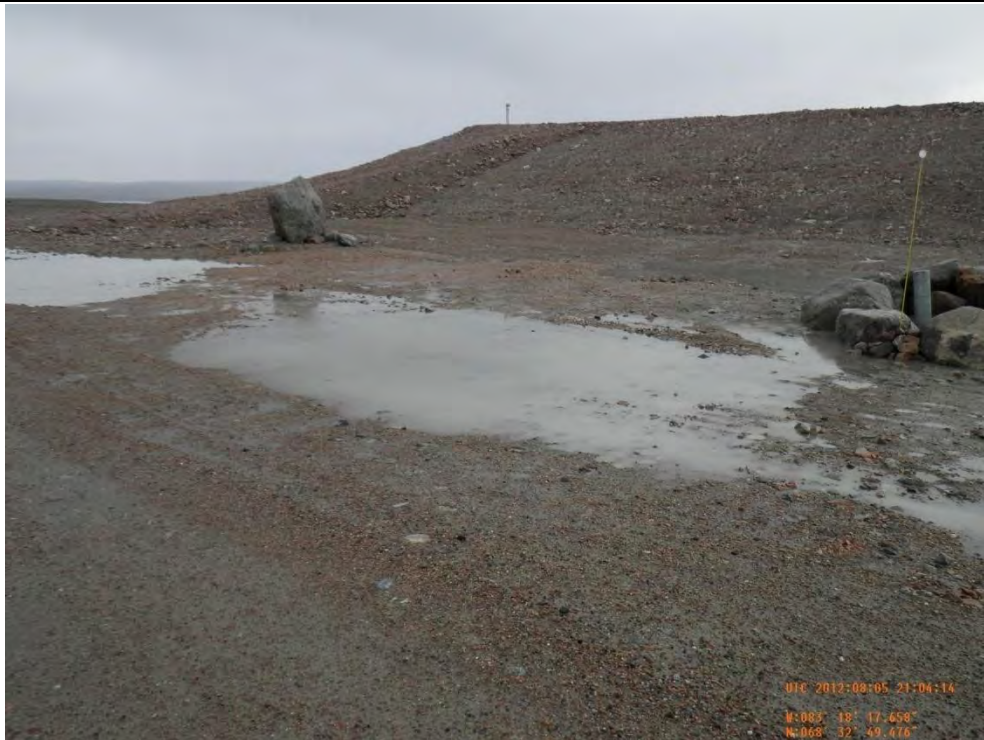
Settlement depression features A and B were observed to the north and northeast of the landfill extents, with no significant change from previous monitoring events (see Picture Viewpoint Numbers (VP) 54 and 55 Figure A-2; Appendix A). Other settlement depressions depicted on Figure A-2, features E (VP 60-61), G (VP 65-66) and U (VP 87) were observed to be very minor and not significantly changed from the previous year. These settlement features do not pose any risk to the landfill integrity. The minor settlement cracking that was observed along the landfill's perimeter and located approximately 4 m up the face of the berm from the toe (see features C, D, F, K, M, O, and T; Figure A-2; Appendix A) was not significantly changed, with the exception that the cracking observed in previous years was less evident in 2012.

Ponded water near airstrip. Viewpoint 54 (Figure A-2; Appendix A). Photograph reference RIMG0054 (CD-ROM). Direction photo taken: S

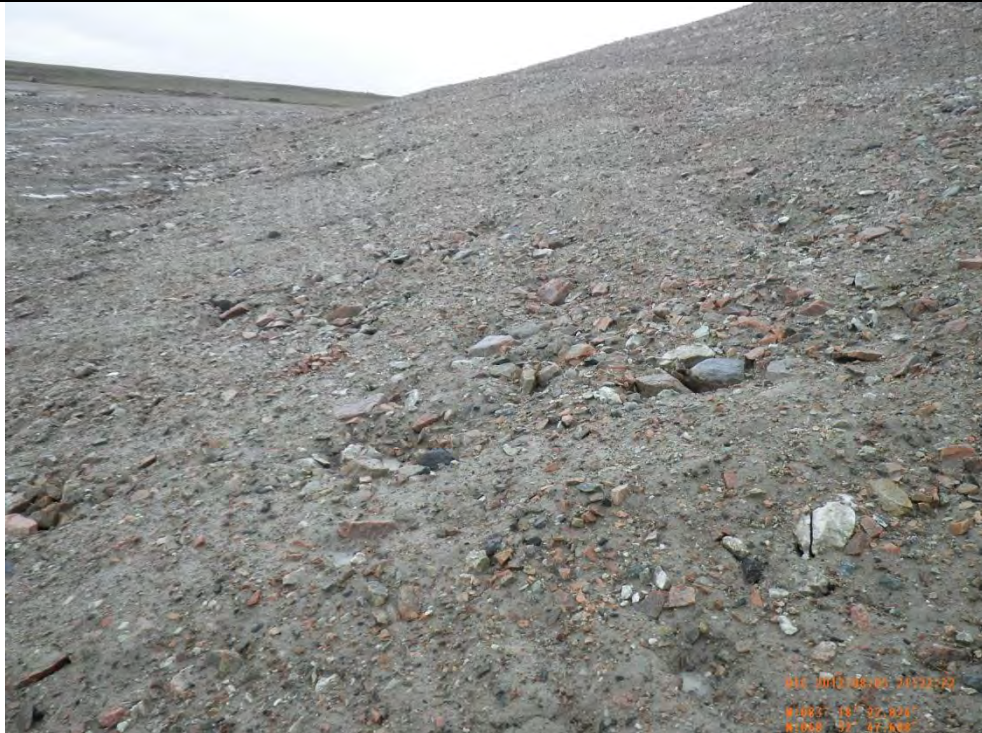
West slope of SSDF; location of feature D, fine cracks observed in 2011 were not present in 2012. Viewpoint 58 (Figure A-2; Appendix A). Photograph reference RIMG0058 (CD-ROM). Direction photo taken: N

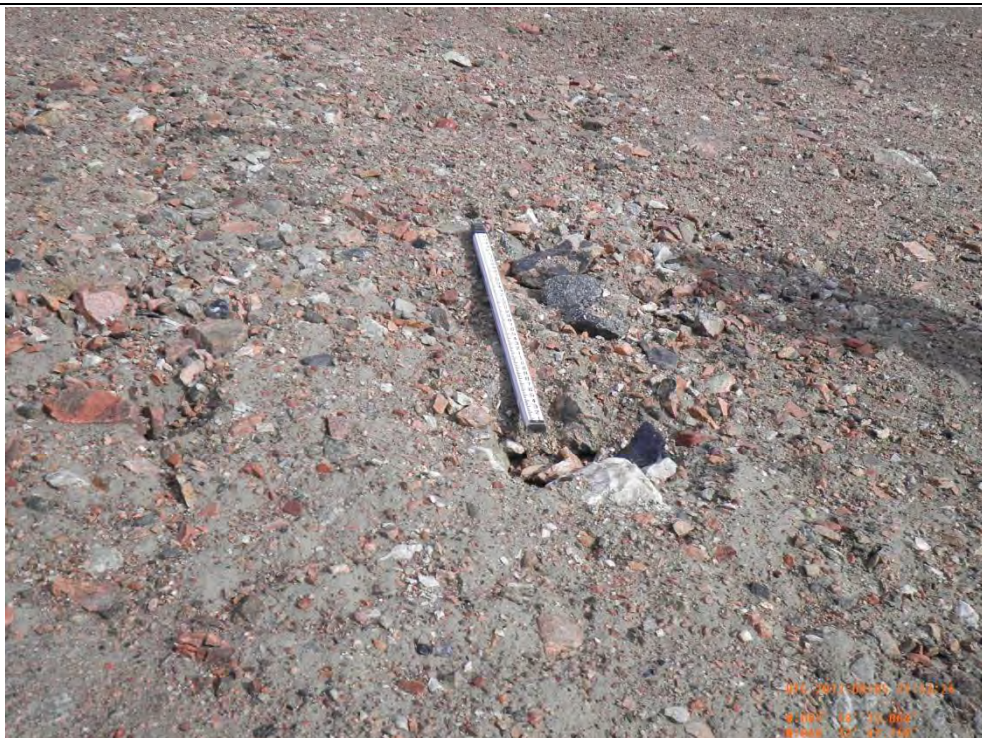
Angular cobble has been exposed in a small, localized area, where fine-grained fill has been washed out on some of the structure's slopes and top, although no significant change from previous years is apparent. Potholes observed in 2008, 2009, 2010 and 2011 were not significantly changed in 2012.

Pothole on west slope of SSDF (foreground end of survey level). Viewpoint 66 (Figure A-2; Appendix A). Photograph reference RIMG0066 (CD-ROM). Direction photo taken: E

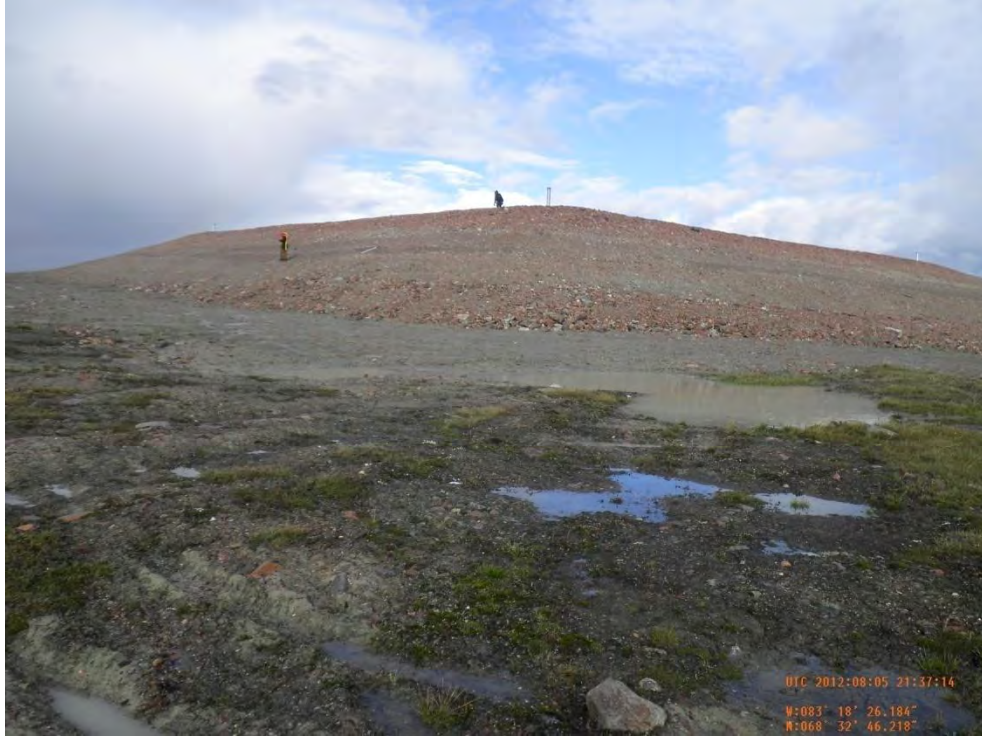
The small preferred-drainage channels observed in previous years at the toe on the southwest side of the SSDF are still apparent (see features I (VP 73-75), J (VP 95-96), N (VP 79-80), and Q (VP 82-84); Figure A-2; Appendix A). Based on a comparison with photo documentation from 2008-2011, there does not appear to be an appreciable increase in the length or depth of these channels.

Five seepage points (see features I, J, N, Q, and R; Figure A-2; Appendix A) were observed along the southern toe of the landfill in 2012. Two of the active seepage points (I and J; Figure A-2; Appendix A) exhibited active flowing water during the 2012 Site visit. Two of the seepage points (I and Q; Figure A-2; Appendix A) terminated at standing ponded water. In comparison to previous Site visits, the volume of seepage water does not appear to have significantly changed. A direct relationship between active seepage and recent precipitation events was proposed in 2011. As in 2011, conditions were wet during the 2012 site visit and similar seepage was observed as in the previous year.

Ponding from active seepage at the southwest corner. Viewpoint 73 (Figure A-2; Appendix A). Photograph reference RIMG0073 (CD-ROM). Direction photo taken: NE

These active seepage features directly correlate with the observations of erosion noted above. These features should be monitored closely, as they may present a pathway for landfill contents should the seepages worsen in subsequent years.

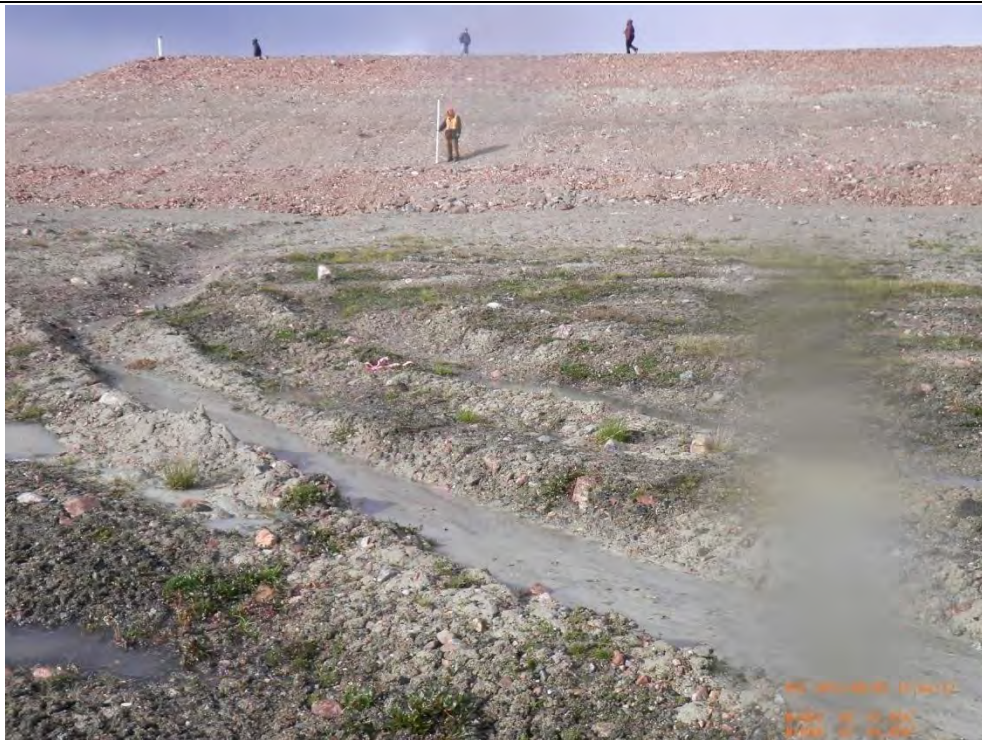
Active erosion from active seepage along the south toe of the SSDF. Viewpoint 80 (Figure A-2; Appendix A). Photograph reference RIMG0080 (CD-ROM). Direction photo taken: N

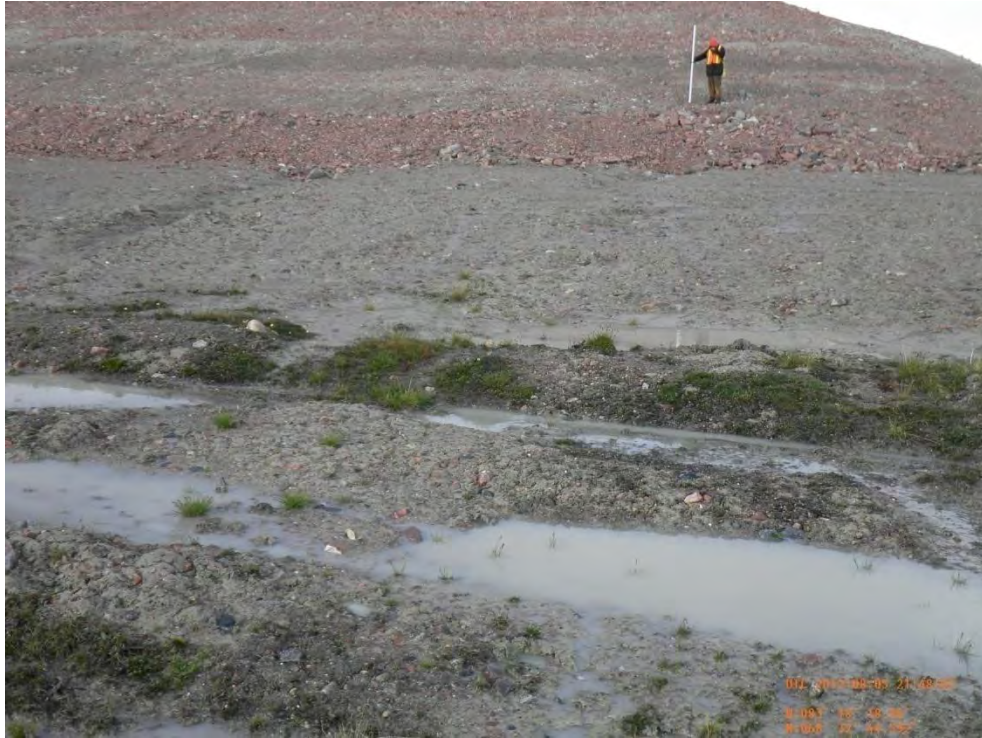
Ponded water from the active seep near the southeast corner of the SSDF. Viewpoint 84 (Figure A-2; Appendix A).
Photograph reference RIMG0084 (CD-ROM). Direction photo taken: SE

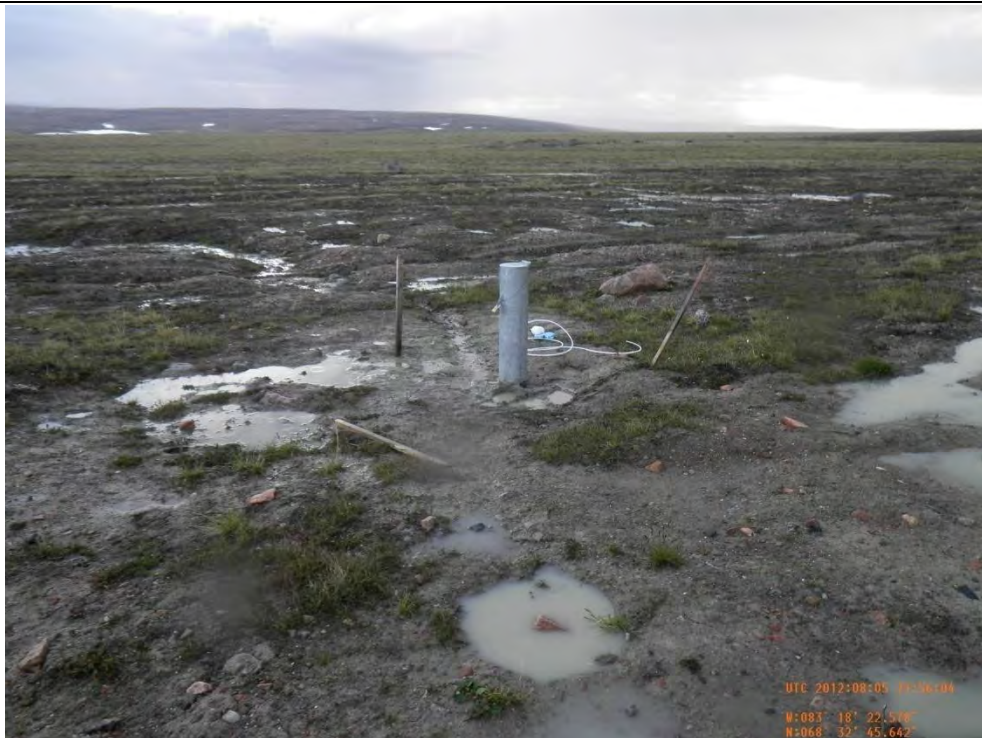
Monitoring well MW0606 and former soil monitoring point location. Viewpoint 89 (Figure A-2; Appendix A).
Photograph reference RIMG0089 (CD-ROM). Direction photo taken: SE

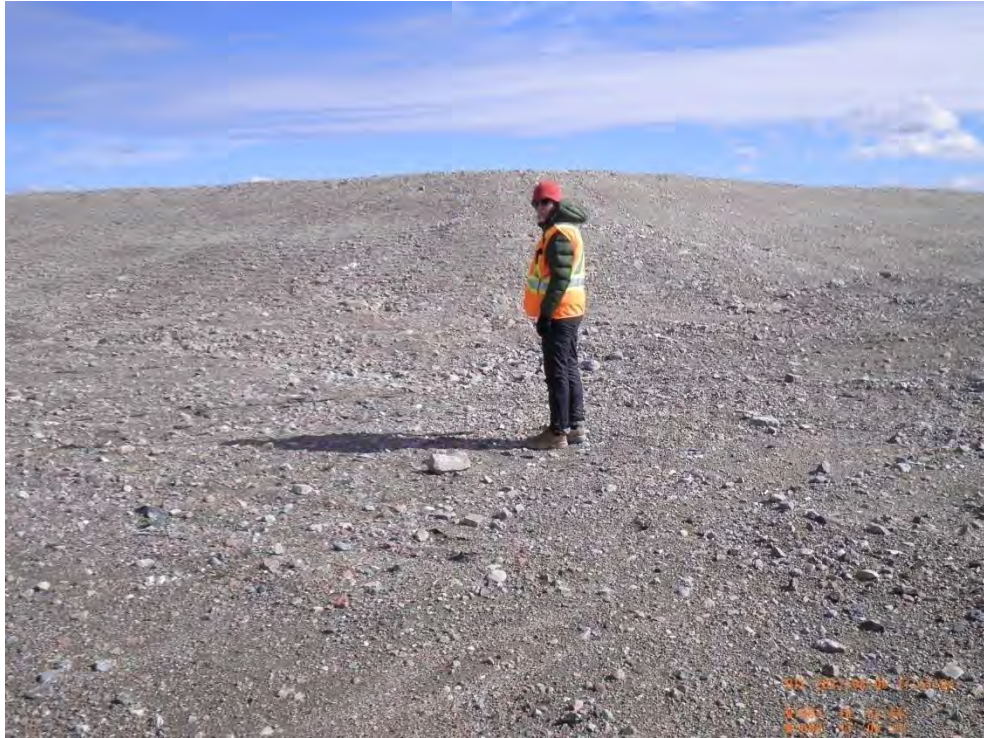
West corner of the NHL. Viewpoint 2 (Figure A-3; Appendix A). Photograph reference RIMG0002 (CD-ROM).
Direction photo taken: E

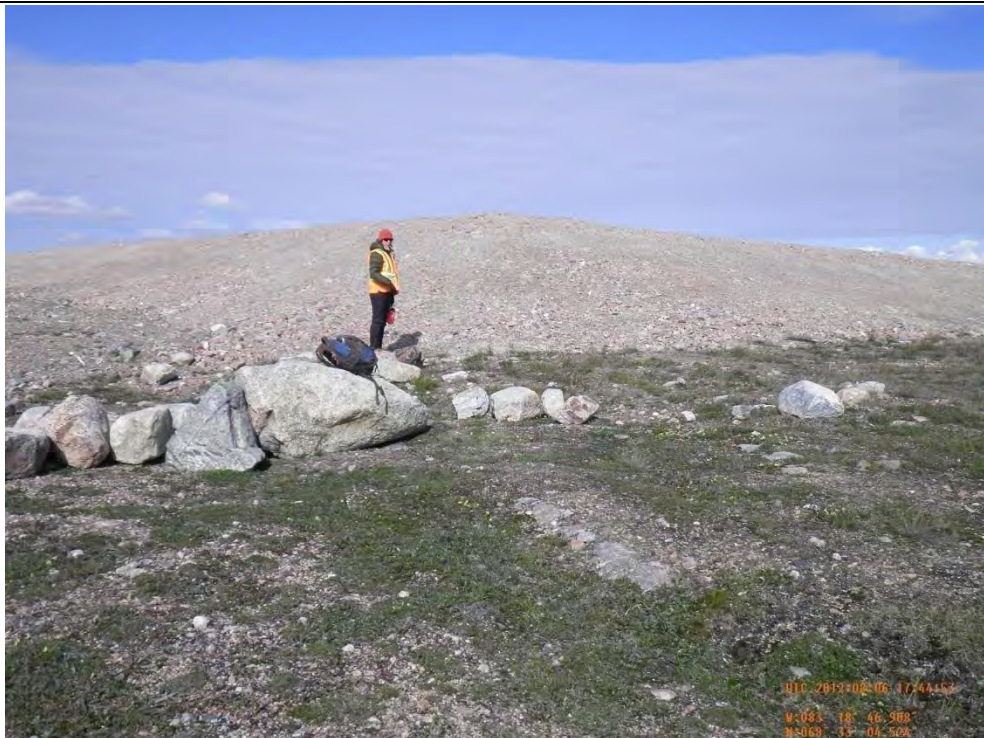
South corner of the NHL. Viewpoint 10 (Figure A-3; Appendix A). Photograph reference RIMG0010 (CD-ROM).
Direction photo taken: N

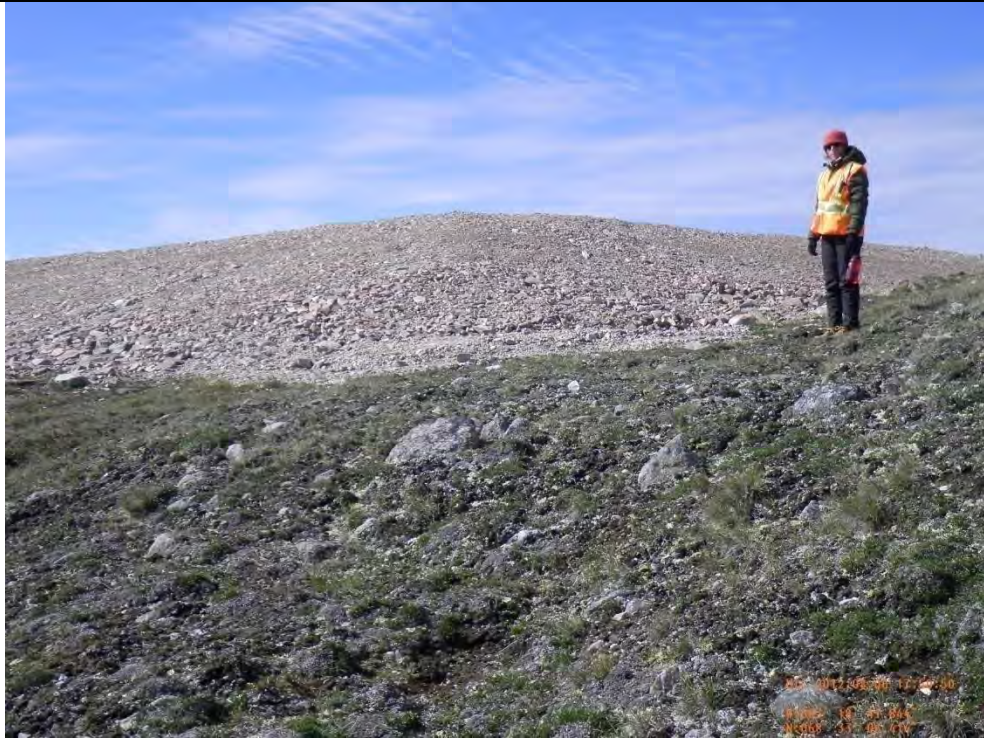
East corner of the NHWL. Viewpoint 20 (Figure A-3; Appendix A). Photograph reference RIMG0020 (CD-ROM).
Direction photo taken: W

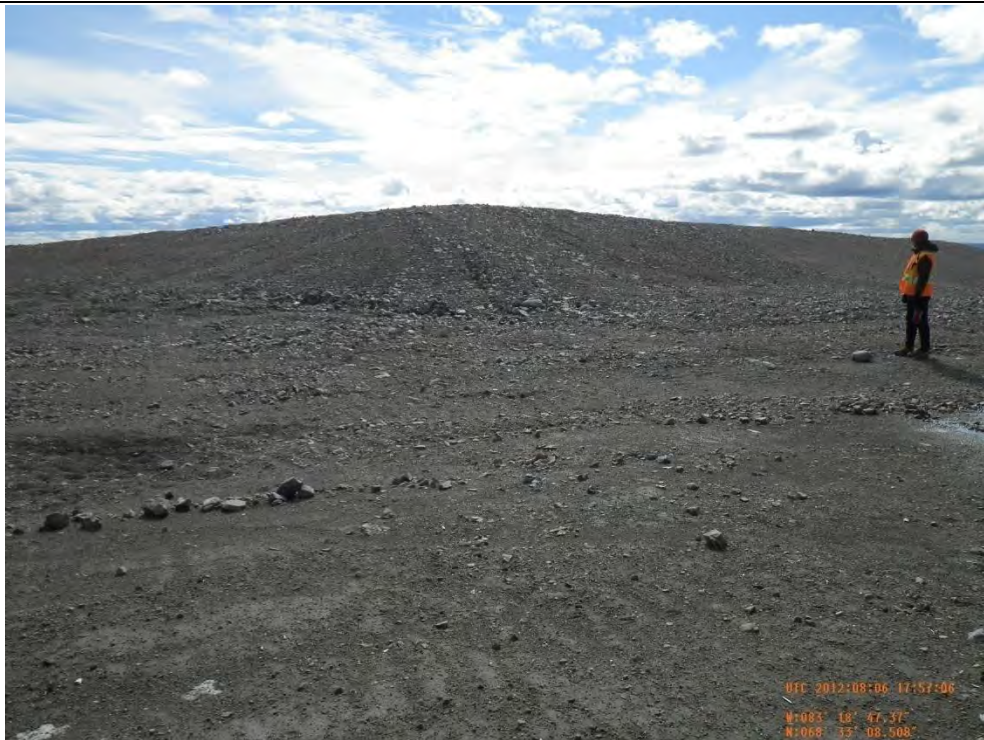
West corner of the NHWL. Viewpoint 28 (Figure A-3; Appendix A). Photograph reference RIMG0028 (CD-ROM).
Direction photo taken: S

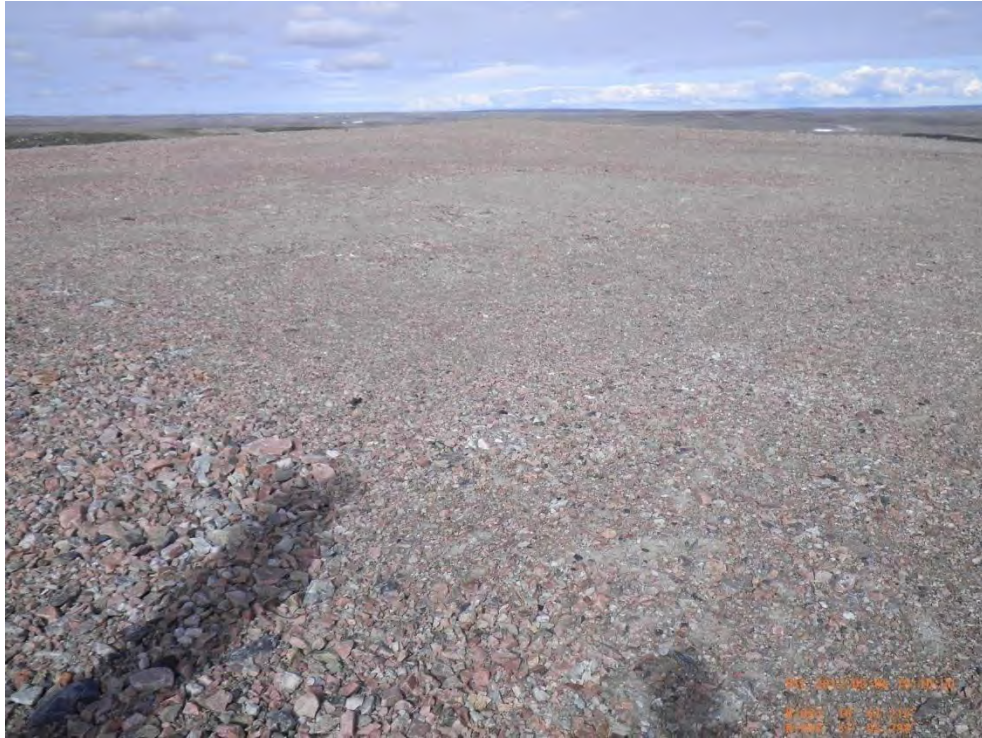
Top of the NHWL from west corner. Viewpoint 39 (Figure A-3; Appendix A). Photograph reference RIMG0039 (CD-ROM). Direction photo taken: N

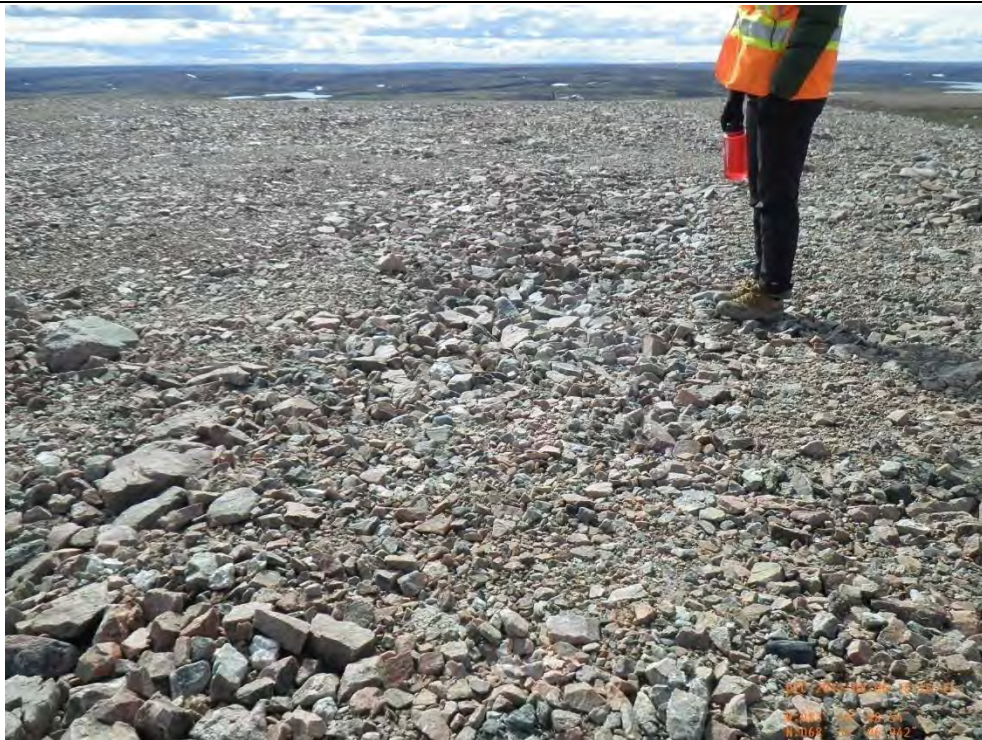
Feature A – small depression on top of the NHWL. Viewpoint 48 (Figure A-3; Appendix A). Photograph reference RIMG0048 (CD-ROM). Direction photo taken: SW

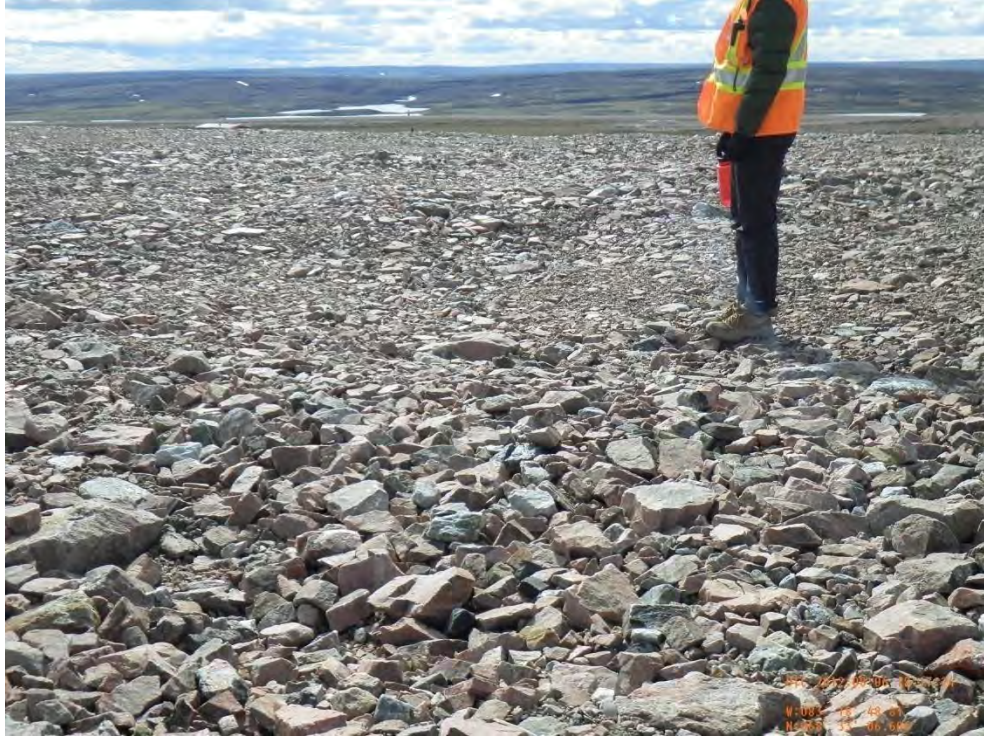
Feature B – large depression on top of the NHWL. Viewpoint 49 (Figure A-3; Appendix A). Photograph reference RIMG0049 (CD-ROM). Direction photo taken: S

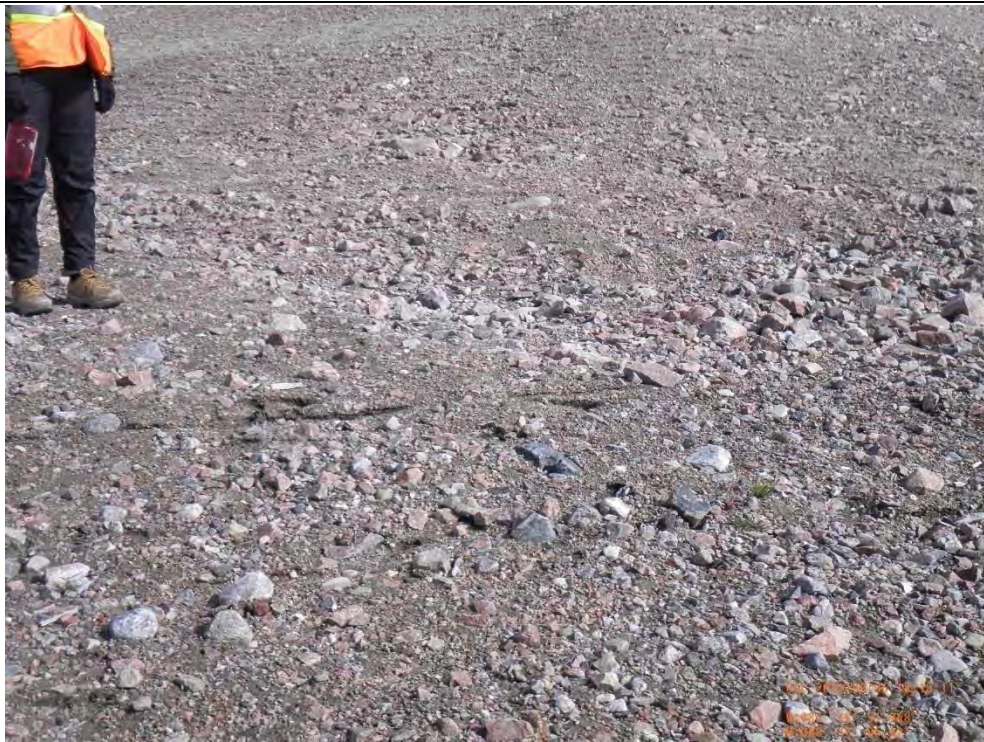
Feature C –Slight low area near the west corner of the NHWL. Viewpoint 50 (Figure A-3; Appendix A). Photograph reference RIMG0050 (CD-ROM). Direction photo taken: W

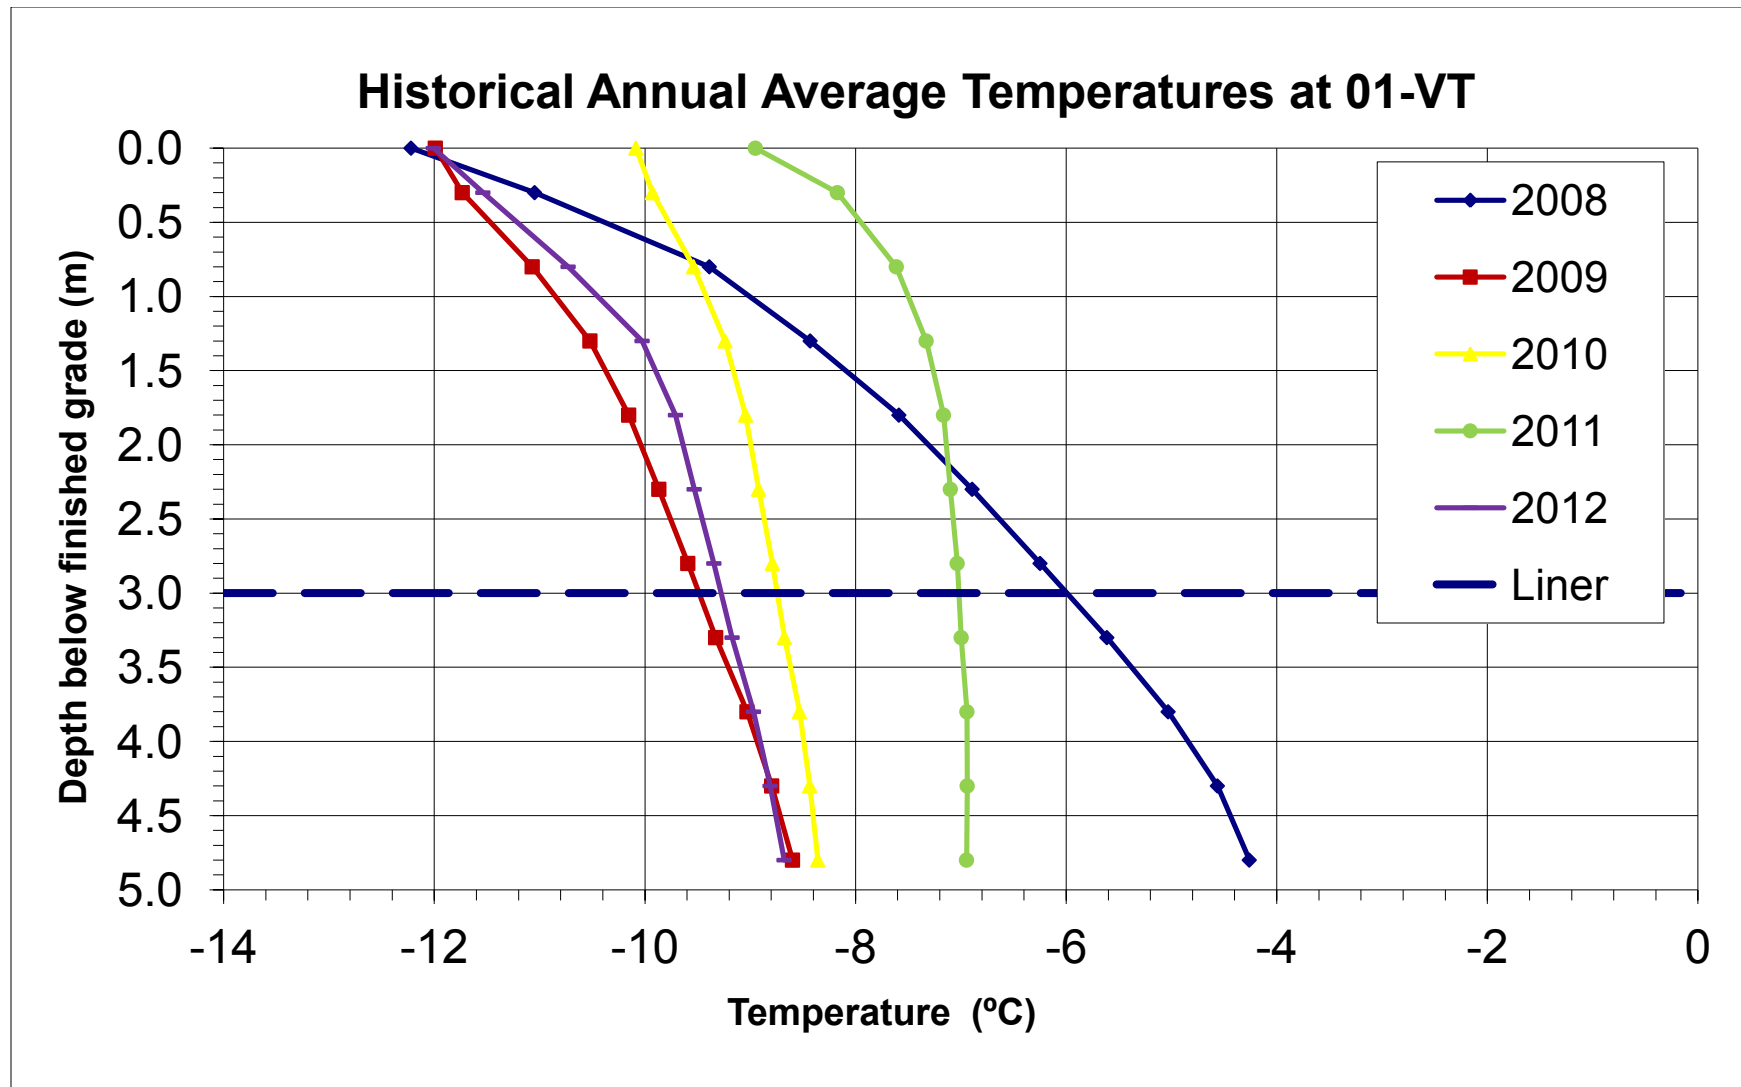
Figure H- 3: Historical Annual Average Temperatures for thermistor 01-VT.

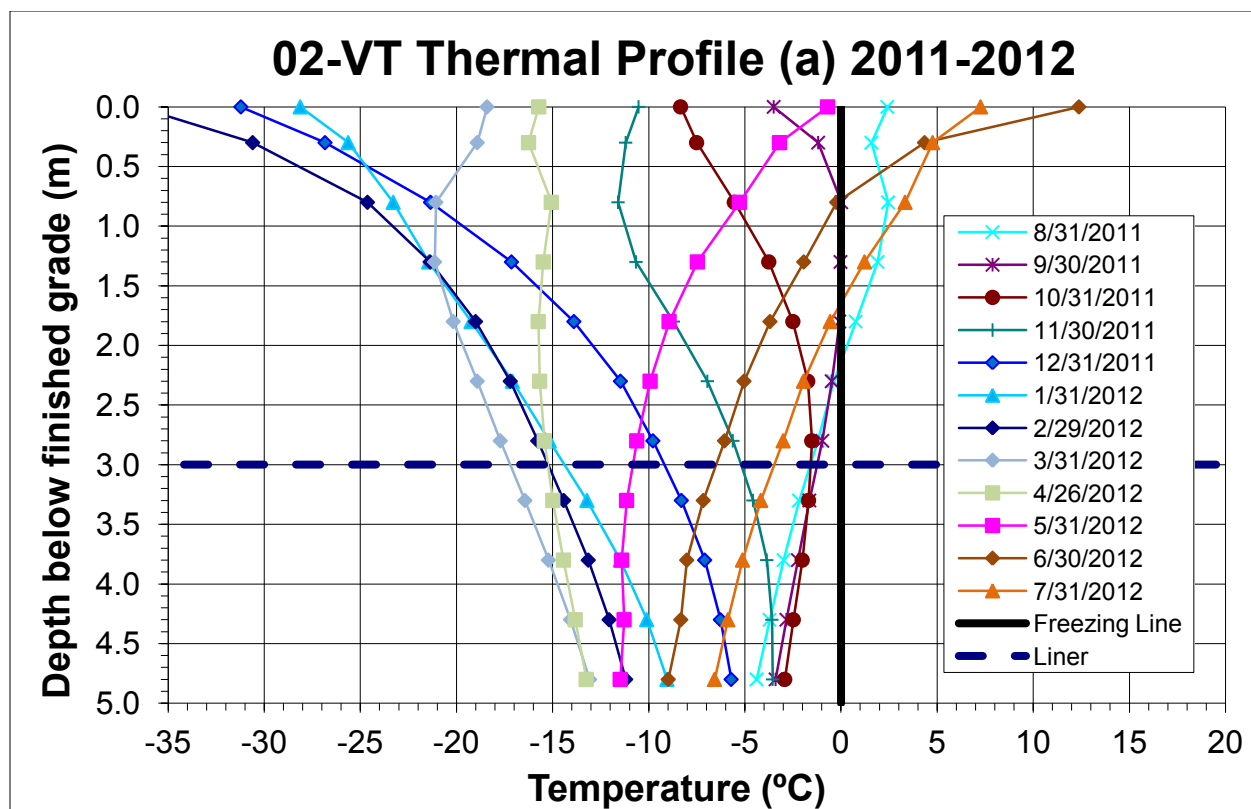
Figure H- 8: Profiles at 02-VT for 2011-2012: (a) monthly data (last day of the month) (b) full year record

A complete memory transfer was successfully performed on each thermistor data logger. The position of the 0°C isotherm was calculated at each location from ground temperatures collected on August 5, 2012 and compared to the position as determined from the previous years' data (Table 5-4). The maximum depth of the active layer – depth to the 0 °C isotherm, or permafrost – was also interpolated from the deepest points during the year at which temperatures straddled the freezing point. Regional climate and aggregate historical temperature data for the SSDF are plotted and presented Figures H-1 to H-6 in Appendix H. Temperature profile plots of (a) depth versus temperature and (b) temperature versus time for each thermistor string in 2011-2012 are presented in Figures H-7 to H-10, Appendix H.
