Re: Water Use License 1BR-SHE0510, 2007 Annual Report

Project Name: CAM-3, Shepherd Bay DEW Line Clean Up

**2007 GEOTECHNICAL QUALITY ASSURANCE
OVERALL SITE PLAN/BORROW AREAS**

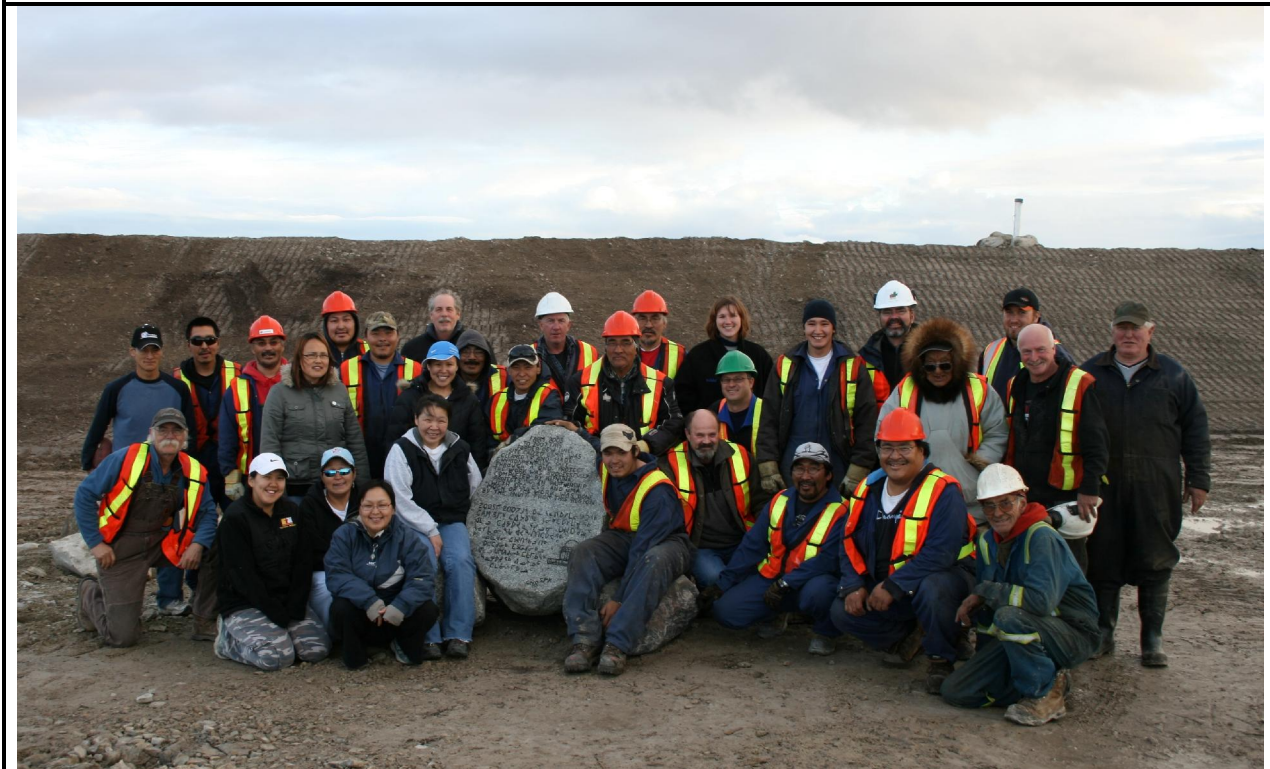
Photo 2: Site monument and Crew in front of Tier II Landfill

Tier II Soil Disposal Facility: The Tier II Soil Disposal Facility was completed, including installation of the liner system, and capped in 2007. Additional granular material from the original design was placed on the facility after reviewing recent climate change data. Approximately 1,009 cubic metres of Tier II soils were placed in the facility.

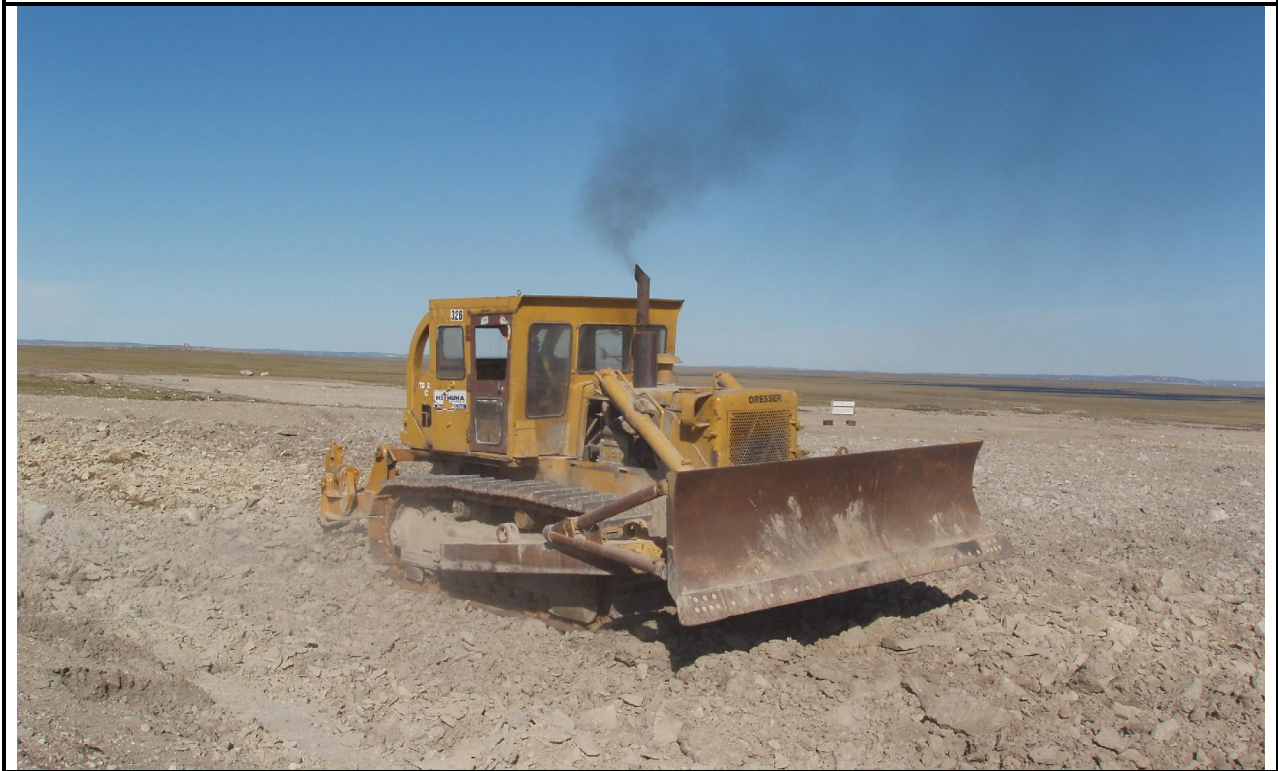
Photo 4: Working the Landfarm

Landfarm: The landfarm was decommissioned in 2007, which included removal of the liner and drain lines (placed in the Non-Haz Landfill), the perimeter berms were leveled, the drainage ditch filled, the area graded for positive drainage, and decommissioning of the monitoring wells. Approximately 3,635 cubic metres of hydrocarbon-impacted soil was treated in the landfarm.

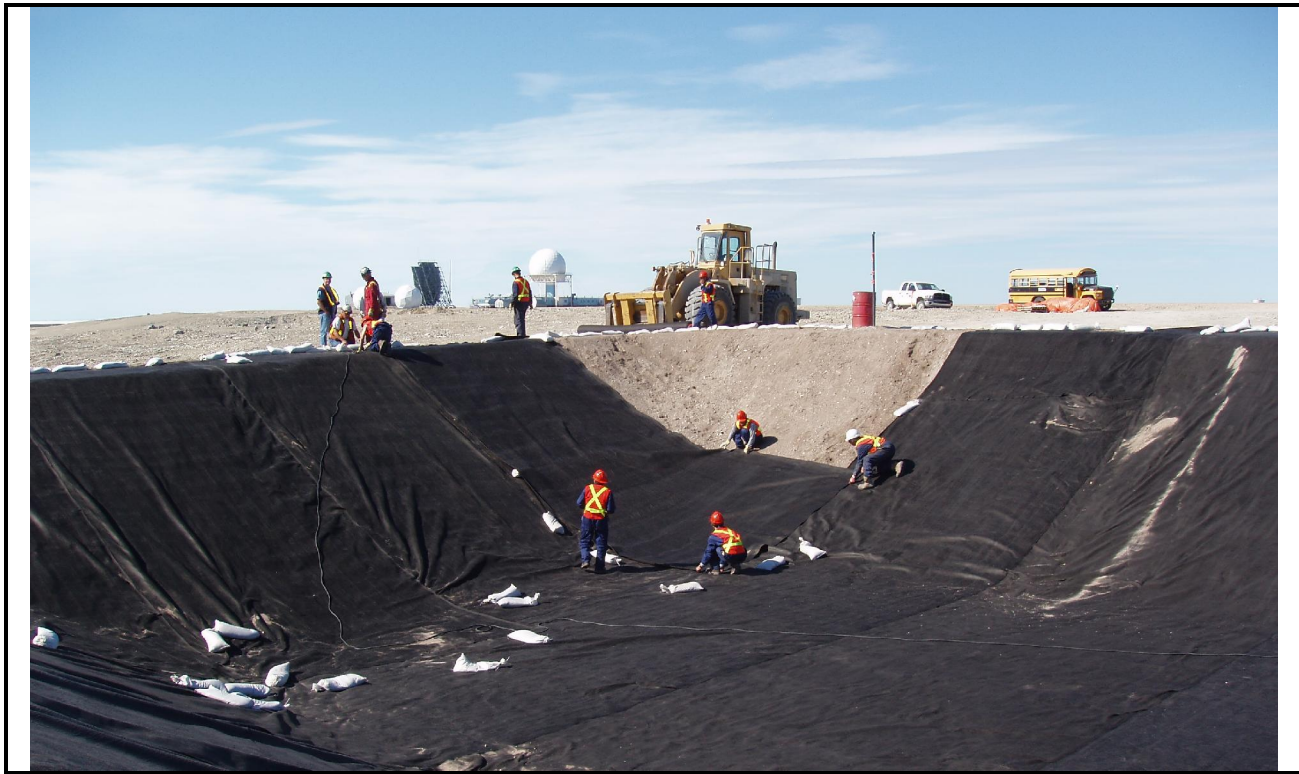
Photo 5: Tier II Landfill base liner installation

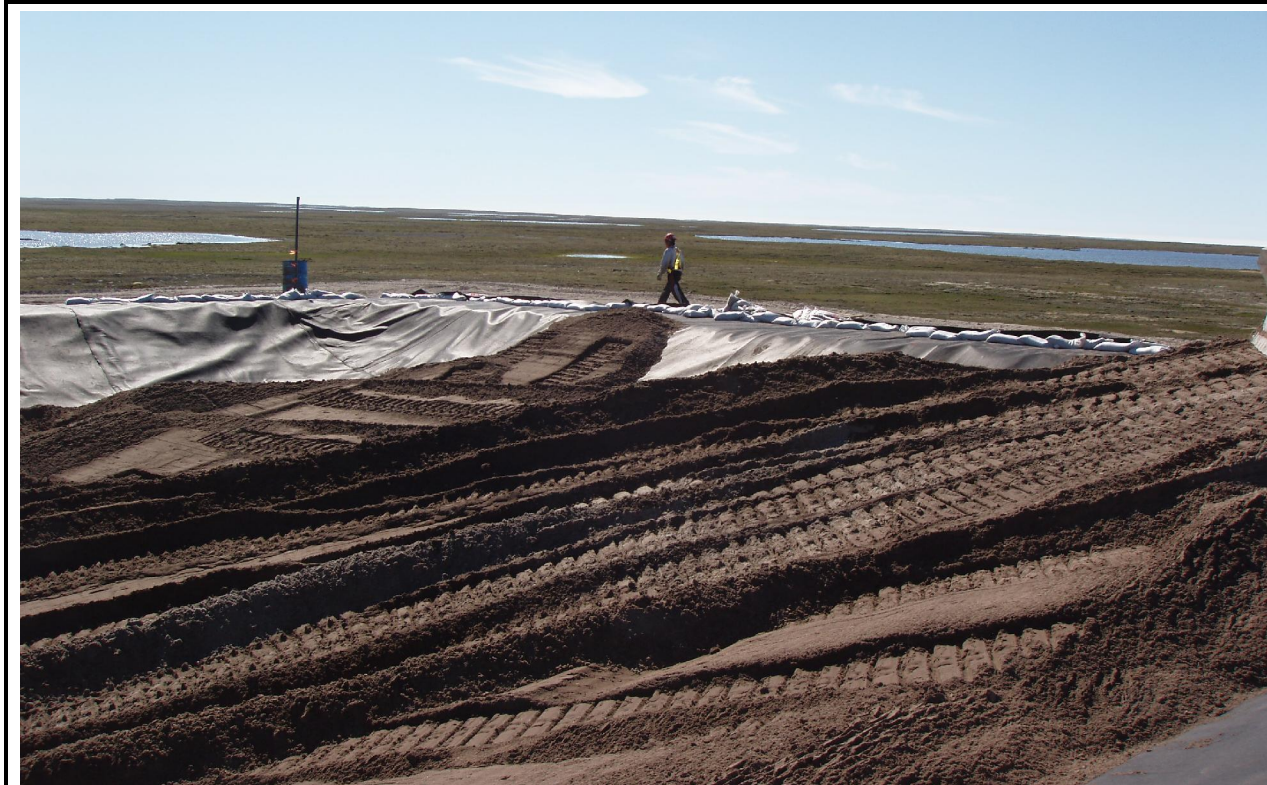
Photo 6: Tier II Landfill, adding base Type 5 granular fill

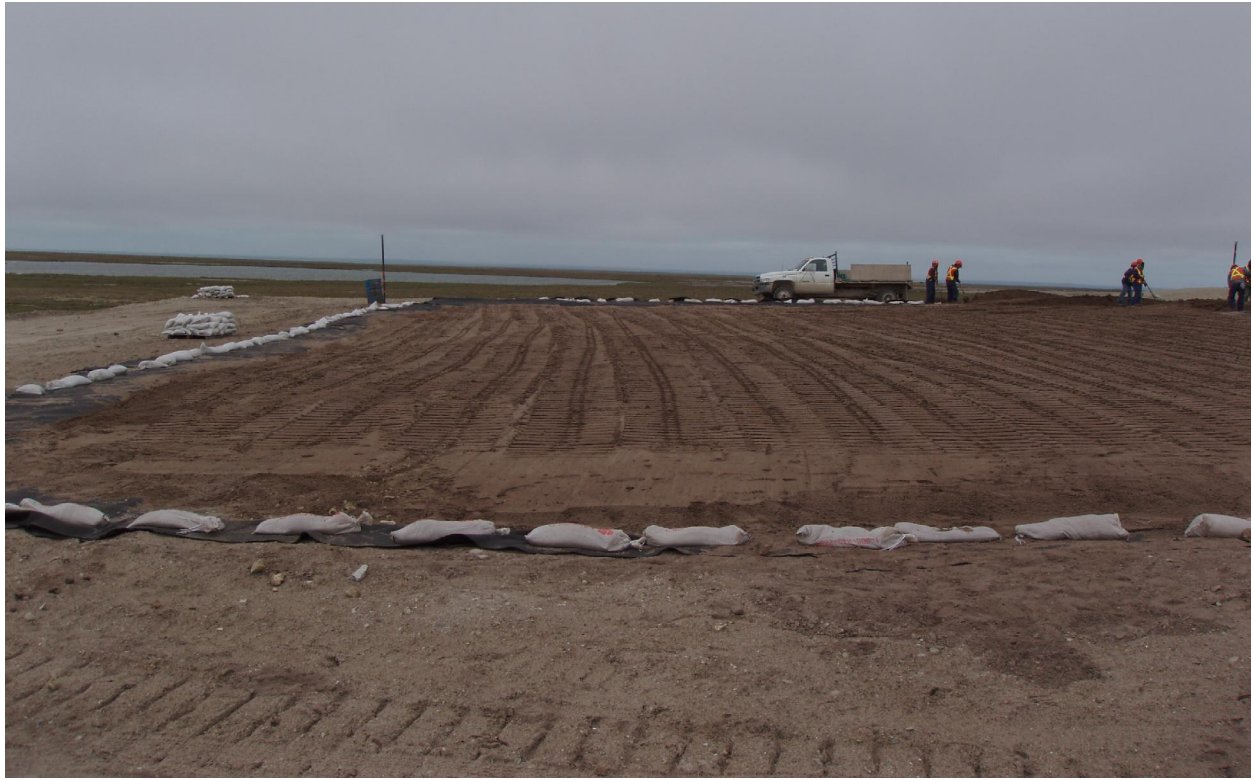
Photo 7: Tier II Landfill, compacted Tier II contaminated soil (prior to addition of liner and cap material)

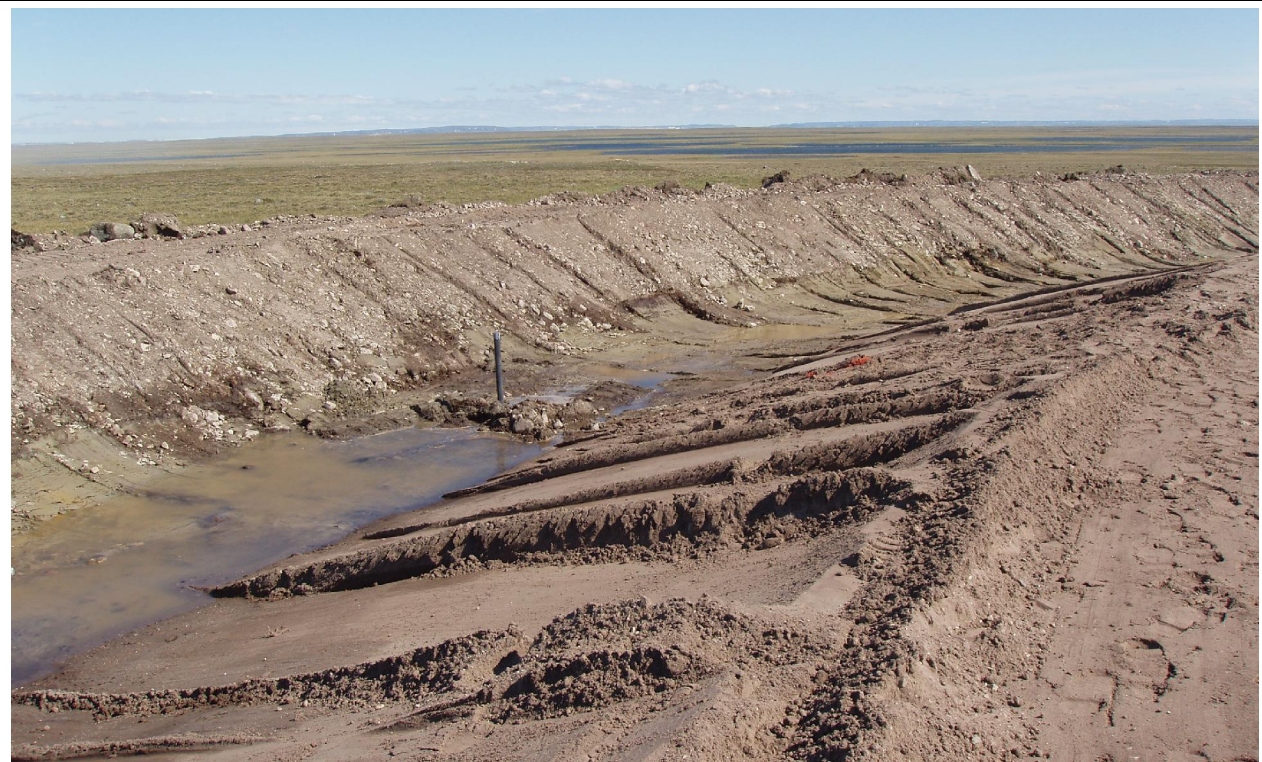
Photo 8: USAF Landfill liner key trench

Landfill Remediation: Leveling, placement and compaction and closure of the USAF Landfill was completed in 2007, and included installation of thermistors for thermal monitoring. Additional granular material from the original design was placed on the facility after reviewing recent climate change data.

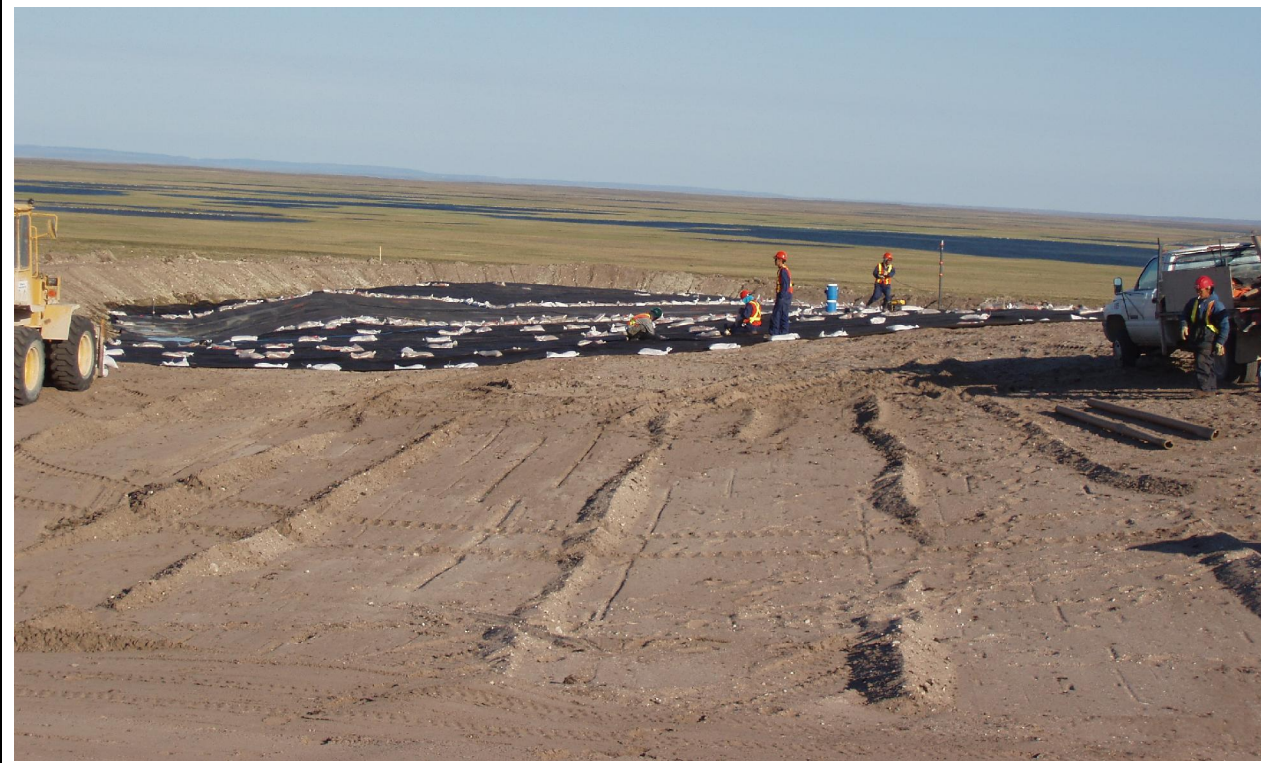
Photo 9: USAF Landfill liner installation, looking east

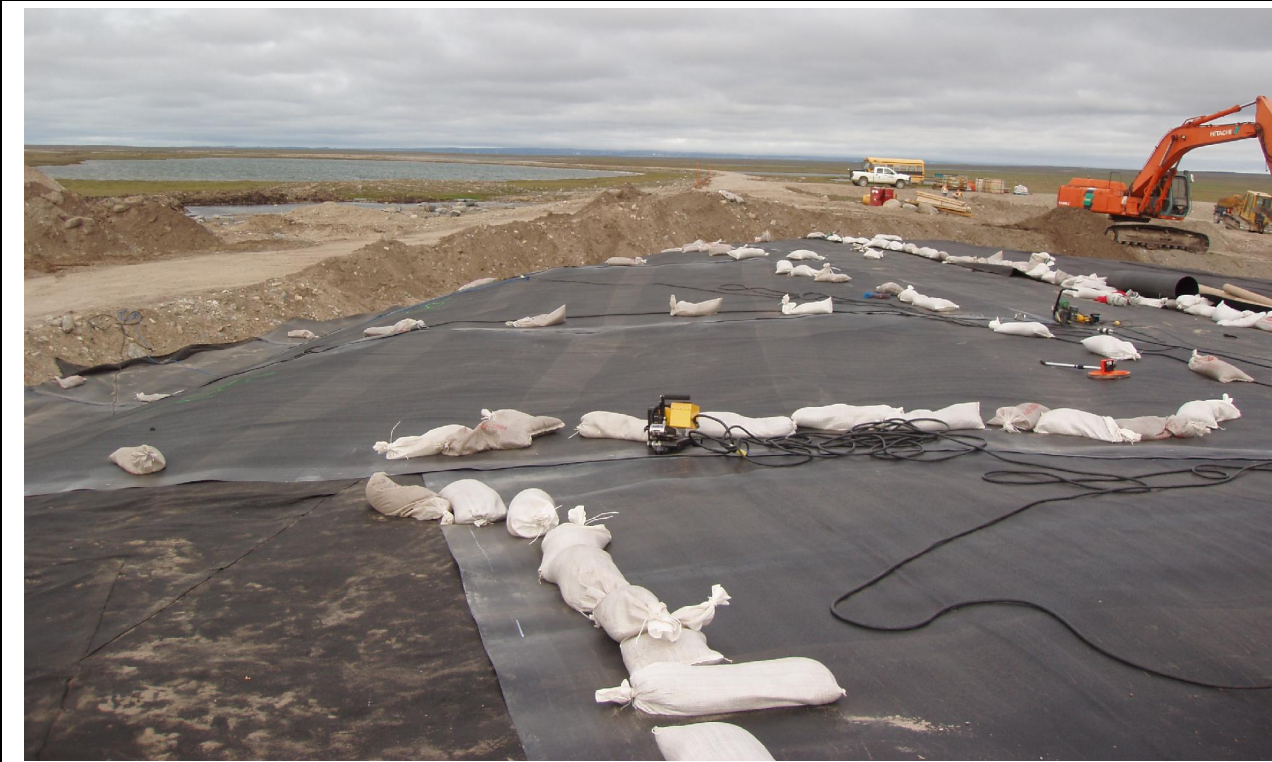
Photo 10: USAF Landfill, installing geomembrane, geotextile then type 5 granular fill over landfill

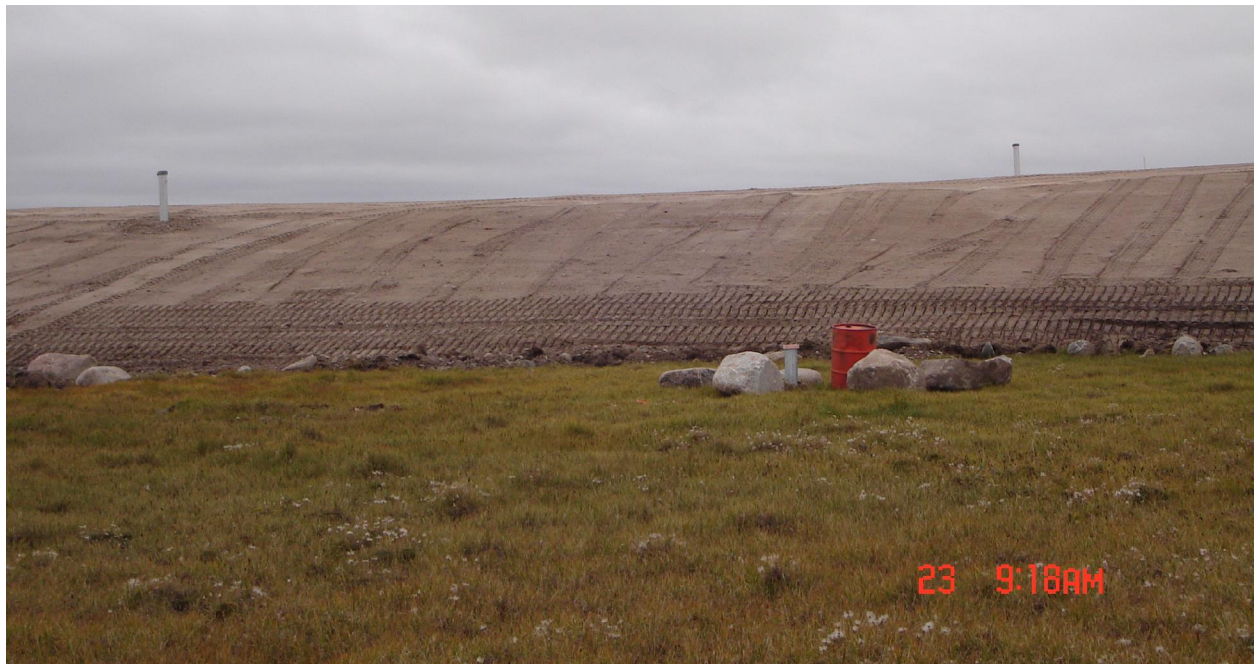
Photo 11: USAF Landfill, completed with themistors installed

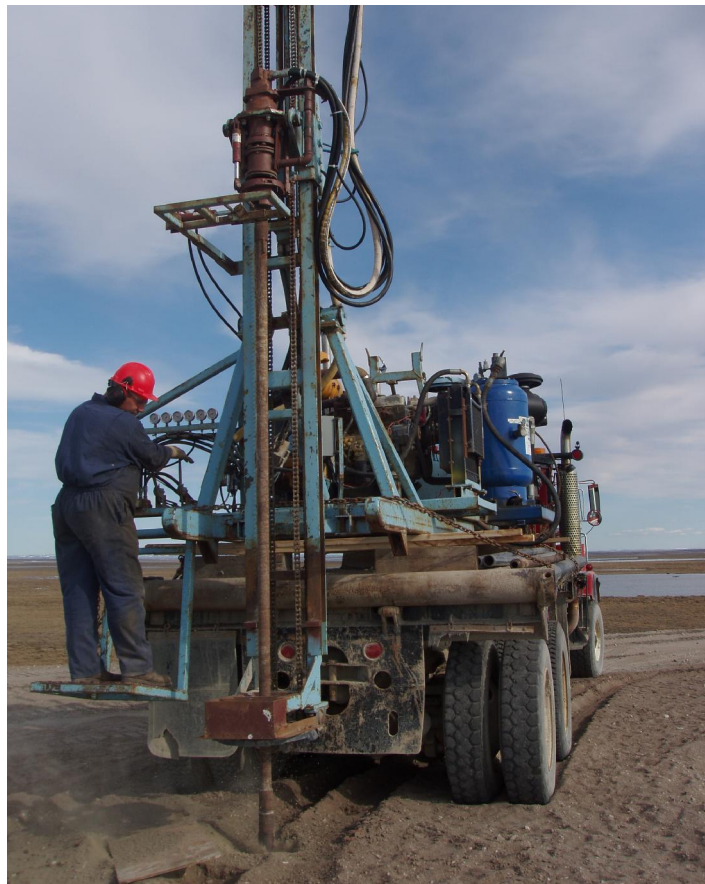
Photo 12: Drilling Thermistor borehole on Tier II Landfill

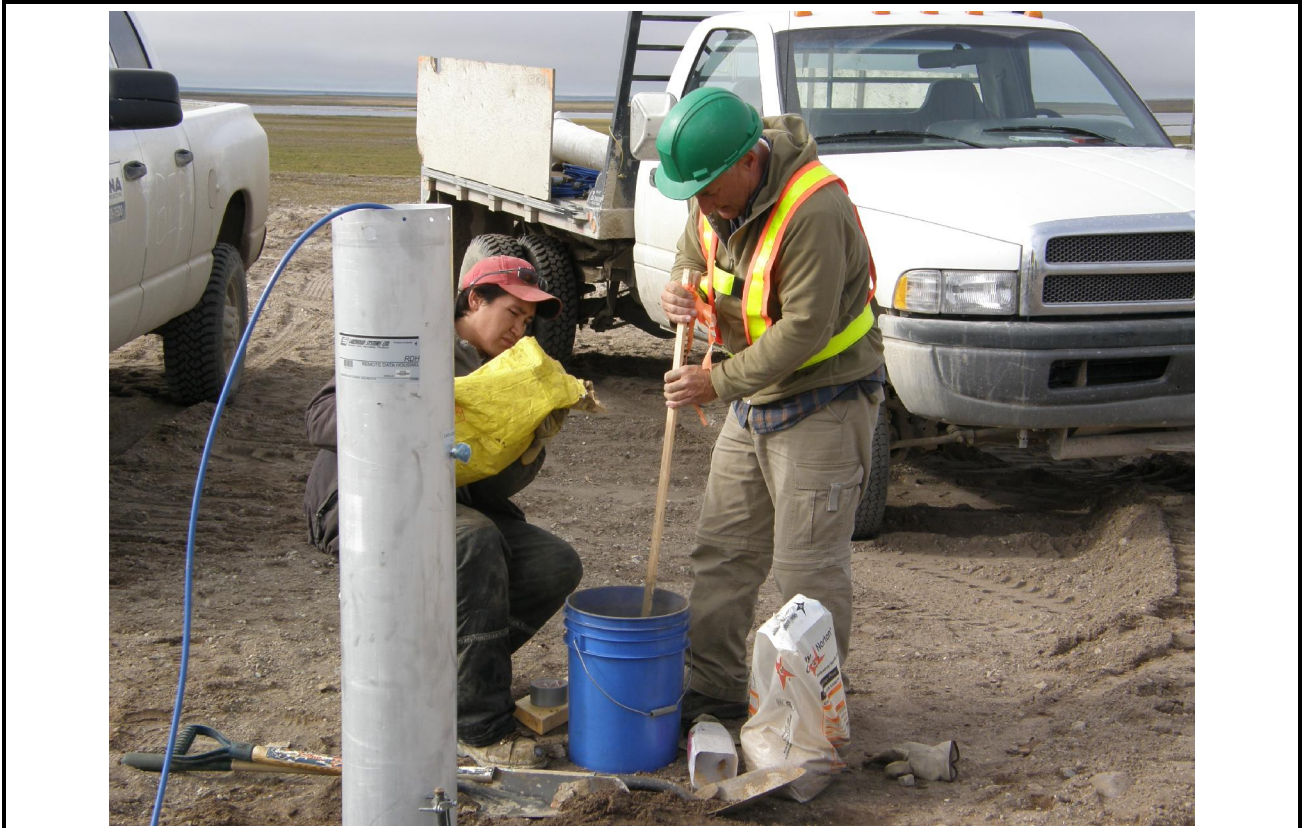
Photo 13: Installing Thermistor

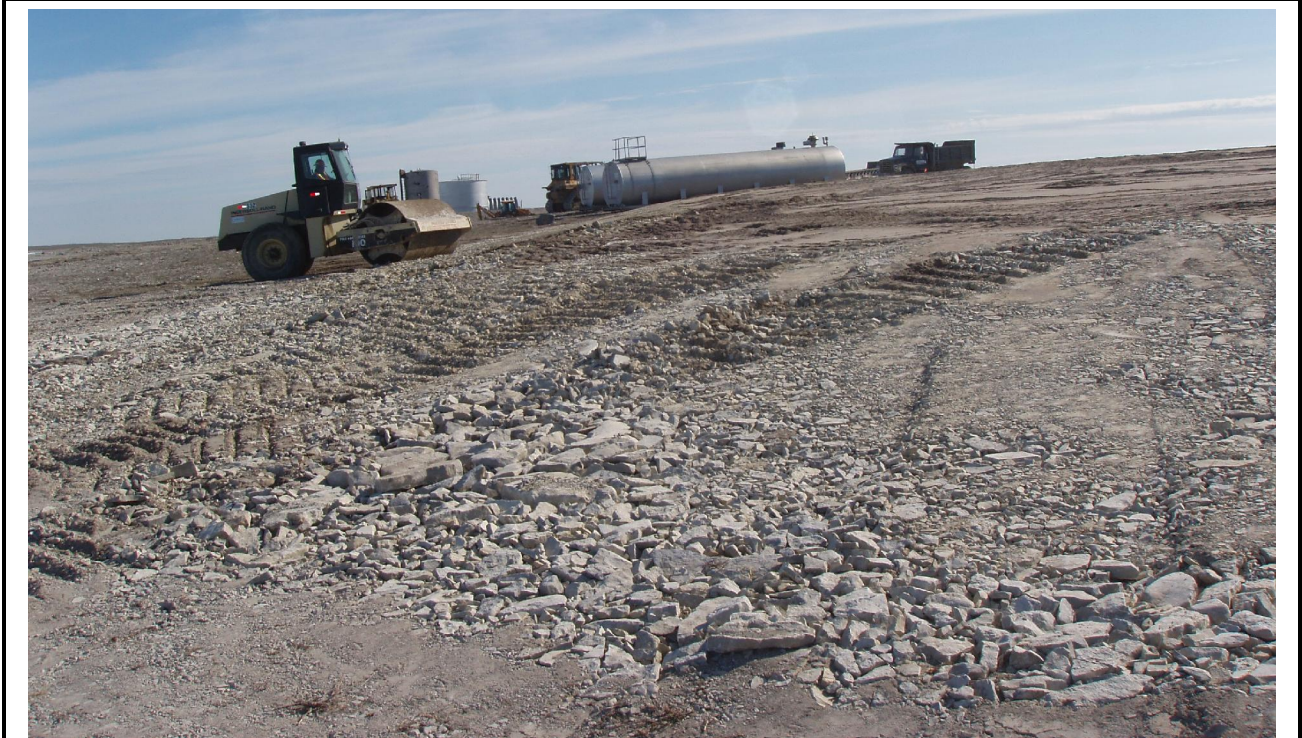
Photo 14: Beach Landfill (Regrade #1) compacting cover material

Regrading requirements at the Station Landfill, Beach Landfill, North Warning System (NWS) Landfill, and Northeast Landfill were completed in 2007.

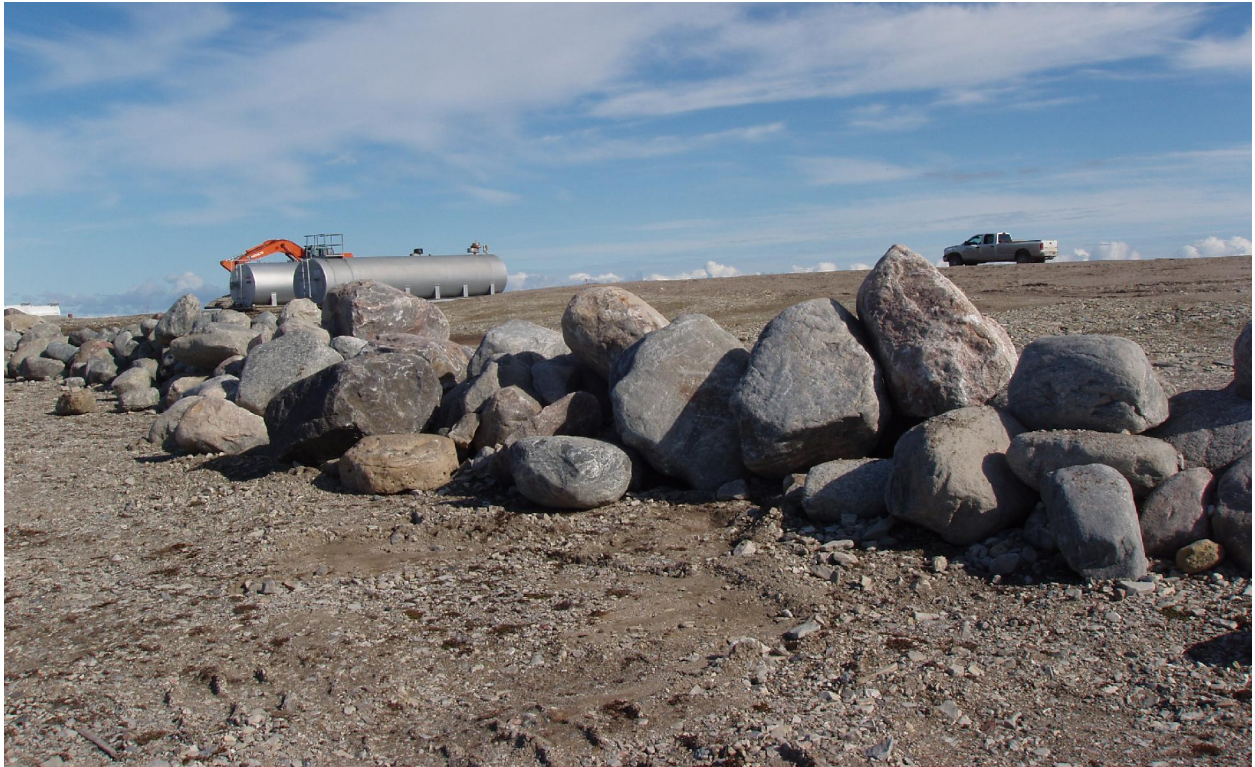
Photo 15: Beach Landfill Rip Rap

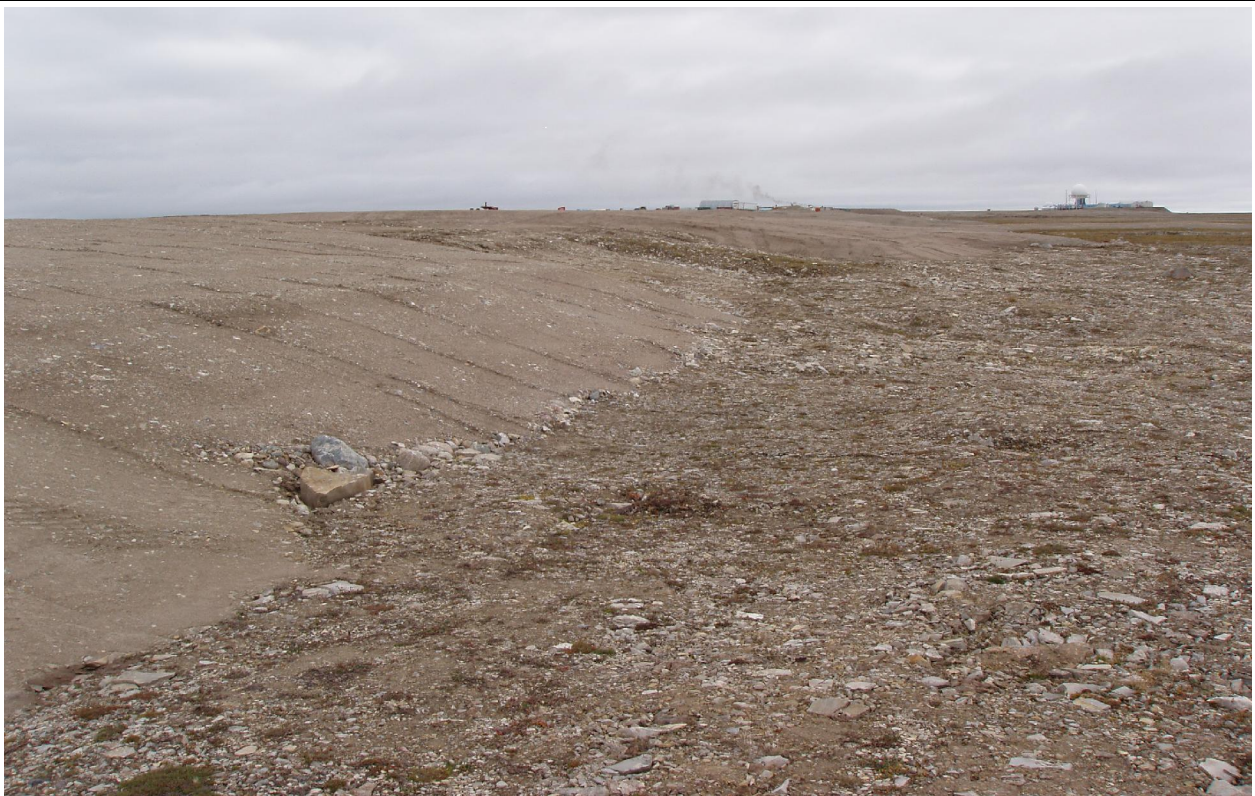
Photo 16: NELF: Regrade #15

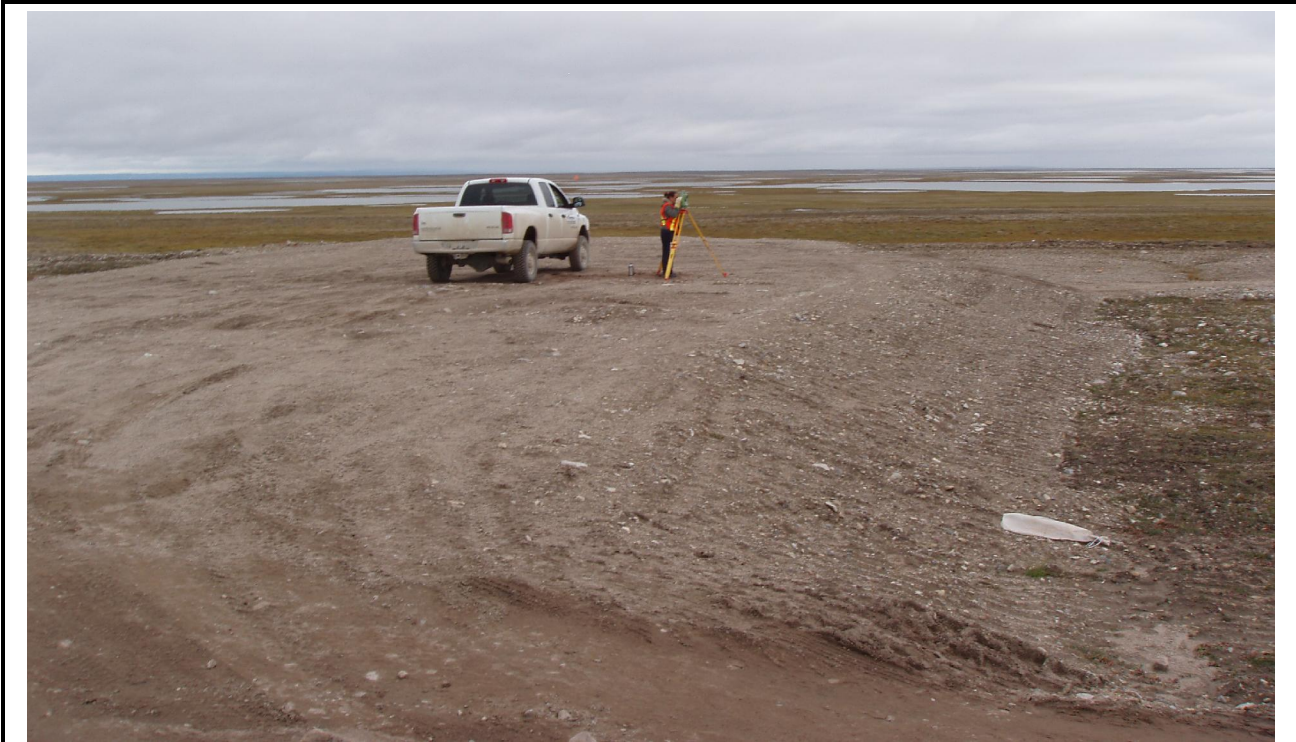
Photo 17: NWS Landfill: Regrade #20

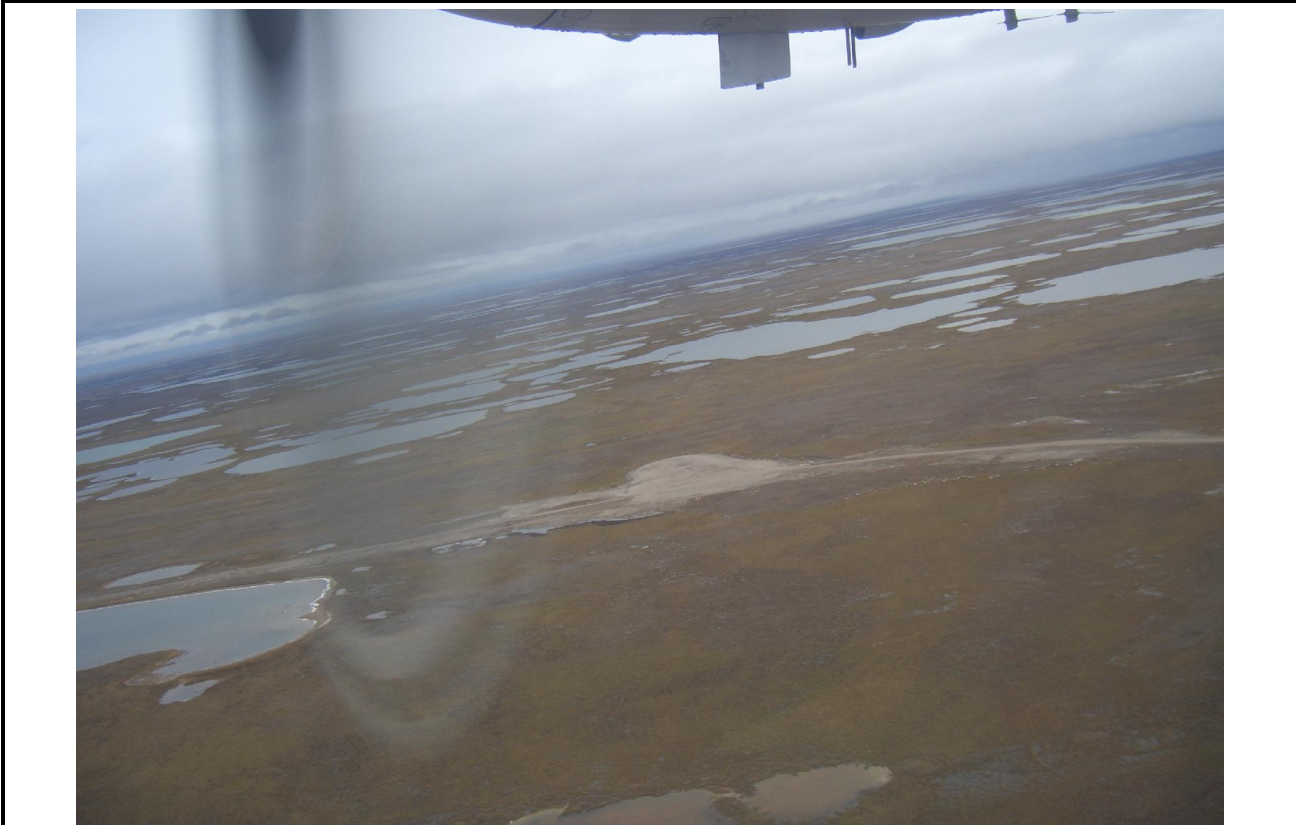
Photo 18: Completed USAF and NWS Landfill Areas
