DEW Line Cleanup
Landfill Monitoring Plan
CAM-3 Shepherd Bay

USAF and NWS Landfills
Figure CAM-3.7

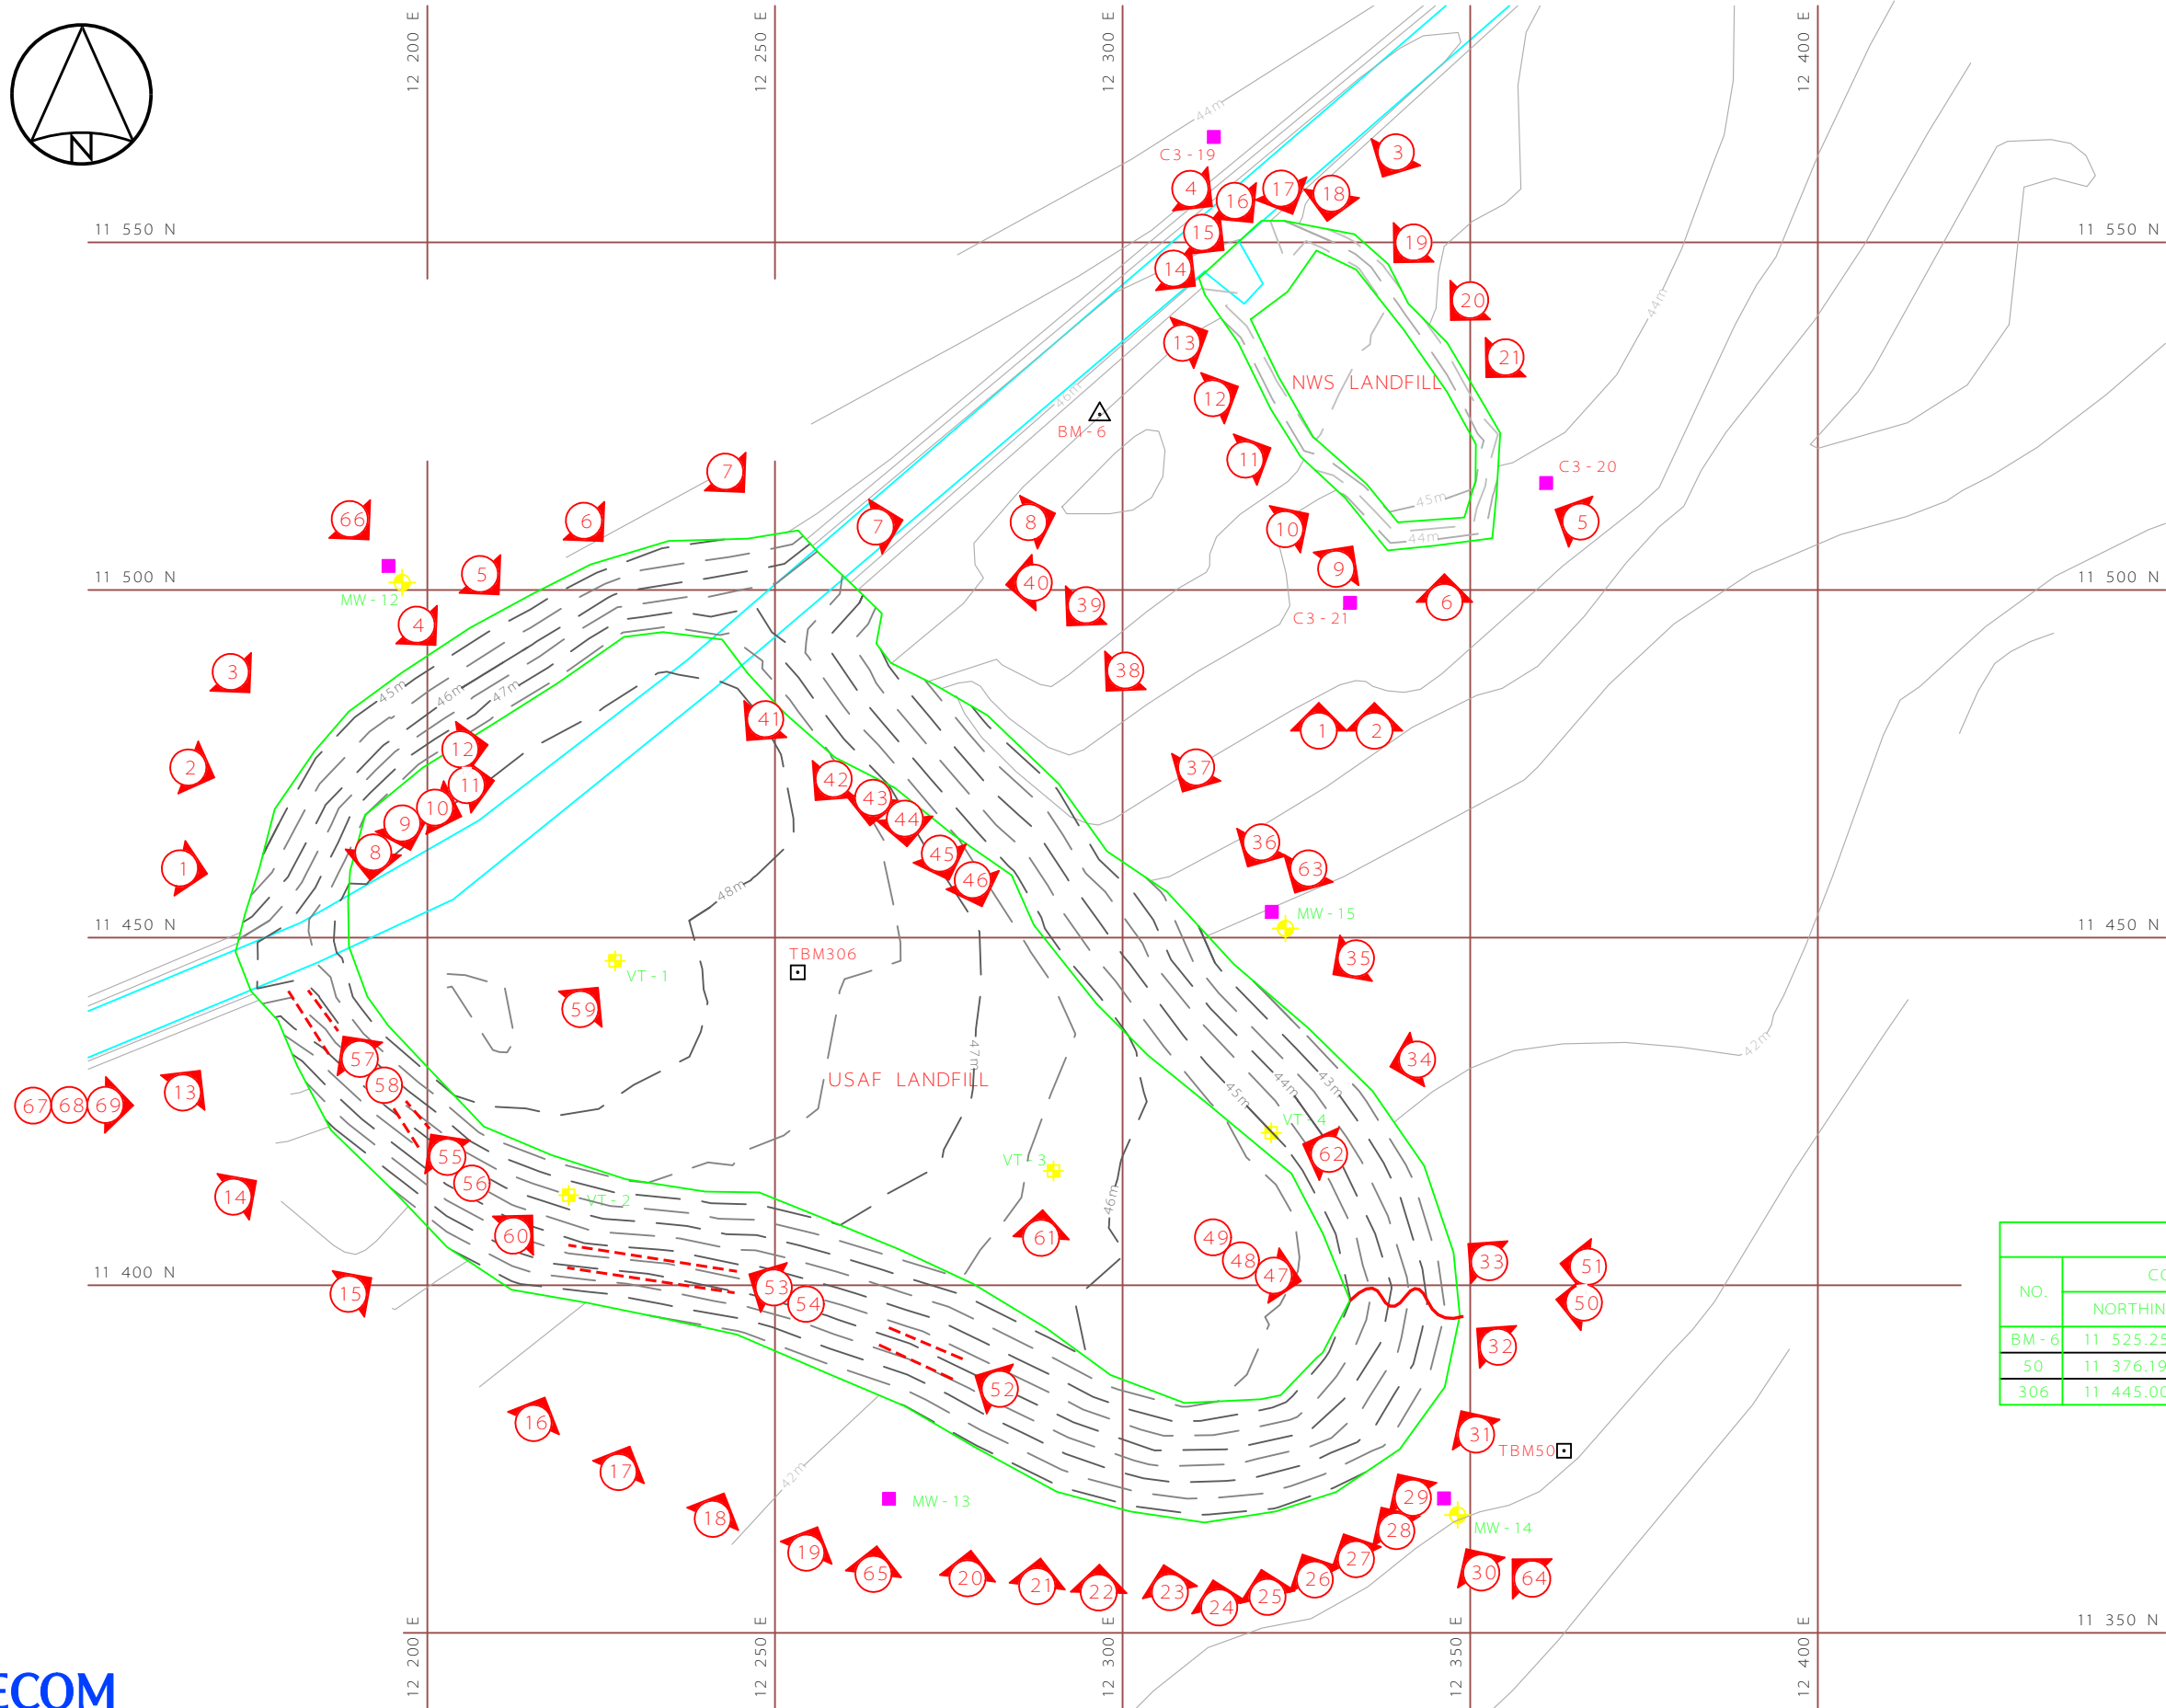
- Picture Number Viewpoint
- Survey Control Monument
- Temporary Benchmark
- Monitoring Well Location
- Vertical Thermistor
- Monitoring Soil Sample Location
- Erosion
- Cracks (3-5 mm wide)
