Long-Term Monitoring, 2012 CAM-D, Simpson Lake, Nunavut

FINAL REPORT

Figure A-2: Non-Hazardous Waste Landfill

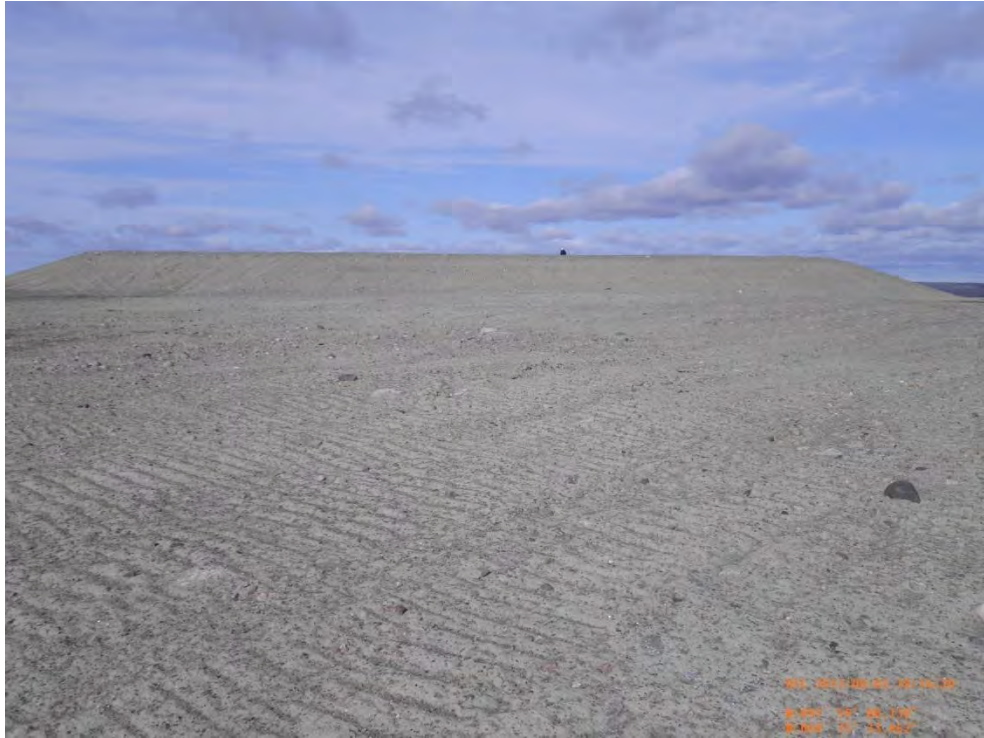
South side of the SSDF. Viewpoint 1 (Figure A-2; Appendix A). Photograph reference RIMG0001.
Direction photo taken: N

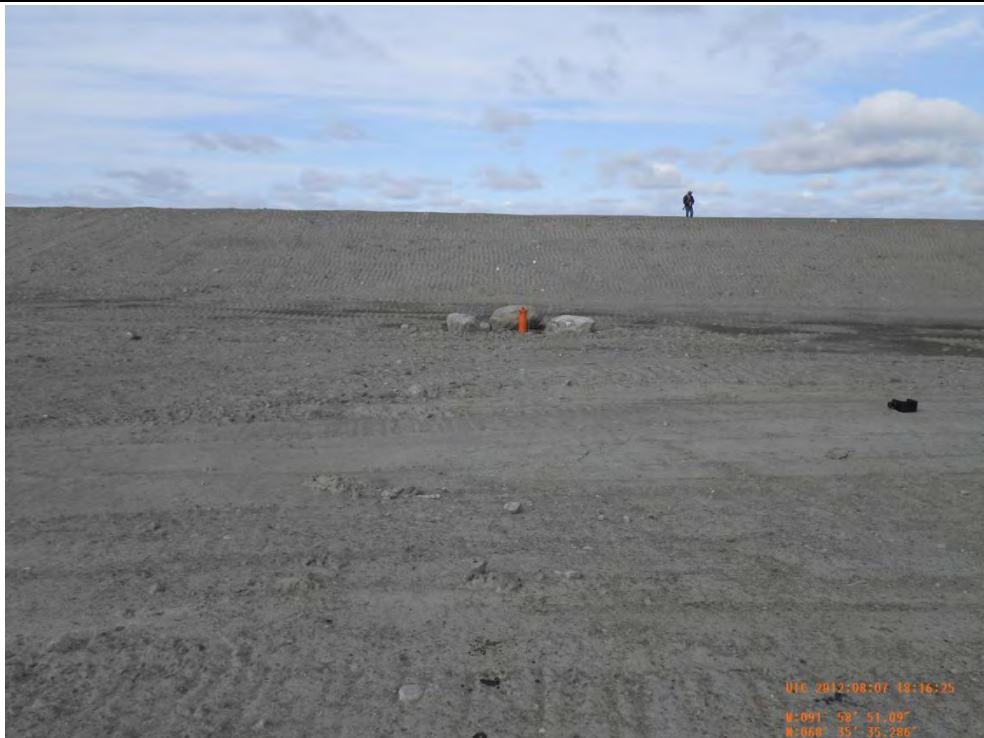
South side of the SSDF. Viewpoint 2 (Figure A-2; Appendix A). Photograph reference RIMG0002.
Direction photo taken: N

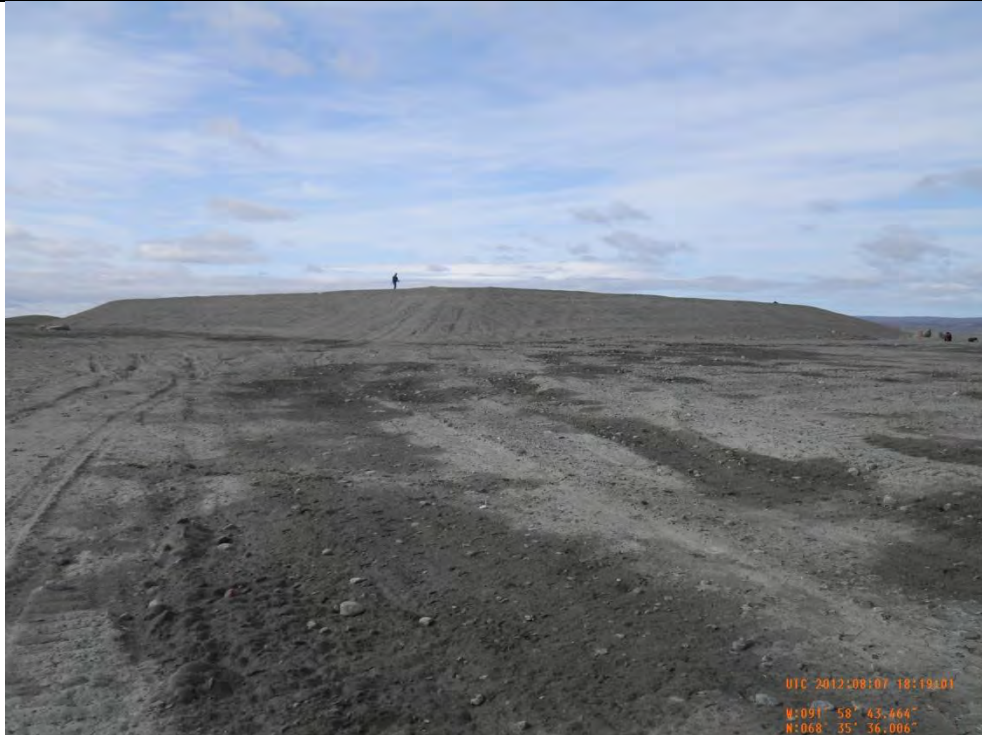
Southeast corner of the SSDF. Viewpoint 3 (Figure A-2; Appendix A). Photograph reference RIMG0003.
Direction photo taken: NW

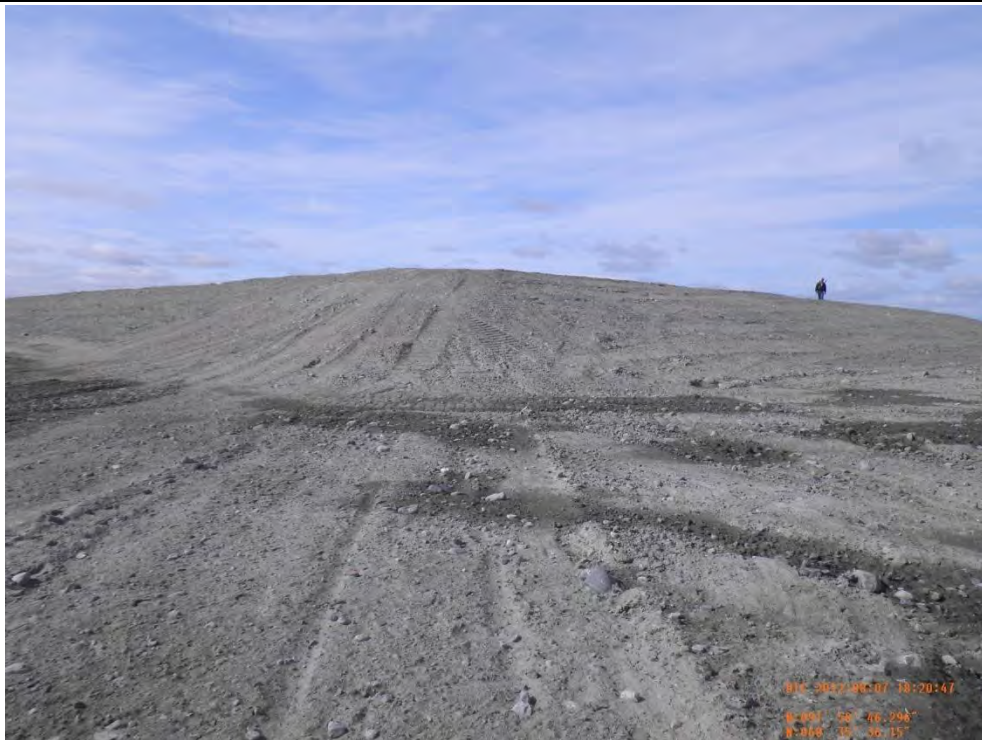
Southeast corner of the SSDF. Viewpoint 4 (Figure A-2; Appendix A). Photograph reference RIMG0004.
Direction photo taken: NW

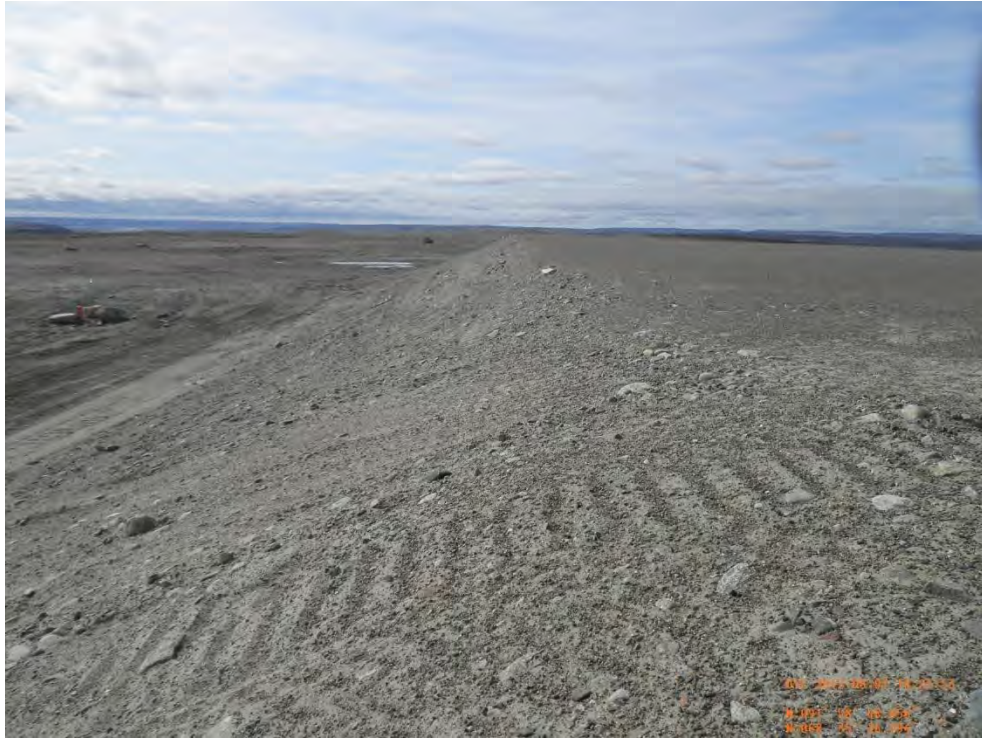
South side of the SSDF from the Southeast corner. Viewpoint 5 (Figure A-2; Appendix A). Photograph reference RIMG0005. Direction photo taken: W

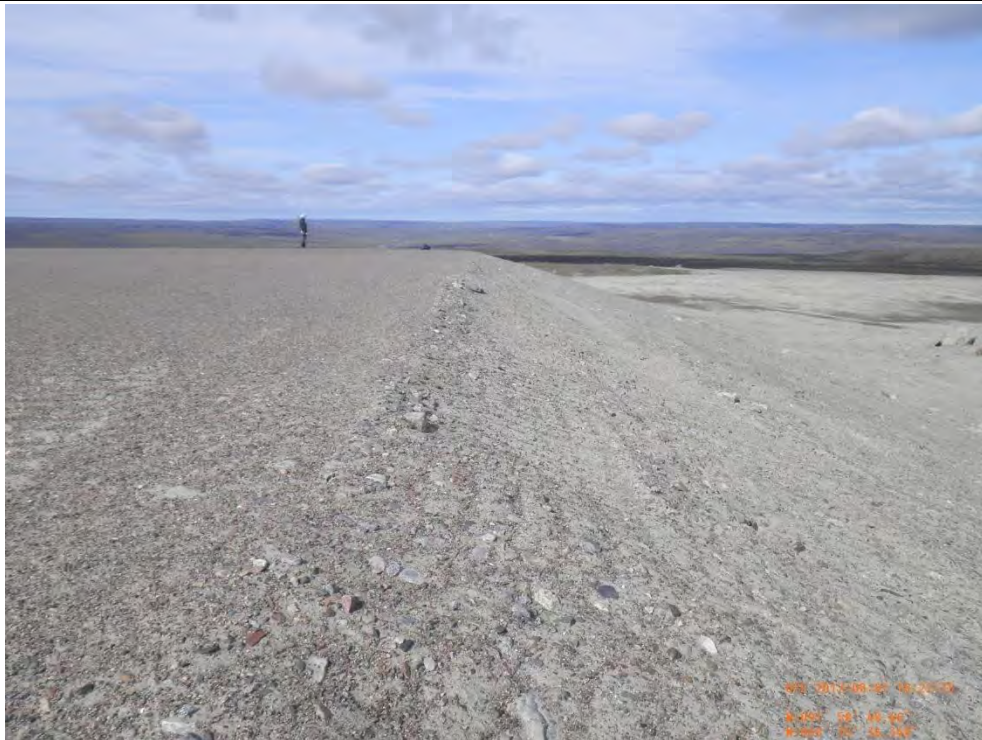
East side of the SSDF from the Southeast corner. Viewpoint 6 (Figure A-2; Appendix A). Photograph reference RIMG0006. Direction photo taken: N

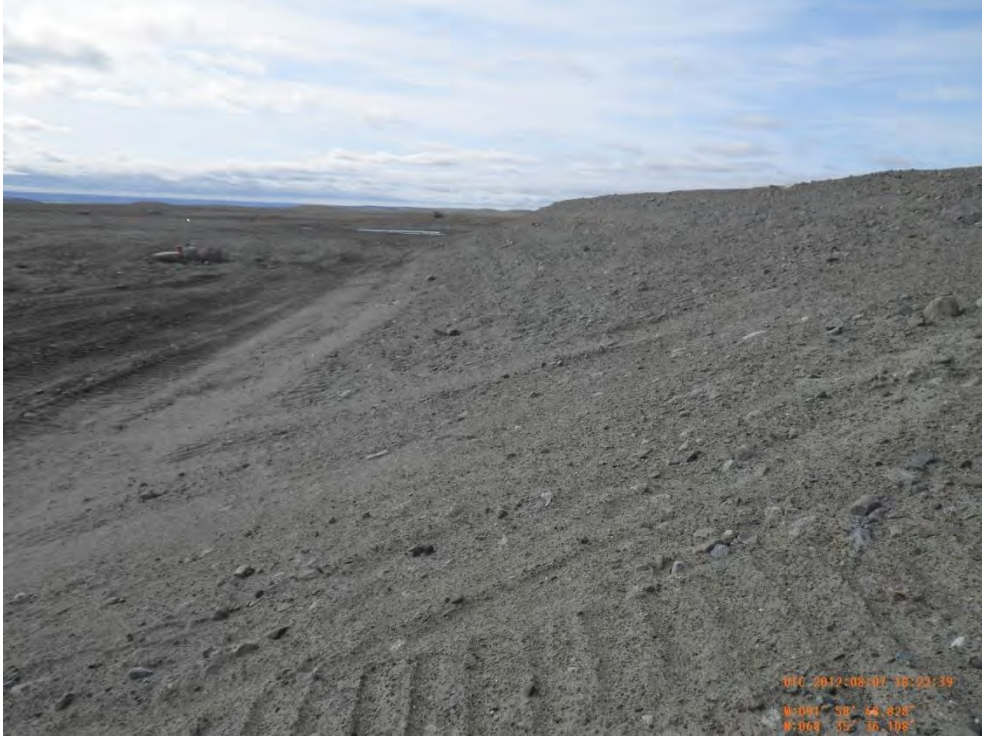
South side of the SSDF from the Southeast corner. Viewpoint 7 (Figure A-2; Appendix A). Photograph reference RIMG0007. Direction photo taken: W

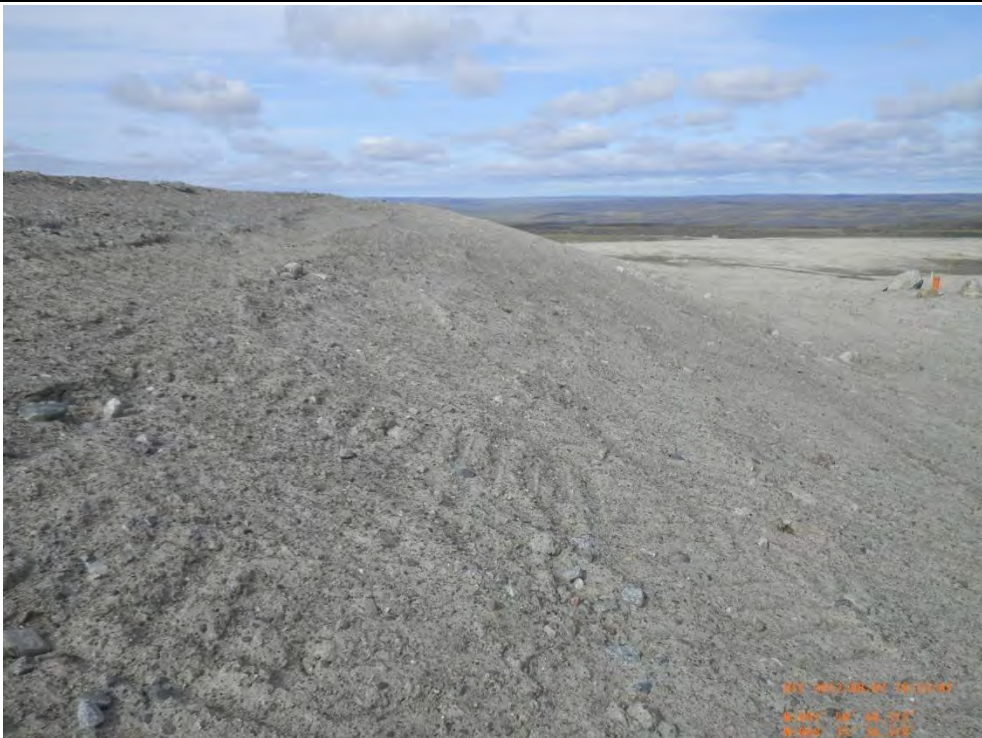
East side of the SSDF from the Southeast corner. Viewpoint 8 (Figure A-2; Appendix A). Photograph reference RIMG0008. Direction photo taken: N

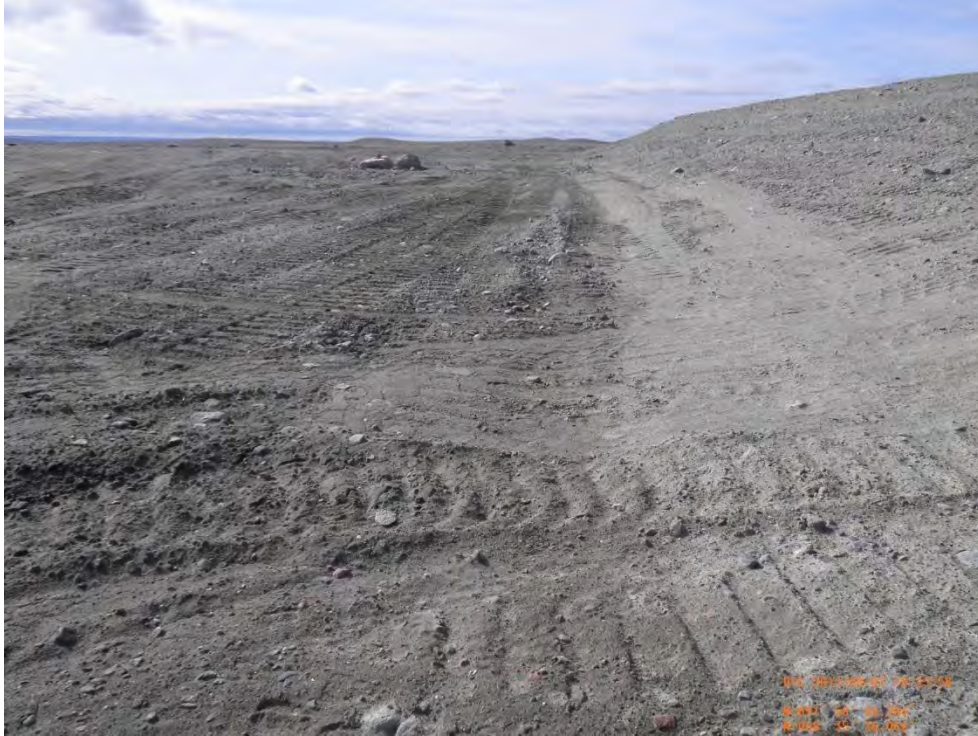
South side of the SSDF from the Southeast corner. Viewpoint 9 (Figure A-2; Appendix A). Photograph reference RIMG0009. Direction photo taken: W

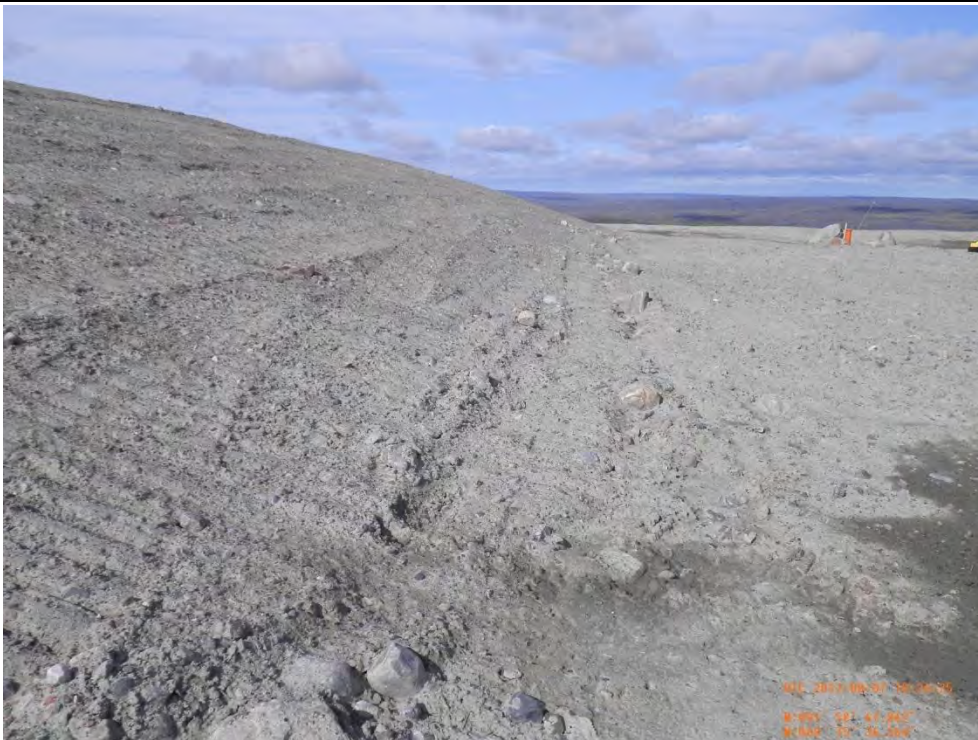
East side of the SSDF from the Southeast corner. Viewpoint 10 (Figure A-2; Appendix A). Photograph reference RIMG0010. Direction photo taken: N

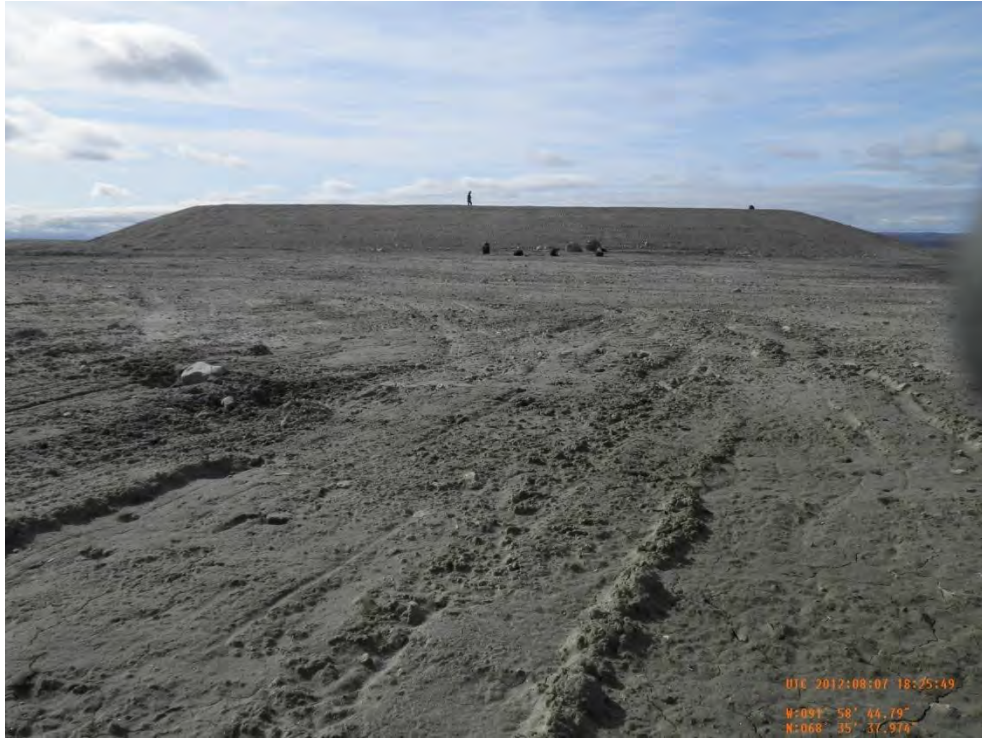
East side of the SSDF. Viewpoint 11 (Figure A-2; Appendix A). Photograph reference RIMG0011.
Direction photo taken: W

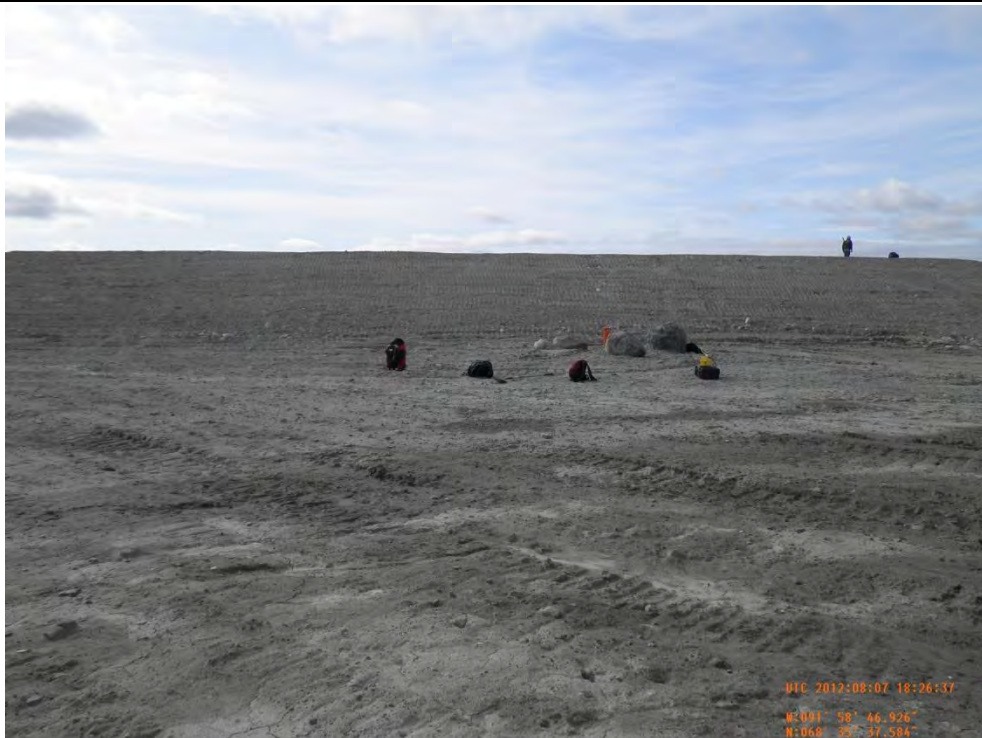
East side of the SSDF. Viewpoint 12 (Figure A-2; Appendix A). Photograph reference RIMG0012.
Direction photo taken: W

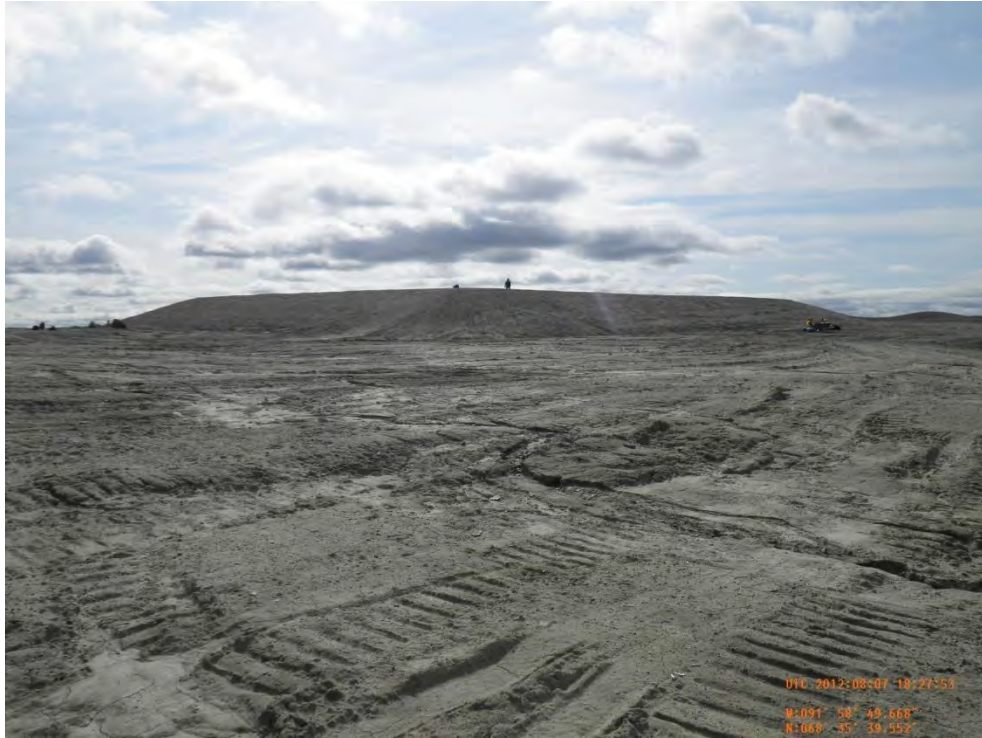
Northeast corner of the SSDF. Viewpoint 13 (Figure A-2; Appendix A). Photograph reference RIMG0013.
Direction photo taken: SW

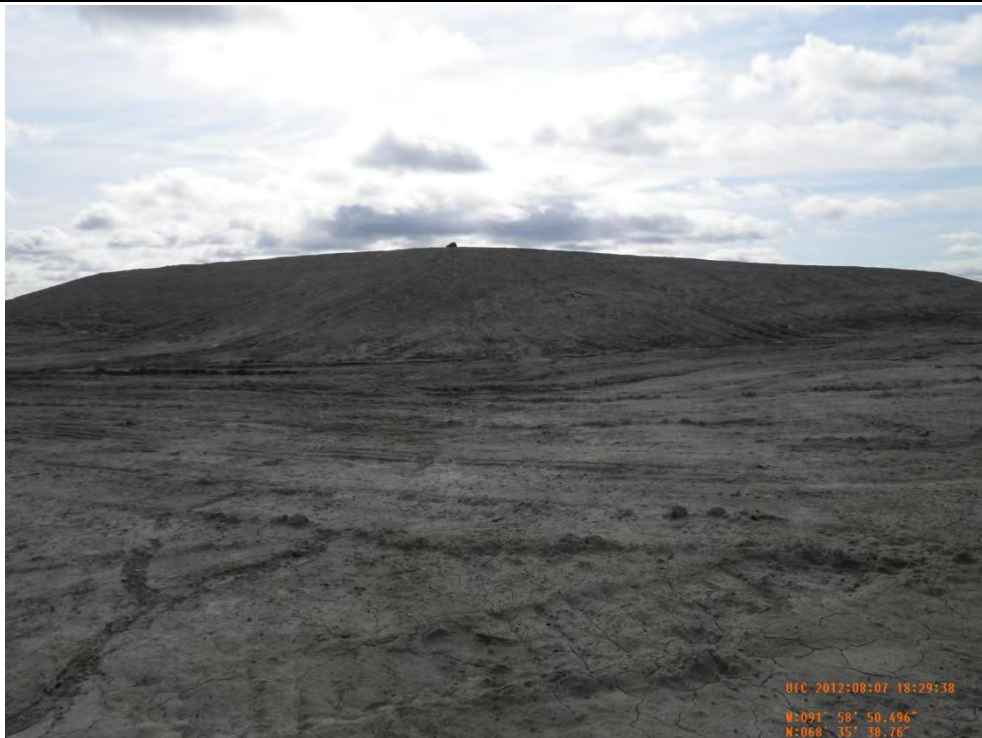
Northeast corner of the SSDF. Viewpoint 14 (Figure A-2; Appendix A). Photograph reference RIMG0014.
Direction photo taken: SW

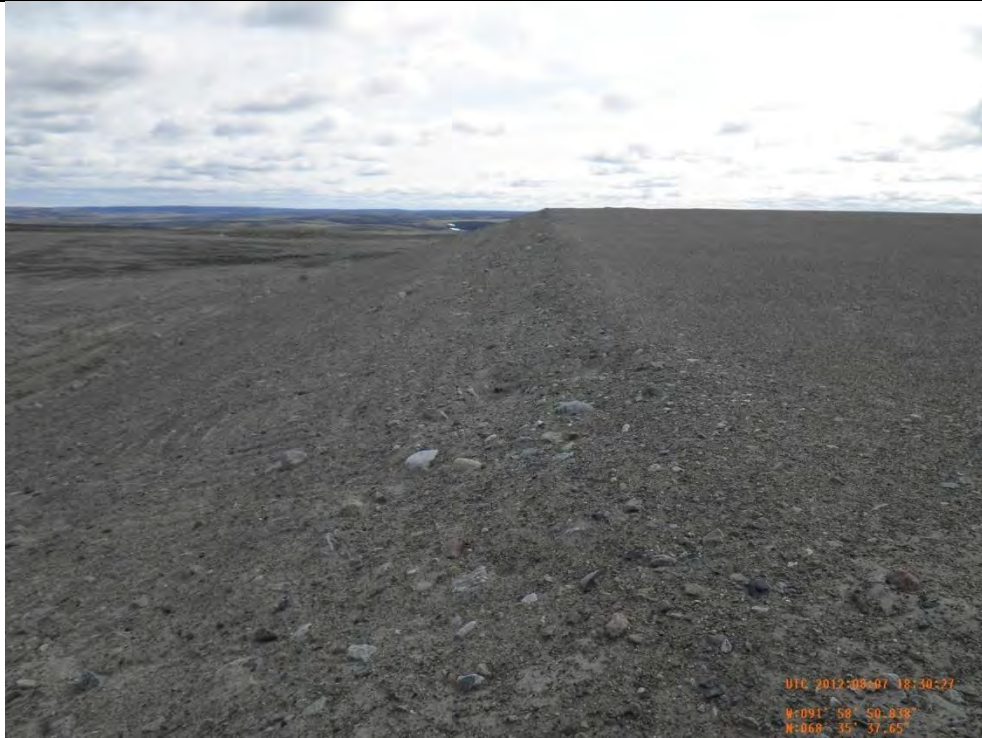
East side of the SSDF from the Northeast corner. Viewpoint 15 (Figure A-2; Appendix A). Photograph reference RIMG0015. Direction photo taken: S

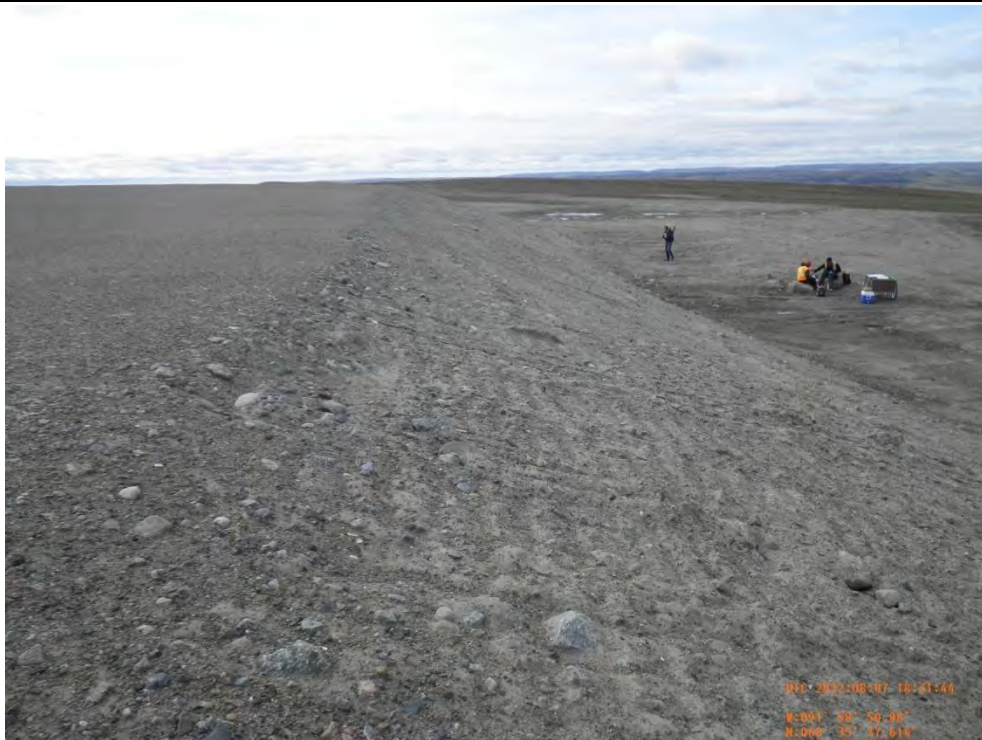
North side of the SSDF from the Northeast corner. Viewpoint 16 (Figure A-2; Appendix A). Photograph reference RIMG0016. Direction photo taken: W

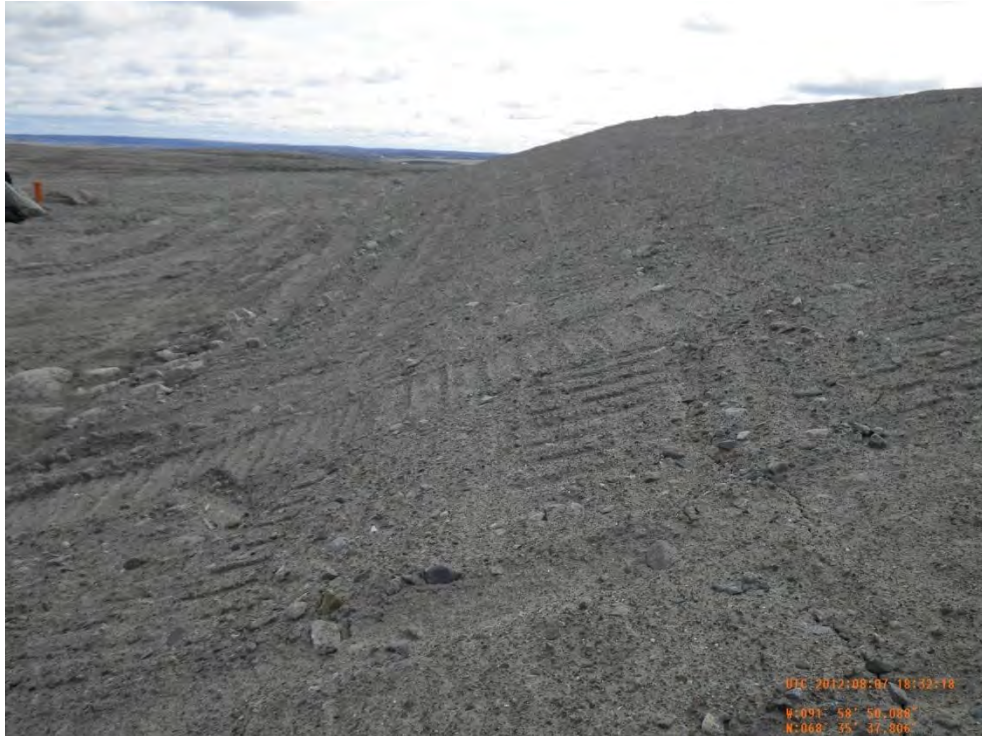
East side of the SSDF from the Northeast corner. Viewpoint 17 (Figure A-2; Appendix A). Photograph reference RIMG0017. Direction photo taken: S

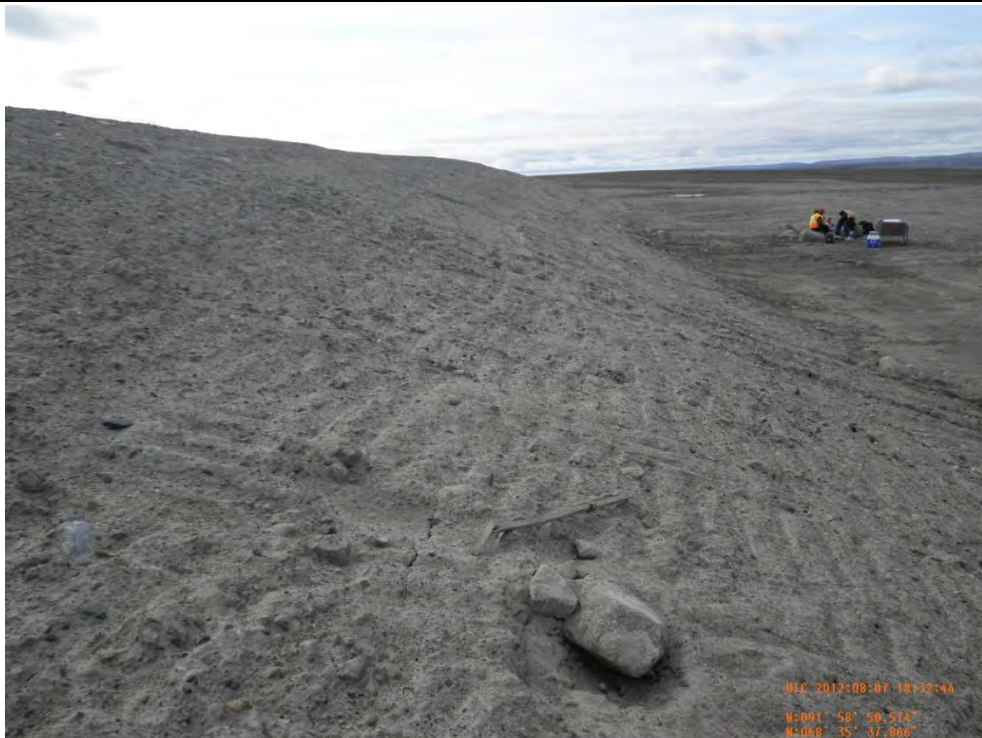
North side of the SSDF from the Northeast corner. Viewpoint 18 (Figure A-2; Appendix A). Photograph reference RIMG0018. Direction photo taken: W

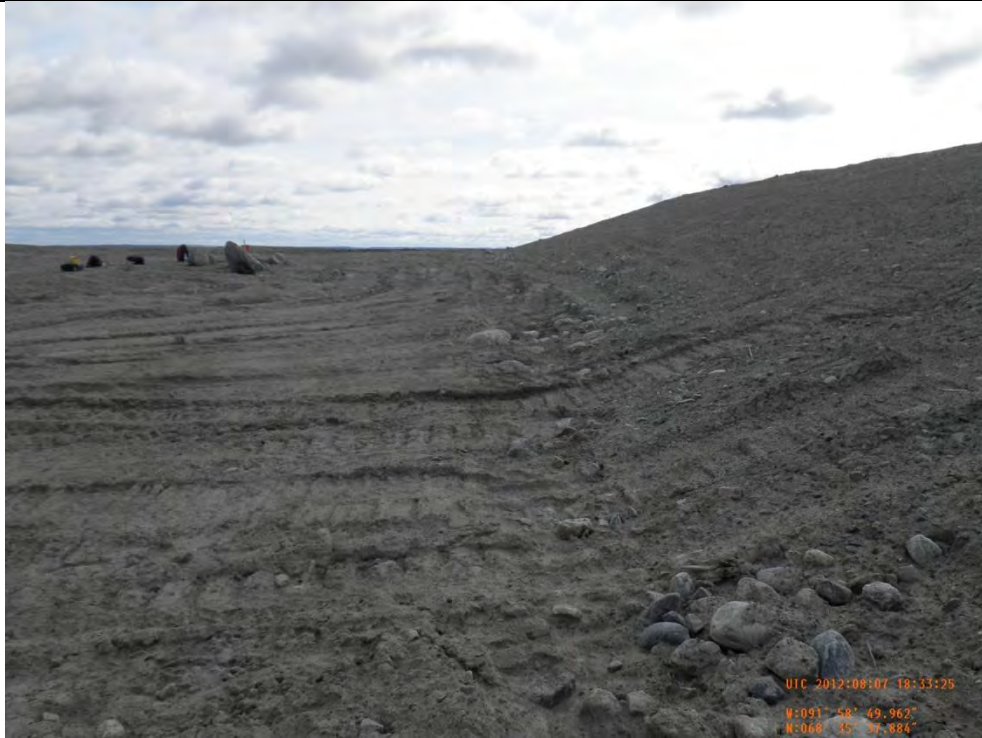
East side of the SSDF from the Northeast corner. Viewpoint 19 (Figure A-2; Appendix A). Photograph reference RIMG0019. Direction photo taken: S

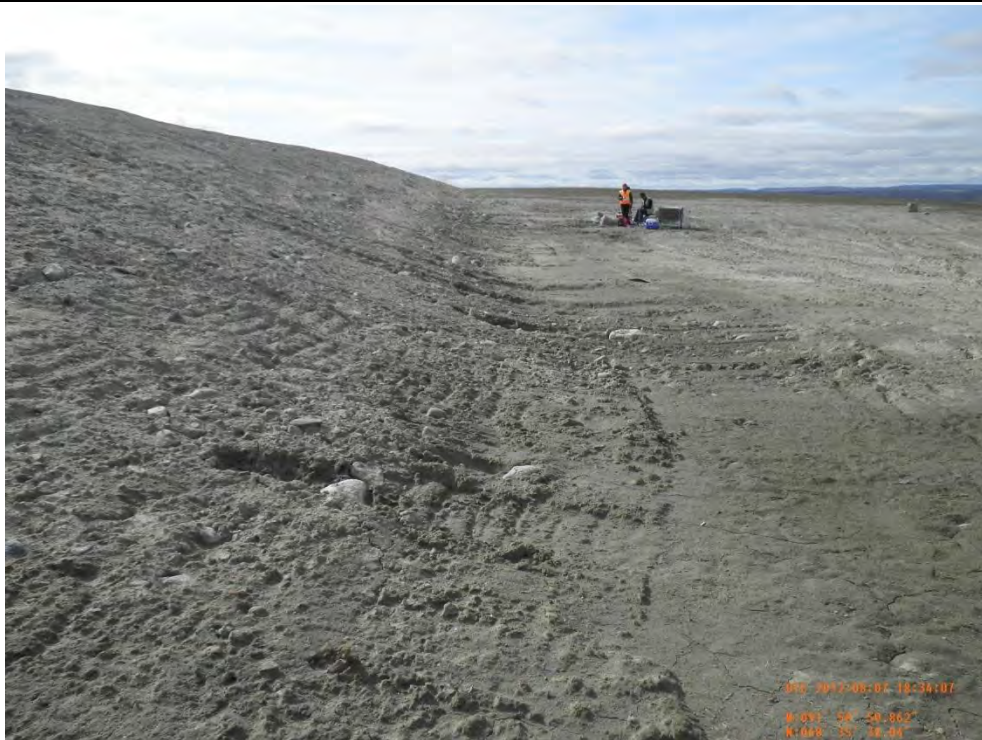
North side of the SSDF from the Northeast corner. Viewpoint 20 (Figure A-2; Appendix A). Photograph reference RIMG0020. Direction photo taken: W

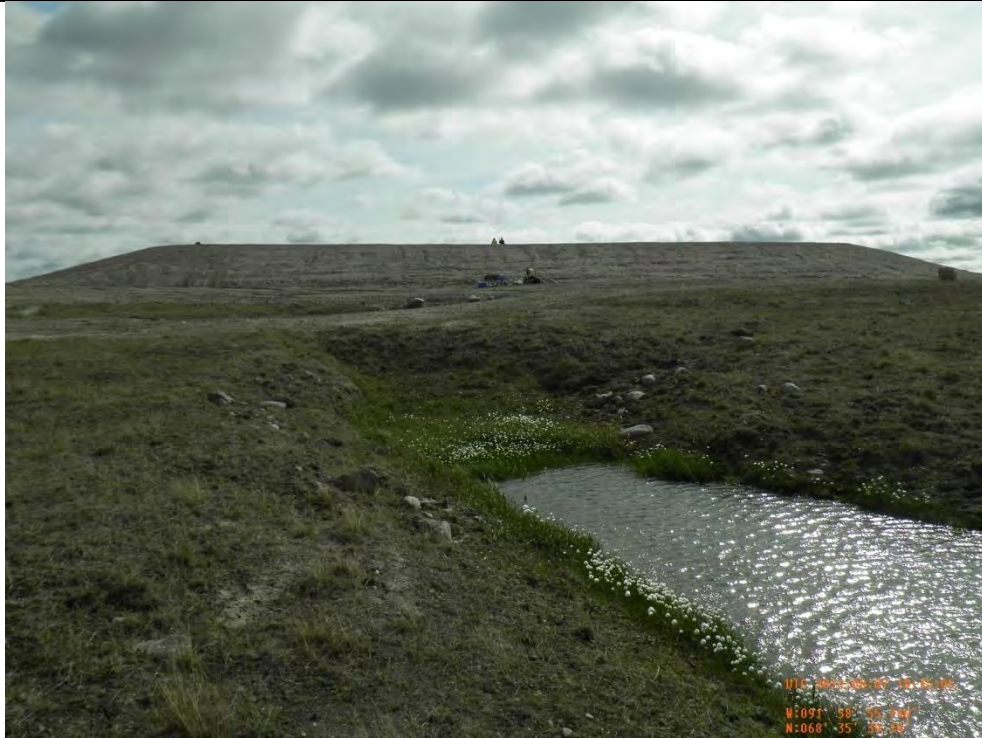
North side of the SSDF. Viewpoint 21 (Figure A-2; Appendix A). Photograph reference RIMG0021.
Direction photo taken: S

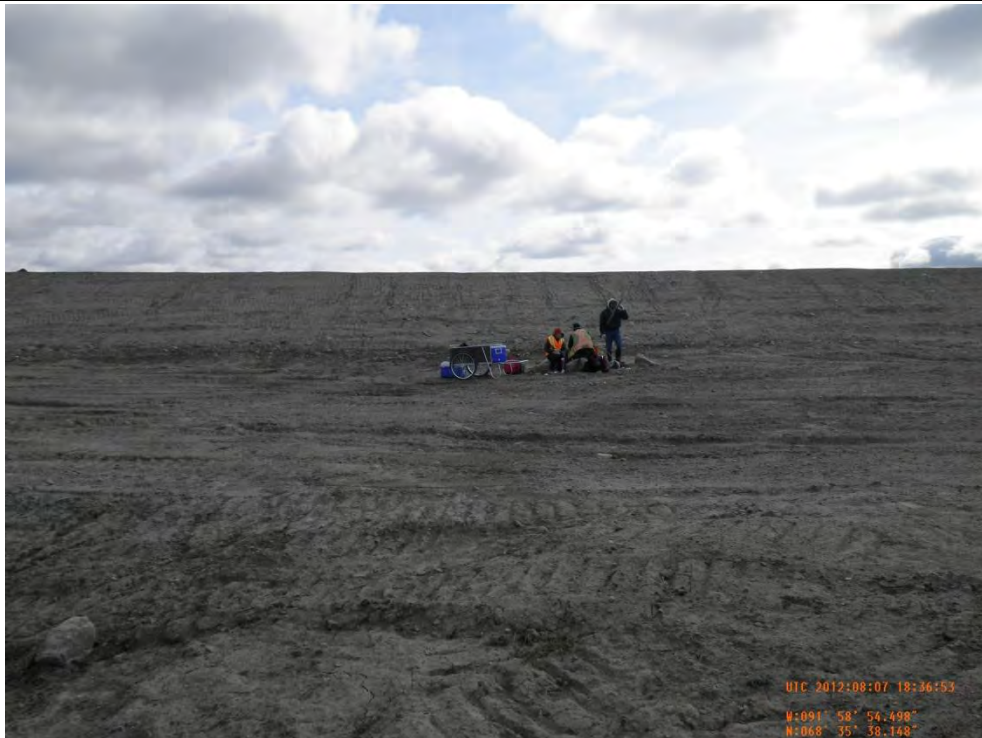
North side of the SSDF. Viewpoint 22 (Figure A-2; Appendix A). Photograph reference RIMG0022.
Direction photo taken: S

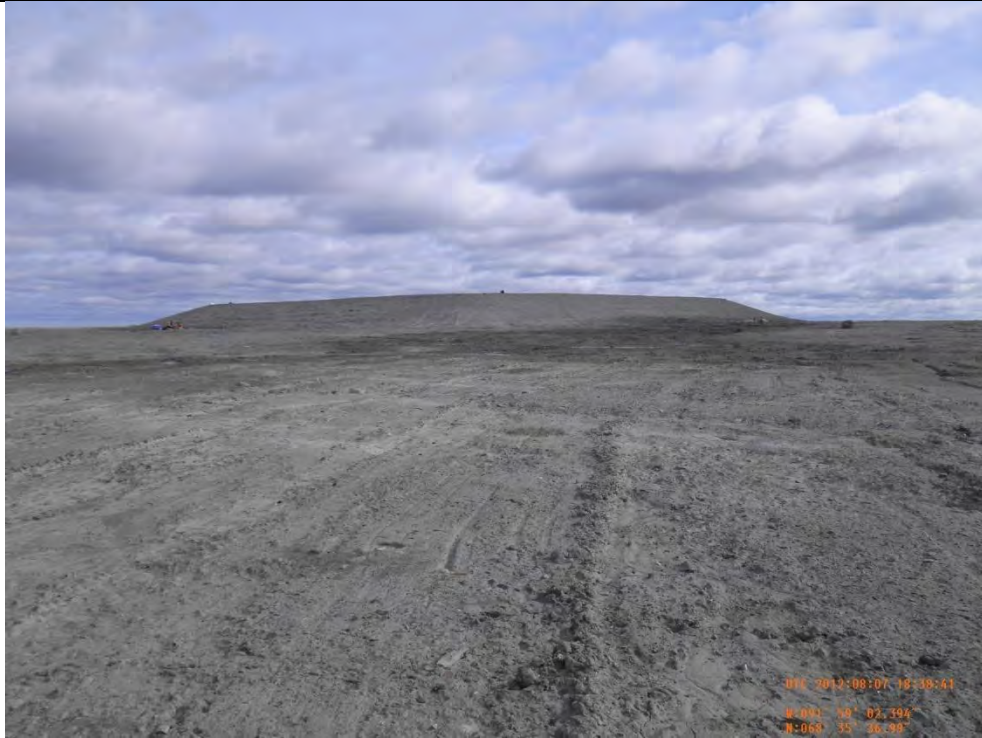
Northwest corner of the SSDF. Viewpoint 23 (Figure A-2; Appendix A). Photograph reference RIMG0023.
Direction photo taken: SE

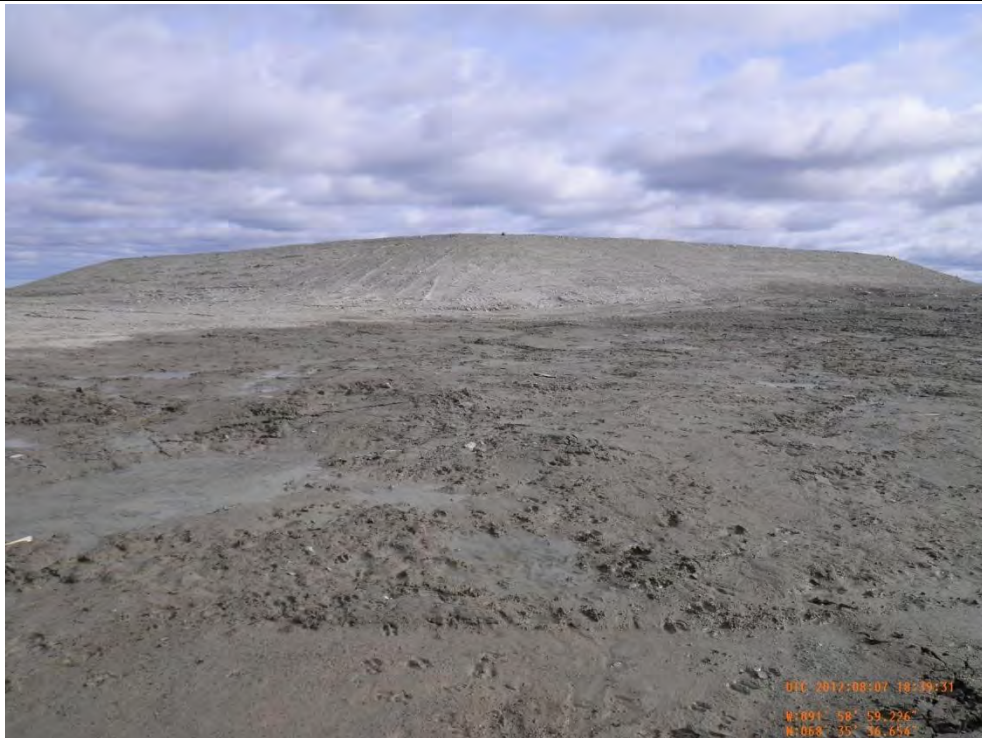
Northwest corner of the SSDF. Viewpoint 24 (Figure A-2; Appendix A). Photograph reference RIMG0024.
Direction photo taken: SE

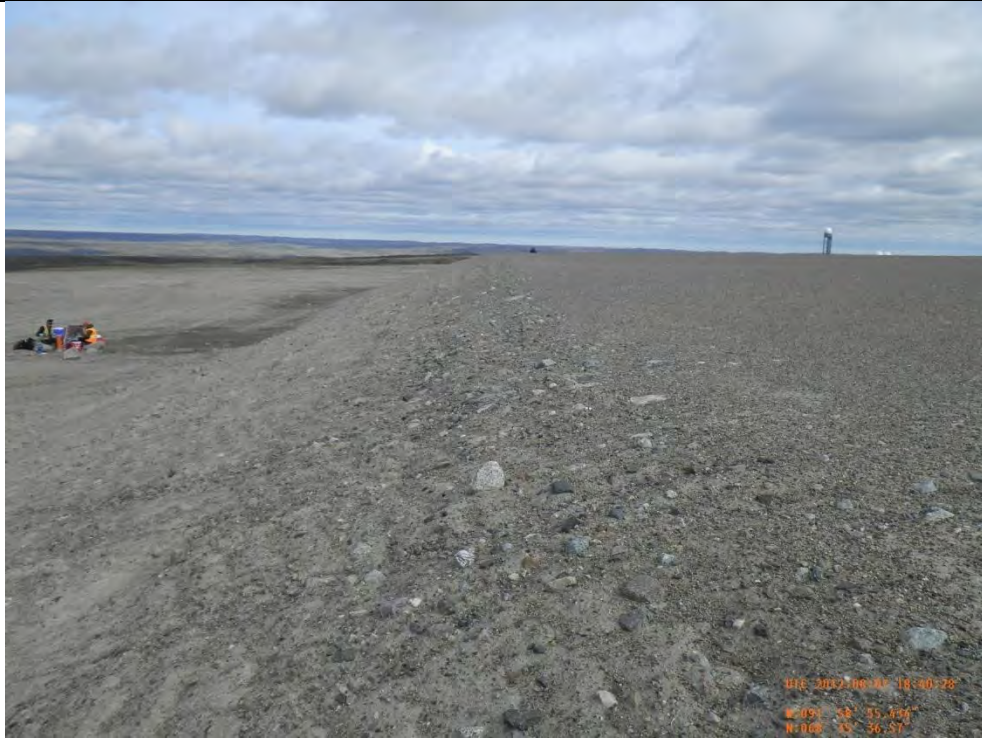
North side of the SSDF from the Northwest corner. Viewpoint 25 (Figure A-2; Appendix A). Photograph reference RIMG0025. Direction photo taken: E

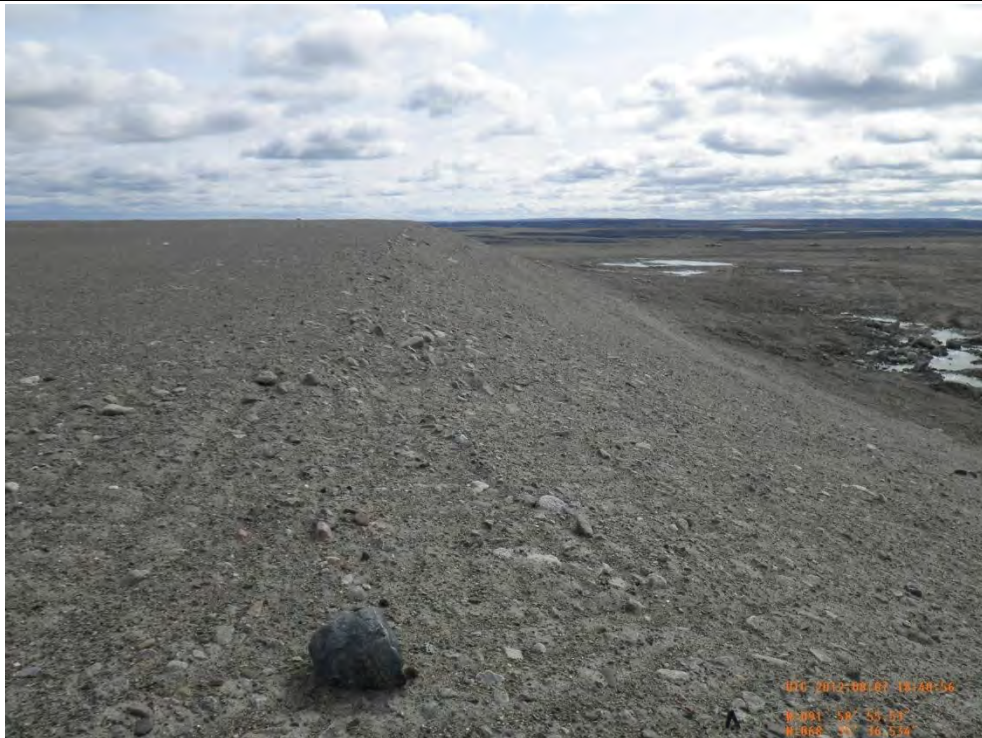
West side of the SSDF from the Northwest corner. Viewpoint 26 (Figure A-2; Appendix A). Photograph reference RIMG0026. Direction photo taken: S

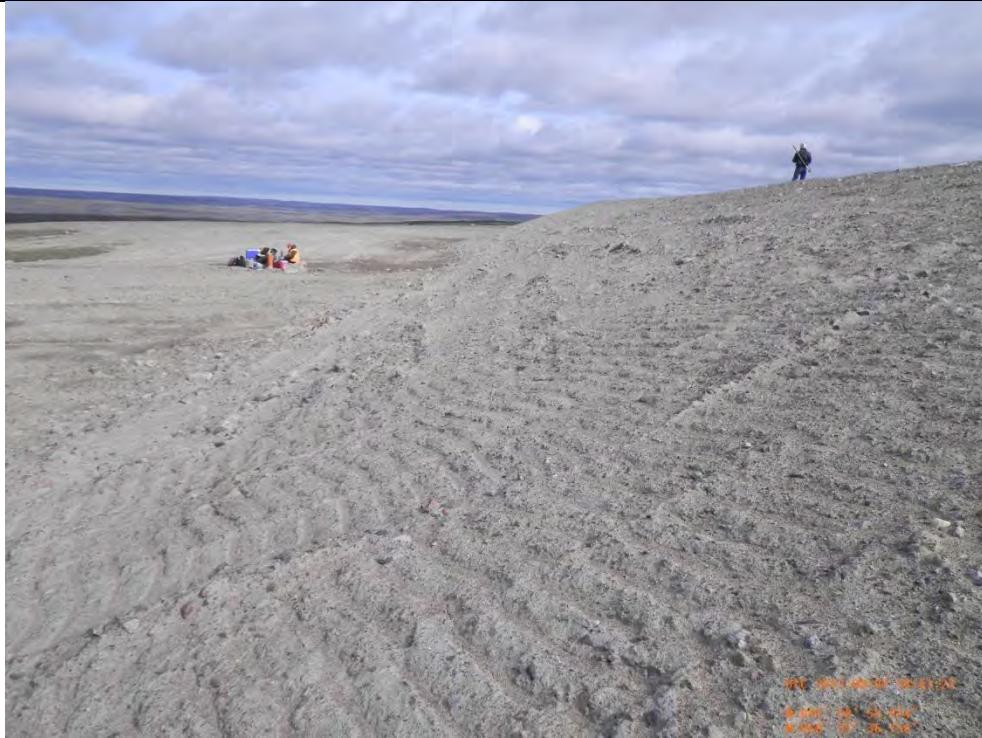
North side of the SSDF from the Northwest corner. Viewpoint 27 (Figure A-2; Appendix A). Photograph reference RIMG0027. Direction photo taken: E

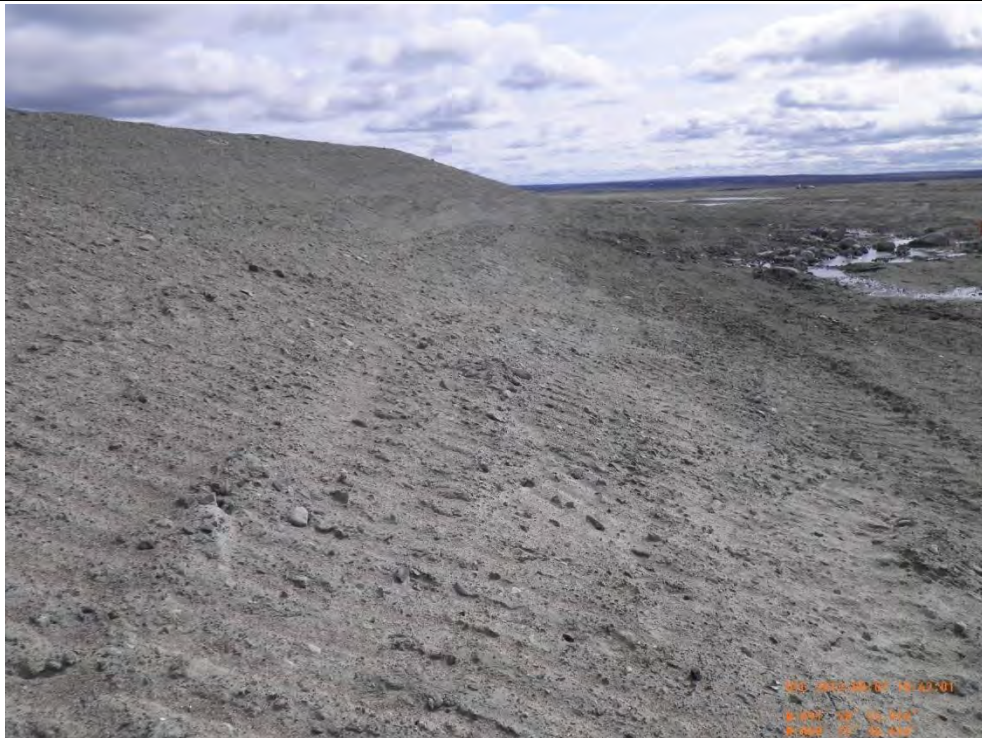
West side of the SSDF from the Northwest corner. Viewpoint 28 (Figure A-2; Appendix A). Photograph reference RIMG0028. Direction photo taken: S

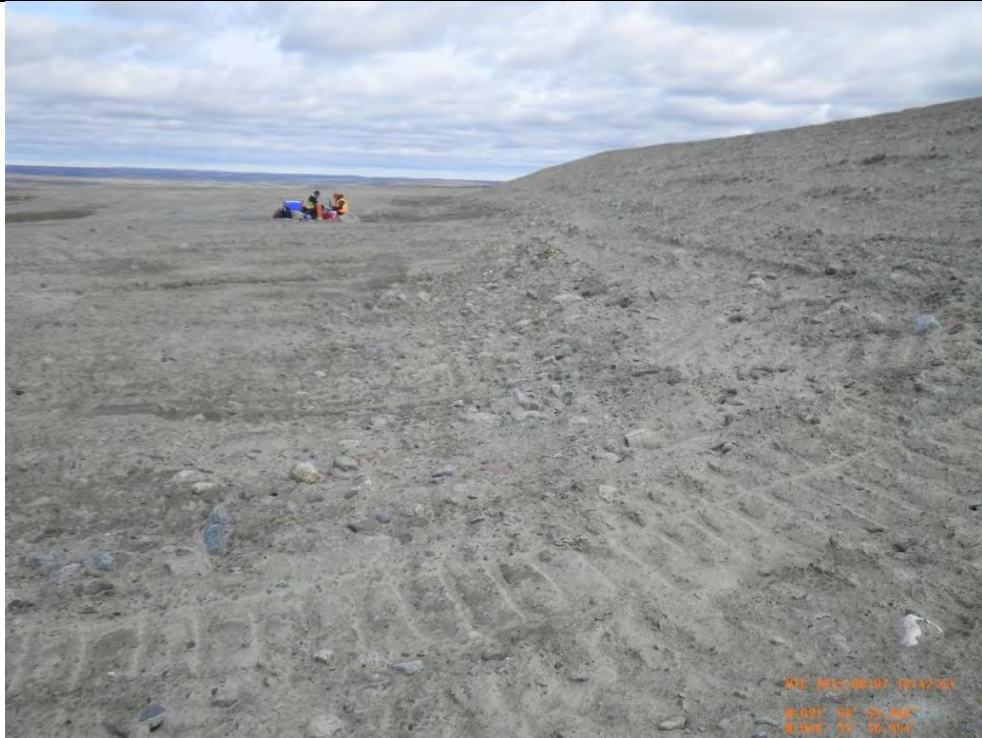
North side of the SSDF from the Northwest corner. Viewpoint 29 (Figure A-2; Appendix A). Photograph reference RIMG0029. Direction photo taken: E

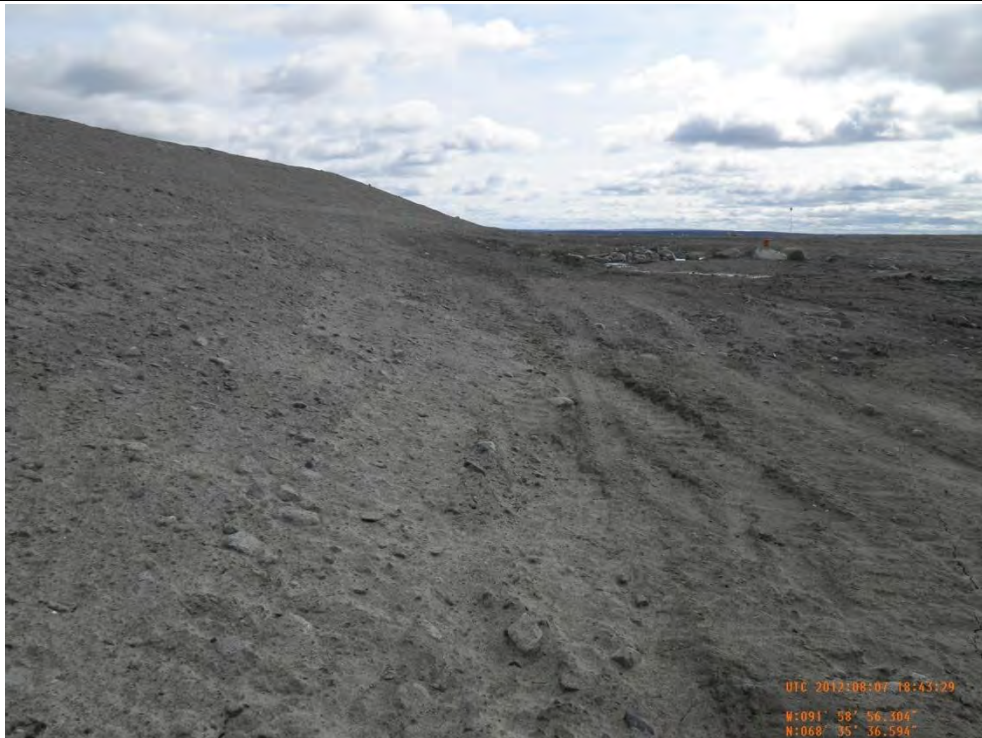
West side of the SSDF from the Northwest corner. Viewpoint 30 (Figure A-2; Appendix A). Photograph reference RIMG0030. Direction photo taken: S
