Long-Term Monitoring, 2012 CAM-D, Simpson Lake, Nunavut

FINAL REPORT

Figure A-2: Non-Hazardous Waste Landfill

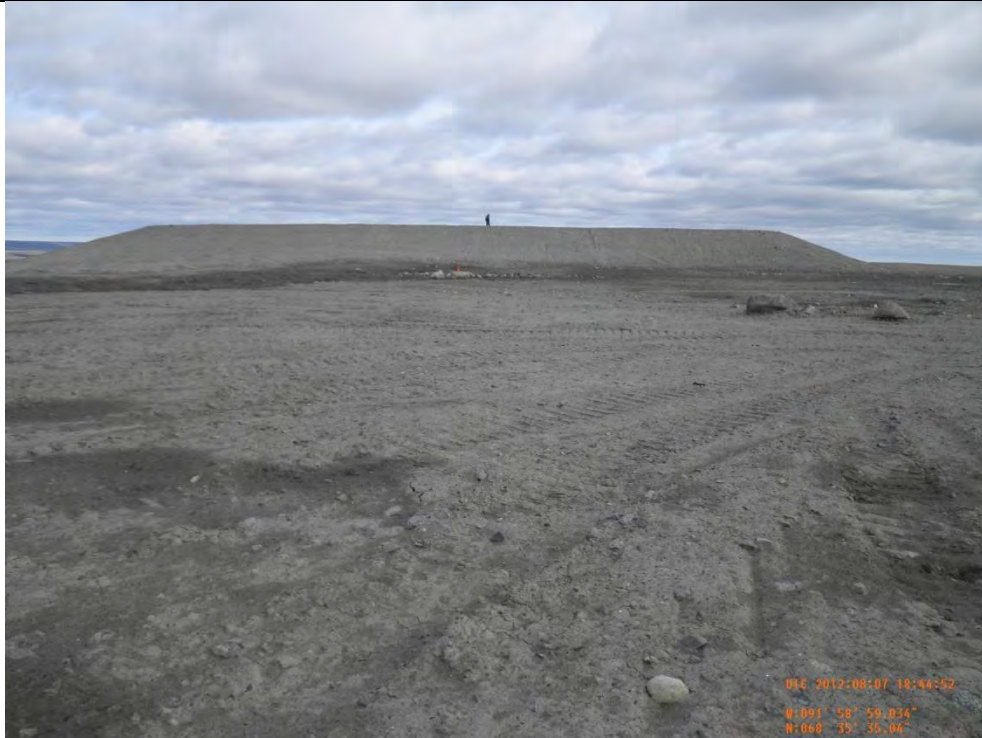
West side of the SSDF. Viewpoint 31 (Figure A-2; Appendix A). Photograph reference RIMG0031.
Direction photo taken: E

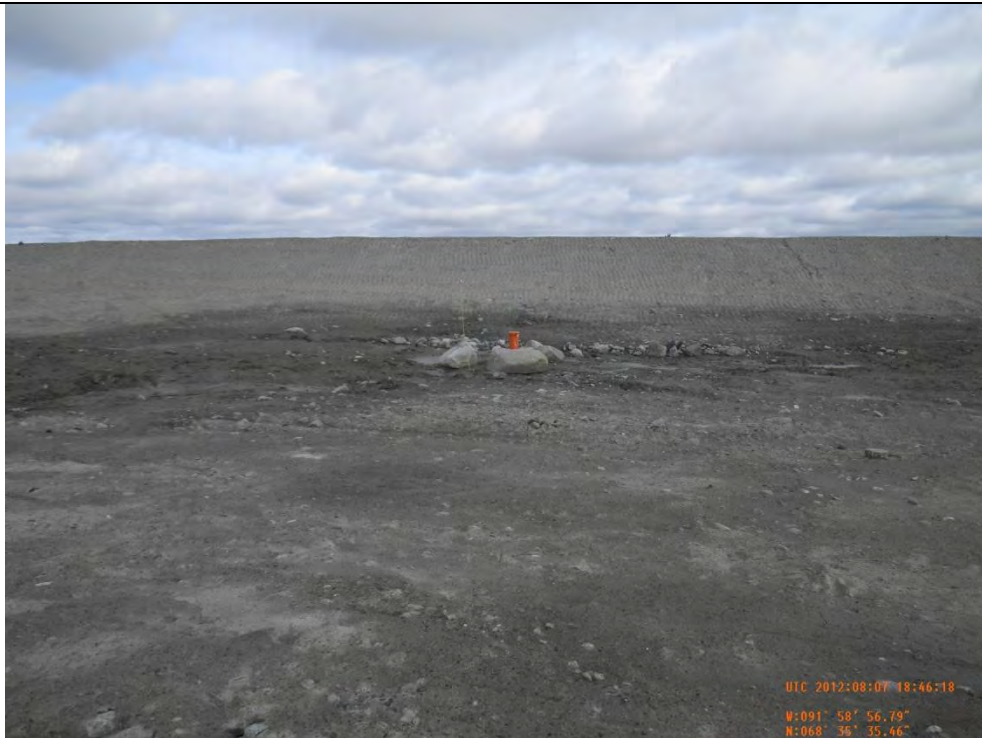
West side of the SSDF. Viewpoint 32 (Figure A-2; Appendix A). Photograph reference RIMG0032.
Direction photo taken: E

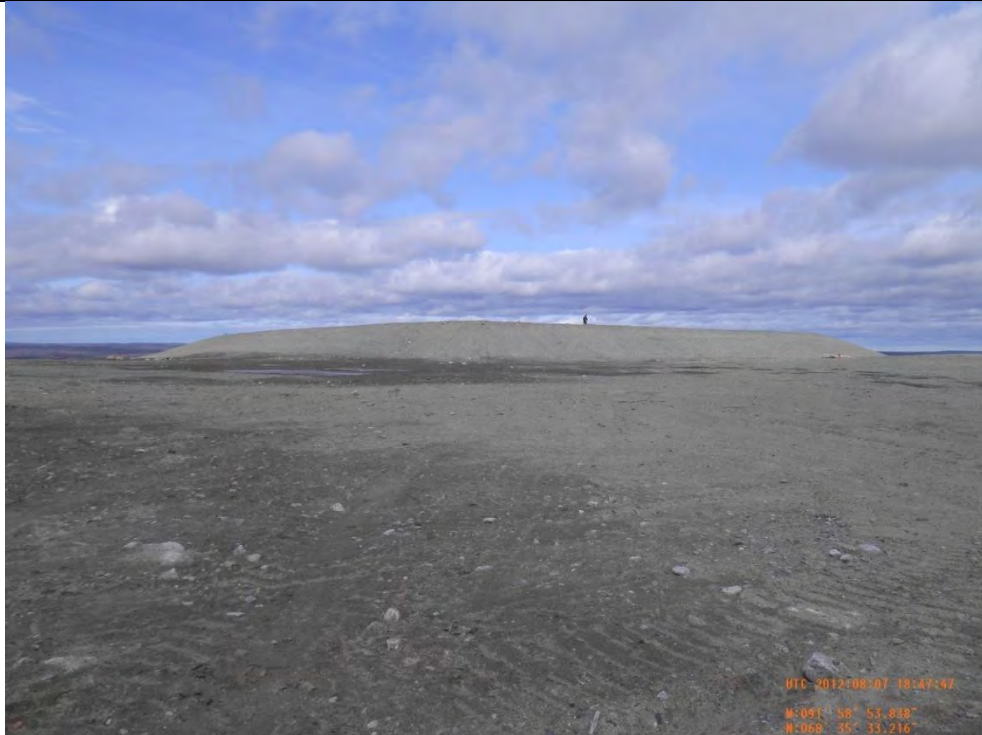
Southwest corner of the SSDF. Viewpoint 33 (Figure A-2; Appendix A). Photograph reference RIMG0033.
Direction photo taken: NE

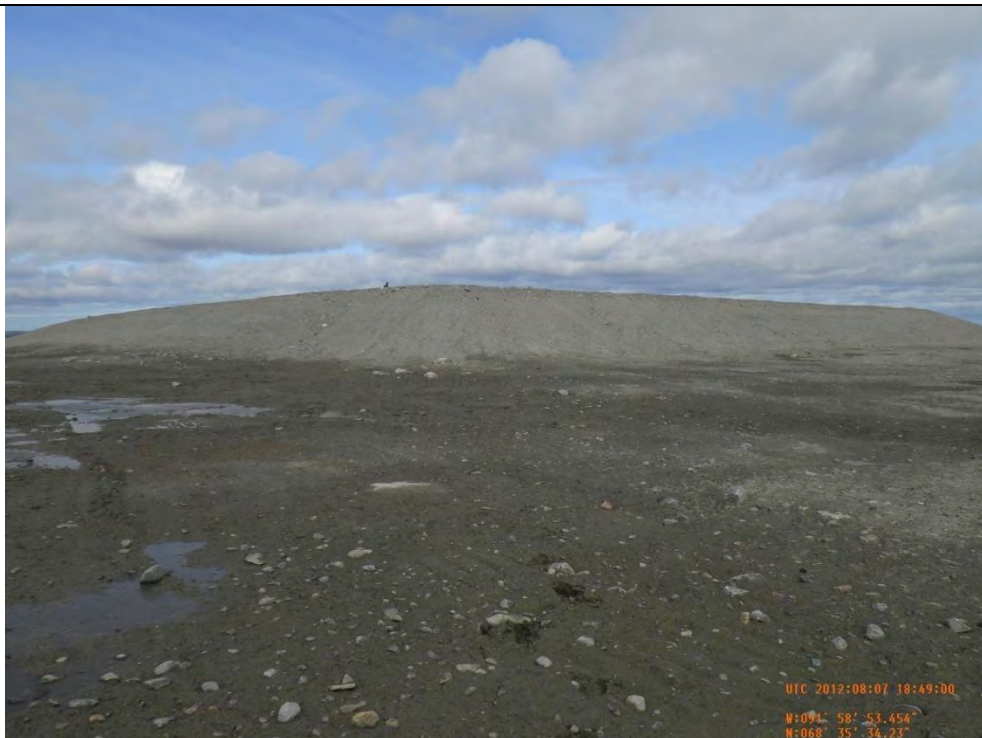
Southwest corner of the SSDF. Viewpoint 34 (Figure A-2; Appendix A). Photograph reference RIMG0034.
Direction photo taken: NE

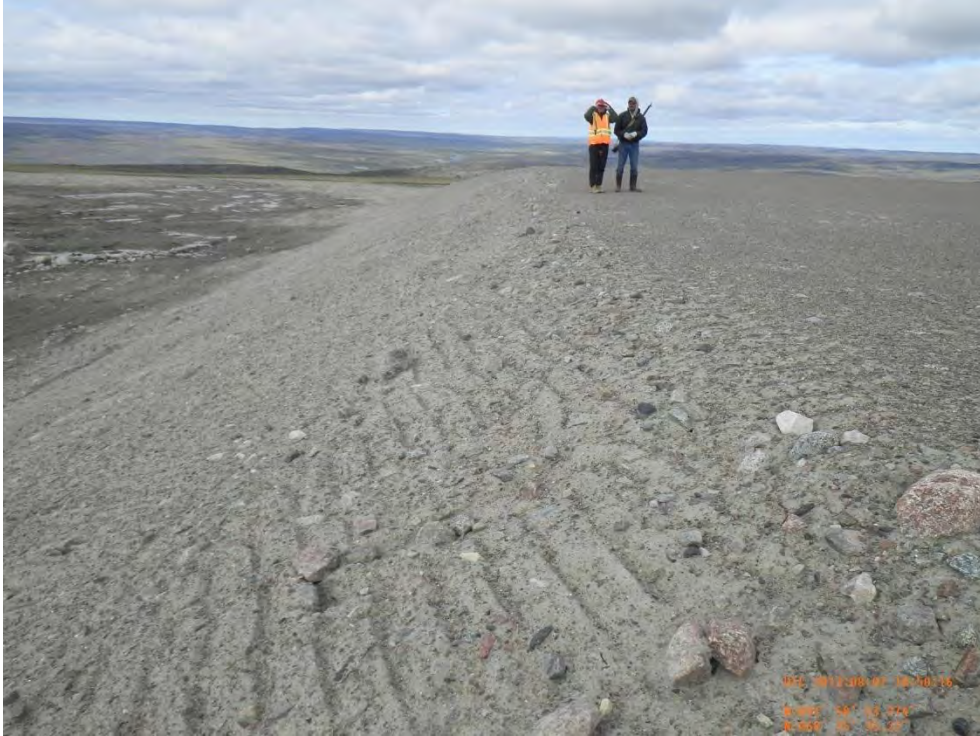
West side of the SSDF from the Southwest corner. Viewpoint 35 (Figure A-2; Appendix A). Photograph reference RIMG0035. Direction photo taken: N

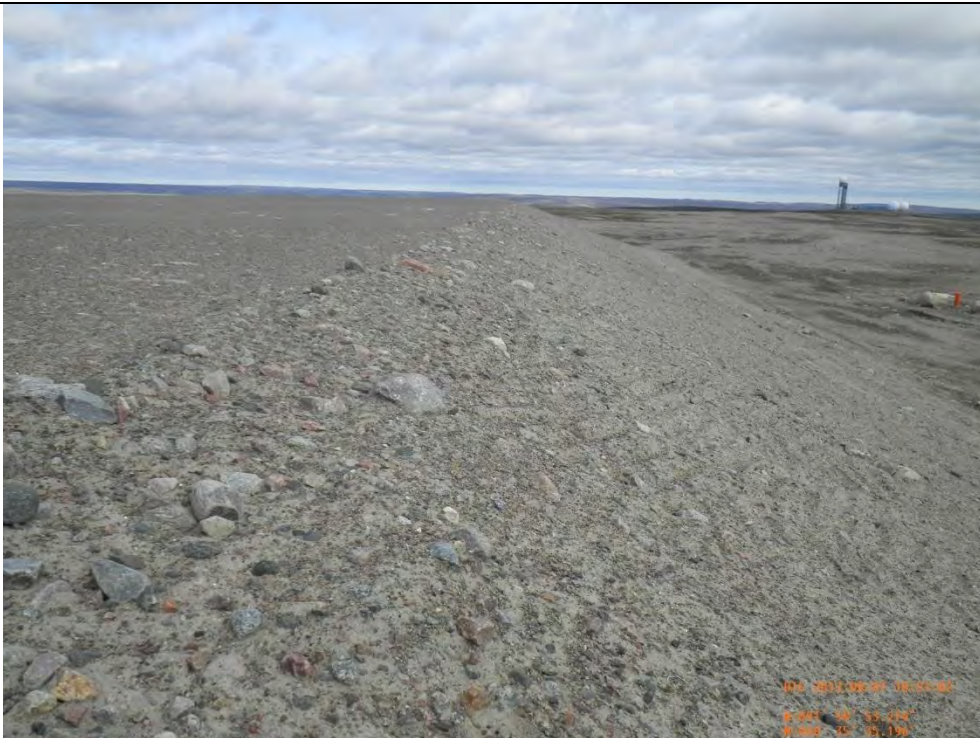
South side of the SSDF from the Southwest corner. Viewpoint 36 (Figure A-2; Appendix A). Photograph reference RIMG0036. Direction photo taken: E

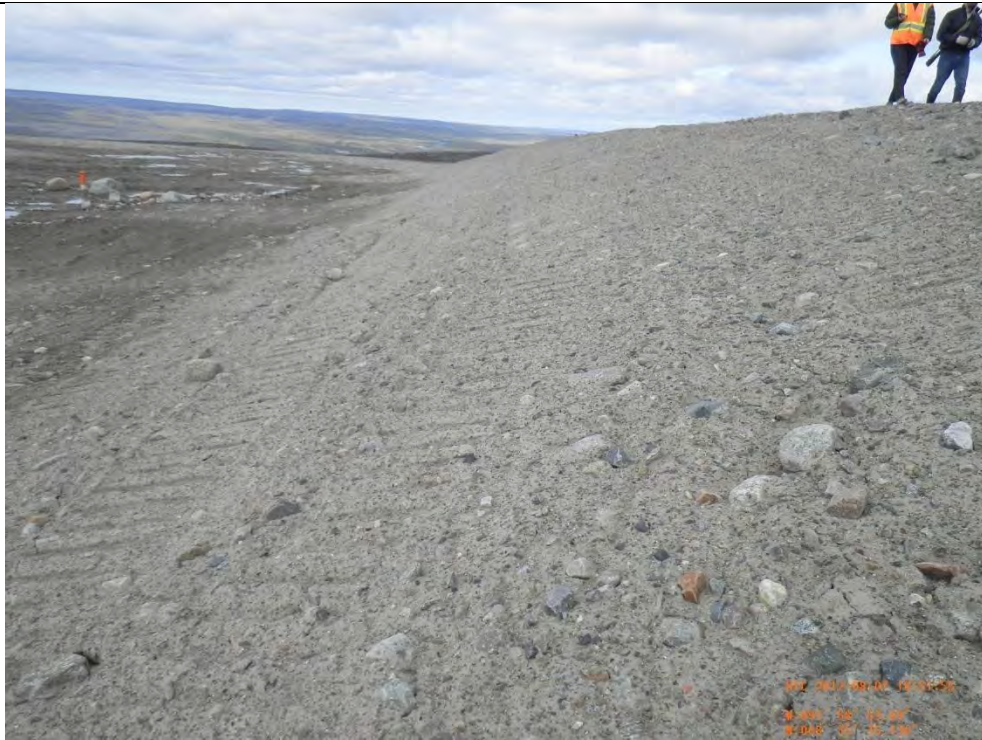
West side of the SSDF from the Southwest corner. Viewpoint 37 (Figure A-2; Appendix A). Photograph reference RIMG0037. Direction photo taken: N

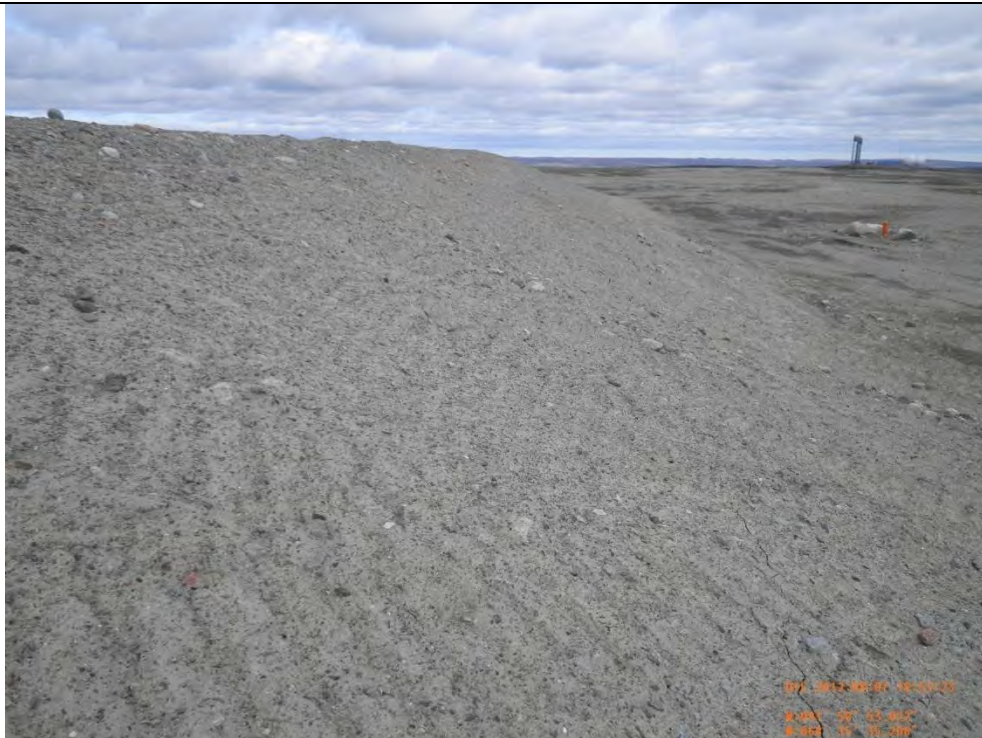
South side of the SSDF from the Southwest corner. Viewpoint 38 (Figure A-2; Appendix A). Photograph reference RIMG0038. Direction photo taken: E

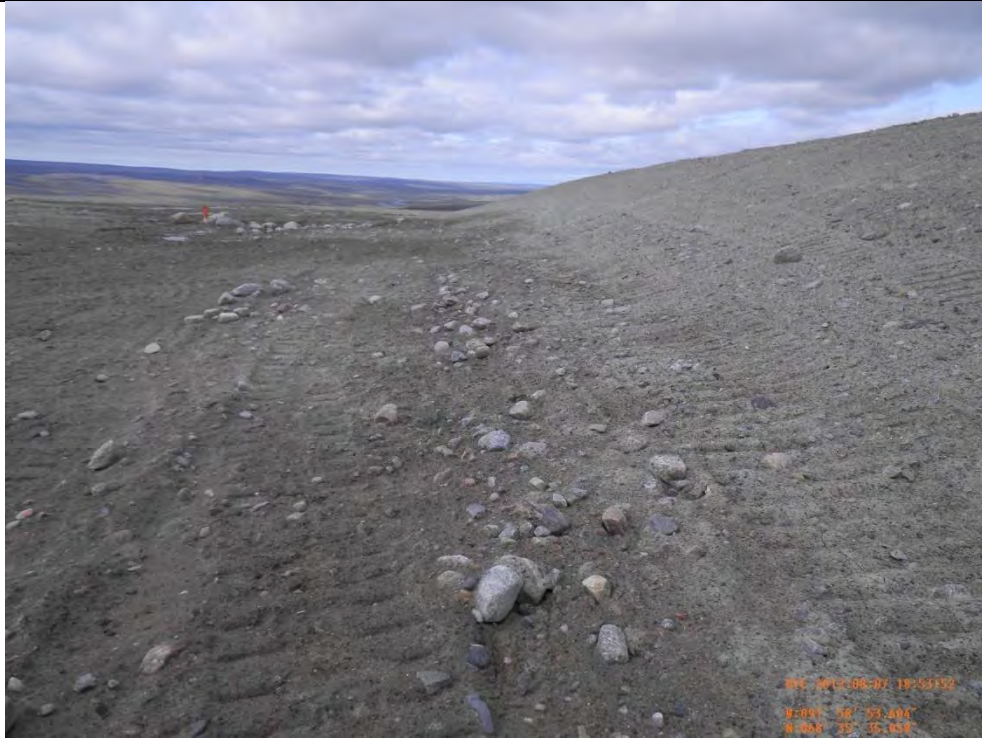
West side of the SSDF from the Southwest corner. Viewpoint 39 (Figure A-2; Appendix A). Photograph reference RIMG0039. Direction photo taken: N

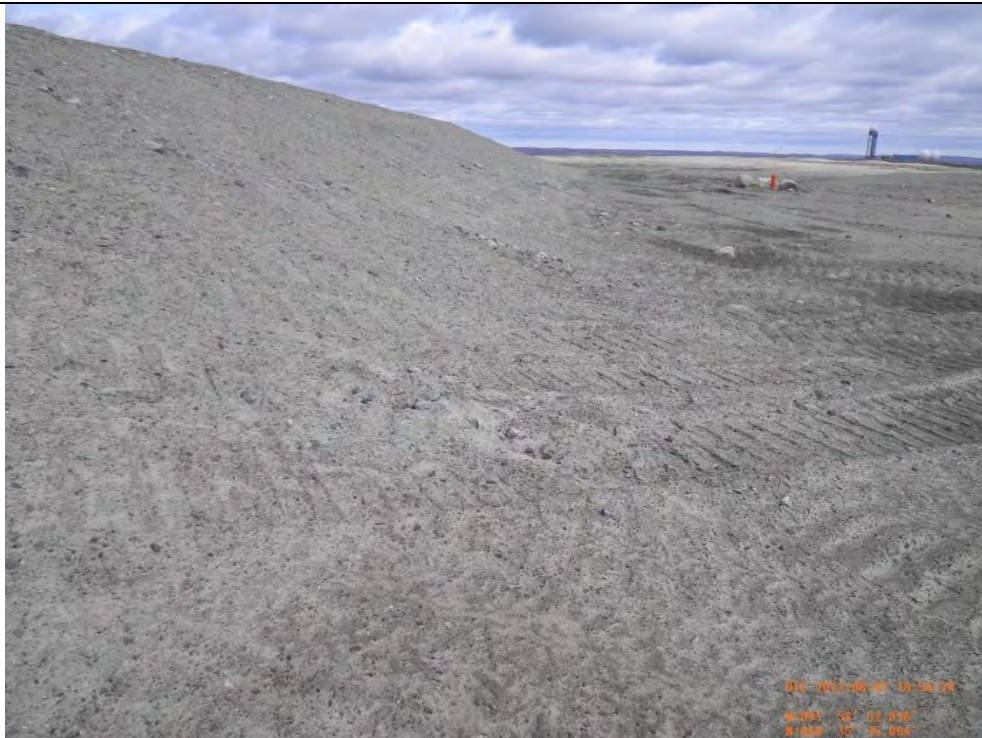
South side of the SSDF from the Southwest corner. Viewpoint 40 (Figure A-2; Appendix A). Photograph reference RIMG0040. Direction photo taken: E

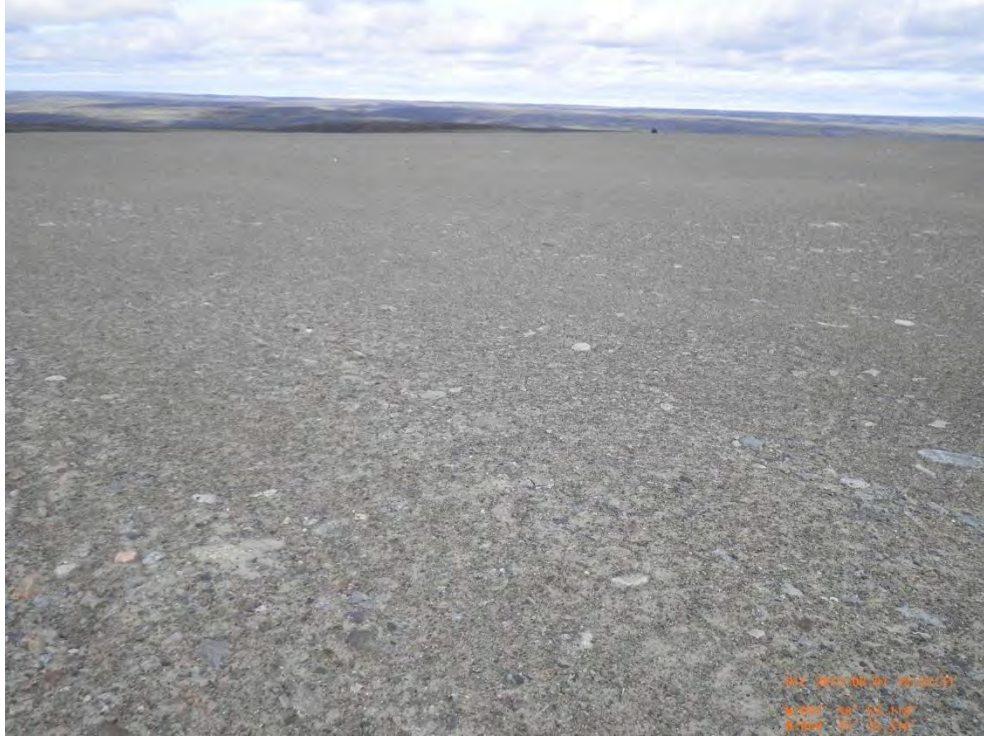
Top of the SSDF from the Southwest corner. Viewpoint 41 (Figure A-2; Appendix A). Photograph reference RIMG0041. Direction photo taken: NE

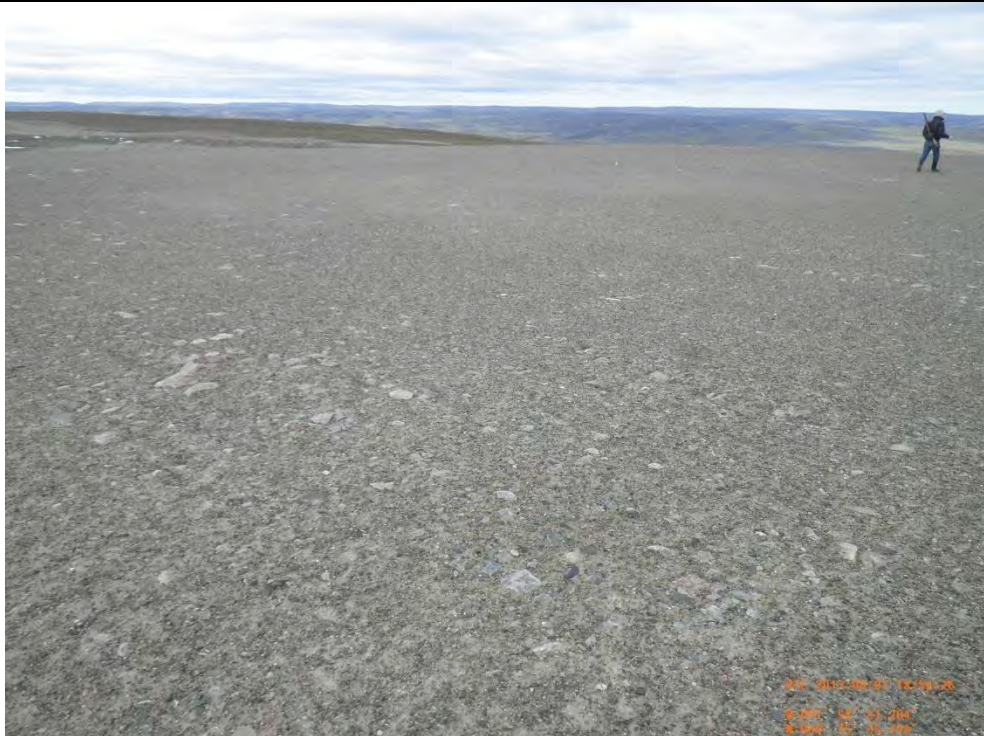
Top of the SSDF from the Southeast corner. Viewpoint 42 (Figure A-2; Appendix A). Photograph reference RIMG0042. Direction photo taken: NW

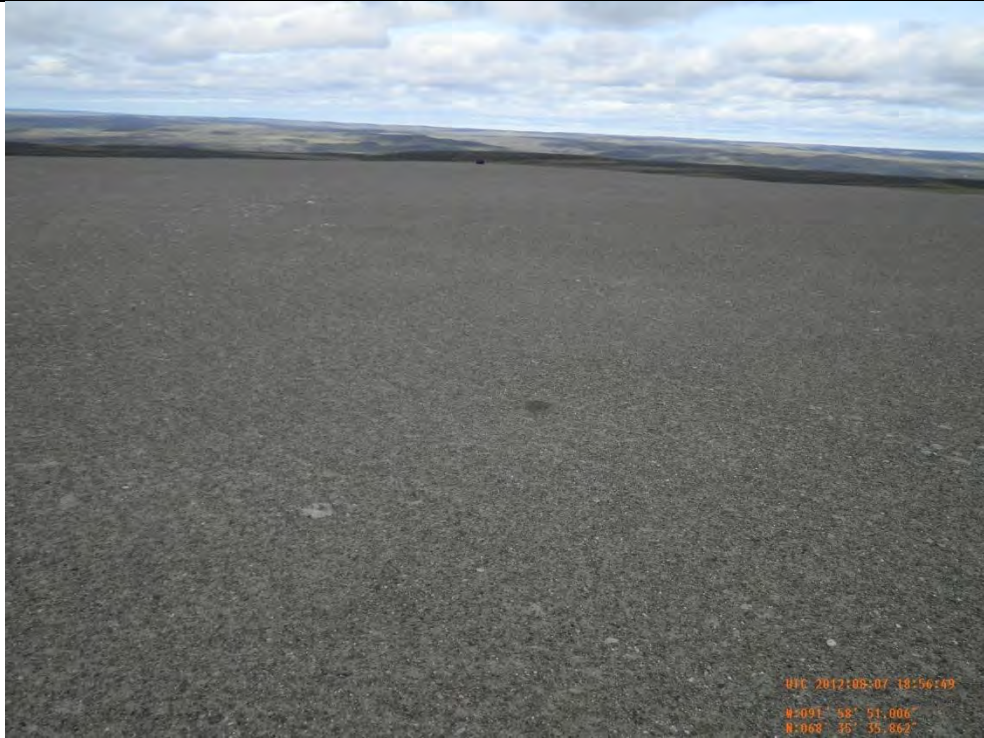
Top of the SSDF from the Northeast corner. Viewpoint 43 (Figure A-2; Appendix A). Photograph reference RIMG0043. Direction photo taken: SW

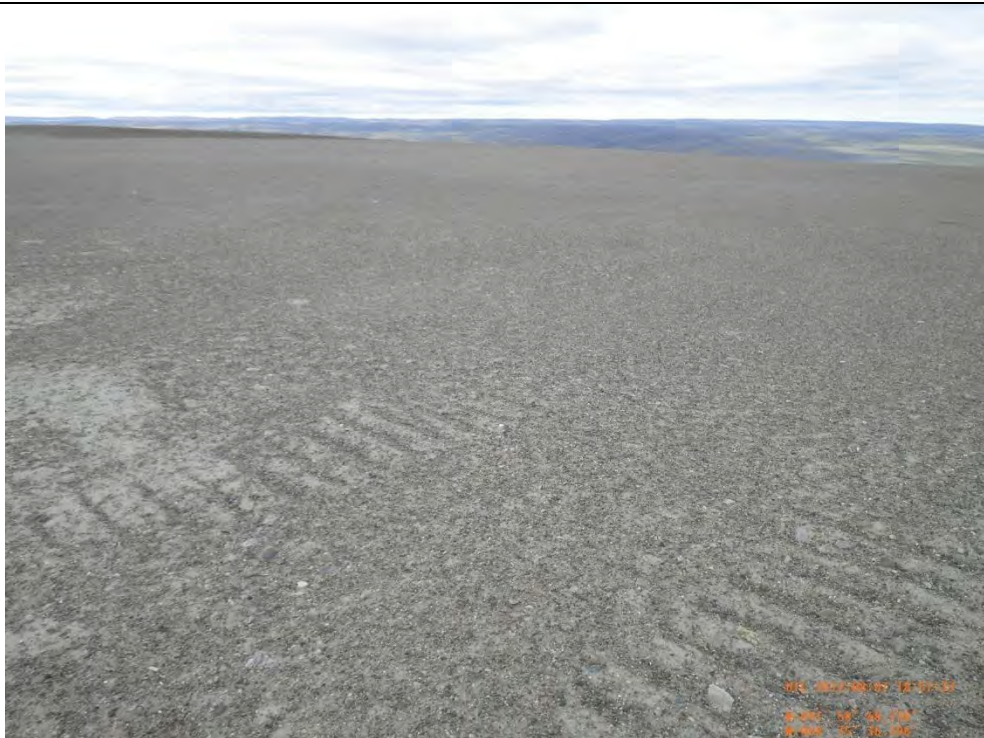
Top of the SSDF from the Northwest corner. Viewpoint 44 (Figure A-2; Appendix A). Photograph reference RIMG0044. Direction photo taken: SE

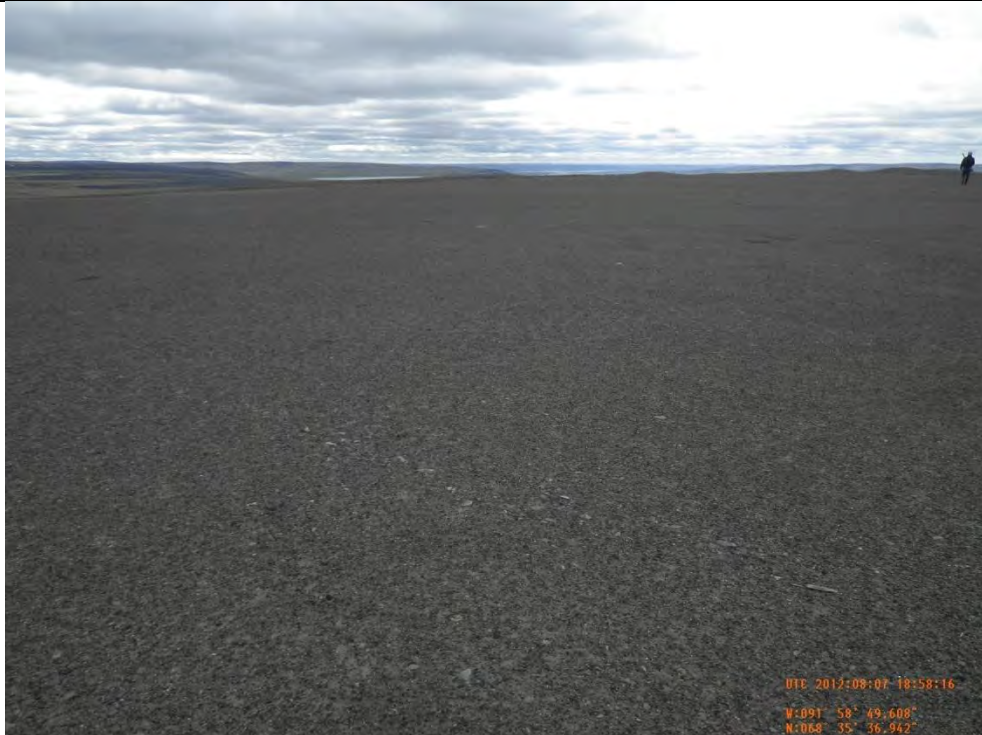
Top of the SSDF from the West side. Viewpoint 45 (Figure A-2; Appendix A). Photograph reference RIMG0045.
Direction photo taken: NE

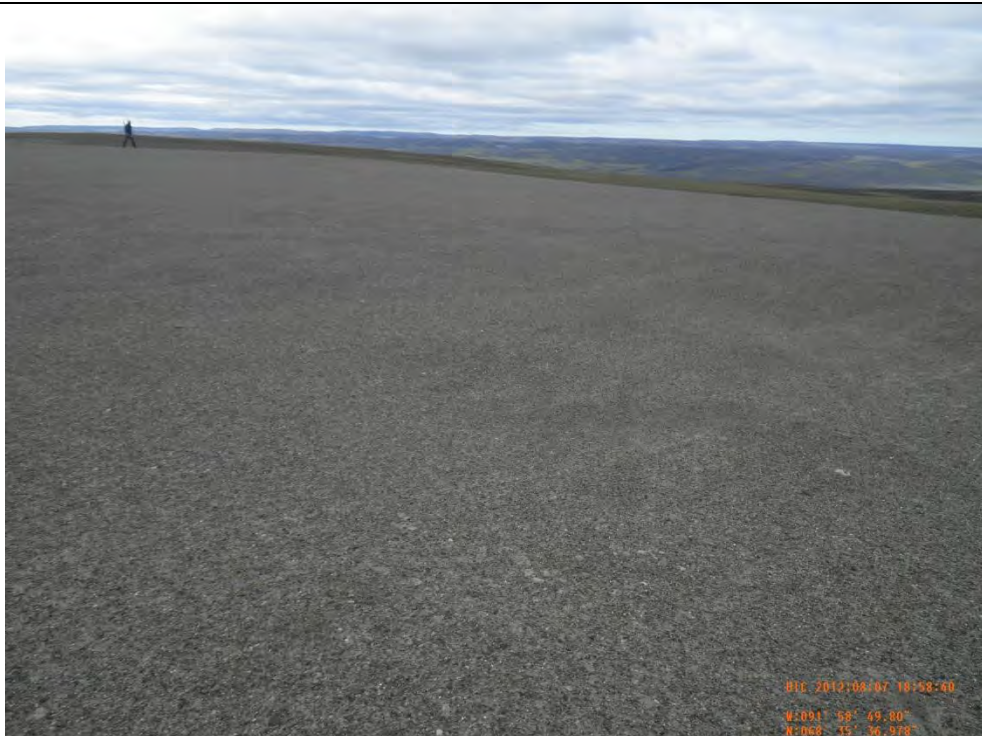
Top of the SSDF from the West side. Viewpoint 46 (Figure A-2; Appendix A). Photograph reference RIMG0046.
Direction photo taken: SE

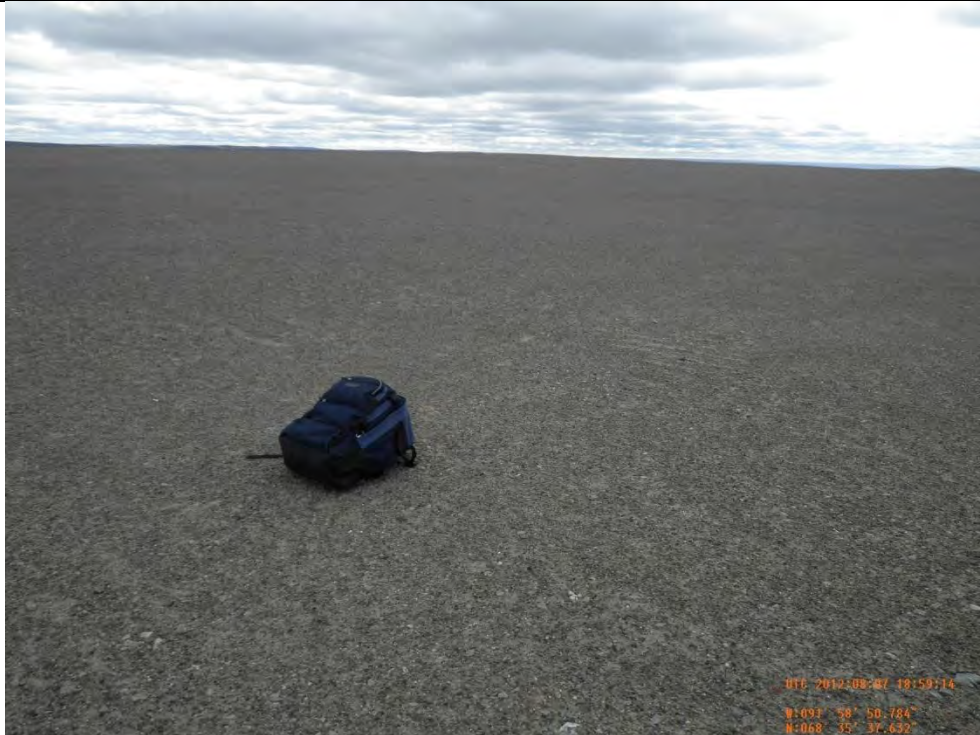
Top of the SSDF from the South side. Viewpoint 47 (Figure A-2; Appendix A). Photograph reference RIMG0047.
Direction photo taken: NW

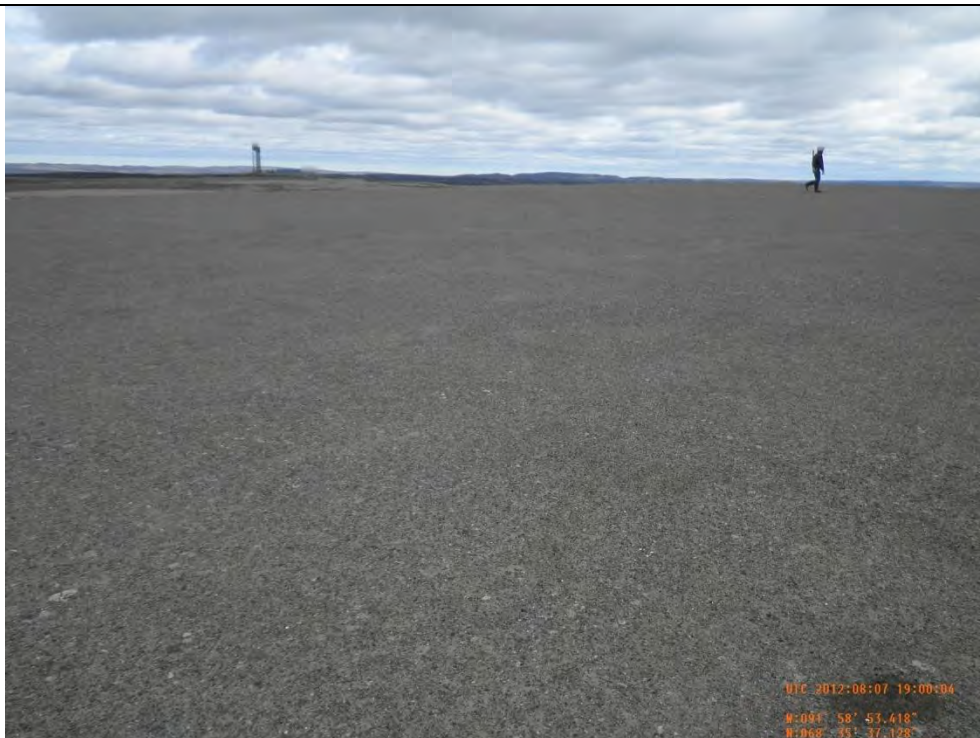
Top of the SSDF from the South side. Viewpoint 48 (Figure A-2; Appendix A). Photograph reference RIMG0048.
Direction photo taken: NE

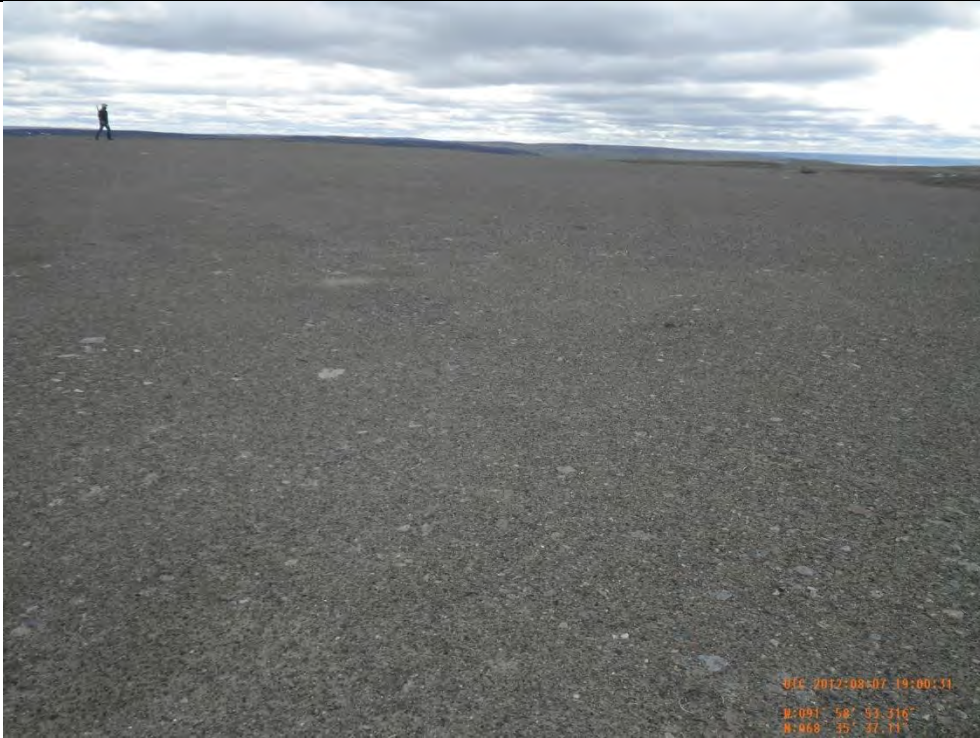
Top of the SSDF from the East side. Viewpoint 49 (Figure A-2; Appendix A). Photograph reference RIMG0049.
Direction photo taken: SW

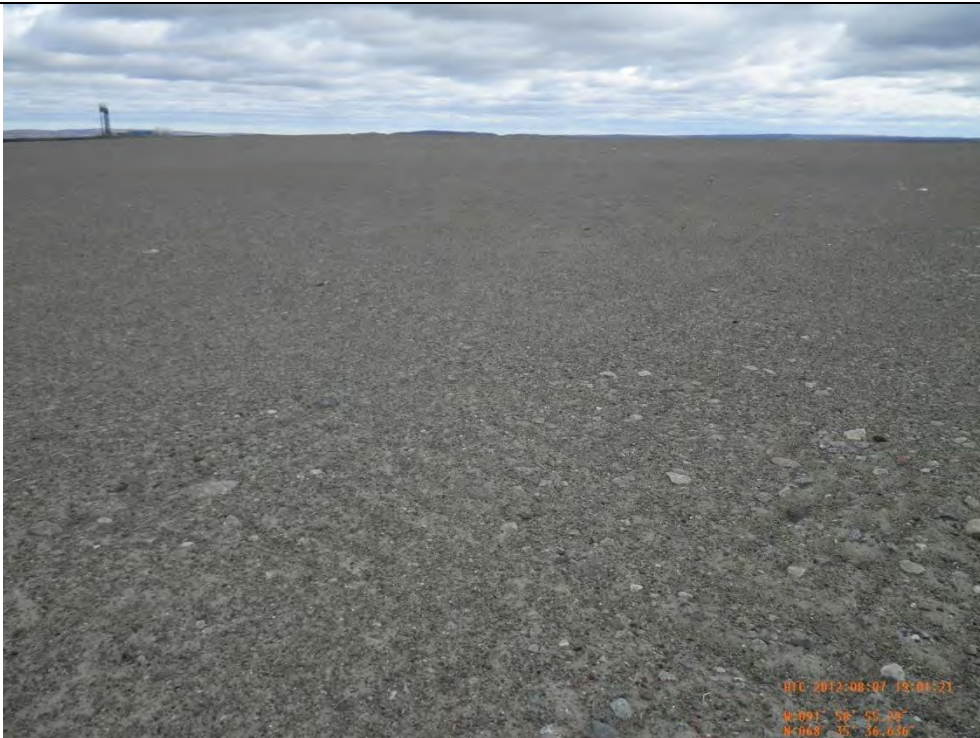
Top of the SSDF from the East side. Viewpoint 50 (Figure A-2; Appendix A). Photograph reference RIMG0050.
Direction photo taken: NW

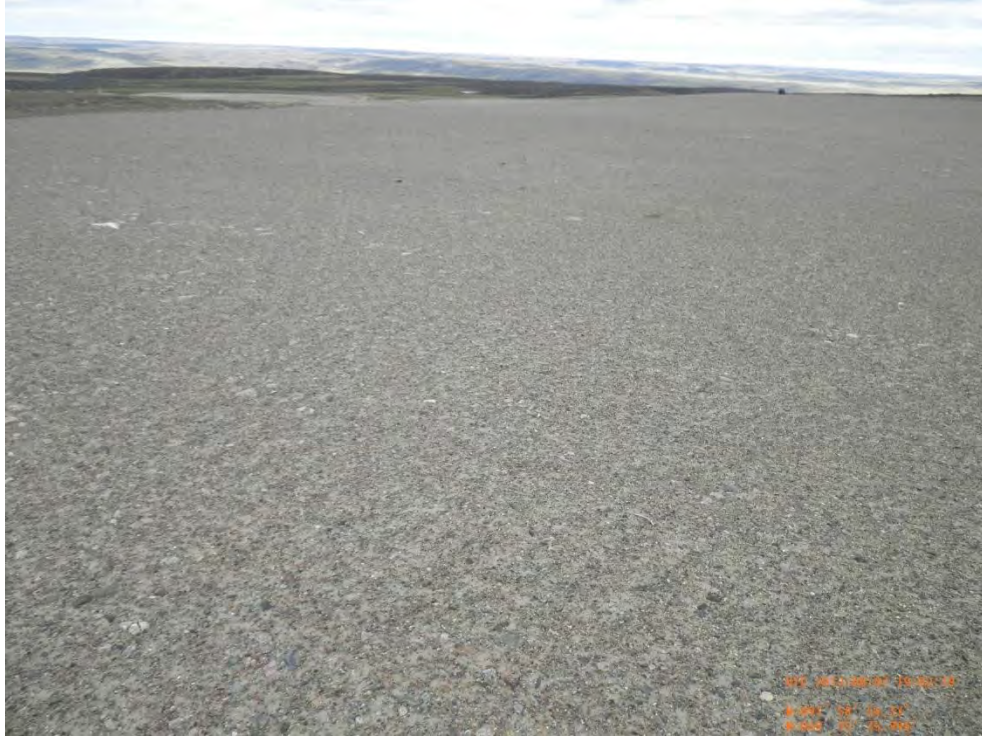
Top of the SSDF from the North side. Viewpoint 51 (Figure A-2; Appendix A). Photograph reference RIMG0051.
Direction photo taken: SE

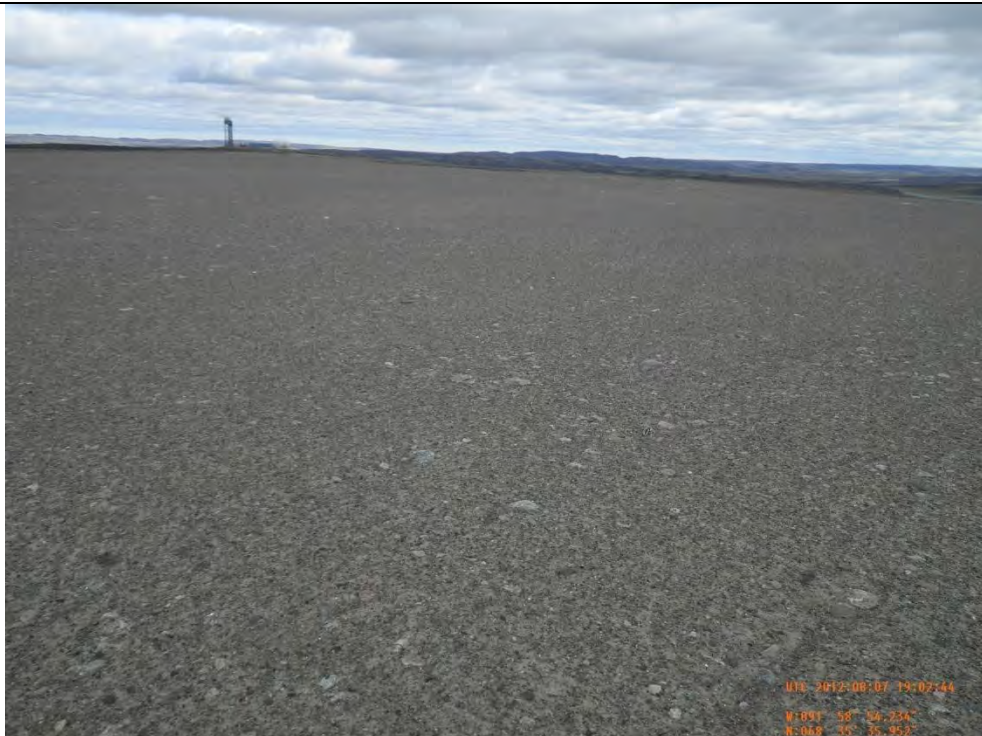
Top of the SSDF from the North side. Viewpoint 52 (Figure A-2; Appendix A). Photograph reference RIMG0052.
Direction photo taken: SW

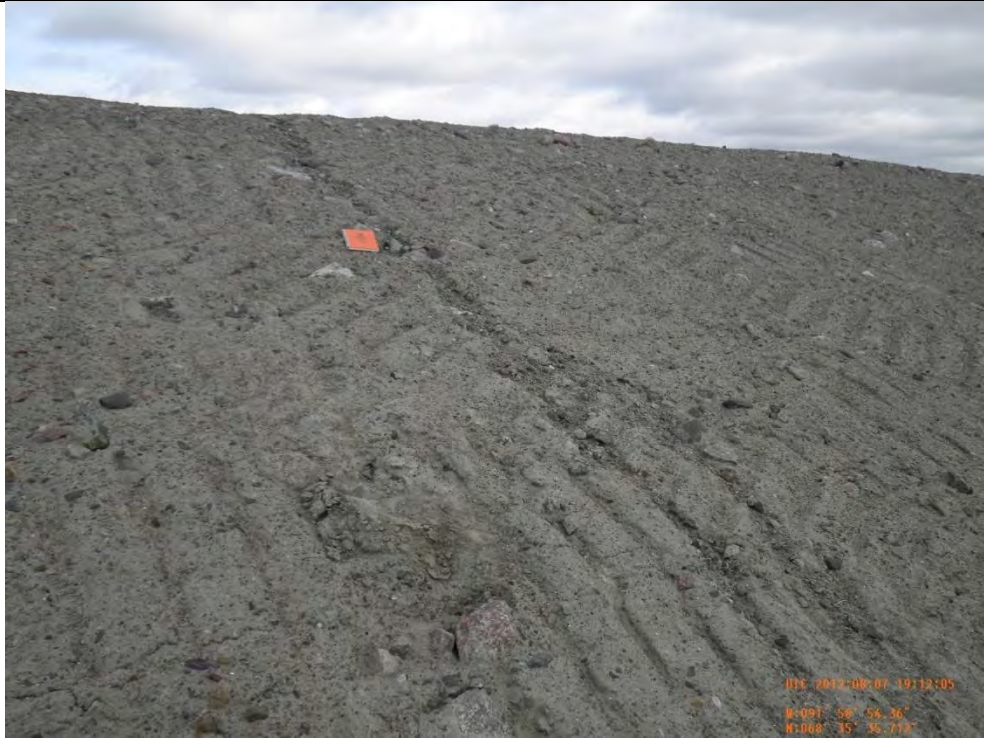
Cracking on West slope of SSDF. Viewpoint 53 (Figure A-2; Appendix A). Photograph reference RIMG0053.
Direction photo taken: E

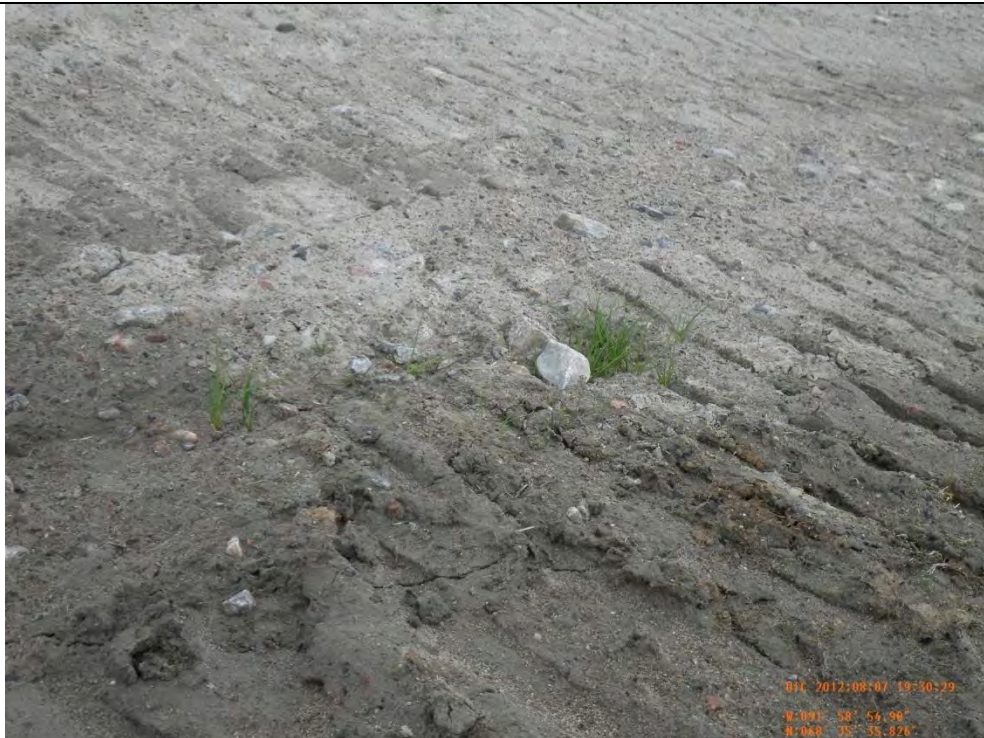
A lone area of vegetation (sedge grass) was observed to be taking root at the southwest toe of the NHWL; it is identified as feature B in Figure A-2, Appendix A, see Photo 54.

Edge of West slope of SSDF. Viewpoint 54 (Figure A-2; Appendix A). Photograph reference RIMG0054.
Direction photo taken: SE

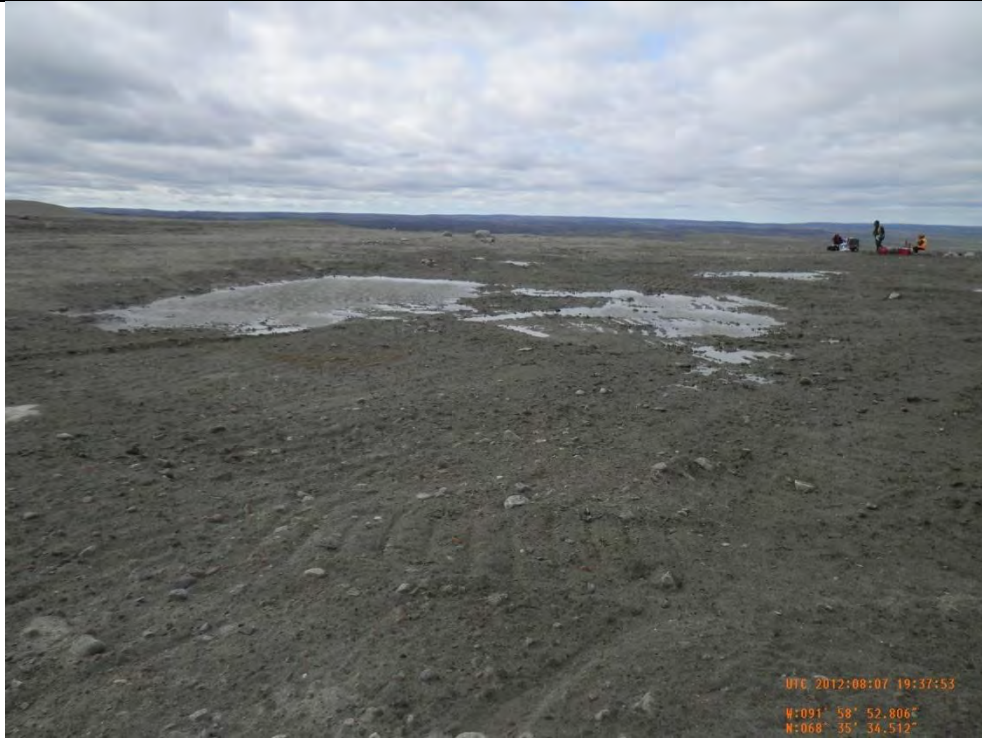
Two areas of ponded water were observed 5 m from southwest toe of the landfill; they did not contain any evidence of staining or product seepage from the landfill. Conditions at the site were generally wet due to recent rainfall, and many areas of saturated soil were observed around the NHWL at the ground surface.

Ponding at Southwest corner. Viewpoint 55 (Figure A-2; Appendix A). Photograph reference RIMG0055.
Direction photo taken: NW

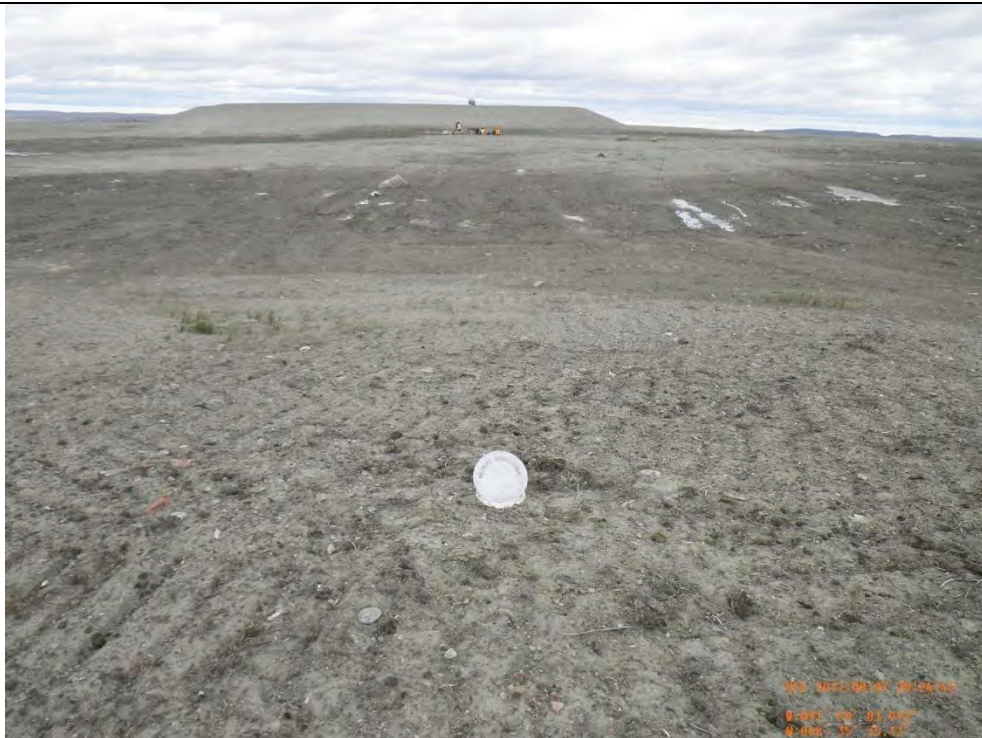
Monument. Viewpoint 56 (Figure A-2; Appendix A). Photograph reference RIMG0056.
Direction photo taken: E

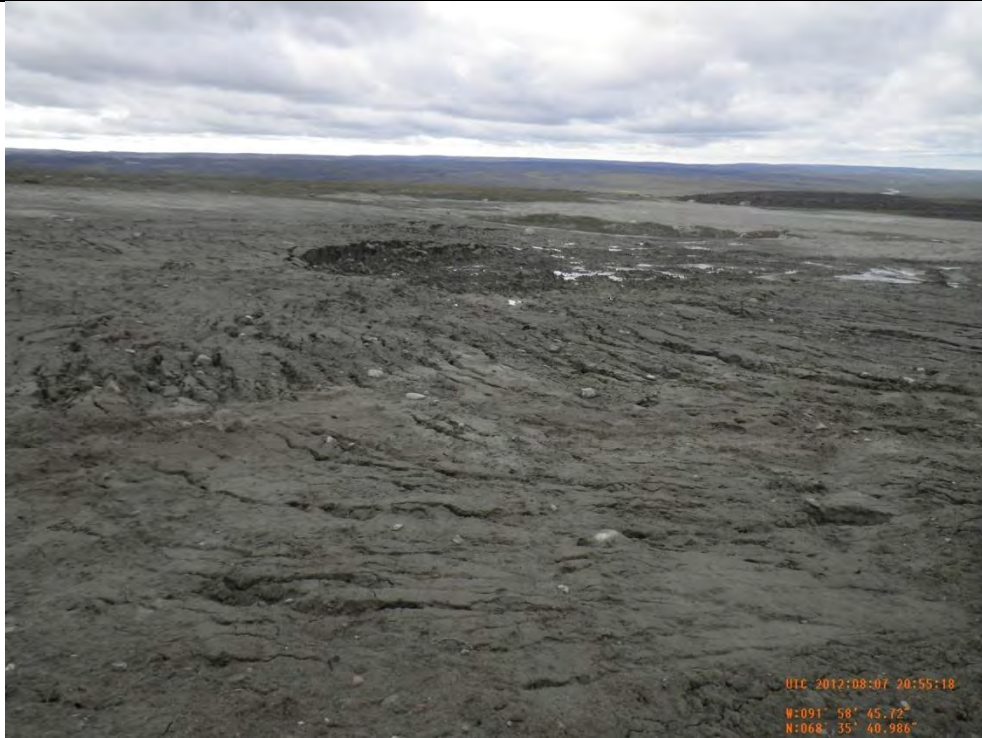
One small area along the west side of the landfill had evidence of erosion, a small erosion rill was observed and is likely due to preferential drainage and associated down-slope washing of fine-grained fill between cobbles and boulders. The south toe of the landfill remains unaffected.

Erosion feature. Viewpoint 57 (Figure A-2; Appendix A). Photograph reference RIMG0057.
Direction photo taken: SE

Based on the results of the first year of long-term monitoring, FRANZ recommends continued monitoring of the features identified, especially the small erosion rill along the southwest slope of NHWL (Feature A, Figure A-2, Appendix A) and the road from the airstrip to the NHWL.

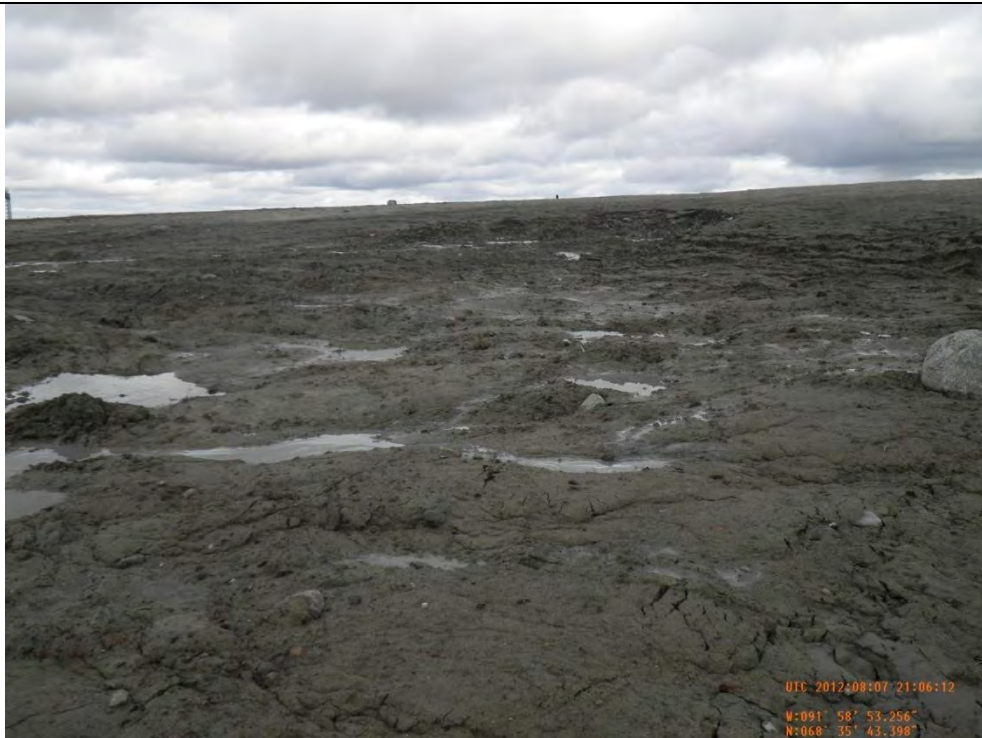
Erosion feature. Viewpoint 58 (Figure A-2; Appendix A). Photograph reference RIMG0058.
Direction photo taken: NW

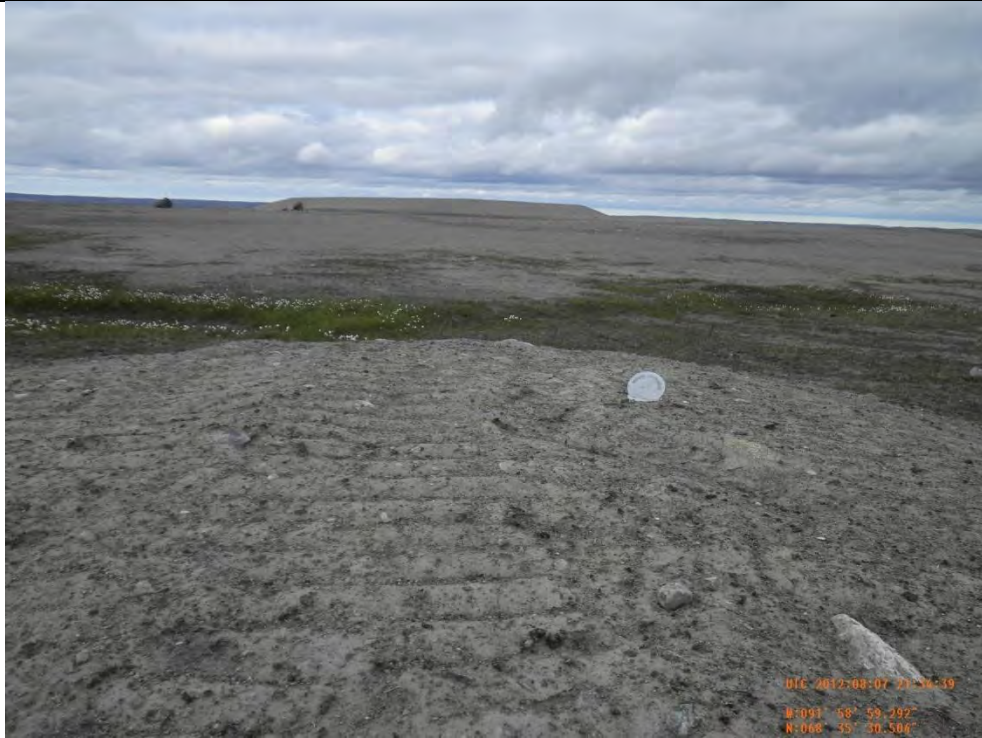
Monument. Viewpoint 59 (Figure A-2; Appendix A). Photograph reference RIMG0059.
Direction photo taken: E

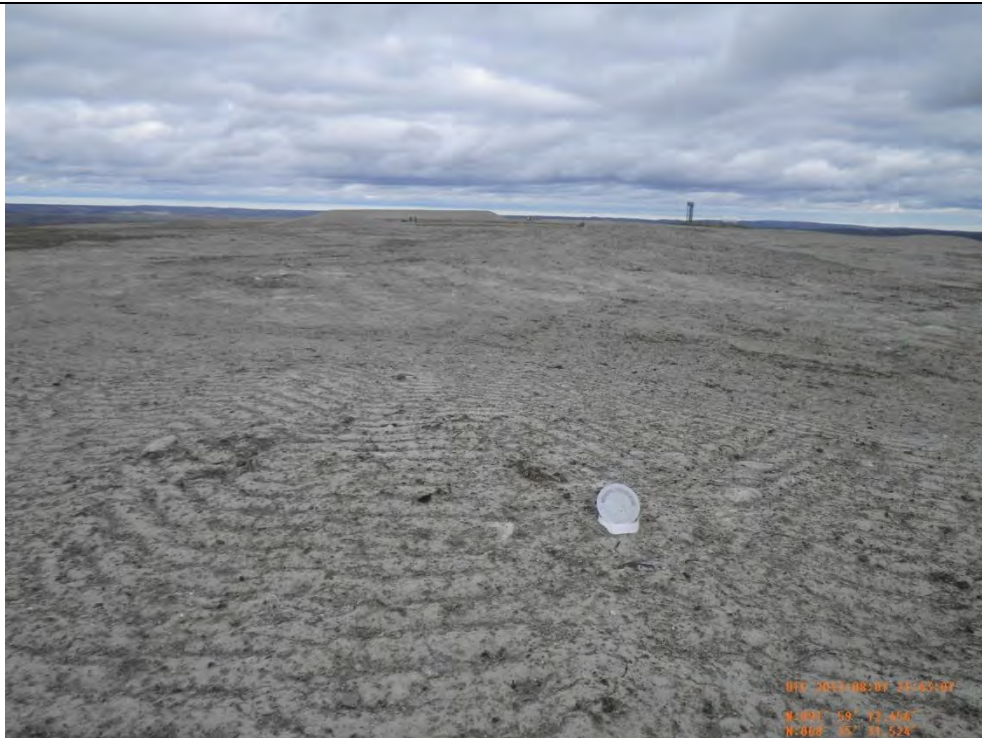
Monument. Viewpoint 60 (Figure A-2; Appendix A). Photograph reference RIMG0060.
Direction photo taken: E
