Long-Term Monitoring, 2014 CAM-D, Simpson Lake, Nunavut

FINAL REPORT

Project No. 1697-1401
March 13, 2015

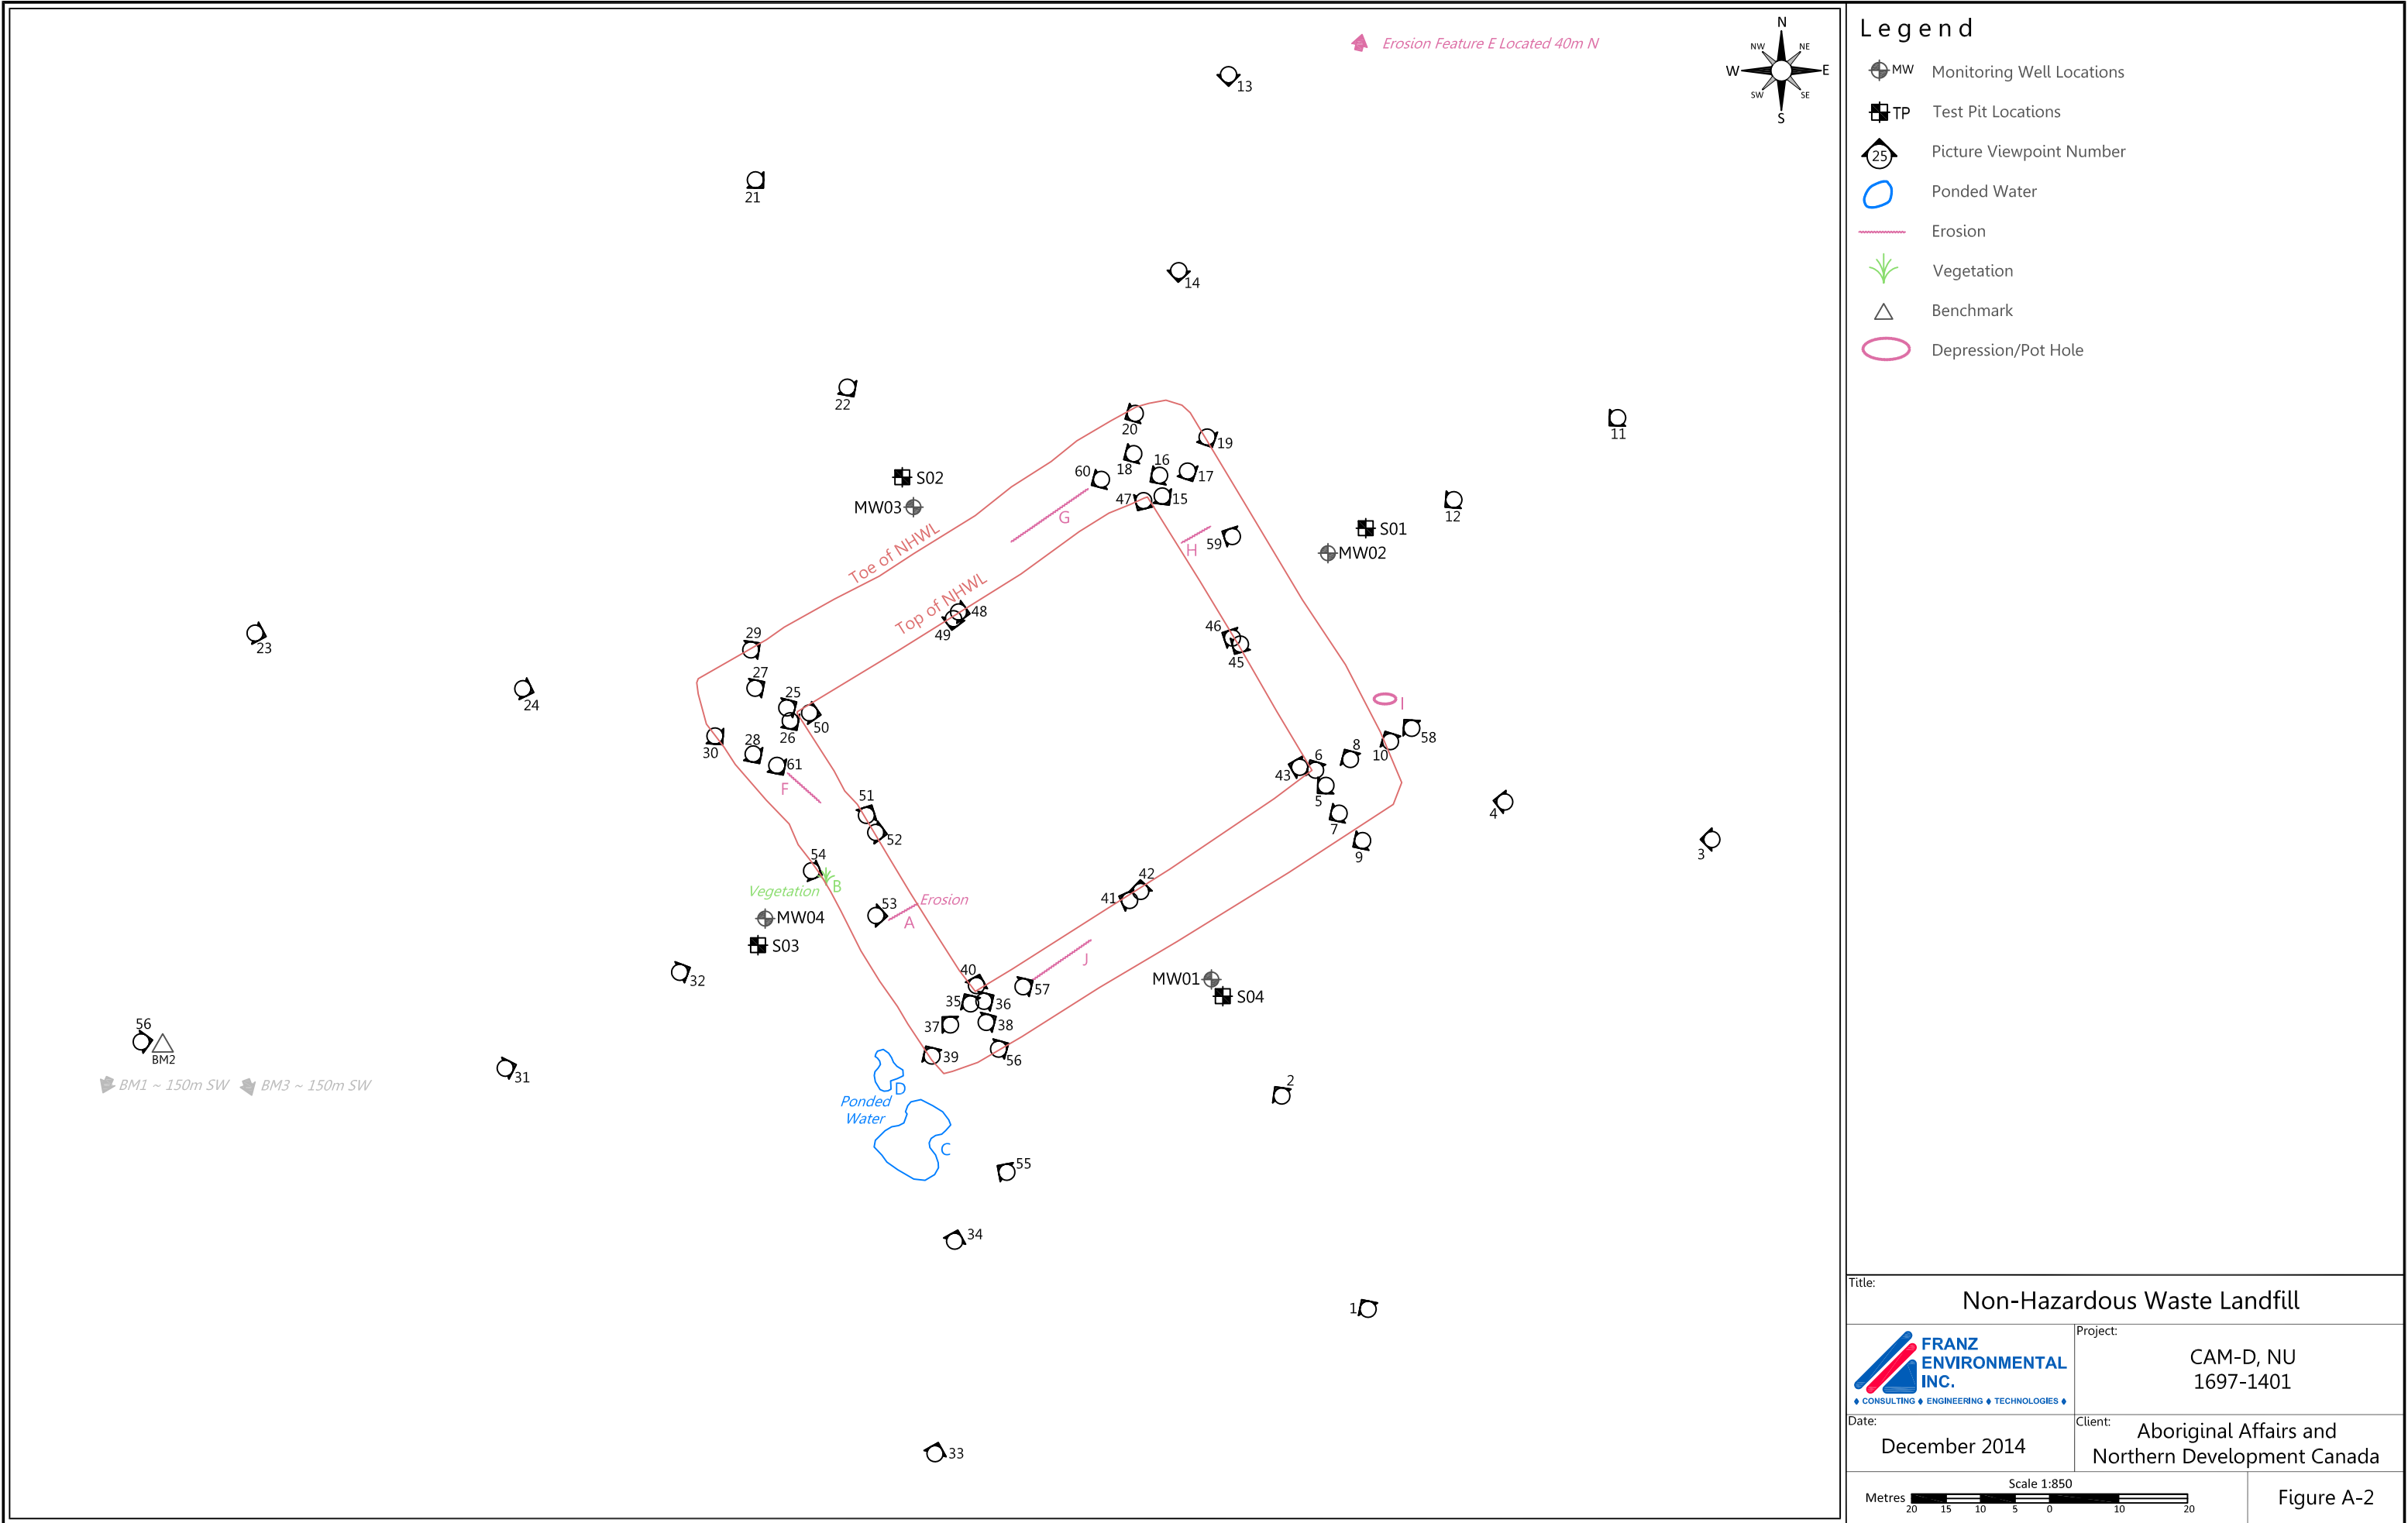
Figure A-2: Non-Hazardous Waste Landfill

A lone area of vegetation (sedge grass) was observed to be taking root at the southwest toe of the NHWL; it is identified as feature B in Figure A-2, Appendix A, see Photo 54.

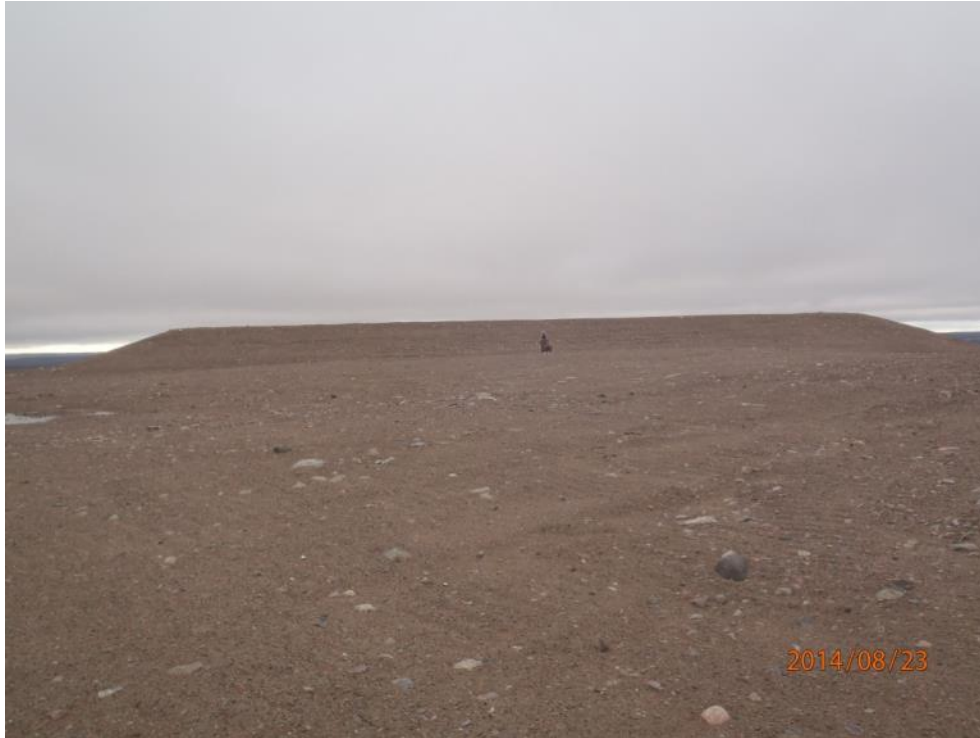
South side of the SSDF. Viewpoint 1 (Figure A-2; Appendix A). Photograph reference P8230001.
Direction photo taken: N

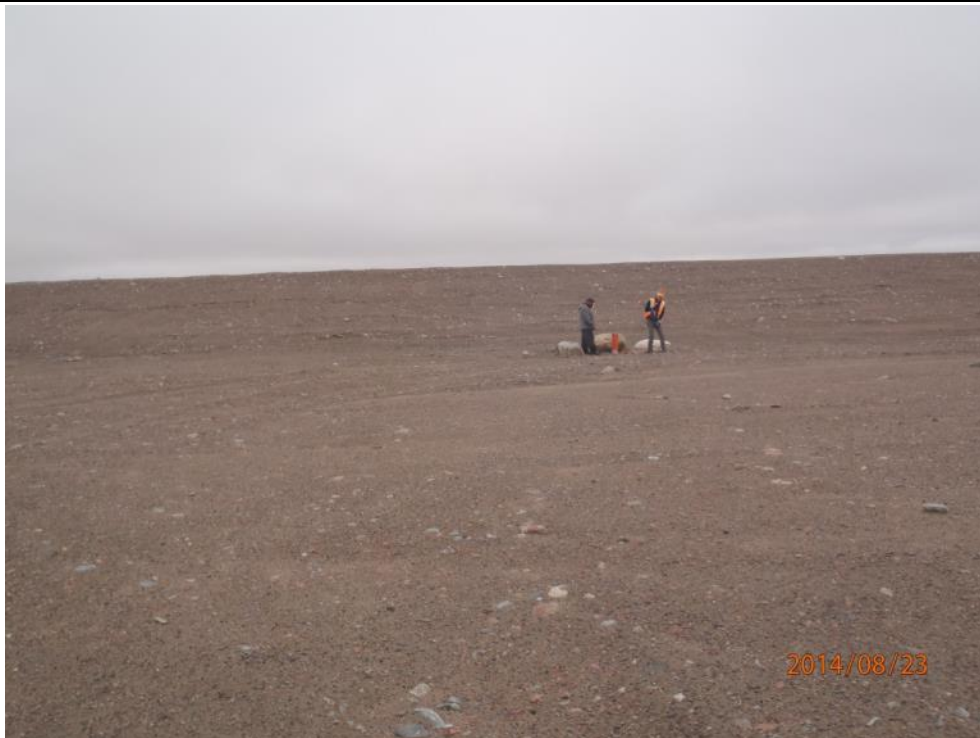
South side of the SSDF. Viewpoint 2 (Figure A-2; Appendix A). Photograph reference P8230002.
Direction photo taken: N

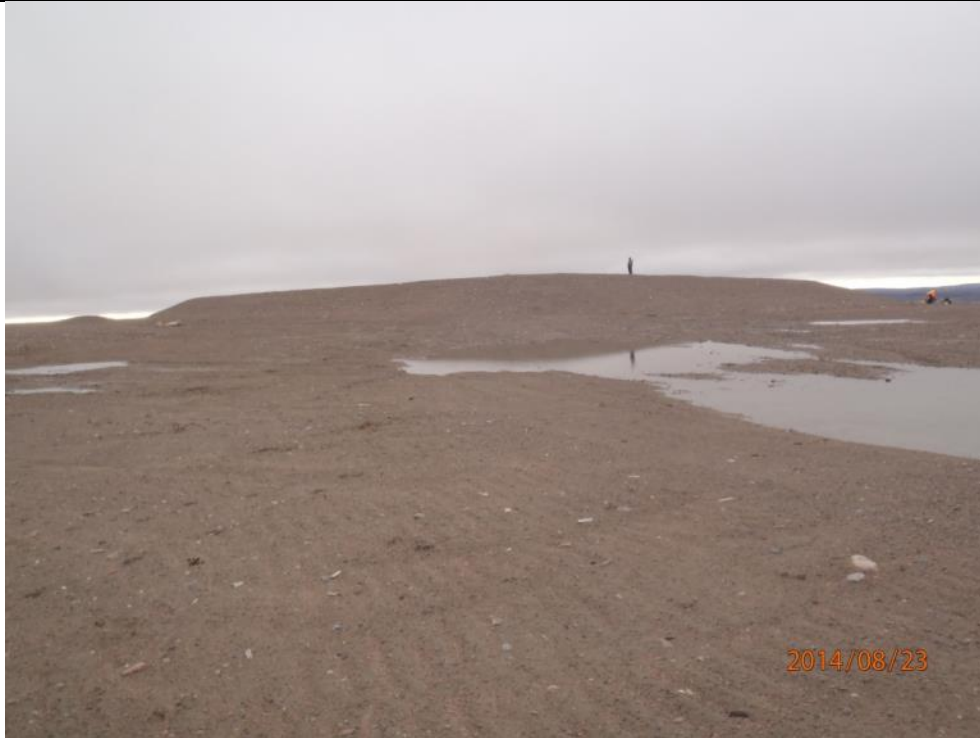
Southeast corner of the SSDF. Viewpoint 3 (Figure A-2; Appendix A). Photograph reference P8230003.
Direction photo taken: NW

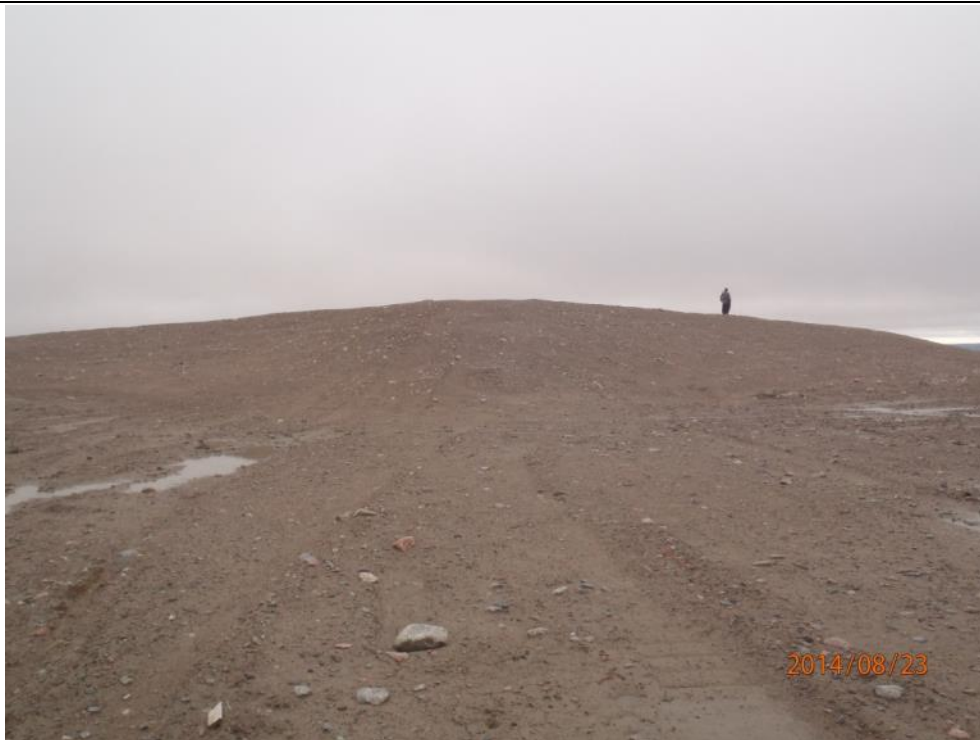
Southeast corner of the SSDF. Viewpoint 4 (Figure A-2; Appendix A). Photograph reference P8230004.
Direction photo taken: NW

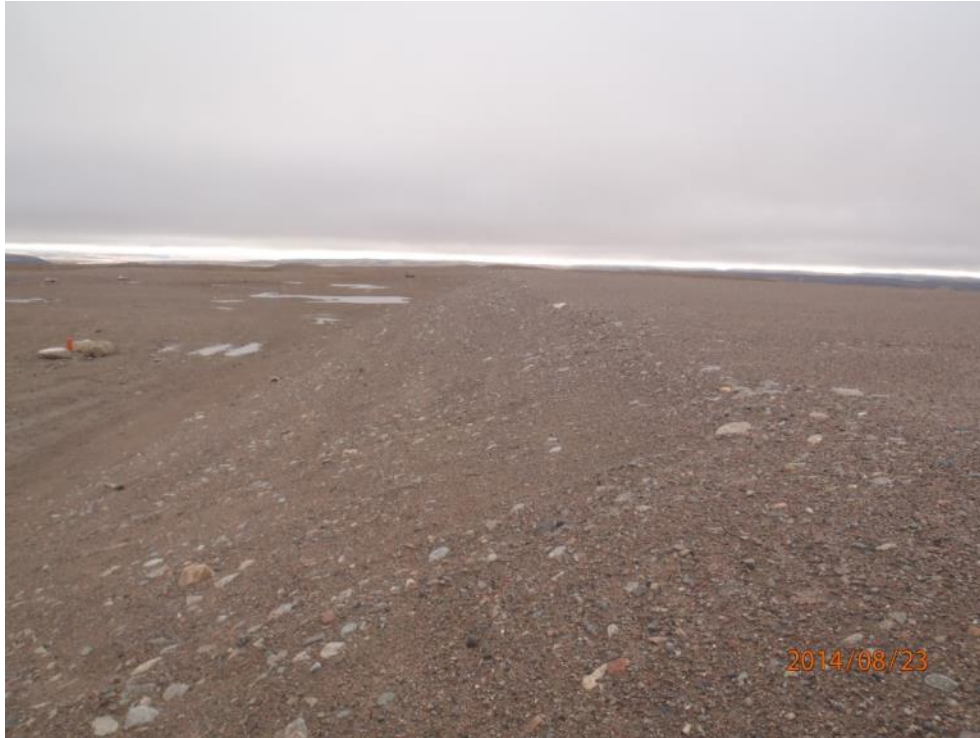
South side of the SSDF from the Southeast corner. Viewpoint 5 (Figure A-2; Appendix A). Photograph reference P8230005. Direction photo taken: W

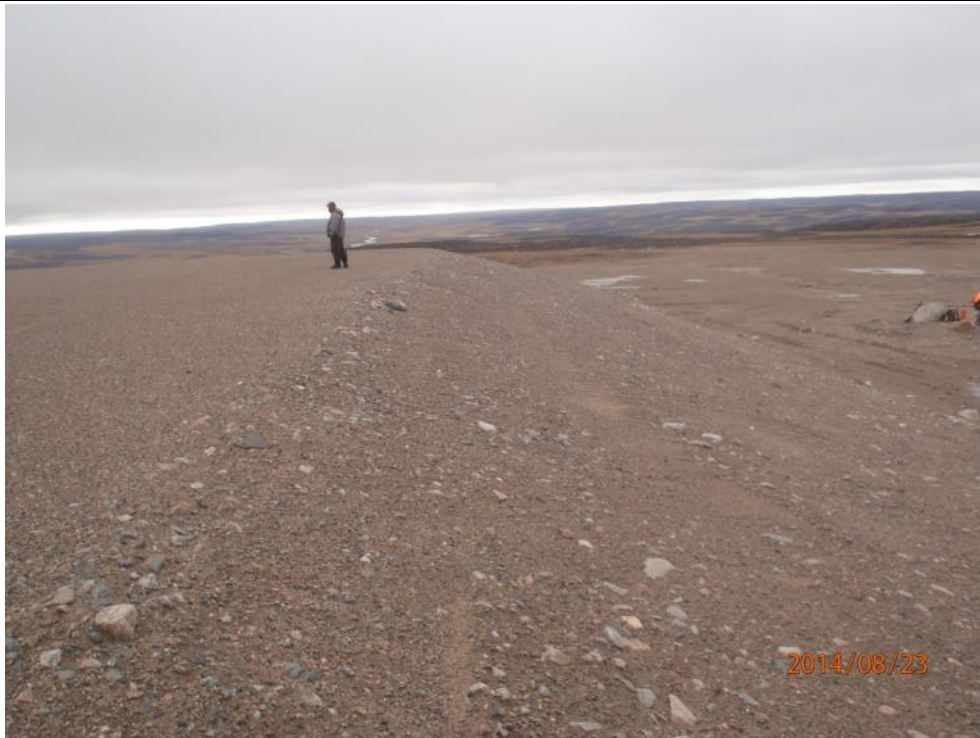
East side of the SSDF from the Southeast corner. Viewpoint 6 (Figure A-2; Appendix A). Photograph reference P8230006. Direction photo taken: N

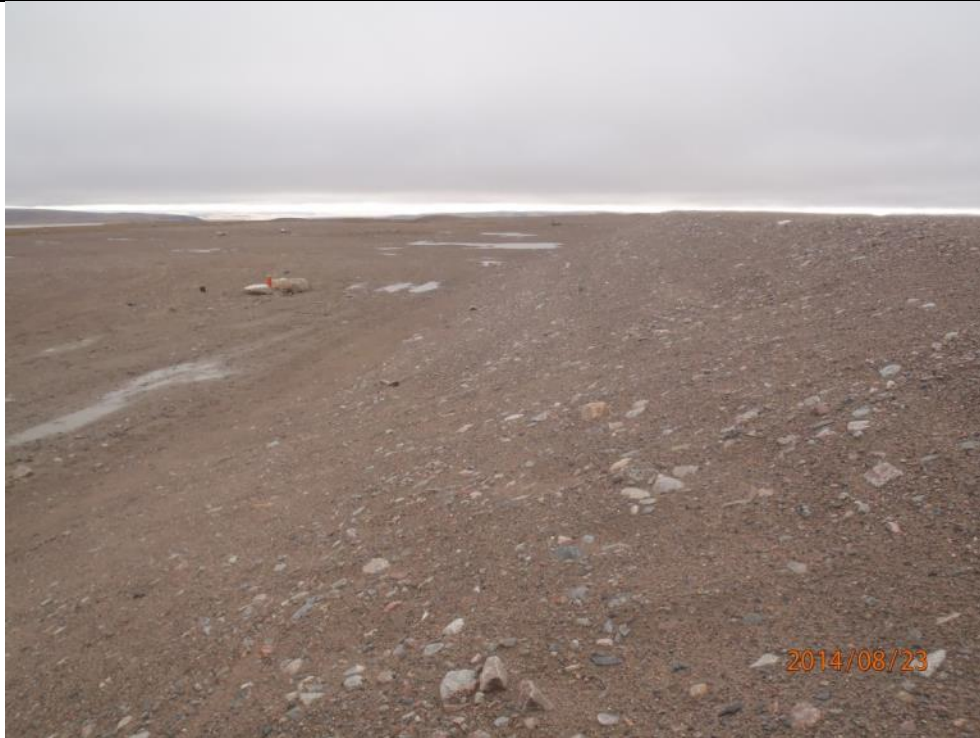
South side of the SSDF from the Southeast corner. Viewpoint 7 (Figure A-2; Appendix A). Photograph reference P8230007. Direction photo taken: W

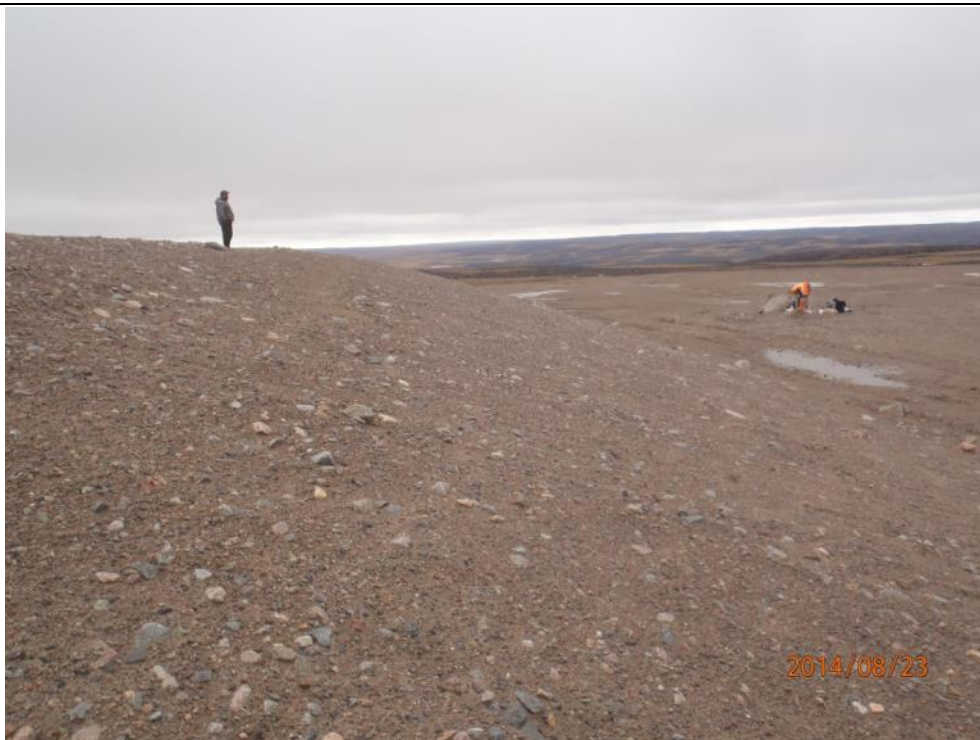
East side of the SSDF from the Southeast corner. Viewpoint 8 (Figure A-2; Appendix A). Photograph reference P8230008. Direction photo taken: N

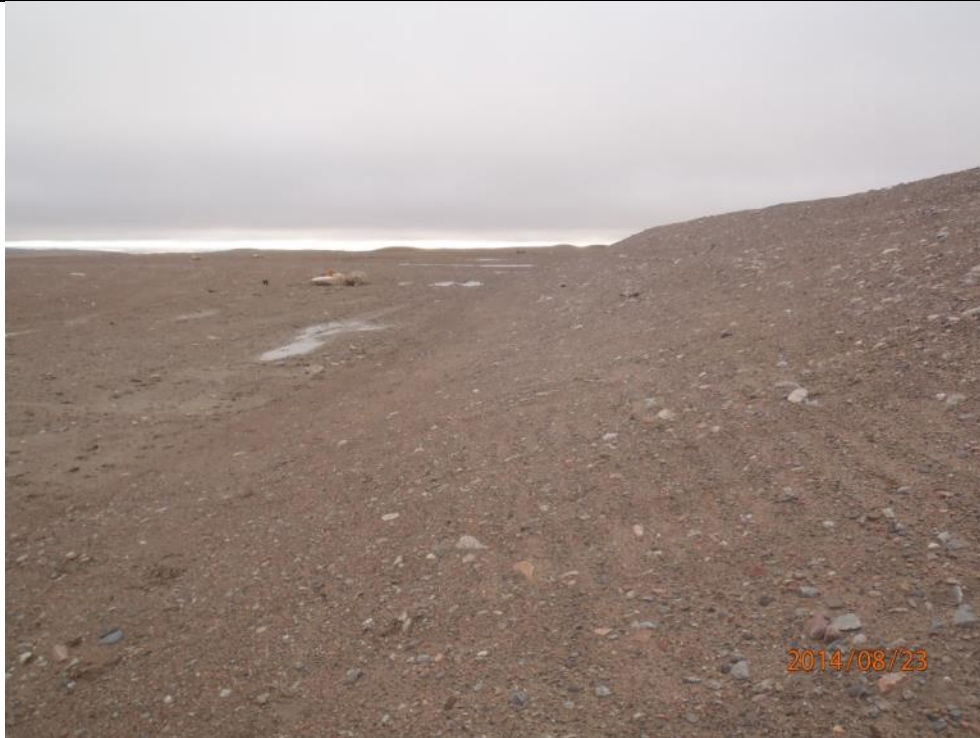
South side of the SSDF from the Southeast corner. Viewpoint 9 (Figure A-2; Appendix A). Photograph reference P8230009. Direction photo taken: W

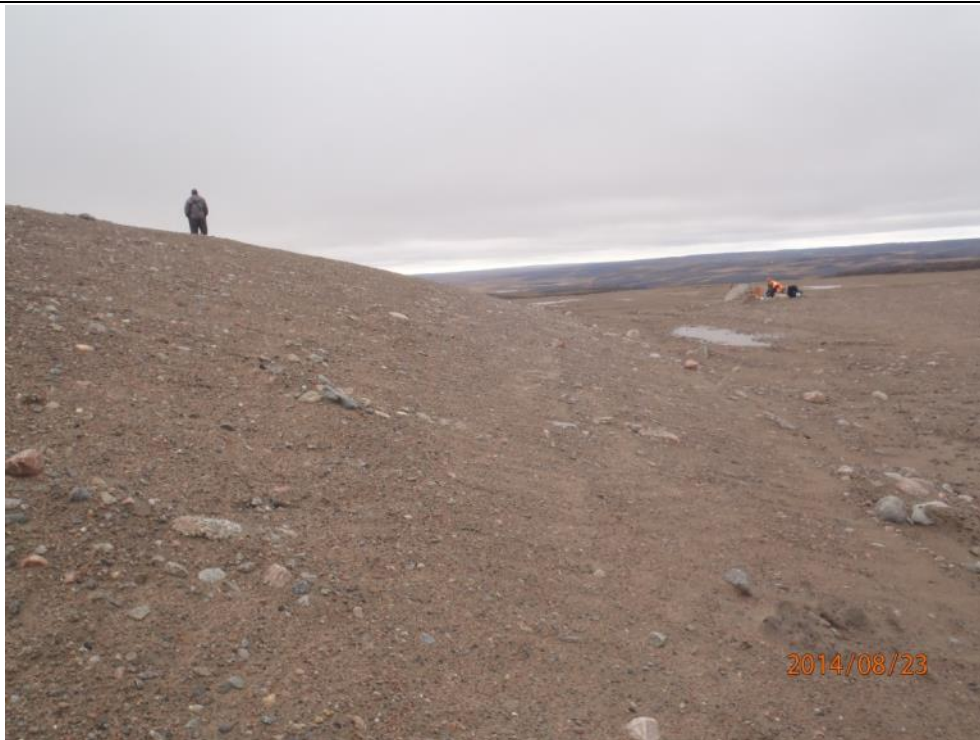
East side of the SSDF from the Southeast corner. Viewpoint 10 (Figure A-2; Appendix A). Photograph reference P8230010. Direction photo taken: N

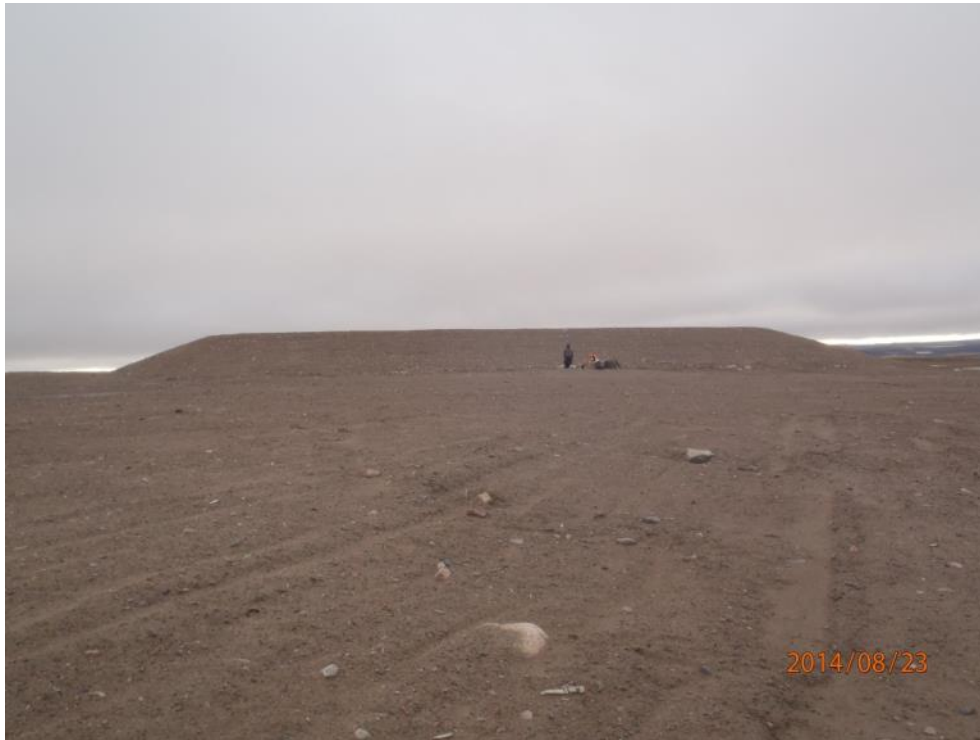
East side of the SSDF. Viewpoint 11 (Figure A-2; Appendix A). Photograph reference P8230011.
Direction photo taken: W

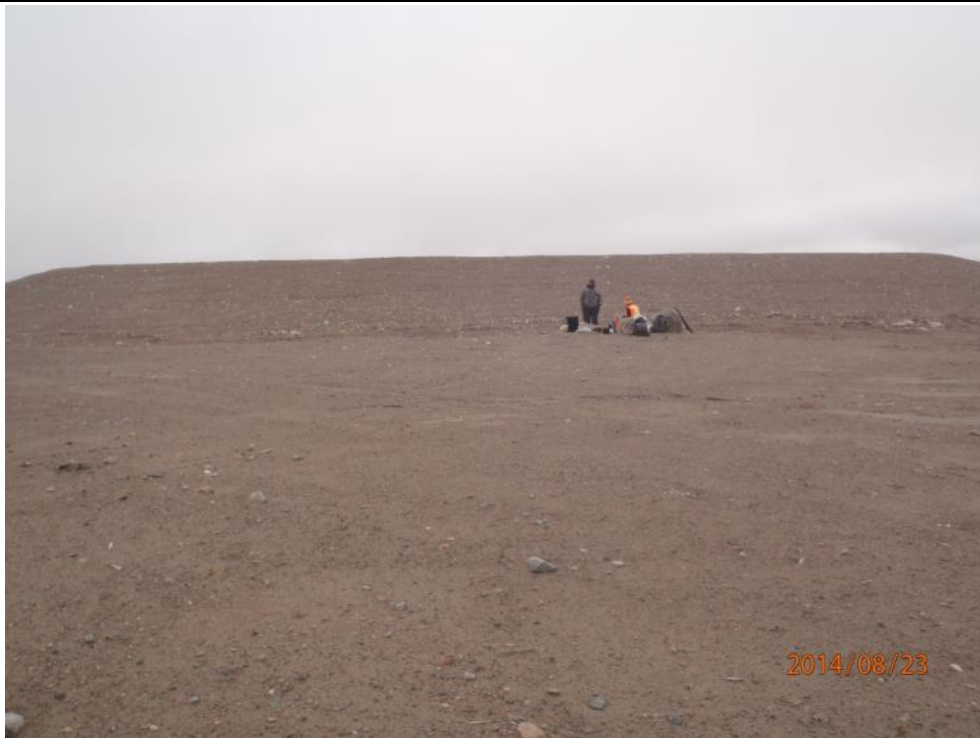
East side of the SSDF. Viewpoint 12 (Figure A-2; Appendix A). Photograph reference P8230012.
Direction photo taken: W

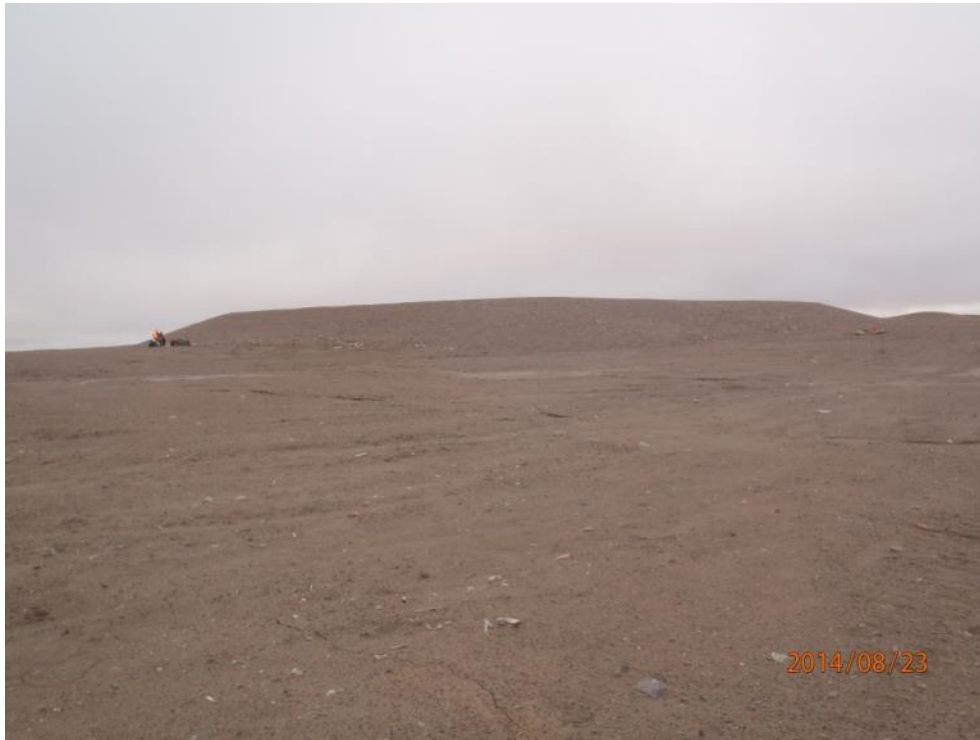
Northeast corner of the SSDF. Viewpoint 13 (Figure A-2; Appendix A). Photograph reference P8230013.
Direction photo taken: SW

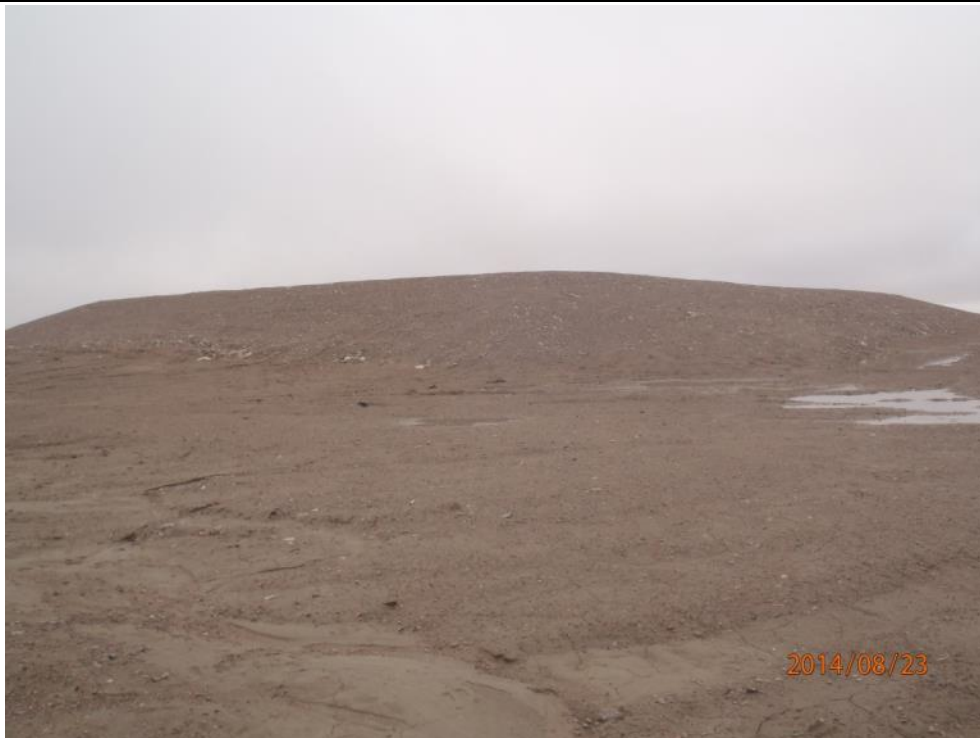
Northeast corner of the SSDF. Viewpoint 14 (Figure A-2; Appendix A). Photograph reference P8230014.
Direction photo taken: SW

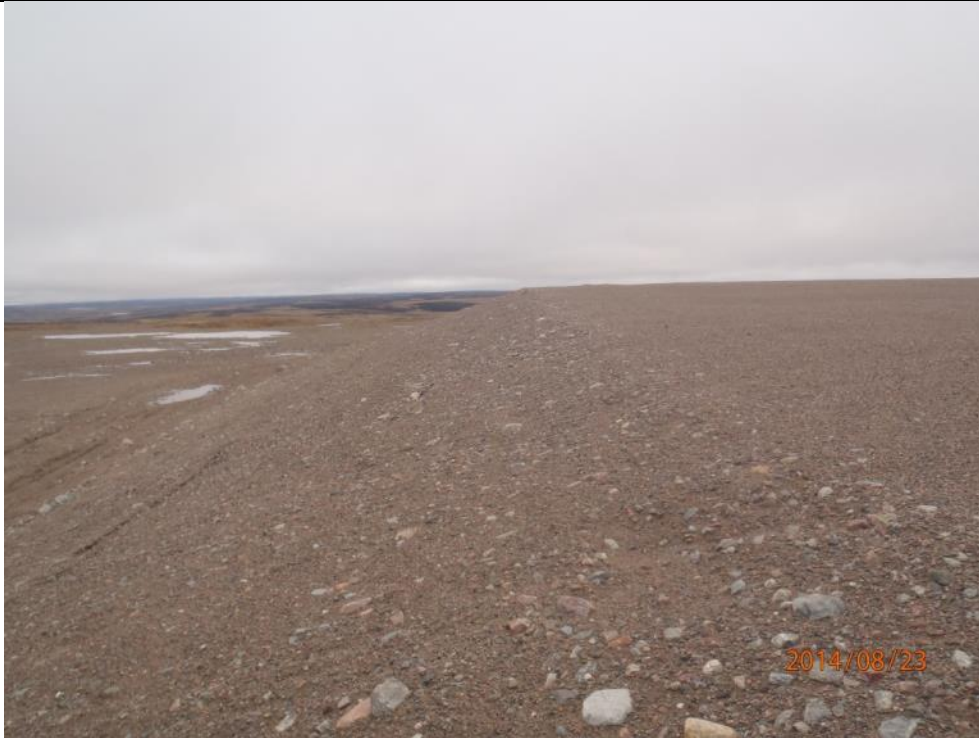
East side of the SSDF from the Northeast corner. Viewpoint 15 (Figure A-2; Appendix A). Photograph reference P8230015. Direction photo taken: S

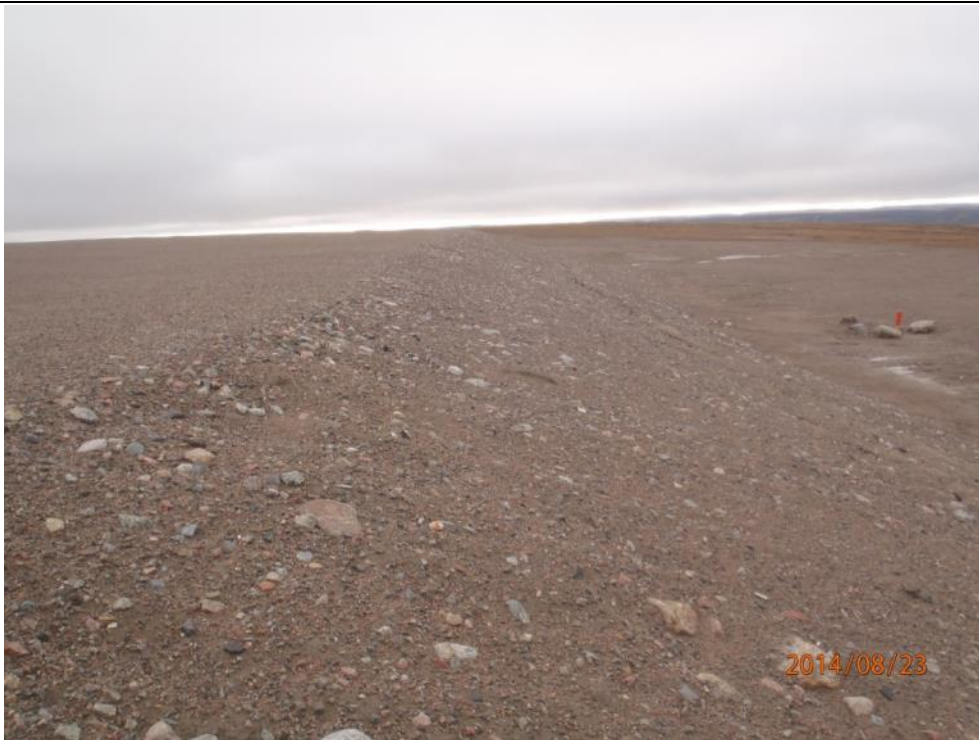
North side of the SSDF from the Northeast corner. Viewpoint 16 (Figure A-2; Appendix A). Photograph reference P8230016. Direction photo taken: W

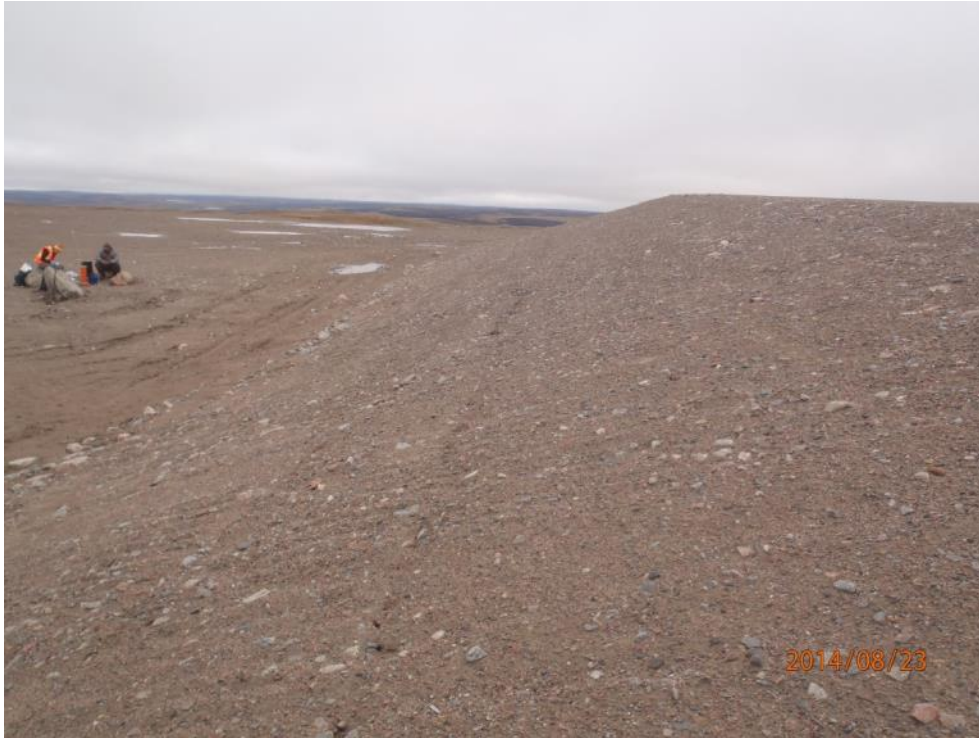
East side of the SSDF from the Northeast corner. Viewpoint 17 (Figure A-2; Appendix A). Photograph reference P8230017. Direction photo taken: S

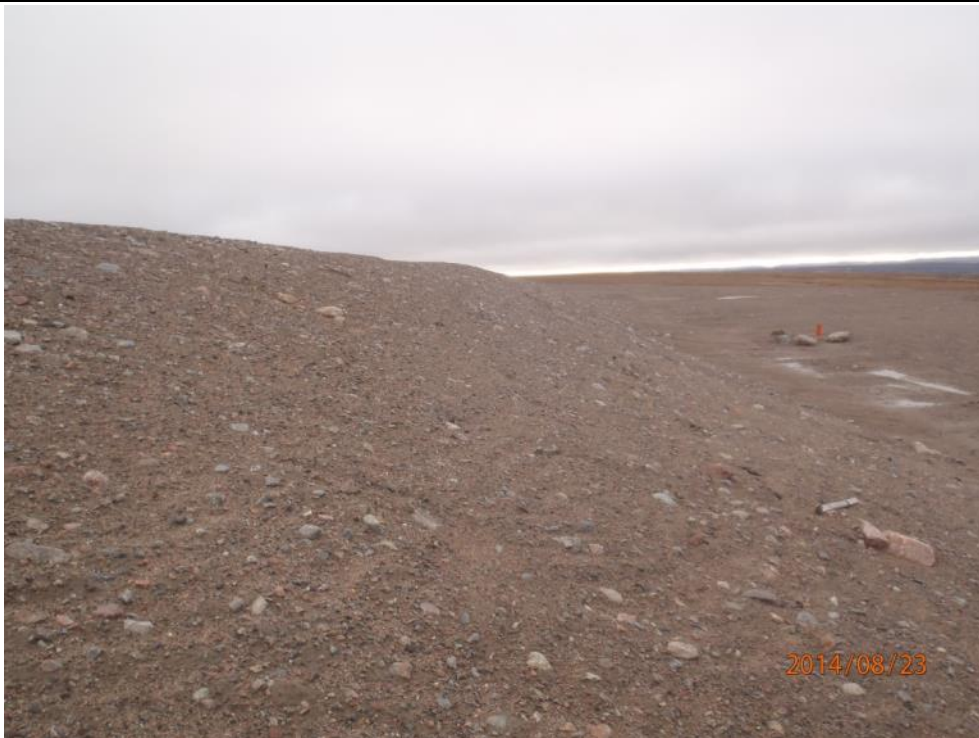
North side of the SSDF from the Northeast corner. Viewpoint 18 (Figure A-2; Appendix A). Photograph reference P8230018. Direction photo taken: W

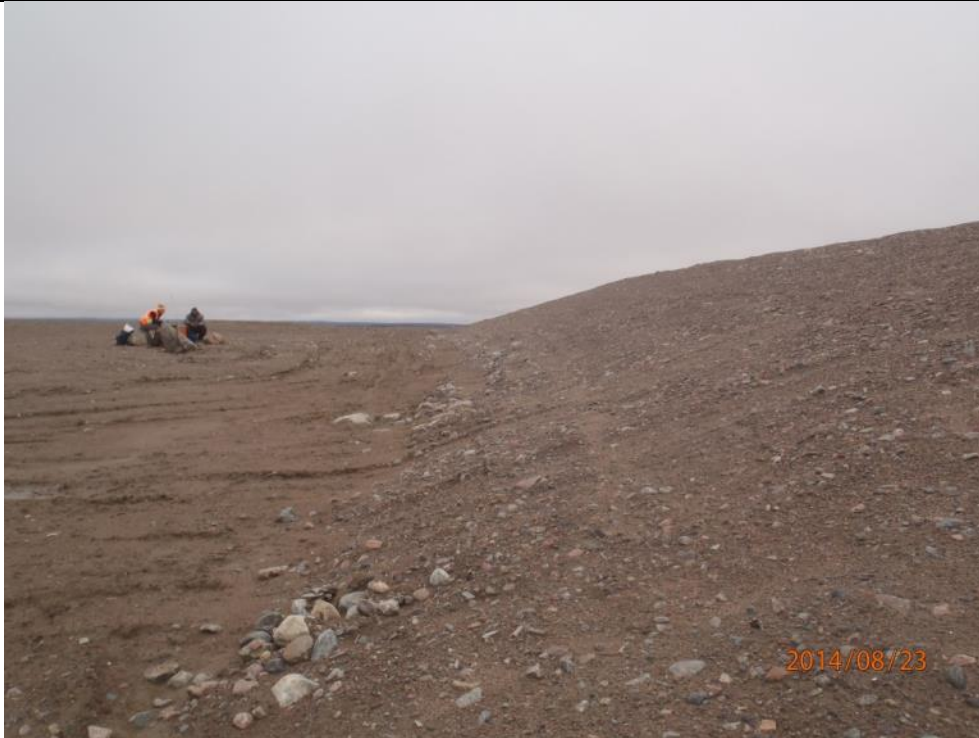
East side of the SSDF from the Northeast corner. Viewpoint 19 (Figure A-2; Appendix A). Photograph reference P8230019. Direction photo taken: S

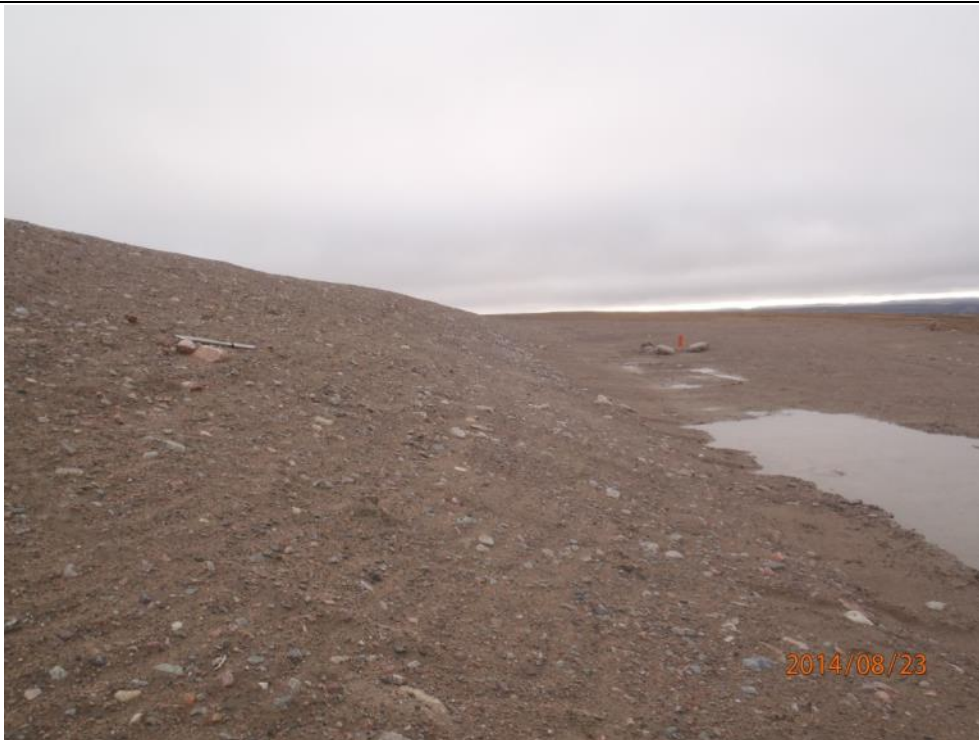
North side of the SSDF from the Northeast corner. Viewpoint 20 (Figure A-2; Appendix A). Photograph reference P8230020. Direction photo taken: W

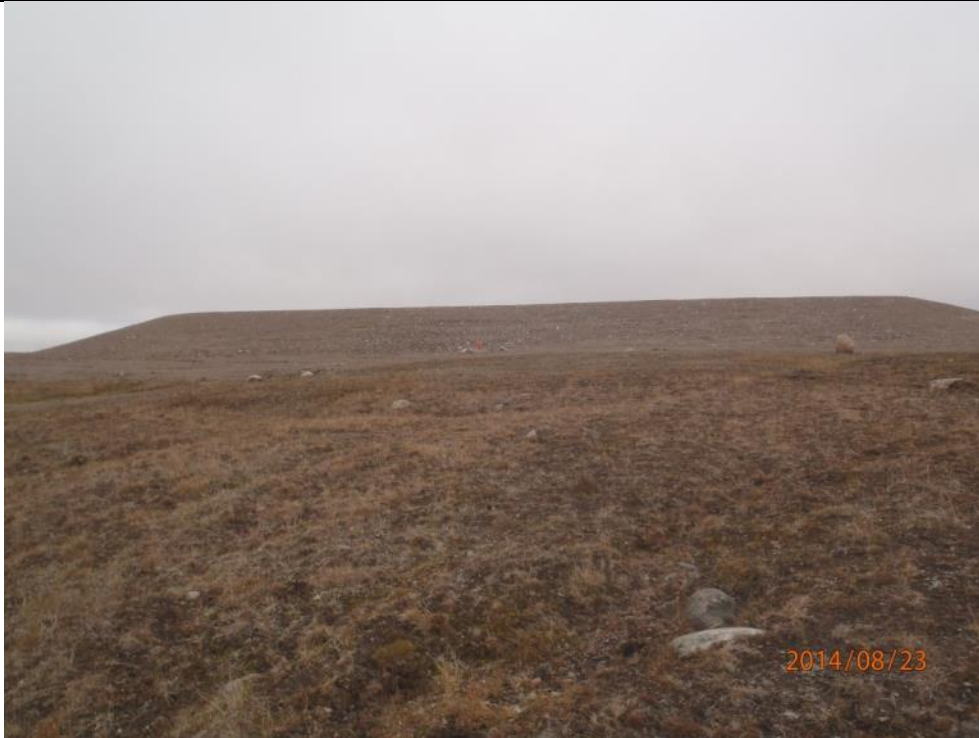
North side of the SSDF. Viewpoint 21 (Figure A-2; Appendix A). Photograph reference P8230021.
Direction photo taken: S

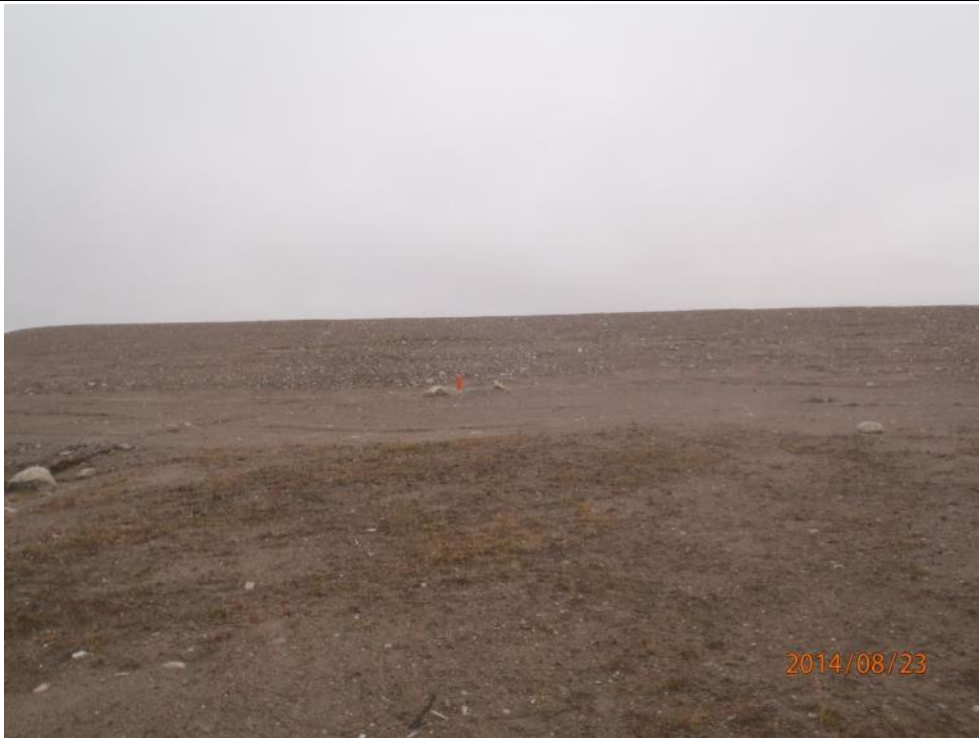
North side of the SSDF. Viewpoint 22 (Figure A-2; Appendix A). Photograph reference P8230022.
Direction photo taken: S

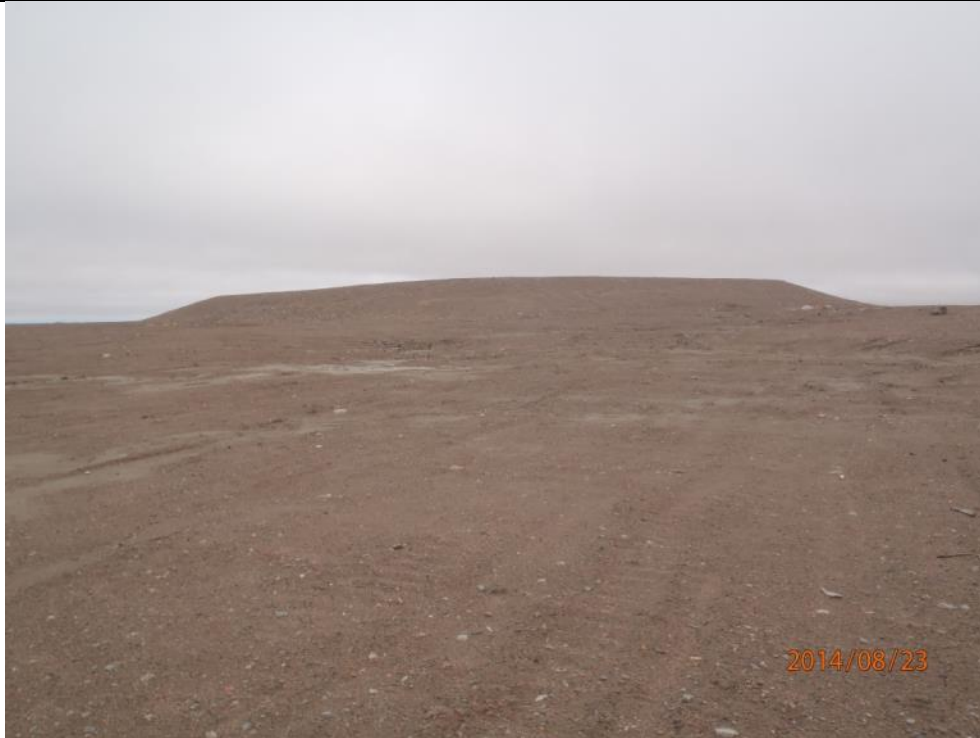
Northwest corner of the SSDF. Viewpoint 23 (Figure A-2; Appendix A). Photograph reference P8230023.
Direction photo taken: SE

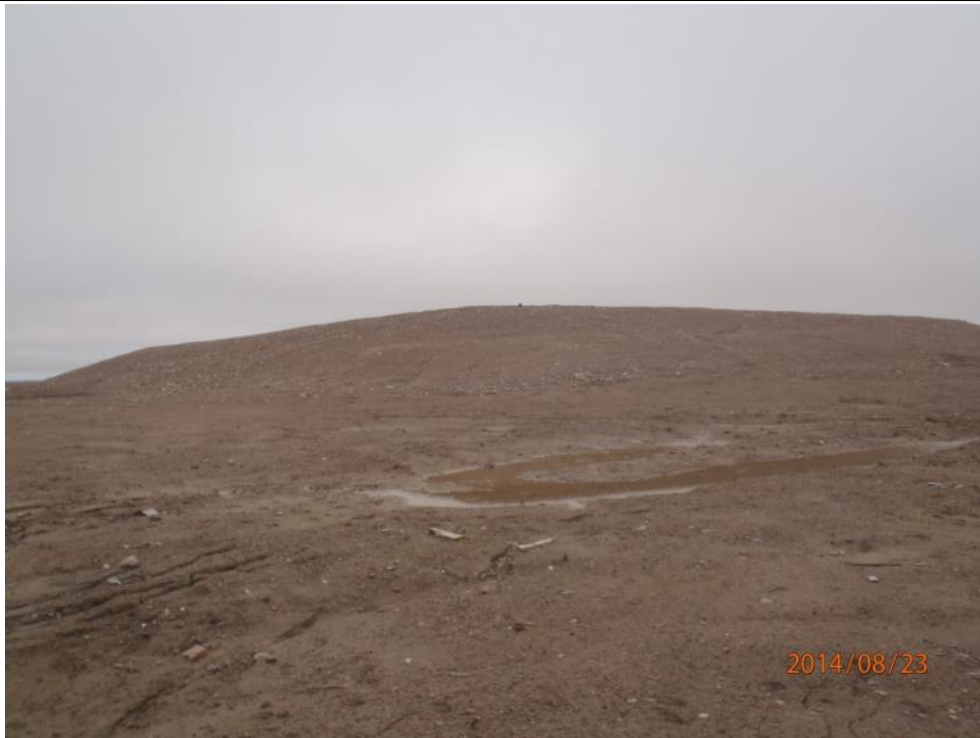
Northwest corner of the SSDF. Viewpoint 24 (Figure A-2; Appendix A). Photograph reference P8230024.
Direction photo taken: SE

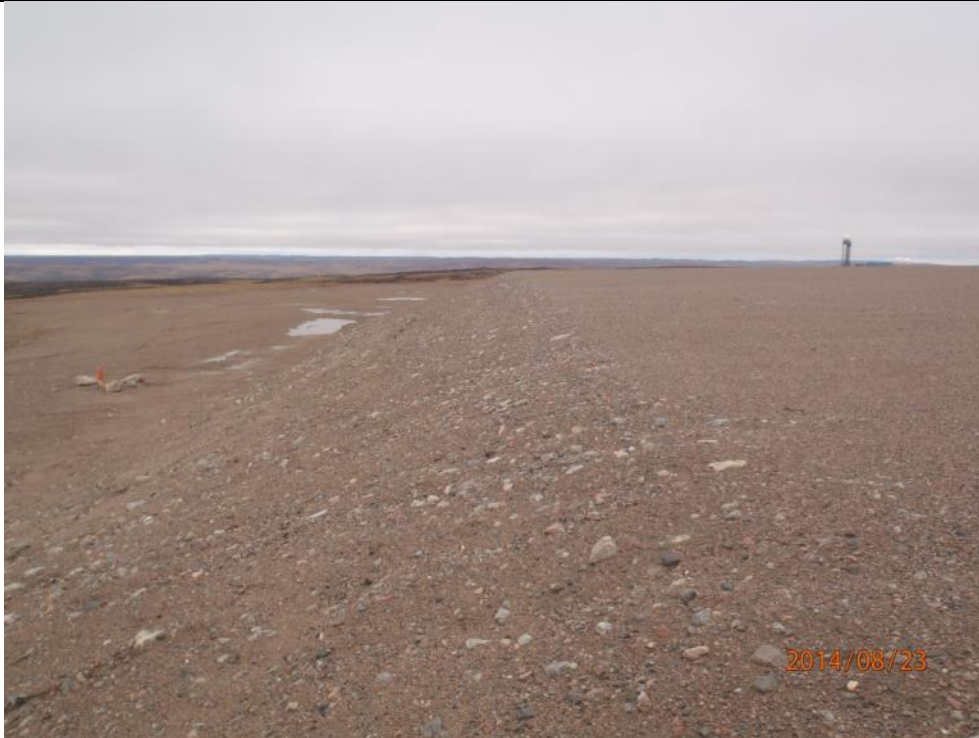
North side of the SSDF from the Northwest corner. Viewpoint 25 (Figure A-2; Appendix A). Photograph reference P8230025. Direction photo taken: E
