Long-Term Monitoring, 2014 CAM-D, Simpson Lake, Nunavut

FINAL REPORT

Project No. 1697-1401
March 13, 2015

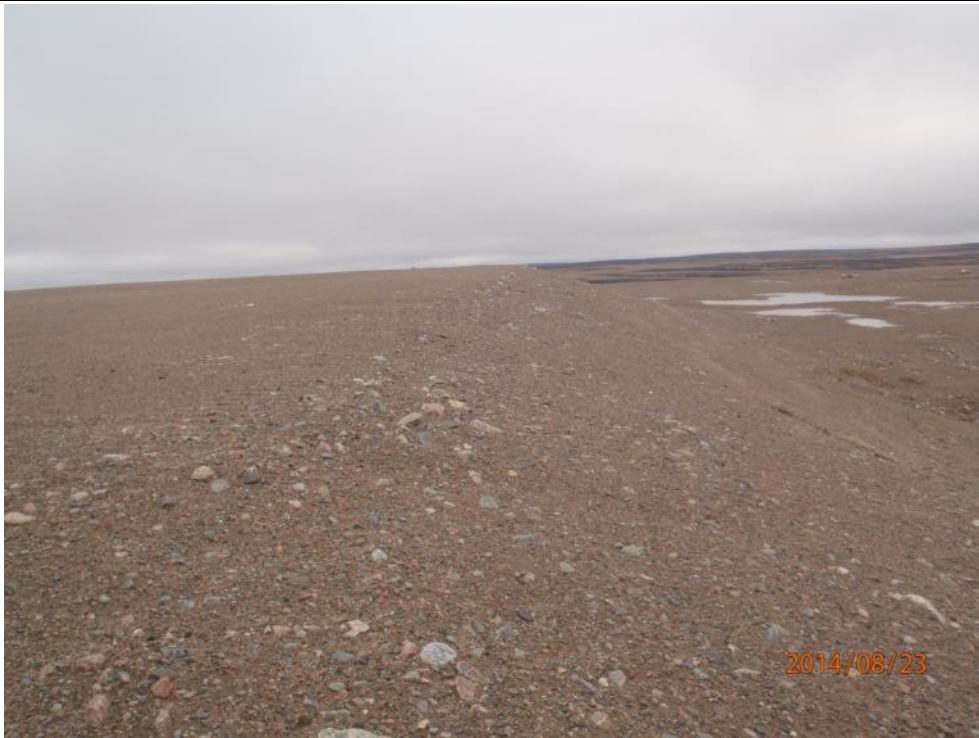
West side of the SSDF from the Northwest corner. Viewpoint 26 (Figure A-2; Appendix A). Photograph reference P8230026. Direction photo taken: S

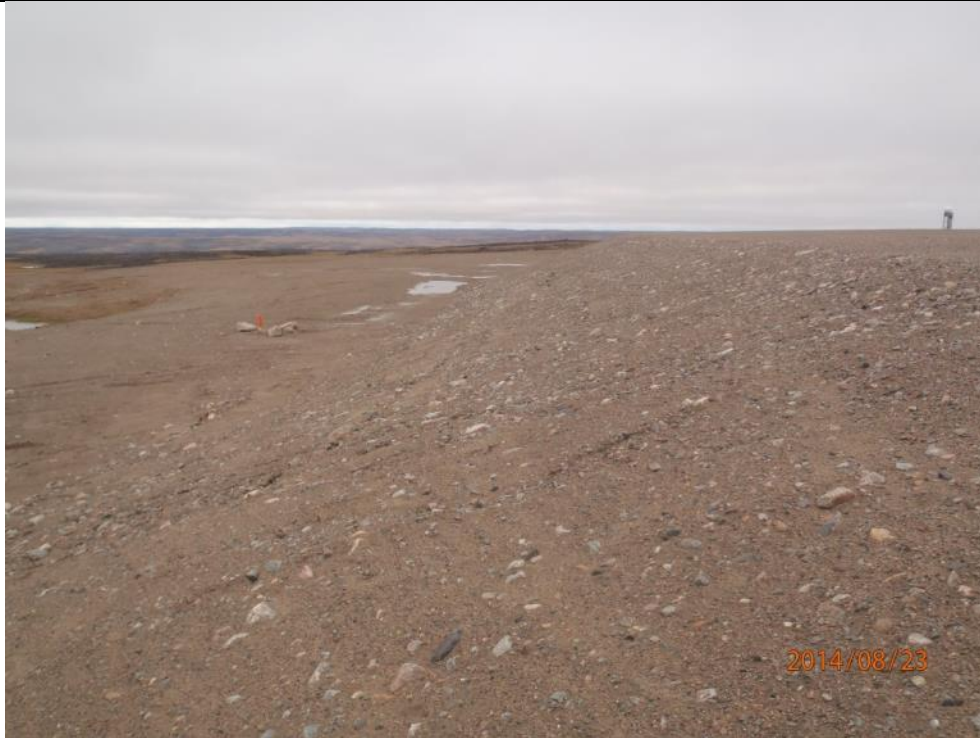
North side of the SSDF from the Northwest corner. Viewpoint 27 (Figure A-2; Appendix A). Photograph reference P8230027. Direction photo taken: E

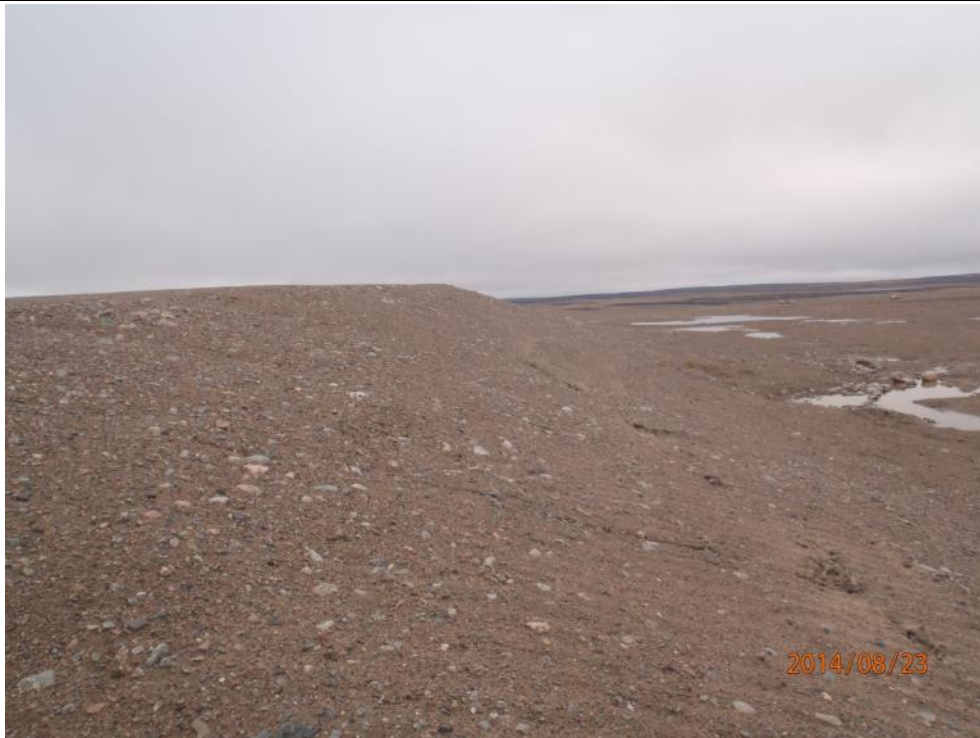
West side of the SSDF from the Northwest corner. Viewpoint 28 (Figure A-2; Appendix A). Photograph reference P8230028. Direction photo taken: S

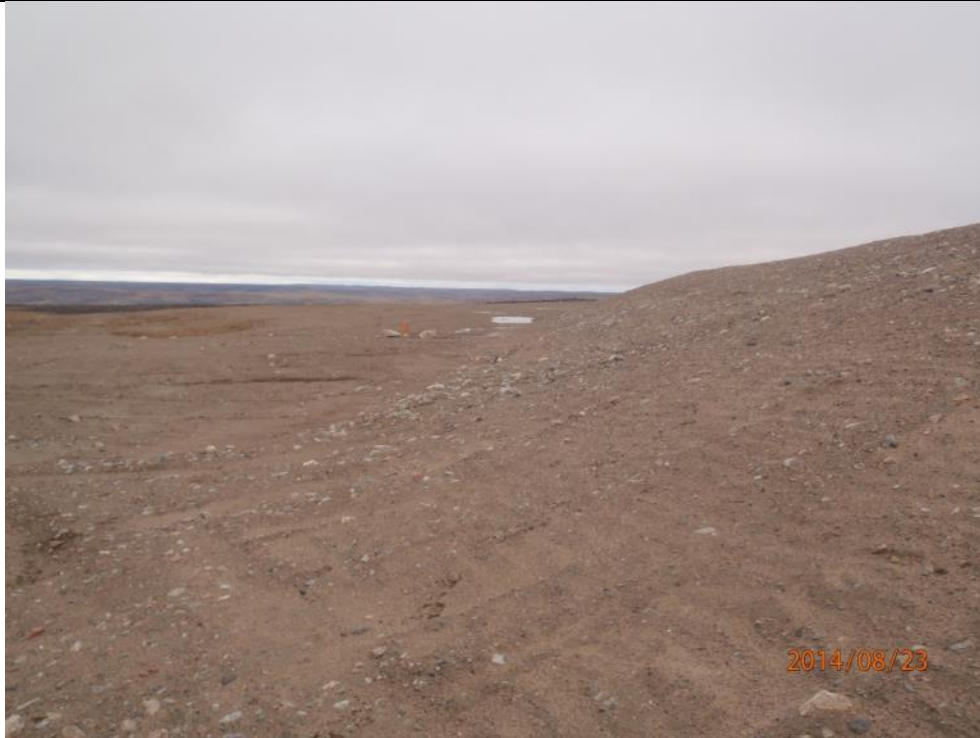
North side of the SSDF from the Northwest corner. Viewpoint 29 (Figure A-2; Appendix A). Photograph reference P8230029. Direction photo taken: E

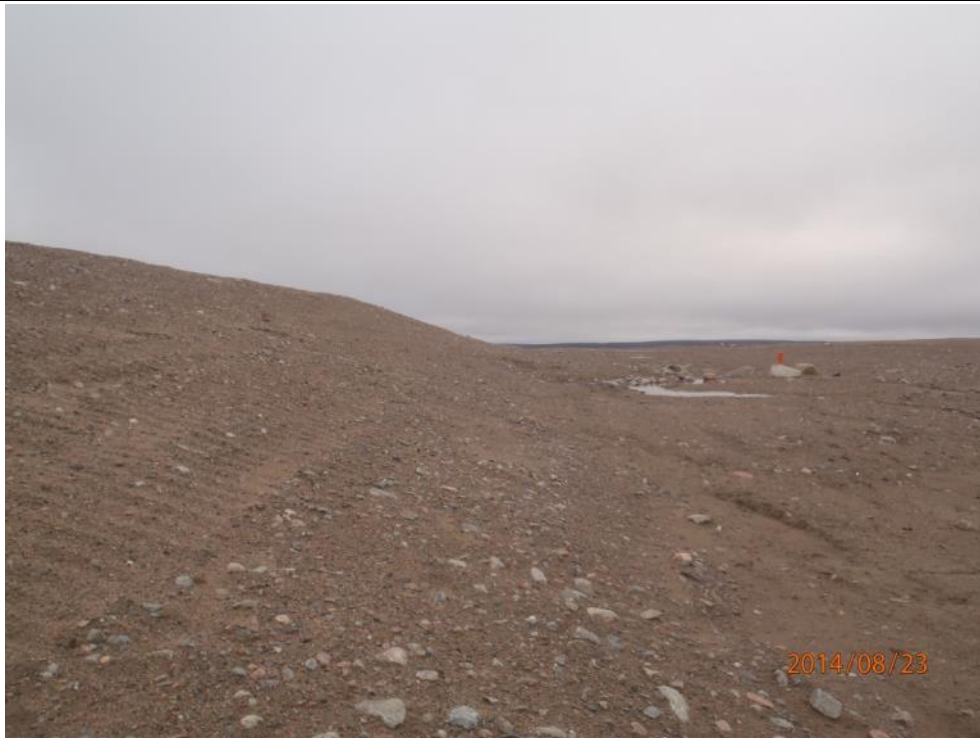
West side of the SSDF from the Northwest corner. Viewpoint 30 (Figure A-2; Appendix A). Photograph reference P8230030. Direction photo taken: S

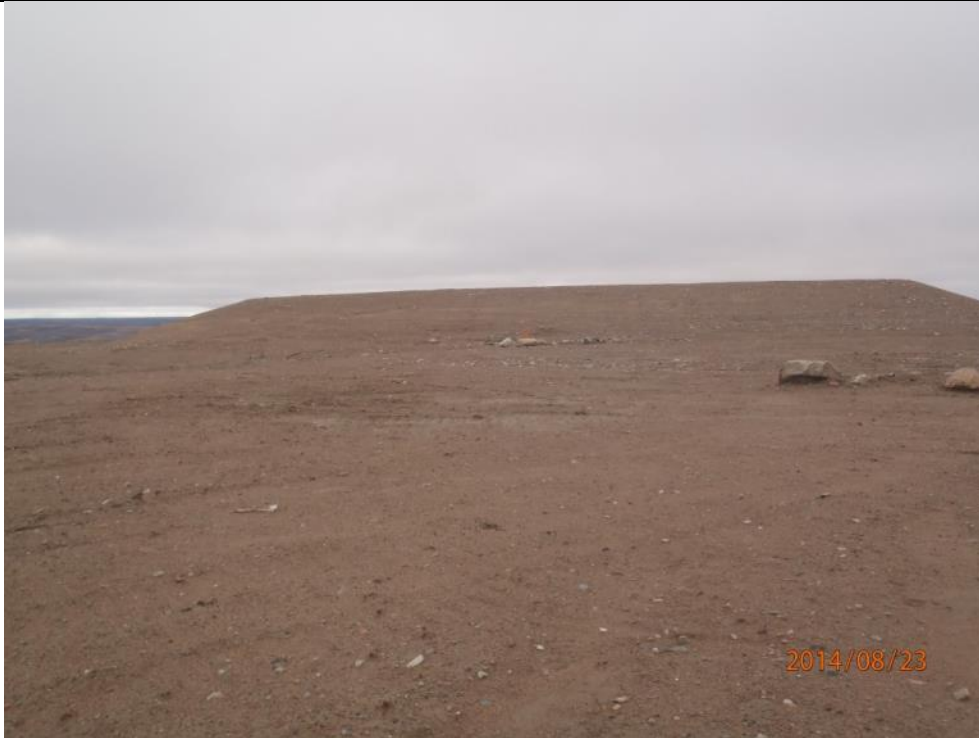
West side of the SSDF. Viewpoint 31 (Figure A-2; Appendix A). Photograph reference P8230031.
Direction photo taken: E

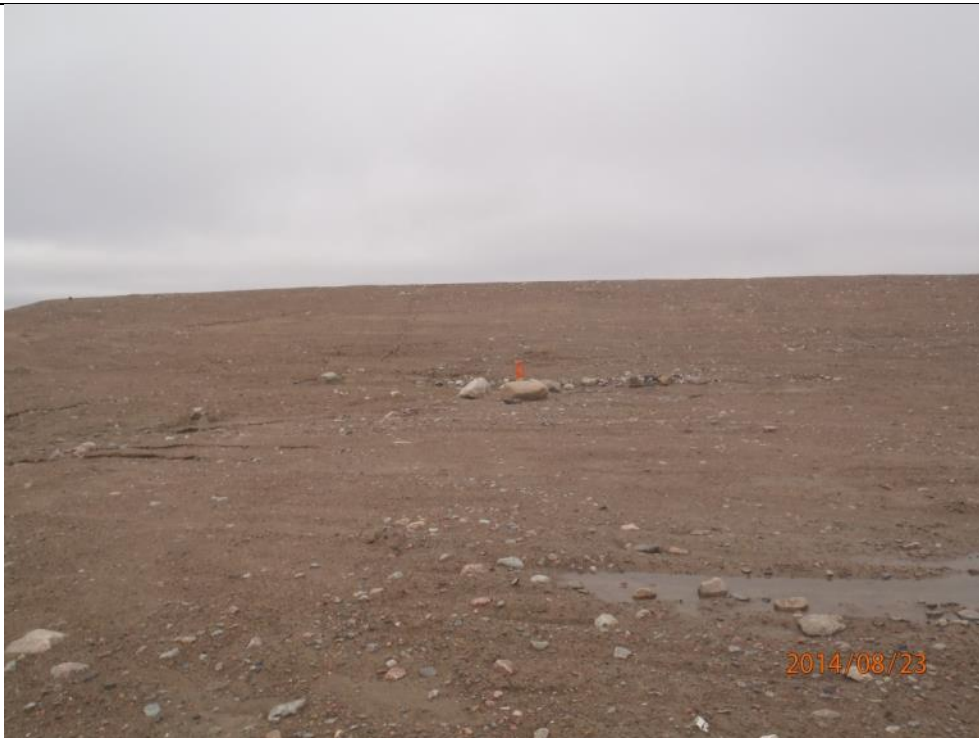
West side of the SSDF. Viewpoint 32 (Figure A-2; Appendix A). Photograph reference P8230032.
Direction photo taken: E

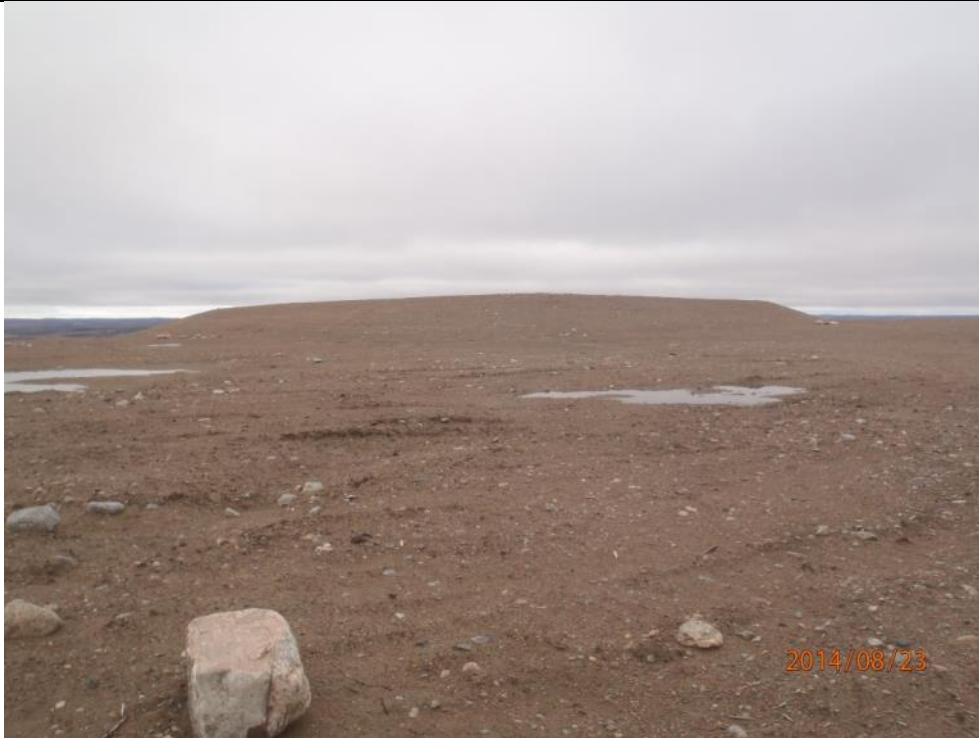
Southwest corner of the SSDF. Viewpoint 33 (Figure A-2; Appendix A). Photograph reference P8230033.
Direction photo taken: NE

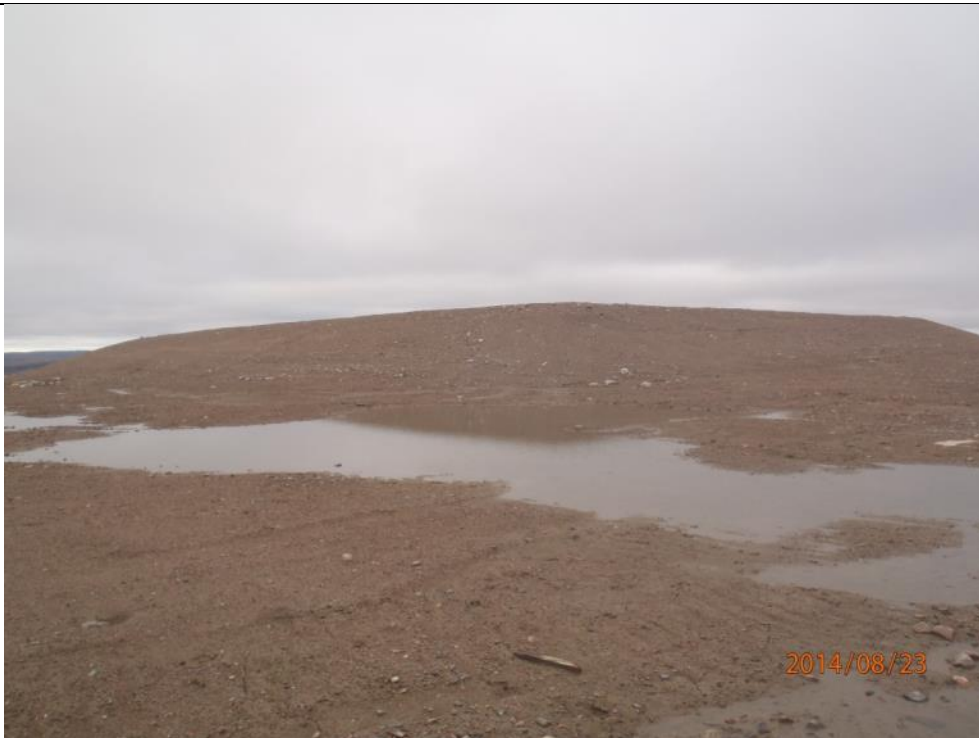
Southwest corner of the SSDF. Viewpoint 34 (Figure A-2; Appendix A). Photograph reference P8230034.
Direction photo taken: NE

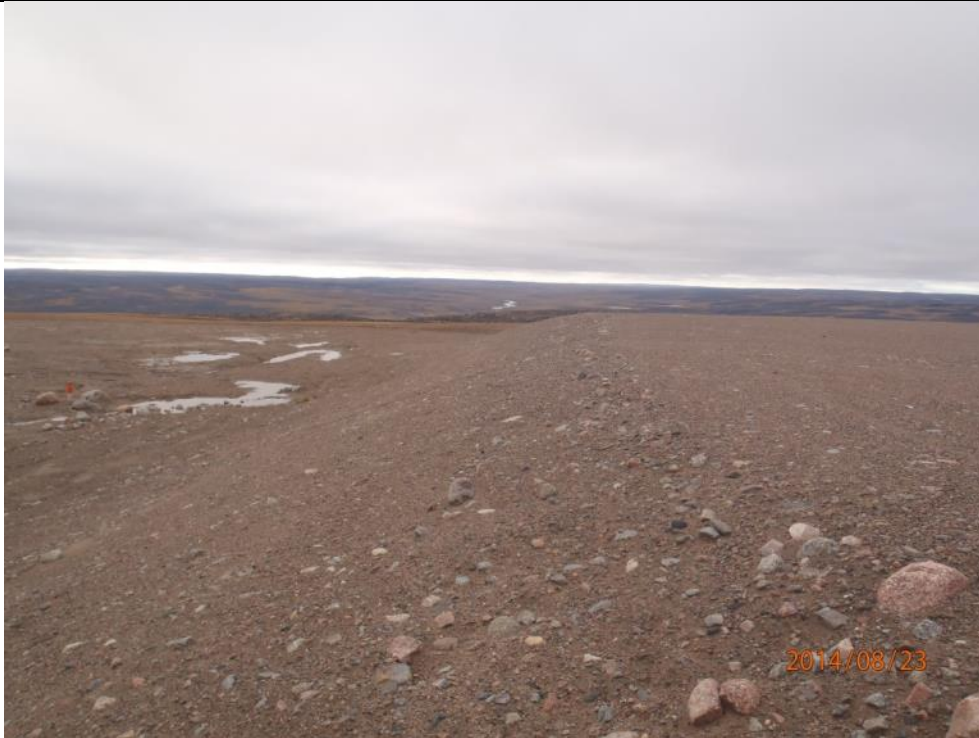
West side of the SSDF from the Southwest corner. Viewpoint 35 (Figure A-2; Appendix A). Photograph reference P8230035. Direction photo taken: N

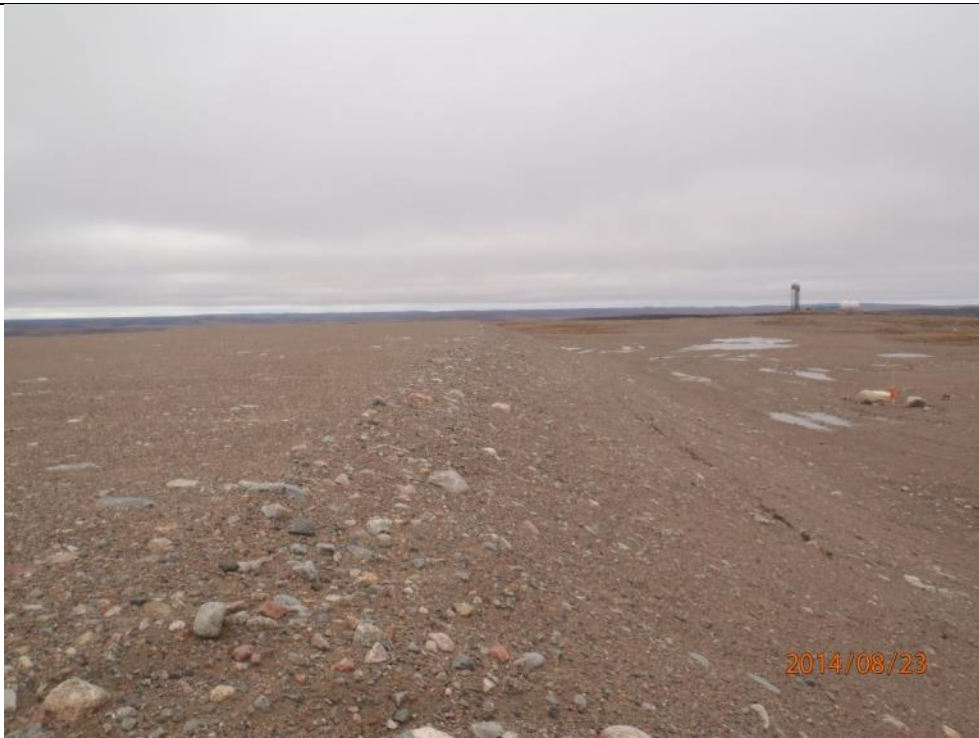
South side of the SSDF from the Southwest corner. Viewpoint 36 (Figure A-2; Appendix A). Photograph reference P8230036. Direction photo taken: E

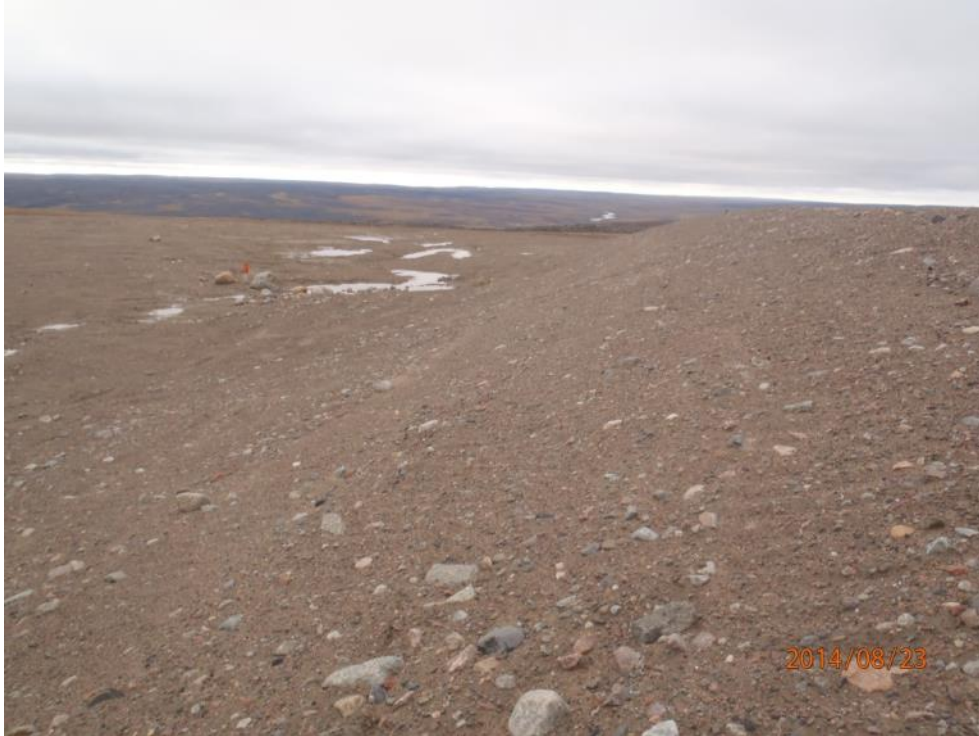
West side of the SSDF from the Southwest corner. Viewpoint 37 (Figure A-2; Appendix A). Photograph reference P8230037. Direction photo taken: N

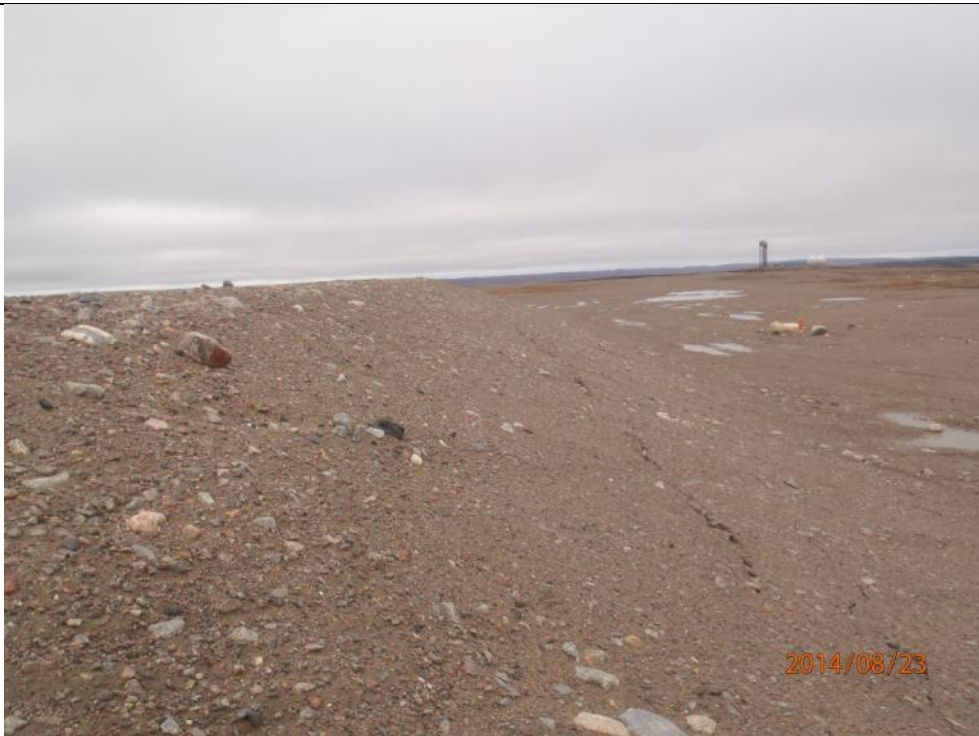
South side of the SSDF from the Southwest corner. Viewpoint 38 (Figure A-2; Appendix A). Photograph reference P8230038. Direction photo taken: E

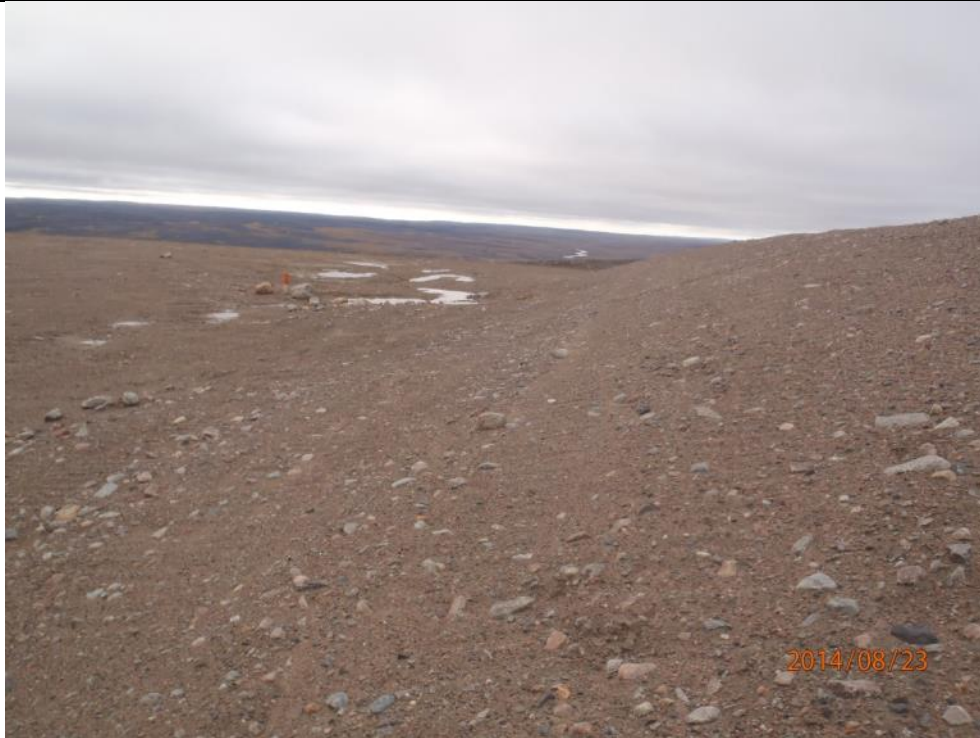
West side of the SSDF from the Southwest corner. Viewpoint 39 (Figure A-2; Appendix A). Photograph reference P8230039. Direction photo taken: N

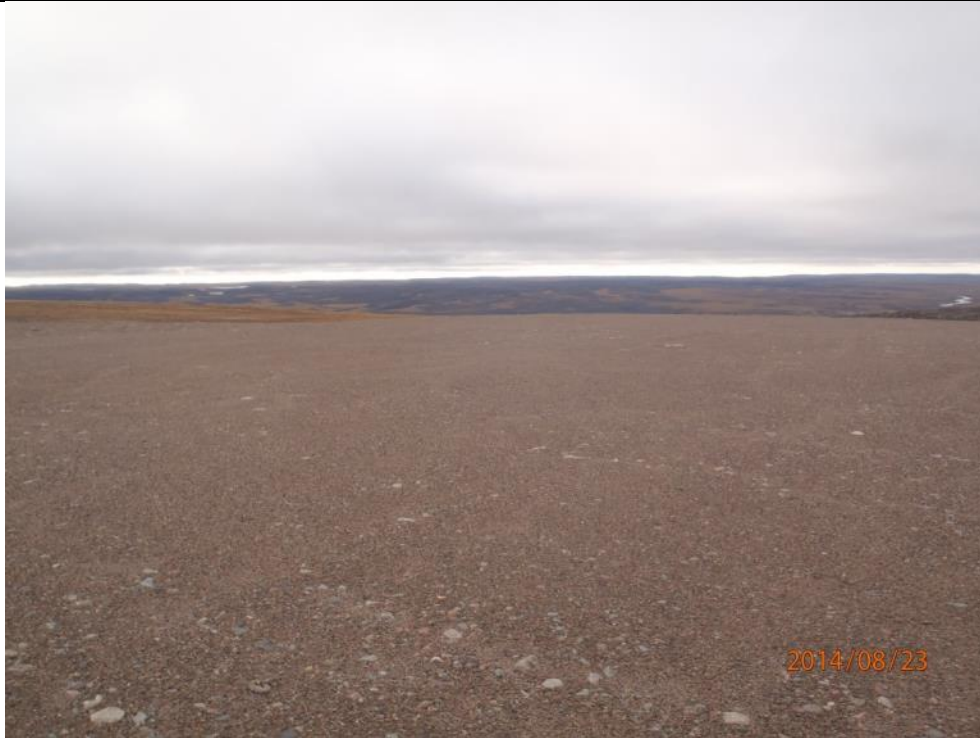
Top of the SSDF from the Southwest corner. Viewpoint 41 (Figure A-2; Appendix A). Photograph reference P8230041. Direction photo taken: NE

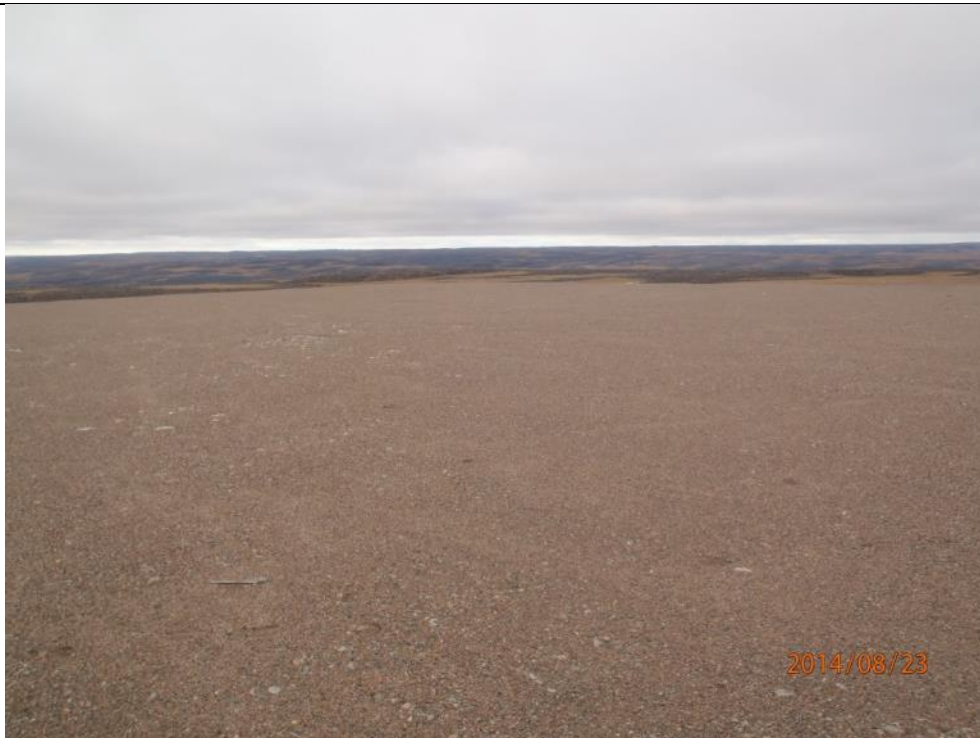
Top of the SSDF from the Southeast corner. Viewpoint 42 (Figure A-2; Appendix A). Photograph reference P8230042. Direction photo taken: NW

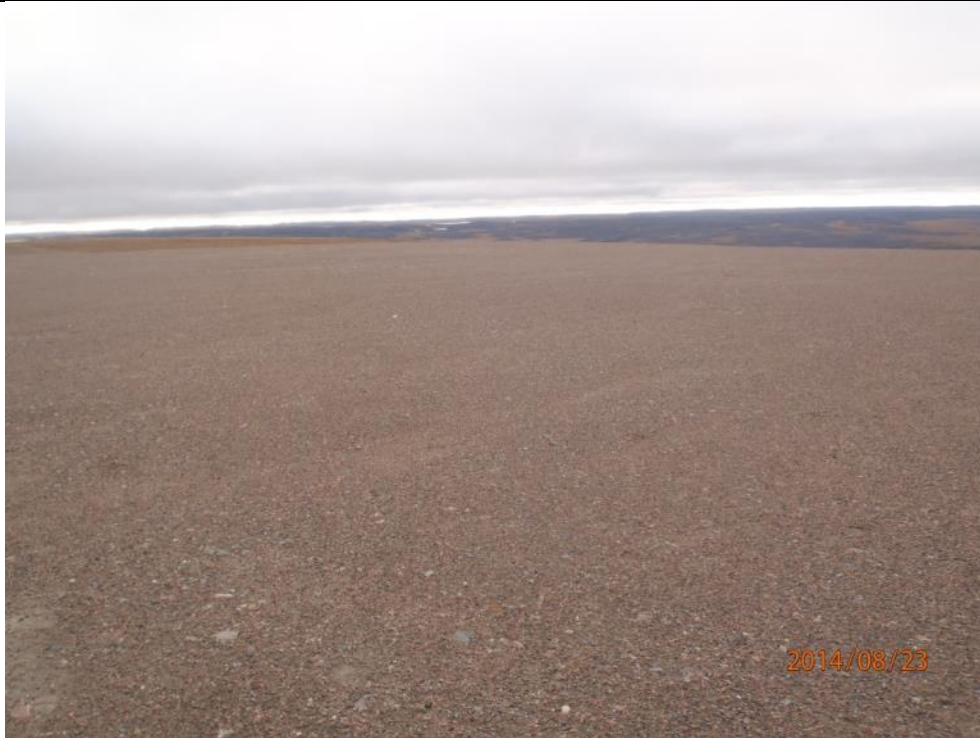
Top of the SSDF from the Northeast corner. Viewpoint 43 (Figure A-2; Appendix A). Photograph reference P8230043. Direction photo taken: SW

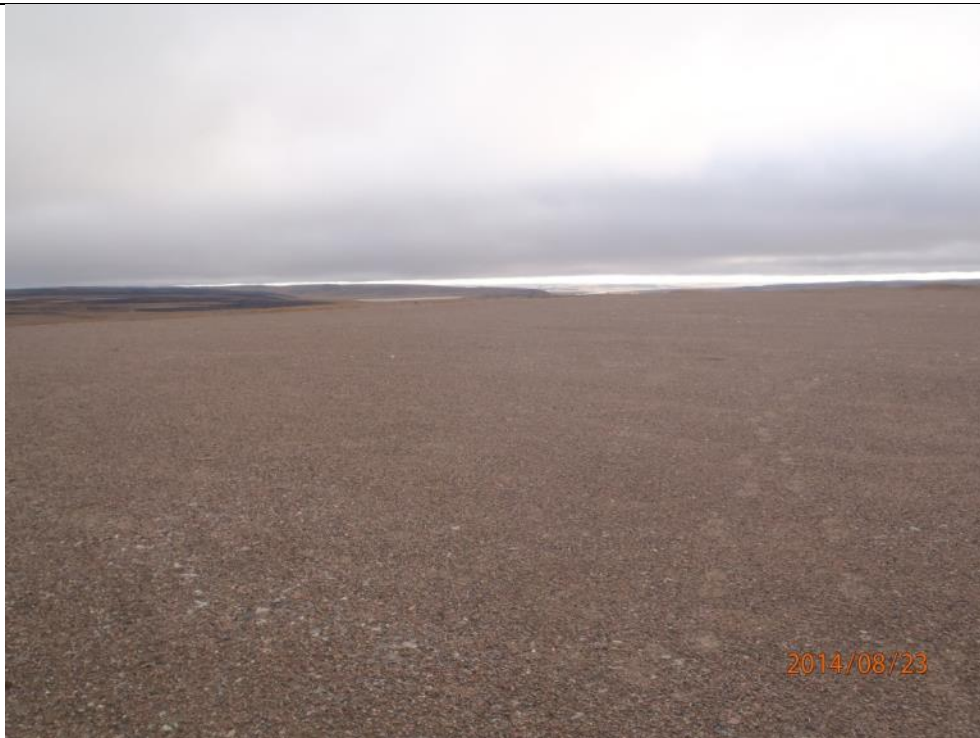
Top of the SSDF from the Northwest corner. Viewpoint 44 (Figure A-2; Appendix A). Photograph reference P8230044. Direction photo taken: SE

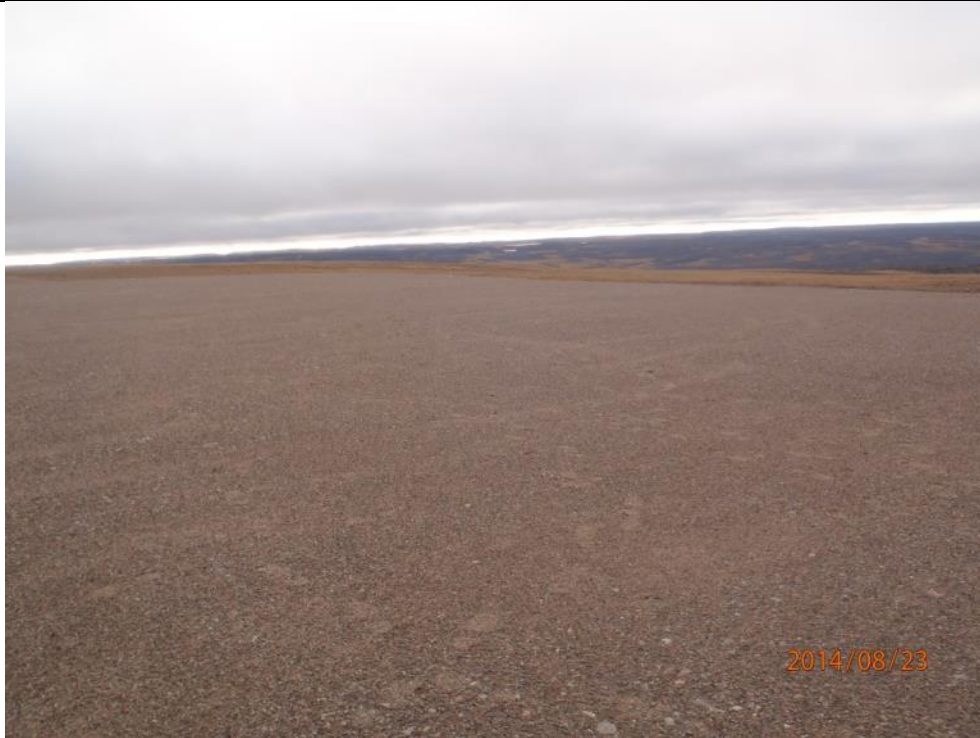
Top of the SSDF from the West side. Viewpoint 45 (Figure A-2; Appendix A). Photograph reference P8230045. Direction photo taken: NE

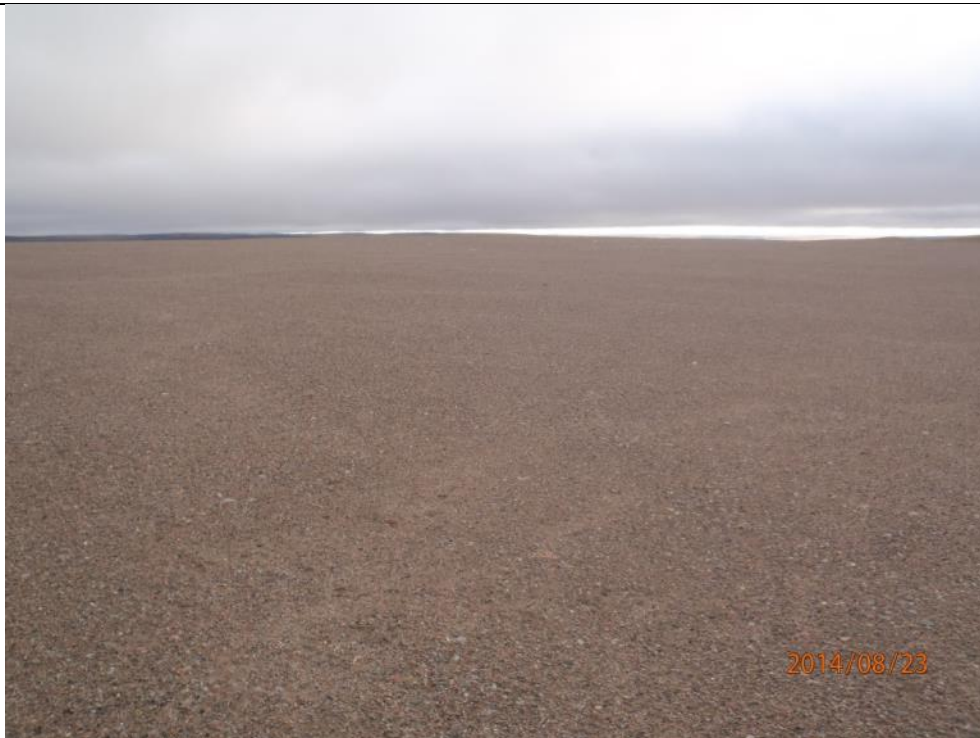
Top of the SSDF from the West side. Viewpoint 46 (Figure A-2; Appendix A). Photograph reference P8230046.
Direction photo taken: SE

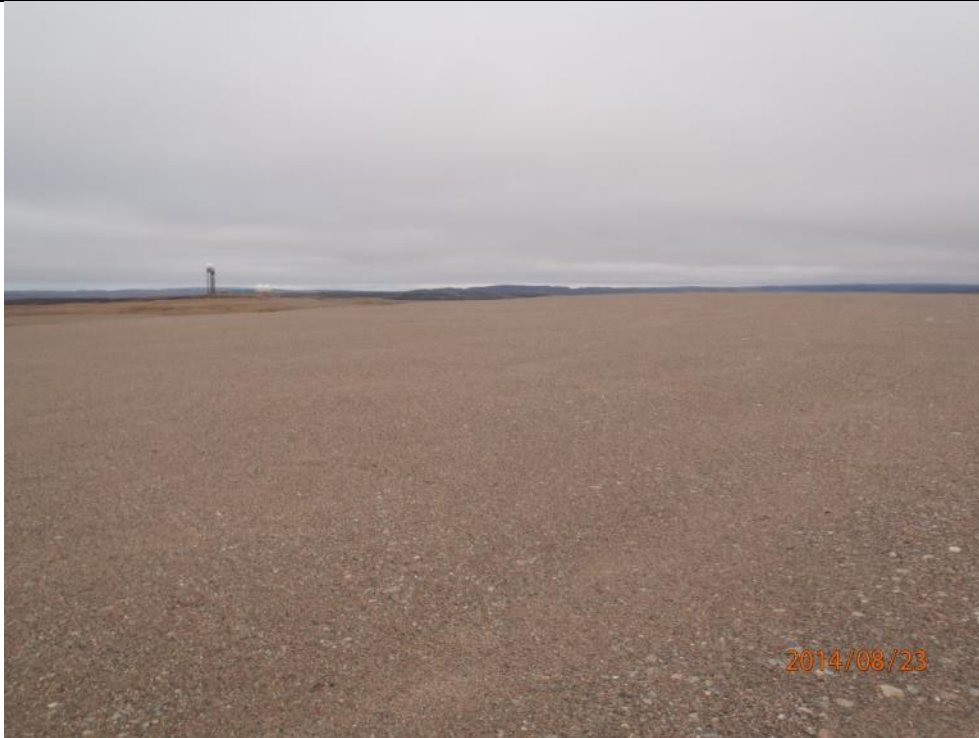
Top of the SSDF from the South side. Viewpoint 47 (Figure A-2; Appendix A). Photograph reference P8230047.
Direction photo taken: NW

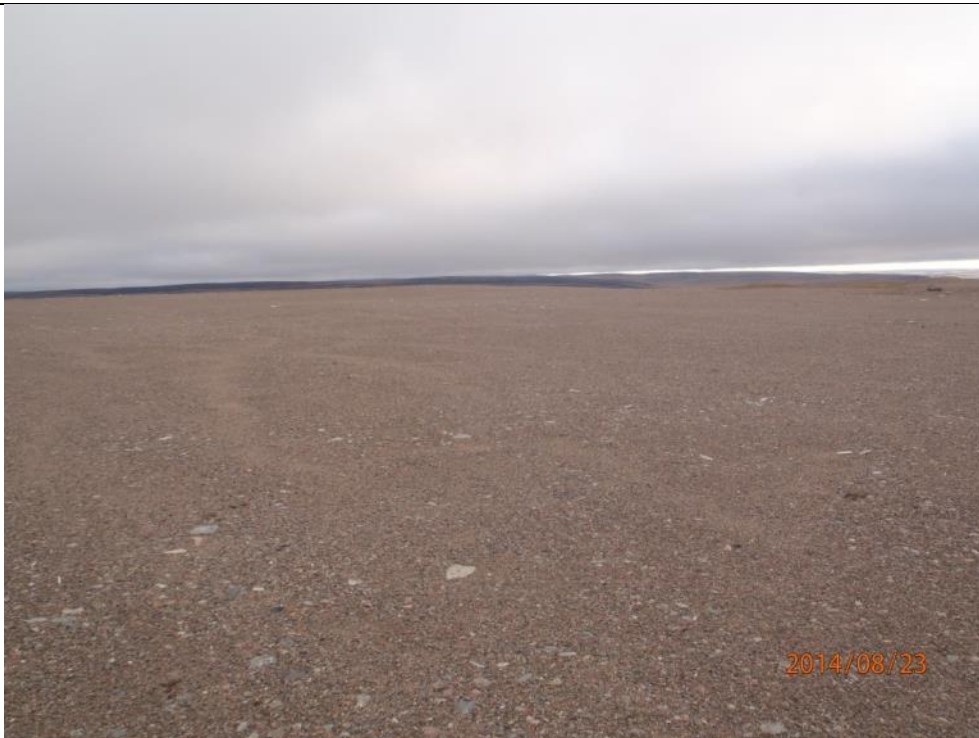
Top of the SSDF from the South side. Viewpoint 48 (Figure A-2; Appendix A). Photograph reference P8230048.
Direction photo taken: NE

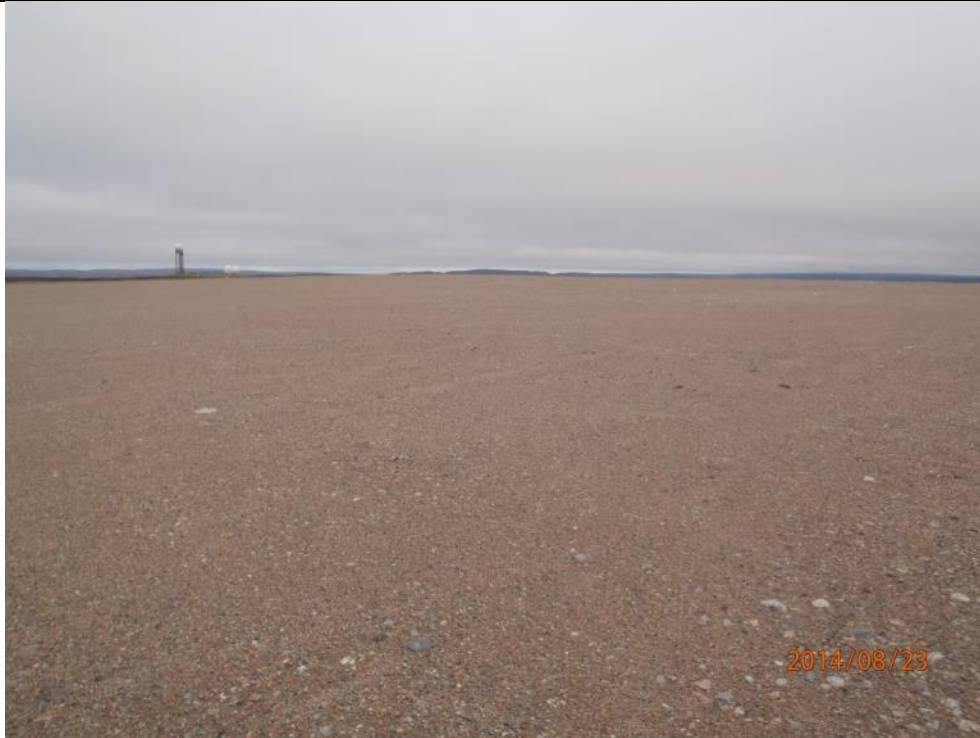
Top of the SSDF from the East side. Viewpoint 49 (Figure A-2; Appendix A). Photograph reference P8230049.
Direction photo taken: SW

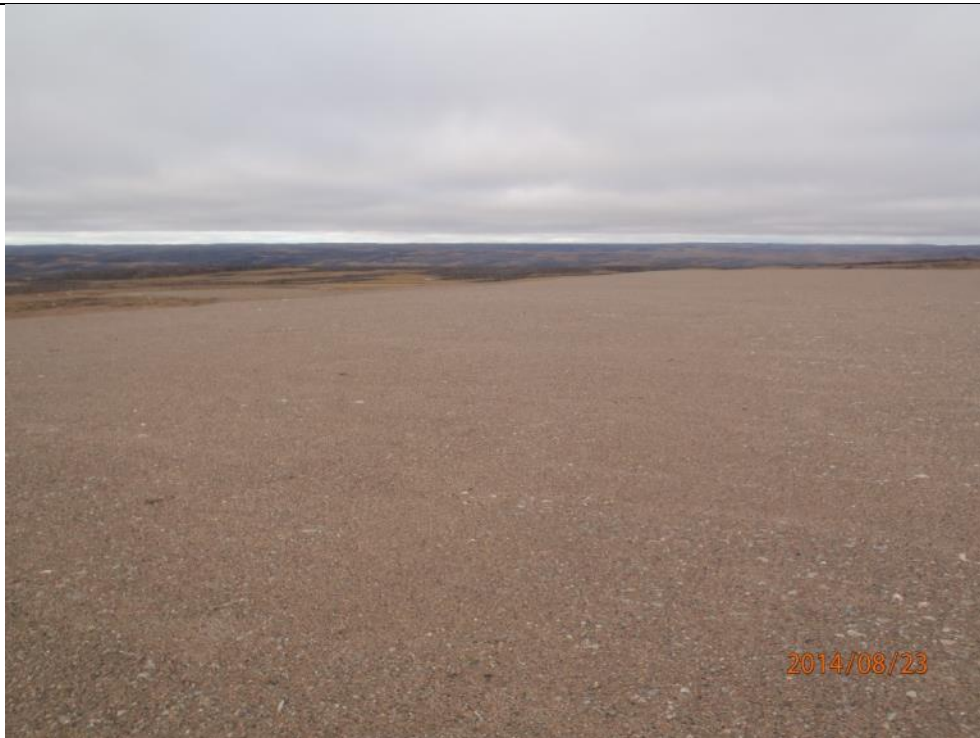
Top of the SSDF from the East side. Viewpoint 50 (Figure A-2; Appendix A). Photograph reference P8230050.
Direction photo taken: NW

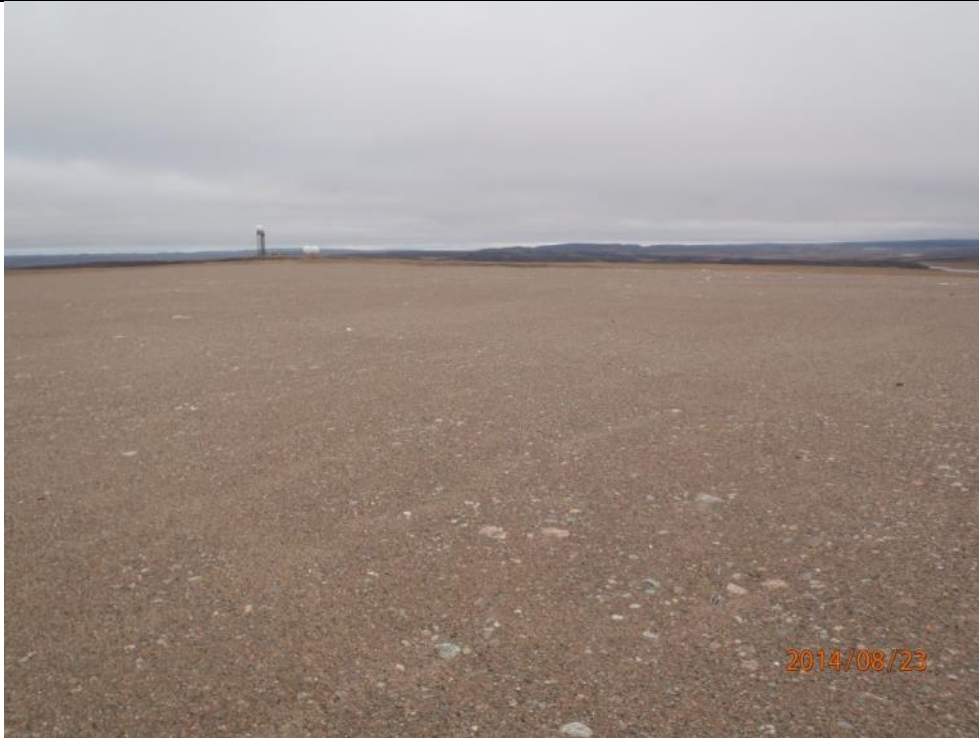
Top of the SSDF from the North side. Viewpoint 51 (Figure A-2; Appendix A). Photograph reference P8230051.
Direction photo taken: SE

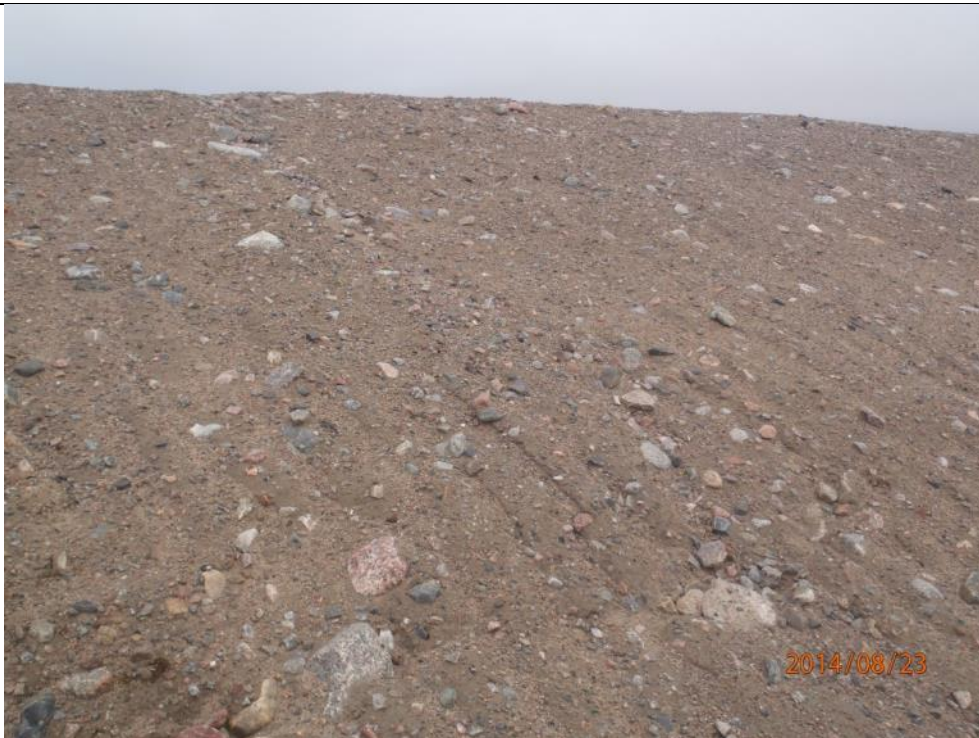
Cracking on West slope of SSDF. Viewpoint 53 (Figure A-2; Appendix A). Photograph reference P8230053.
Direction photo taken: E

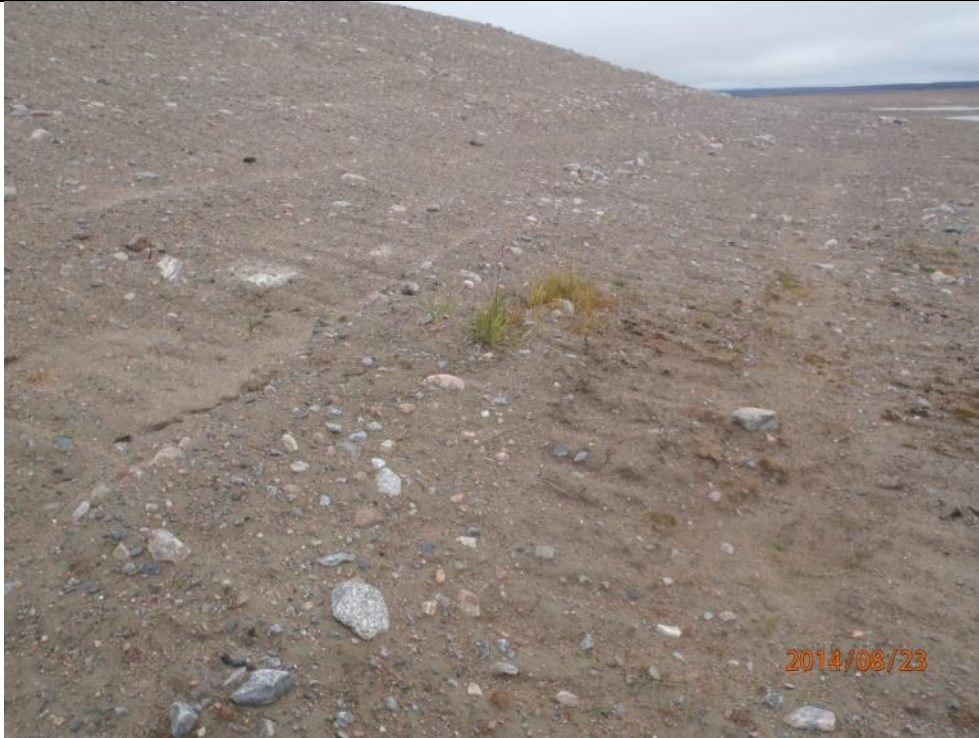
A lone area of vegetation (sedge grass) was observed to be taking root at the southwest toe of the NHWL; it is identified as feature B in Figure A-2, Appendix A, see Photo 54.

Edge of West slope of SSDF. Viewpoint 54 (Figure A-2; Appendix A). Photograph reference P8230054.
Direction photo taken: SE

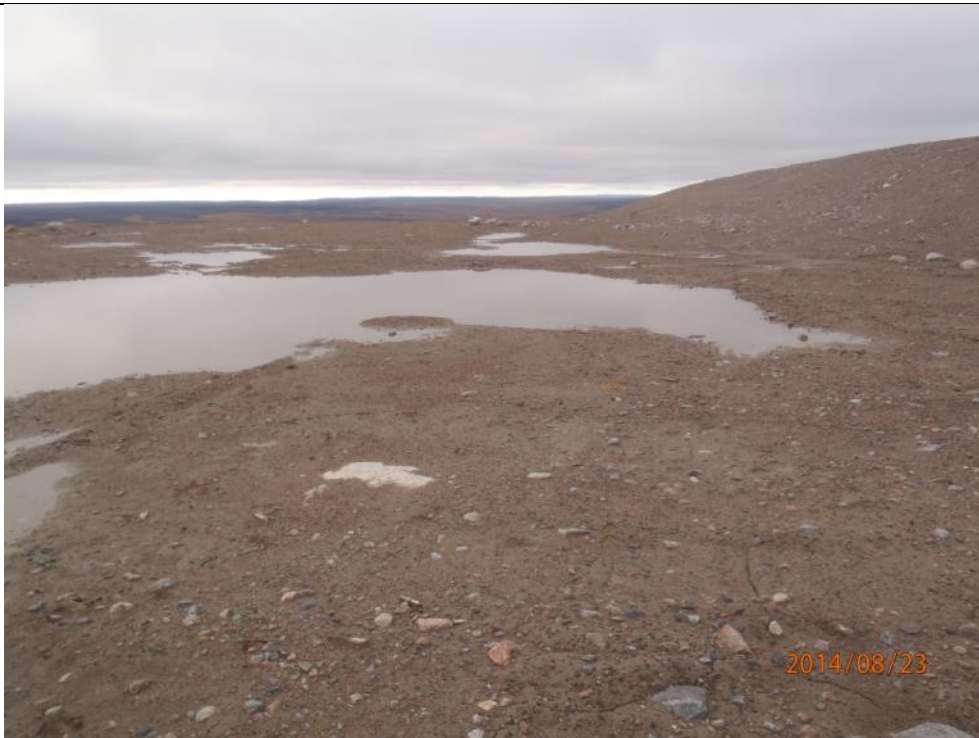
Two areas of ponded water were observed 5 m from southwest toe of the landfill; they did not contain any evidence of staining or product seepage from the landfill. Conditions at the site were generally wet due to recent rainfall, and many areas of saturated soil were observed around the NHWL at the ground surface.

Ponding at Southwest corner. Viewpoint 55 (Figure A-2; Appendix A). Photograph reference P8230055.
Direction photo taken: NW

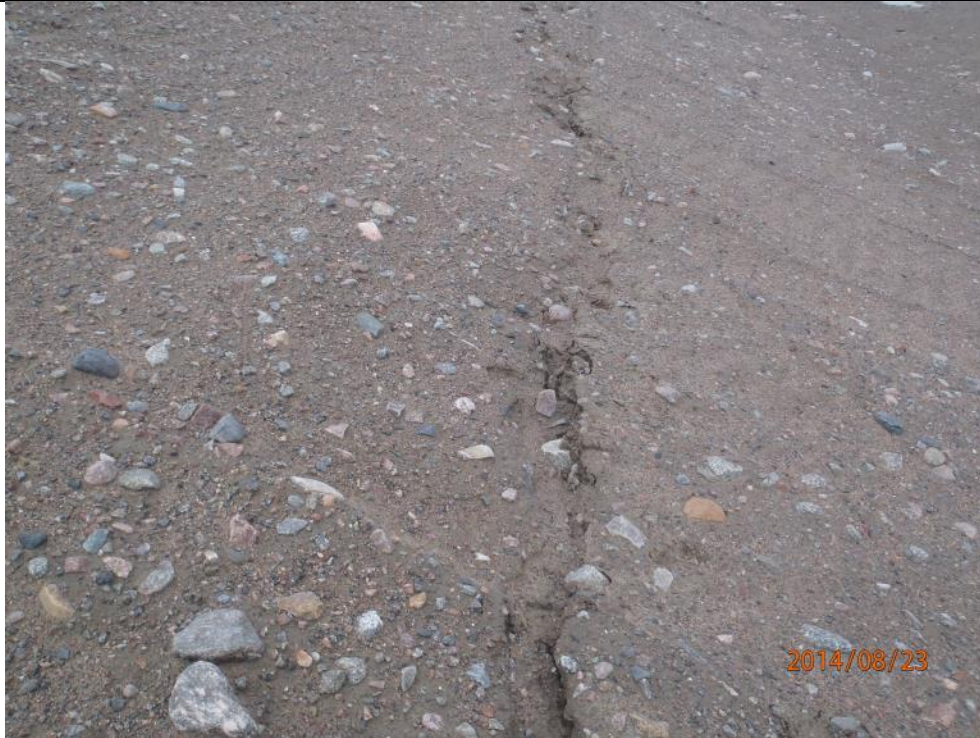
An additional four small erosion channels were observed on all four slopes of the berms of the NHWL. These appeared to be minor areas of erosional slumping of the surface fill material. All were minor in nature at this time. Additional very small erosion rills were observed along much of the northeast slope of the NHWL; however, these rills were considered too small at the present time to be identified as features and mapped.

Erosion on southeast berm. Viewpoint 57 (Figure A-2; Appendix A). Photograph reference P8230057.
Direction photo taken: NA

Based on the results of Year 3 of long-term monitoring at CAM-D, FRANZ recommends continued monitoring of the areas of erosion on the berms of NHWL and the road from the airstrip to the NHWL.

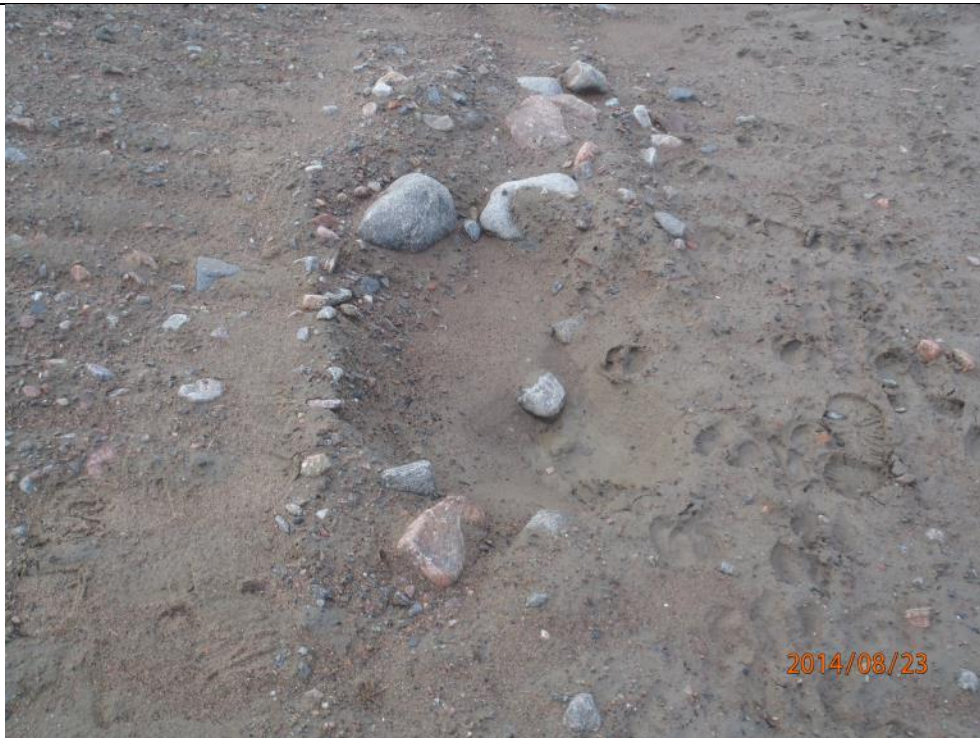
Areas of settlement were not observed. One small pothole was observed along the base of the east corner of the NHWL. This pothole was considered small in nature and does not impact the integrity of the landfill.

Pothole on east corner of NHWL. Viewpoint 58 (Figure A-2; Appendix A). Photograph reference P8230058.
Direction photo taken: NA
