Long-Term Monitoring, 2014 CAM-D, Simpson Lake, Nunavut

FINAL REPORT

Project No. 1697-1401
March 13, 2015

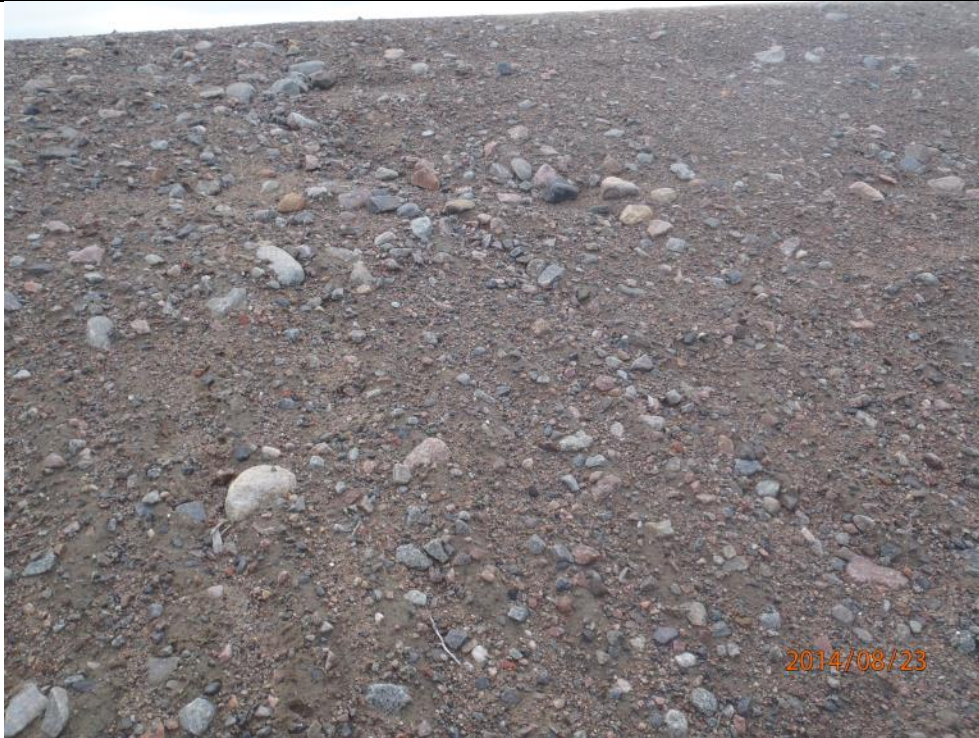
An additional four small erosion channels were observed on all four slopes of the berms of the NHWL. These appeared to be minor areas of erosional slumping of the surface fill material. All were minor in nature at this time. Additional very small erosion rills were observed along much of the northeast slope of the NHWL; however, these rills were considered too small at the present time to be identified as features and mapped.

Minor erosion at Feature H. Viewpoint 59 (Figure A-2; Appendix A). Photograph reference P8230059.
Direction photo taken: NA

Based on the results of Year 3 of long-term monitoring at CAM-D, FRANZ recommends continued monitoring of the areas of erosion on the berms of NHWL and the road from the airstrip to the NHWL.

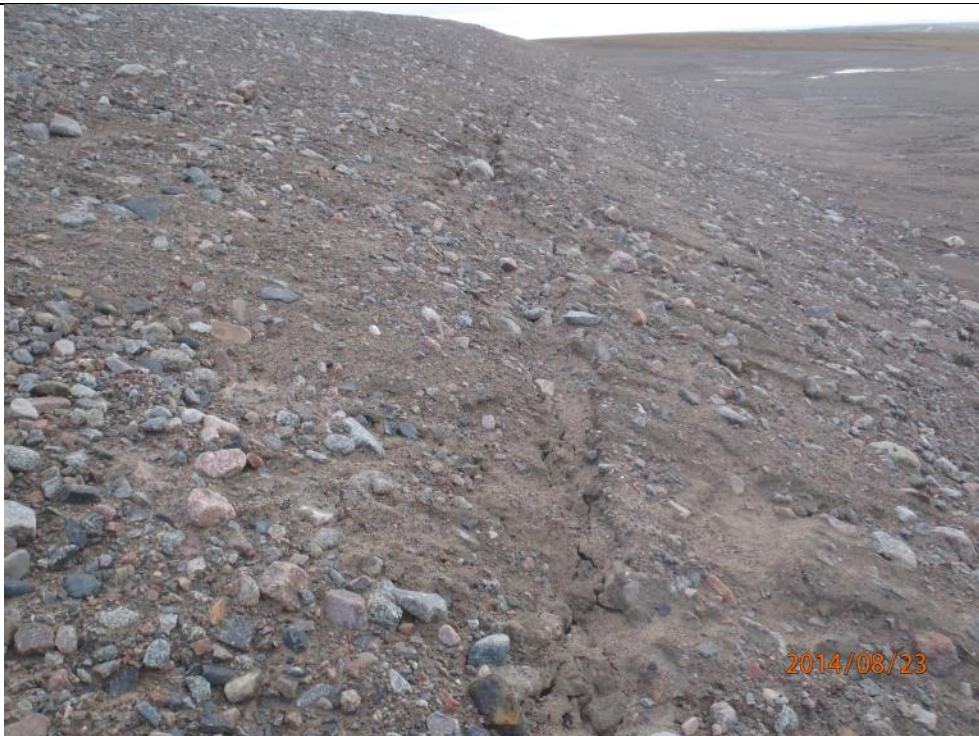
Two small areas along the northwest and southwest sides of the landfill had evidence of erosion. Two small erosion rills were observed which are likely due to preferential drainage and associated down-slope washing of fine-grained fill between cobbles and boulders.

Erosion on northwest berm. Viewpoint 60 (Figure A-2; Appendix A). Photograph reference P8230060.
Direction photo taken: SW

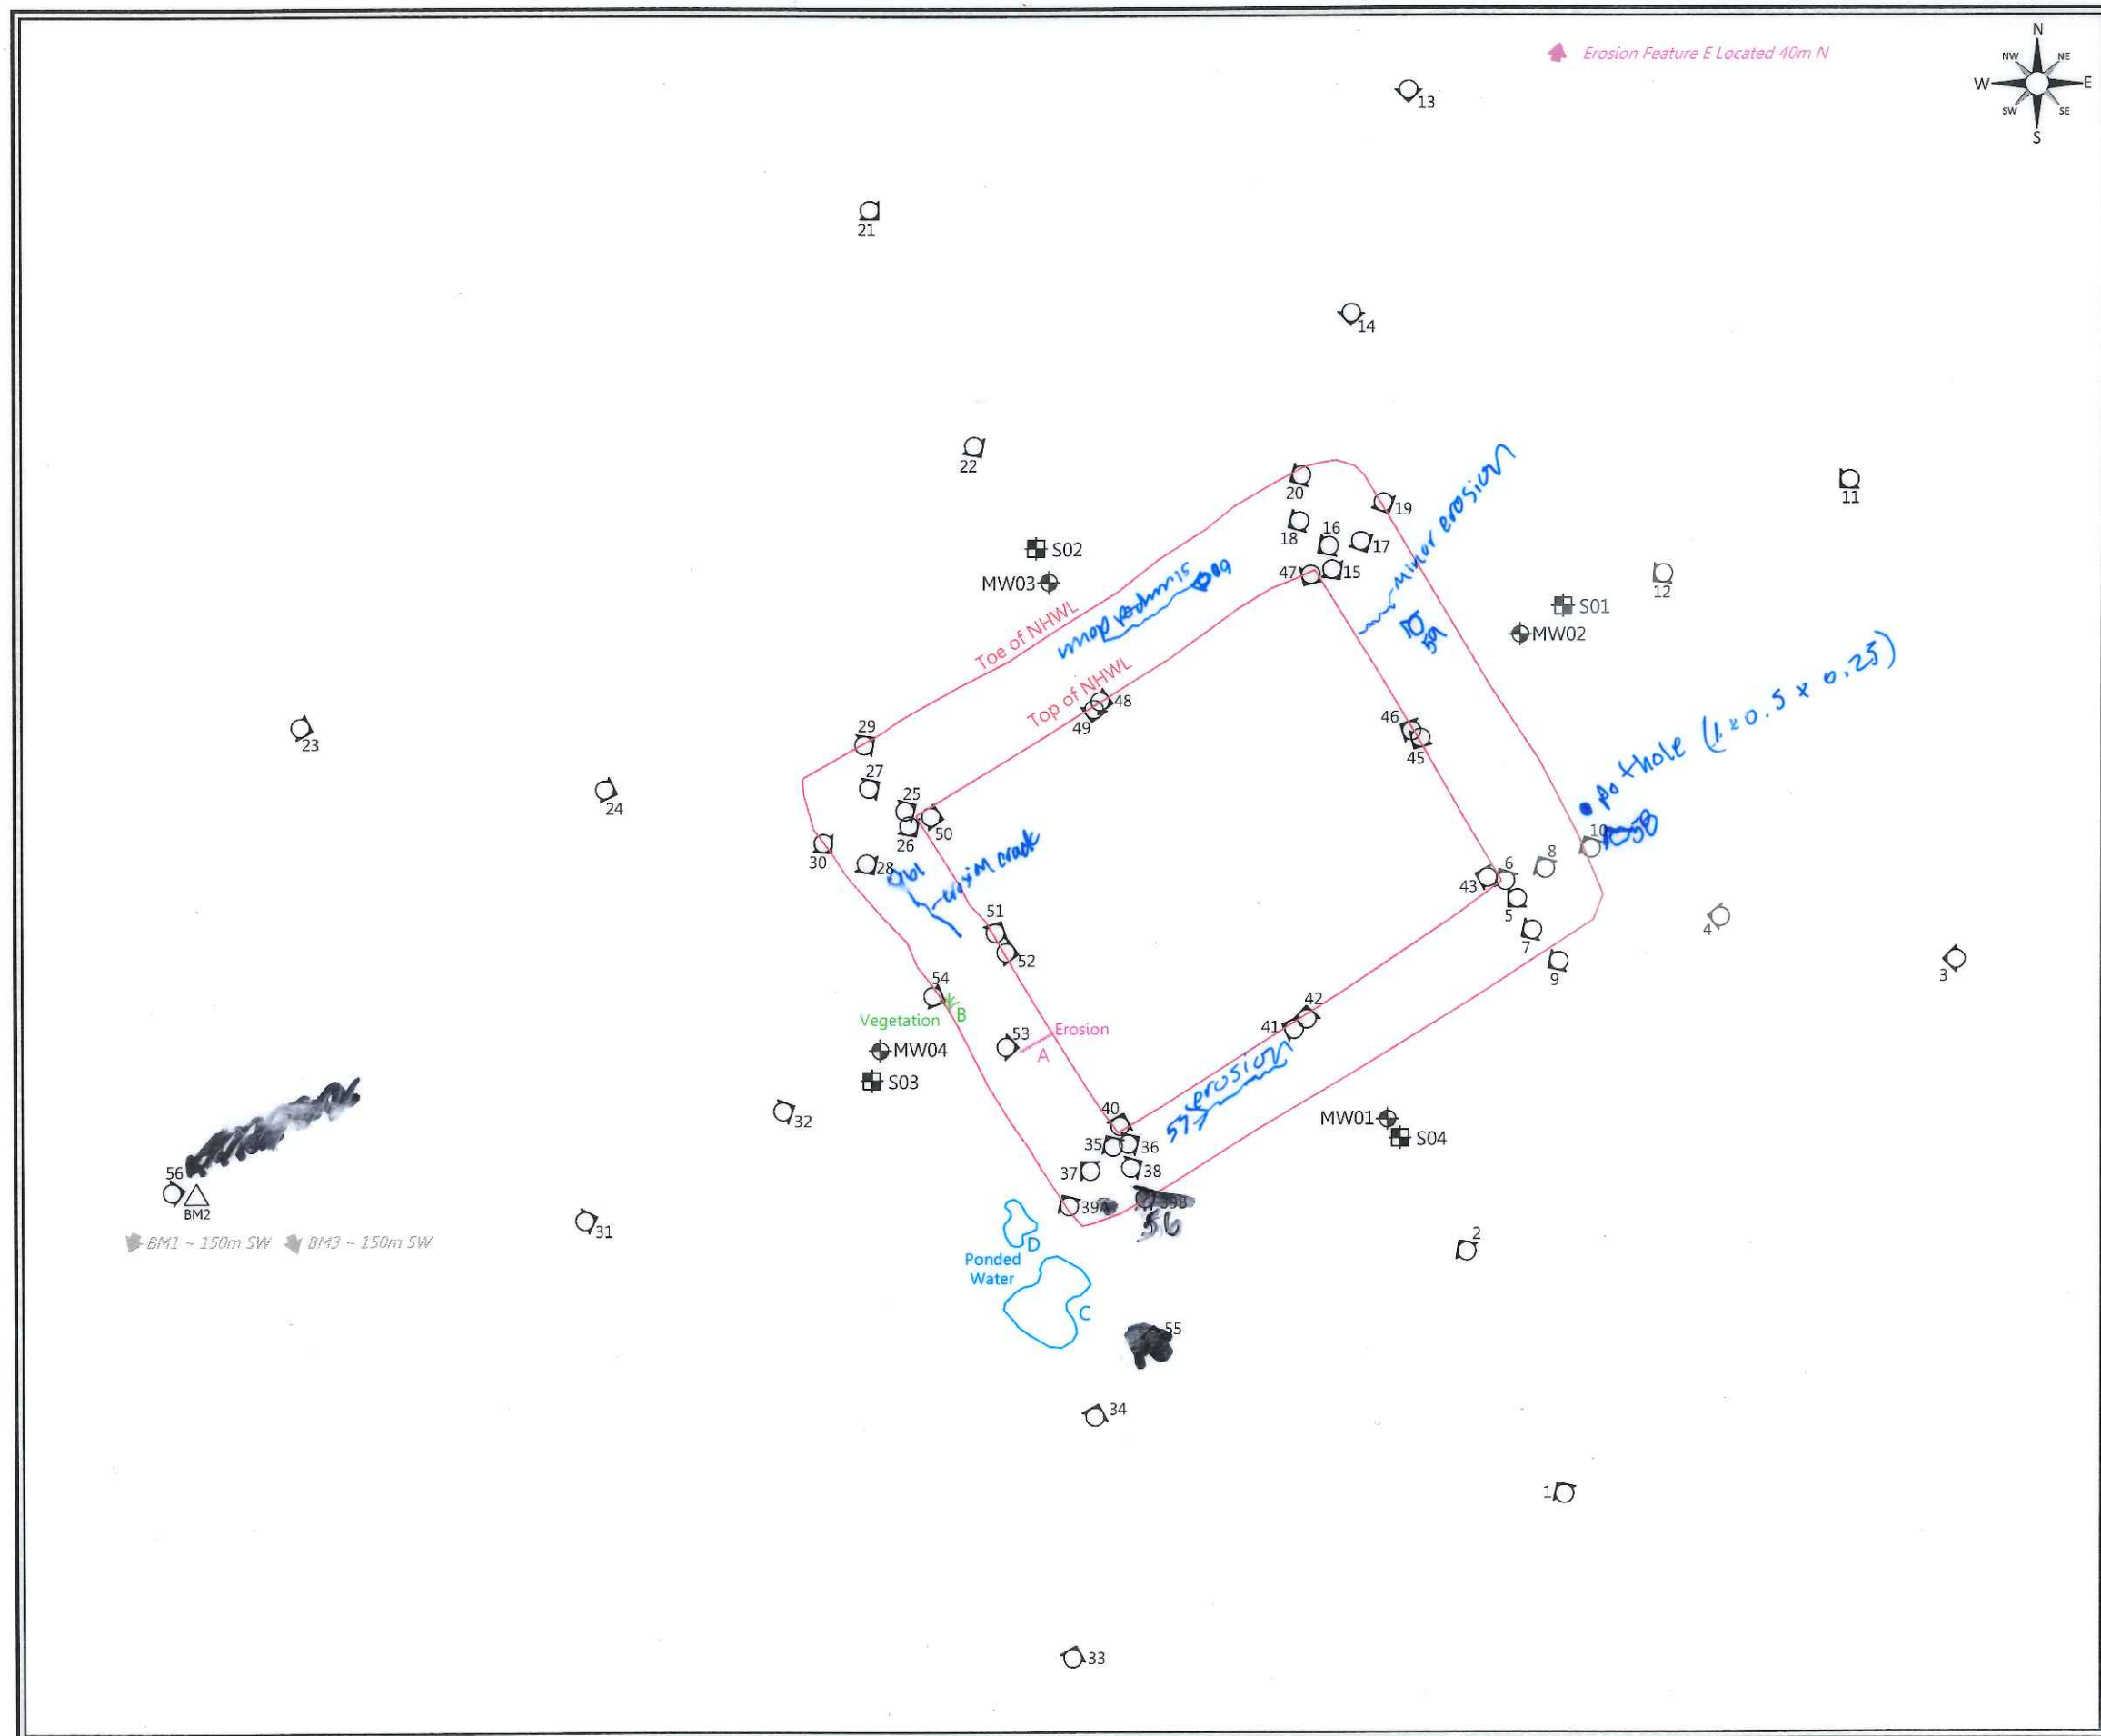
- erosion features to add - see map.
