## **Long-Term Monitoring, 2014 CAM-D, Simpson Lake, Nunavut**

### **FINAL REPORT**

Project No. 1697-1401  
March 13, 2015

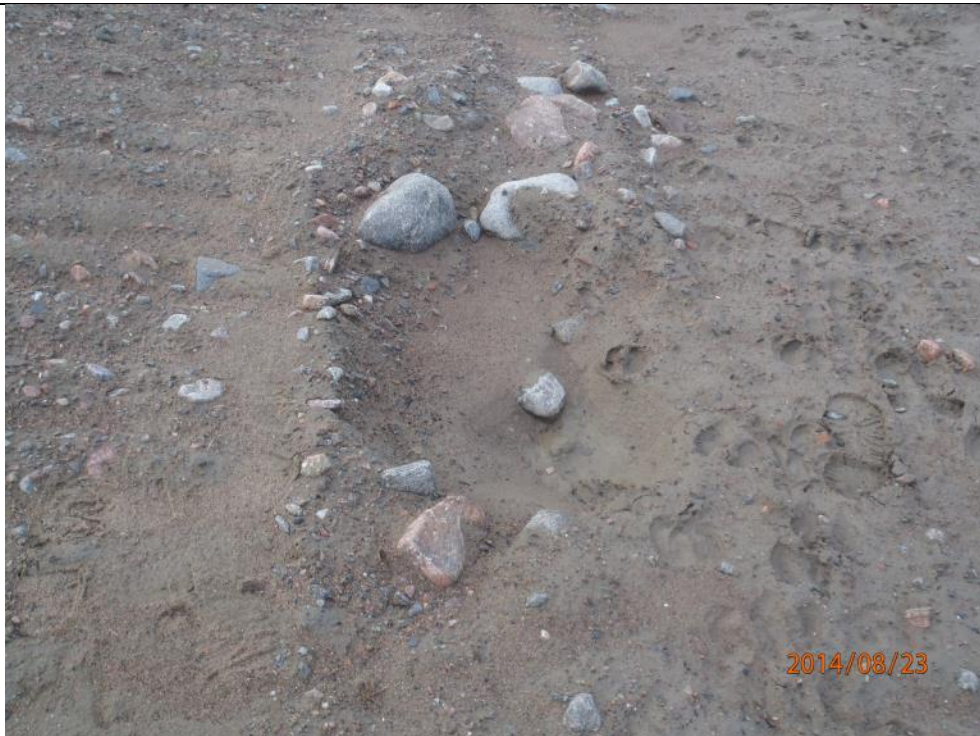
Areas of settlement were not observed. One small pothole was observed along the base of the east corner of the NHWL. This pothole was considered small in nature and does not impact the integrity of the landfill.

Pothole on east corner of NHWL. Viewpoint 58 (Figure A-2; Appendix A). Photograph reference P8230058.  
Direction photo taken: NA

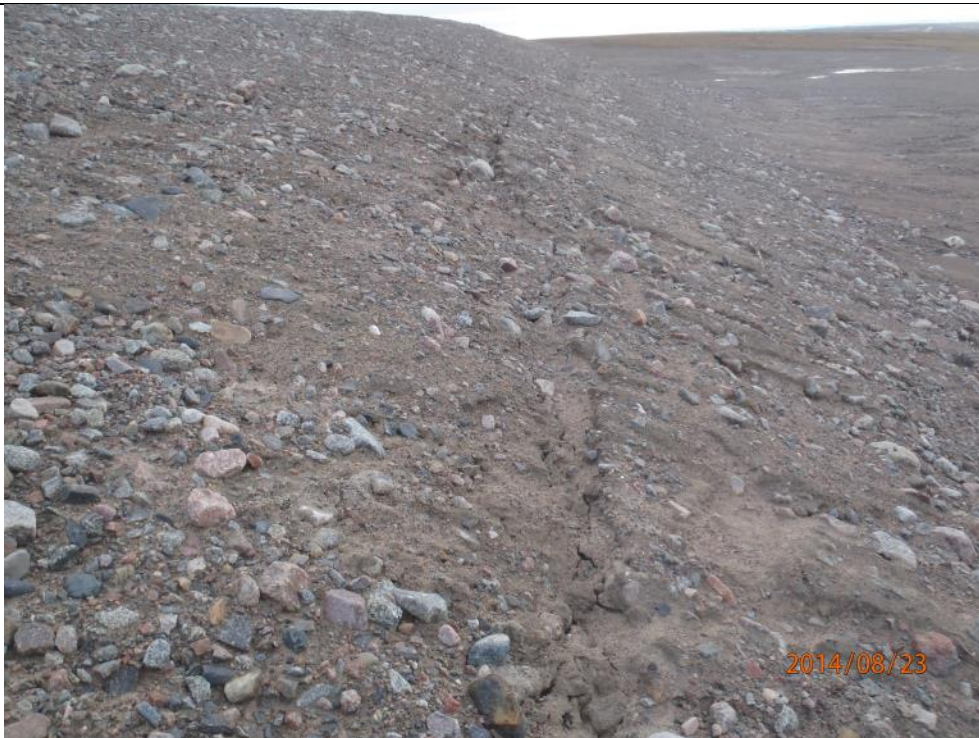
Two small areas along the northwest and southwest sides of the landfill had evidence of erosion. Two small erosion rills were observed which are likely due to preferential drainage and associated down-slope washing of fine-grained fill between cobbles and boulders.

Erosion on northwest berm. Viewpoint 60 (Figure A-2; Appendix A). Photograph reference P8230060.  
Direction photo taken: SW

Based on the results of Year 3 of long-term monitoring at CAM-D, FRANZ recommends continued monitoring of the areas of erosion on the berms of NHWL and the road from the airstrip to the NHWL.
