**CAM-D Simpson Lake Long Term Monitoring Event  
Kivalliq Region, Nunavut**

**2018 Long Term Monitoring Report**

**CROWN-INDIGENOUS RELATIONS AND NORTHERN AFFAIRS CANADA  
NUNAVUT REGIONAL OFFICE**

**December 2018  
SLR Project No. 209.40585.00000**

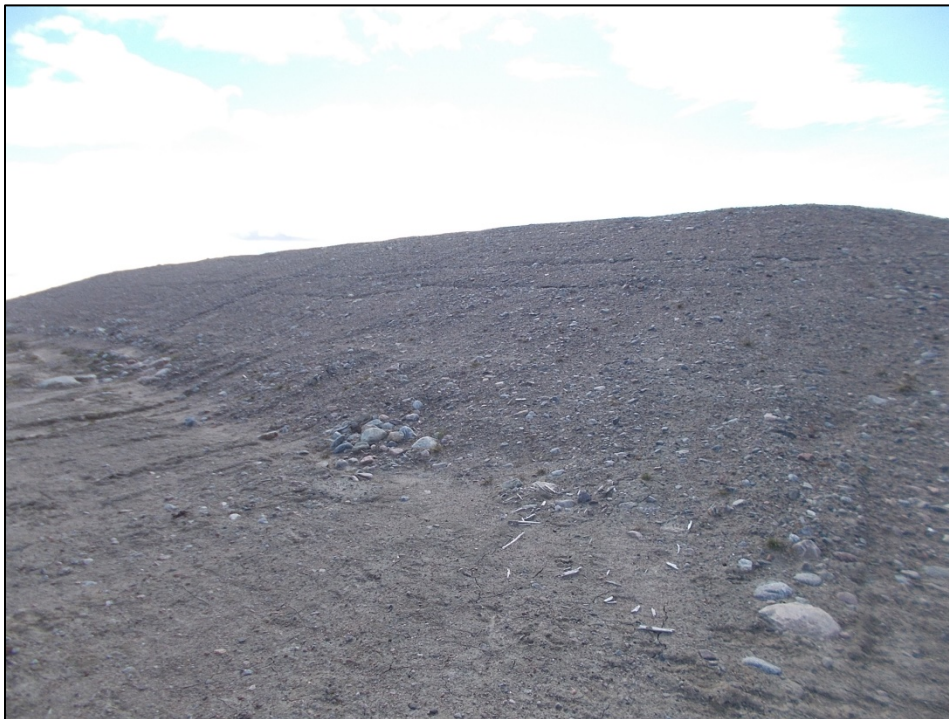
Evidence of frost action or cracking was observed on all flanks of the NHWL (**Photos 1-7, Appendix A**). Comparison with photographs from the 2016 monitoring event reveals cracking on the NE side of the NHWL appears to have grown in size and extent.

**Photograph 1. View along NE Flank, facing SE**

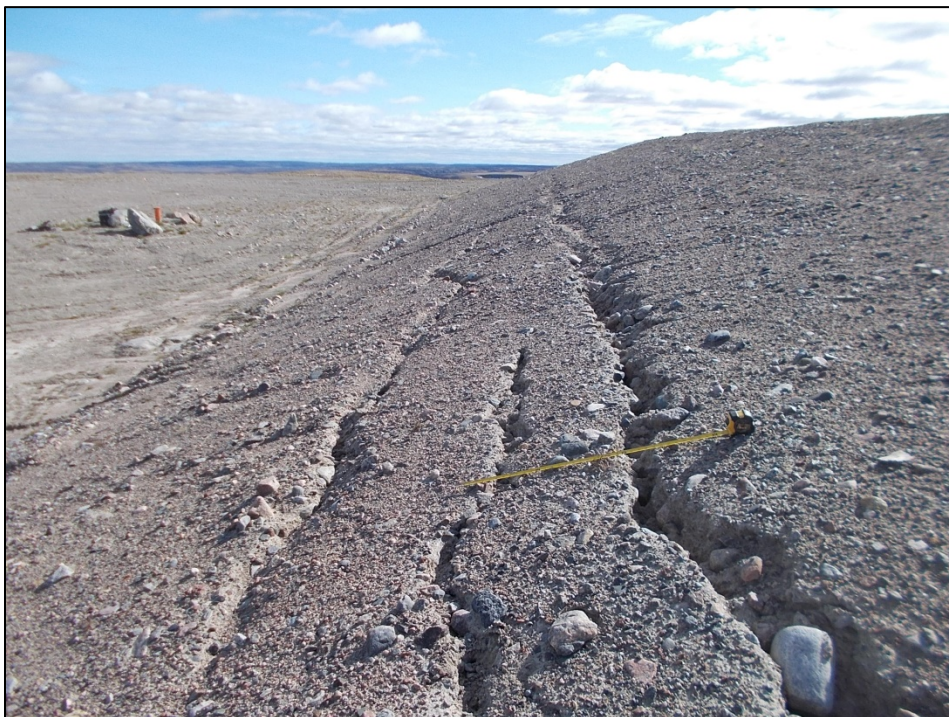
The previous monitoring report classified the NHWL as marginal with respect to these cracking features, meaning the physical performance appears to be deteriorating with time. Currently, the cracks do not expose any debris from the NHWL and do not appear to impact the landfill stability to date. However, these cracks should be monitored closely during future monitoring events as potential for failure is assessed at low to moderate.

**Photograph 2. Cracking along NE Flank, facing SE**

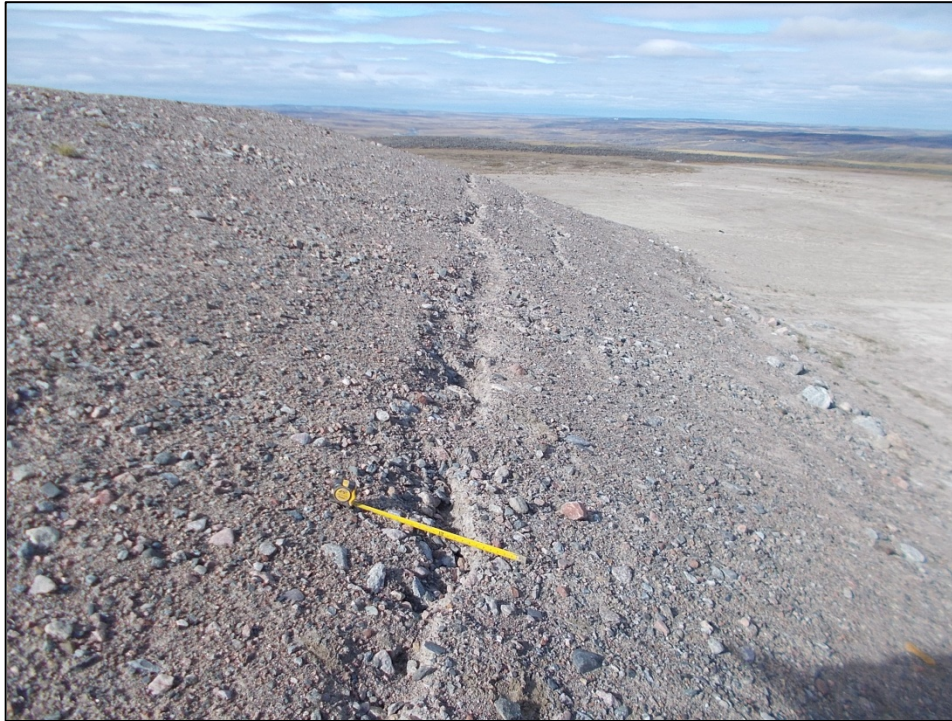
Erosional features have been previously noted on the SW and NE flanks of the NHWL. These features were observed in 2018 but appear to be of similar size and extent as observed previously (**Photo 3, Appendix A, Photo 32, Attached USB**).

**Photograph 3.** Cracking on NE flank, facing NW

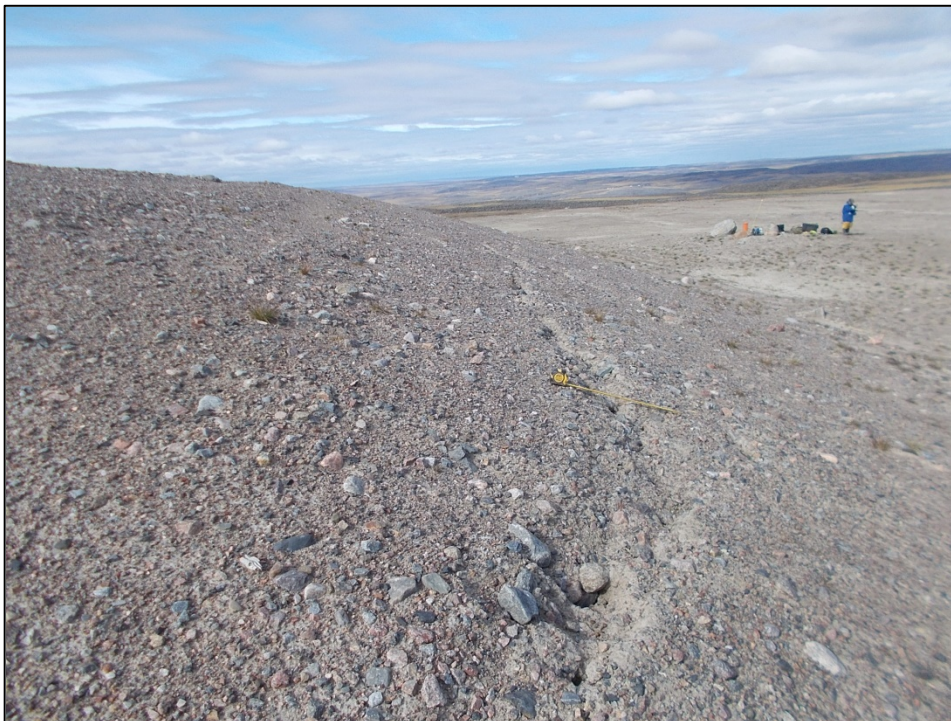
**Photograph 4.** Cracking on NE flank, facing NW

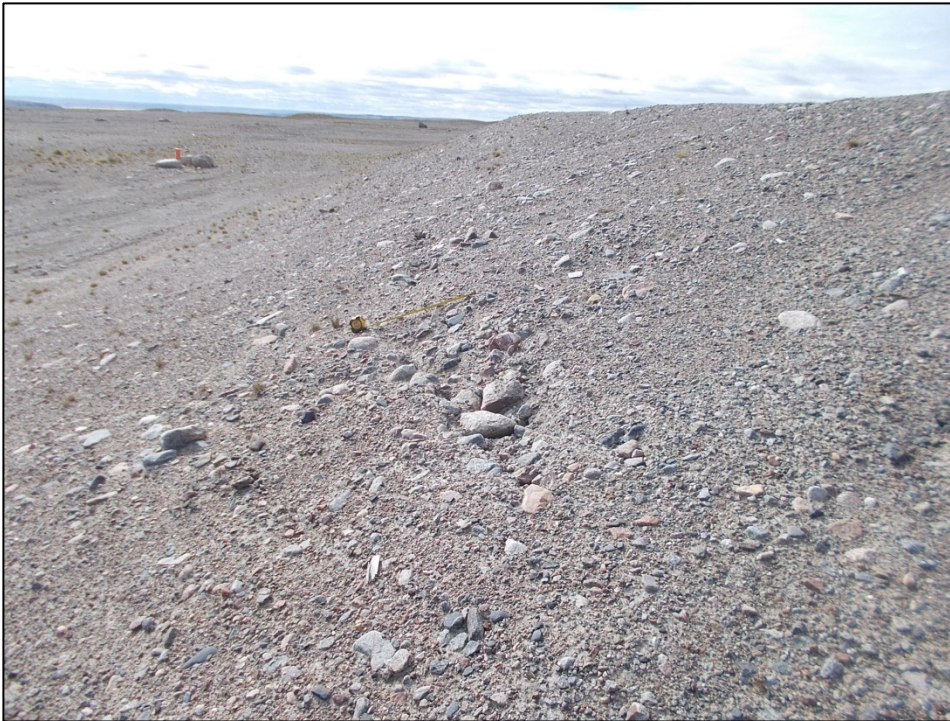
**Photograph 5.** Cracking on SE flank, facing SW

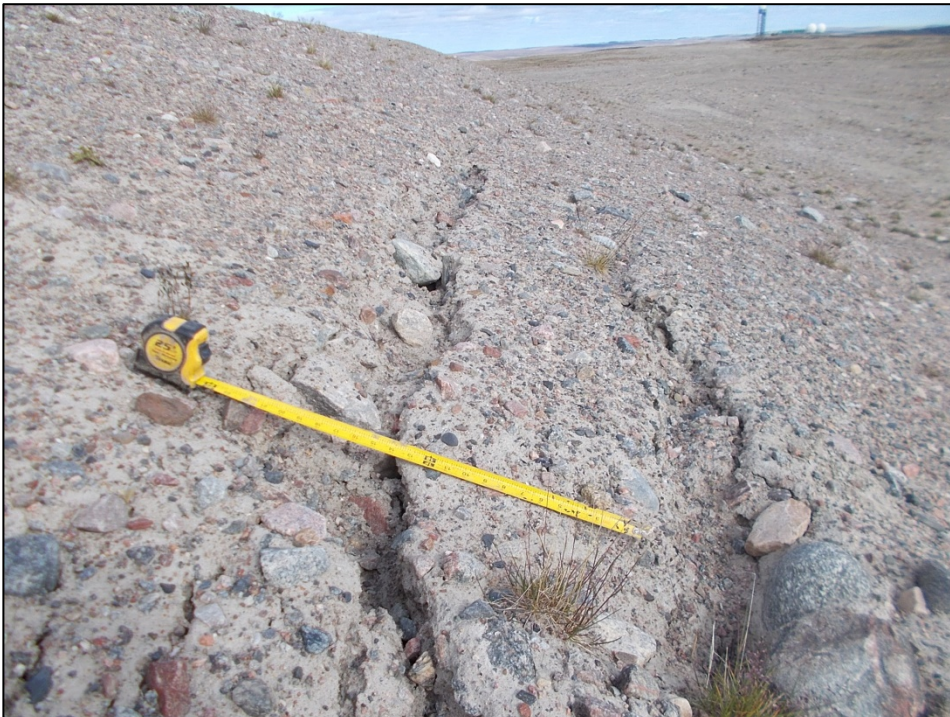
**Photograph 6.** Cracking on SE flank, facing NE

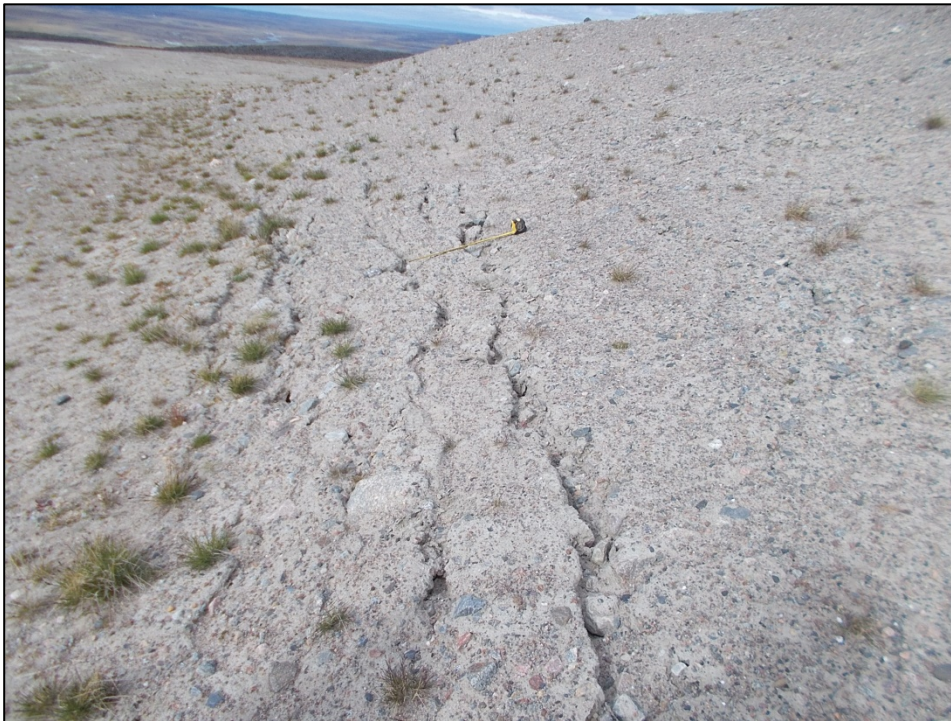
Additional erosional features were noted on the NW flank (**Photo 9, Appendix A**), and the SW flank (**Photo 7, Appendix A**). These erosional features are characterized by exposed cobbles, runnels, and minor sediment slumping. Currently, these features do not appear to be impacting the integrity of the landfill.

Re-establishment of vegetation is likely to take a significant amount of time due to the coarse materials used to construct the landfill (i.e. coarse gravel) and due to the fact that the growing season is short in northern regions. Vegetation regrowth was observed on the SW flank of the NHWL; however, cover is still less than 5% (**Photo 7, Appendix A**).

**Photograph 7.** Erosion on SW flank, facing NE

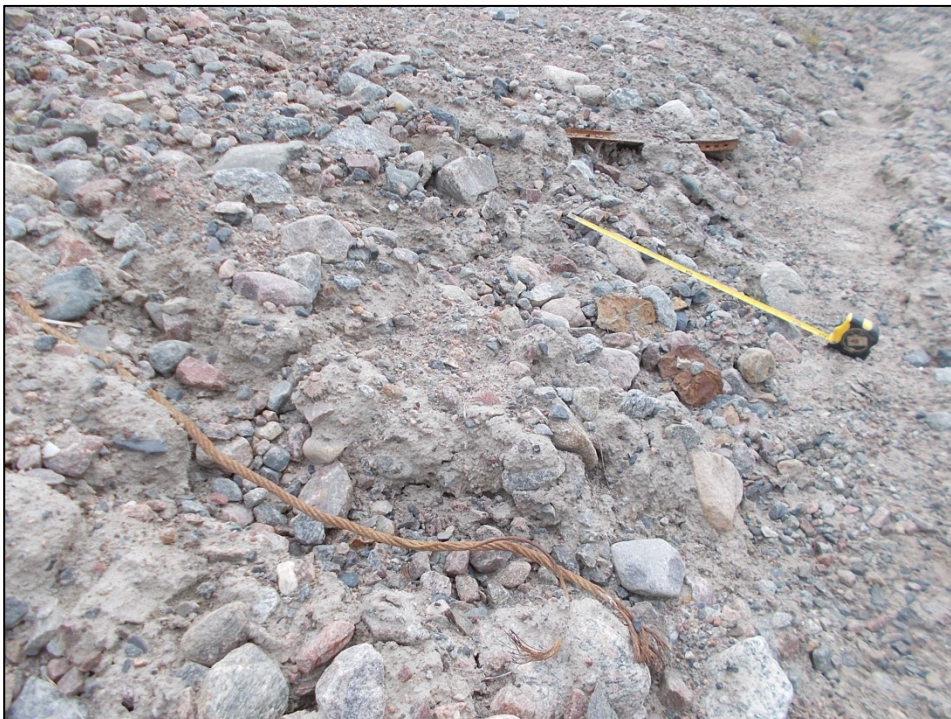
**Photograph 8.** Metal debris on NW flank, facing NW

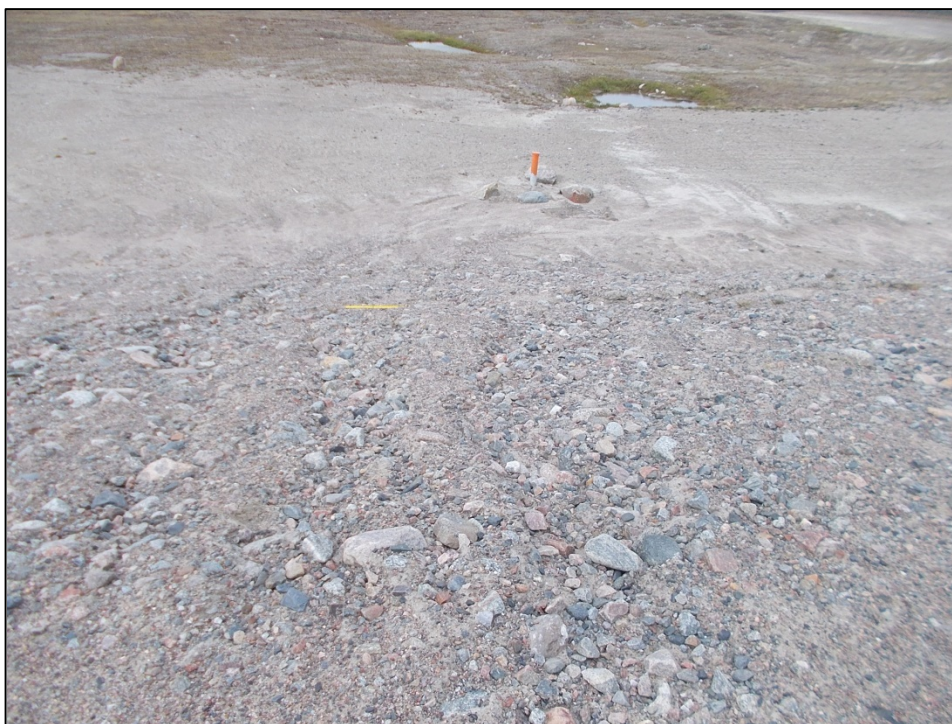
**Photograph 9.** Erosion on NW flank, facing NW

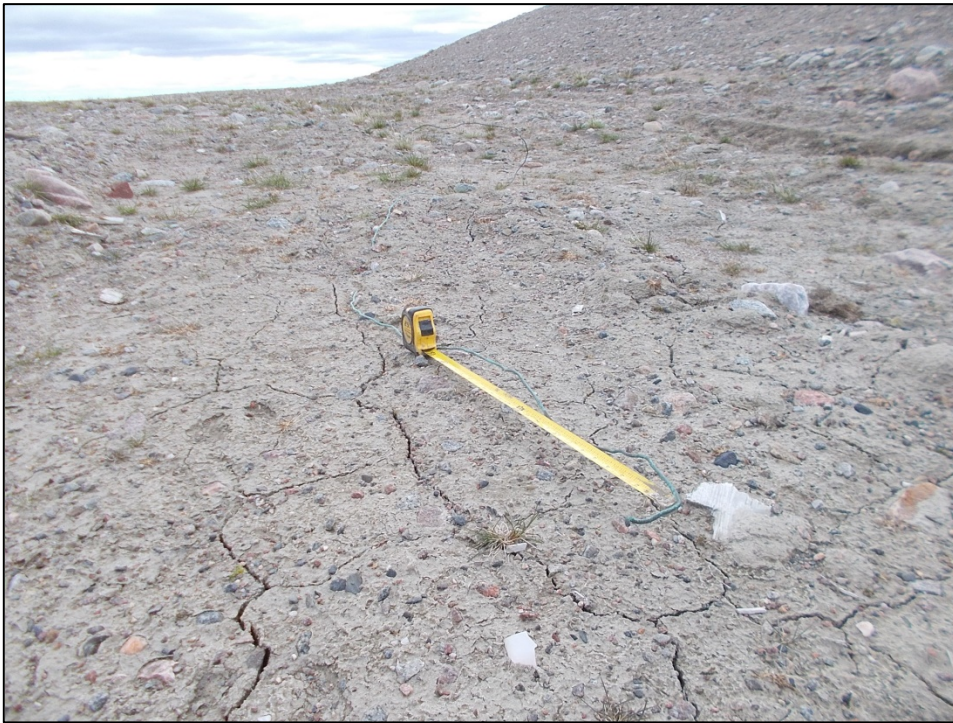
**Photograph 13.** Wire at toe of landfill cap, facing SE

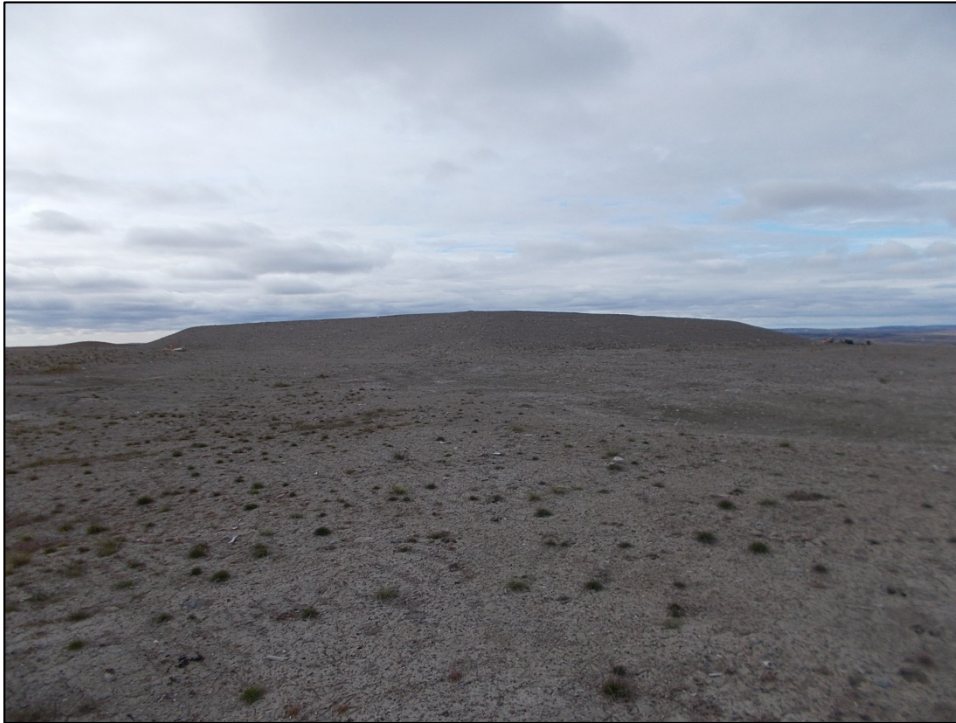
Many depressions are located on the landscape surrounding the NHWL and are thought to be naturally occurring (**Photos 15, 18, and 19, Appendix A**). Many of these depressions were filled with ponded water during the last site visit but have since dried. Cracking in the sediment is observed where ponded water has evaporated. The settlement does not appear to have grown in size since the last monitoring event.

**Photograph 15.** East corner of NHWL, facing W

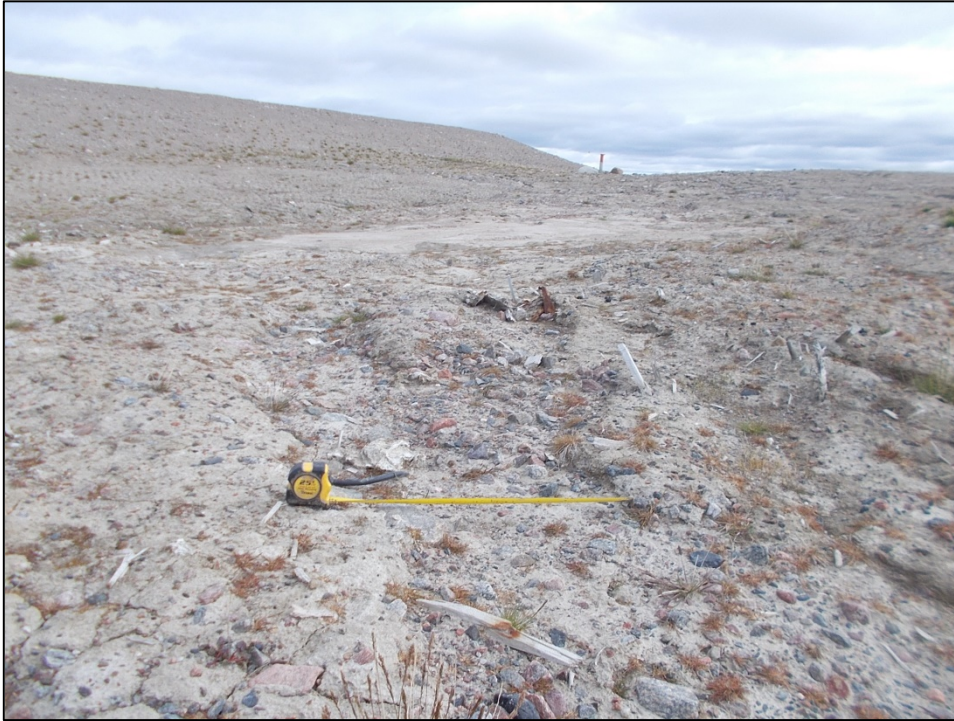
**Photograph 17.** Erosion on SW flank, facing W

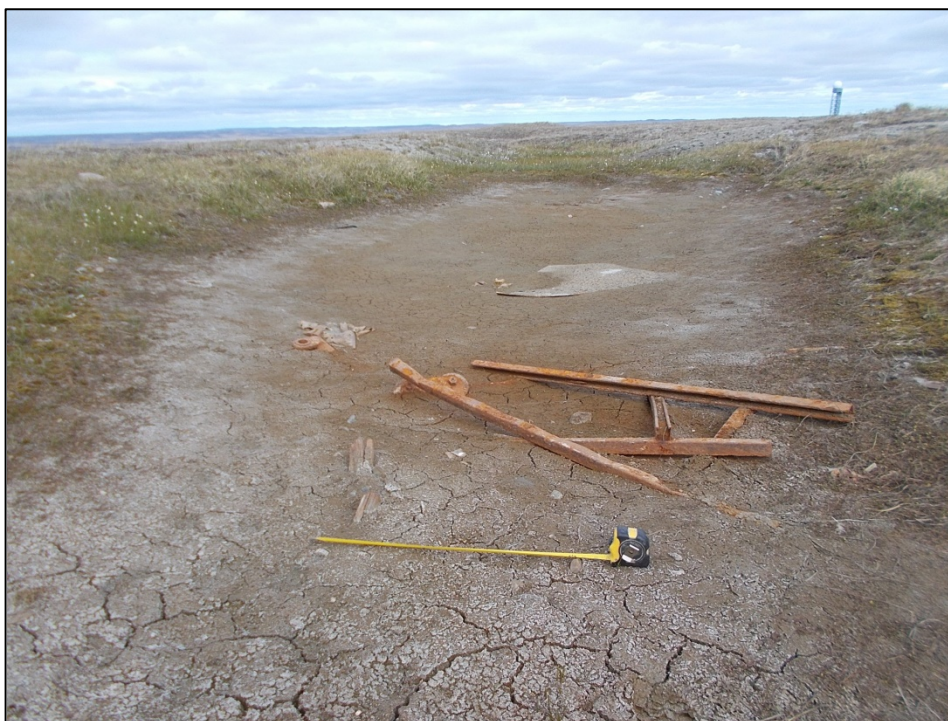
Exposed debris was observed in multiple areas on and surrounding the NHWL. A pile of metal debris was observed NE of the NHWL (**Photo 19, Appendix A**). The debris appears as though it may be situated in an area of previously ponded water. The debris does not appear to be associated with the NHWL.

**Photograph 19.** Metal debris NE of Landfill, facing N

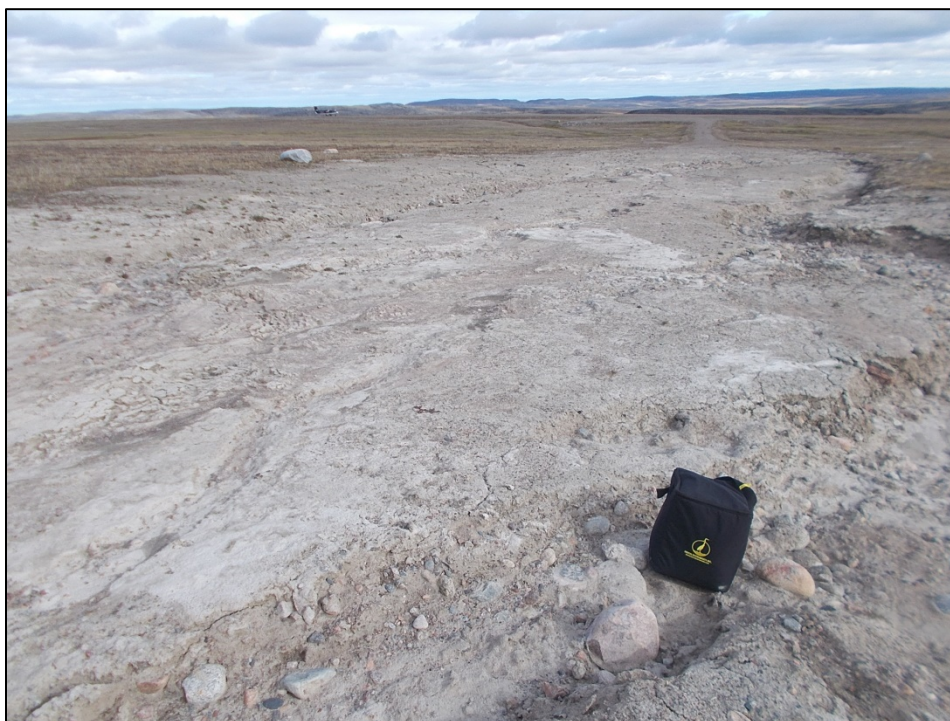
Erosion was noted on the access road leading from the airstrip to the NHWL (**Photo 20, Appendix A**). The erosion does not currently pose any access issues to the NHWL.

The access road leading from the airstrip to the NHWL continues to erode although the erosion does not pose any access issues at the moment (**Photo 20, Appendix A**). A culvert that was created out of old drums is located along the access road to the NHWL. The culvert itself appears to be in good condition, but cracking is noted along the road in the area where the culvert is buried (**Photo 21, Appendix A**). The airstrip appears to be in good condition and no issues were noted.

**Photograph 20.** Erosion on access road, facing E

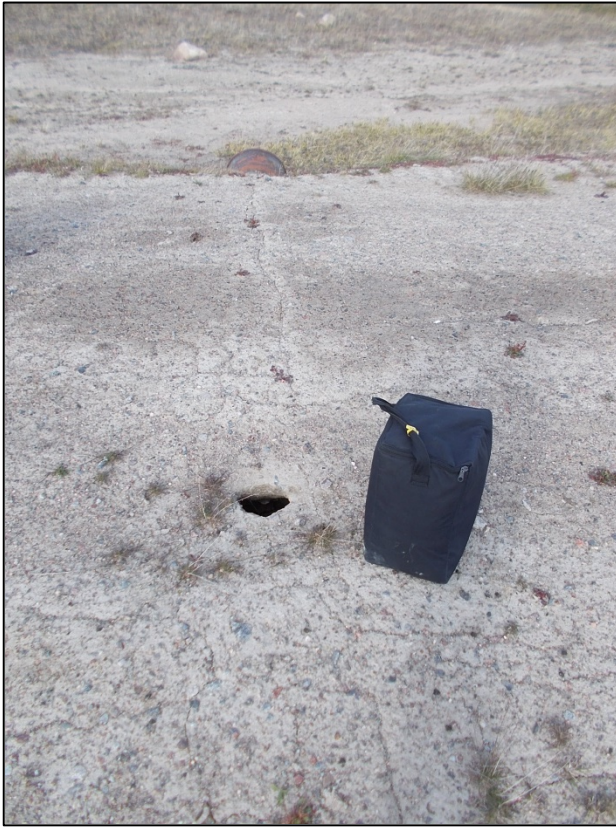
No wildlife was observed during the site visit. Caribou tracks and scat, goose tracks, and siksik burrows were observed on the access road and areas surrounding the NHWL (**Photo 21, Appendix A**).

**Photograph 21.** Siksik burrows and cracking from culvert on access road
