**ENVIRONMENTAL IMPACT ASSESSMENT
SPEERS LAKE SITES
KITIKMEOT REGION, NUNAVUT**

BLM-KEL-60

Project Number: 240355

March 31, 2025

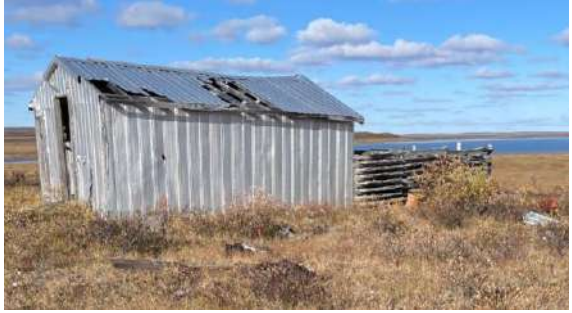
1	Debris Area 2 consists of the area within AEC 2, located approximately 15 m north of Debris Area 1. This area contains the metal sided and roofed core shed, which was observed to be still standing. Additionally, 3 upright core racks and 3 collapsed core racks, both containing cores were observed. One lead acid battery, collapsed outhouse and associated toilet, 3 metal cots, insulation, plywood, scrap metal and one full metal barrel were also observed in this area.	<p>205 L of liquid in one barrel Lead acid battery</p> <p>Total Liquid: 205 L Total Other: 1 battery</p>	<p>Misc. building debris: 20 m³ Metal barrels (crushed): 0.3 m³ (0.04 m³) Misc. metal debris: 1 m³ Cores and racks: 6 m³</p> <p>Total: 27.3 m³ (27.04 m³ crushed)</p>
2	<p>Main Collapsed Structure and Metal Debris</p>

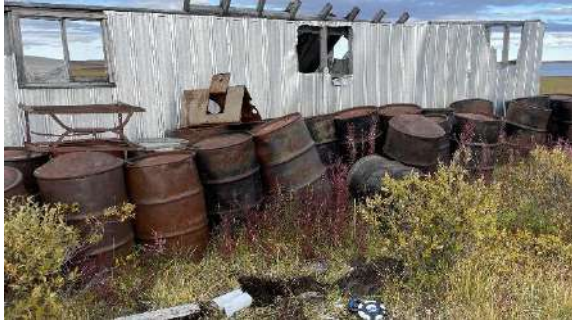
2	Debris Area 1 consists of the area within APEC 1. This area comprises of the largest partially collapsed structure on the site and contains mixed building material debris in the form of: metal siding, metal roof, dimensional lumber, plywood, pink insulation and wood shelving, mixed metal debris in the form of stove piping, metal bed frames and piping scattered throughout. Additionally, 33 metal barrels (of which 4 were full and 2 half-full) and 2 mini barrels were observed grouped along the exterior southern wall of the structure. 1 additional full barrel was observed on the west side as well as 5 barrels on the east side of the structure. Scrap metal drill casings were observed along the north side of the structure.	<p>5 full and 2 half full barrels</p> <p>Total Liquid: 1230 L</p>	<p>Misc. building debris: 45 m³ - includes 22.5 m³ of wood Misc. metal debris: 2 m³ Metal barrels (crushed): 12 m³ (1.6 m³)</p> <p>Total: 59 m³ (48.6 m³ crushed)</p>

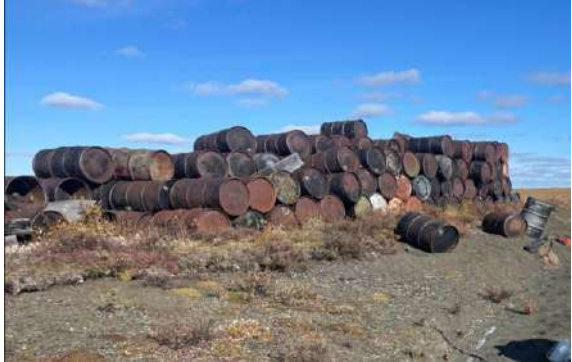
3	Debris Area 3 consists of the area within AEC 3, and the beach area directly to the east. This area is located approximately 80 m northeast of Debris Area 1. There are 194 barrels, 16 mini barrels and 1 jerry can in this area. The barrels and jerry can were empty. Scattered scrap metal including metal cots and an anchor; wood debris including a collapsed dock; and 2 lead batteries were also observed in this area.	<p>2 lead batteries</p> <p>Total Other: 2 batteries</p>	<p>Metal barrels (crushed): 60.6 m³ (8.08 m³) Wood debris: 2.5 m³ Metal debris: 1.3 m³</p> <p>Total: 64.4 m³ (11.88 m³ crushed)</p>
4	<p>Historical Structure and Debris</p>

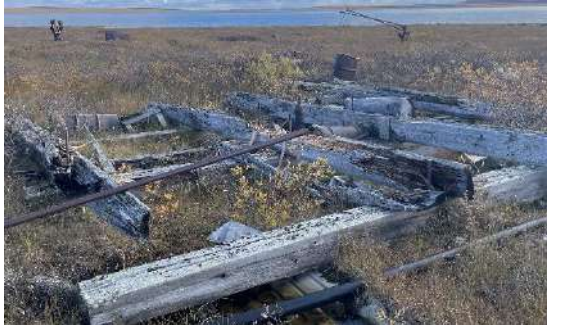
4	Debris Item 4 consists of the area within APEC 4. The area consists of scrap wood, metal, and barrels. A wooden floor structure is in the middle of the APEC and around this structure 4 metal basins, 2 metal barrels, drill casings that had sunken into the earth, one smaller collapsed wooden structure, a metal lift, plastic tubing, a drill head still in the ground, and scattered scrap metal were observed. Additionally, 37 barrels were observed in the area. The barrels were empty.	<p>None</p>	<p>Structure debris: 15 m³ - includes 7.5 m³ of wood Metal barrels (crushed): 11.7 m³ (1.56 m³) Misc. wood debris: 2 m³ Misc. metal debris: 8 m³ Metal drill casings: 5 m³ Plastic tubing: 1 m³</p> <p>Total: 42.7 m³ (32.56 m³ crushed)</p>

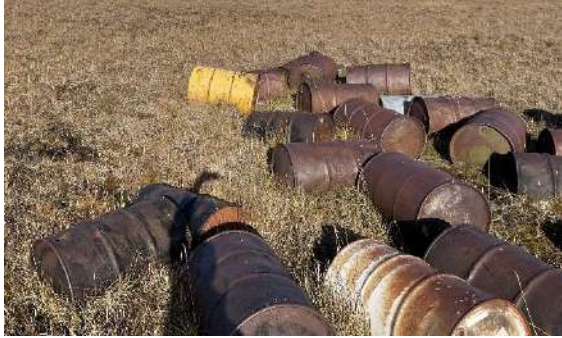
5	Debris Item 5 consists of the area within AEC 5. This debris is largely metal barrels. One group of 26 metal barrels were observed in this area in addition, 2 barrels were full.	410 L in 2 full barrels Total Liquid: 410 L	Metal barrels (crushed): 7.8 m ³ (1.04 m ³) Total: 7.8 m³ (1.04 m³ crushed)
6	Scattered Debris in South Beach Area

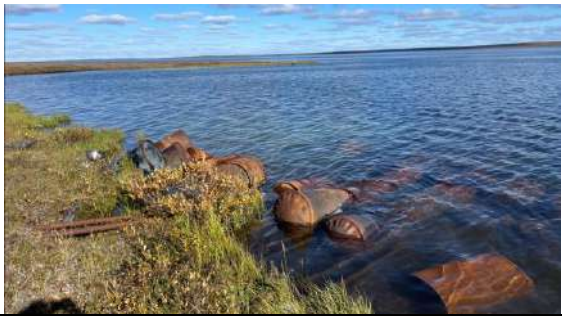
6	Debris Item 6 consists of the area within AEC 6. This debris is made up of 19 metal barrels in a group submerged in the water (some of which have partially disintegrated), and 10 additional barrels along the shoreline, one of which was full. Scattered metal debris including >100 drill casings (most submerged in water) and wood debris is also present throughout the area.	205 L in 1 full metal barrels Total Liquid: 205 L	Metal debris: 12 m ³ Wood debris: 2 m ³ Metal barrels (crushed): 8.7 m ³ (1.16 m ³) Total: 22.7 m³ (15.16 m³ crushed)

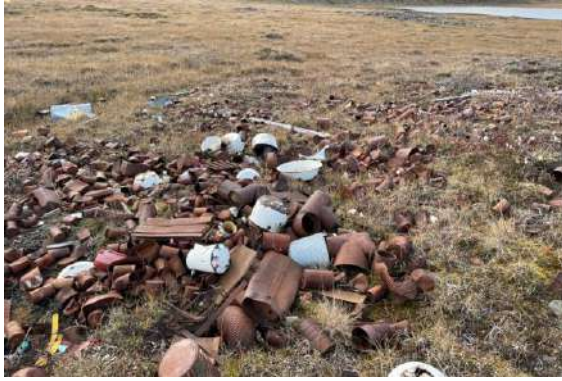
-	Debris Item 7 consists of scattered miscellaneous metal debris located approximately 170 m northwest of Debris Item 1.	None	Metal debris: 2 m ³ Total: 2 m³
8	Scattered Plastic Debris

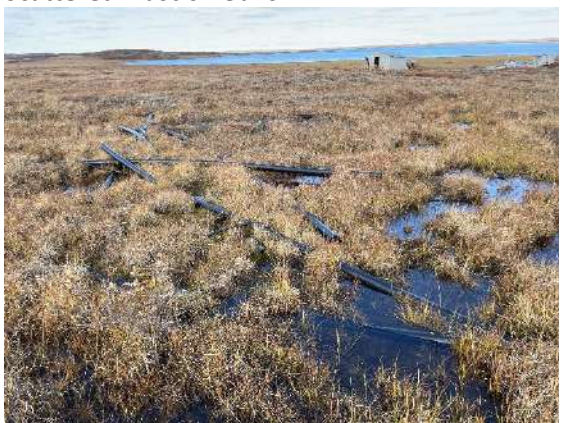
-	Debris item 8 consists of scattered plastic pipe located approximately 60 m south west of APEC 1.	-	Plastic Debris: 3 m ³ Total: 3 m³

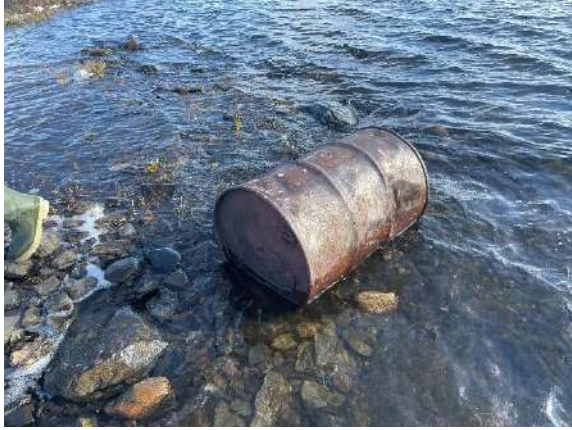
Debris item 9 consists of a barrel on the shoreline approximately 60 m northeast of AEC 3.	-	Metal barrels (crushed): 0.3 m ³ (0.04 m ³) Total: 0.3 m³ (0.04 m³ crushed)
Total Volume Estimates				Total Liquid: 2,050 L Total Other: 3 lead acid batteries	Total (debris): 229.2 m³ (141.32 m³ crushed)

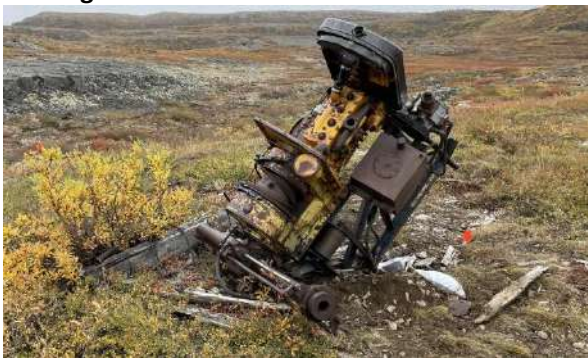
1	Debris Item 1 consists of a disused drill rig. Yellow paint was observed on the drill rig. A sample of this paint was sent for analysis, and it was confirmed to be lead containing.	<p>Lead Paint: 2 m² (assumed 2.25 m³ volume of lead painted metal debris)</p> <p>Total: 2 m² (2.25 m³ painted metal debris)</p>	<p>Metal debris: 2.25 m³</p> <p>Total: 2.25 m³</p>
2	<p>Misc. Metal, Drill Rods and Wood Debris</p>

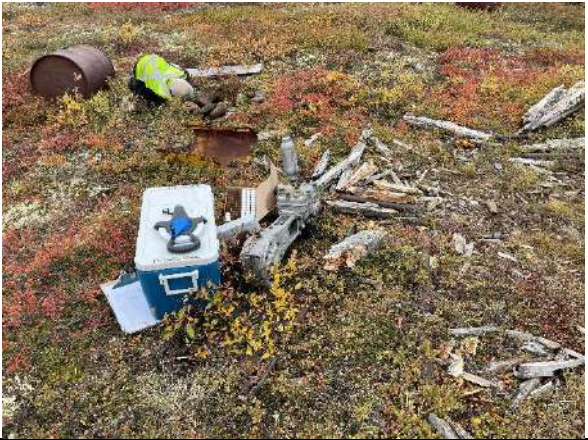
1	Debris Item 2 consists of approximately 16 to 20 metal drill rod casings, ranging in length from 1.2 to 1.8 metres scattered in the area immediately around and to the south of the drill rig. Other miscellaneous metal and wood debris were observed in this area as well, including an additional smaller sized internal combustion motor.	None	<p>Metal drill rods: 1 m³</p> <p>Other metal debris: 1.25 m³</p> <p>Wood debris: 0.75 m³</p> <p>Total: 3.0 m³</p>

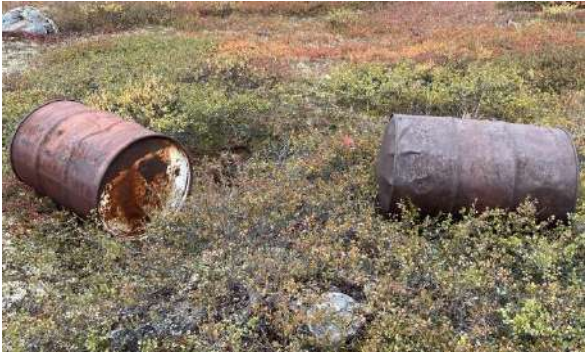
1	Debris Item 3 consists of five 205 litre metal barrels scattered in the area to the south of the Debris Item 1 drill rig.	None	<p>Metal barrels (crushed): 1.5 m³ (0.2 m³)</p> <p>Total: 1.5 m³ (0.2 m³ crushed)</p>
4	<p>Misc. Metal Debris</p>

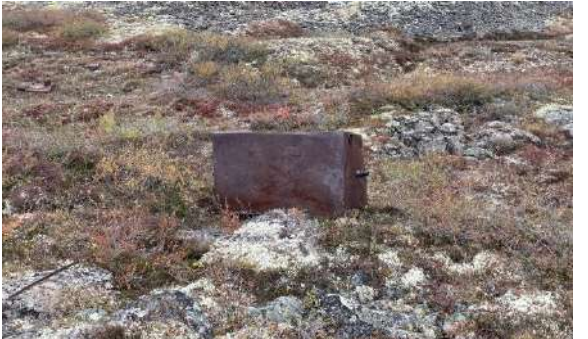
-	Debris Item 4 consists of miscellaneous metal debris scattered to the west of Debris Item 1.	None	<p>Metal debris: 1.13 m³</p> <p>Total: 1.13 m³</p>

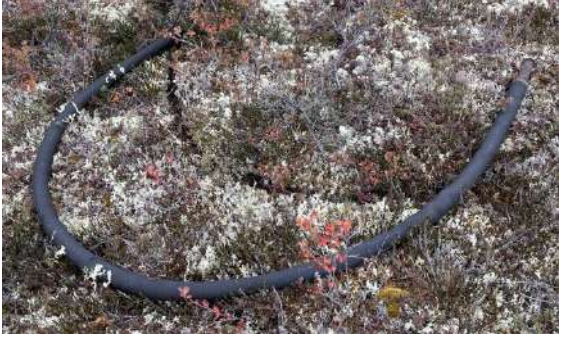
1	Debris Item 5 consists of two lengths of hydraulic hose located approximately three to five metres to the west of Debris Item 1.	None	<p>Hydraulic hose: 0.2 m³</p> <p>Total: 0.2 m³</p>
6	<p>Kitchen Stove and other Misc. Debris</p>

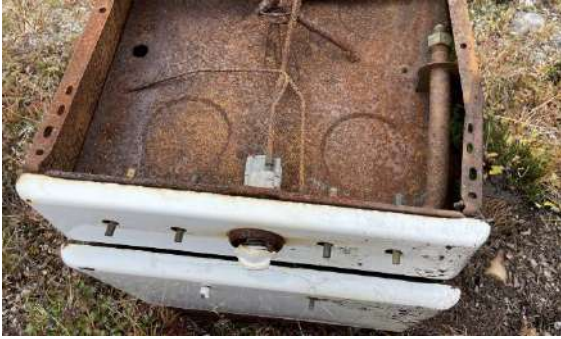
3	Debris Item 6 consists of a metal kitchen stove and other miscellaneous metal and wooden debris scattered around the area of sample WK154-TP12 approximately 135 m to the south of Debris Item 1.	None	<p>Metal stove: 1 m³</p> <p>Misc. Metal: 0.25 m³</p> <p>Misc. Wood: 0.25 m³</p> <p>Total: 1.5 m³</p>
7	<p>Metal Barrel</p>

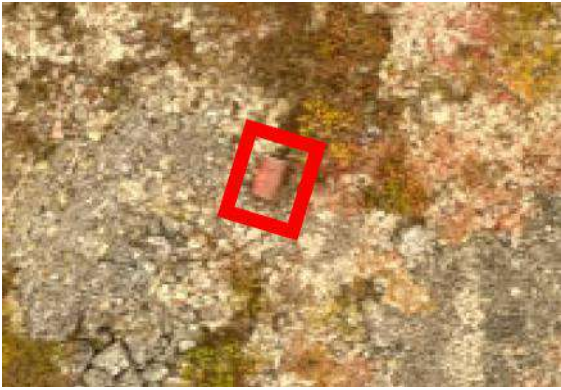
2	Debris Item 7 consists of one metal barrel located approximately 25 metres north of Debris Item 1.	None	<p>Metal barrels (crushed): 0.3 m³ (0.04 m³)</p> <p>Total: 0.3 m³ (0.04 m³ crushed)</p>
8	<p>Metal Barrel</p>

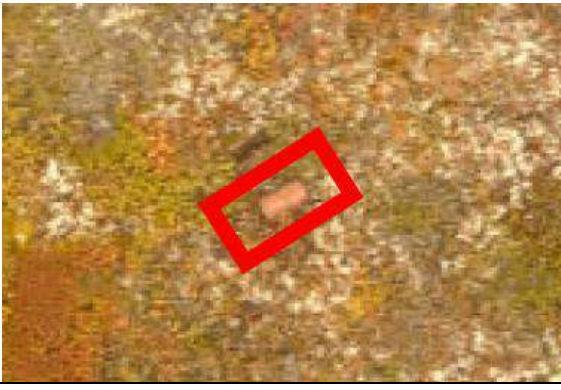
3	Debris Item 8 consists of one metal barrel located approximately 40 metres southwest of Debris Item 6.	None	<p>Metal barrels (crushed): 0.3 m³ (0.04 m³)</p> <p>Total: 0.3 m³ (0.04 m³ crushed)</p>

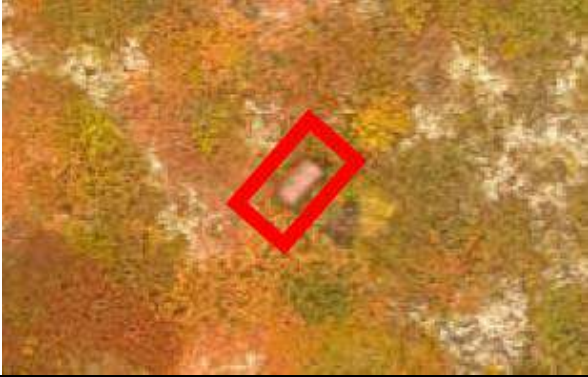
3	Debris Item 9 consists of one metal barrel located approximately 40 metres west of Debris Item 6.	None	<p>Metal barrels (crushed): 0.3 m³ (0.04 m³)</p> <p>Total: 0.3 m³ (0.04 m³ crushed)</p>
10	<p>Metal Barrel</p>

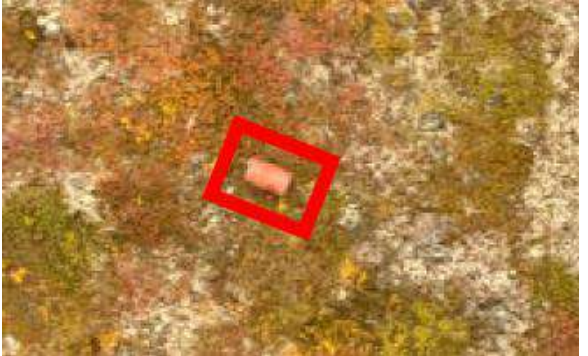
3	Debris Item 10 consists of one metal barrel located approximately 40 metres north of Debris Item 6.	None	<p>Metal barrels (crushed): 0.3 m³ (0.04 m³)</p> <p>Total: 0.3 m³ (0.04 m³ crushed)</p>
11	<p>Rubber Hose and Metal debris</p>

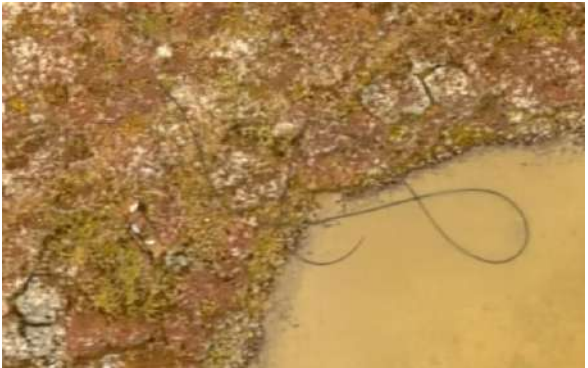
-	Debris Item 11 was seen after review aerial photography of the Site. This area is located approximately 170 m south east of AEC 1. Debris Item 11 consists of some rubber hose, as well as some metal debris which looks to be consistent with the items found in debris item 4.	None	<p>Metal debris: 2 m³ Rubber hose: 1 m³</p> <p>Total: 3 m³</p>

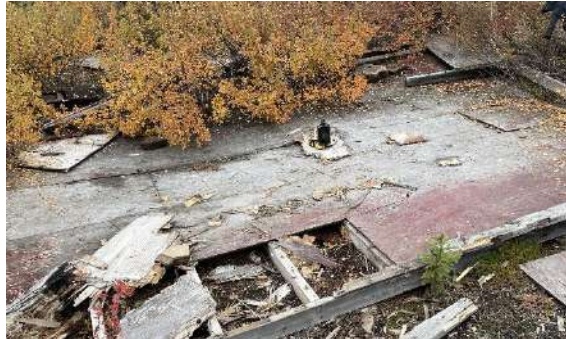
3	<p>Debris Item 1 consists of the area within APEC 3. All structures in this area have collapsed. Two former tent pads with a 3.7 m by 4.9 m base made of plywood and dimensional lumber were present. Red paint was present on most of the debris in this area. A sample of this paint was obtained and sent for analysis and came back as non-hazardous. Also present is half of a metal barrel (empty).</p>	None	<p>Wood debris: 6.75 m³ Metal barrels (crushed): 0.3 m³ (0.04 m³)</p> <p>Total: 7.05 m³ (6.79 m³ crushed)</p>
2	<p>Large Tent Pad in APEC 4</p>

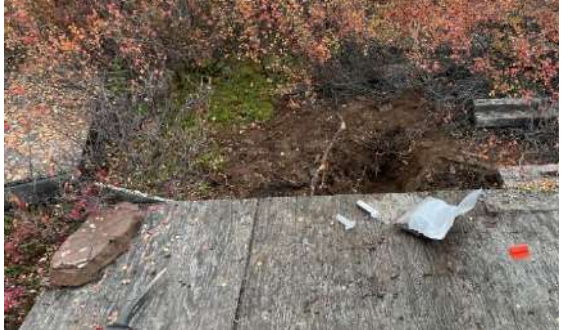
4	<p>Debris Item 2 consists of the area within APEC 4. One tent pad structure had a 3.7 m by 4.9 m base made of plywood and dimensional lumber. No discernable paint or scrap metal was observed in the debris piles. Additional plywood and dimensional lumber was scattered in this area. An old metal 6-foot stepladder was also present.</p>	None	<p>Wood debris: 4.5 m³ Metal debris: 0.2 m³</p> <p>Total: 4.7 m³</p>

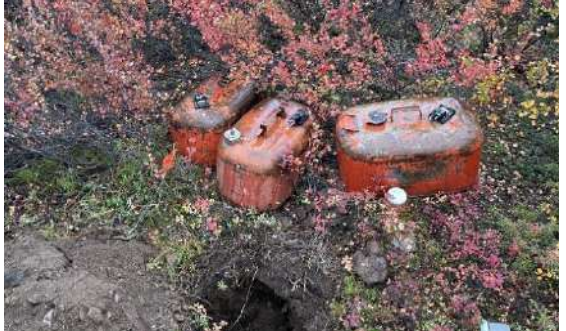
1	<p>Debris Item 3 consists of the area within AEC 1, the area immediately to the southeast of the tent pads of Debris Item 1. There are four metal jerry fuel cans in this area (20L each). Two cans were partially full and two were empty. Results indicate the liquid in the two jerry cans were mostly water (96.9% and 94.8% water).</p>	None	<p>Empty jerry cans (crushed): 0.5m³ (0.05 m³)</p> <p>Total: 0.5 m³ (0.05 m³ crushed)</p>

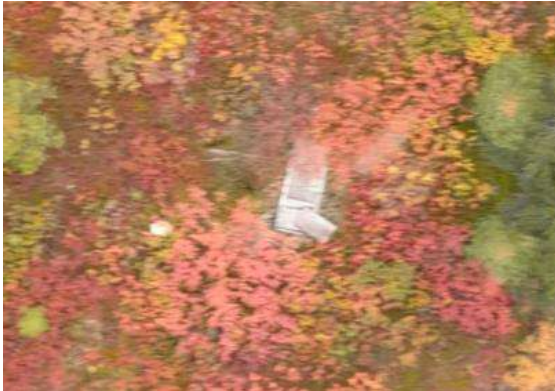
Various	Various pieces of wood debris, both plywood and dimensional lumber are scattered across the site. Plywood debris was noted approximately 20 m to the east of the tent pad of Debris Item 1. An old Privy was also noted approximately 30 m to the southwest of the tent pad of Debris Item 2.	None	Wood debris: 0.75 m ³ Total: 0.75 m ³
Total Volume Estimates				Total Debris: None Total Paint: None Total Liquid: None	Total (debris): 13 m³ (12.29 m³ crushed) Total (liquid): None

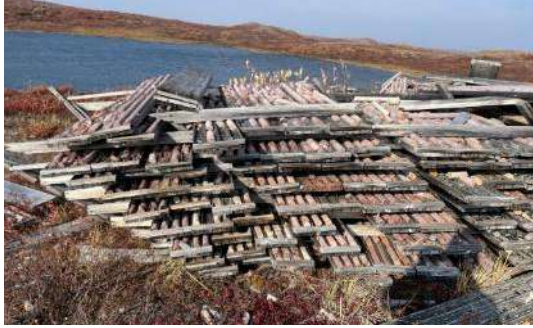
3	Used wooden drill core boxes stacked into piles located East of Fran Lake. Some piles are standing upright while others have begun to lean and collapse. Boxes and support pieces are made of wood with metal nails and fasteners, core samples are arranged throughout.	none	<p>Wood debris and boards 8 m³ Core samples 7 m³</p> <p>Total: 15 m³</p>
2	<p>Scrap Metal Casings and Wood Debris</p>

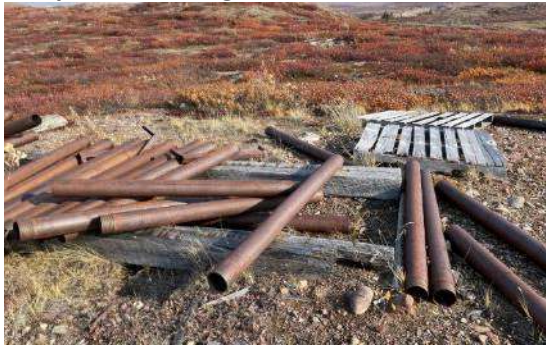
1	No structure remains. Located to the Southeast of the drill core boxes, in excess of 50 metal casings and wood debris made up of pallets and other wooden boards/beams are present in this area.	none	<p>Wood debris 4 m³ Metal debris 3.5 m³</p> <p>Total: 7.5 m³</p>
3	<p>Loose Household Debris</p>

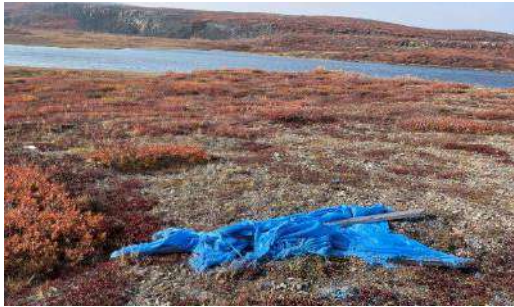
N/a	No structure remains. Wooden debris and household debris (a tarp) are located in this area to the South of the core sample boxes.	none	<p>Wood debris 0.02 m³ Household debris (tarp) 0.2 m³</p> <p>Total: 0.22 m³</p>

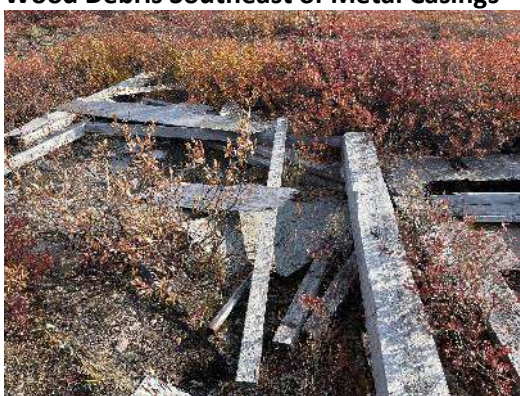
1	No structure remains. Wooden plywood, planks and beams are located in this area to the Southeast of Area/Item 2.	none	<p>Wood debris 3m³</p> <p>Total: 3 m³</p>

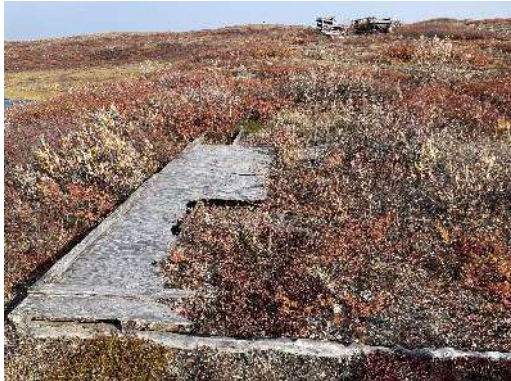
4	No structure remains. Wooden debris, plywood, beams, and planks are present in this area west of the drill core boxes.	none	Wood debris 1.5 m ³ Total: 1.5 m³
7	Camp Dump and Metal Debris

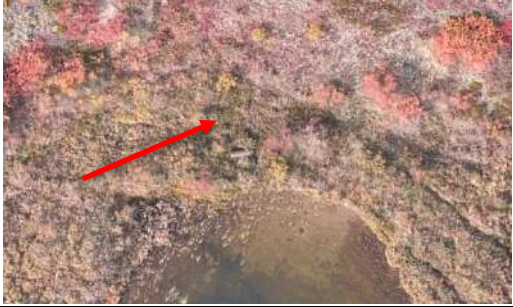
6	A single barrel to the north of the main Site area.	unknown	Metal barrels (crushed): 0.3 m ³ (0.04 m ³) Total: 0.3 m³ (0.04 m³ crushed)
9	Historical stick up

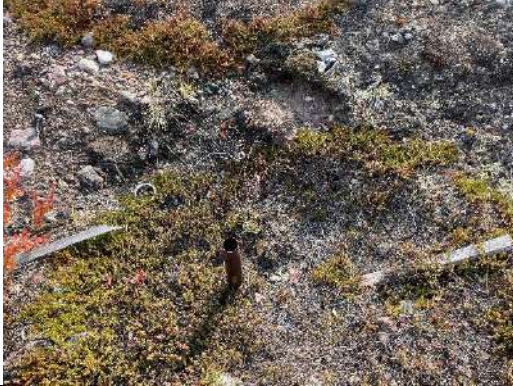
-	An old metal stick up from historical drilling activity. It is unknown how deep this drill rod extends.	N/A	Metal debris: <0.1 m ³ Total: <0.1 m³
Total Volume Estimates				Total Debris: None Total Paint: None Total Liquid: None	Total (debris): 28.57m³ (28.05 m³ crushed) Total (liquid): None

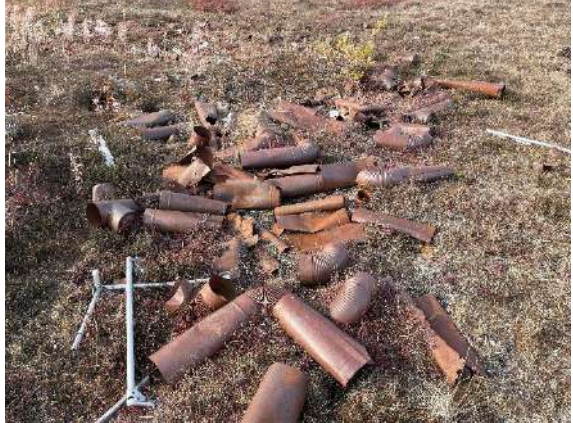
1	Debris Area 1 consists of the area within APEC 1. This area looks to be the historical camp dump and contains many pieces of stove pipe, old metal food cans, various other pieces of metal, and some glass bottles.	none	<p>Metal debris: 3 m³ Glass debris: <0.1 m³</p> <p>Total: 3 m³</p>
2	<p>Barrel Contents</p>

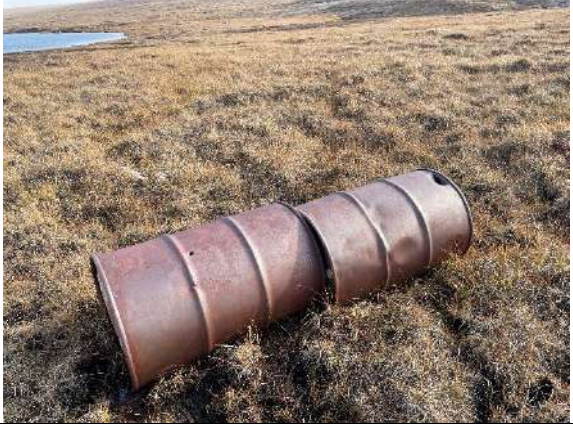
2	Debris Area 2 consists of the area within APEC 2 and the area directly north. There are 2 empty barrels and 1 full barrel remaining in this area.	<p>205 L of liquid in one barrel</p> <p>Total Liquid: 205 L</p>	<p>Metal barrels (crushed): 0.9 m³ (0.12 m³)</p> <p>Total: 0.9 m³ (0.12 m³ crushed)</p>
3	<p>Barrel Cache</p>

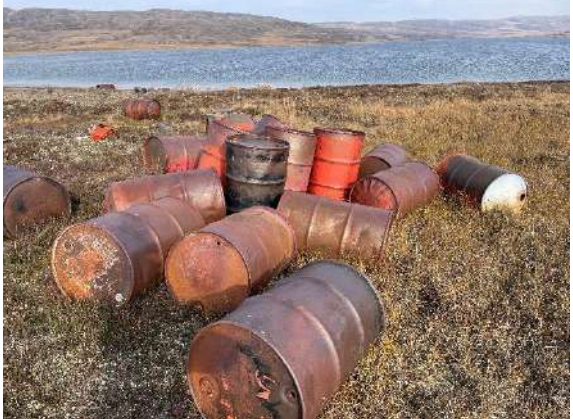
3	Debris Area 3 consists of the area within AEC 3, the area directly north of AEC 3, and the beach area. There are 30 barrels and 1 mini barrel in this area. Four barrels are full of unknown liquids, and 2 are half full. The remaining barrels (24 full sized and 1 mini barrel) are empty.	<p>1,025 L of liquid in six barrels</p> <p>Total Liquid: 1,025 L</p>	<p>Metal barrels (crushed): 9.15 m³ (1.22 m³)</p> <p>Total: 9.15 m³ (1.22 m³ crushed)</p>

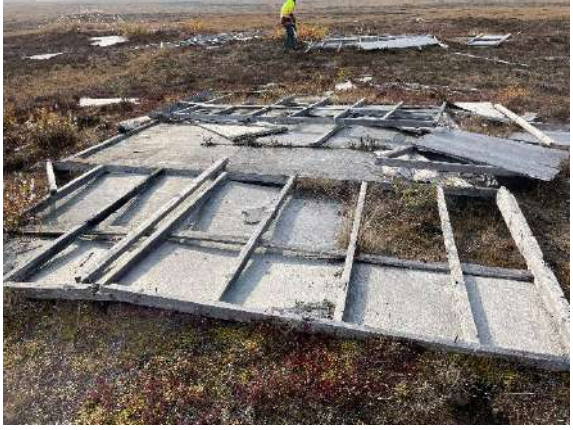
4	All structures at APEC 4 have collapsed. There are remnants of 5 different structures located in this area. Each structure had a 3.7 m by 4.3 m base and each was built from dimensional lumber and plywood. No paint or scrap metal was observed in the debris piles. Four barrels (3 full sized and 1 mini) are located within or just outside of APEC 4; one barrel is half full and the others are empty.	103 L of liquid in one barrel Total Liquid: 103 L	Metal barrels (crushed): 1.05 m ³ (0.14 m ³) Wood debris 40 m ³ Total: 41.05 m³ (40.14 m³ crushed)
5	Scattered Debris West of APEC 4

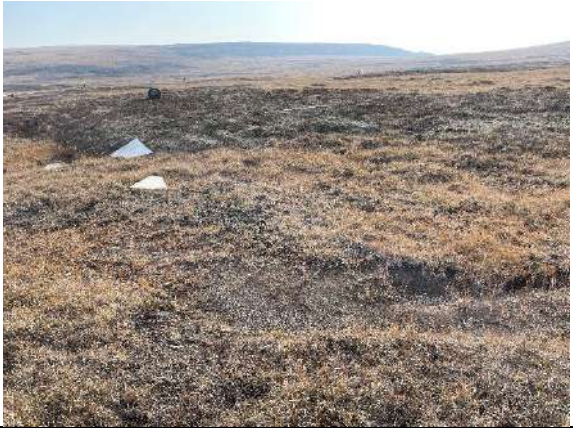
5	No structure remains. Wood debris is scattered to the west of APEC 4. This debris is largely dimensional lumber and plywood. There are also 9 barrels scattered throughout the area; 2 are full of liquid, 2 are half full of liquid, and 2 have trace amounts of liquid (approximately 10 L each), the remaining are empty.	635 L of liquid in six barrels Total Liquid: 635 L	Wooden debris 4.4 m ³ Metal barrels (crushed): 2.7 m ³ (0.36 m ³) Total: 7.1 m³ (4.76 m³ crushed)

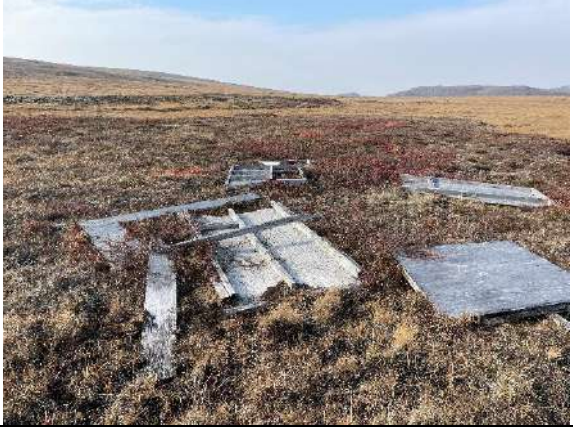
N/A	No structure remains. Wooden debris is scattered north of APEC 4, including an old outhouse that has since collapsed, several sheets of plywood and mixed dimensional lumber.	none	Wood debris 3.3 m ³ Total: 3.3 m³
Total Volume Estimates				Total Liquid: 1,968 L	Total (debris): 64.5 m³ (52.54 m³ crushed)

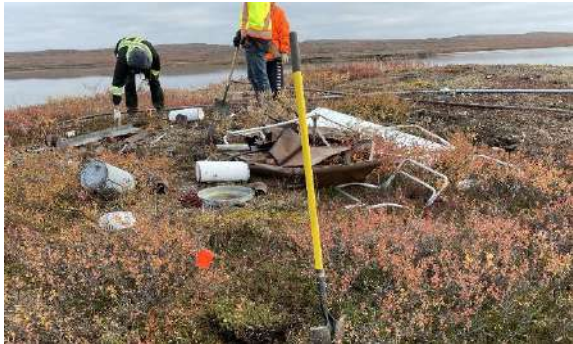
3	Debris Item 1 consists of a variety of scattered metal debris including long metal pipes/poles, canisters, stove pipes, sheet metal, and tubing. This area also contains some piles of drill cores.	None	Metal debris: 5 m ³ Drill cores: 0.5 m ³ Total: 5.5 m³
2	<p>Hot Water Tank</p>

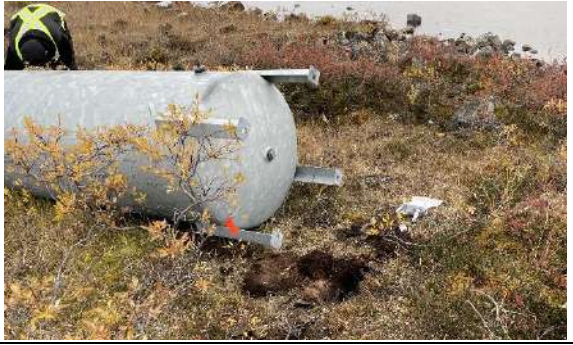
6	Debris Item 2 consists of a hot water tank and a concrete pad located southwest of the scattered metal debris of Debris Item 1. No discernable paint was observed on the items.	None	Hot water tank: 1.5 m ³ Concrete pad: 1 m ³ Total: 2.5 m³
3	<p>Propane Tanks</p>

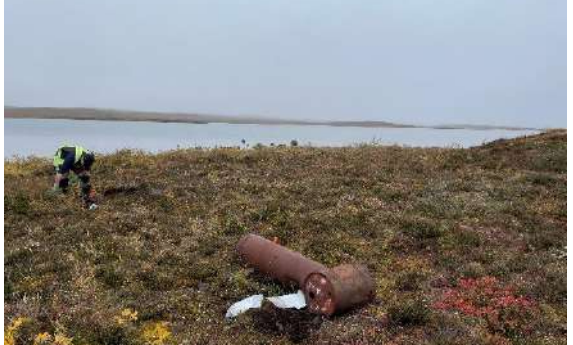
5	Debris Item 3 consists of one 100-pound propane tank and one mini barrel located south-southeast of the scattered metal debris of Debris Item 1. Both tanks were empty.	None	Empty propane tanks: 0.5 m ³ Metal barrels (crushed): 0.15 m ³ (0.02 m ³) Total: 0.65 m³ (0.52 m³ crushed)

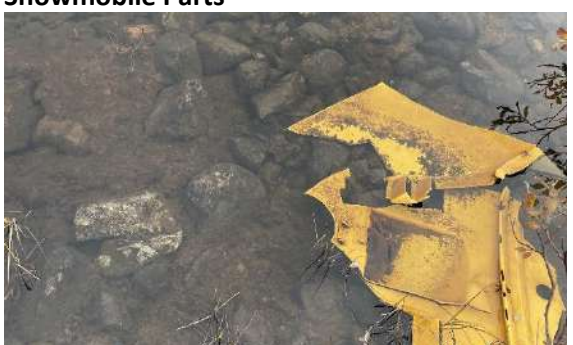
4	Debris Item 4 consists of snowmobile parts, in an area along the shoreline southeast of the metal debris of Debris Item 1. Debris is majority yellow plastic with some pieces semi-submerged in the water.	None	Plastic debris: 0.3 m ³ Total: 0.3 m³

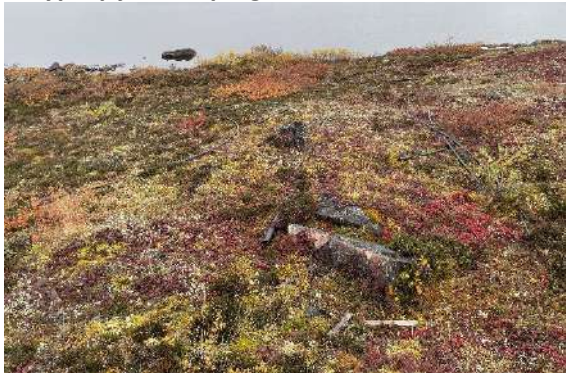
NA	Debris Item 5 consists of black polypropylene piping, scattered throughout the area. Approximately 50 m of this pipe is located on Site.	None	Plastic debris: 1 m ³ Total: 1 m³
6	Propane Tank 2

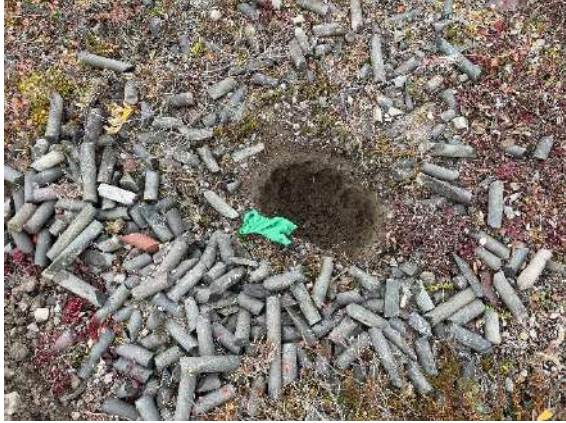
1	Debris Item 7 consists of several piles of drill cores, scattered throughout the area. No racking system was present in the area.	None	Drill cores: 1 m ³ Total: 1 m³
Total Volume Estimates				None	Total (debris): 11.45 m³ (11.32 m³)

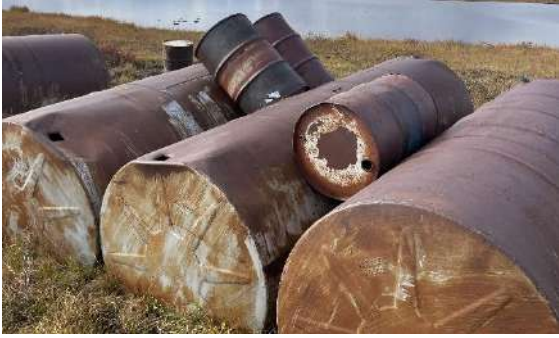
1	Debris Item 1 consists of six large metal tanks, seven 205 litre (L) metal barrels, one mini barrel and one 20 L jerry can. One metal tank was observed to be approximately 10% full of an unknown liquid. Analytical results indicated that the liquid was > 90% water.	None ¹	<p>Metal tanks (crushed): 29.16 m³ (2.92 m³) Metal barrels (crushed): 2.25 m³ (0.3 m³) Other metal debris (crushed): 0.2 m³ (0.05 m³)</p> <p>Total: 31.61 m³ (3.27 m³ crushed)</p>
2	<p>Smaller Metal Tanks and Barrels</p>

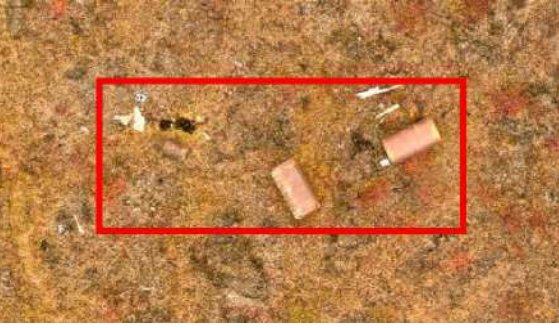
2	Debris Item 2 consists of two smaller metal tanks, one 205 L metal barrel, one mini barrel, and some wood debris. This area is located approximately 30 metres (m) south-southeast of APEC 1.	None	<p>Tank Volume: 4.85 m³ (0.49 m³ crushed) Barrel Volume: 0.45 m³ (0.06 m³ crushed) Wood Debris: 1 m³</p> <p>Total: 6.3 m³ (1.55 m³ crushed)</p>

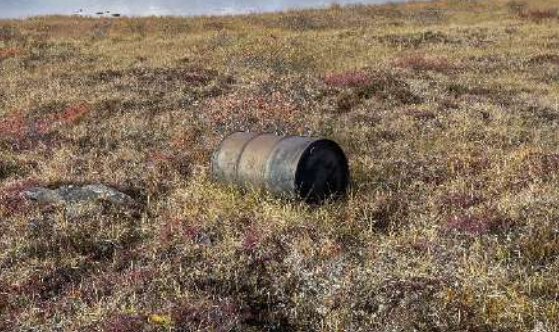
2	Debris Item 3 consists of one 205 L metal barrel tank located between Debris Items 1 & 2.	None	<p>Metal barrels (crushed): 0.3 m³ (0.04 m³)</p> <p>Total: 0.3 m³ (0.04 m³ crushed)</p>
4	<p>Metal Barrels</p>

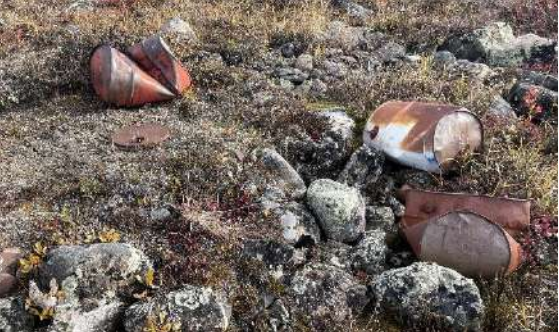
-	Debris Item 4 consists of three semi-crushed 205 L metal barrels located approximately 30 m southeast of Debris Item 2.	None	<p>Metal barrels (crushed): 0.9 m³ (0.12 m³)</p> <p>Total: 0.9 m³ (0.12 m³ crushed)</p>

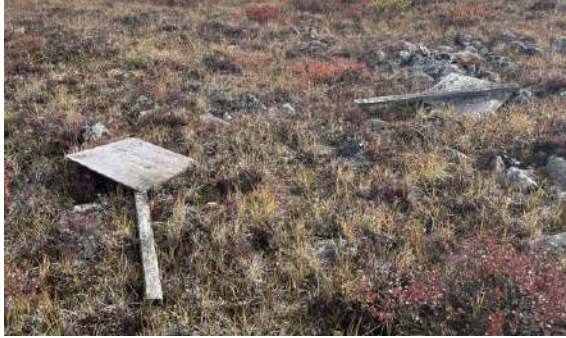
-	Debris Item 5 consists of two wooden signs made of plywood and dimensional lumber located directly south of Debris Item 4.	None	Wooden debris: 0.2 m ³ Total: 0.2 m³
6	Propane Tank

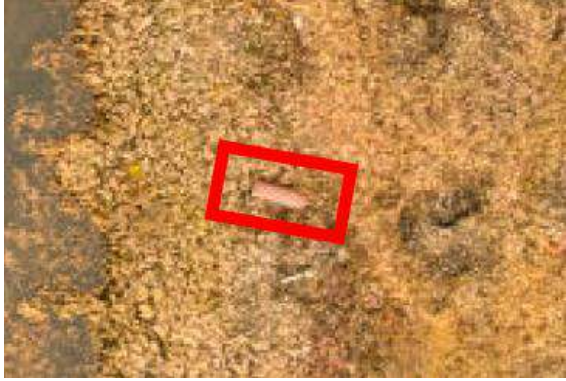
-	Debris Item 6 consists of one 100-pound metal propane tank located approximately 30 m northwest of Debris Item 1.	None	Metal tank: 0.5 m ³ Total: 0.5 m³
7	Collapsed Wooden Dock Structure

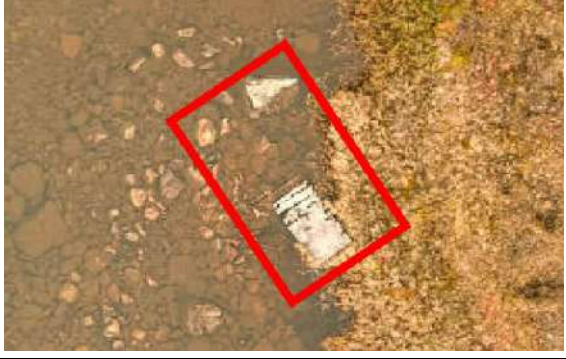
-	Debris Item 7 consists of two wooden docks made of plywood and dimensional lumber located directly northwest of Debris Item 6.	None	Wooden debris: 0.75 m ³ Total: 0.75 m³
8	Camp Dump

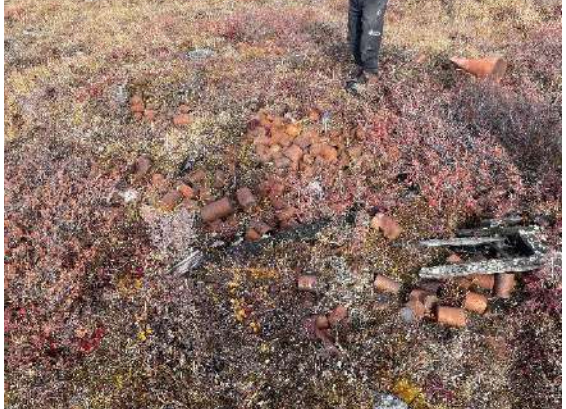
3	Debris Item 8 consists of the camp dump, which includes various small metal barrels/buckets, various metal debris, and some wood debris.		Metal barrels/buckets: 0.4 m ³ Wooden debris: 0.1 m ³ Total: 0.5 m³

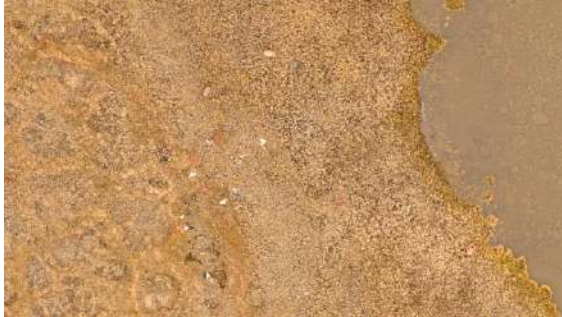
5	Additional Debris was seen across the Unnamed Lake to the east. This area was only seen from the air. Three additional barrels and some wooden debris was seen scattered in this area.		Metal barrels (crushed): 0.9 m ³ (0.12 m ³) Wooden debris: 1 m ³ Total: 1.9 m³ (1.12 m³ crushed)
Total Volume Estimates				Liquid: 0	Total (debris): 42.96 m³ (8.05 m³ crushed)
