**REMEDIAL ACTION PLAN  
SPEERS LAKE SITES  
NUNAVUT**

**Public Services and  
Procurement Canada**

**BLM-KEL-60**

Project Number: 230468

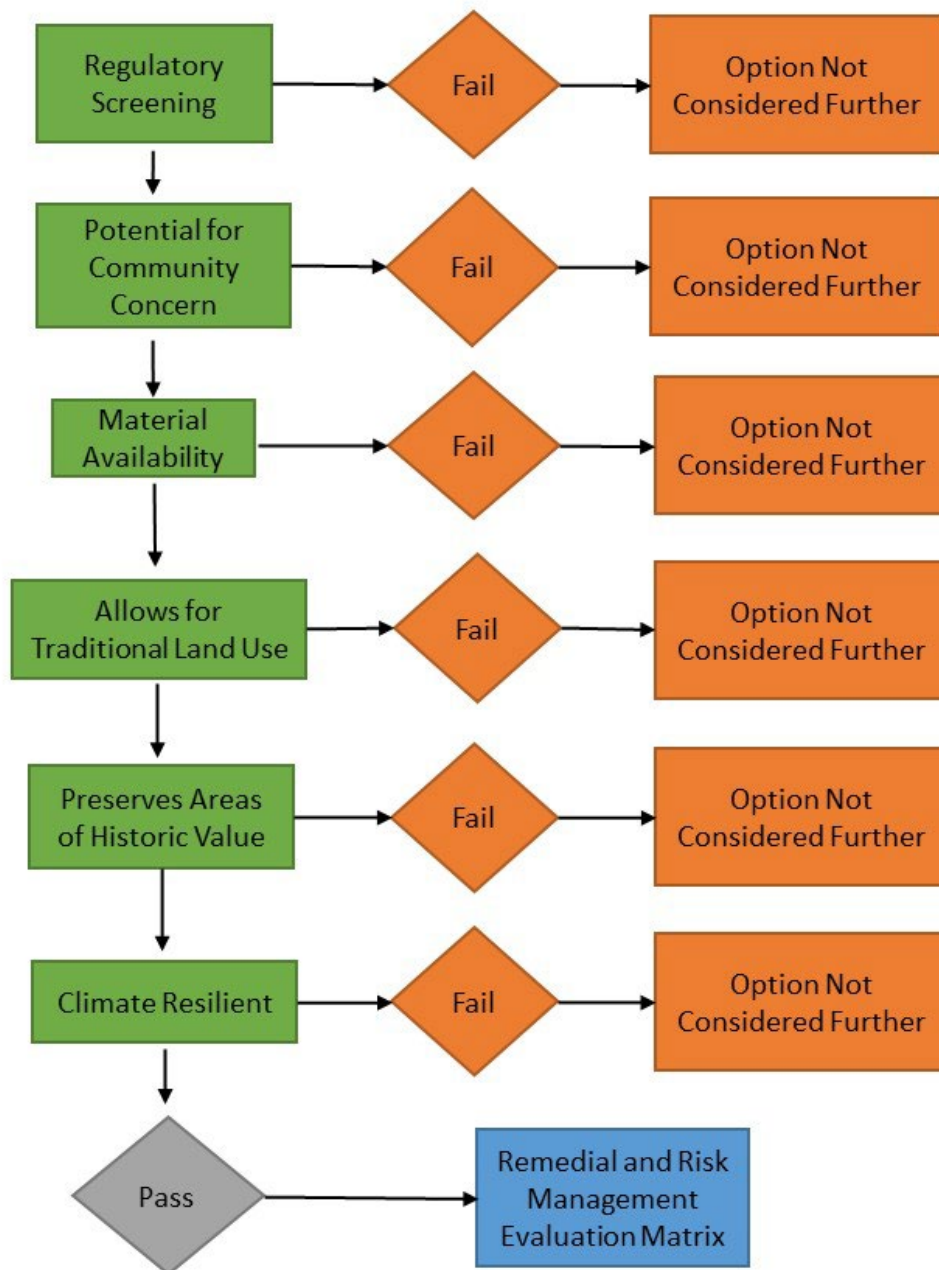
**Diagram 1: Remedial Options Pre-screening**

If any remedial option considered fails a step, it is no longer considered in the evaluation process. If the remedial option passes all six steps, it is carried forward as a viable option to be evaluated using the Remedial and Risk Management matrix. Each of the pre-screening steps is described in detail in the following paragraphs.

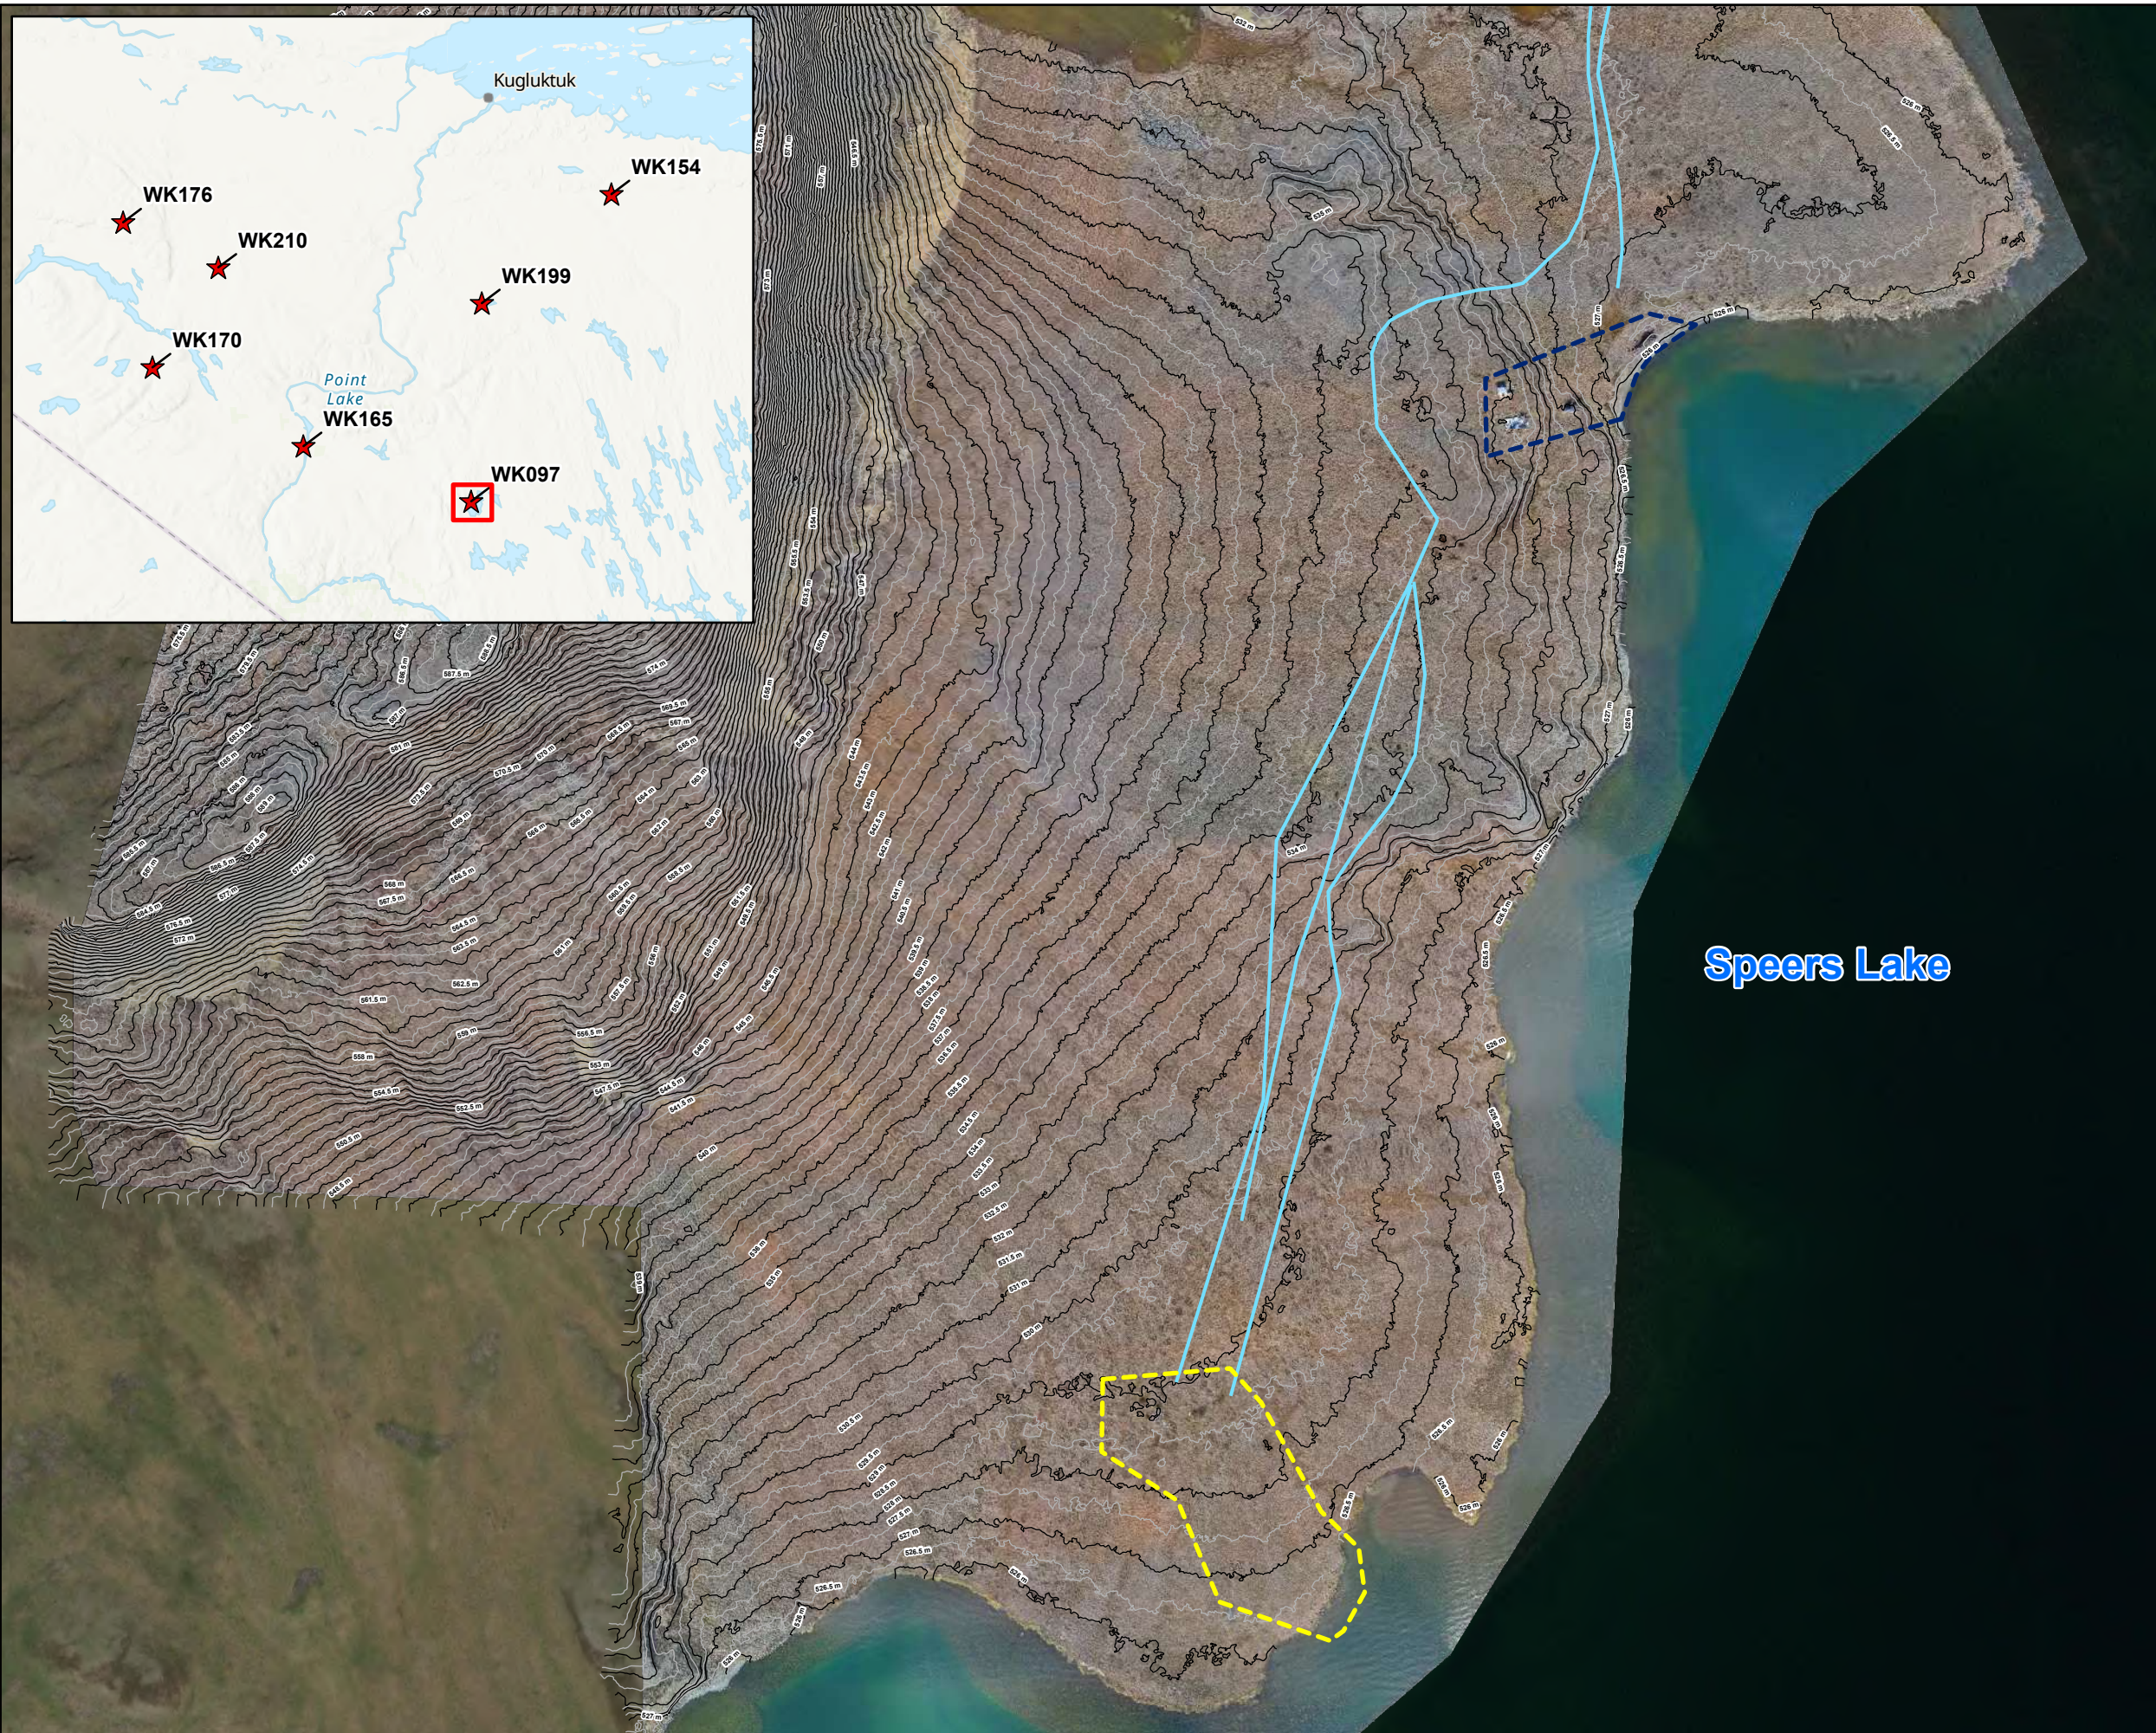
- North Site Outline
- South Site Outline
- Intermediate Contour (0.5 m)
- Major Contour (1 m)
- Approximate CAT Train Trail
- Site Locations

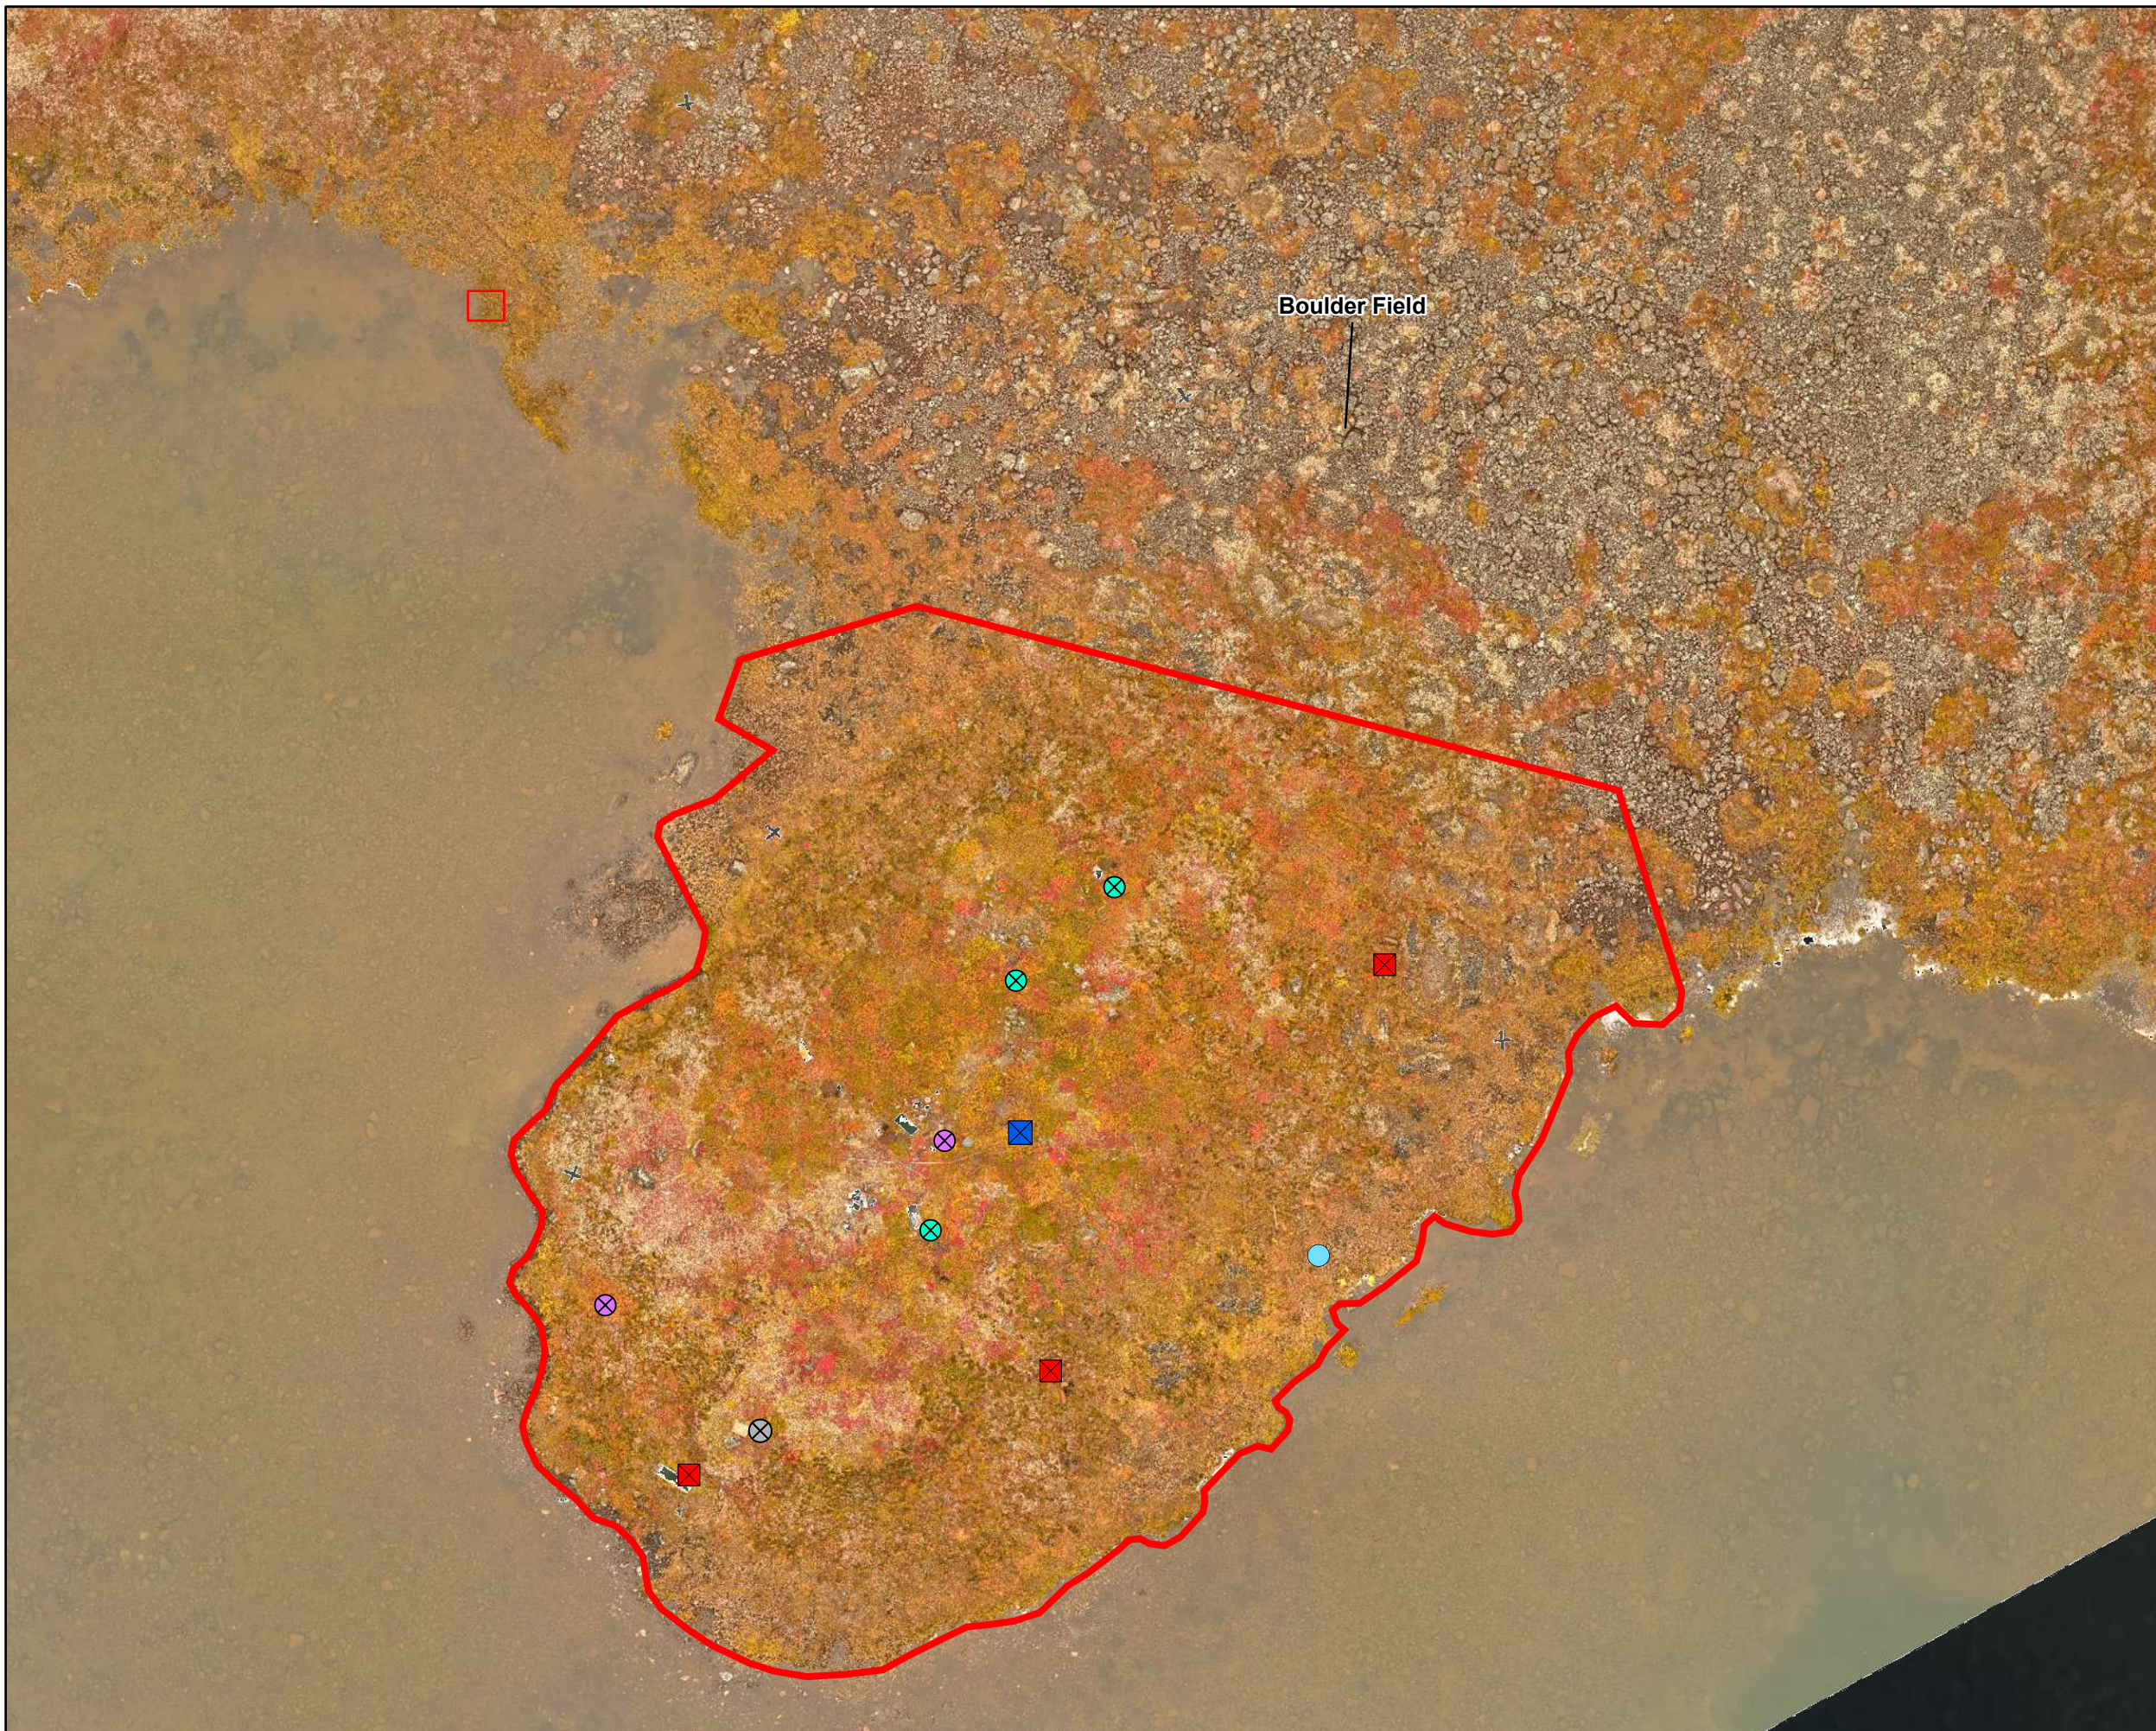
PROJECT # <b>230468</b>	DATE <b>October 01, 2024</b>
DRAWN <b>PB</b>	CHECKED <b>SA</b>
FIG NO. <b>14</b>	REV <b>0</b>

- Debris
- Barrel
- Concrete Pad
- Burn Pit
- Machinery
- Drill Core
- Tank

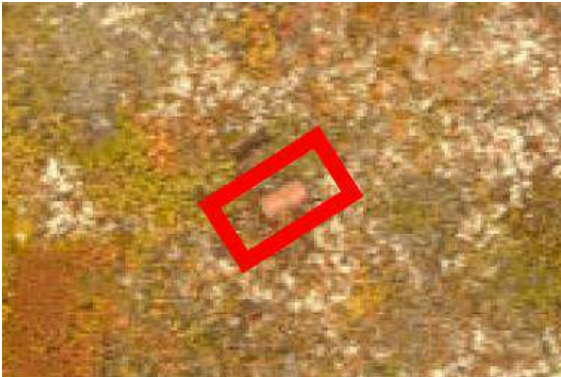
3	Debris Item 8 consists of one metal barrel located approximately 40 metres southwest of Debris Item 6.	None	<p>Metal barrels (crushed): 0.3 m<sup>3</sup> (0.04 m<sup>3</sup>)</p> <p><b>Total: 0.3 m<sup>3</sup> (0.04 m<sup>3</sup> crushed)</b></p>

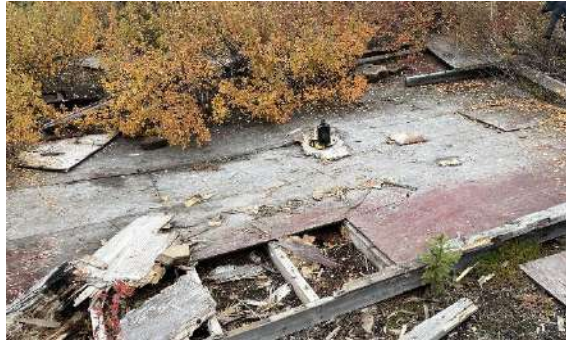
3	Debris Item 1 consists of the area within APEC 3. All structures in this area have collapsed. Two former tent pads with a 3.7 m by 4.9 m base made of plywood and dimensional lumber were present. Red paint was present on most of the debris in this area. A sample of this paint was obtained and sent for analysis and came back as non-hazardous. Also present is half of a metal barrel (empty).	None	<p>Wood debris: 6.75 m<sup>3</sup>                      Metal barrels (crushed): 0.3 m<sup>3</sup> (0.04 m<sup>3</sup>)</p> <p><b>Total: 7.05 m<sup>3</sup> (6.79 m<sup>3</sup> crushed)</b></p>
2	<p><b>Large Tent Pad in APEC 4</b></p>

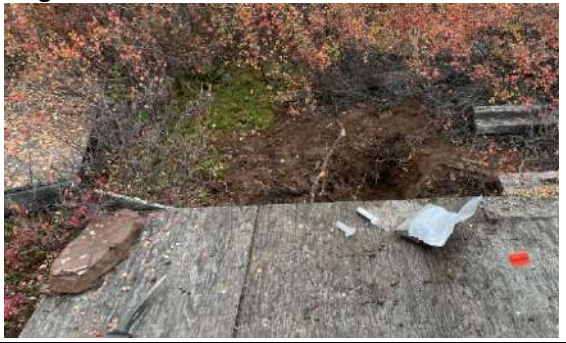
4	Debris Item 2 consists of the area within APEC 4. One tent pad structure had a 3.7 m by 4.9 m base made of plywood and dimensional lumber. No discernable paint or scrap metal was observed in the debris piles. Additional plywood and dimensional lumber was scattered in this area. An old metal 6-foot stepladder was also present.	None	<p>Wood debris: 4.5 m<sup>3</sup>                      Metal debris: 0.2 m<sup>3</sup></p> <p><b>Total: 4.7 m<sup>3</sup></b></p>

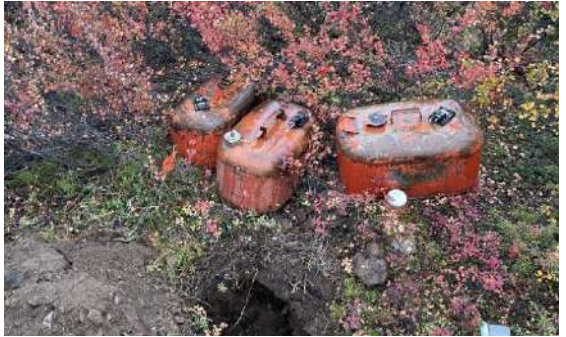
1	Debris Item 3 consists of the area within AEC 1, the area immediately to the southeast of the tent pads of Debris Item 1. There are four metal jerry fuel cans in this area (20L each). Two cans were partially full and two were empty. Results indicate the liquid in the two jerry cans were mostly water (96.9% and 94.8% water).	None	<p>Empty jerry cans (crushed): 0.5m<sup>3</sup> (0.05 m<sup>3</sup>)</p> <p><b>Total: 0.5 m<sup>3</sup> (0.05 m<sup>3</sup> crushed)</b></p>

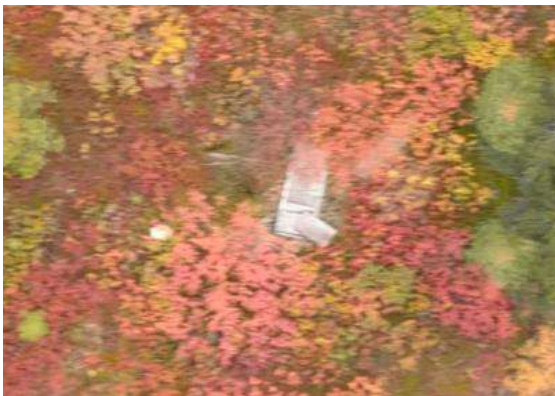
Various	<p>Various pieces of wood debris, both plywood and dimensional lumber are scattered across the site. Plywood debris was noted approximately 20 m to the east of the tent pad of Debris Item 1. An old Privy was also noted approximately 30 m to the southwest of the tent pad of Debris Item 2.</p>	None	<p>Wood debris: 0.75 m<sup>3</sup></p> <p><b>Total: 0.75 m<sup>3</sup></b></p>
<b>Total Volume Estimates</b>				<p><b>Total Debris: None</b>  <b>Total Paint: None</b>  <b>Total Liquid: None</b></p>	<p><b>Total (debris): 13 m<sup>3</sup> (12.29 m<sup>3</sup> crushed)</b>  <b>Total (liquid): None</b></p>

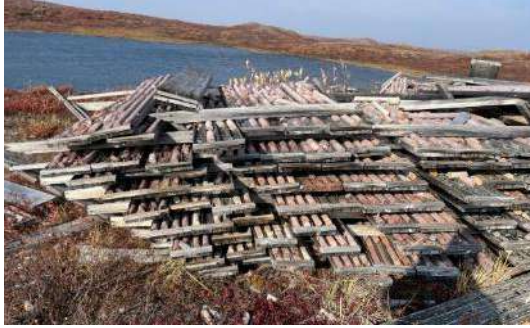
3	Used wooden drill core boxes stacked into piles located East of Fran Lake. Some piles are standing upright while others have begun to lean and collapse. Boxes and support pieces are made of wood with metal nails and fasteners, core samples are arranged throughout.	none	Wood debris and boards 8 m <sup>3</sup> Core samples 7 m <sup>3</sup>  <b>Total: 15 m<sup>3</sup></b>
2	<p><b>Scrap Metal Casings and Wood Debris</b></p>

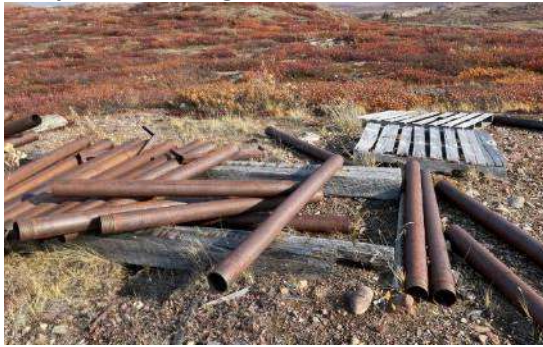
1	No structure remains. Located to the Southeast of the drill core boxes, in excess of 50 metal casings and wood debris made up of pallets and other wooden boards/beams are present in this area.	none	Wood debris 4 m <sup>3</sup> Metal debris 3.5 m <sup>3</sup>  <b>Total: 7.5 m<sup>3</sup></b>
3	<p><b>Loose Household Debris</b></p>

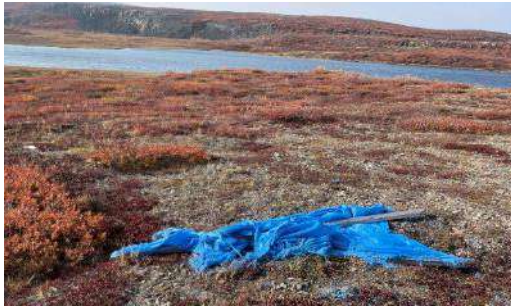
N/a	No structure remains. Wooden debris and household debris (a tarp) are located in this area to the South of the core sample boxes.	none	Wood debris 0.02 m <sup>3</sup> Household debris (tarp) 0.2 m <sup>3</sup>  <b>Total: 0.22 m<sup>3</sup></b>

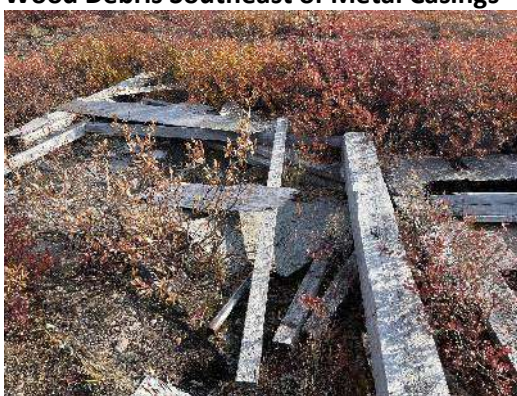
1	No structure remains. Wooden plywood, planks and beams are located in this area to the Southeast of Area/Item 2.	none	Wood debris 3m <sup>3</sup>  <b>Total: 3 m<sup>3</sup></b>

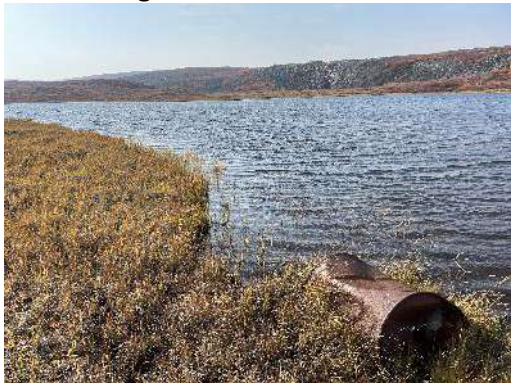
5	No structure remains. Single empty barrel is present in this area West North West of the drill core boxes.	none	<p>Metal barrels (crushed): 0.3 m<sup>3</sup> (0.04 m<sup>3</sup>)</p> <p><b>Total: 0.3 m3 (0.04 m<sup>3</sup> crushed)</b></p>
6	<p><b>Camp Pad</b></p>

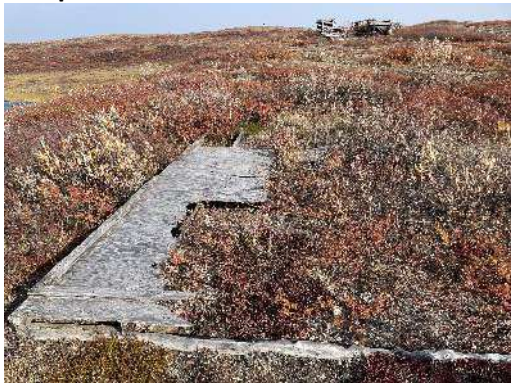
4	No structure remains. Wooden debris, plywood, beams, and planks are present in this area west of the drill core boxes.	none	<p>Wood debris 1.5 m<sup>3</sup></p> <p><b>Total: 1.5 m<sup>3</sup></b></p>
7	<p><b>Camp Dump and Metal Debris</b></p>

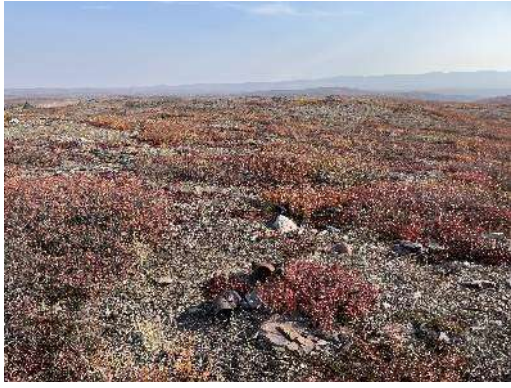
N/a	No structure remains. Metal debris and household debris (tarp) are present in this area to the South of the drill core boxes.	none	<p>Metal debris 0.73 m<sup>3</sup></p> <p>Household debris (tarp) 0.02 m<sup>3</sup></p> <p><b>Total: 0.75 m<sup>3</sup></b></p>

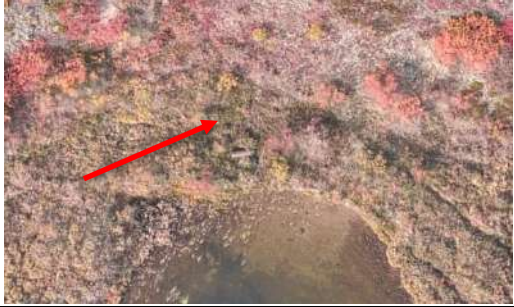
6	A single barrel to the north of the main Site area.	unknown	<p>Metal barrels (crushed): 0.3 m<sup>3</sup> (0.04 m<sup>3</sup>)</p> <p><b>Total: 0.3 m<sup>3</sup> (0.04 m<sup>3</sup> crushed)</b></p>
9	<p><b>Historical stick up</b></p>

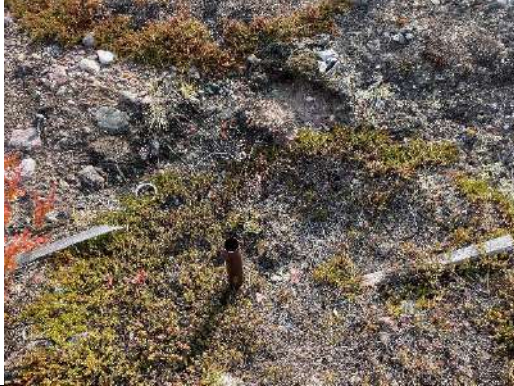
-	An old metal stick up from historical drilling activity. It is unknown how deep this drill rod extends.	N/A	<p>Metal debris: &lt;0.1 m<sup>3</sup></p> <p><b>Total: &lt;0.1 m<sup>3</sup></b></p>
<b>Total Volume Estimates</b>				<p><b>Total Debris: None</b>  <b>Total Paint: None</b>  <b>Total Liquid: None</b></p>	<p><b>Total (debris): 28.57m<sup>3</sup> (28.05 m<sup>3</sup> crushed)</b>  <b>Total (liquid): None</b></p>

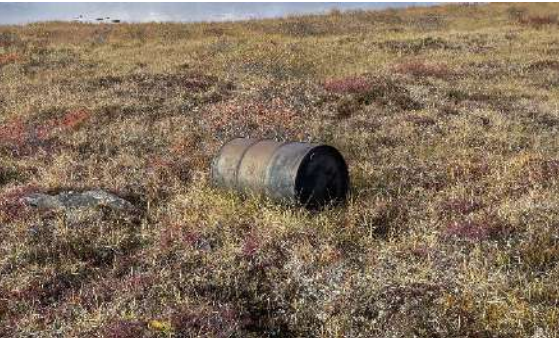
3	<p><b>Metal Barrel</b></p>

2	Debris Item 3 consists of one 205 L metal barrel tank located between Debris Items 1 & 2.	None	<p>Metal barrels (crushed): 0.3 m<sup>3</sup> (0.04 m<sup>3</sup>)</p> <p><b>Total: 0.3 m<sup>3</sup> (0.04 m<sup>3</sup> crushed)</b></p>
4	<p><b>Metal Barrels</b></p>

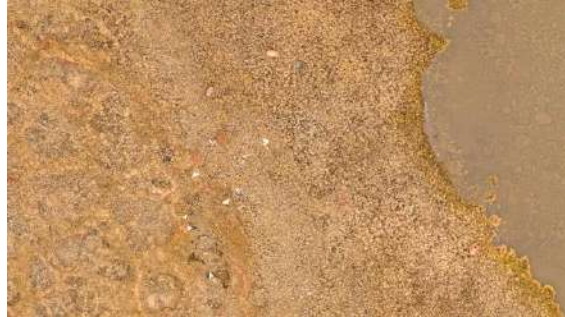
5	Additional Debris was seen across the Unnamed Lake to the east. This area was only seen from the air. Three additional barrels and some wooden debris was seen scattered in this area.		Metal barrels (crushed): 0.9 m <sup>3</sup> (0.12 m <sup>3</sup> ) Wooden debris: 1 m <sup>3</sup>  <b>Total: 1.9 m<sup>3</sup> (1.12 m<sup>3</sup> crushed)</b>
<b>Total Volume Estimates</b>				<b>Liquid: 0</b>	<b>Total (debris): 42.96 m<sup>3</sup> (8.05 m<sup>3</sup> crushed)</b>
