Biofarm Cell Construction and Remediation of Re-Supply Area, Taloyoak, Nunavut

**Biofarm Cell Construction and
Remediation of Re-Supply Area,
Taloyoak, Nunavut**

Government of Nunavut
Public Works & Services
Petroleum Products Division

02-0456

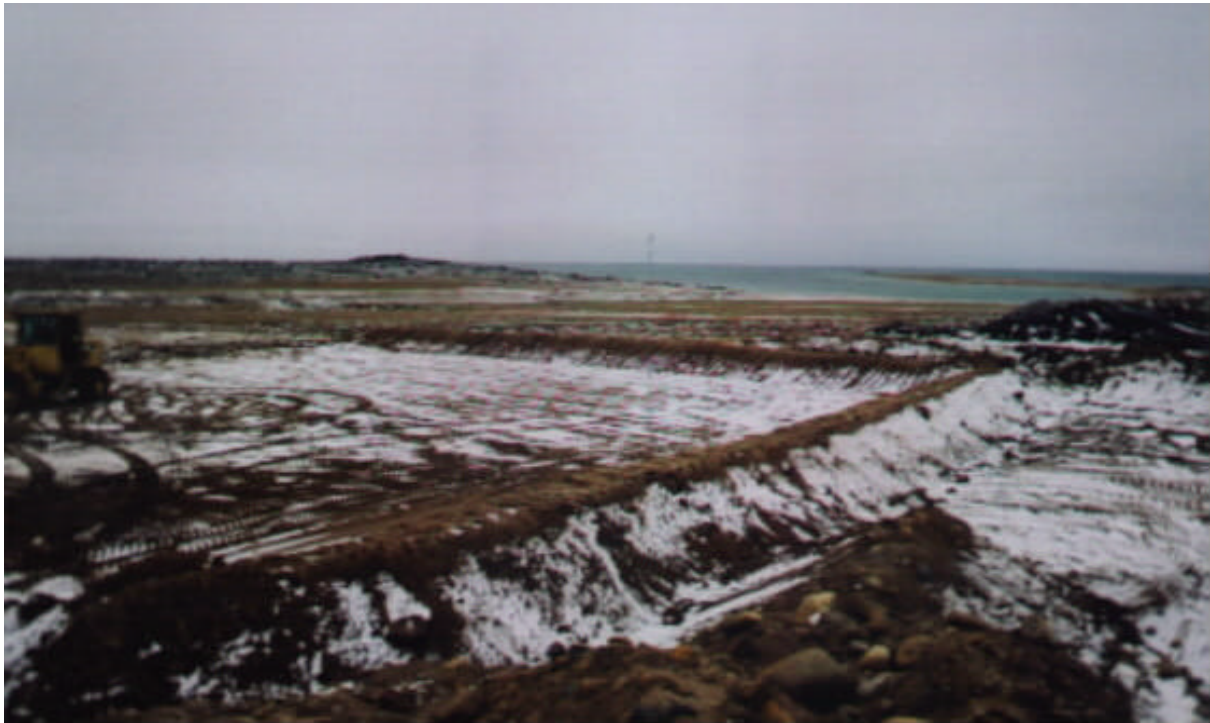
Photo 1: Berm under construction looking southeast

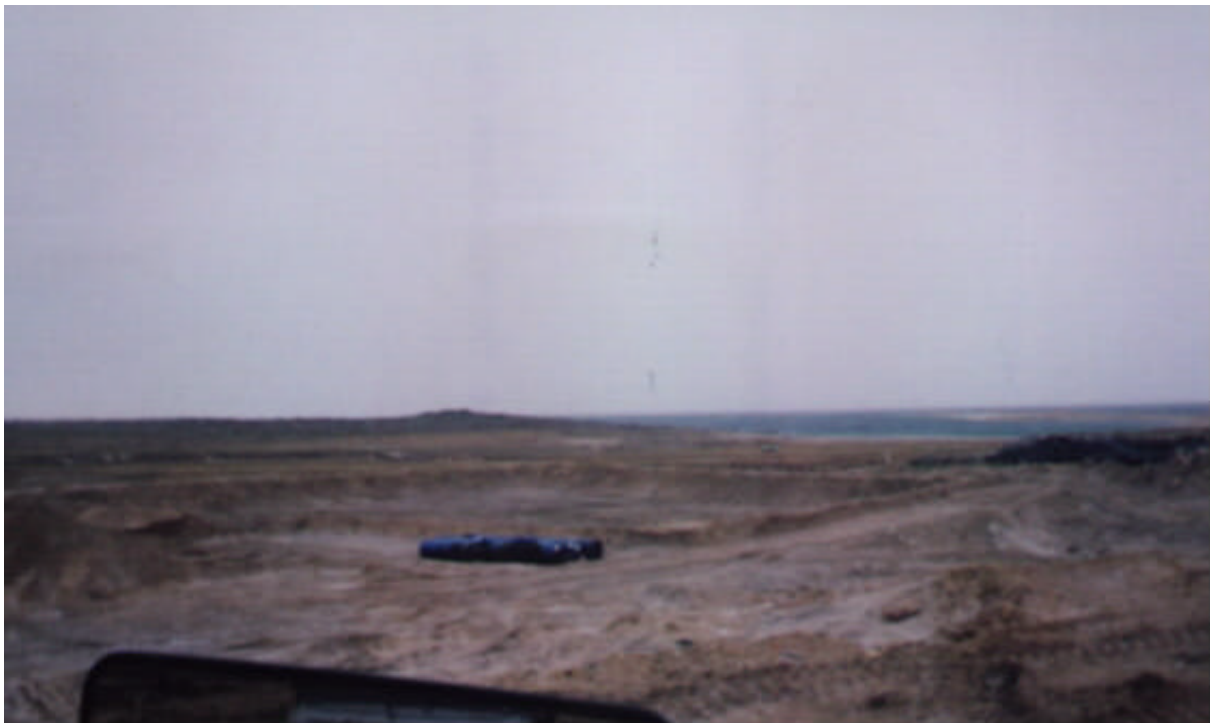
Photo 2: Berm construction complete and ready for liner.

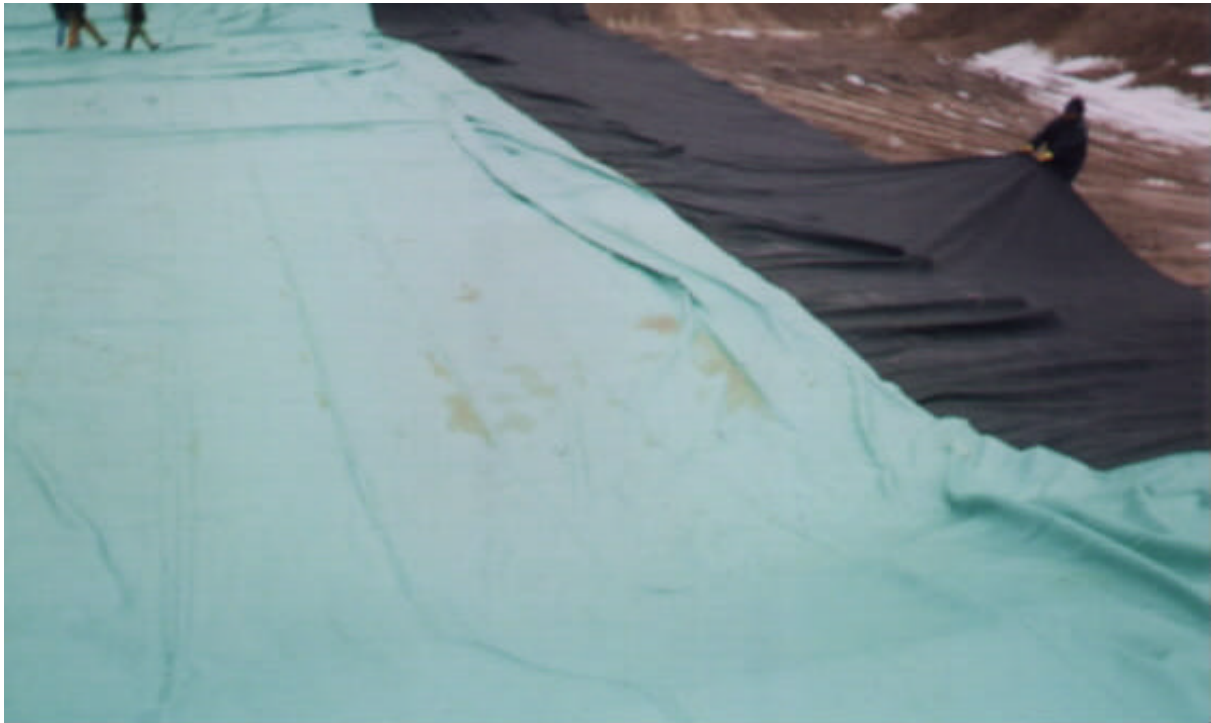
Photo 3: Installation of geomembrane on geotextile.

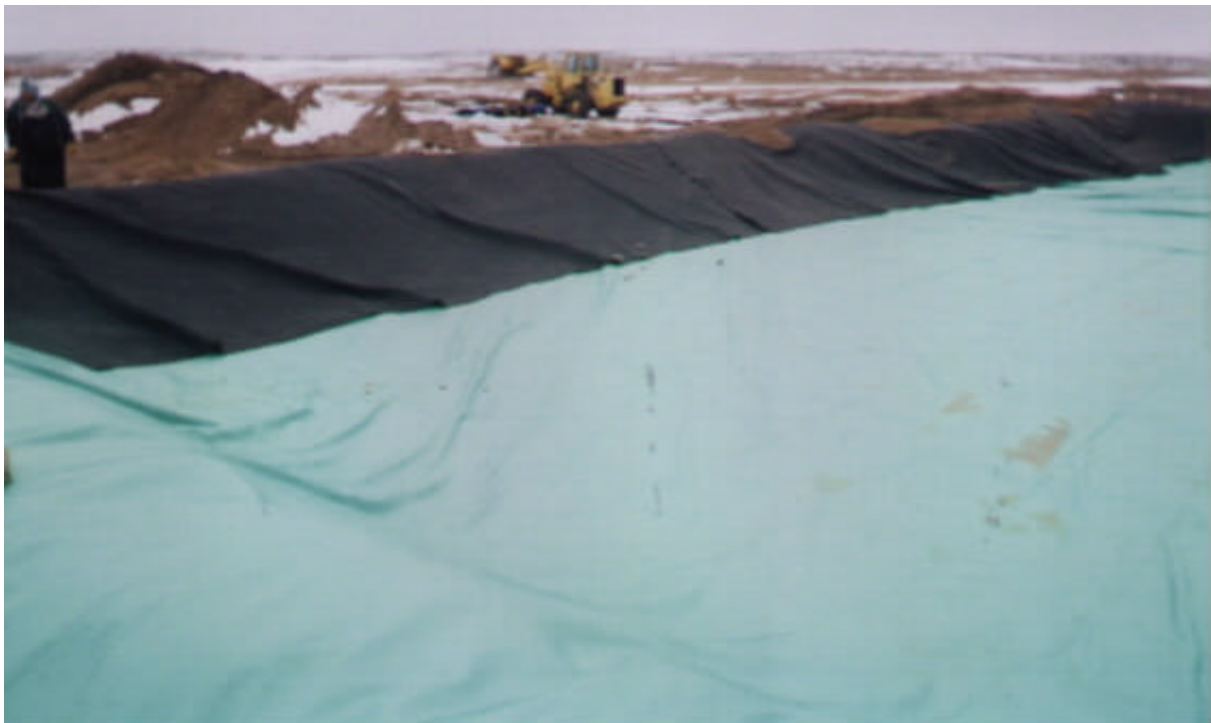
Photo 4: Installation of geotextile on top of geomembrane.

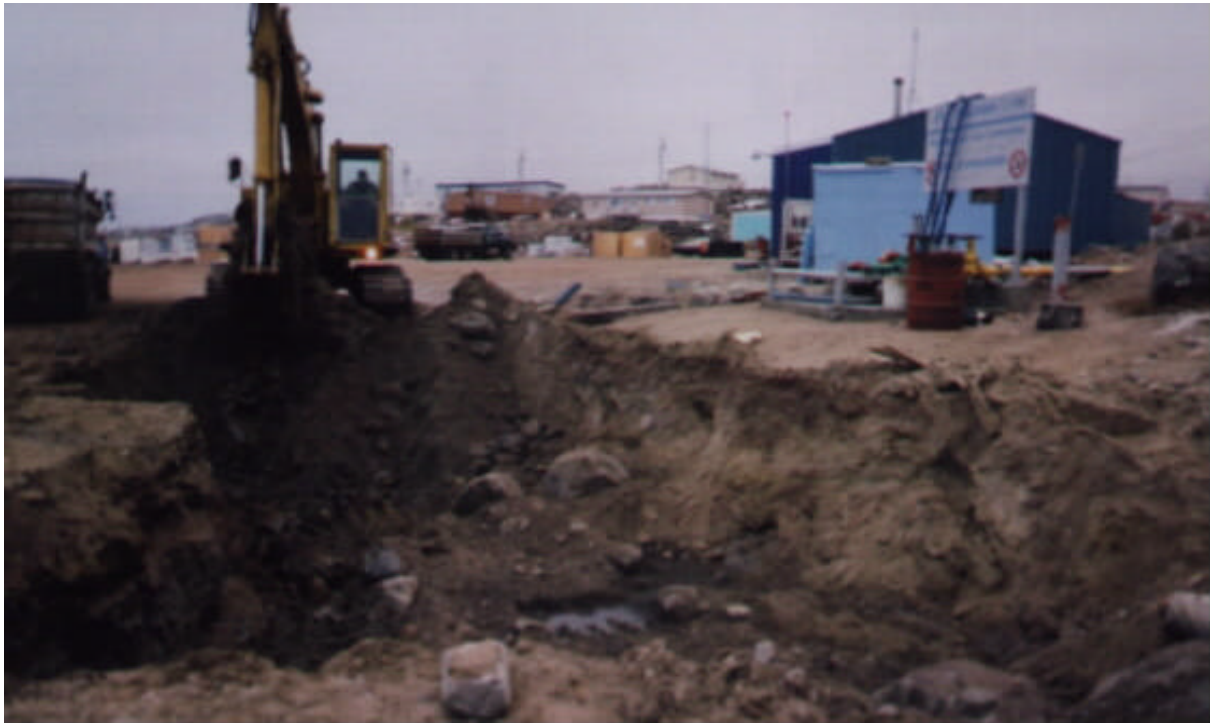
Photo 5: Excavation of contaminated material near fuel pipeline.

The first excavation of contaminated material began at the northeast end of the site and proceeded southwest to the area in front of the re-supply pipeline. The contaminated material was excavated down to permafrost (approximately 1 m below surface) and was not excavated within 45E of any structural footings.

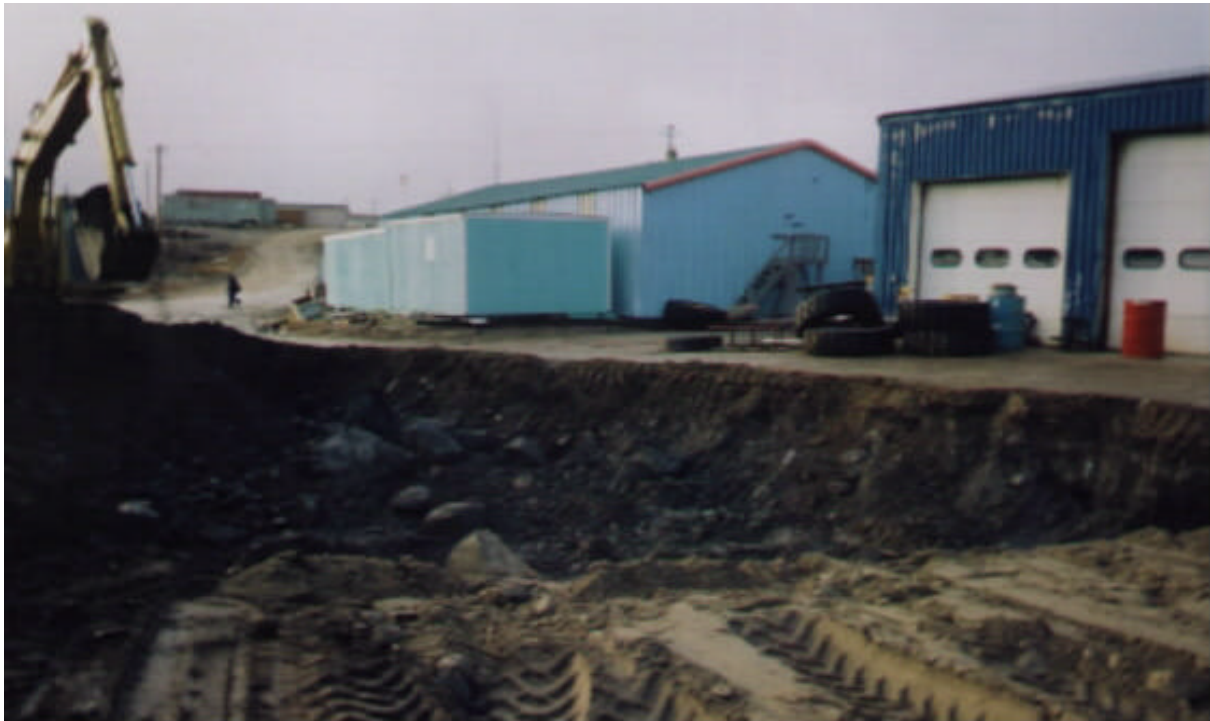
Photo 6: Excavation of contaminated material in front of garage.

The second excavation began northeast of the bay doors of the on-site garage and proceeded in both a south and west direction. The excavation stopped approximately 1.2 m below ground surface, in a layer of grey clay that did not appear to be contaminated. The excavation was not advanced beyond 45E of any structural footings.

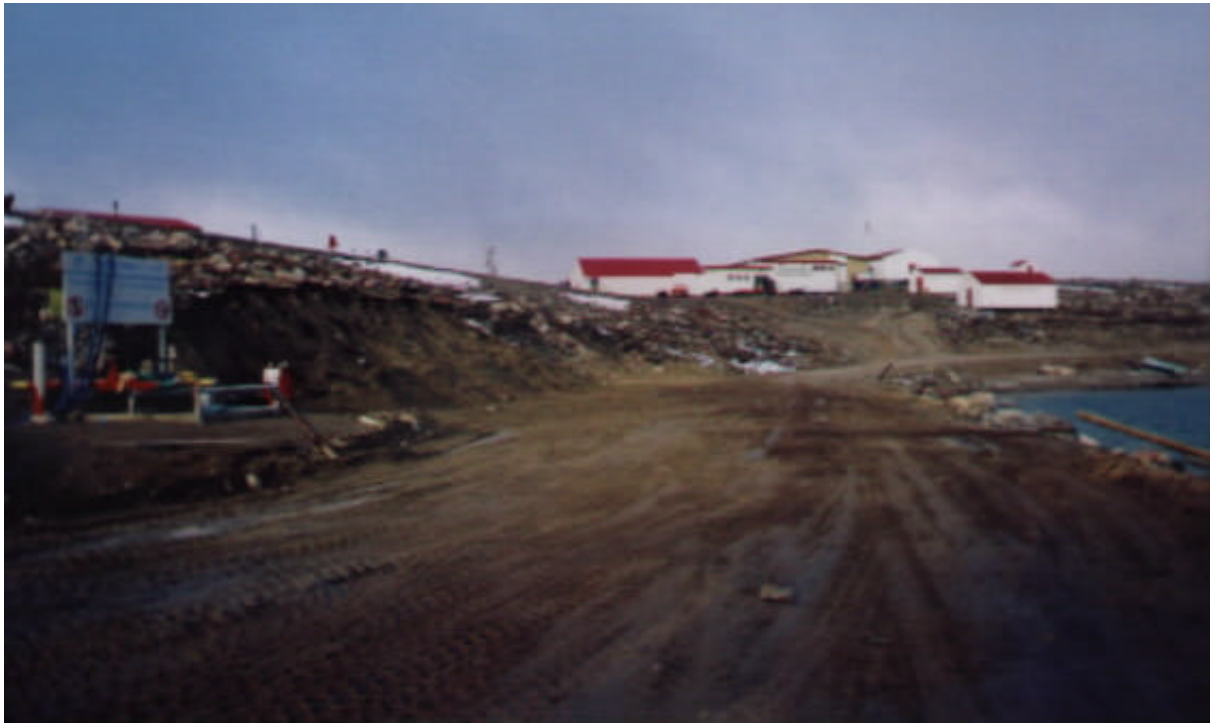
Photo 7: Eastern side of site after backfilling and grading looking East

After confirmatory samples were obtained, backfilling was commenced using clean, native material. The fill material was compacted and graded to match existing elevations.

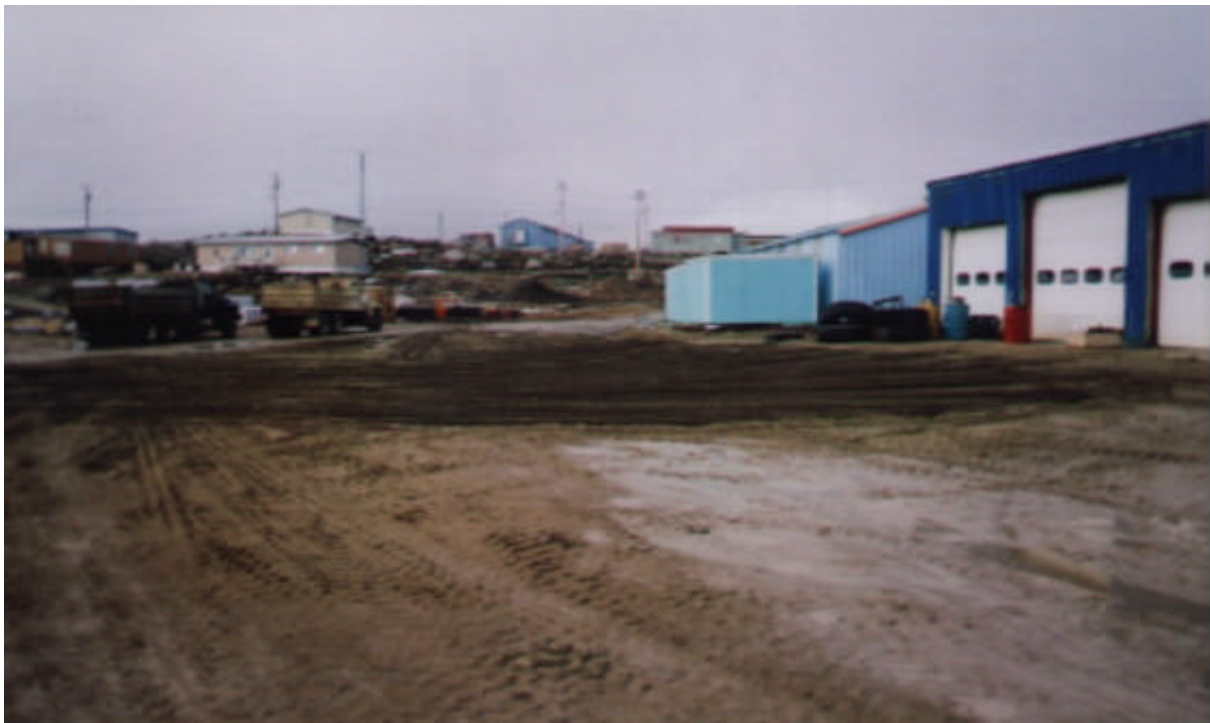
Photo 8: Western side of site after backfilling and grading looking West

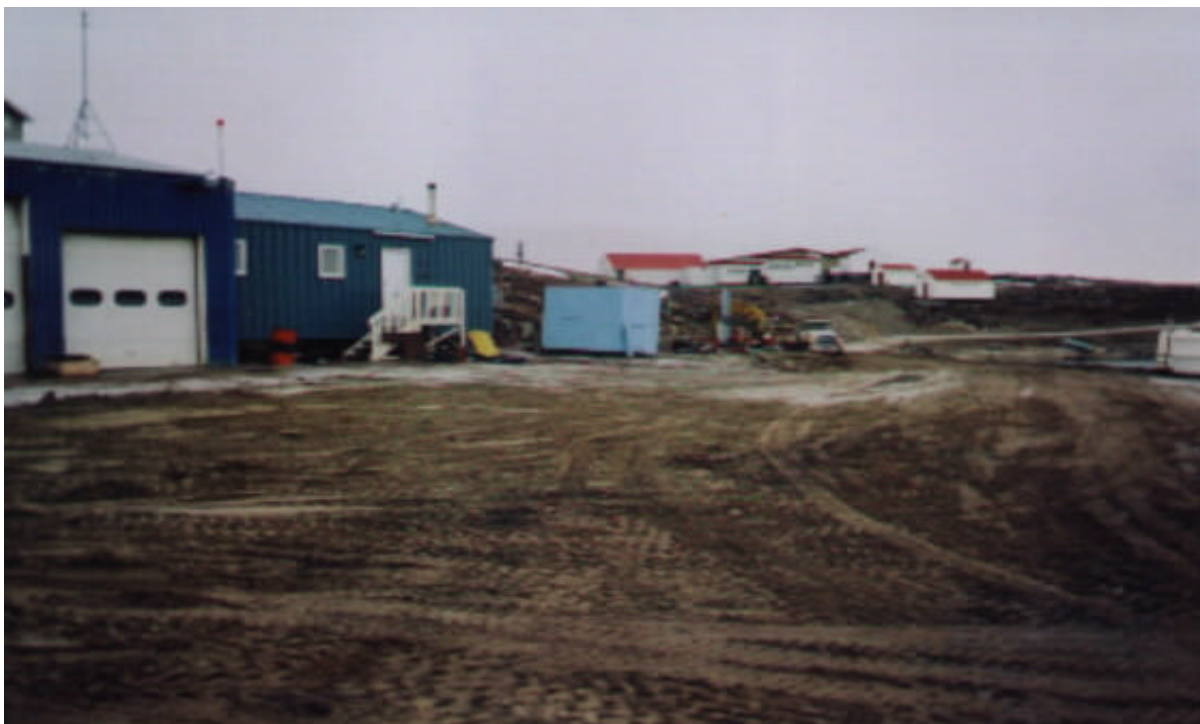
Photo 9: Western side of site after backfilling and grading looking East

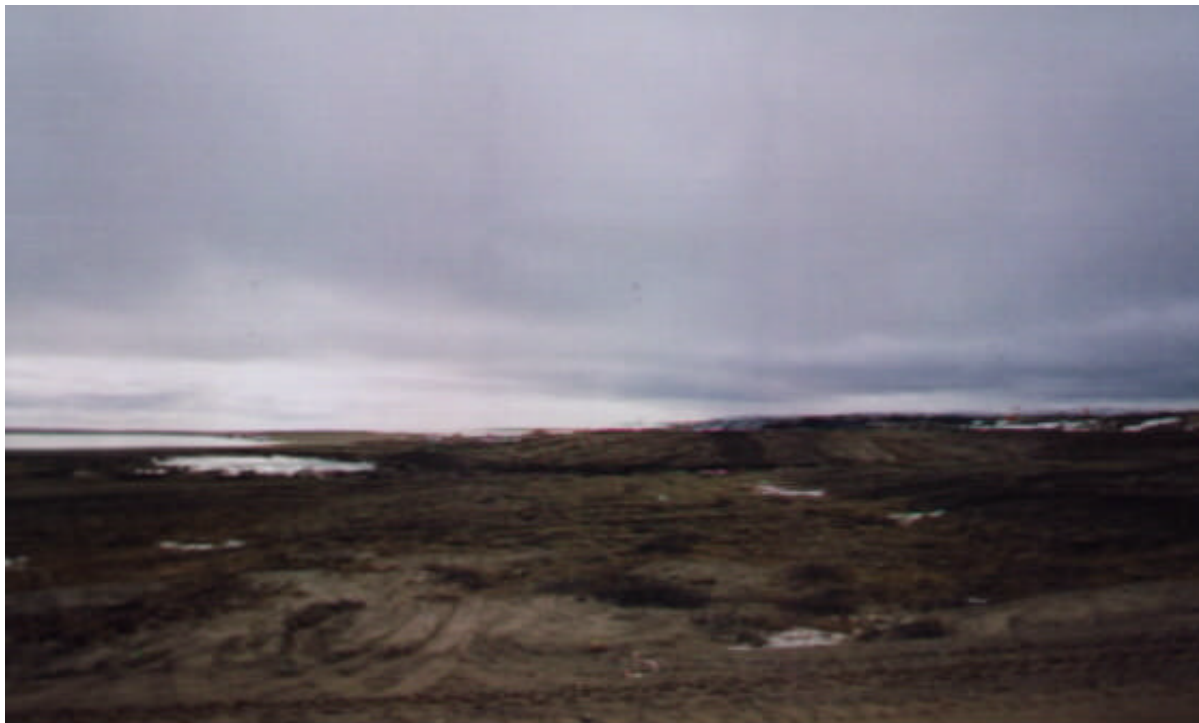
Photo 10: Completed berm looking southwest from road.

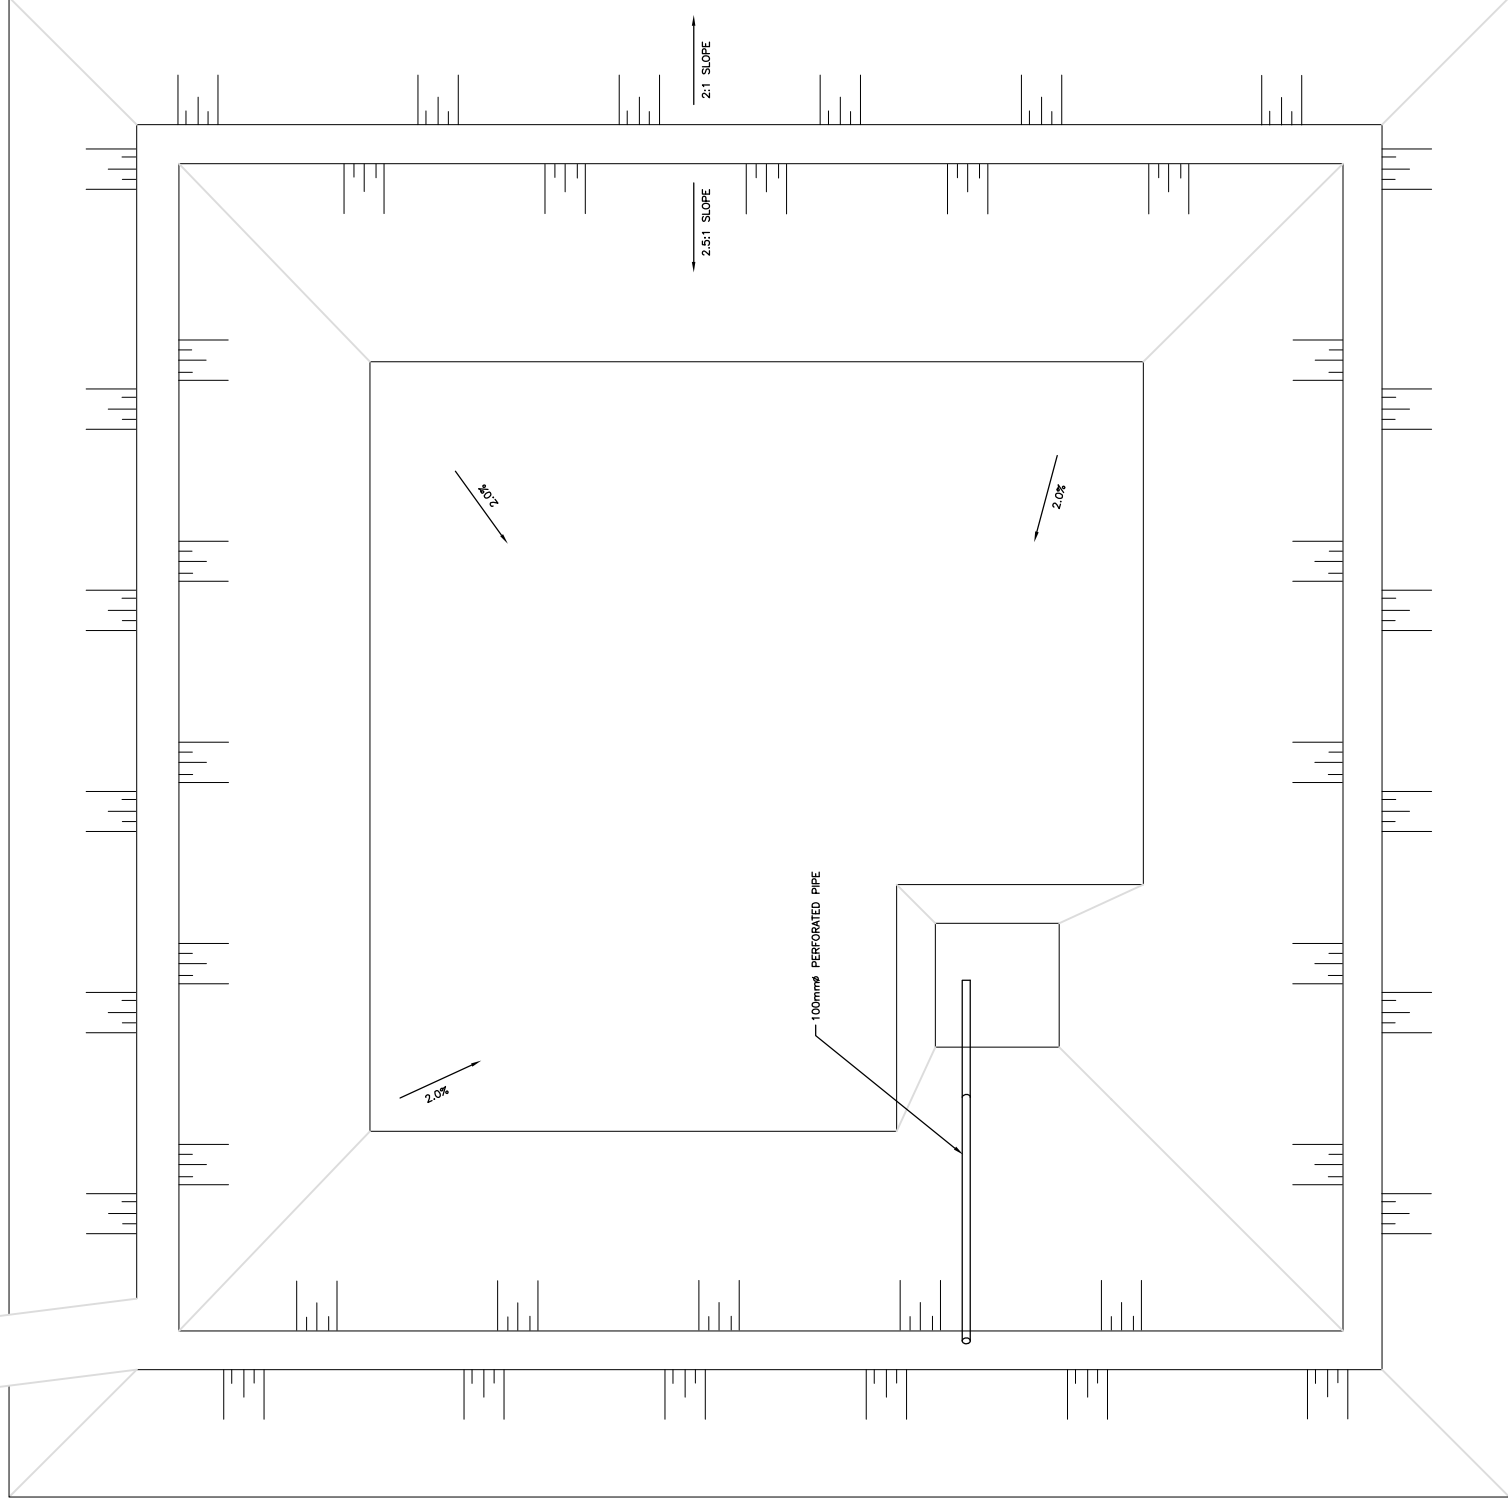
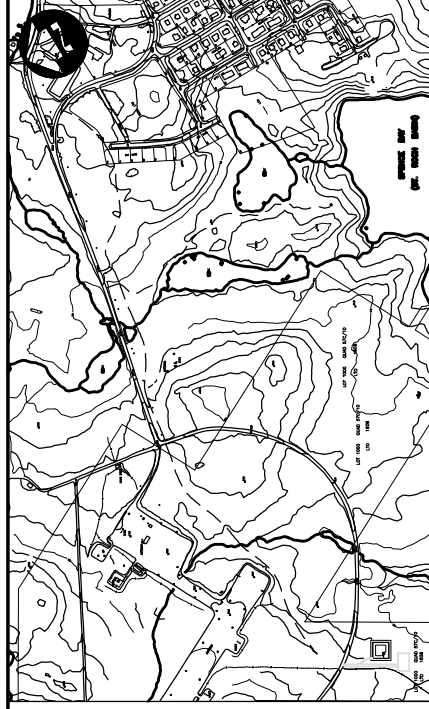
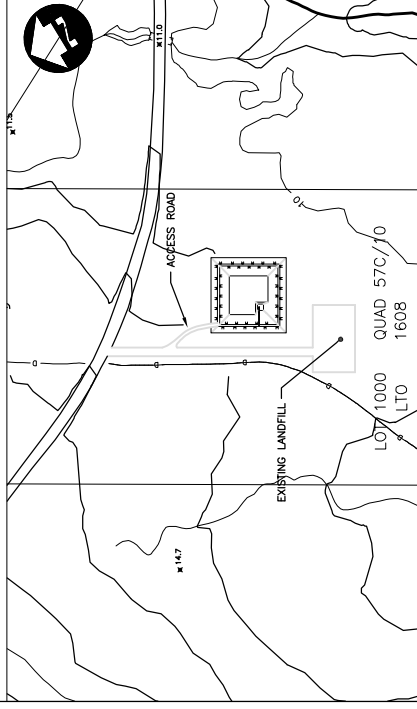
LAND FARM PLAN

The biofarm cell is approximately 1.8 m in height and 33 m by 33 m in length and width. The cell is constructed of recompacted native fill, and is covered with an impermeable membrane which is keyed into the top of the berm on all four sides. The impermeable membrane consists of a 300 mm Arctic Liner® that is underlain and overlain by a 10oz/yard Non-Woven Geotextile, and covered by 50 mm fine granular material.

The slopes of the berm are 2.5:1 on the inside slope and 2:1 on the outside slope. A 1.1 m deep (3.5 m square) retention basin is located in the western corner of the cell, and filled with fine granular material. A 100 mm HDPE perforated leachate collection pipe is located at the bottom of the retention basin, connects to a solid pipe on the sloped face and runs to the top of the berm. The leachate collection pipe can be used to control moisture content by removing leachate or water from the retention basin and spraying it back onto the contaminated soil (See drawing T1 and T2 for design specifications, and landfarm plan and sections views).

EXCAVATION DETAIL - RESUPPLY AREA

Based on the analytical results of the Phase III ESA (Dillon, 2000), approximately 780 m³ of hydrocarbon impacted soil was characterized as contaminated with hydrocarbons. Two separate areas of contamination were identified at the re-supply connection, as indicated on drawing T1.

It is Dillon's recommendation that the remaining hydrocarbon contaminated soil at the re-supply connection be excavated and transported to the biofarm cell. The location of the remaining contaminated soil at TAR-11 is indicated on drawing T1.
