WATER LICENCE INSPECTION FORM

<u>Background</u>												
On August 20, 2014 the Nunavut Water Board issued a type "B" Water Licence 1BR-THI1419 to Qikiqtaaluk												
Environmental Inc. (QE) to allow for the disposal of waste during the operation of a commercial Hydrocarbon Impacted												
Water Treatment Facility located within the City of Igaluit, Nunavut.												
,,												
Inspection												
On June 16, 2019 an inspection was conducted by Jonathan MESHER a Water Resource Officer (WRO) of Crown-												
Indigenous Relations and Northern Affairs Canada (CIRNAC) and accompanied by Oliver Simard of Qikiataaluk Environmental.												
Environmental.

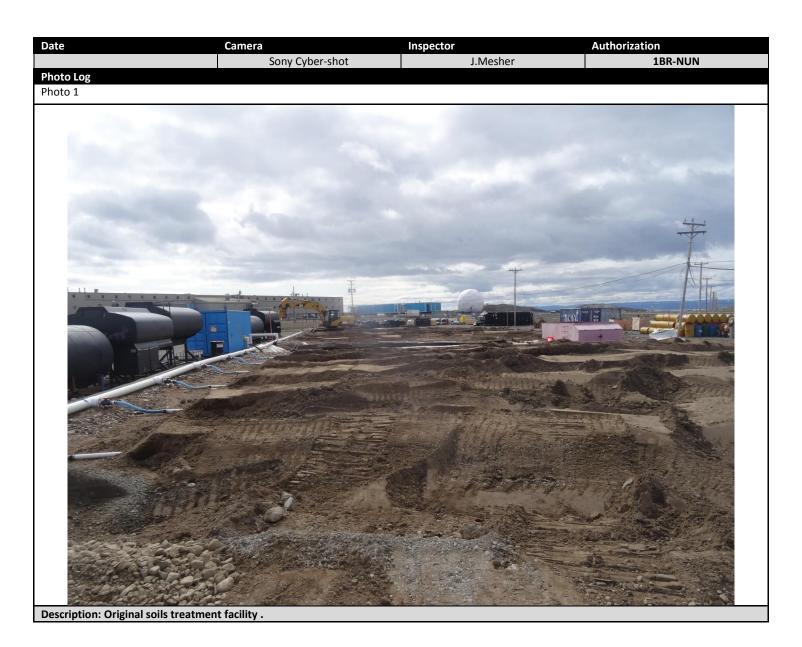
1. The original soil treatment cell appears to be operating as intended; the soil appears to be laid out in a way to												
	increase aera	ation. (se	e photo #	1 for the referr	ed to containm	ent ce	II)

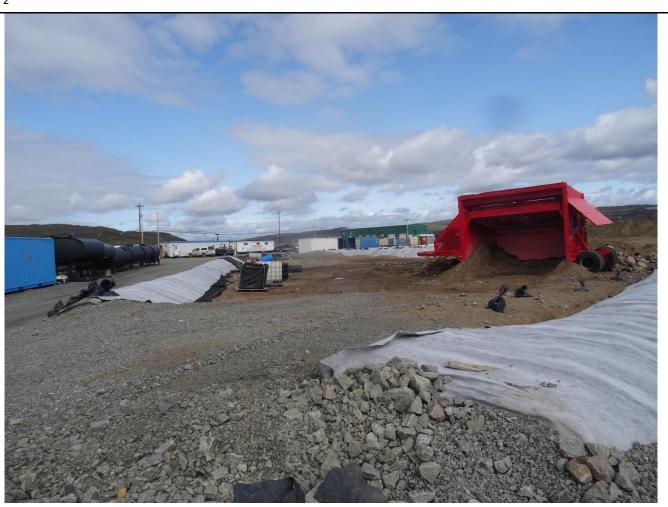
Photo Log Photo 2

2.												
	construction has not been approved by the NWB. The licensee has submitted an amendment to the NIRB (file #											
	15XH051) and to the NPC (file # 149195) and are waiting for the conformity determination prior to submitting											
	an amendment application to the NWB. (see photo #2 for the recently completed soil treatment facility)

- The Licensee is out of compliance with the Terms of the licence listed below because; they have constructed structures to hold waste prior to obtaining approval from the NWB.
 - I. Part G, Item 1
 - II. Part F, Item 1
