ABANDONMENT AND RESTORATION PLAN

ENVIRONMENTAL WASTE PROCESSING FACILITY 2020 AMENDMENT TO 1BR-THI2027

Environmental Waste Processing Facility 2020 AMENDMENT TO 1BR-THI2027

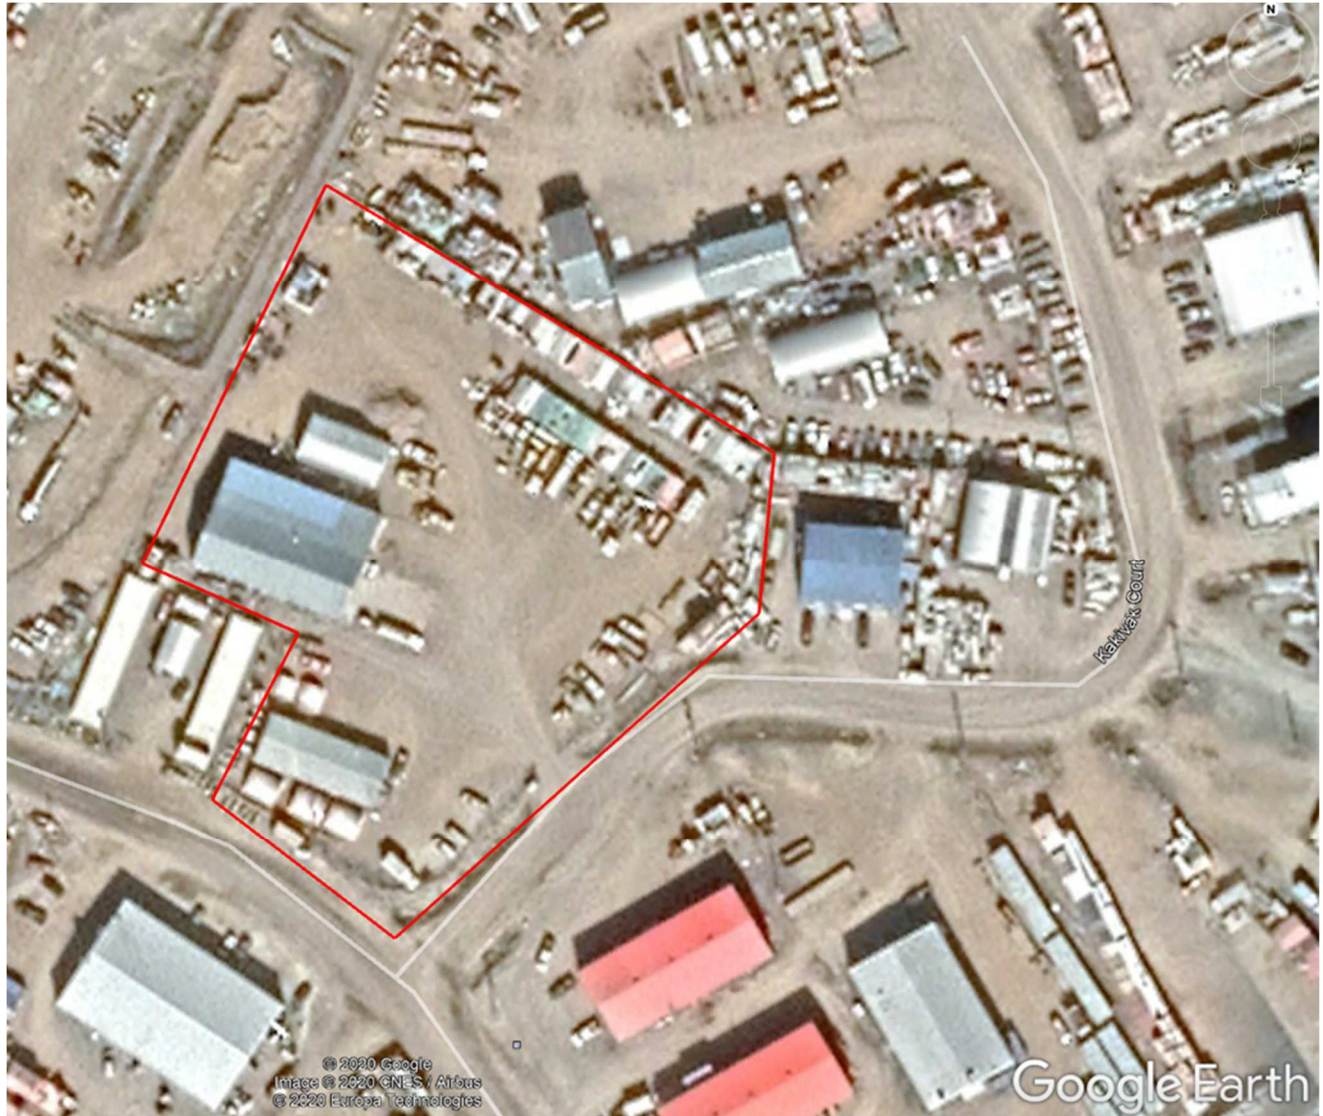
FIGURE 1
Location of Former QE Waste Transfer Station

The following figures show the approximate boundaries of the lot described above as well as the waste storage location, water treatment and water discharge location.

Prior to its current EWPF location, QE occupied a small part of Lot 3, Block 228 on the corner of Federal Road and Kakivak Court (coordinates 63° 45' 44"N and 68° 32' 41"W) owned by Qikiqtaaluk Corporation in Iqaluit, Nunavut (also referred to as "previous location"). This property is zoned for industrial use. QE's sister company, Qikiqtani Industry Ltd., has been operating its business on this lot for over 10 years. Amongst other things, they own, operate, store and repair vehicles and heavy equipment for civil works and snow clearing on this property. QE moved to its current location in the spring of 2016.
