Kiggavik Sissons  
Exploration Project  
Preliminary Site Visit  
July 9 and 10, 2002  
Kiggavik Camp  
Pointer Lake (core boxes)  
Andrew Lake Site  
Long Lake

## **APPENDIX 2**

July 2002 Site Inspection

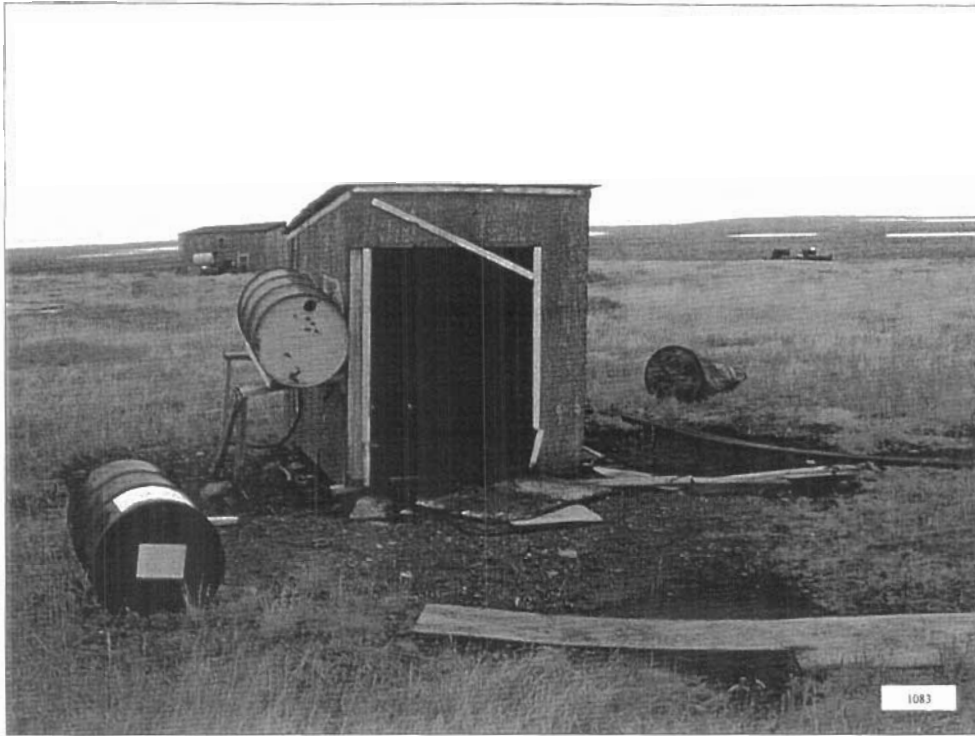
Generator building - note contaminated soil.

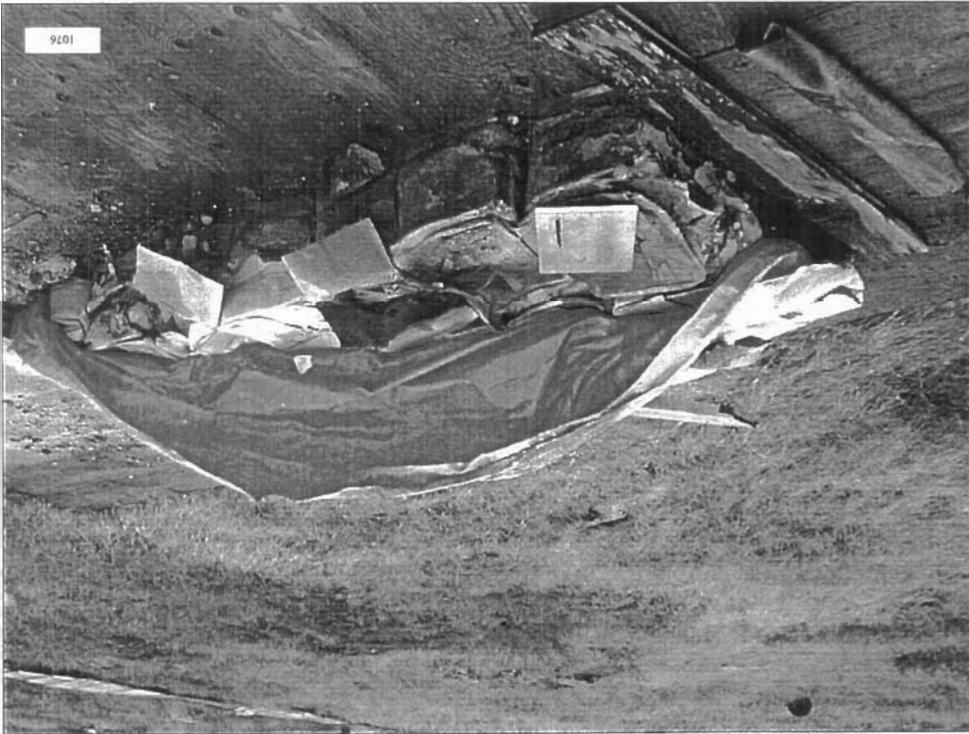
Platform - Samples of drill cuttings on platform - Automess reading 0.05 to 0.17  $\mu\text{Sv/hr}$  @ 1m height

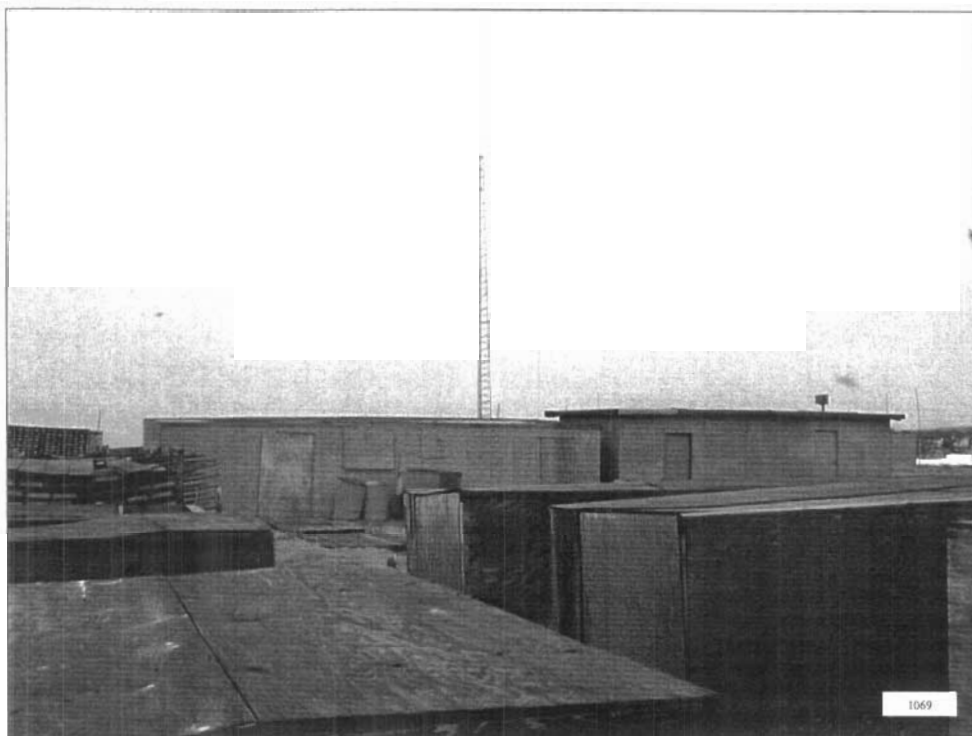
Core shack on left contains 2 stoves, cots, mattresses, pump hoses, electric cables, core splitter and miscellaneous equipment

Left entrance to the right core shack contains more cots, stove parts, spare doors and a 5 gallon can of left over chemicals including NaOH, HNO<sub>3</sub> and FeCl<sub>3</sub>; also several 6 volt batteries.

Right entrance to the right core shack contains tarps, snowshoes, batteries, boat fuel, spools of wire, gas pump, rope, rubber fuel hoses and stove fuel filters, soil sampling equipment, paint, survey stands, ice augers, pails, a small compressor.

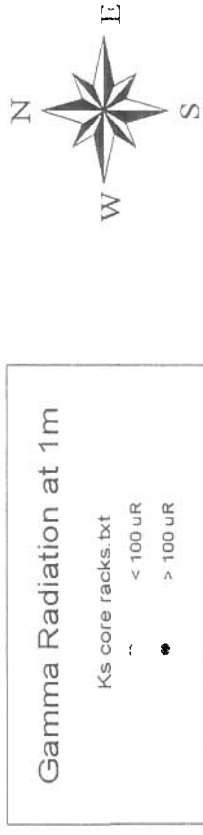
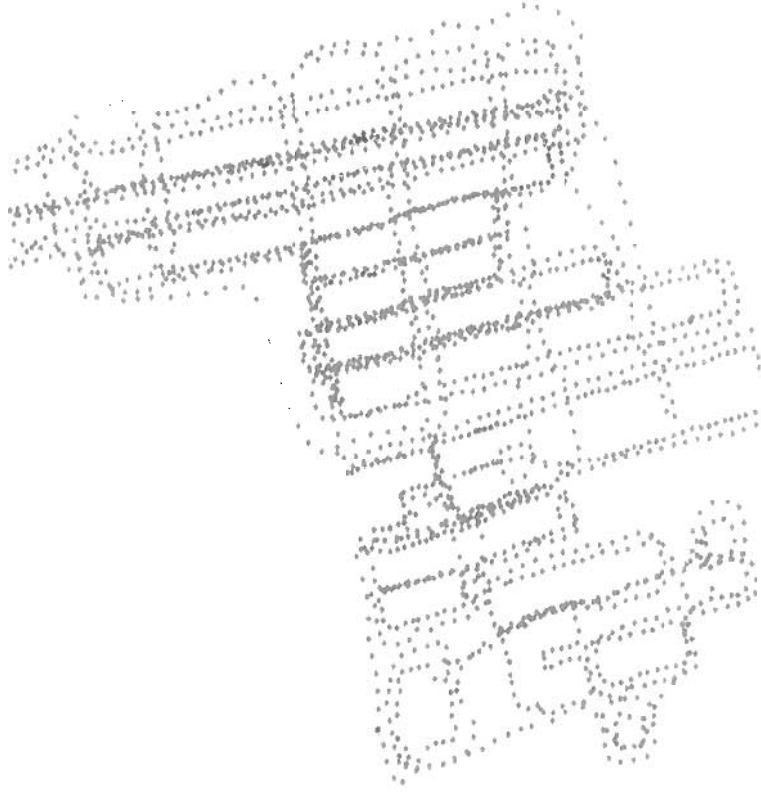
# Kiggavik Core Racks

- Correlation of Ludlum detector (GPS system detector) cpm against Automess measured field in uSv/hr. Measurements taken at Cluff Lake ore pad.
- Next two figures show readings around core rocks with cutoffs of 100 uR/hr (1 uSv/hr) and 35 uR/hr (0.35 uSv/hr), scaled from GPS system detector.

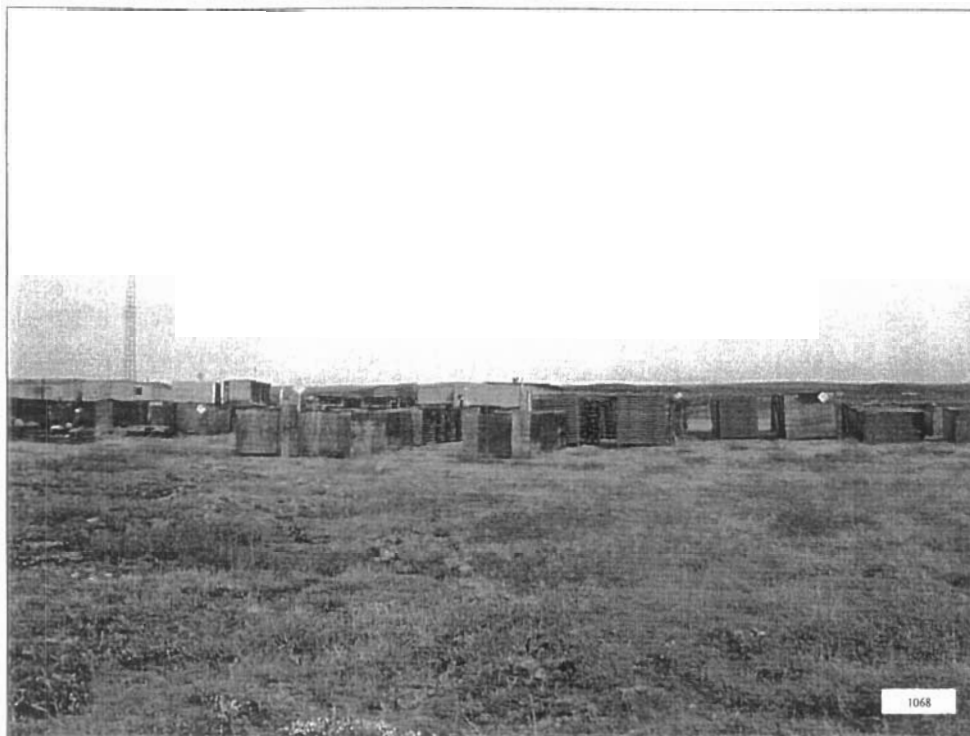
Core racks - Note Darren taking measurements in center foreground; lichen collection taken about 10 m from right side of photo; AutoMess readings in this area 0.1 to 0.28  $\mu\text{Sv/hr}$  taken 1 m above ground.

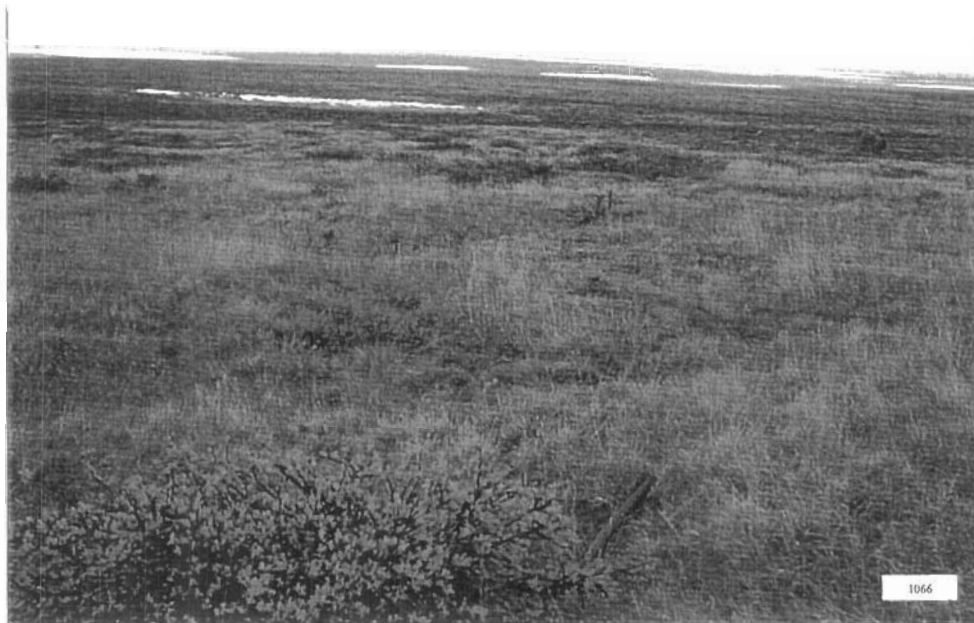
Discharge area for grey water from the dry - AutoMess readings of soil in low lying areas around end of pipe 0.0 to 0.05 uSv/hr; no detectable elevated radioactivity.

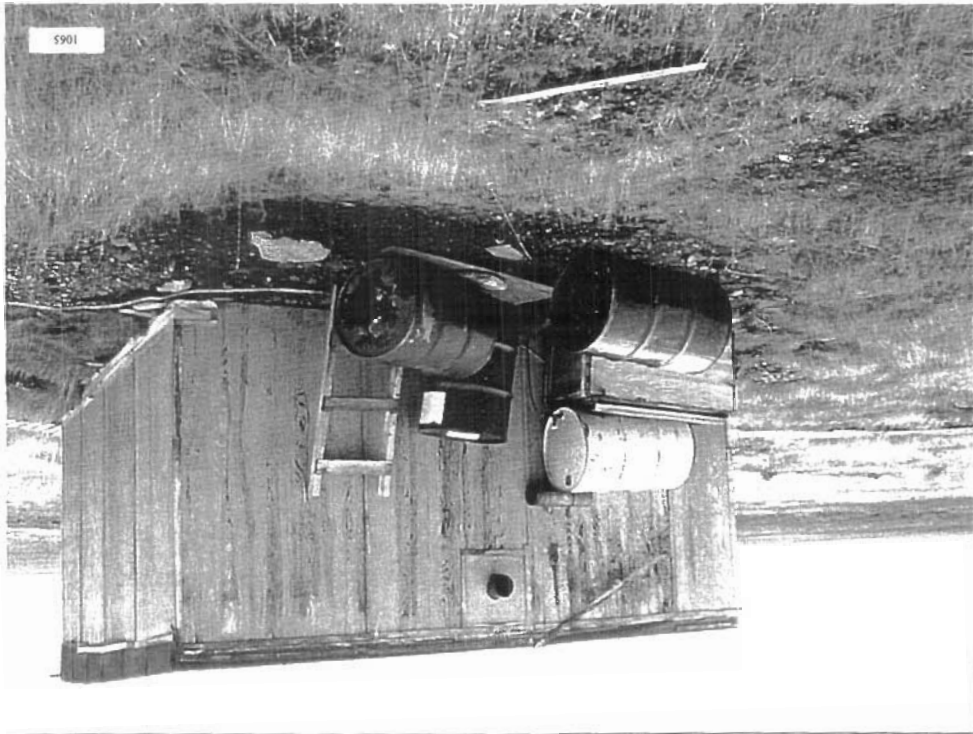
Typical fuel area for stoves behind cabins - Note area of spillage on ground; 2-4 barrels which may be full or partial at each cabin; estimate about 1/3 barrel of contaminated soil at each.

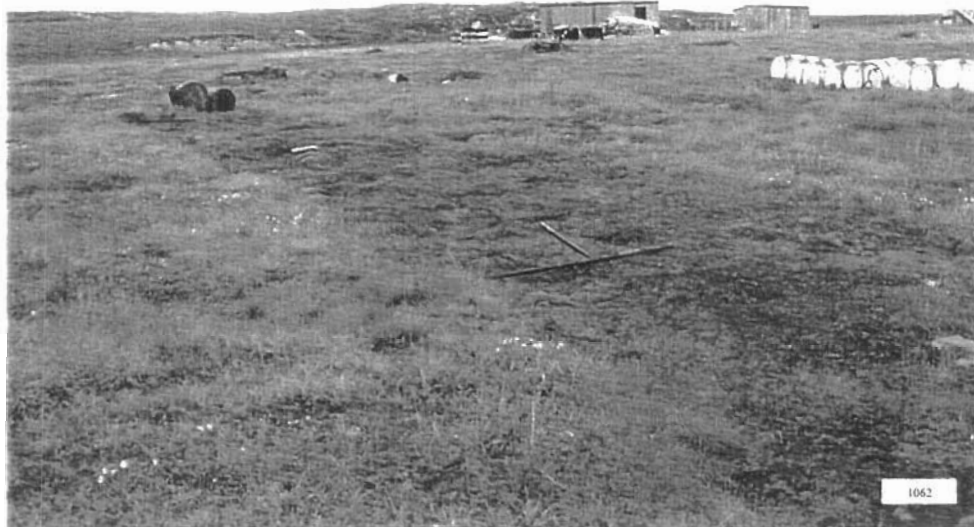
Previous drum laydown area, no apparent spillage - vegetation temporarily impacted but starting to regrow; no further work required.

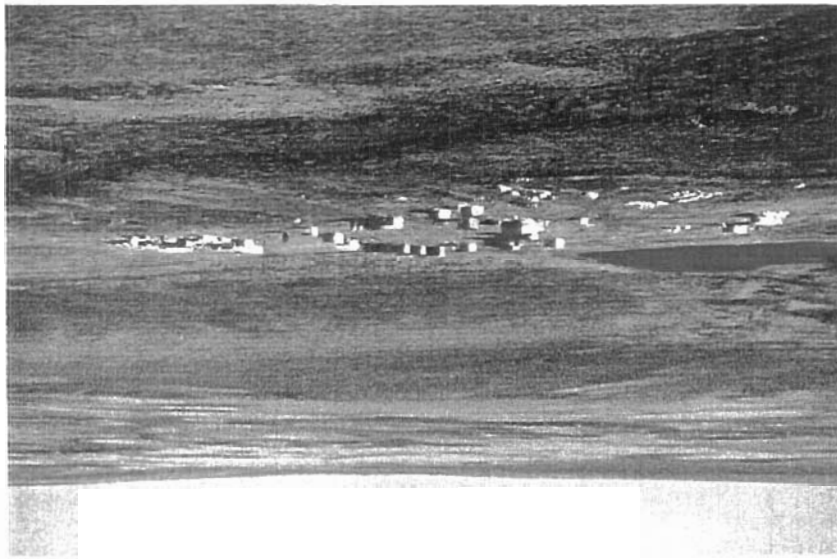
## Kiggavik Main Camp

- Earlier year picture
- Core shack and core racks to the right
- Kitchen, office, dry and personnel cabins in center
- Helicopter landing pad and fuel cache to the left
- See detailed plan on next figure.
