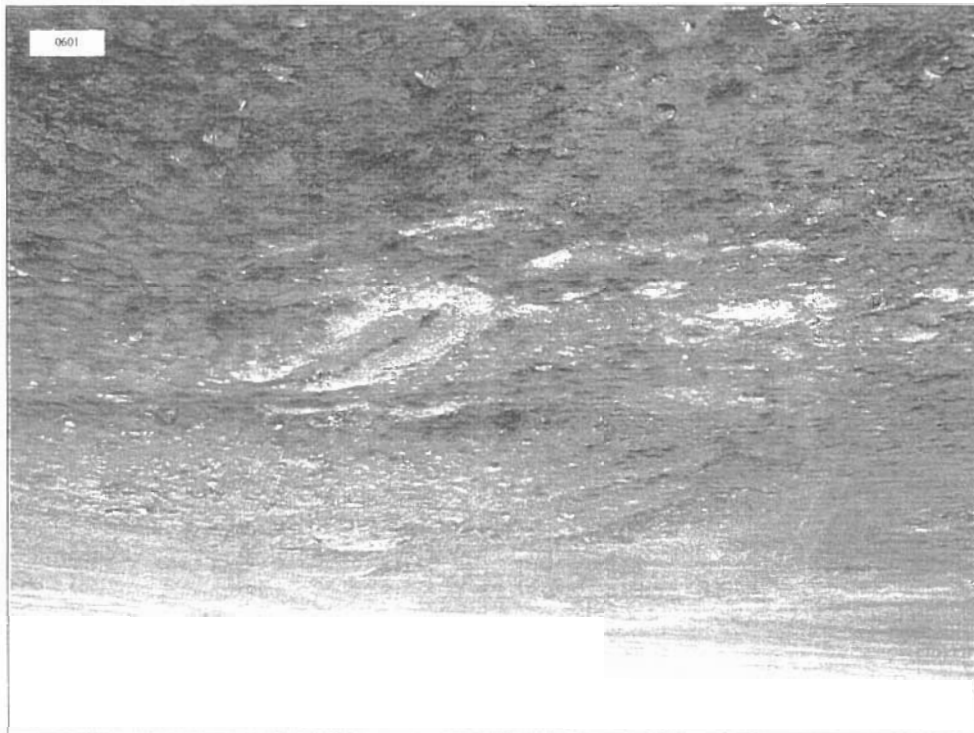
Outcrop and trenches in area of apparently elevated natural radioactivity.

Location of Trench #1 - N7146886.7 E565116.1

Location of Trench #2 - N7146902.3 E565111.9

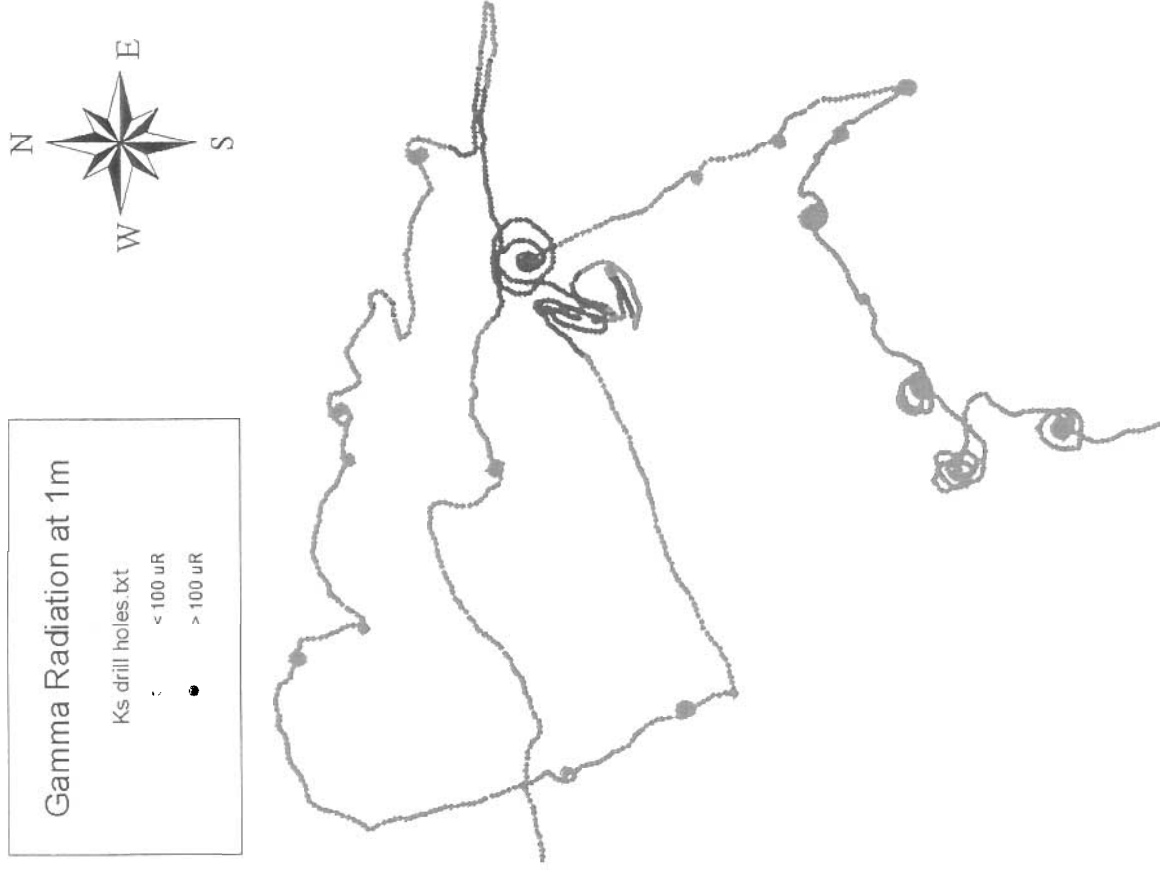
# Kiggavik Drill Holes

Next two figures show readings scaled from GPS system detector, at 100 uR/hr and 35 uR/hr cutoff.

Indication of area of elevated natural radioactivity, with no significantly elevated drill cuttings in this area.

- Readings appear elevated over the entire elevated area.
- Little difference between 35 and 100 uR/hr cutoff.
- No elevated readings right at, and around, boreholes except for one near trenches in elevated area.

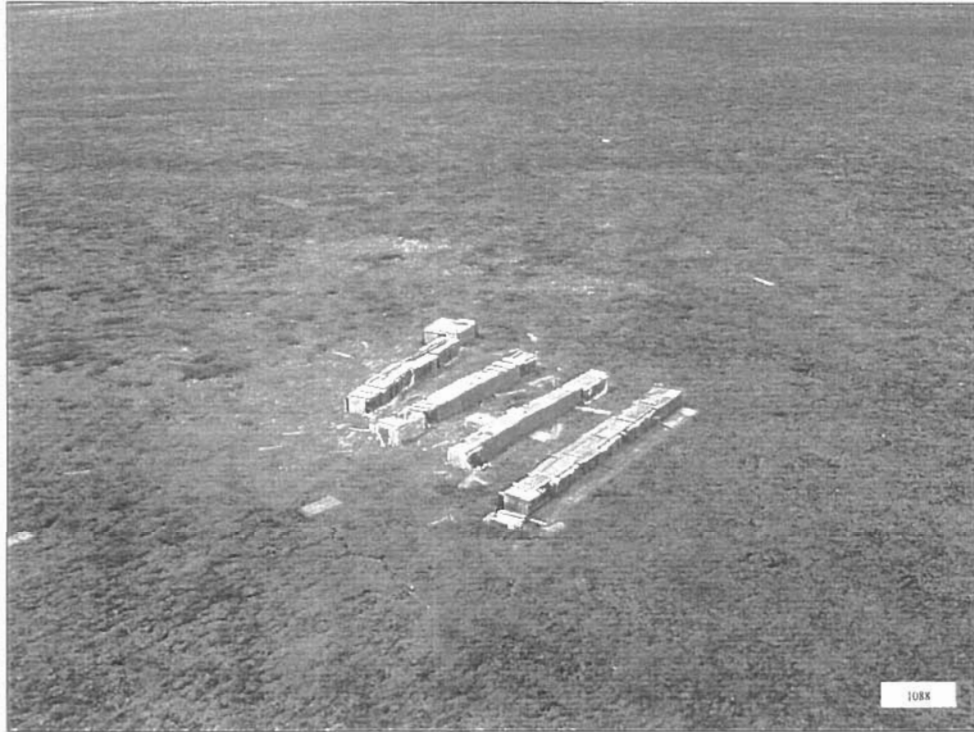
Pointer Lake core racks.

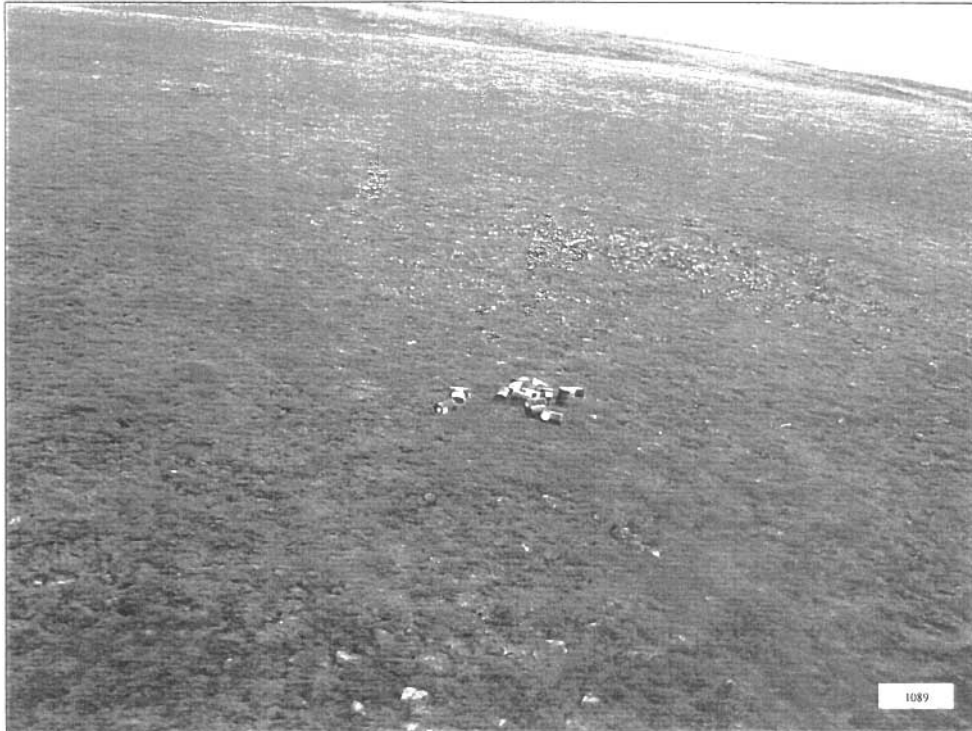
Drums just south of camp.
