**FISH AND HABITAT ASSESSMENT
OF THREE WATERCOURSES
NEAR KUGAARUK, NUNAVUT**

**Jivko Engineering Ltd.
Yellowknife, NT.
and
Hamlet of Kugaaruk, Nunavut**

July 2001

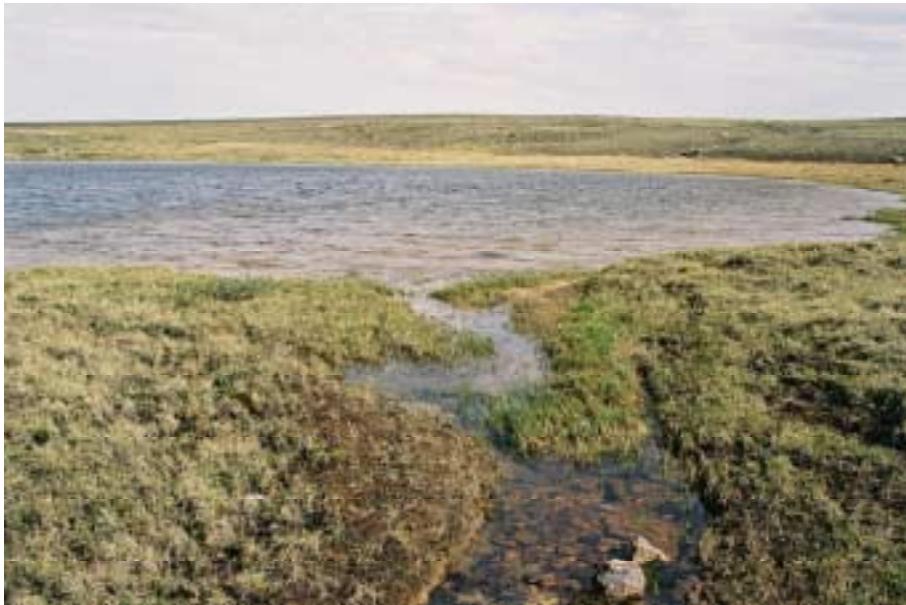
Plate 1 Crossing 1, 12 July 2001. Outlet of ponded area upstream of the road alignment. Note narrow channel width and shallow depths at the outlet. Some evidence of elevated water levels noted on banks in foreground.

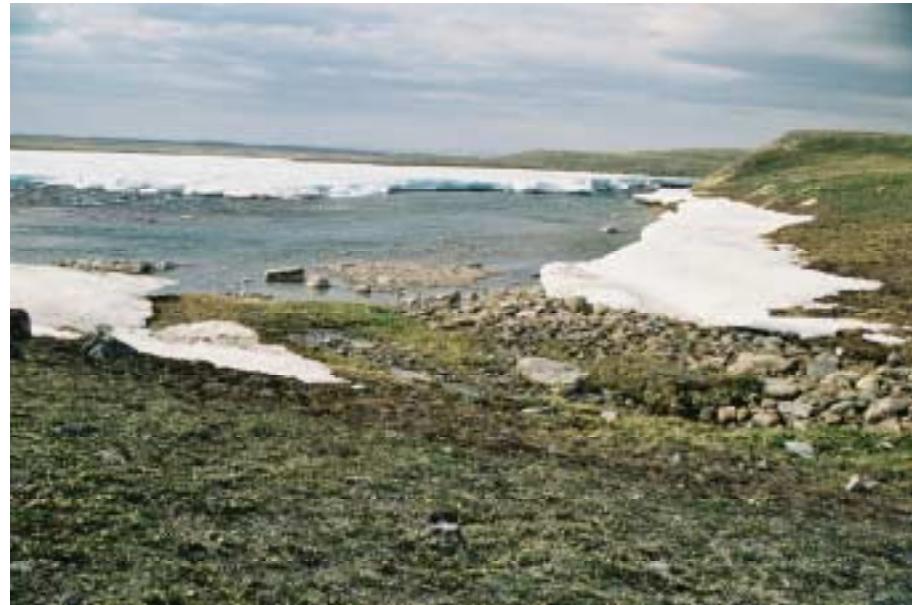
Plate 2 Crossing 1, 12 July 2001. Confluence area of unnamed tributary with Aliarusik River. Tributary enters river from picture right. Note ice cover and ice depth on river.

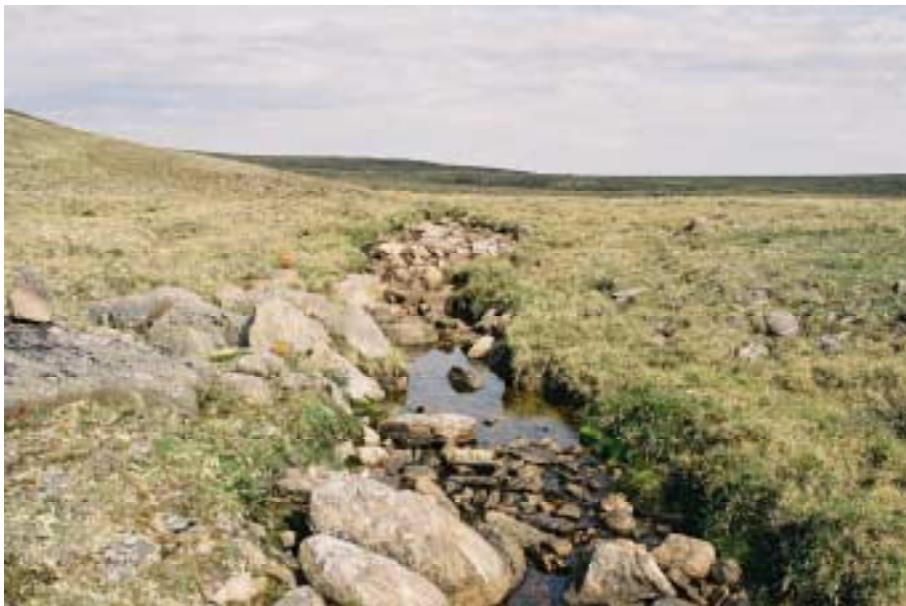
The stream channel at the Crossing 1 location exhibited a steep gradient (approximately 15 m rise in 50 m; 30%), with channel widths ranging from 0.3 to 1.0 m, and depths up to 0.2 m (Plate 3). The presence of a wider channel was noted at the existing ATV crossing, which is located immediately downstream of the proposed installation (Plate 4, 5 and 6). Instream habitat consisted primarily of riffle-pool complexes and abundant cascades over large rocky substrate. Several sections of the stream were characterized by interstitial flow amongst large boulders (Plate 7). Substrate was predominantly boulder and large cobble, although small discrete areas of finer substrate (e.g., gravel and sand) were evident in association with pool habitat (Plate 8). The D90 for the watercourse was estimated to be 75-cm, which reflects the large bed material. Instream cover was provided by interstitial space amongst the substrate and instream vegetation in the pool areas. Water velocities were considered low (e.g., < 0.25 m/s). The habitat suitability of the stream at Crossing 1 was considered low for all life stages of Arctic char (the predominant fish species in the Aliarusik River system) due to the shallow, ephemeral nature of the watercourse.

Plate 3 Crossing 1, 12 July 2001. Upstream view of crossing location. Perched rocks on left side indicate approximate road alignment.

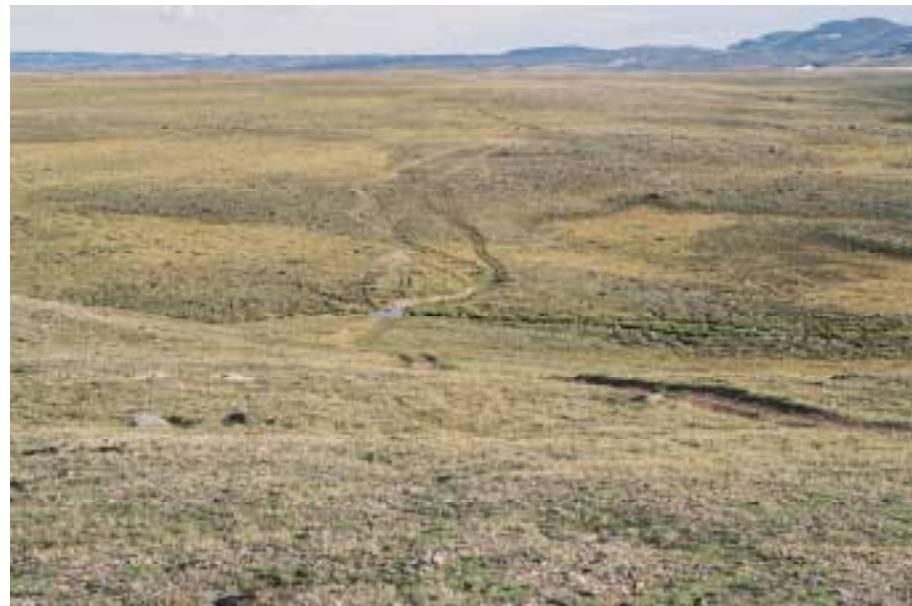
Plate 4 Crossing 1, 12 July 2001. Crossing 1 viewed from top of valley to north of crossing.

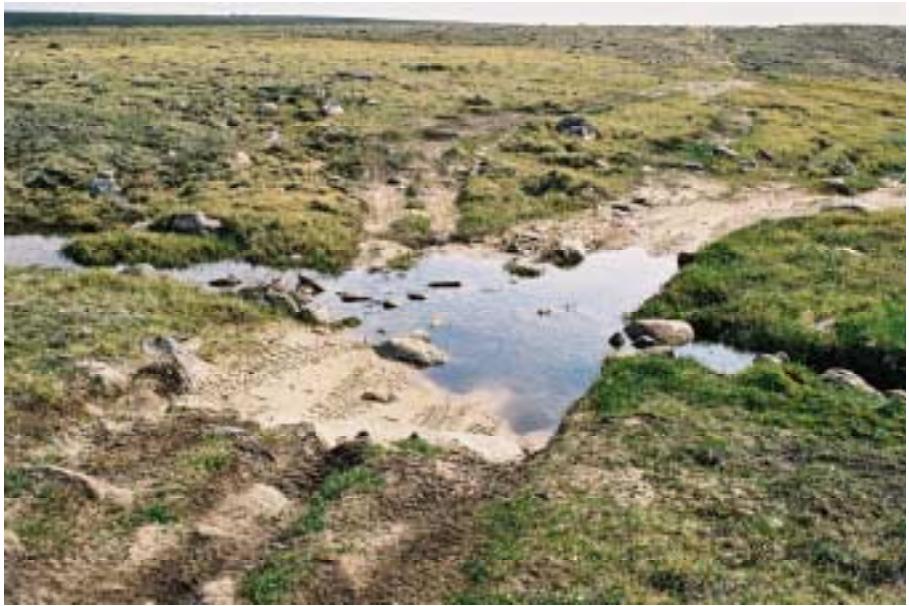
Plate 5 Crossing 1, 12 July 2001. ATV crossing located immediately downstream of the proposed road alignment. Note the extensive bank degradation resulting from repeated ATV forded crossings.

The present ATV crossing location at Crossing 1 (unnamed tributary to the Aliarusik River) consists of a track through the stream channel. The banks on either side of the crossing have been disturbed by repeated crossings (Section 4.1, Plate 5). The culvert structures for Crossing 1 are to be placed approximately 10 m upstream of the existing ATV ford crossing.

The ATV crossing will be rebuilt while construction equipment is working in the area. The banks and streambed will be rebuilt using clean rocky material from the culvert site. All work on this stream (including culvert installation and channel remediation) will be done in the late summer or fall period after the stream has ceased to flow. The stream improvement area is estimated to be approximately 10 m² (10 m length X 1 m stream width).

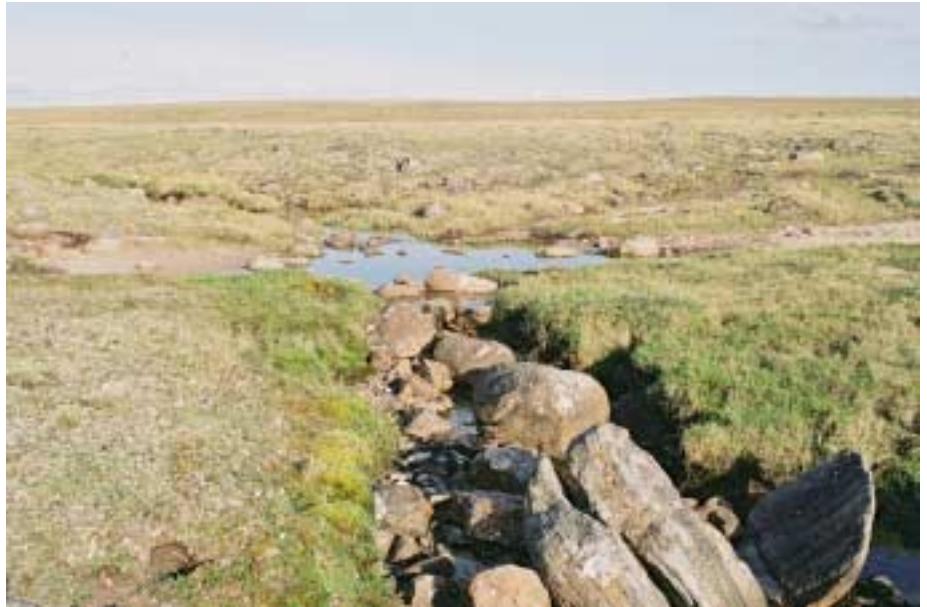
Plate 6 Crossing 1, 12 July 2001. Upstream view of ATV crossing in relation to natural undisturbed channel widths. Note change in gradient immediately downstream of the ATV crossing.

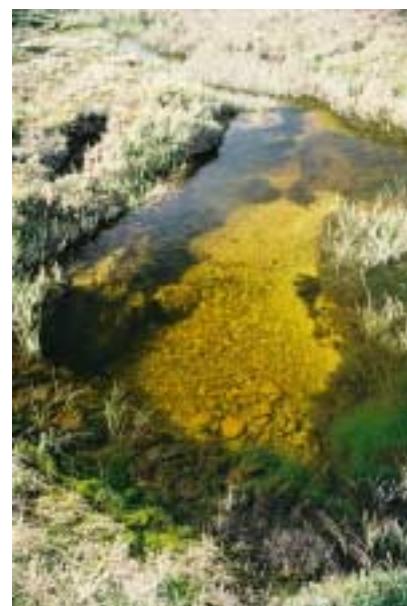
Plate 8 Crossing 1, 12 July 2001. Pool area with finer gravel substrate located downstream of the proposed crossing location.

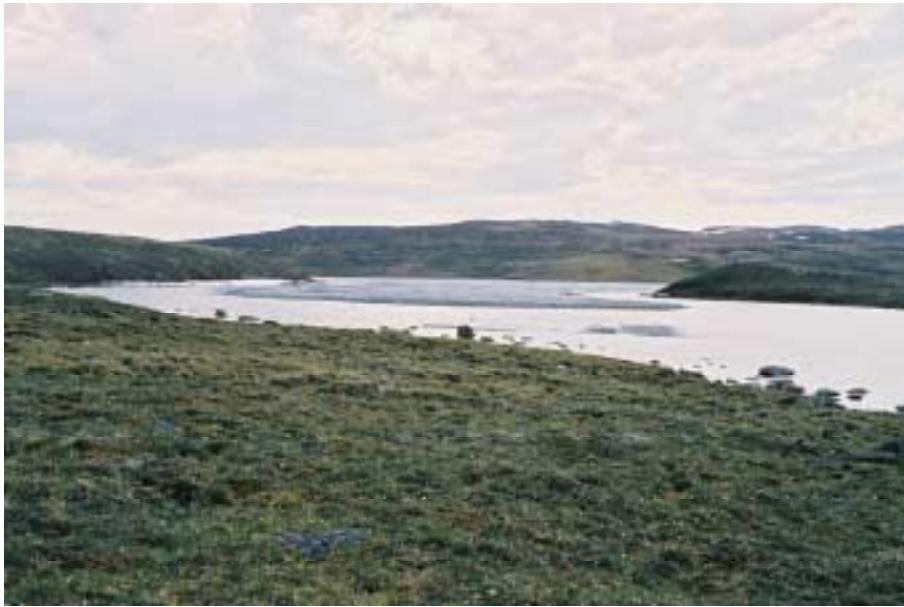
Plate 9 Crossing 2, 12 July 2001. Barrow Lake viewed from near Crossing 2. Outflow of the Aliarusik River is on picture right. Note ice cover still present on the lake.

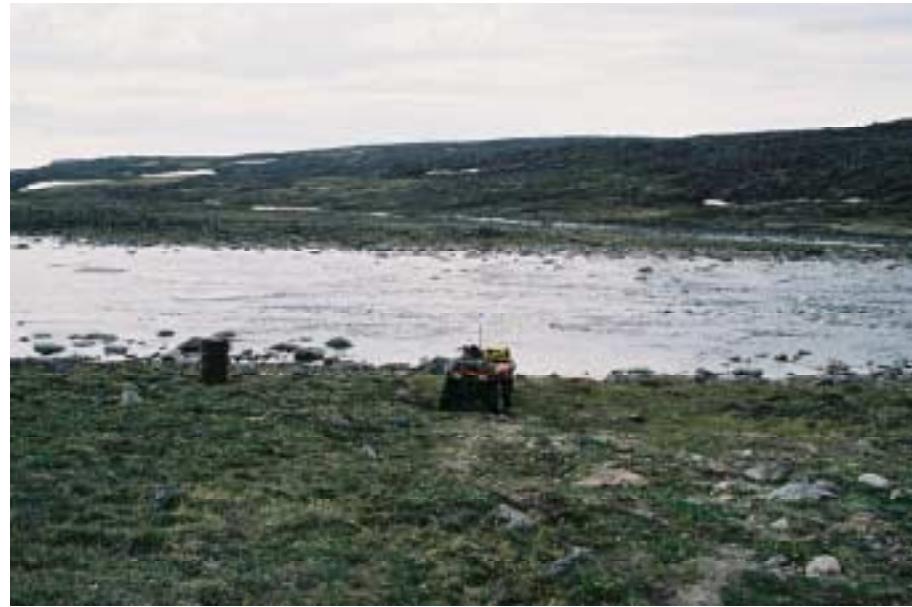
The stream channel at Crossing 2 exhibited a moderate gradient (approximately 5 m rise in 50 m; <1%), with wetted widths of 45 m, and depths up to 0.75 m (Plates 10 through 13). The thalweg was located nearest the east river bank (right side facing downstream) with gradually decreasing depths toward the west bank. Instream habitat was predominantly riffle-boulder garden. Substrate was entirely boulder and large cobble; the D90 for the watercourse was estimated to be 100-cm. Instream cover was provided by interstitial space amongst the boulder streambed. Water velocity at the crossing was considered moderate (e.g., between 0.25 and 0.75 m/s). The habitat suitability of the Aliarusik River at Crossing 2 was considered moderate for Arctic char migration/movement during higher water periods. This suitability was likely to decline as water flows diminished later in the year. The suitability of the habitat was considered low for other life stages of Arctic char and lake trout due to the preponderance of very large substrate and shallow depths at the crossing during most of the year.

Plate 10 Crossing 2, 12 July 2001. Aliarusik River at Crossing 2 viewed from the west bank. Quad marks the approximate centre of the road alignment. Note river flow is from left to right.

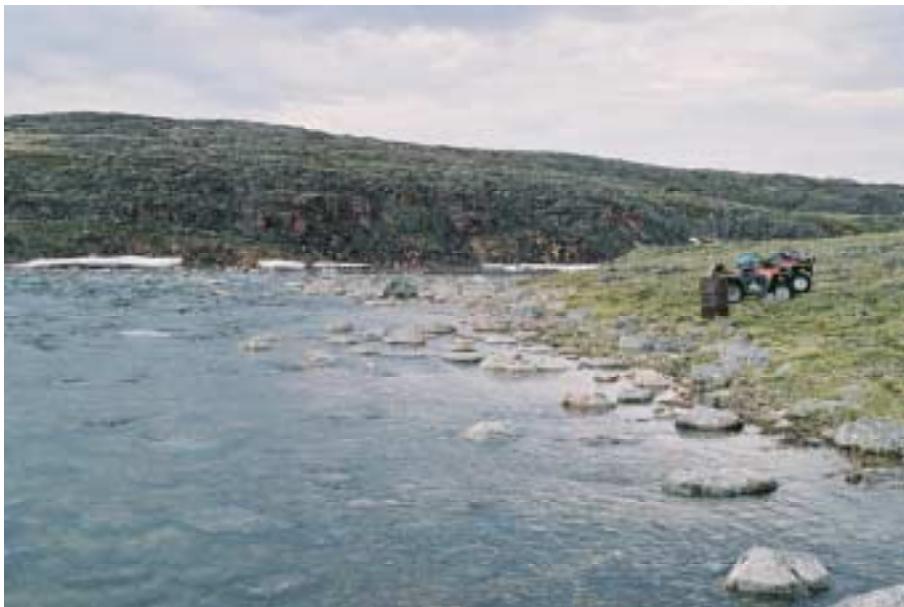
Plate 11 Crossing 2, 12 July 2001. Downstream view along west bank of the Aliarusik River at Crossing 2. Quads mark the road alignment.

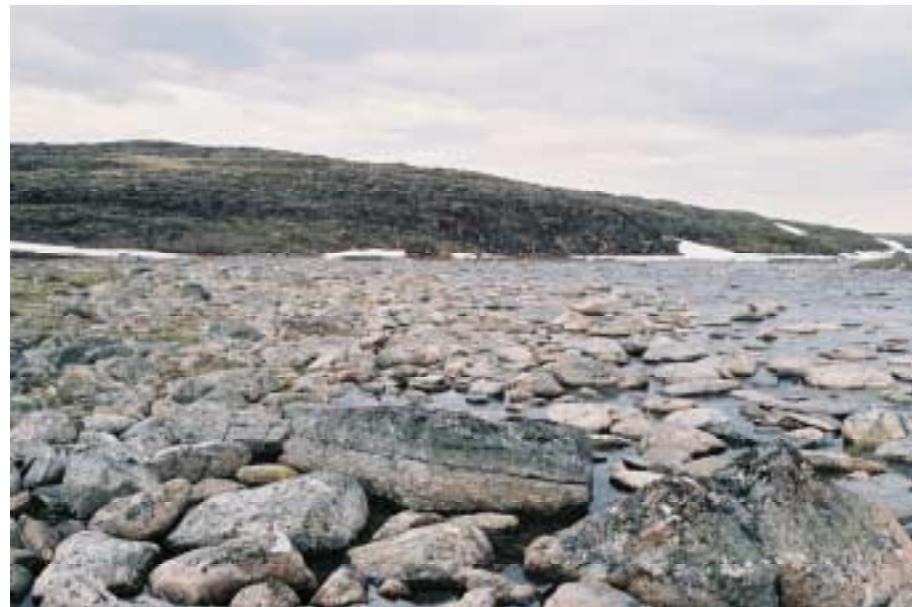
Plate 12 Crossing 2, 12 July 2001. Downstream view along east bank of the Aliarusik River at Crossing 2. Note shallow water in nearshore areas.

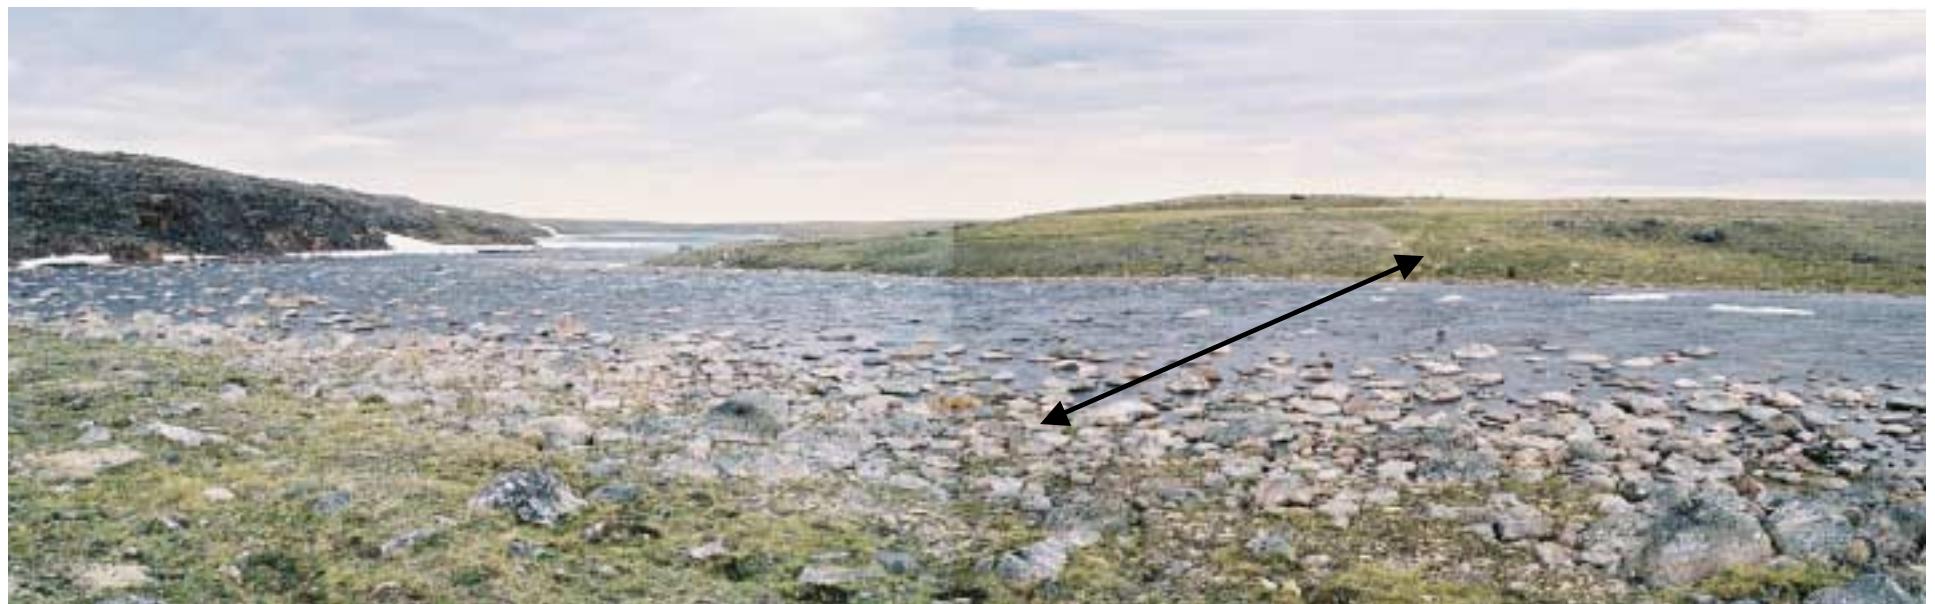
Plate 13 Crossing 2, 12 July 2001. Panoramic view from the east bank of the Aliarusik River at Crossing 2. Barrow Lake is located to the right of the picture. Note the smaller lake downstream of the crossing location. (Dark arrow indicates approximate location of the proposed bridge.)

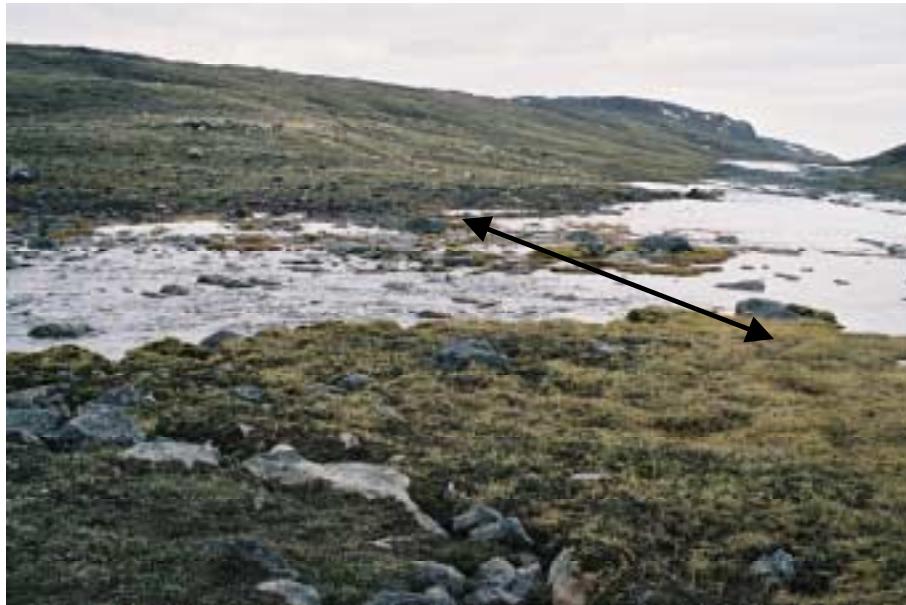
The watercourse bisected by Crossing 3 is a 60 m long overflow channel, which connects an unnamed tributary of the Aliarusik River to Barrow Lake (Figure 4.3). The overflow channel is active, but shallow during freshet (Plate 14) with diminishing flows throughout the summer period.

Plate 14 Crossing 3, 12 July 2001. Overflow channel viewed from the west bank
Arrow denotes proposed crossing location.

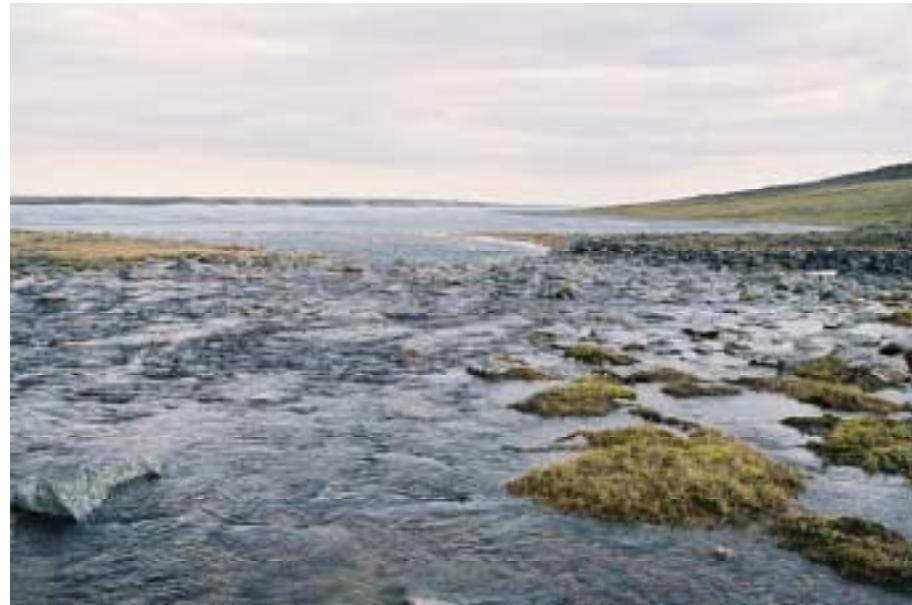
Plate 15 Crossing 3, 12 July 2001. Downstream view from upstream end of
overflow channel toward Barrow Lake. Note abundance large boulders and
high stream gradient.

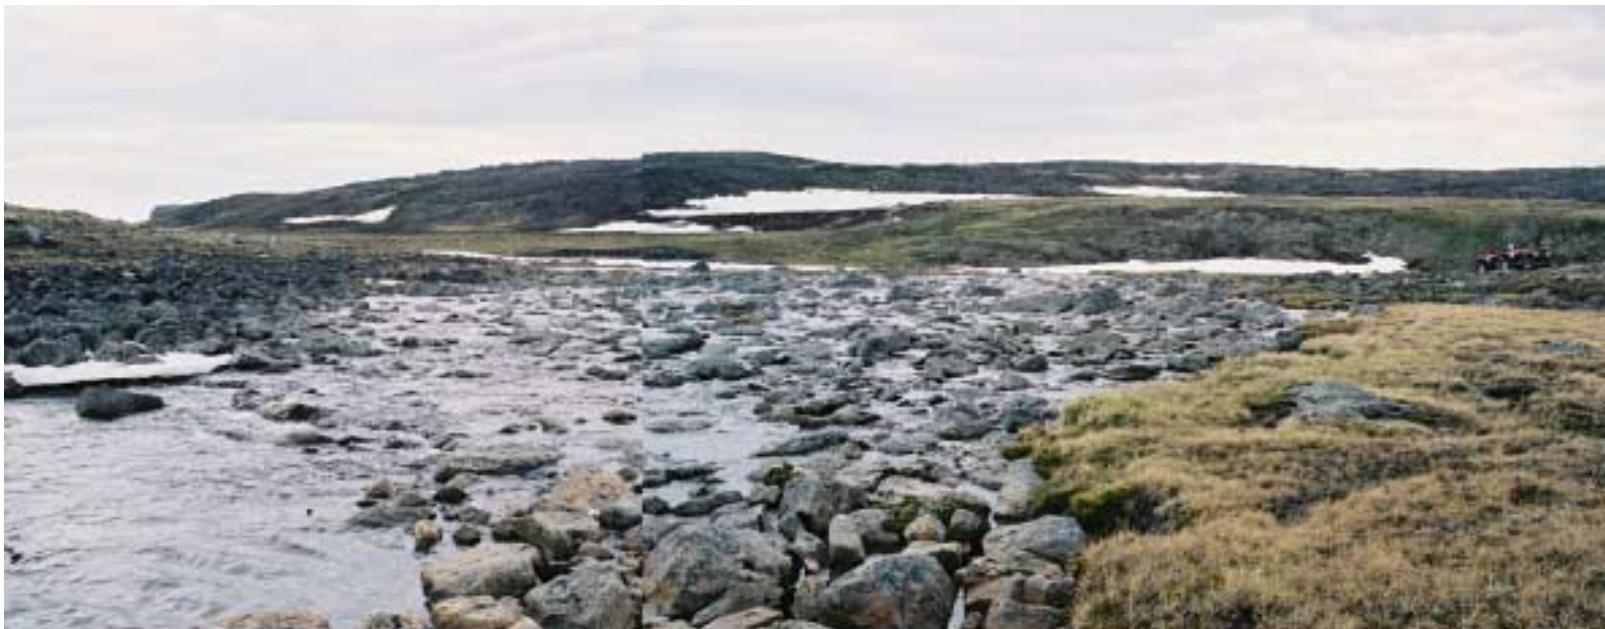
Plate 16 Crossing 3, 12 July 2001. Upstream view of the overflow channel from near Barrow Lake inflow. Note shallow depths amongst riffle-
boulder garden.
