**KUGAARUK NU**  
**ALIARUHIK RIVER SECOND BRIDGE CROSSING AND TWO**  
**CULVERT CROSSINGS**

**Interim Construction Report and  
Request for Extension of the Completion Date for Works  
Affecting Fish Habitat**

Prepared by: *Jivko Engineering*  
November 2001

**KUGAARUK, NU**  
**ACCESS TRAIL TO FOL SITE, KM 22**  
**ALIARUHIK RIVER SECOND BRIDGE**  
**CROSSING**

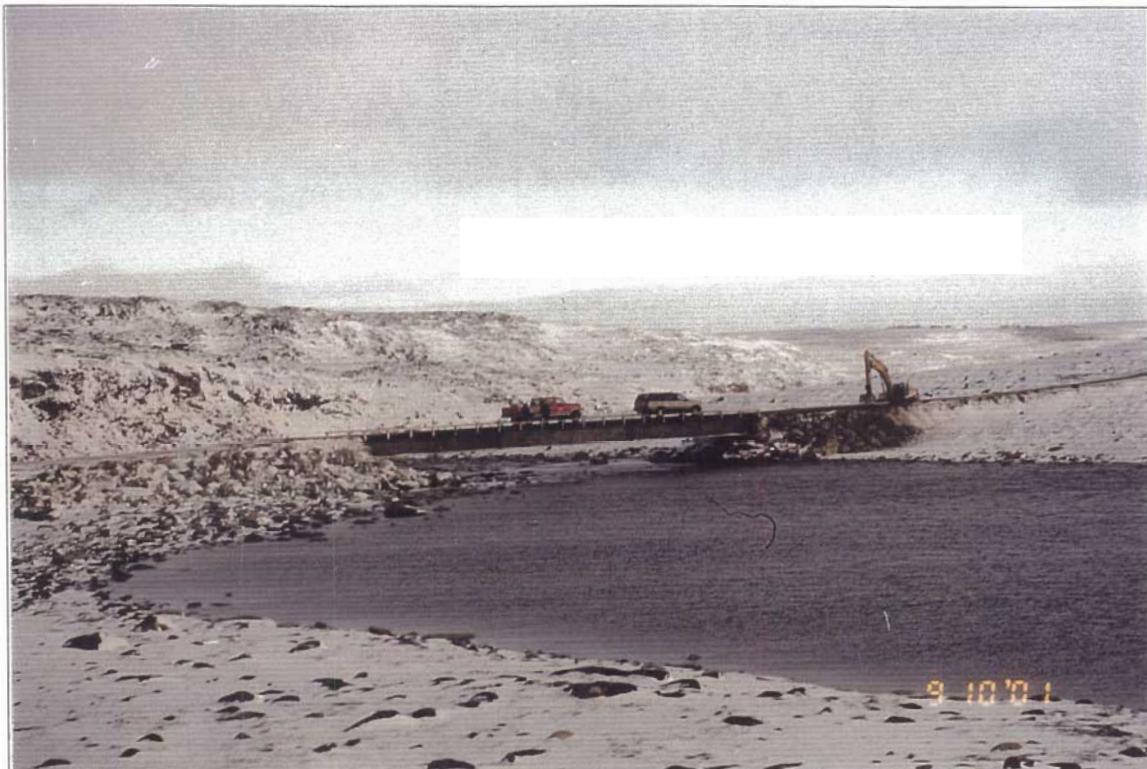
General view of bridge and approaches from Barrow Lake (upstream) side

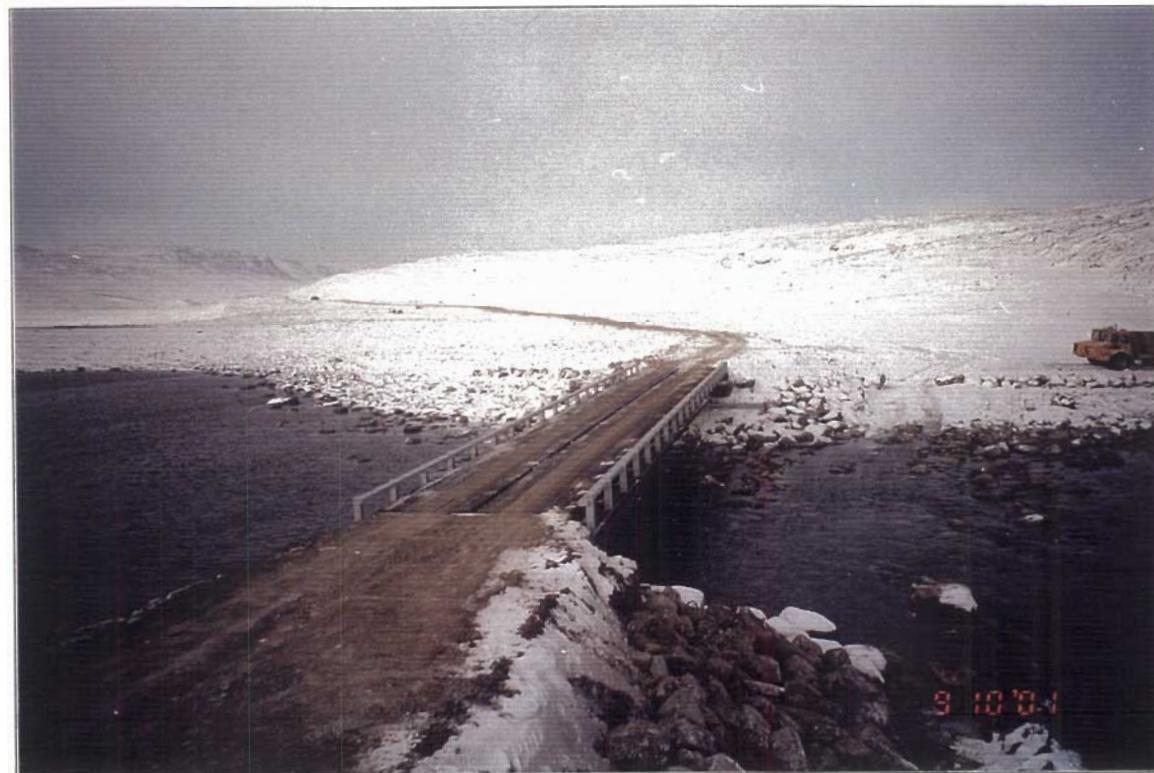
View of bridge deck towards east. Ford on the right of the bridge.

- Outstanding work for next year will include some cleanup and landscaping of the site. Also, placing of some rock may be required on the existing ford located approximately 15 m downstream from the bridge crossing.

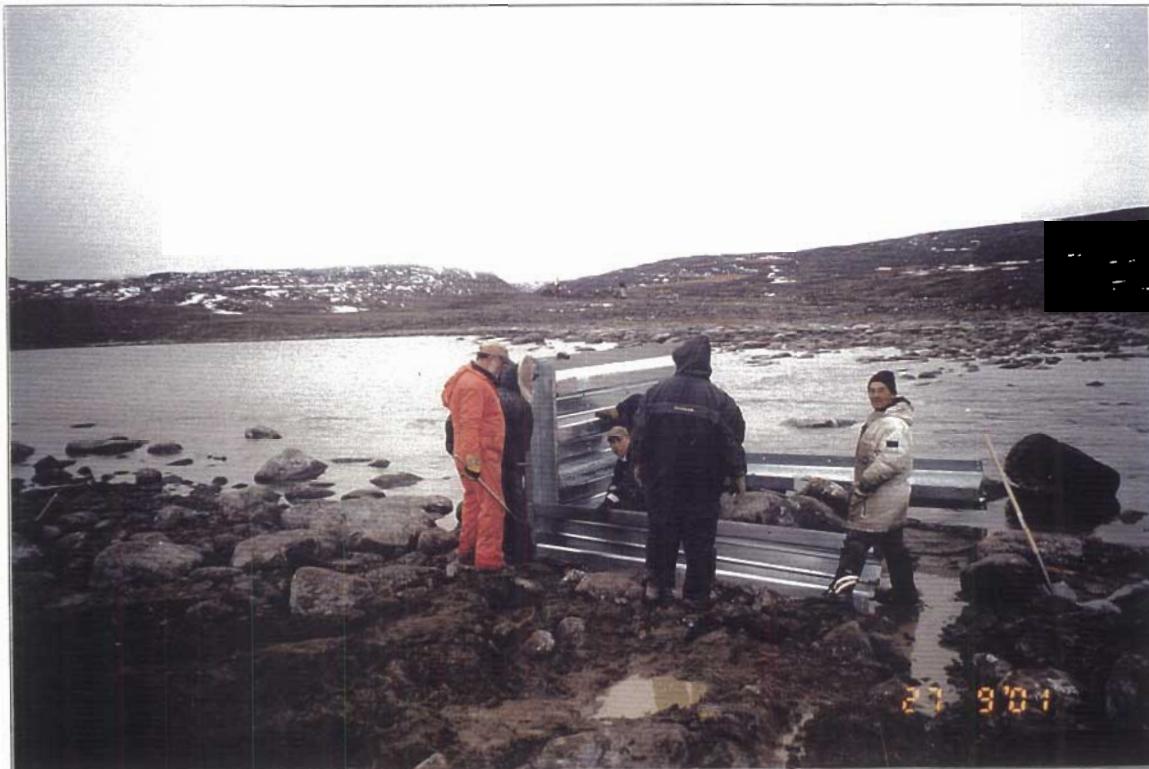
Layout of East Binwall abutment

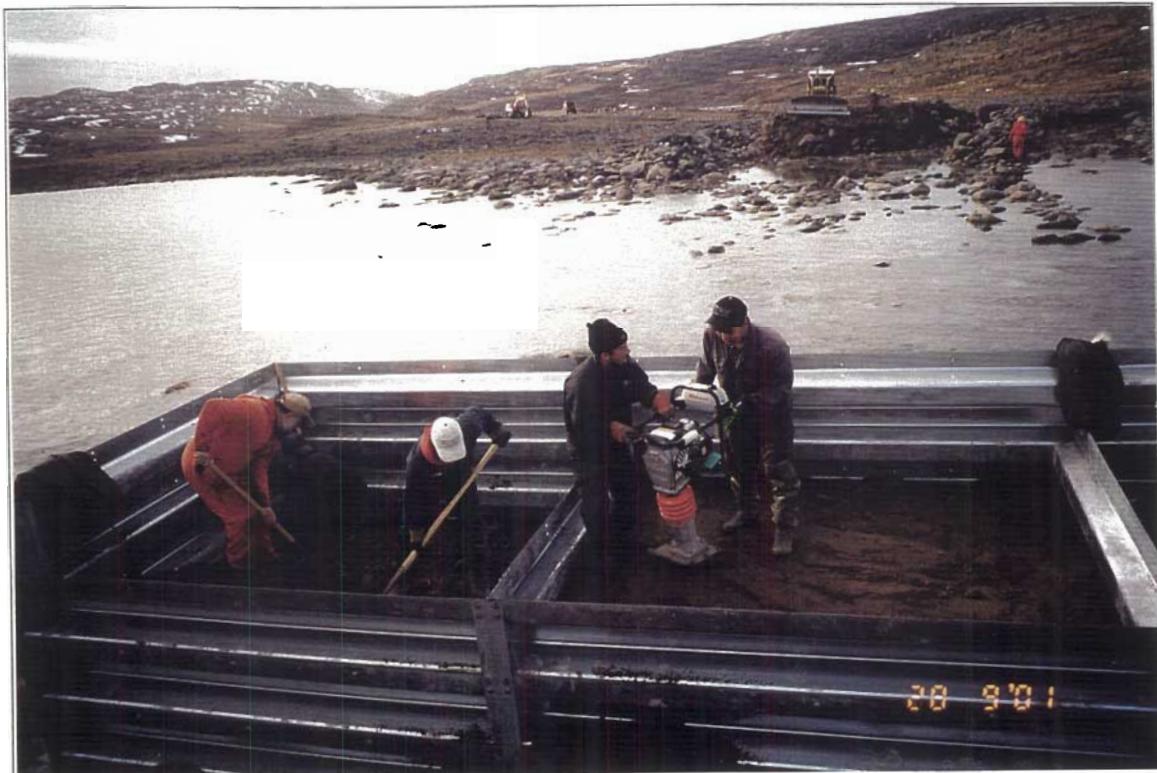
Construction of Binwall on east abutment

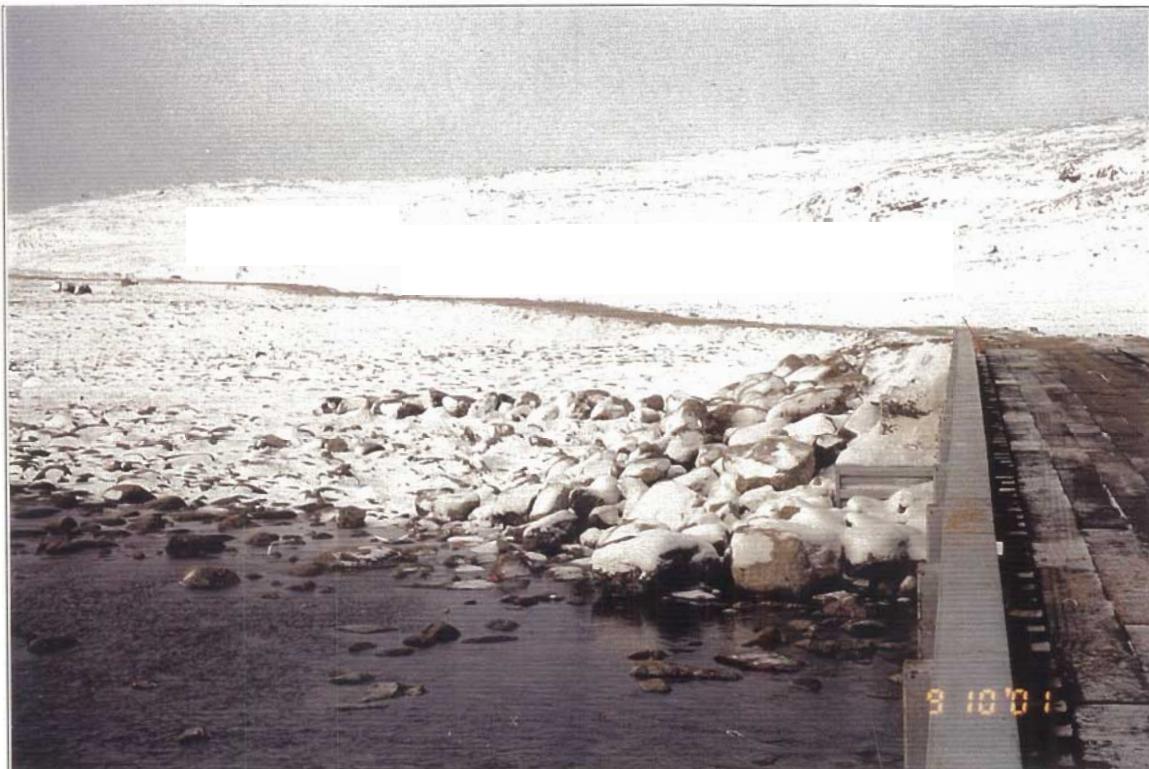
Riprap on west-up stream corner of bridge.

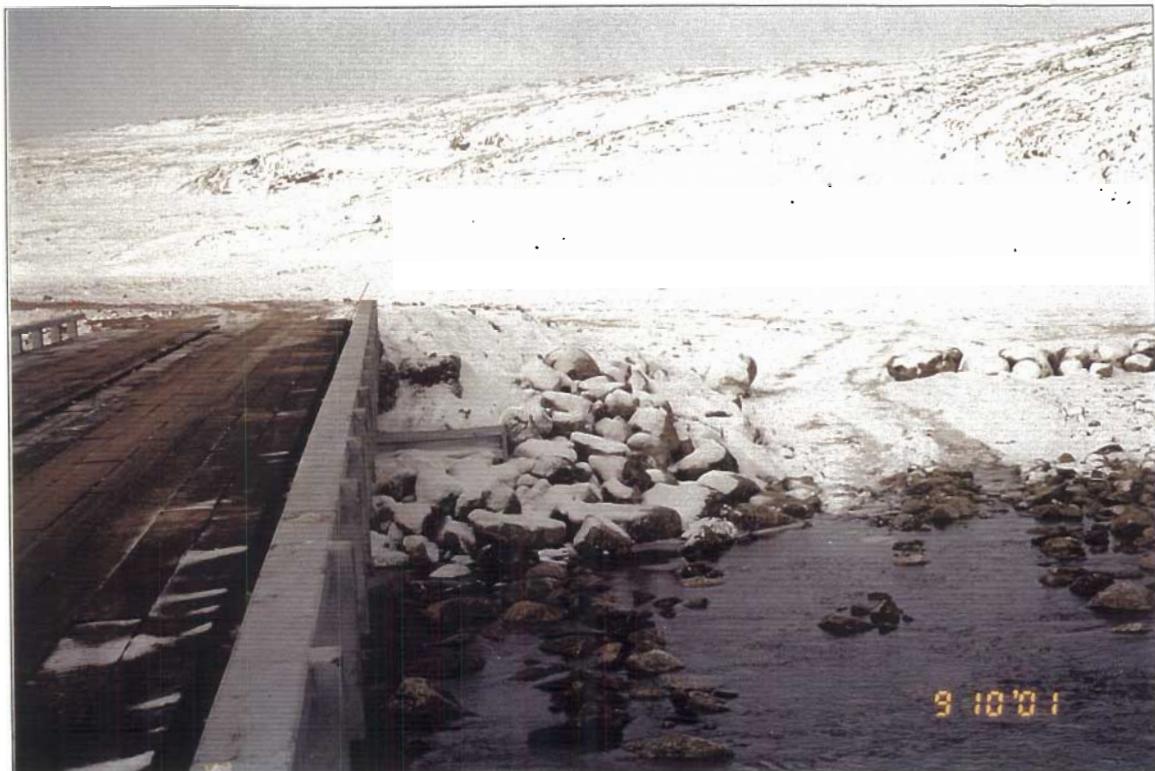
Riprap on west down stream corner of bridge.

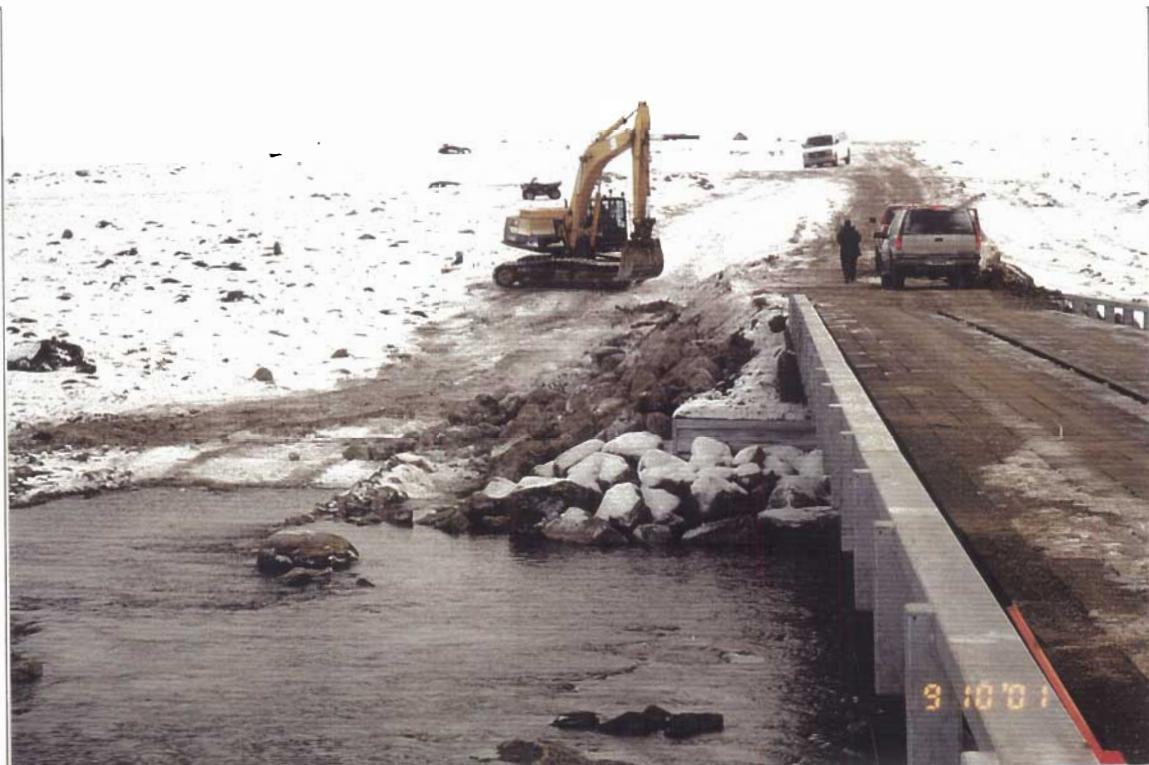
View of east abutment downstream riprap arrangement and ford

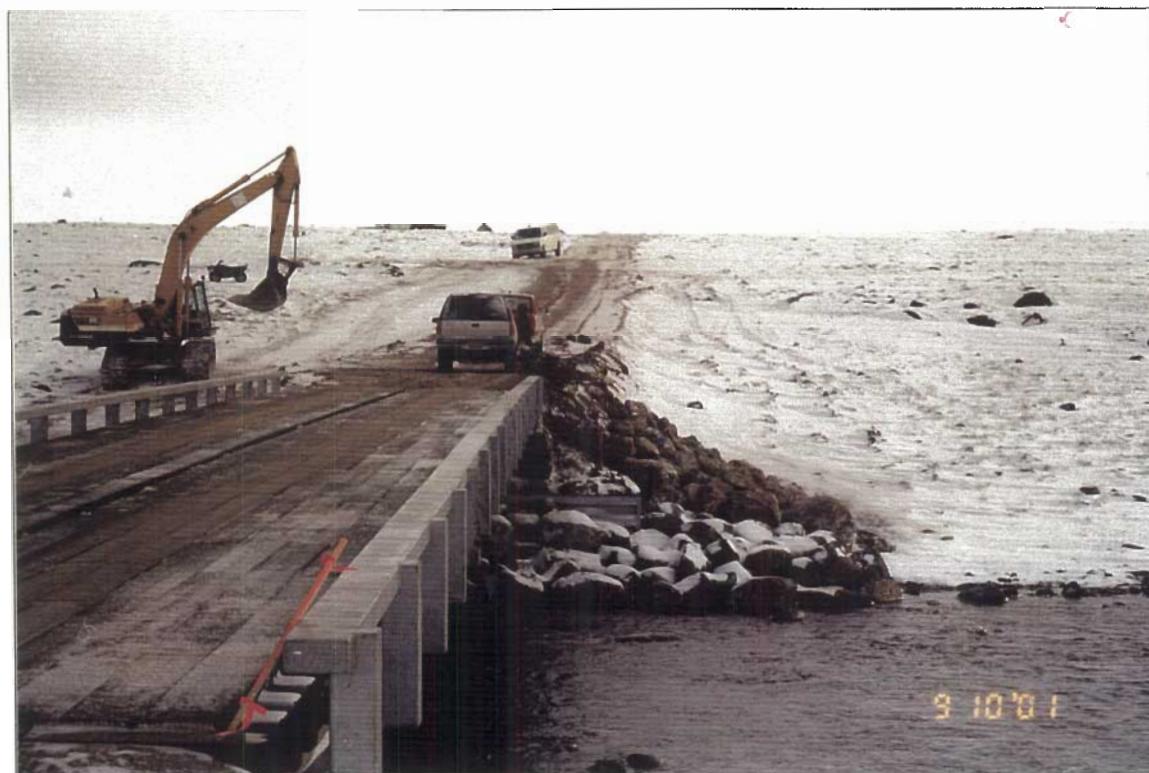
View of east abutment upstream riprap arrangement

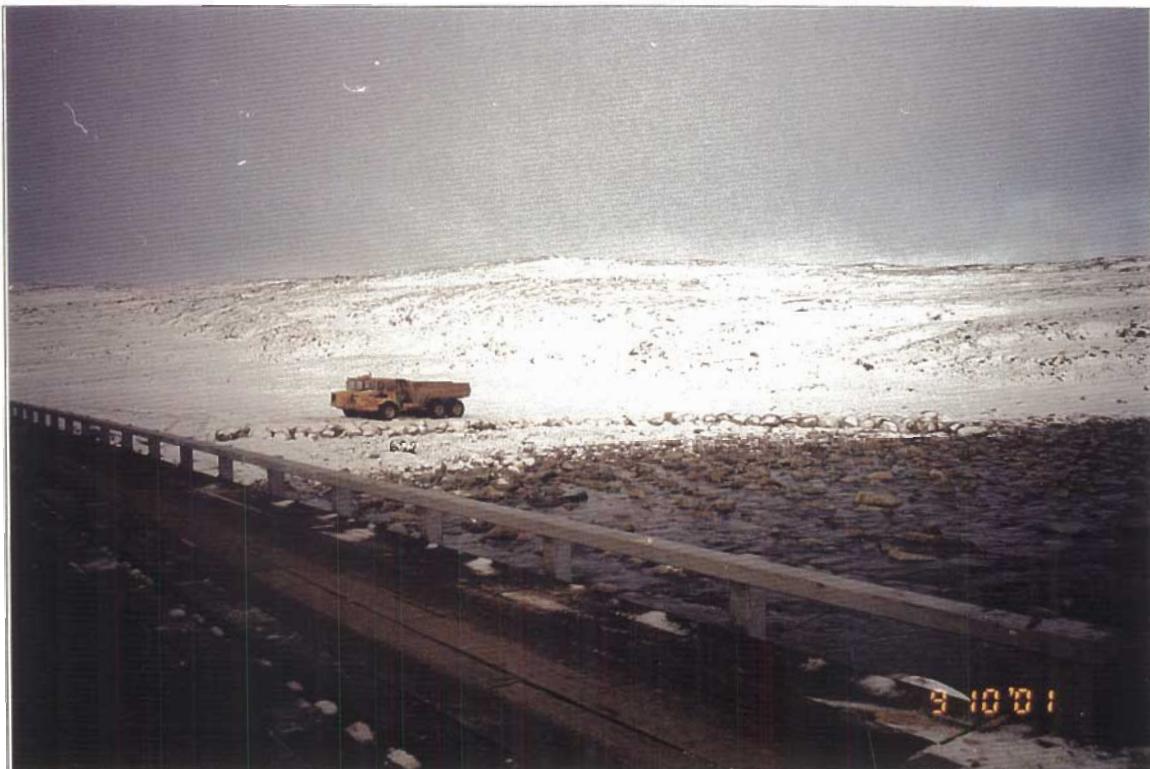
Spur dyke and riprap protection along the high water mark on east downstream abutment.

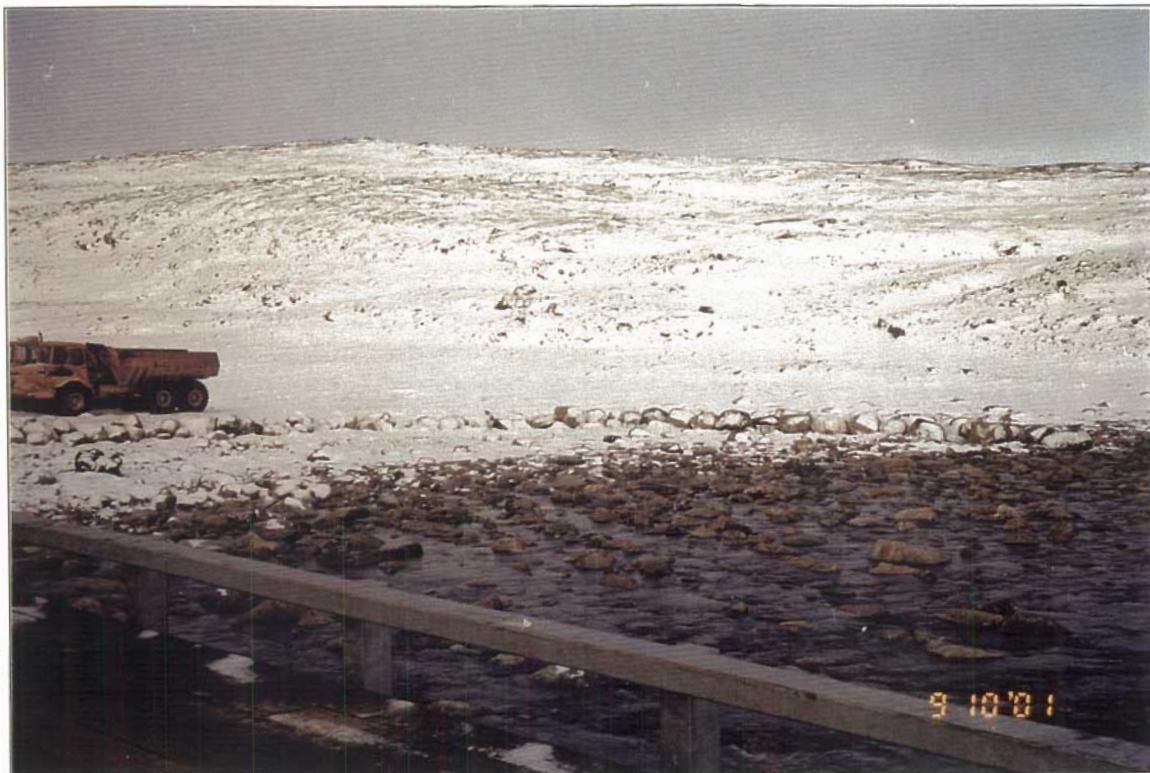
Spur dyke and riprap protection along east downstream shore-detail.

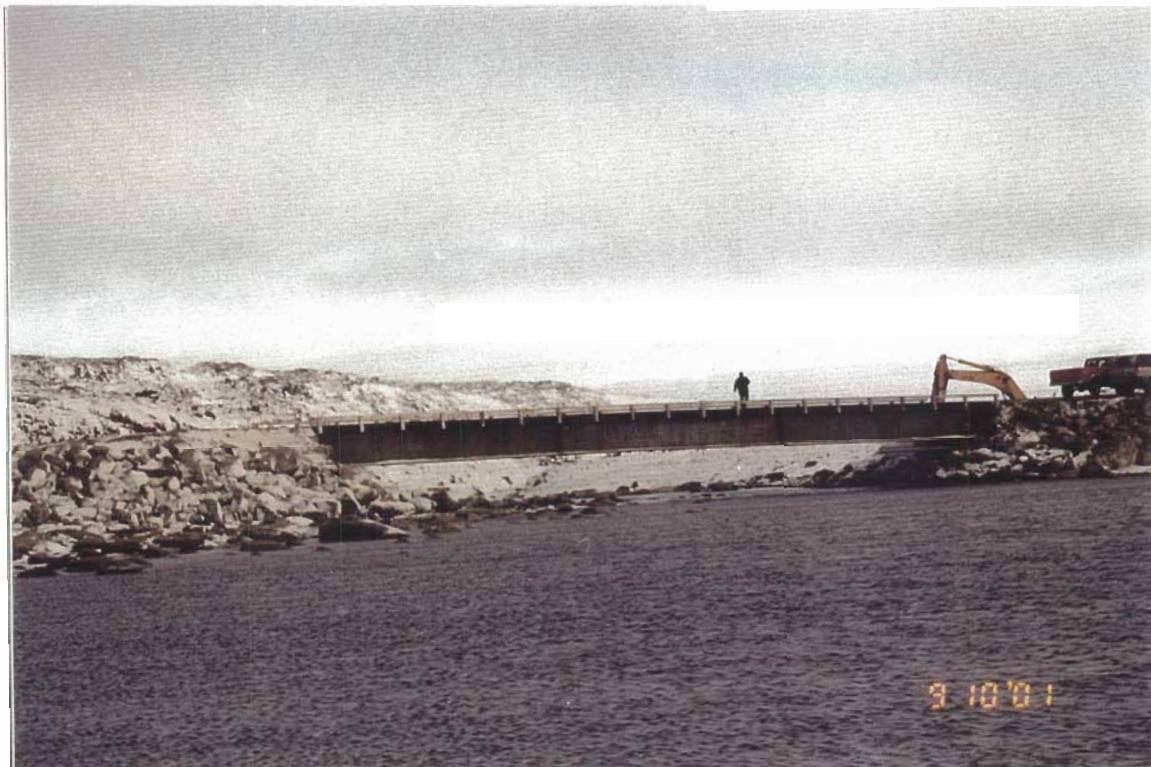
Elevation of Second Bridge Crossing. Bridge span 36 m

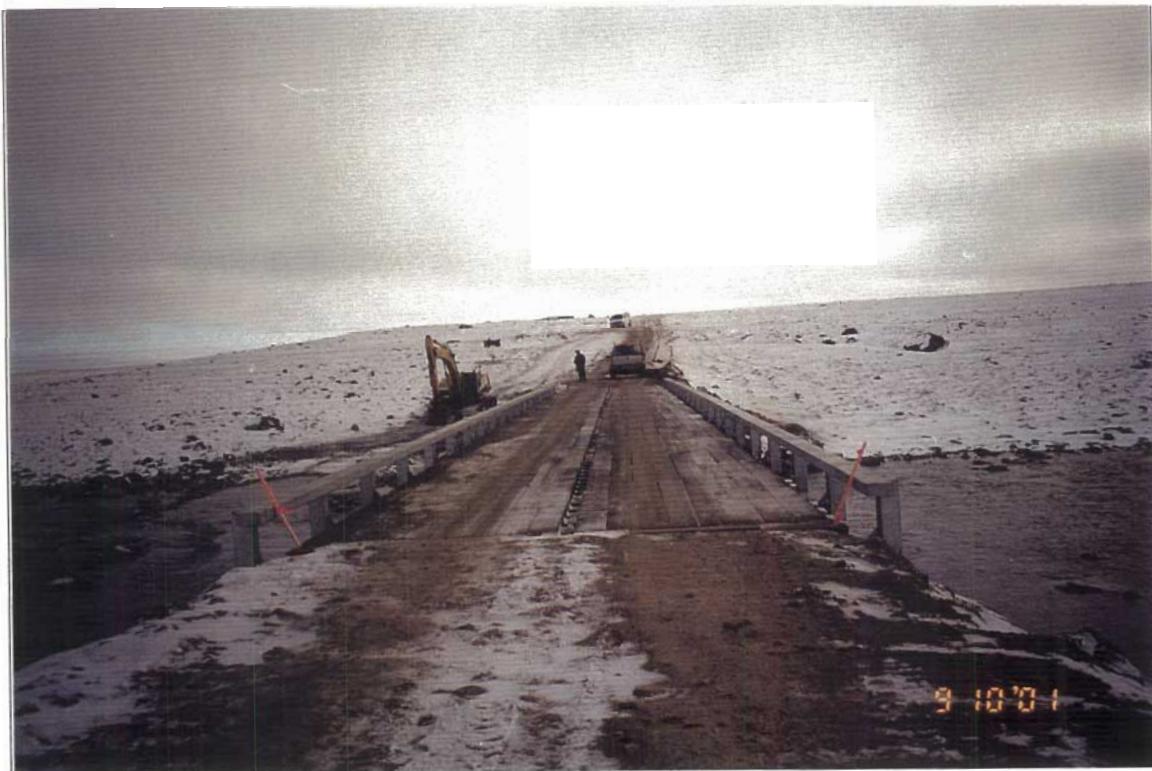
View of timber deck towards west

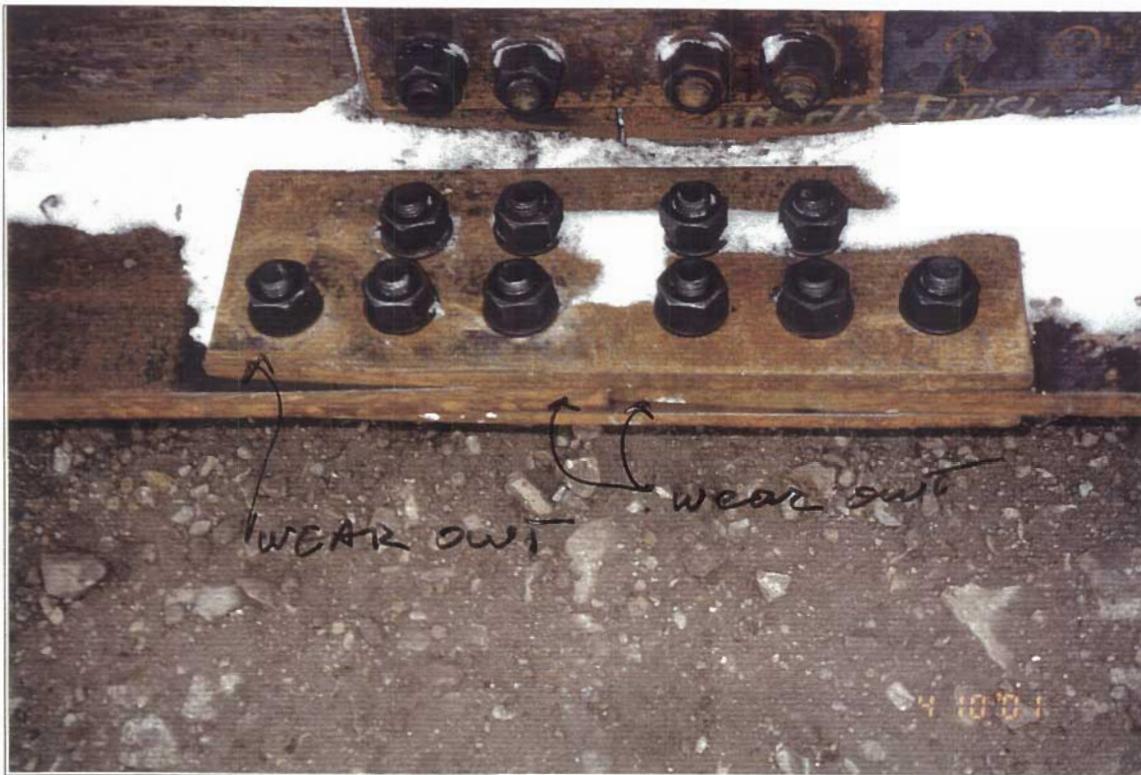
Bottom splice detail. Evidence of damage (wear out) on bottom flange due to dragging of girders on the ground during transportation.

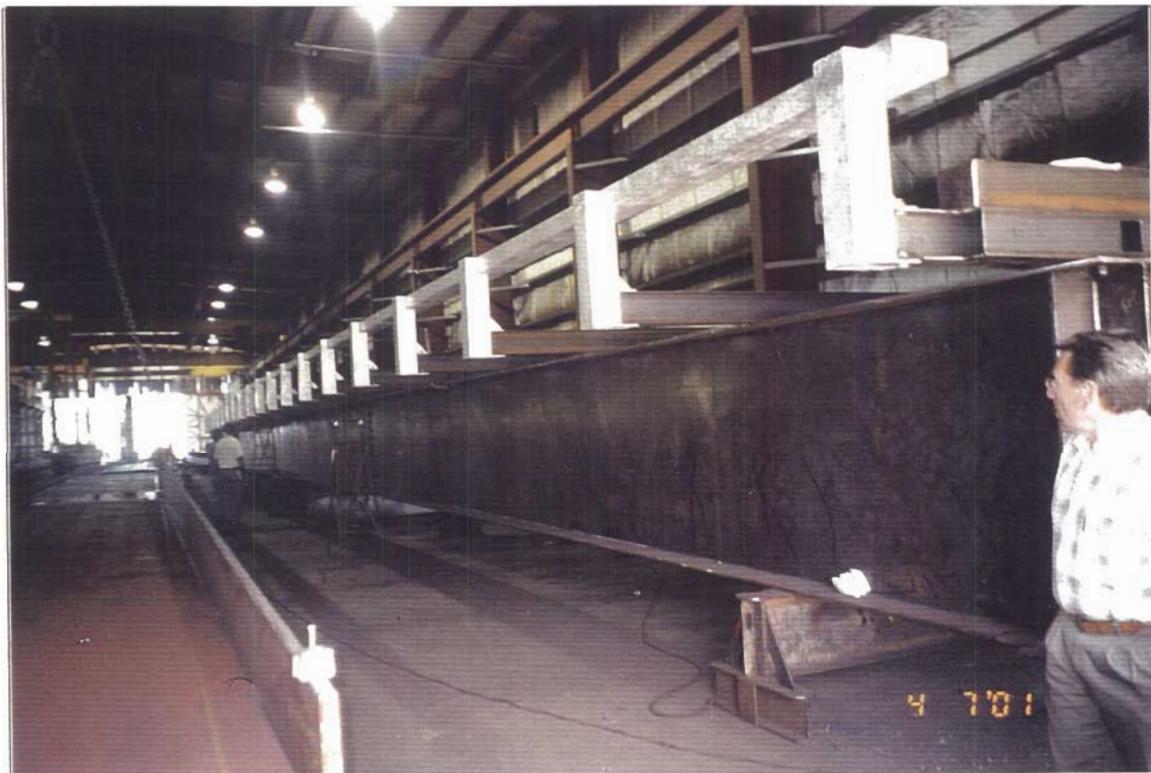
Inspection of pre-assembled bridge in fabrication shop. Side view of bridge.

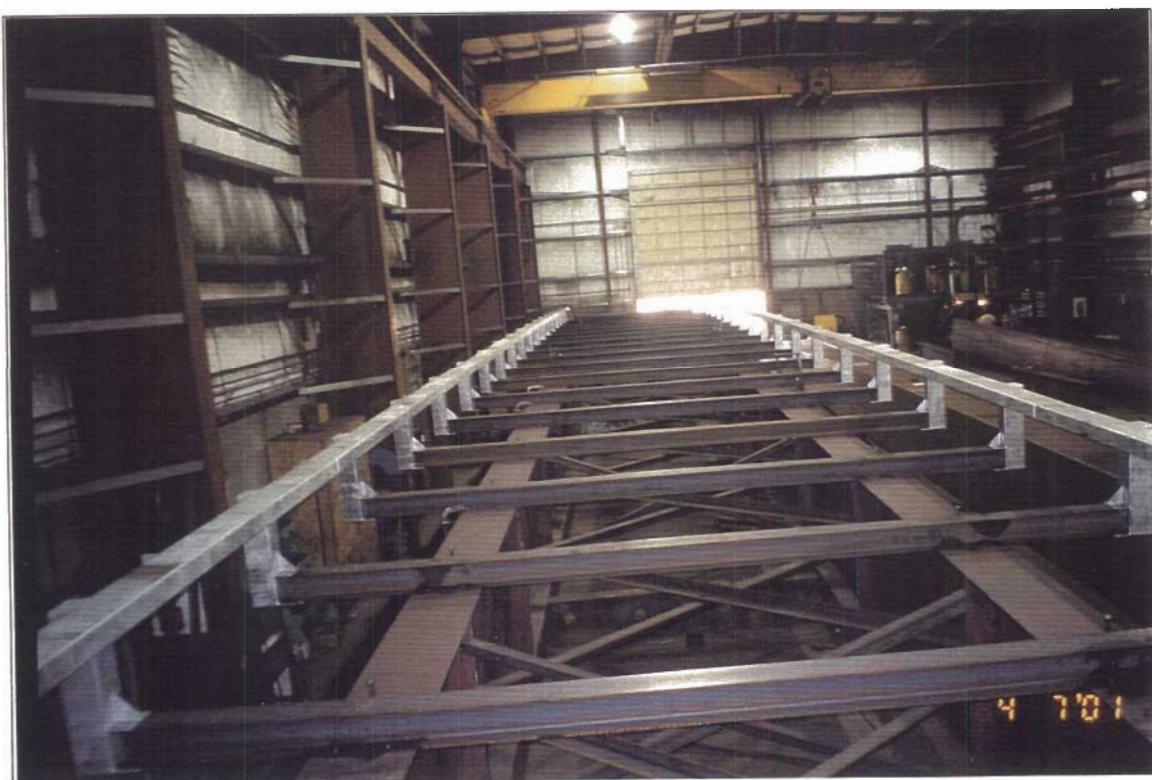
View of bridge floor.

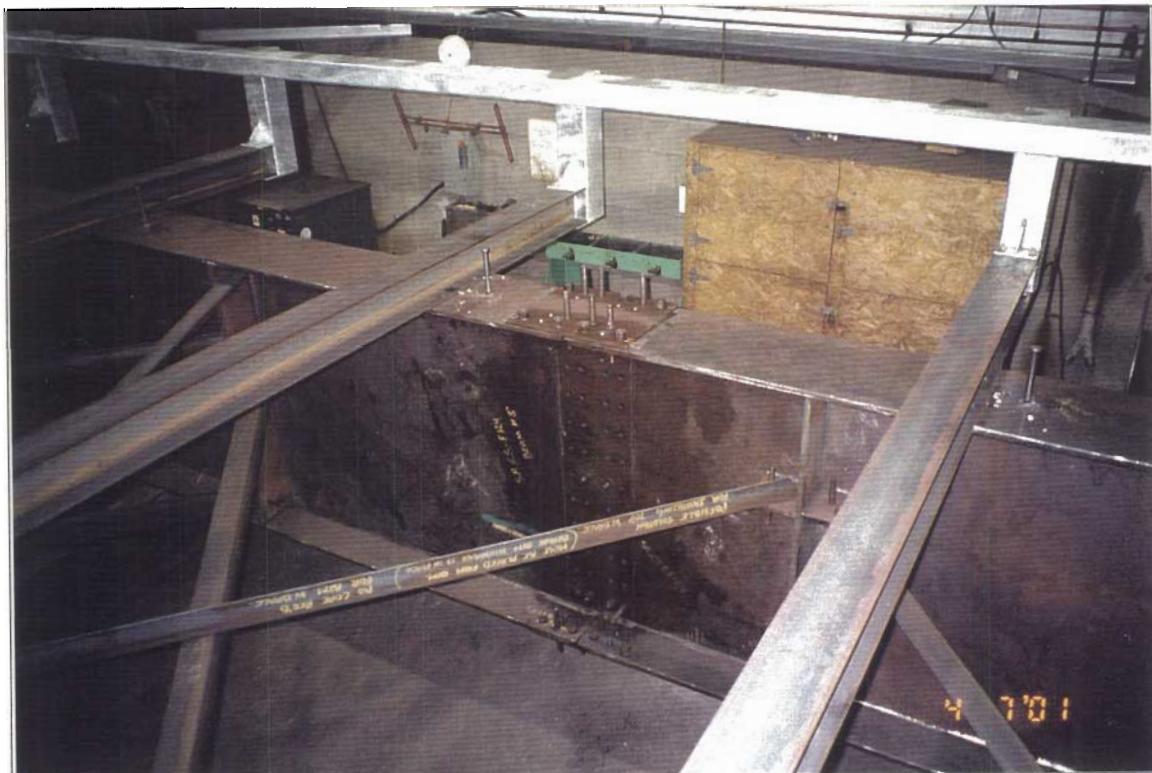
Bridge assembly details

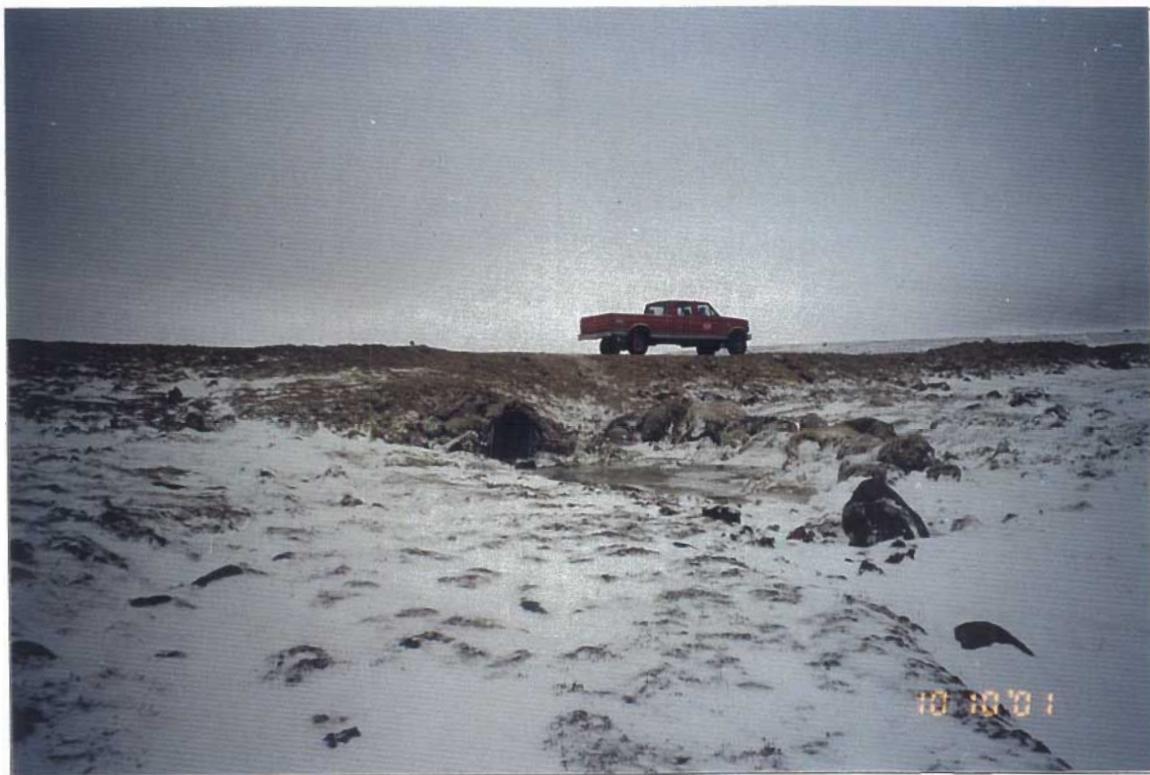
View of outlet with riprap and reflective dyke

- Outstanding work for next summer will include completion of the road embankment above the culvert and on the approaches. An estimated 2,000 cu m of backfill material will be required for the completion of this work. Also, spot improvement on the riprap may have to take place. Site cleaning and landscaping will be carried out at the end of the construction.

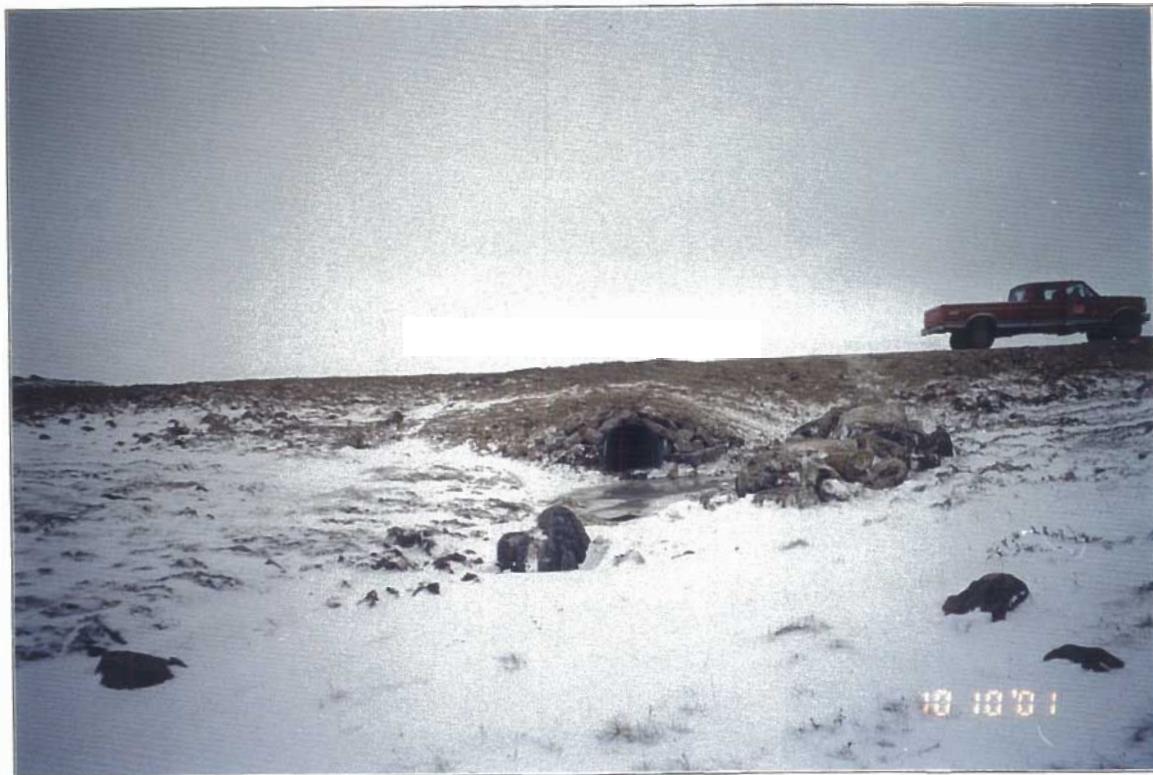
View of outlet

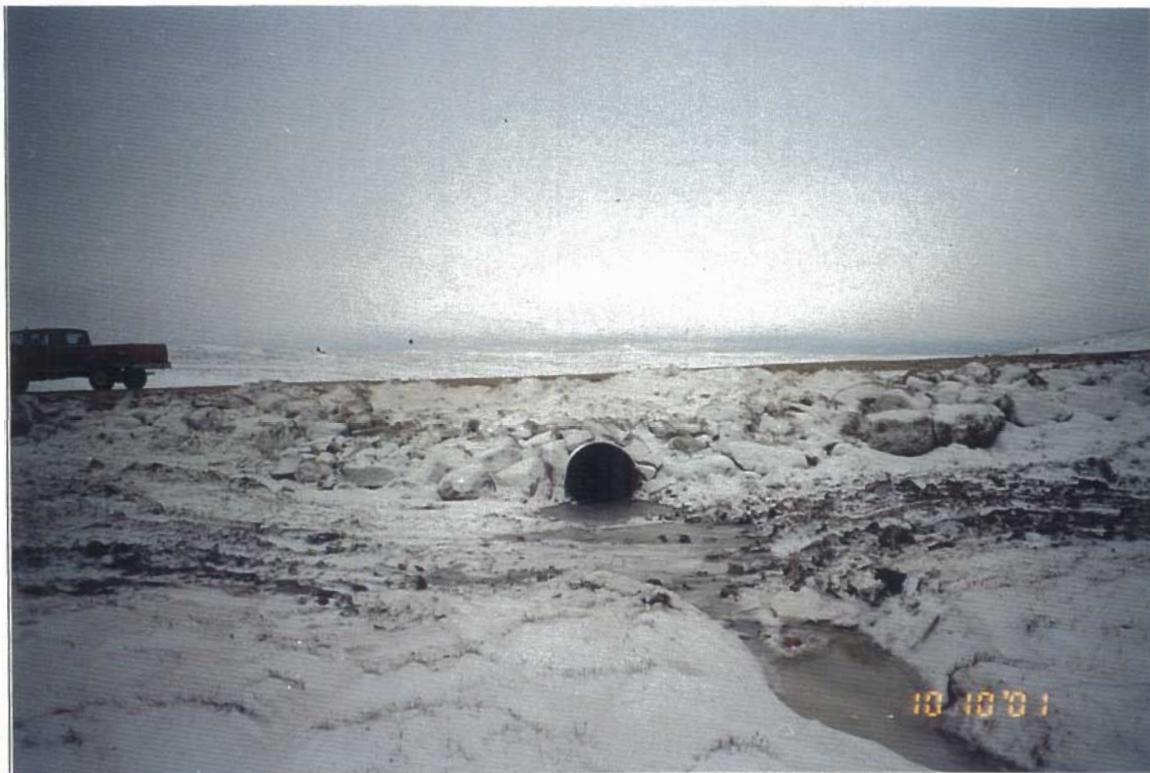
View of inlet with riprap protection. Temporary creek crossing in close plan.

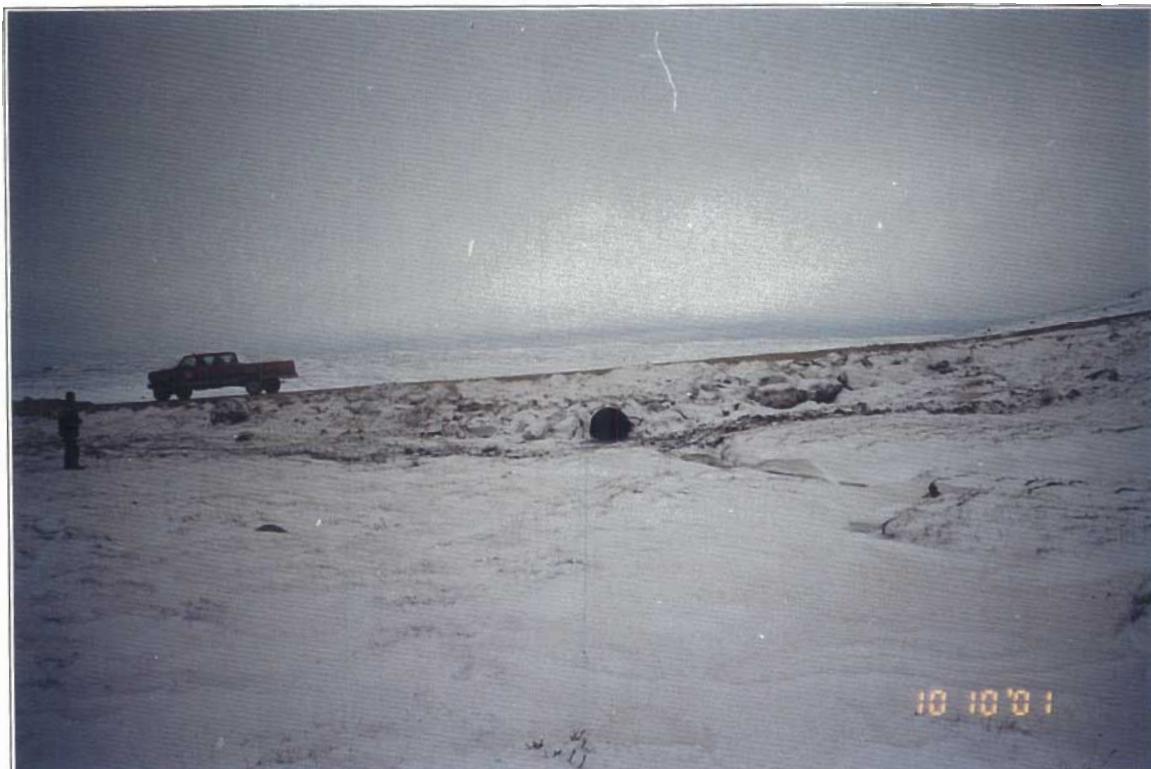
View of inlet with riprap protection.

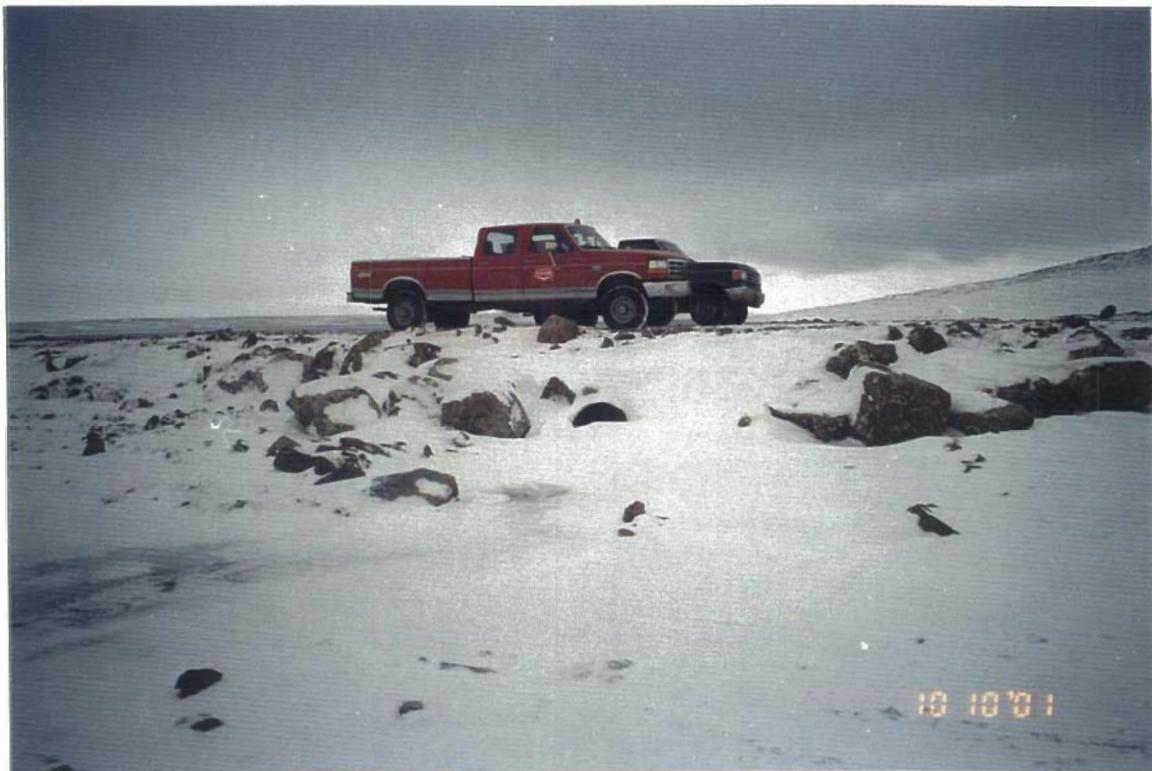
View of inlet with riprap protection.

- Outstanding work for next year will include excavation into the road embankment and installation of the second culvert. The road embankment will be built-up to the design elevation. An estimated 800 cu m of backfill material will be required for this work. Also, spot improvement on the riprap may have to take place. Site cleaning and landscaping will be carried out at the end of the construction.
