JERICHO DIAMOND MINE SITE STABILIZATION PROJECT

NUNAVUT IMPACT REVIEW BOARD FILE #16UN058 2017 ANNUAL REPORT

May 30, 2018

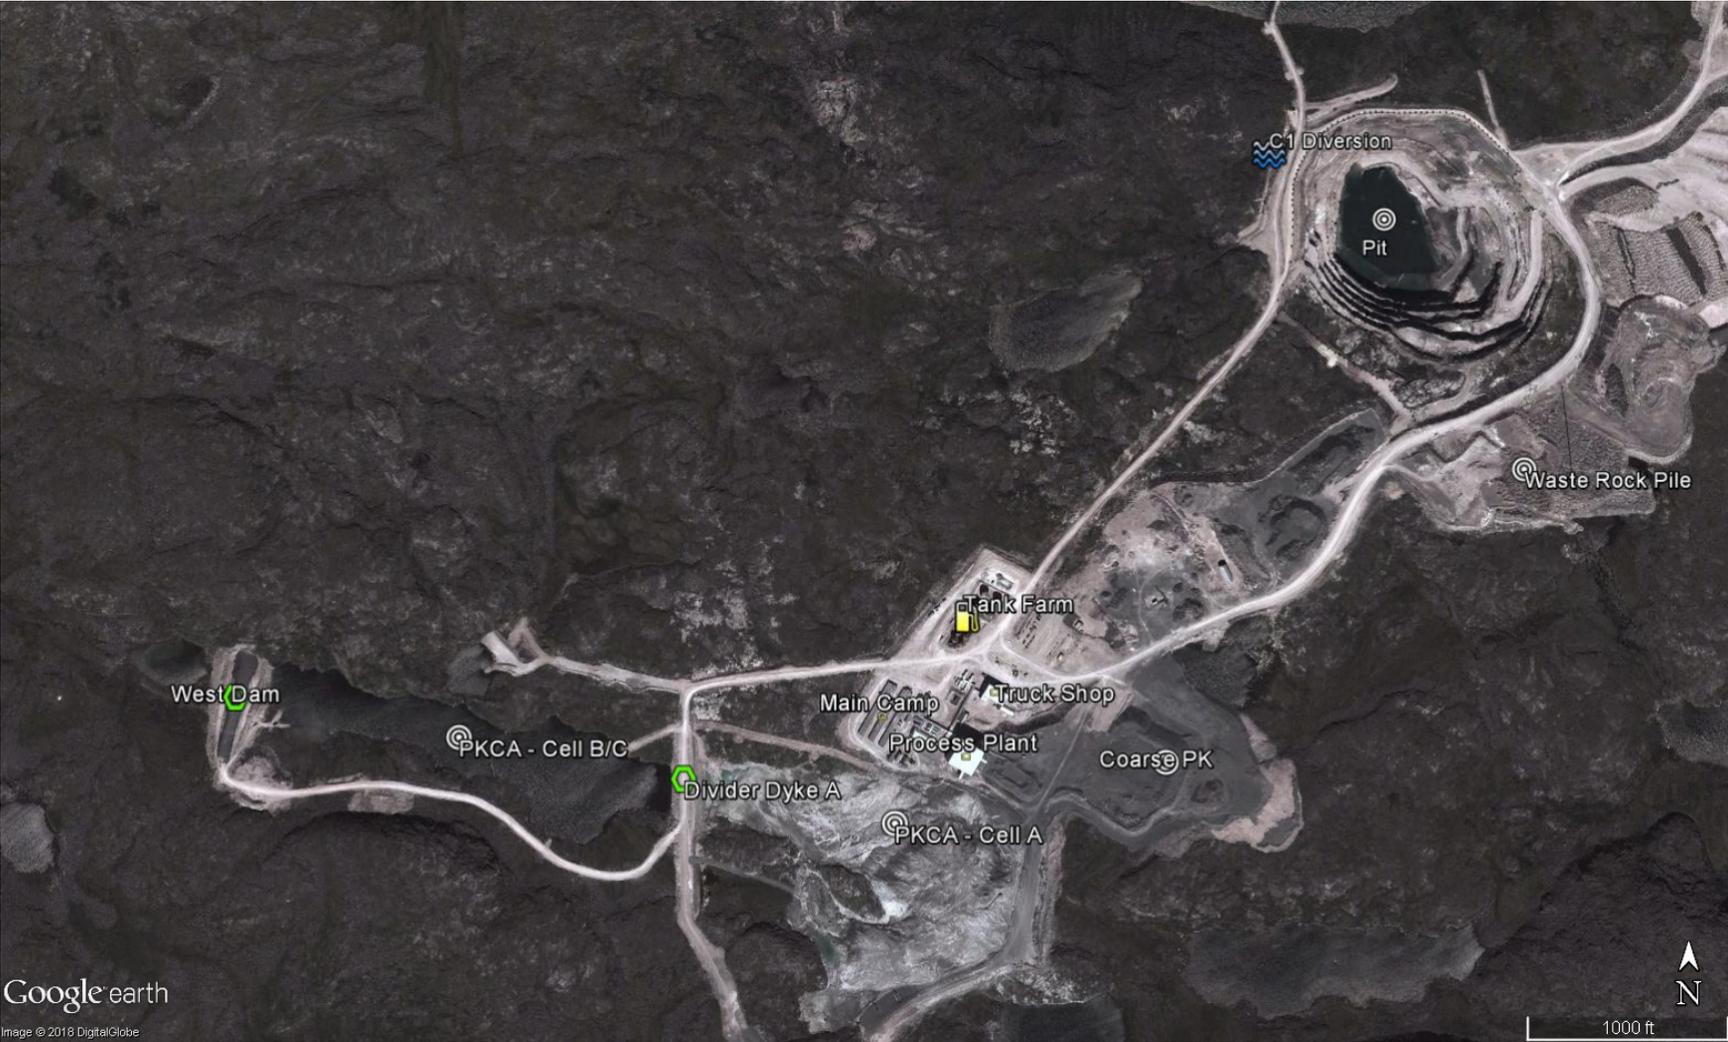
Figure 3: South End of Site – Showing Open Pit, Camp, Process Plant, PKCA and West Dam

See Appendix A, Figure 3. Current fuel storage is limited to drummed fuel located within the Truck Shop Building. This building has an in-ground sump to contain any fuel spills.

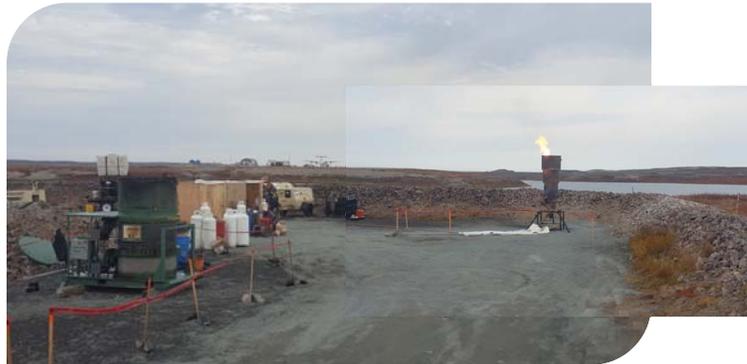
Description of Work- Fuel Tanks and Drums

- 305,000-L of other fuels or waste oils were burned in two Incinerators.

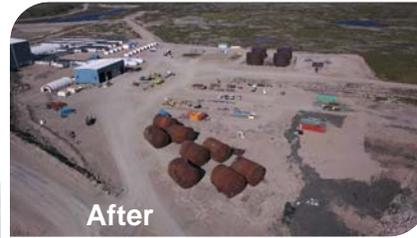
Description of Work- Fuel Tanks and Drums

- Tanks and drums were cleaned and the wash water treated or disposed of off-site.

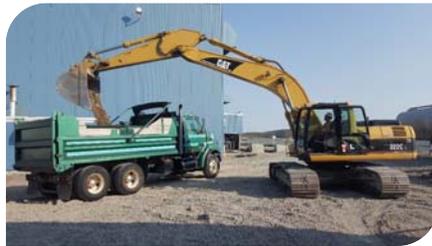
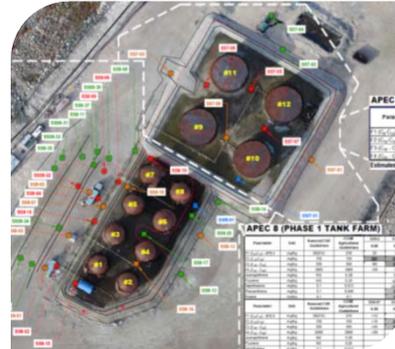
Description of Work – Contaminated Soils

- 165 Truck Loads of Soil stained with fuel was excavated from across the site and placed in an existing lined tank farm.

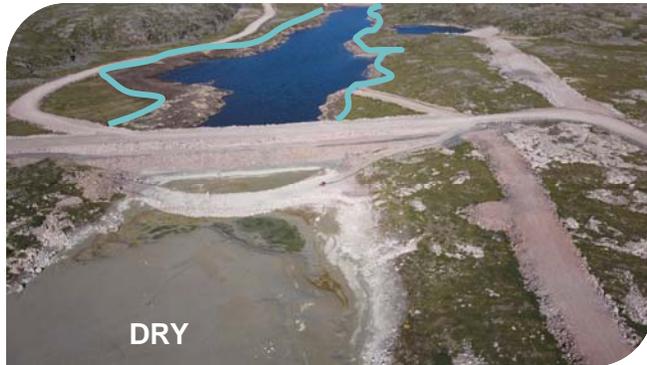
Description of Work – Water Management

- 291,500,000-L of clean water from Cell A and Cell C was tested, pumped and discharged down stream

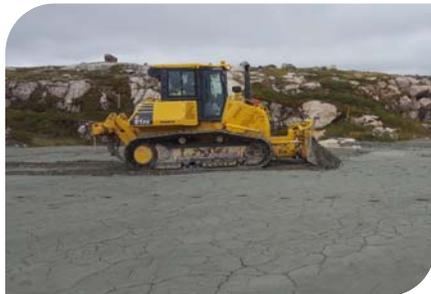
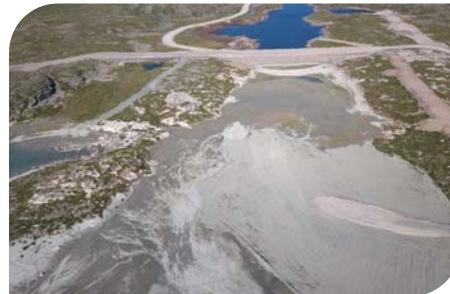
Description of Work – Tailings Cover

- Graded the existing tailings in Cell A to allow water to flow in its original direction (west).

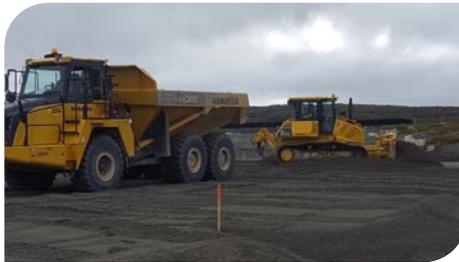
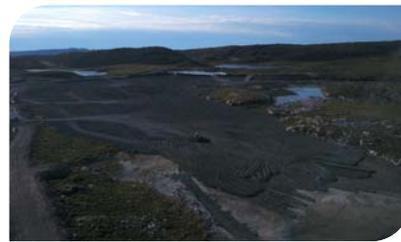
Description of Work – Tailings Cover

- Covered the fine grained tailings with larger, coarse grained aggregate to prevent dust being transported by wind

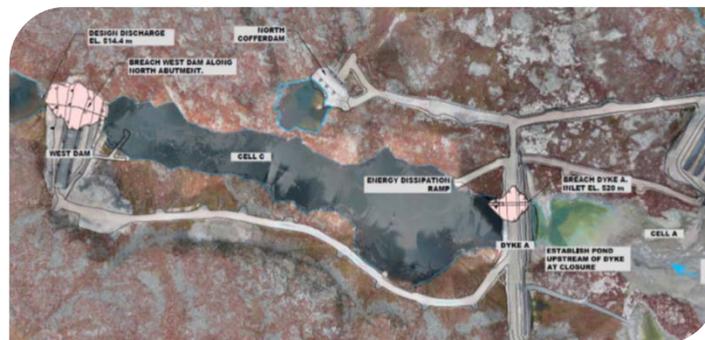
Description of Work – PKCA Breaches

- Lowered the top of Dyke A and West Dam to restore the original natural flow of surface water

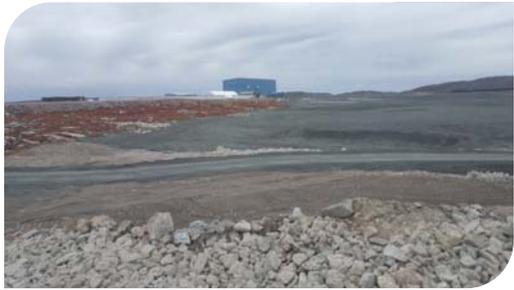
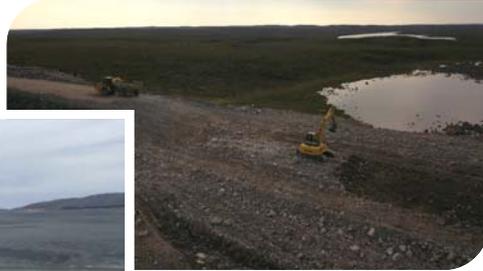
Description of Work – PKCA Breaches

- Dyke A was lowered to allow most of the water through creating a small Lake.

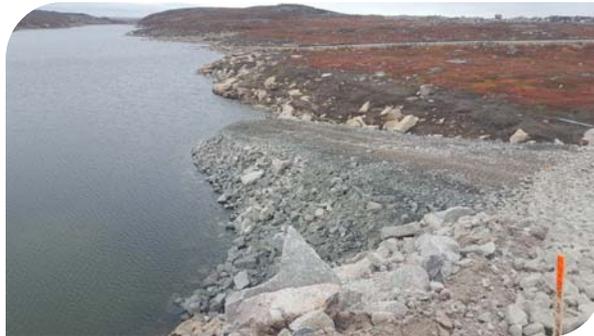
Description of Work – PKCA Breaches

- A ramp on the outflow side was added to reduce erosion.

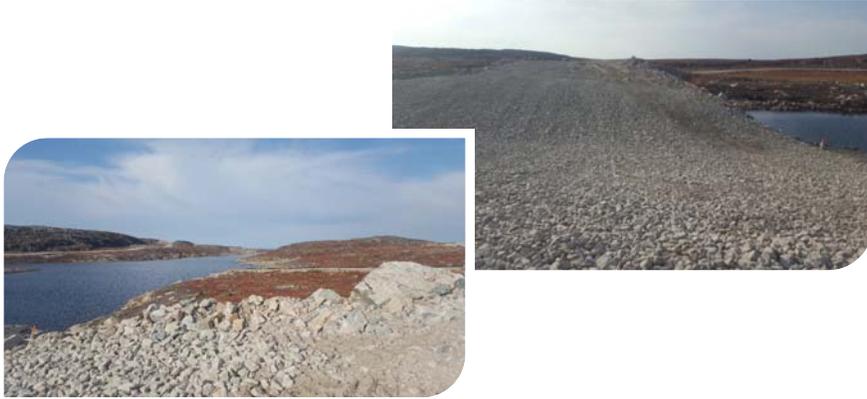
Description of Work – PKCA Breaches

- Large rocks were placed all over to also prevent erosion.

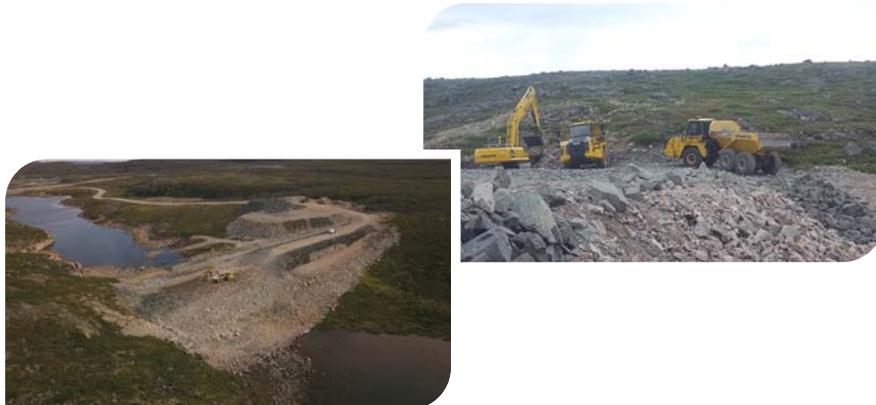
Description of Work – PKCA Breaches

- The West Dam was lowered as far as possible until we hit the frozen core

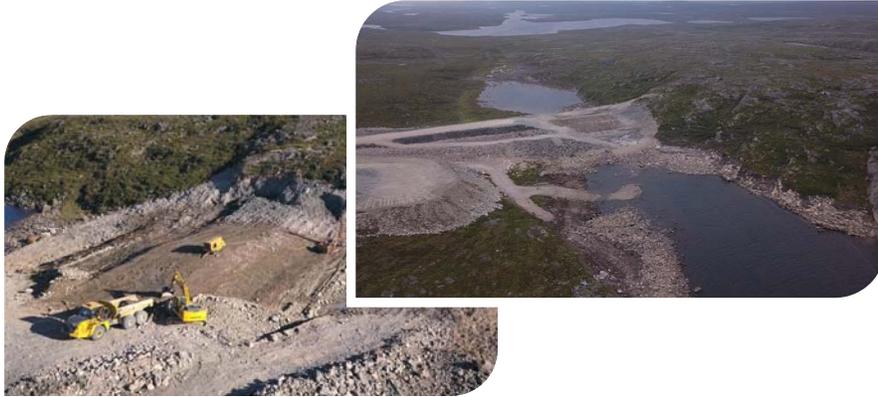
Description of Work – PKCA Breaches

- After getting the right permits, we then blasted the West Dam

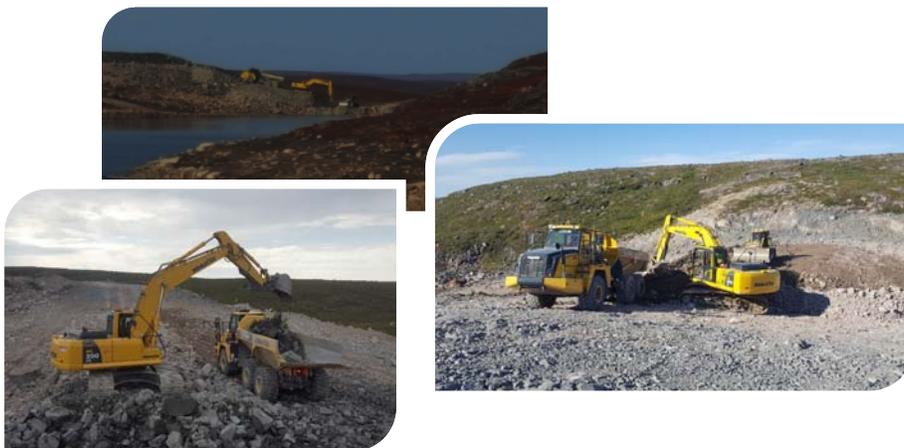
Description of Work – PKCA Breaches

- And then we dug and trucked some more!

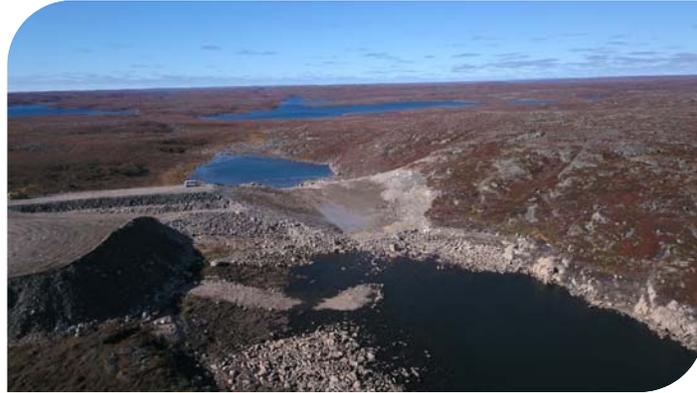
Description of Work – PKCA Breaches

- Large rocks were placed all over to prevent erosion.

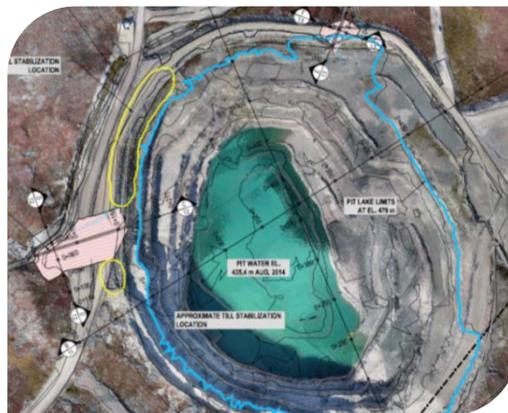
Description of Work – Open Pit Breaches

- Removed the C1 Diversion
- Created an Outflow
- This will allow the Open Pit to fill with water (10-15 years) and to restore the original natural flow of surface water.

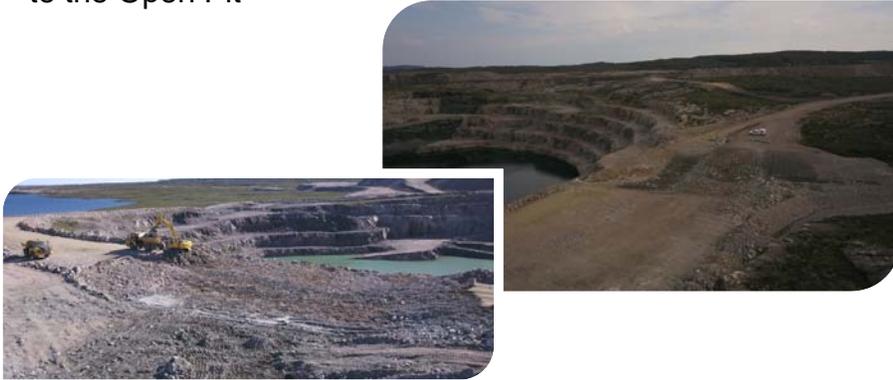
Description of Work – Open Pit Breaches

- We dug through the old Mining road to connect a stream to the Open Pit

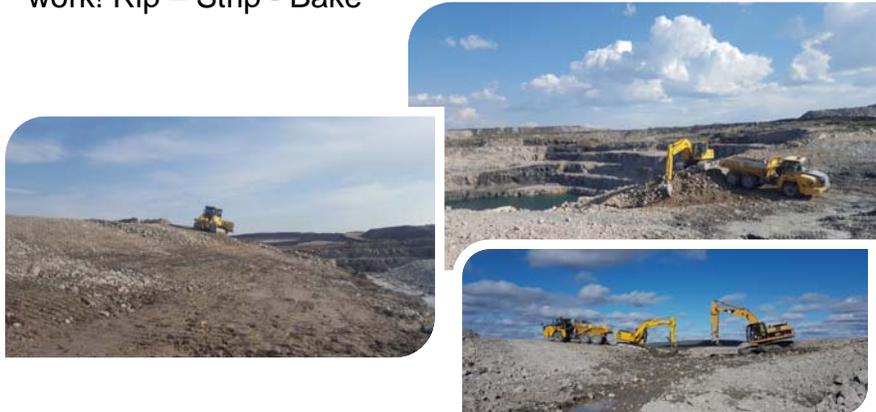
Description of Work – Open Pit Breaches

- Again we hit frozen material, but this time the sun did the work! Rip – Strip - Bake

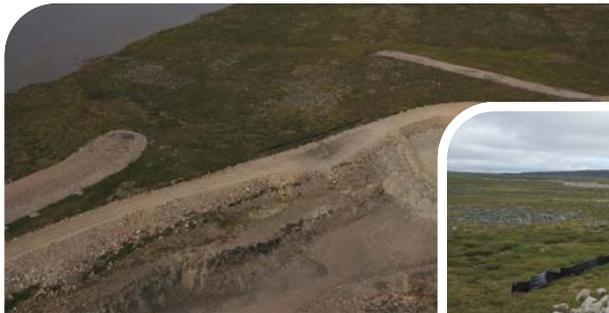
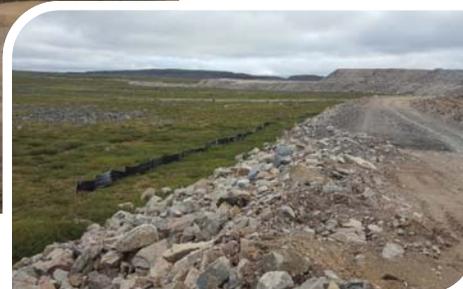
Description of Work – Open Pit Breaches

- We dug through the Mine road again on the north side

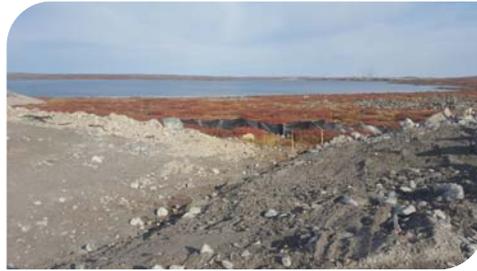
Description of Work – Open Pit Breaches

- This will allow for water to drain out from the filled pit and into Carat lake, restoring the original water flow
