WATER LICENCE INSPECTION FORM

Licensee	Licensee Representative
Transport Canada – Government of Canada	Michael Molinski
Licence No. / Expiry	Representative's Title
1BR-LTU1419 (renewed) exp June 11, 2019	Environmental Officer
Land / Other Authorizations	Land / Other Authorizations
Date of Inspection	Inspector
October 16 th , 2014	A.Keim
Activities Inspected	
<input type="checkbox"/> Camp <input type="checkbox"/> Drilling <input type="checkbox"/> Mining <input type="checkbox"/> Construction <input checked="" type="checkbox"/> Reclamation <input type="checkbox"/> Fuel Storage <input type="checkbox"/> Roads/Hauling <input type="checkbox"/> Other: Water Discharge <input type="checkbox"/> Other: Municipal

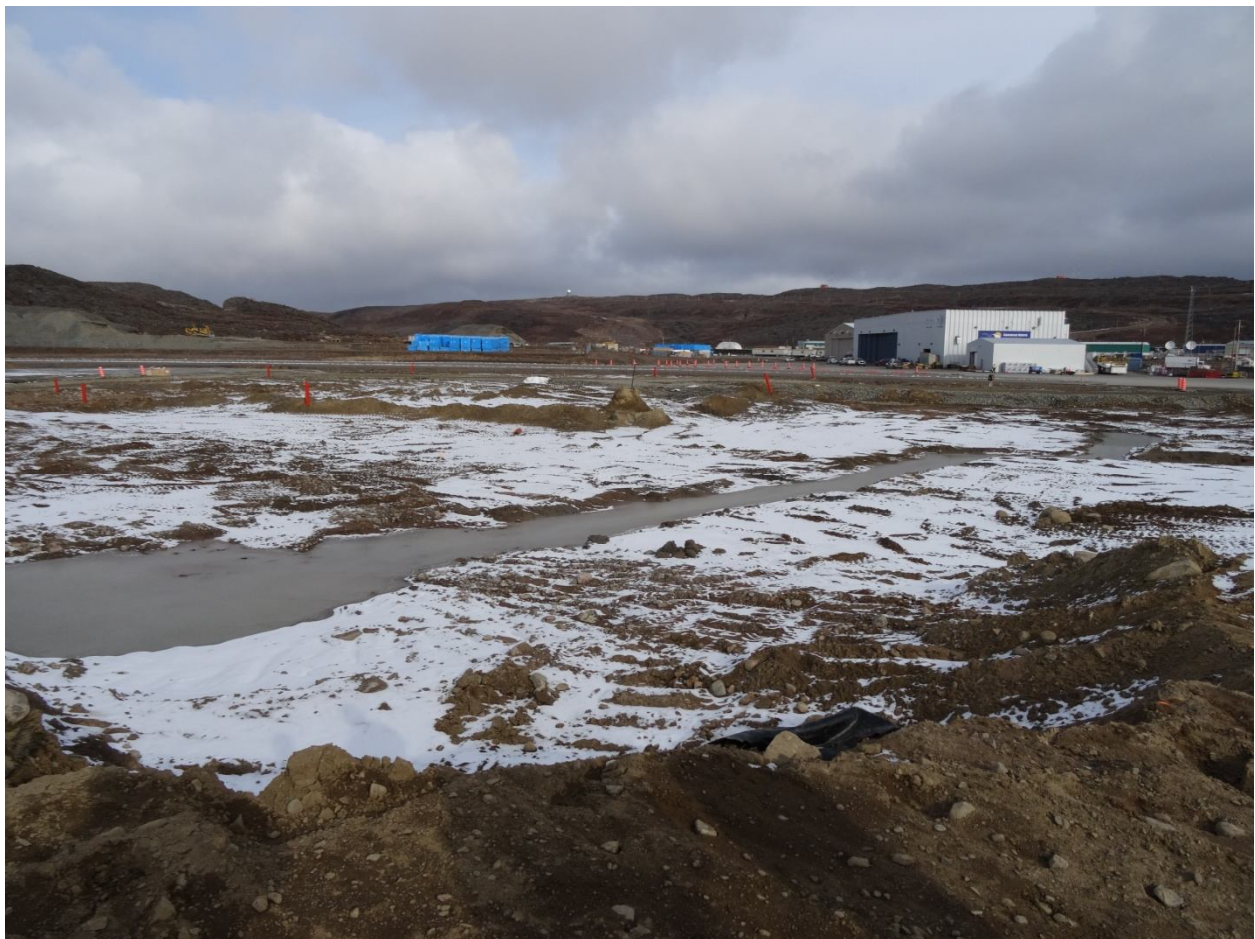
Figure 1 Sept 26th Original Location of Cell D Sept 26th 2014

Based on observations gathered during the Inspection carried out on October 16th, 2014 the Inspector can verify that the original Land Treatment Unit has been leveled and the contaminated soils originally contained within it are no longer present.

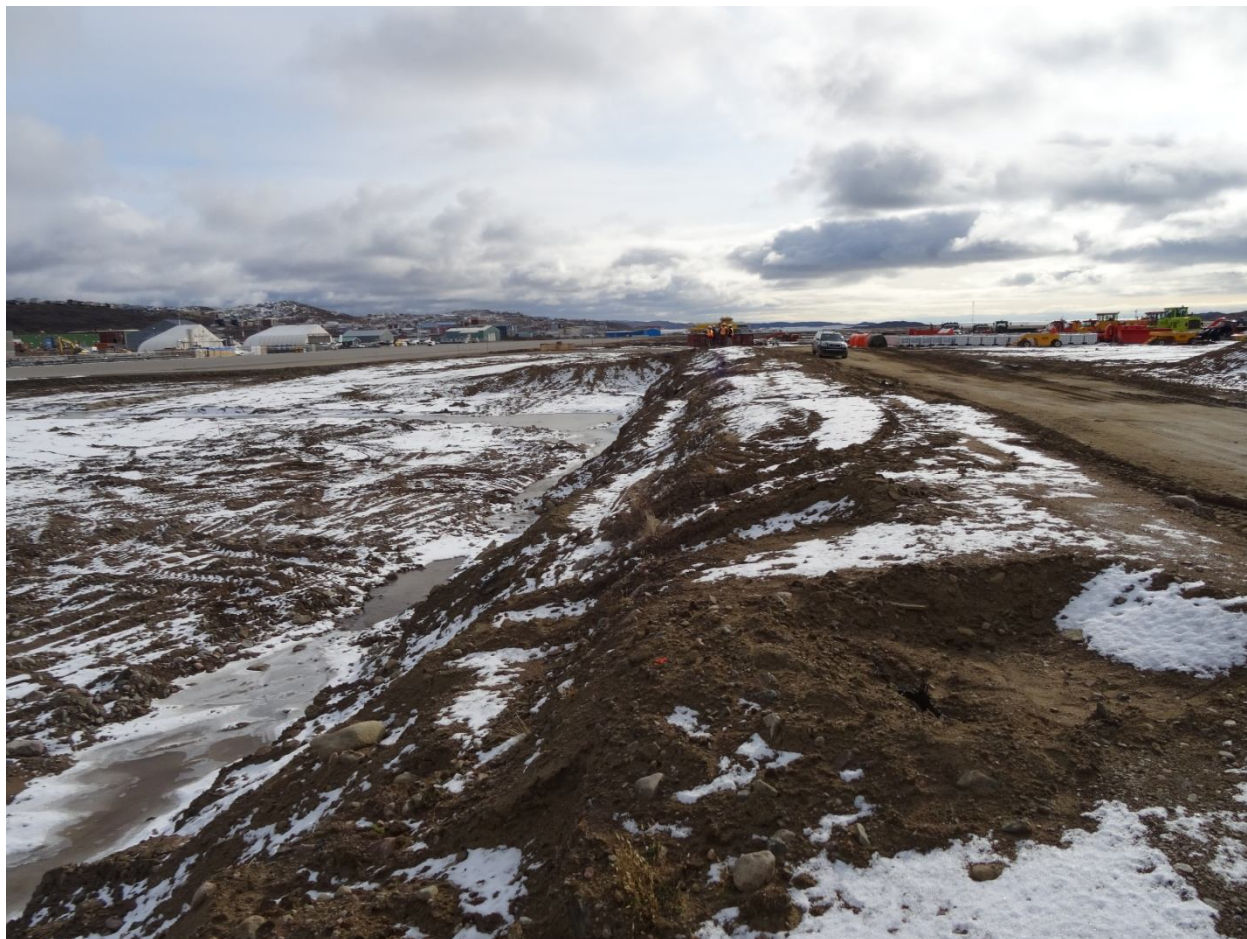
Figure 2 Remaining Berm Wall from Cell C – Sept 26th 2014

On October 16th an AANDC Inspector attended the site of the TC LTU's to observe the removal of an additional 400 plus cubic meters of Contaminated soils that remained on site following the leveling of the facility in July.

During this period of time the Inspector recorded and photographed the work of agents working for TC who removed over 20 truckloads of contaminated soils from the floor and berm wall of Cell C of the LTU.

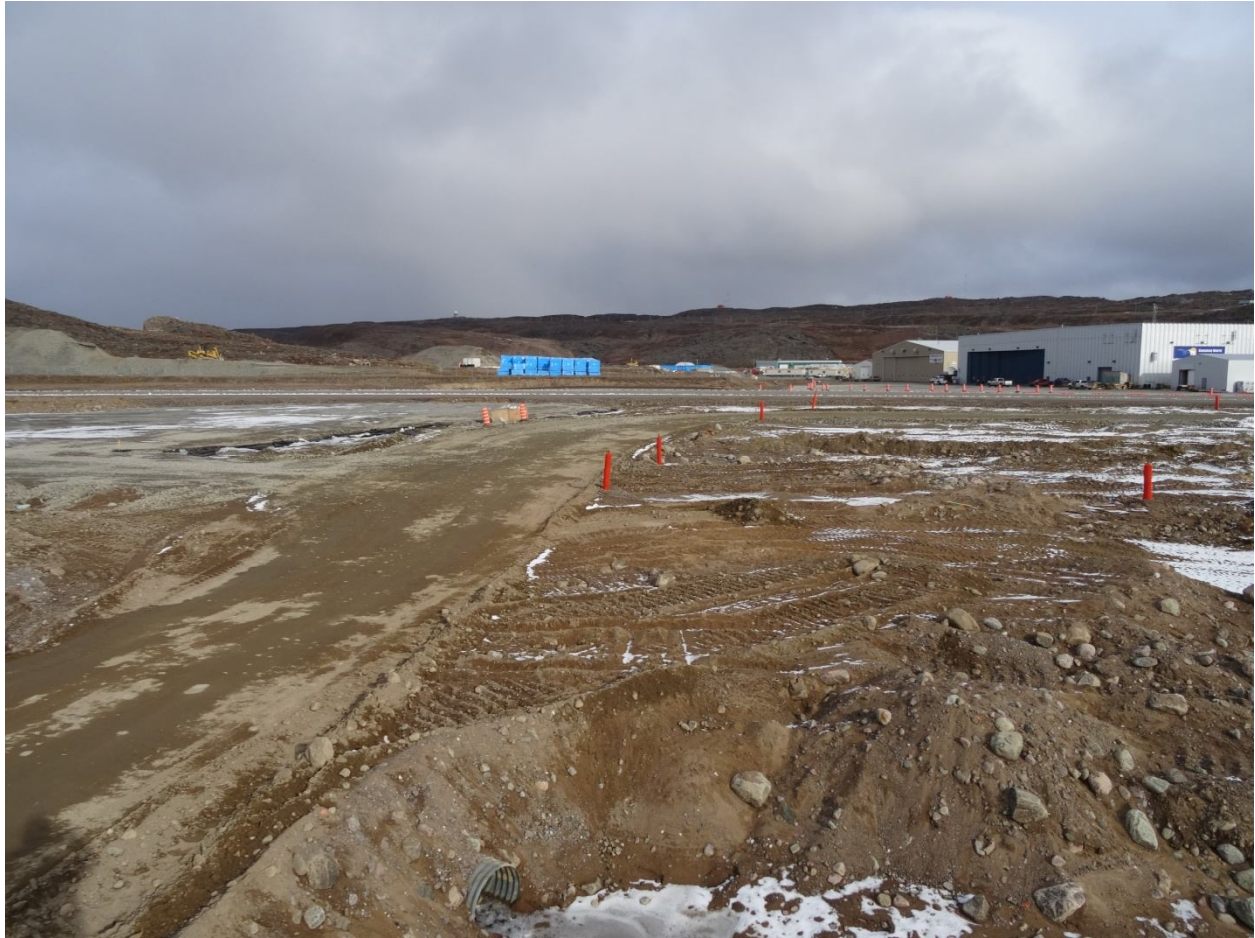
Figure 3 Roadway constructed after the removal of the land treatment units - Sept 26 2014

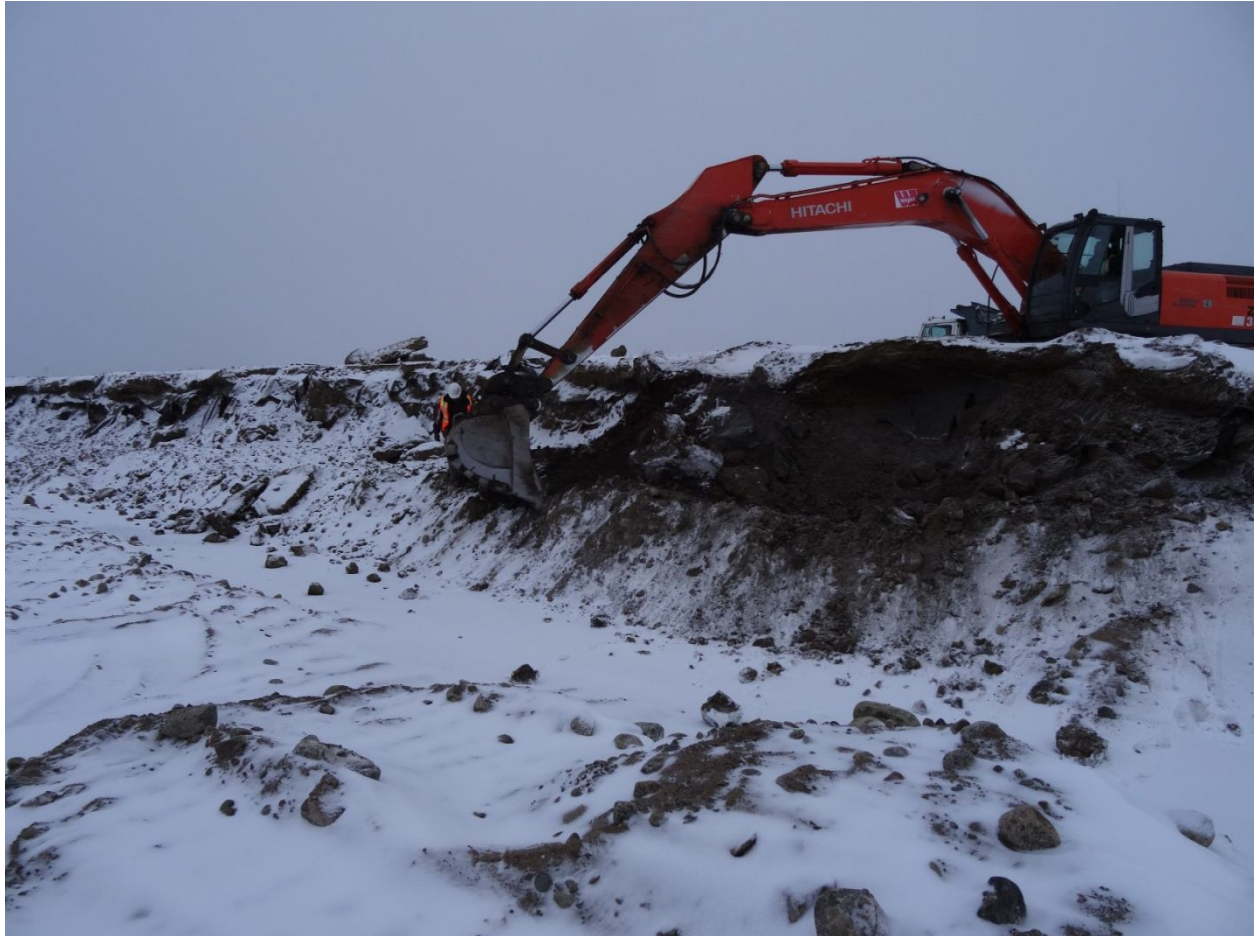
Figure 4 Excavation work on October 16th 2014

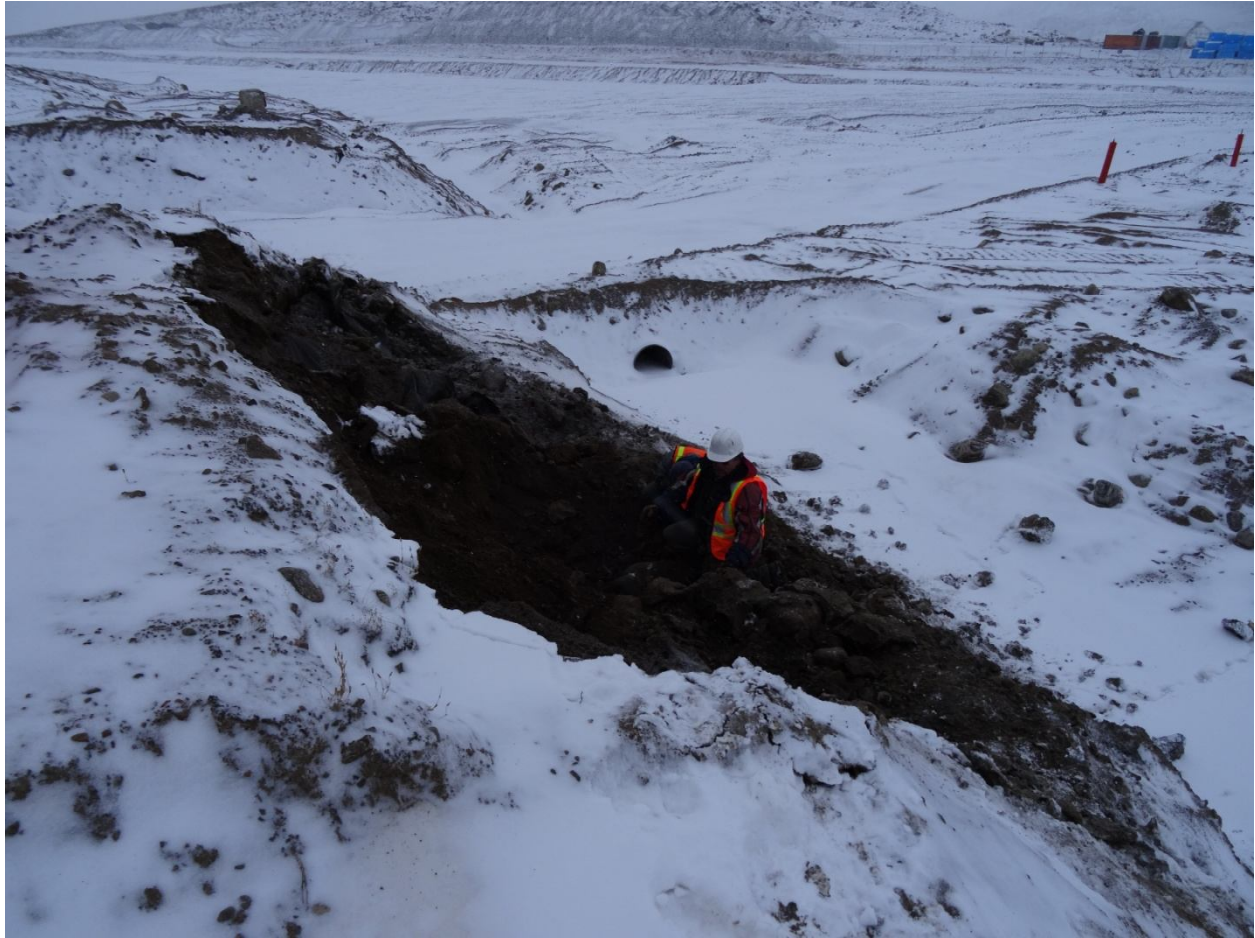
Figure 5 Site of excavation on October 16th 2014

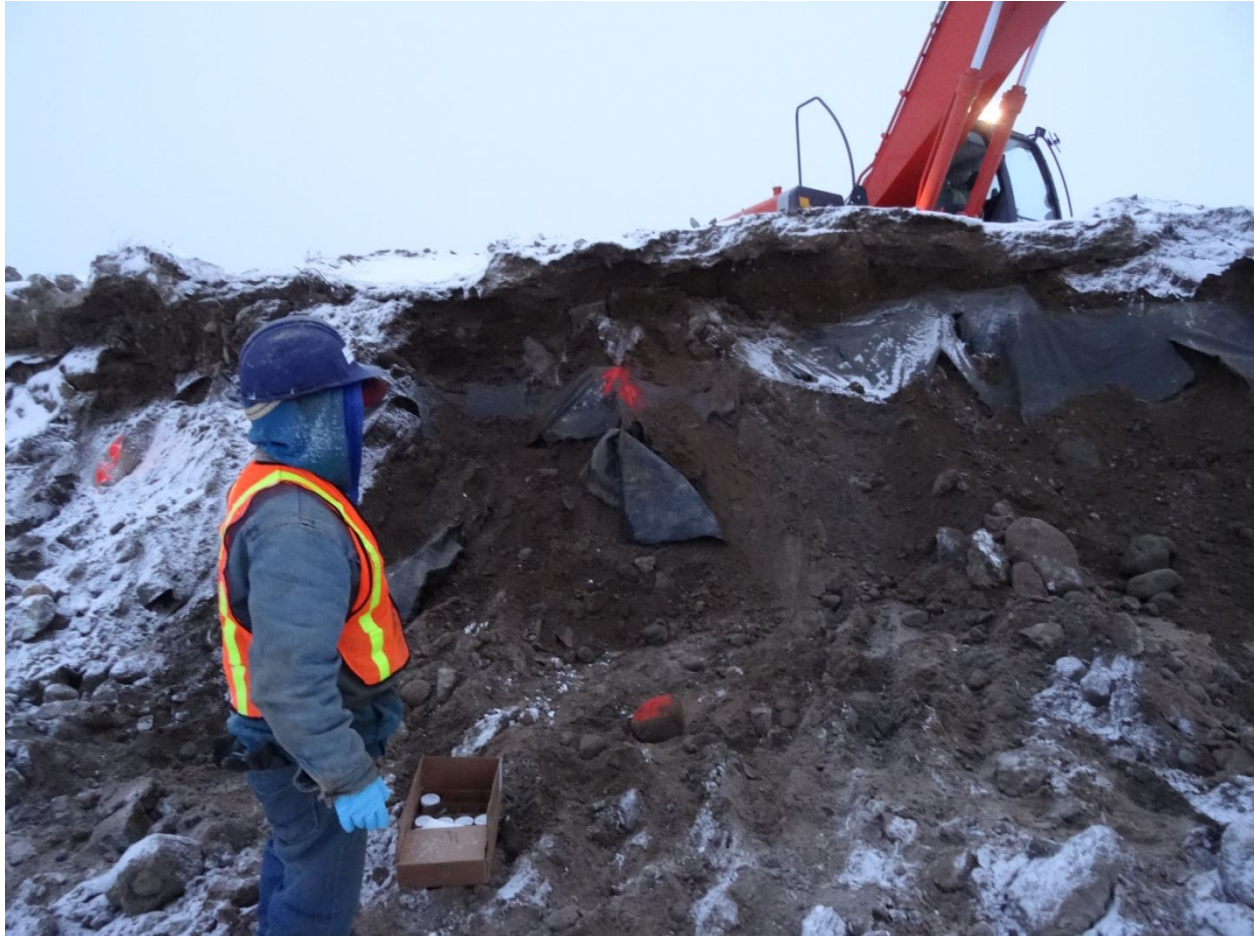
Samples taken by Inspector: <input type="checkbox"/> Yes <input checked="" type="checkbox"/> No	Location(s): 16 corresponding soil samples were collected by the Licensee during the period of the Inspection. One sample from the floor of the excavation and second from the material remaining in the berm wall above the floor of the excavation. One additional confirmatory sample was collected at the North end of cell C
--	---

The Inspector then remained on site and was present during the sampling of both the wall of the berm and the floor of the cell to ensure no contaminated soils remained on site.

Figure 6 Locations of where the confirmatory samples were collected and then marked.

AANDC conducted a review of the sampling results provided to this office and that of the Nunavut Water Board. The Inspector is satisfied that the result provided show that the samples have tested below the criteria set out in the issued license.
