Water Licence: 2BE-BLU0812 Skybridge Development Corp. (subsidiary of Mega Precious Metals); KIA Land Use Permit: KTL308C001

**Inspection photographs –August 1, 2010 for the Sage Lake camp and esker sites (Blue Caribou Project) at  
coordinates N65° 13' 57" W106° 37' 06" (NAD 83)  
(Photos taken by Water Resource Officer M. Joy)**

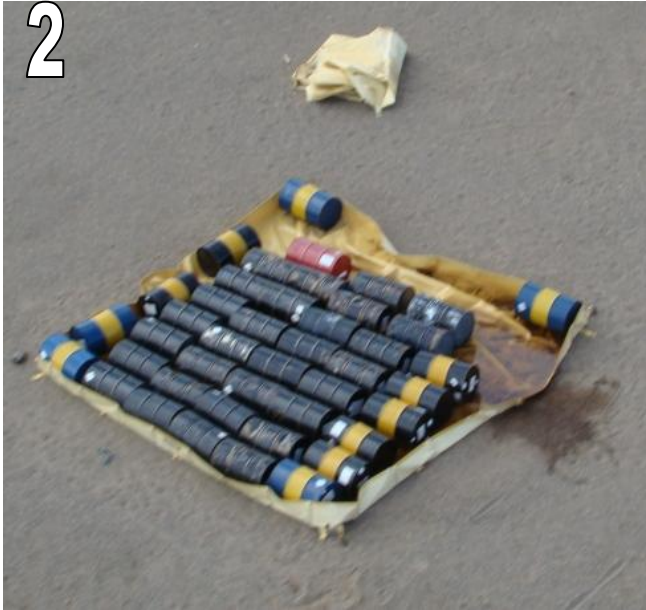
Photographs 2 & 3: (2) Fuel staging area at Sage Esker. Secondary containment is collecting water and requires reinforcement (covering is strongly recommended). (3) Pallets and woody debris left near esker fuel cache

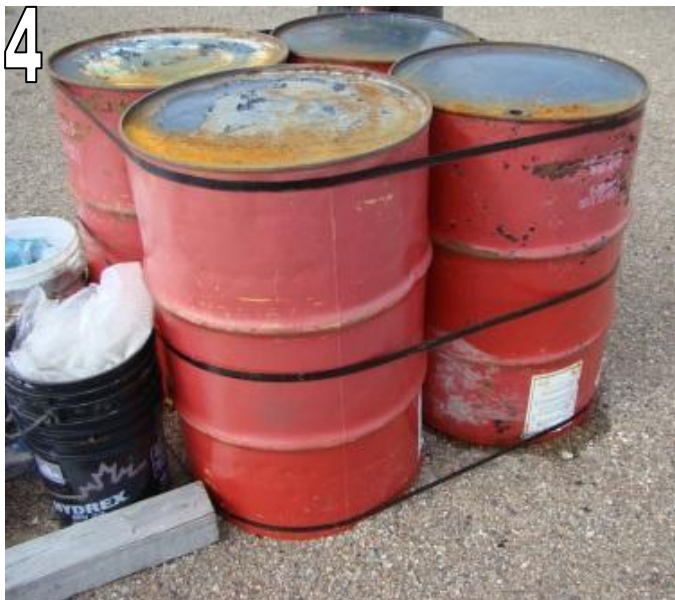
Photographs 4 & 5: (4) Barrels placed upside-down to drain at Sage Lake camp. (5) Latrine pit, located beside latrine shack, has not been filled in and recontoured.

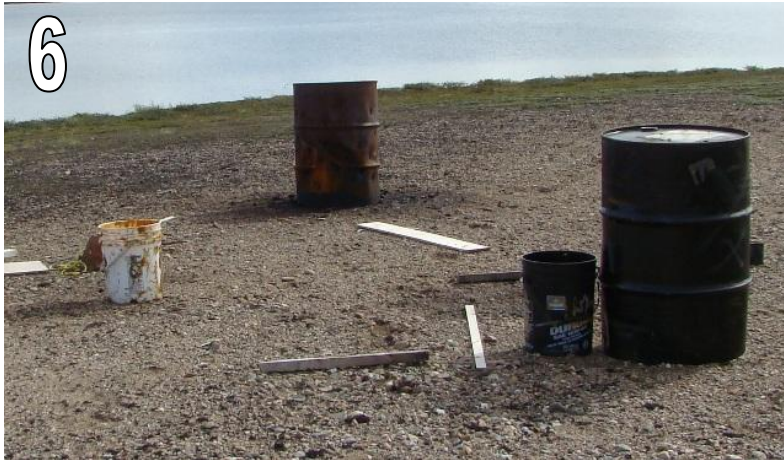
Photographs 6-10: (6) Burn barrel area. (7) Debris left inside burn drum (8). (9, 10) 2 pails left outside uncovered and exposed to the elements.

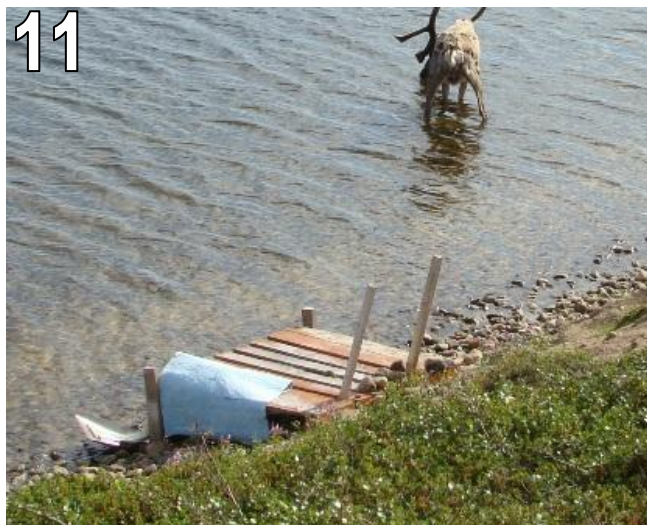
Photographs 11 & 12: Debris in and around Sage Lake – (11) Spill pad and shovel; (12) Styrofoam insulation in the water.

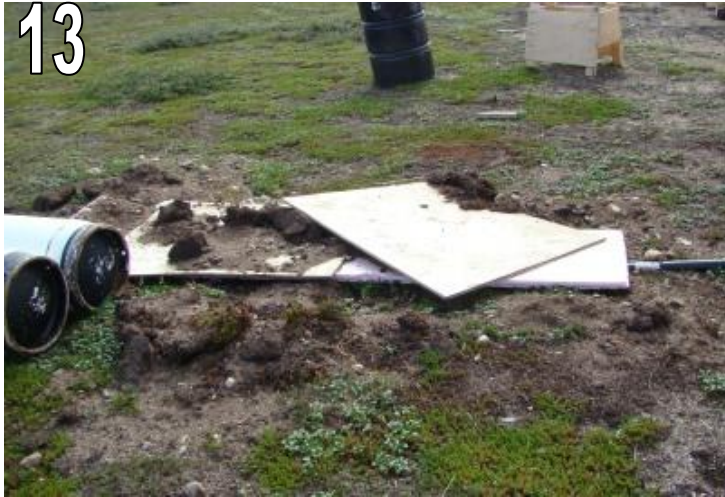
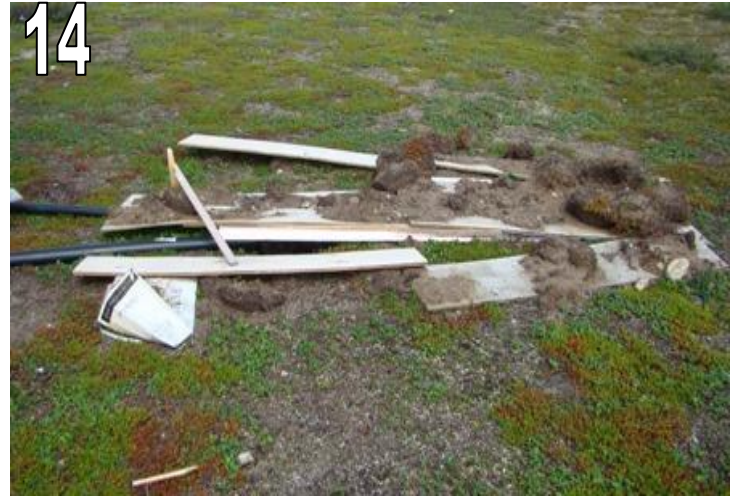
Photographs 13 & 14: Condition of sumps (not filled in); several propane tanks left unsecured on site (13).

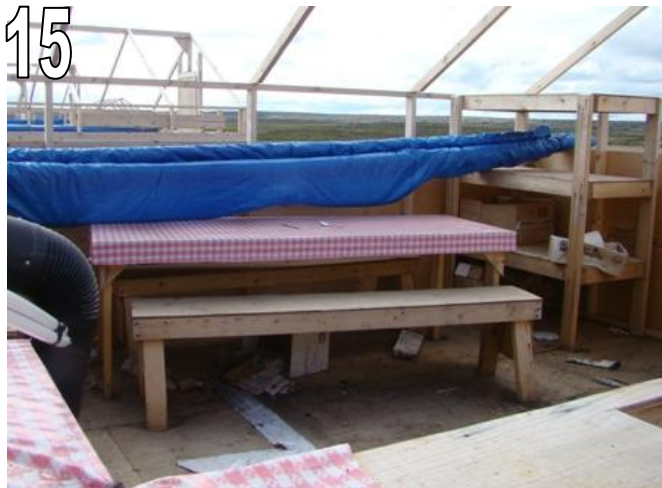
Photographs 15 & 16: (15) Condition of items left in open tent frame. (16) View of some of the woody debris (nails protruding) strewn about the site.

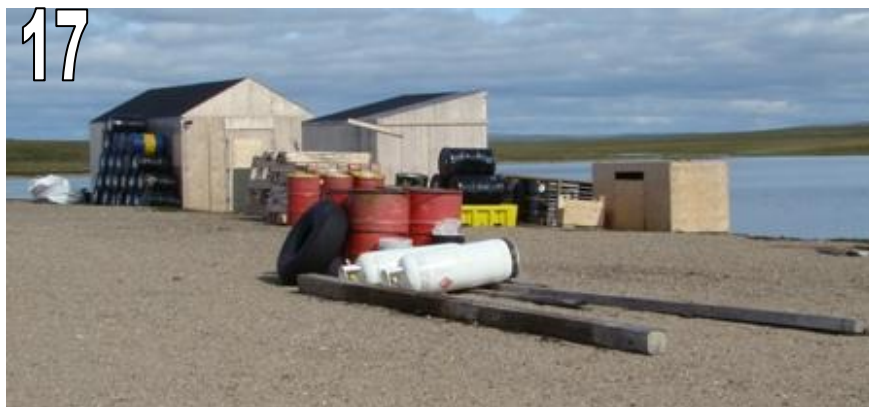
Photograph 17 & 18: (17) View of materials stored near core shack area. (18) Battery left in tent frame.
