Re : Response to Inspection Report **"Inspection of Water Licence 2BE-COR0608, 2BE-CGP1012, 2BE-CGR1012, July 7 2013"**. Inspection report is dated September 5th, 2013.

I am the Geologist who supervised Eureka camp (N67°01'33.7" / W113°39'04.6") in 2011 during its final use before it was permanently closed and removed that year. As part of my role, I was in charge of making sure camp was kept clean and maintained in good order. You recently inspected the camp-site and sent us a copy of your inspection report along with some concerns. Your inspection report says you visited the camp-site July 4th, 2013.

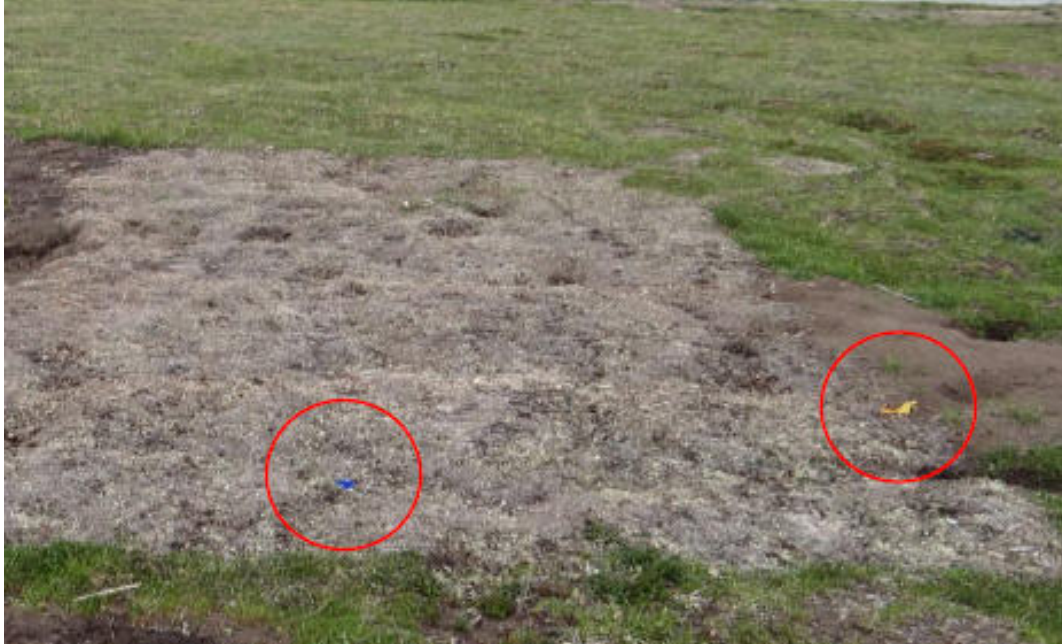
Photo 1 : July 2013 - Garbage needing to be picked up (photo taken from your report).

I was in Yellowknife last week and was able to fly up to the old Eureka camp-site September 18th, 2013, and address the concerns mentioned in your report. I picked up the garbage you identified during your inspection (see Photos 1 & 2 below), refilled the sump (Photos 3 & 4), and re-stacked the core which had been knocked over by a bear (Photos 5 through 8). No signs of fuel contamination were seen.

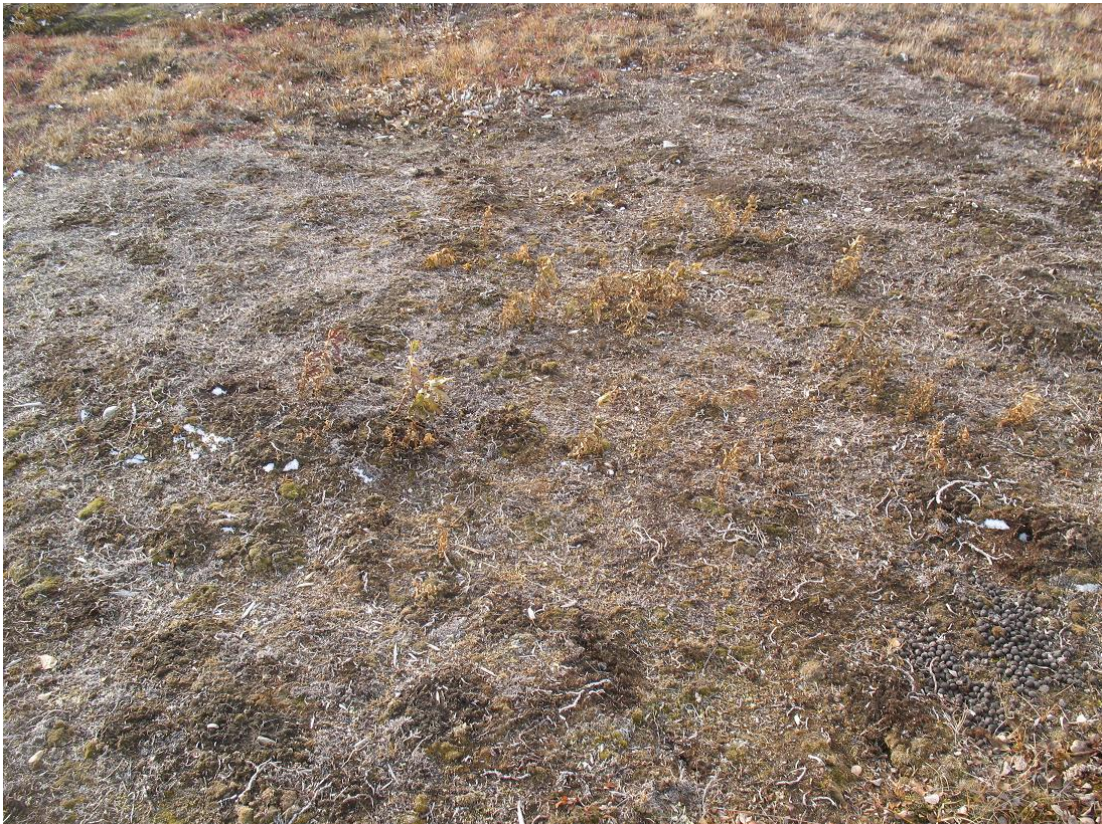
Photo 2 : September 2013 - Garbage all picked up. The blue item was a plastic bottle cap from a juice jug and the yellow item was flagging. Note also the regrowth in vegetation since July (compare with the photo above).

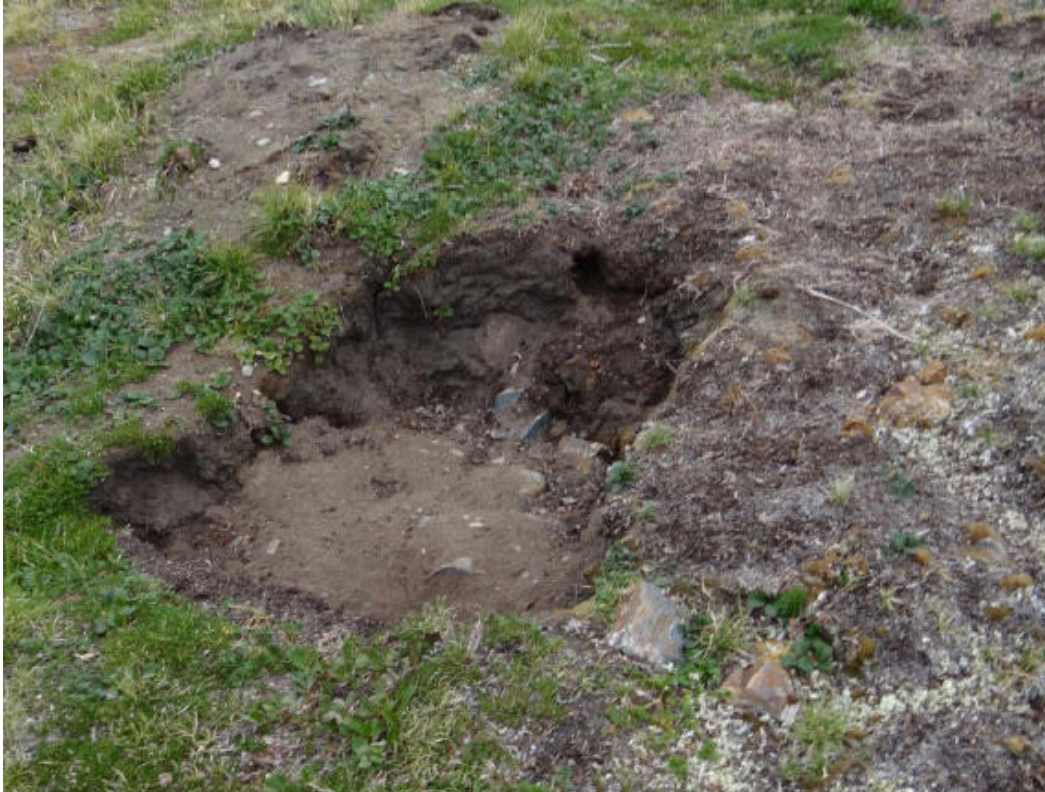
Photo 3 : July 2013 - Old sump needing to be refilled (photo taken from your report).

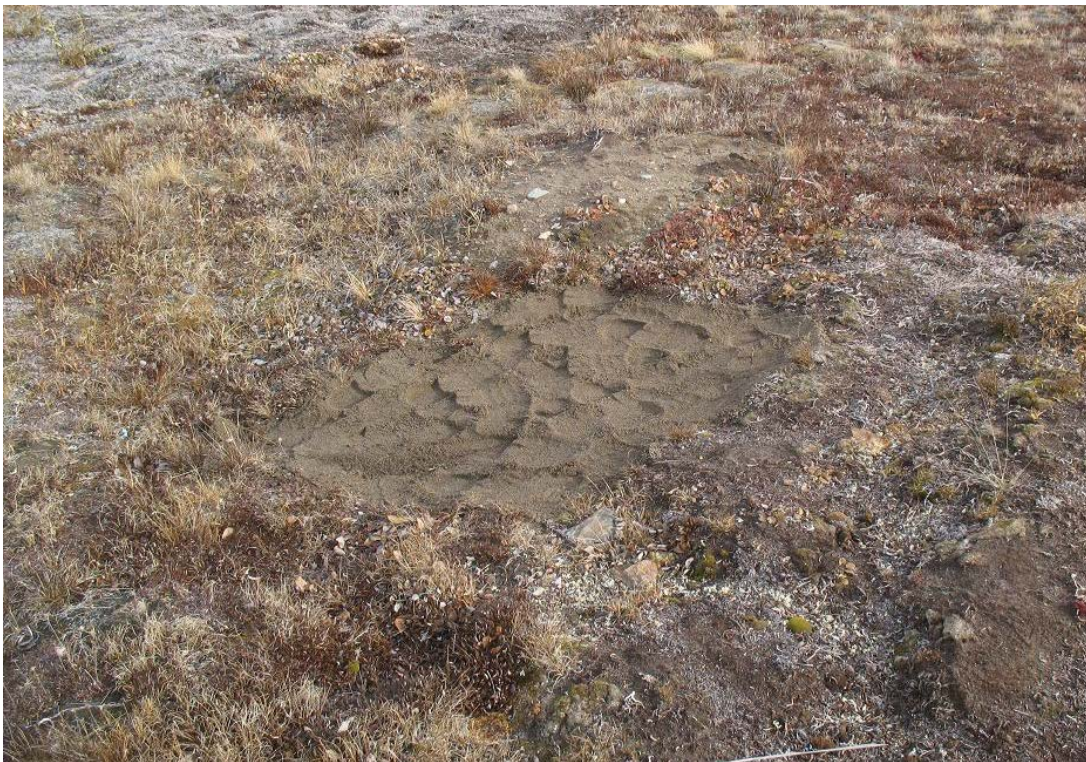
Photo 4 : September 2013 - Sump filled in, levelled, and scarred to promote regrowth.

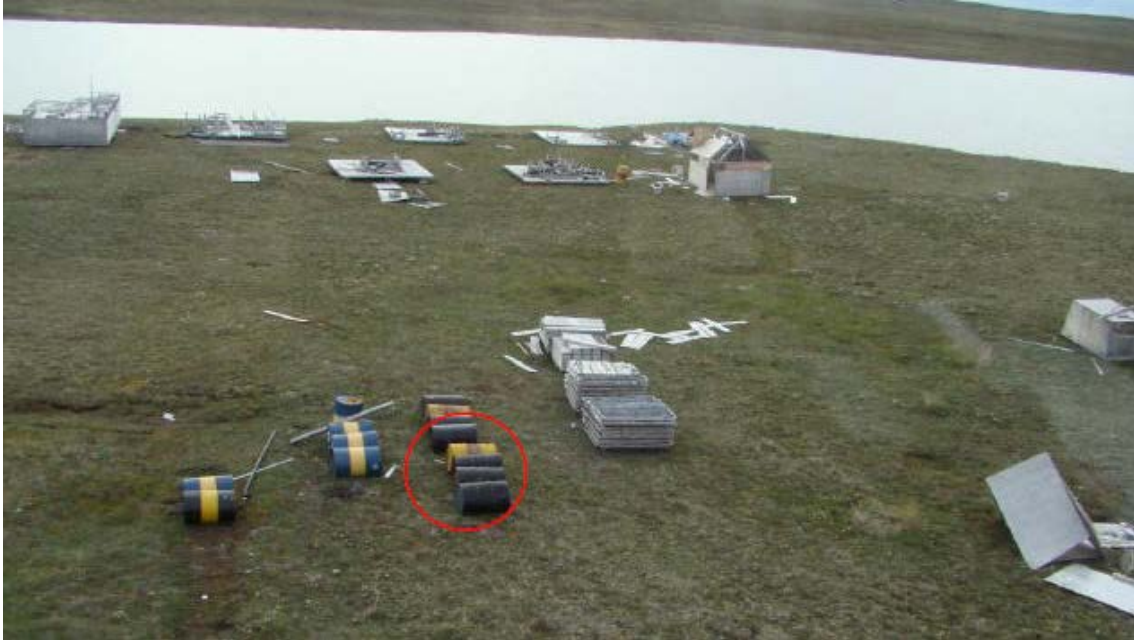
Photo 5 : Old photo of Eureka Camp (taken from your report) from 2009 showing the original position of the core boxes from 2003. The old drums (circled in red) were back-hauled out of camp (no leaks) in 2011, and the new core boxes were placed beside the older ones (see photo below).

Regarding the old drums mentioned on page 6 of your report, a Stornoway representative visited Eureka camp July 21st, 2009, and reported after inspecting the drums that none were leaking or showed any signs of leakage. A letter summarising this visit was sent to John Craig (DINA) by email August 25th, 2009, and by hard copy to Phyllis Beaulieu (NWB) August 28th, 2009. When I arrived in camp in 2011, I saw no leaking drums or signs of contamination, and all drums were back-hauled to Yellowknife that summer.

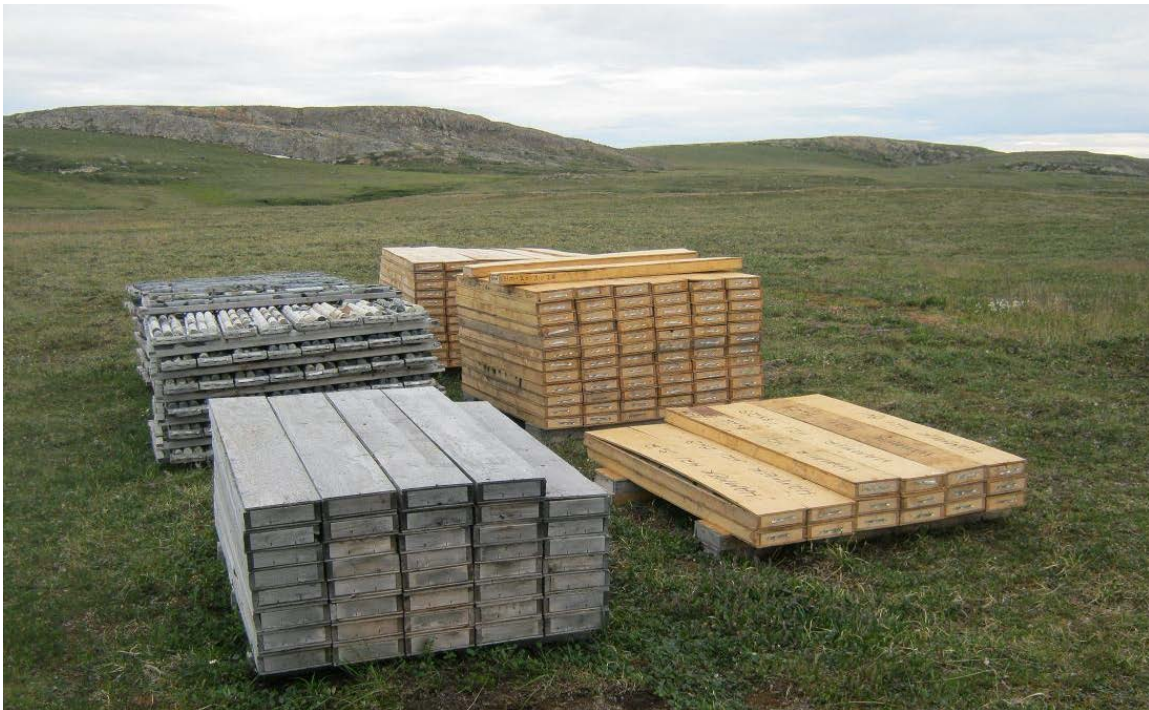
Photo 6 : This is how we left the core in 2011. The older, faded boxes on the left are from 2003 and in their original position (see photo above) while the newer boxes to the right are from 2011. All old drums were back-hauled to Yellowknife and no signs of contamination were seen.

You and I had a phone conversation yesterday afternoon where I explained to you that because I was the Geologist last in charge of Eureka camp, I myself went to the old camp-site to personally make sure all of your concerns were taken care of. I also explained over the phone that no core boxes were ever moved from their original stacks (see Photos 5 through 8 below), and that there were no fuel spills.

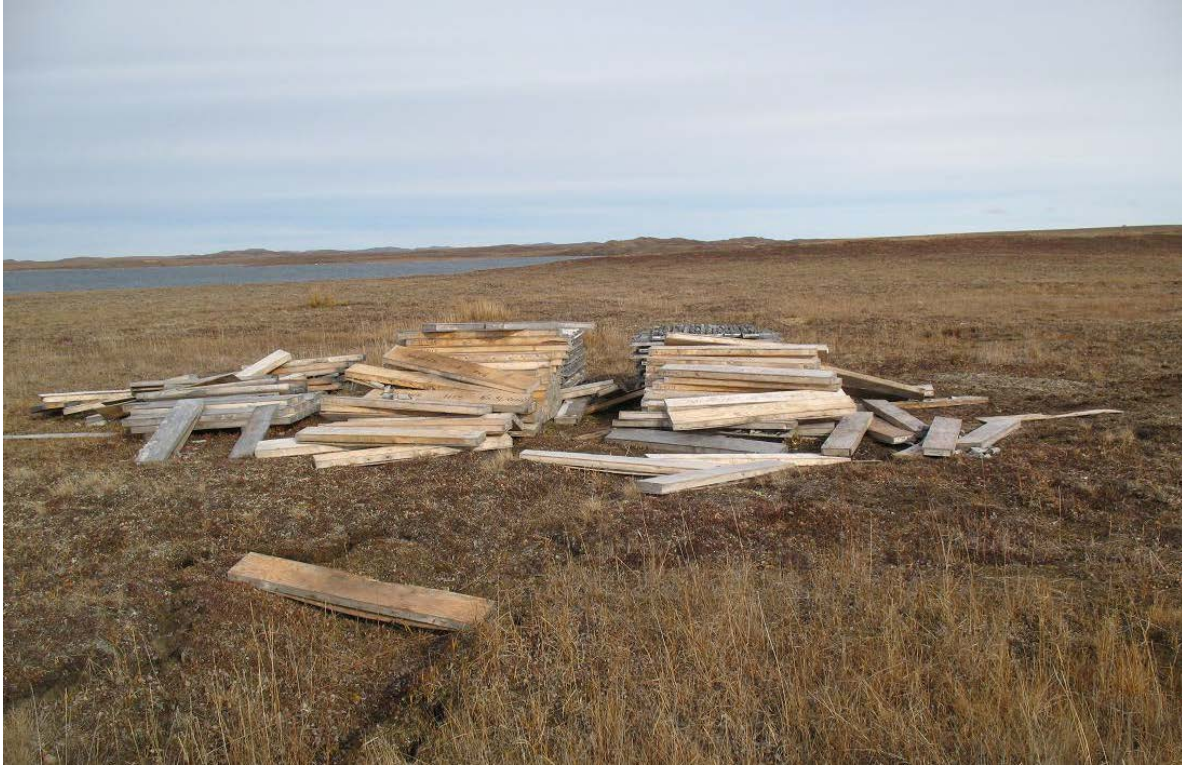
Photo 7 : September 2013 - This is how the core looked during your July camp inspection, all knocked over and spilled about. Claw marks and tufts of white/brown hair around the core boxes suggest this was done by a bear. Several boxes had also been smashed open.

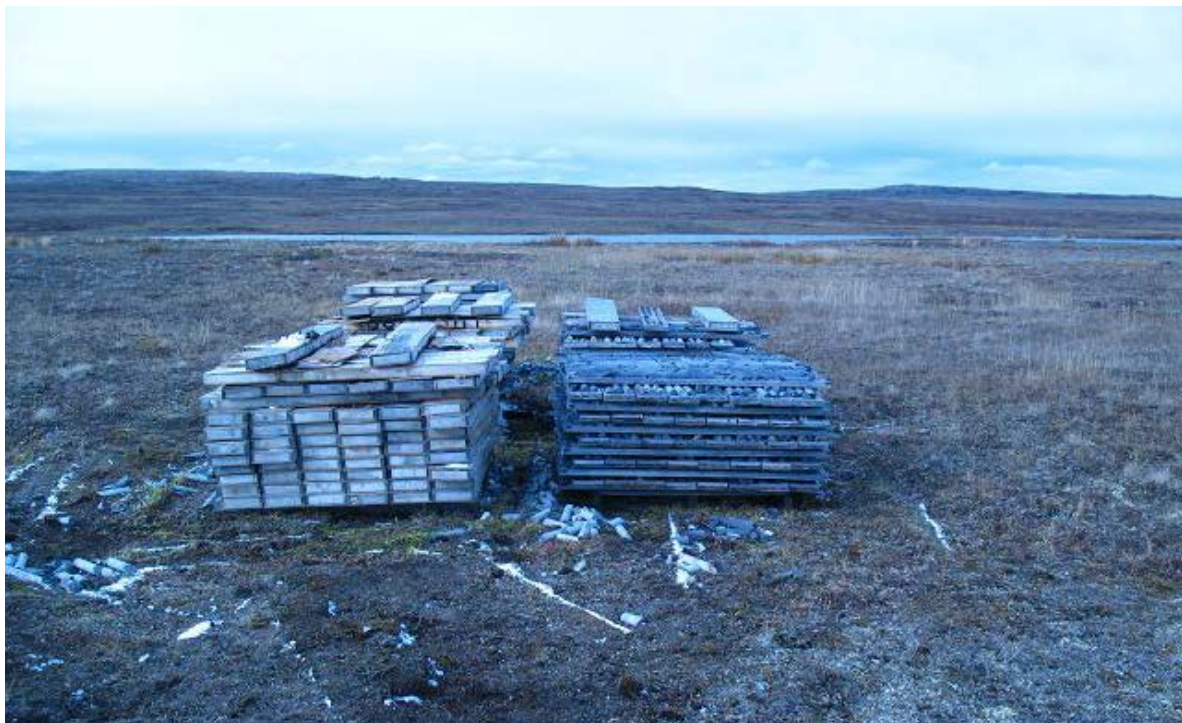
Photo 8 : September 2013 - The core boxes now, all re-stacked in their original piles.
