## CORRECTION FROM THE AANDC INSPECTION JUNE 9<sup>TH</sup> 2015

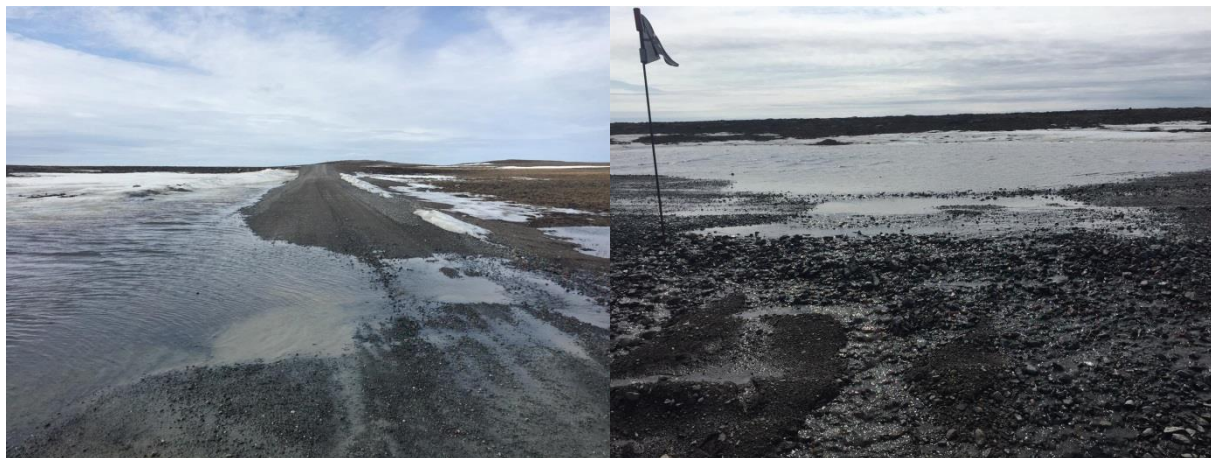
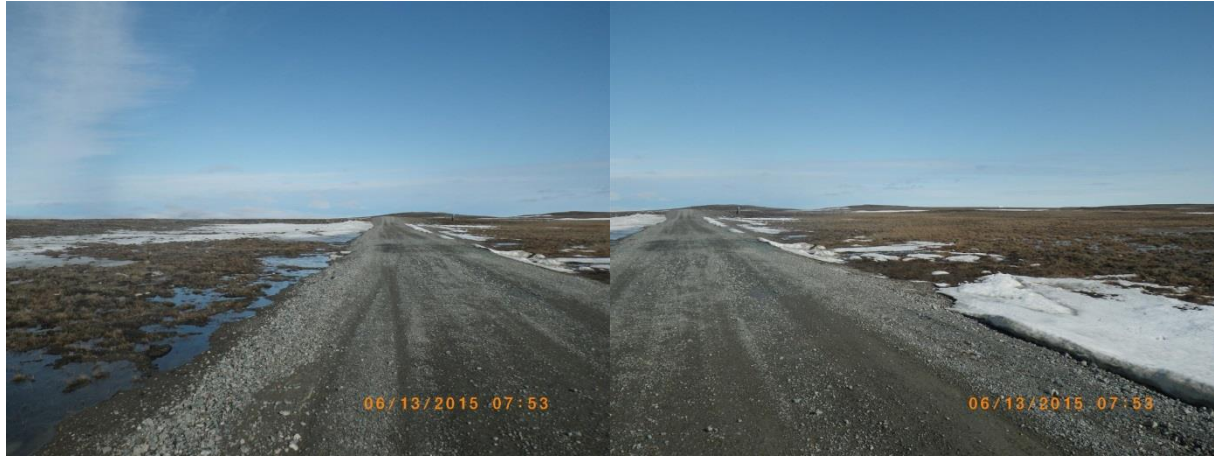
#### Culvert 26:

These four pictures show the water washing out the road, the pooling of water and the effects after the pipes were thawed. The pictures were taken 14 hours apart.
