**APPENDIX D.1**  
**CONSTRUCTION SUMMARY REPORT- MILNE PORT OFF-SPEC PWSP**

**Baffinland Iron Mines Corporation  
Mary River Project**

**Construction Summary Report: Construction Summary Report: Milne  
Port Off-Spec Sewage Effluent Pond (PWSP)**

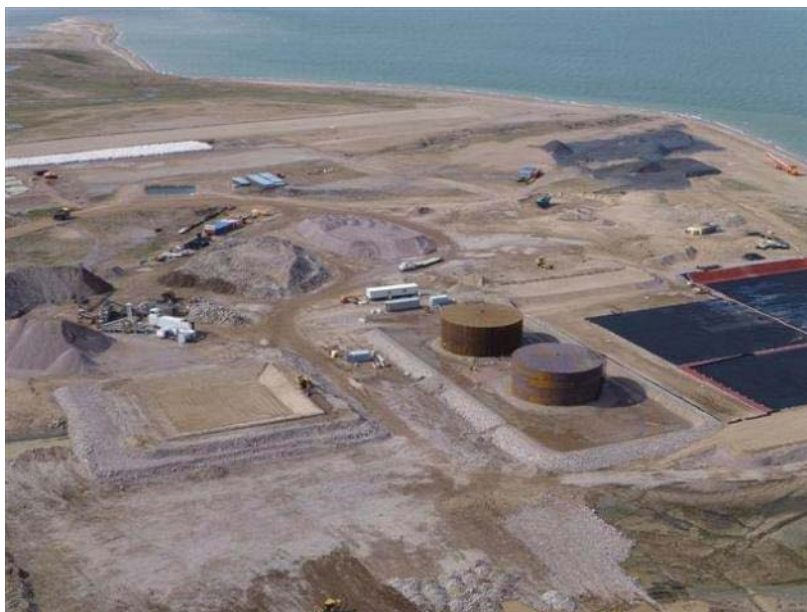
**Figure 4: During – Grading of Final Layer**

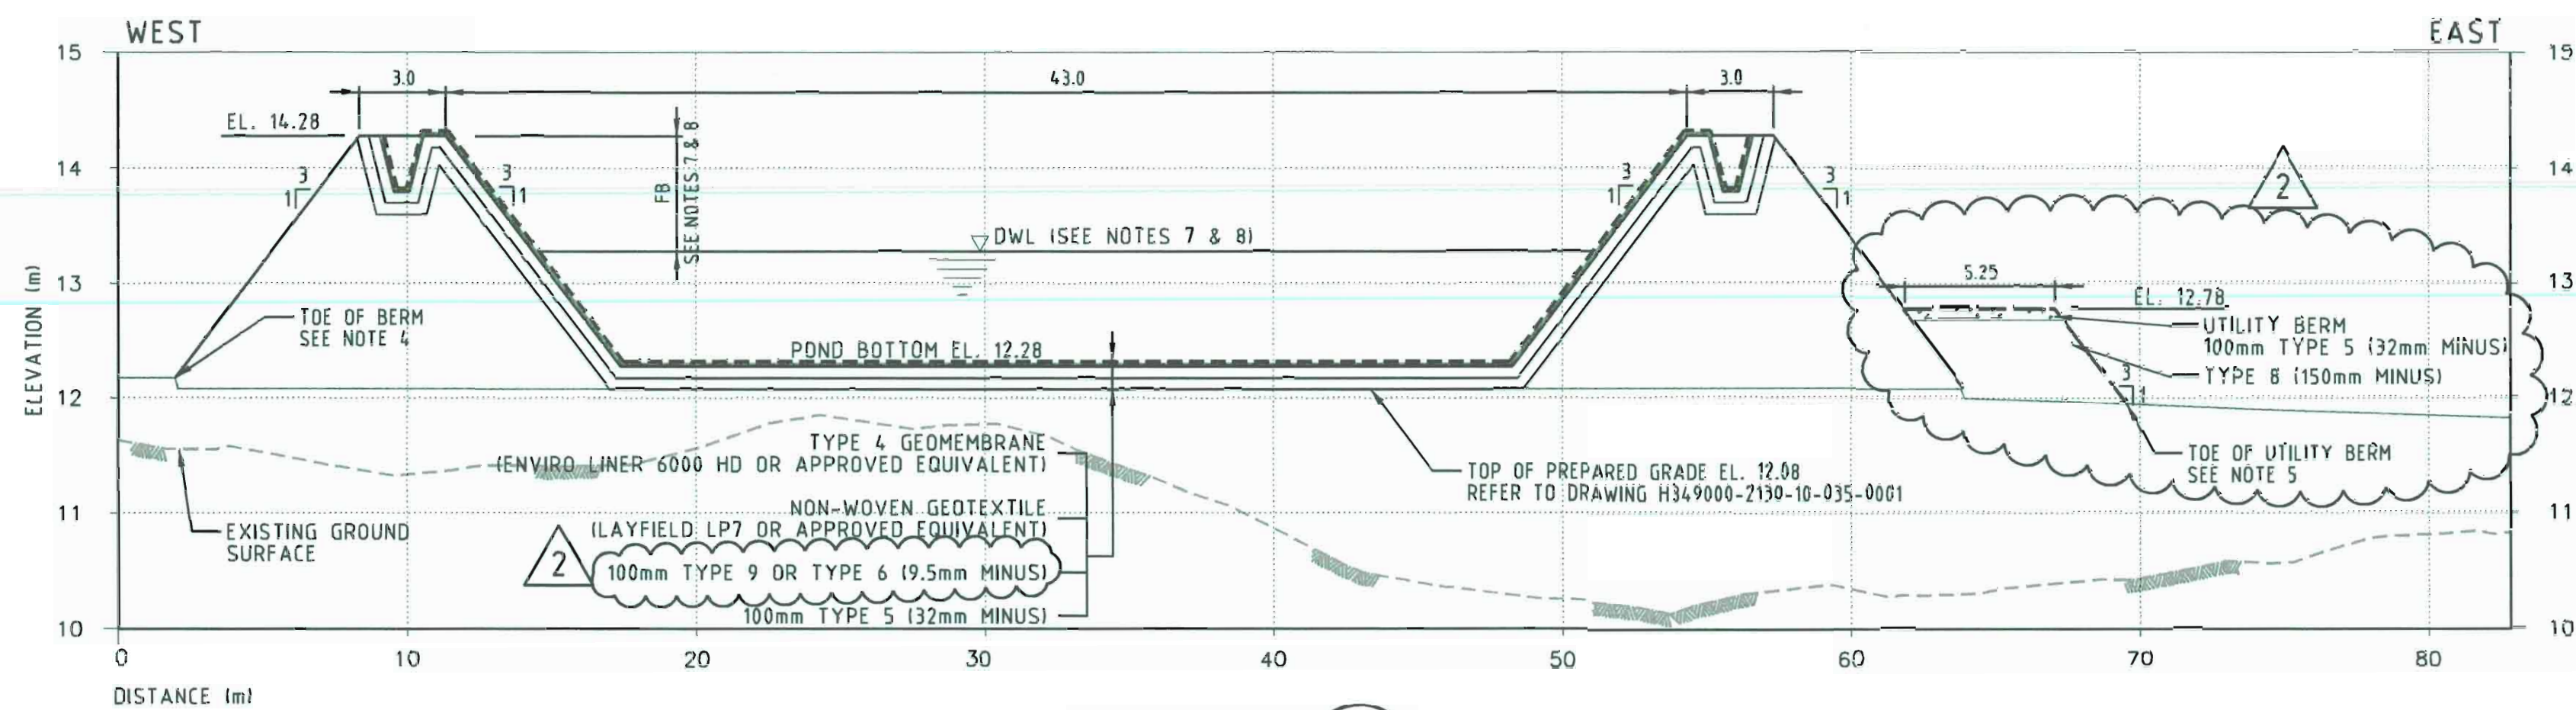
SECTION A  
1:200 H  
1:50 V  
2735-10-035-0001

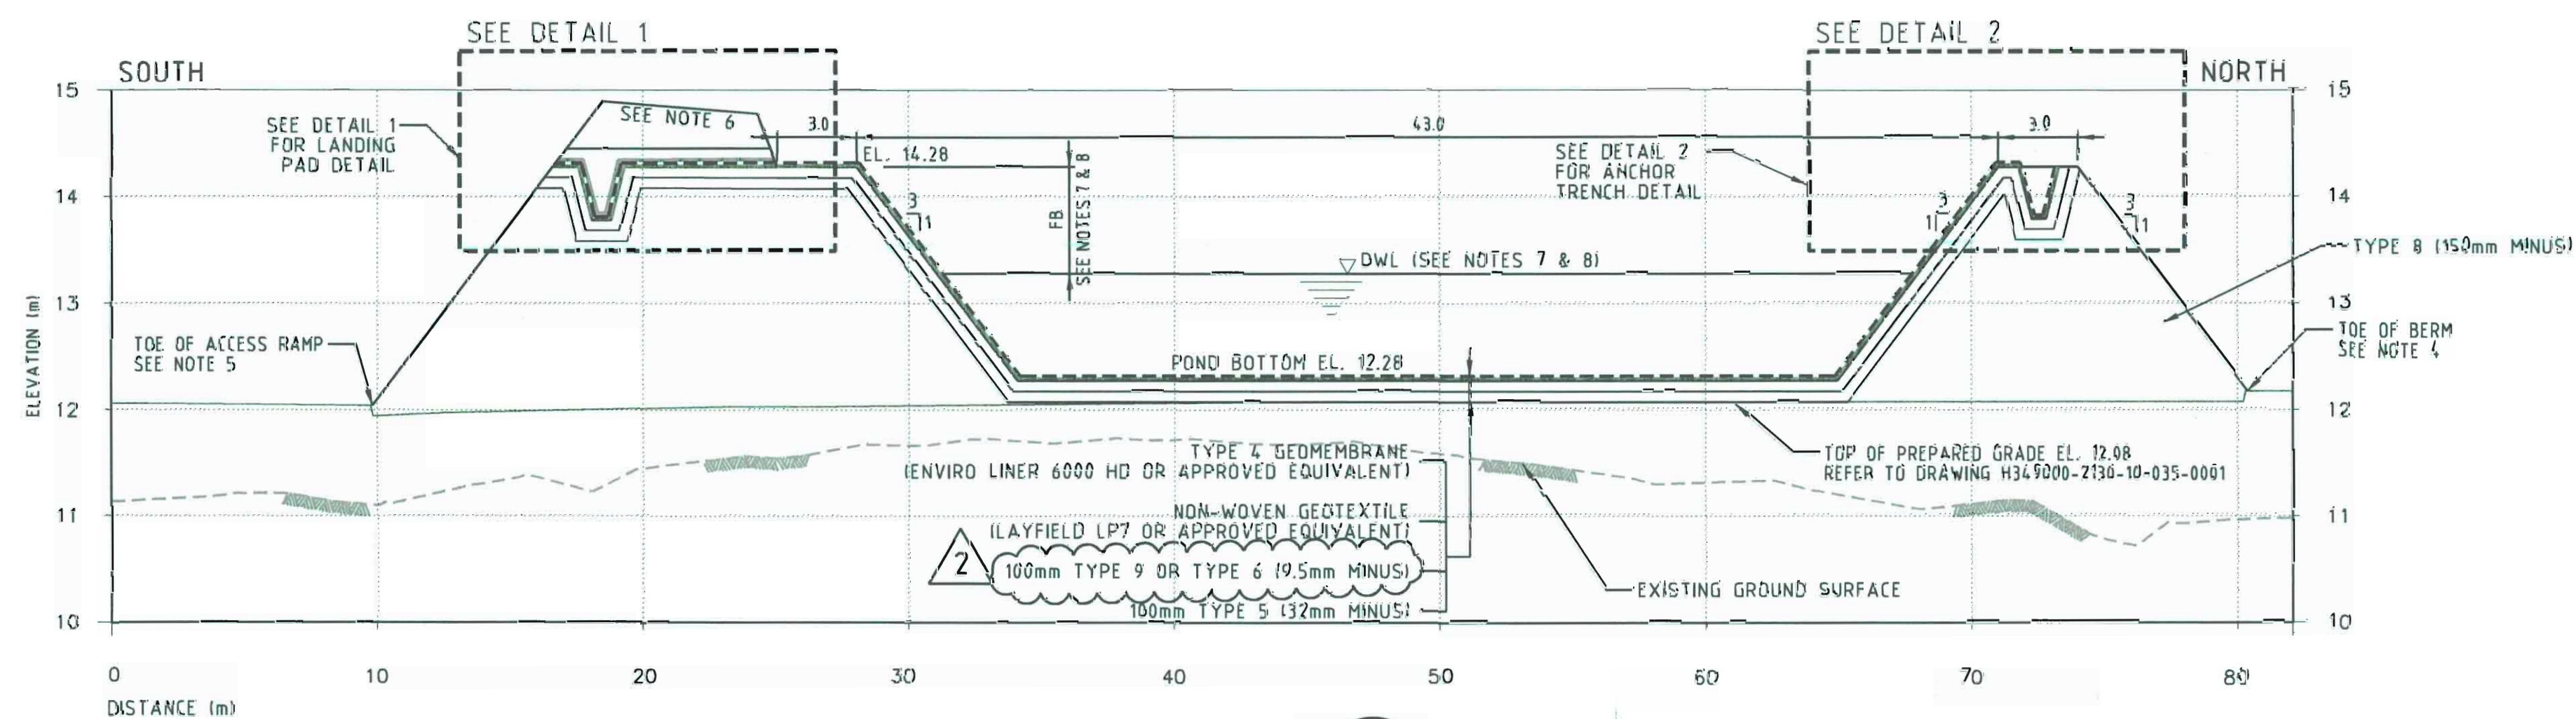
SECTION B  
1:200 H  
1:50 V  
2735-10-035-0001

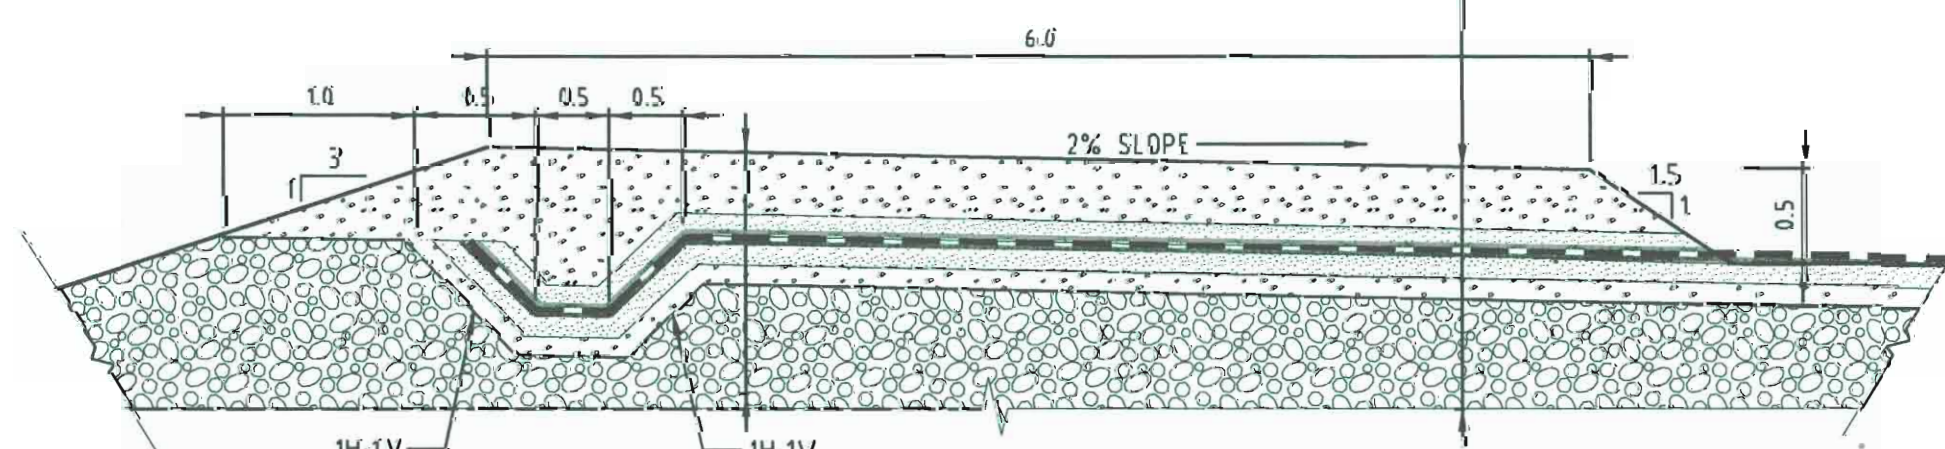
DETAIL 1 - BERM AT LANDING PAD

400mm TYPE 5 (32mm MINUS)  
100mm TYPE 9 OR TYPE 6 (19.5mm MINUS)  
NON-WOVEN GEOTEXTILE (LAYFIELD LP7 OR APPROVED EQUIVALENT)  
TYPE 4 GEOMEMBRANE (ENVIRO LINER 6000 HD OR APPROVED EQUIVALENT)  
NON-WOVEN GEOTEXTILE (LAYFIELD LP7 OR APPROVED EQUIVALENT)  
100mm TYPE 9 OR TYPE 6 (19.5mm MINUS)  
100mm TYPE 5 (32mm MINUS)  
TYPE 8 (150mm MINUS)

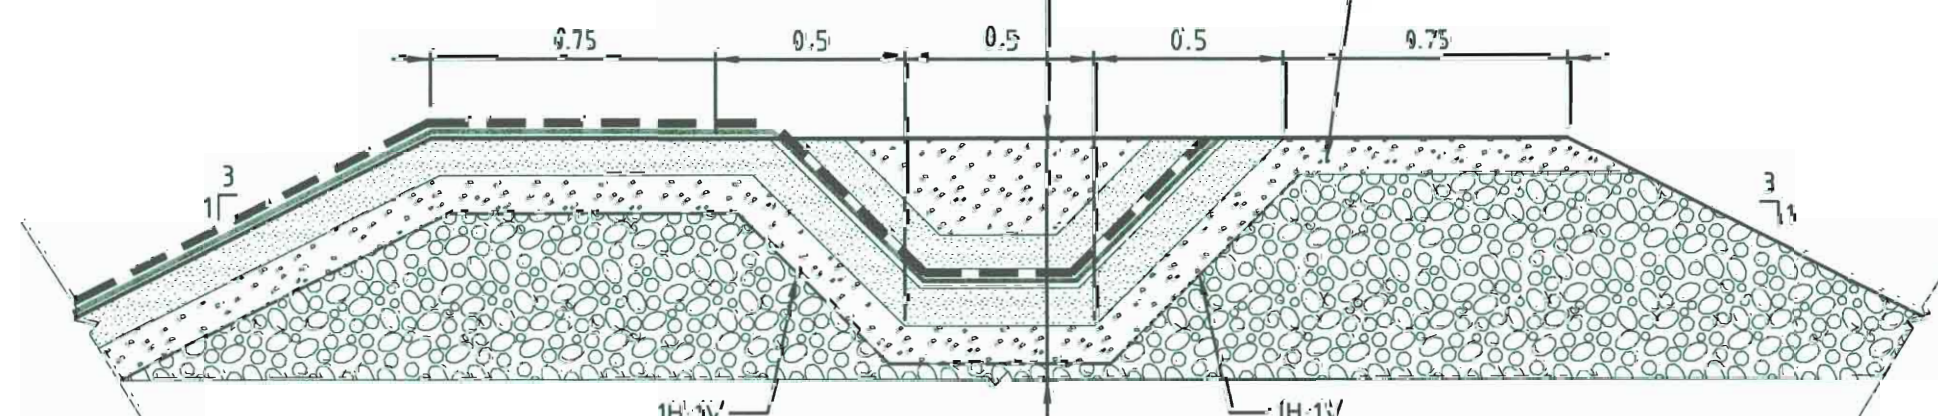
DETAIL 2 - NORMAL BERM

TYPE 5 (32mm MINUS)  
100mm TYPE 9 OR TYPE 6 (19.5mm MINUS)  
TYPE 4 GEOMEMBRANE (ENVIRO LINER 6000 HD OR APPROVED EQUIVALENT)  
NON-WOVEN GEOTEXTILE (LAYFIELD LP7 OR APPROVED EQUIVALENT)  
100mm TYPE 9 OR TYPE 6 (19.5mm MINUS)  
100mm TYPE 5 (32mm MINUS)  
TYPE 8 (150mm MINUS)

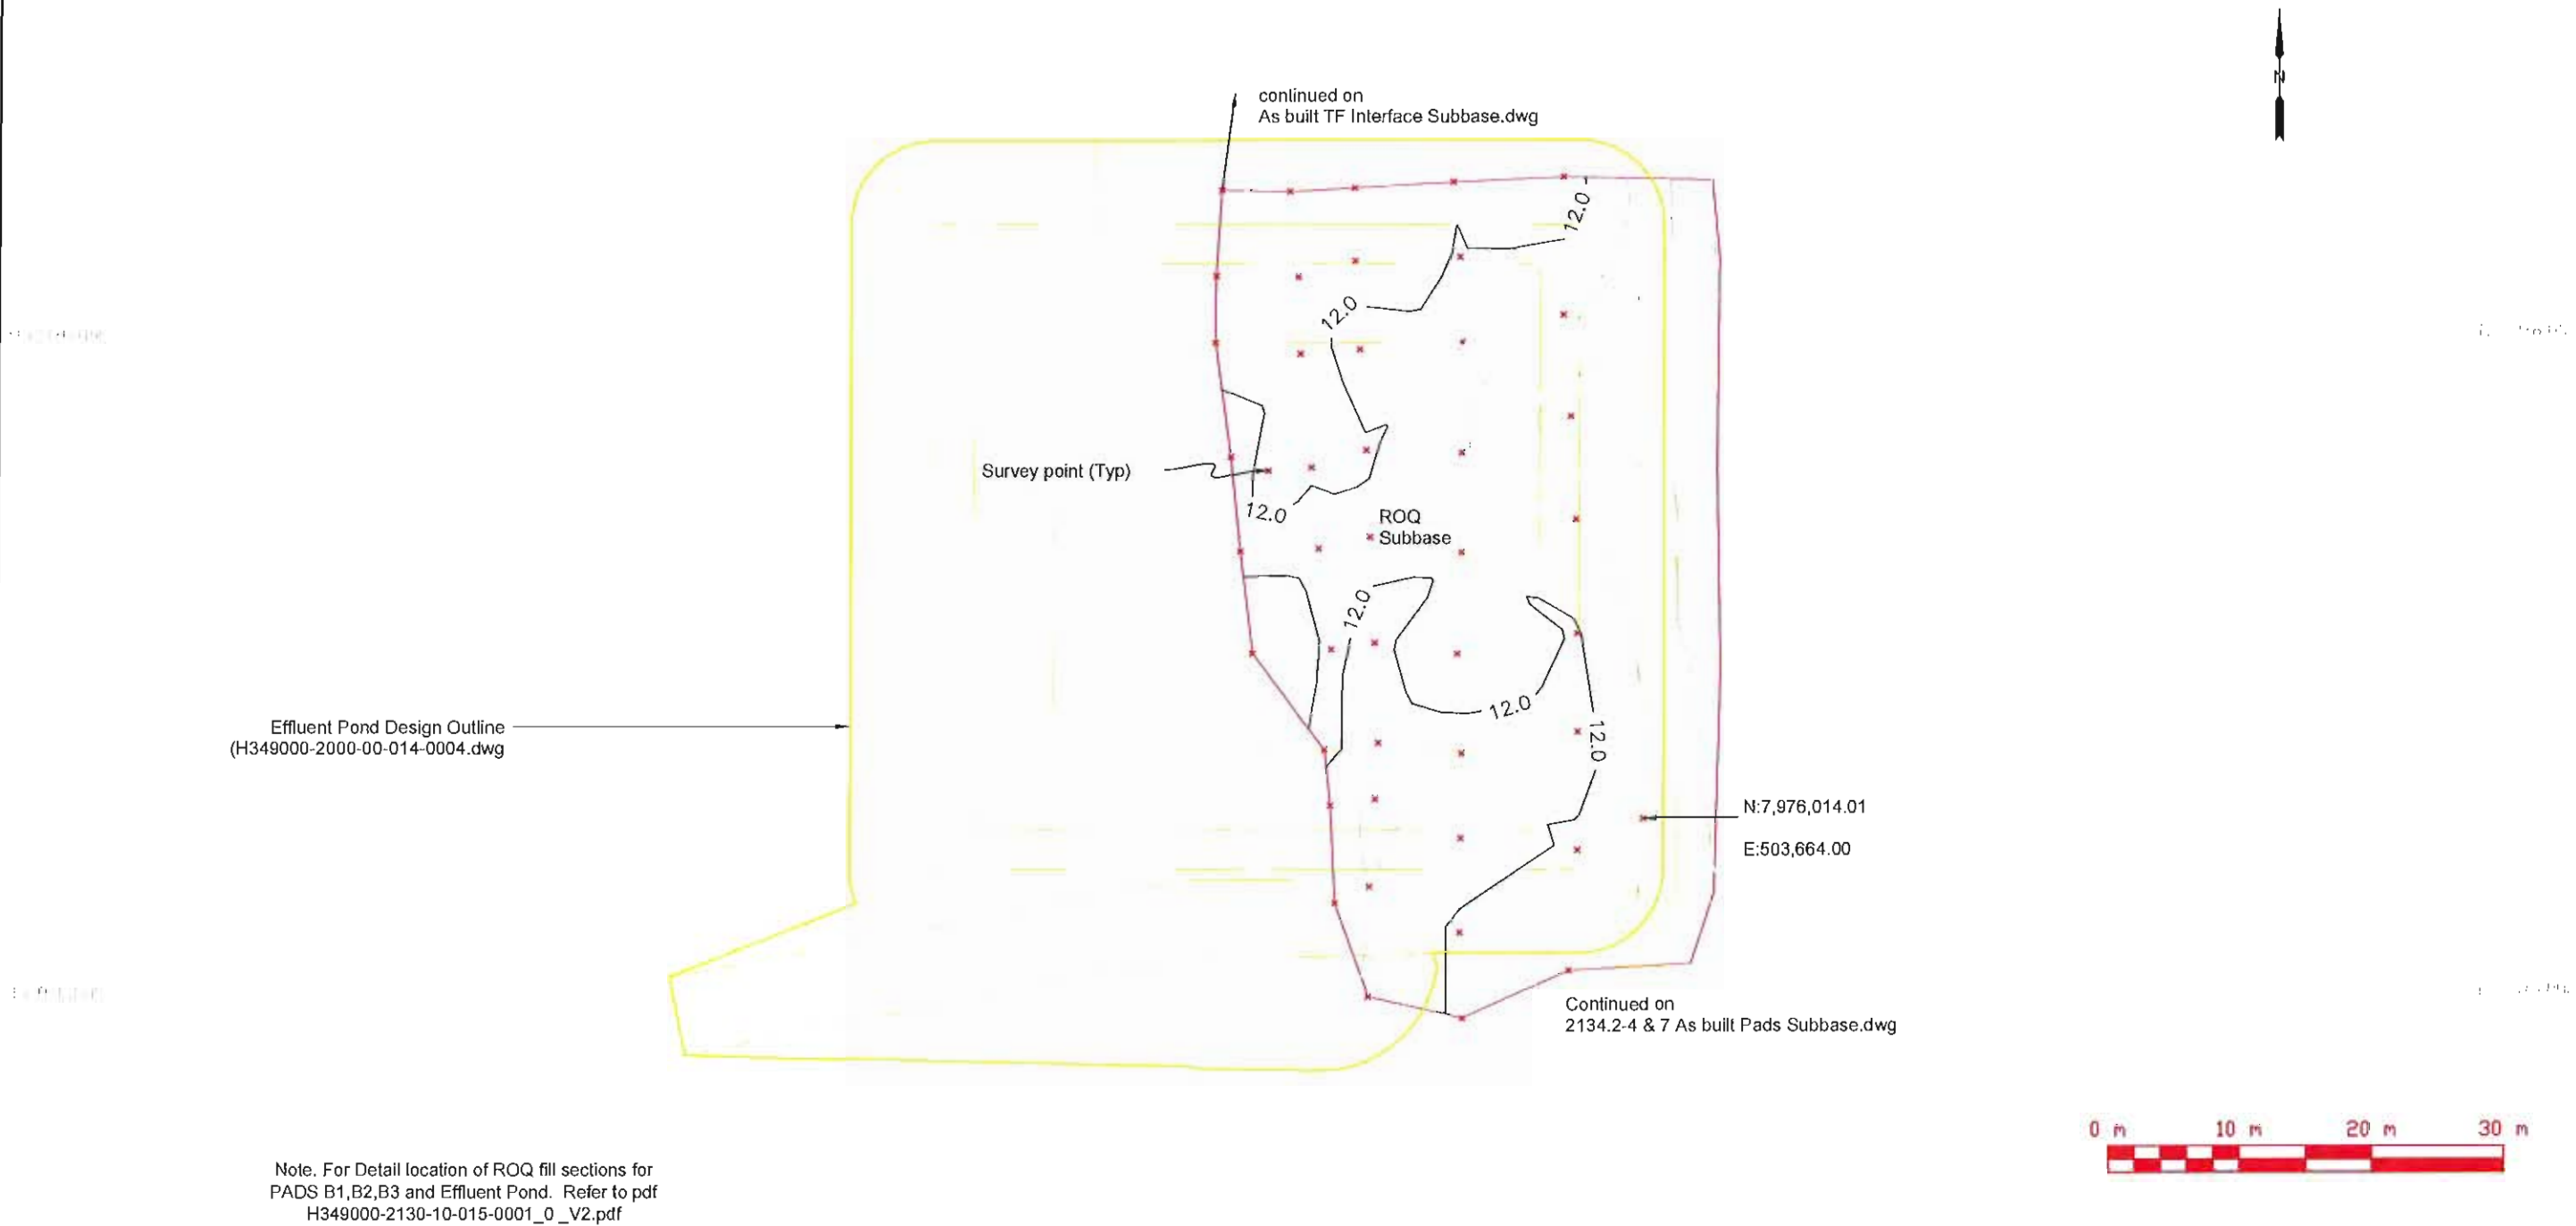
| NOTES:<br><br>Effluent Pond Job No:2999 BIM 2.3.1.12<br>Run of Quarry fill Area: Activity # 4<br>Reference drawing H349000-2130-10-015-0001 Rev 0 | CLIENT:<br><br>Baffinland Iron Mines Corporation | PREPARED BY:<br><br>Nuna East Ltd.<br>9839 - 31 Avenue<br>Edmonton, AB<br>T6N 1C5 | | DRAWING TITLE<br><br>Milne Port-Effluent Pond<br>ROQ Subbase | |

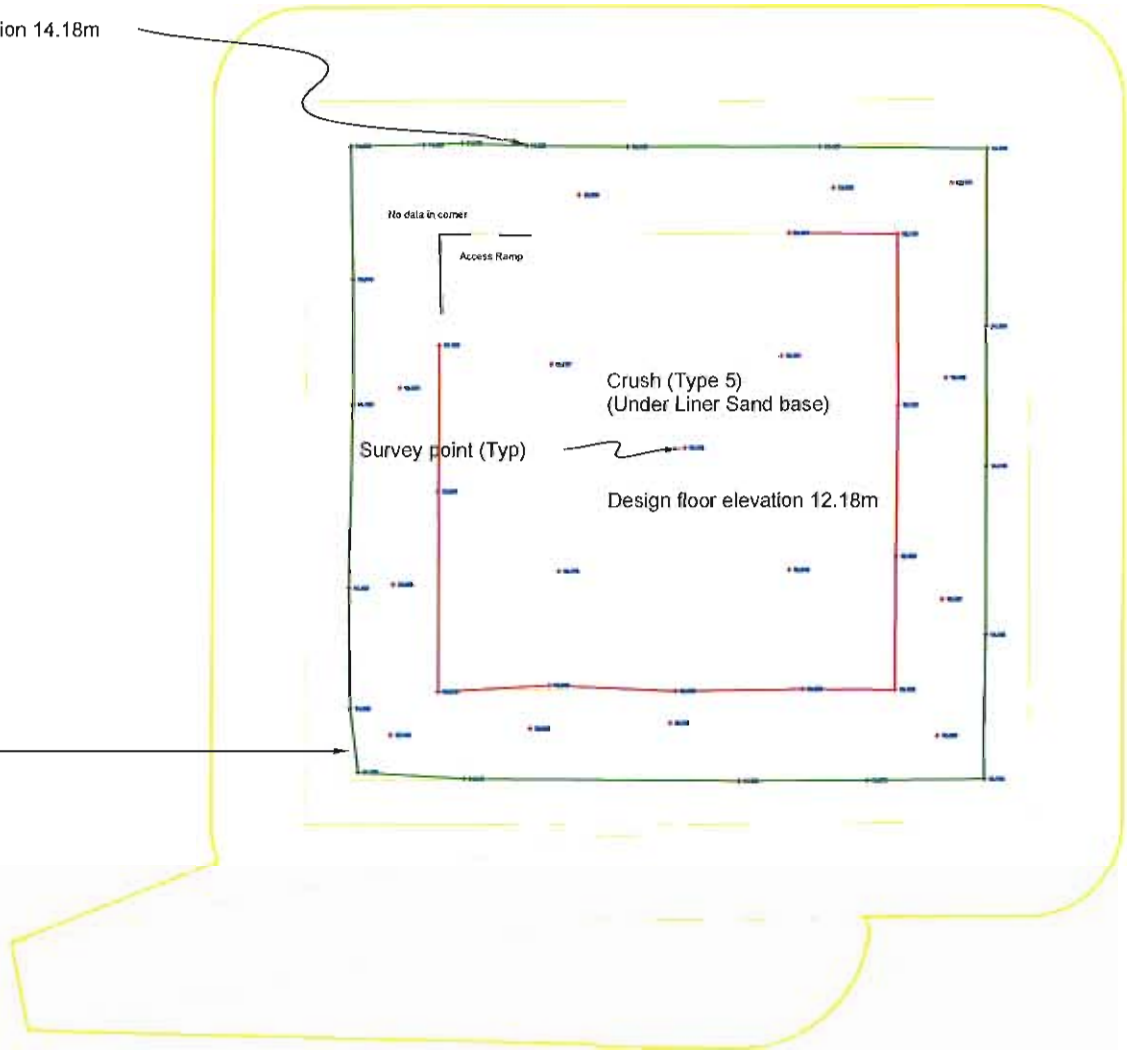
| NOTES:<br>Effluent Pond Job No:2999 BIM 2.3.1.12<br>Pond floor & slopes Crush cover (type 5): Activity # 8 | CLIENT:<br>Baffinland Iron Mines Corporation | PREPARED BY:<br>Nuna East Ltd.<br>9839 - 31 Avenue<br>Edmonton, AB<br>T6N 1C5 | | DRAWING TITLE:<br>Milne Port-Effluent Pond<br>Crush Surface below<br>Liner Sand |

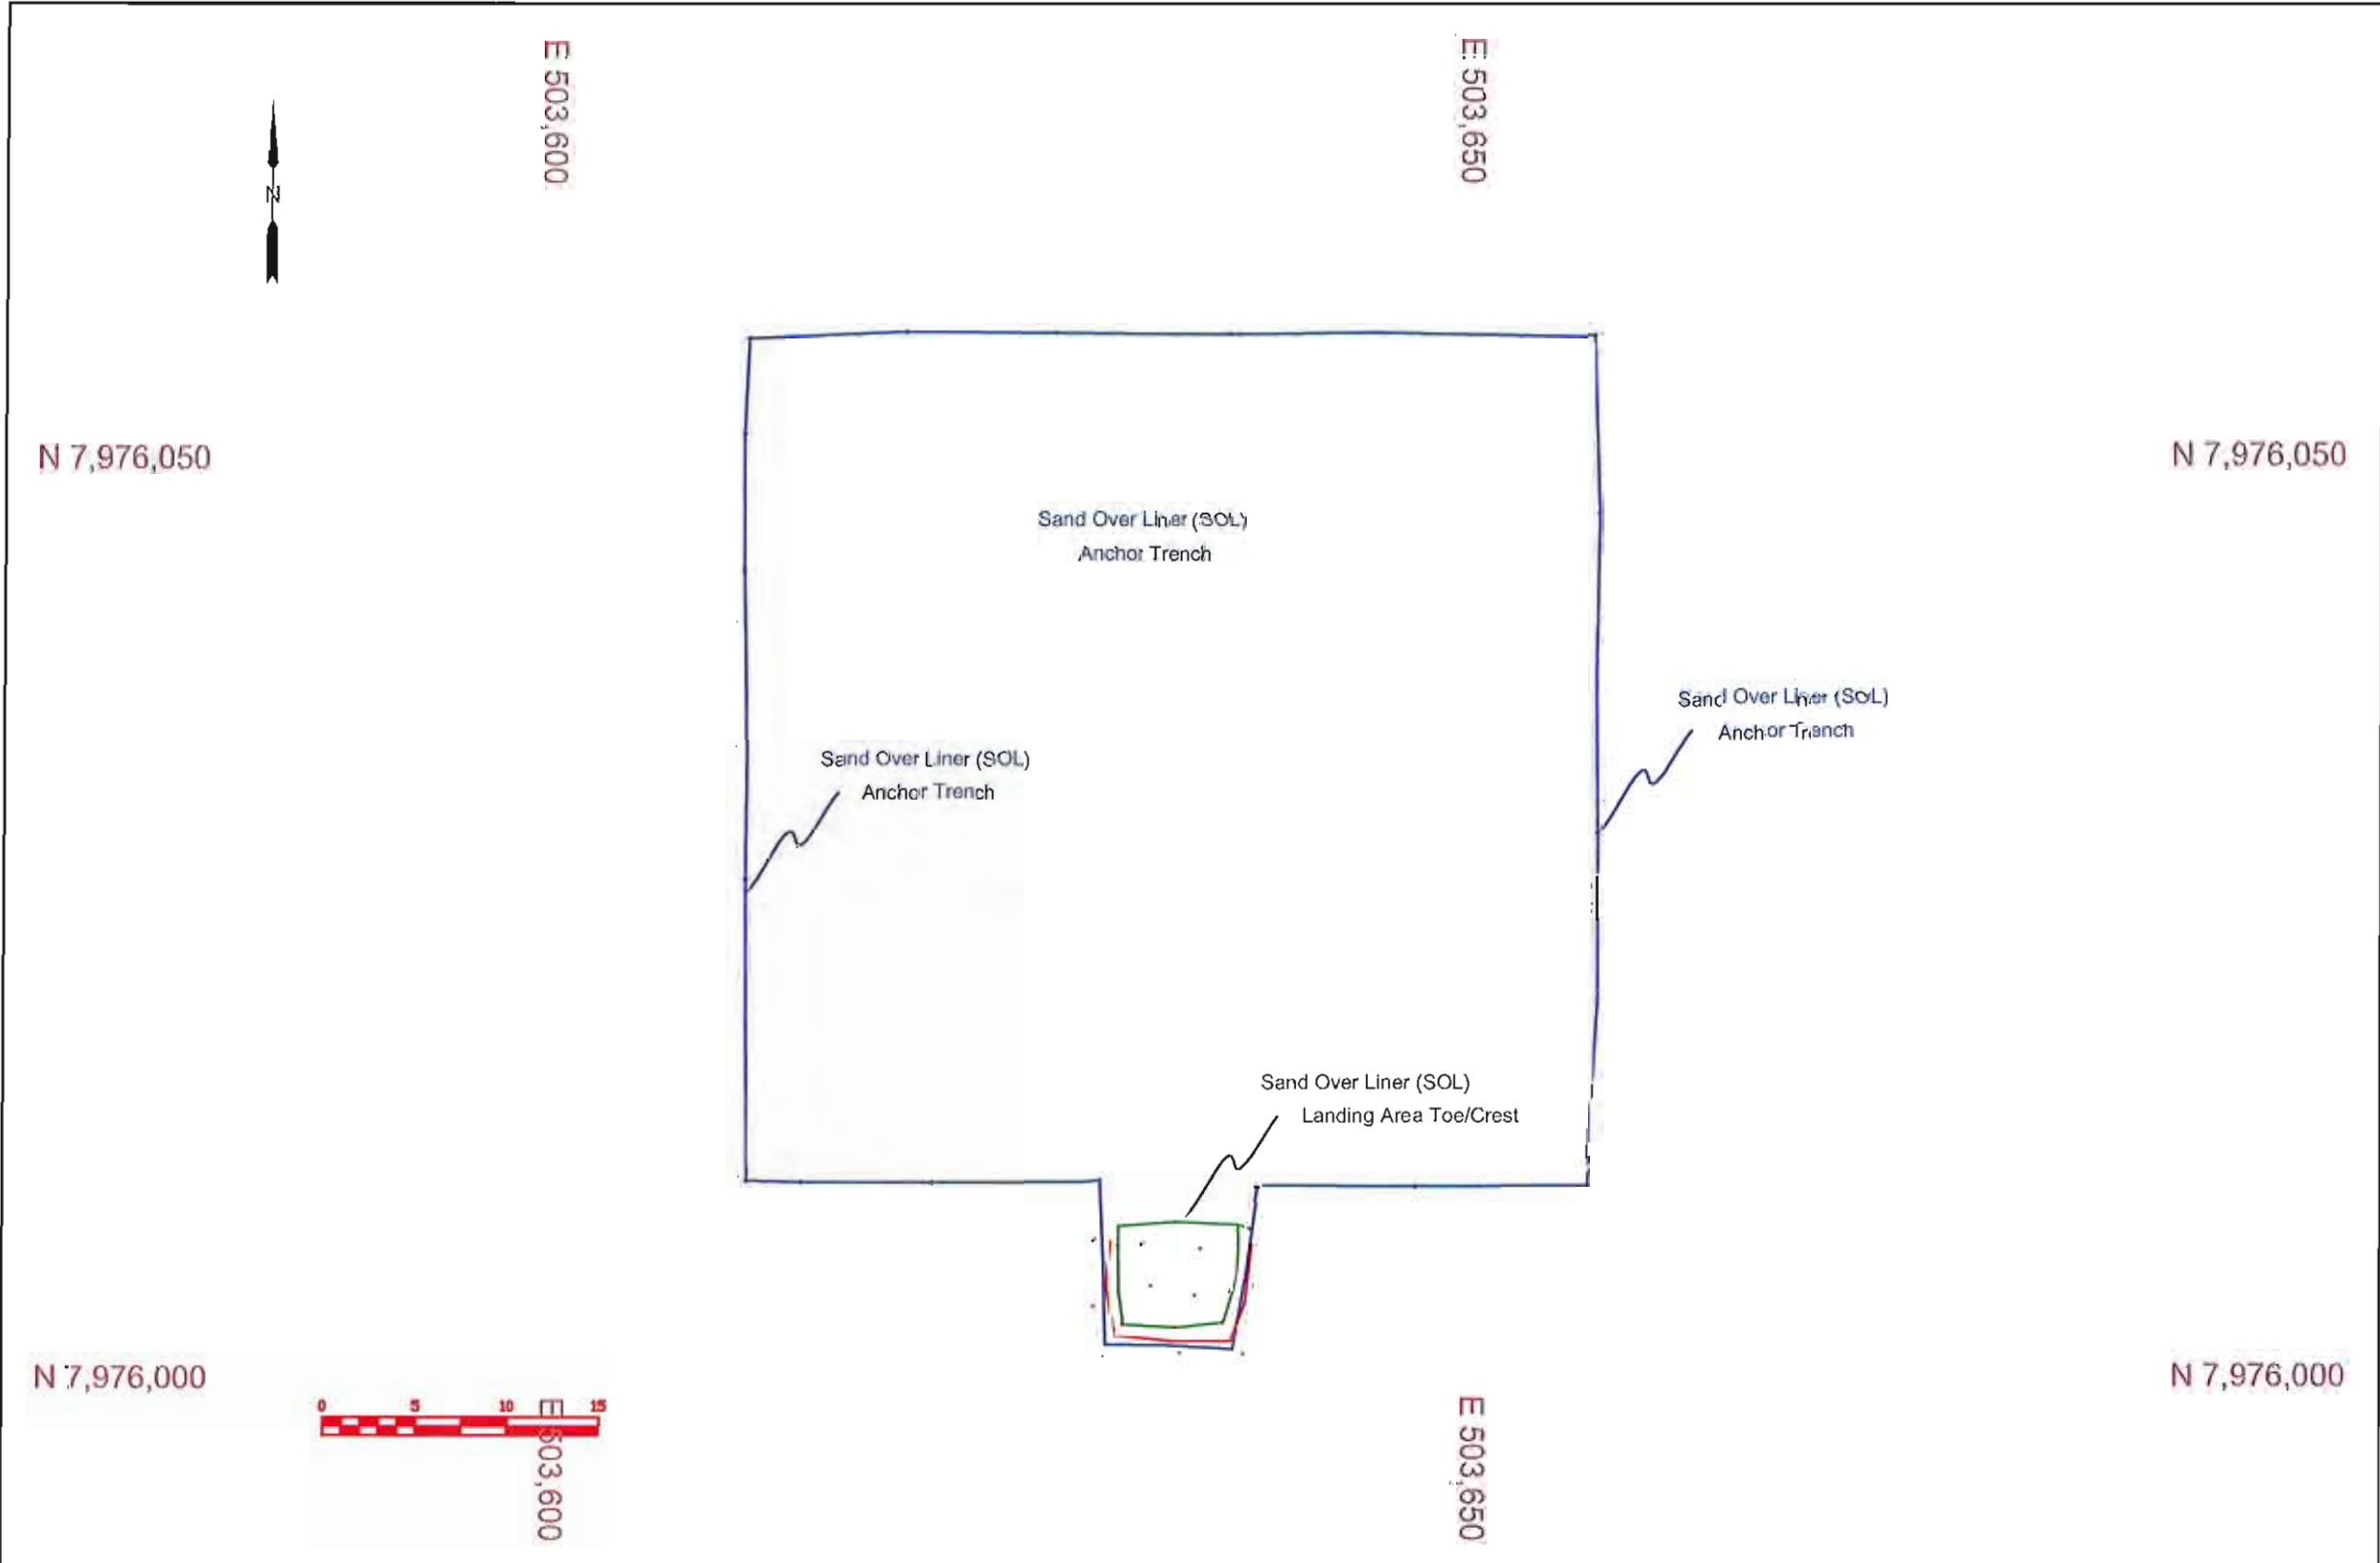
| NOTES: | CLIENT:<br>Baffinland Iron Mines Corporation | PREPARED BY:<br>Nuna East Ltd.<br>9839 - 31 Avenue<br>Edmonton, AB<br>T6N 1C5 | | <b>NUNA</b> | DRAWING TITLE:<br><b>Effluent Pond<br/>Sand Over Liner</b> |

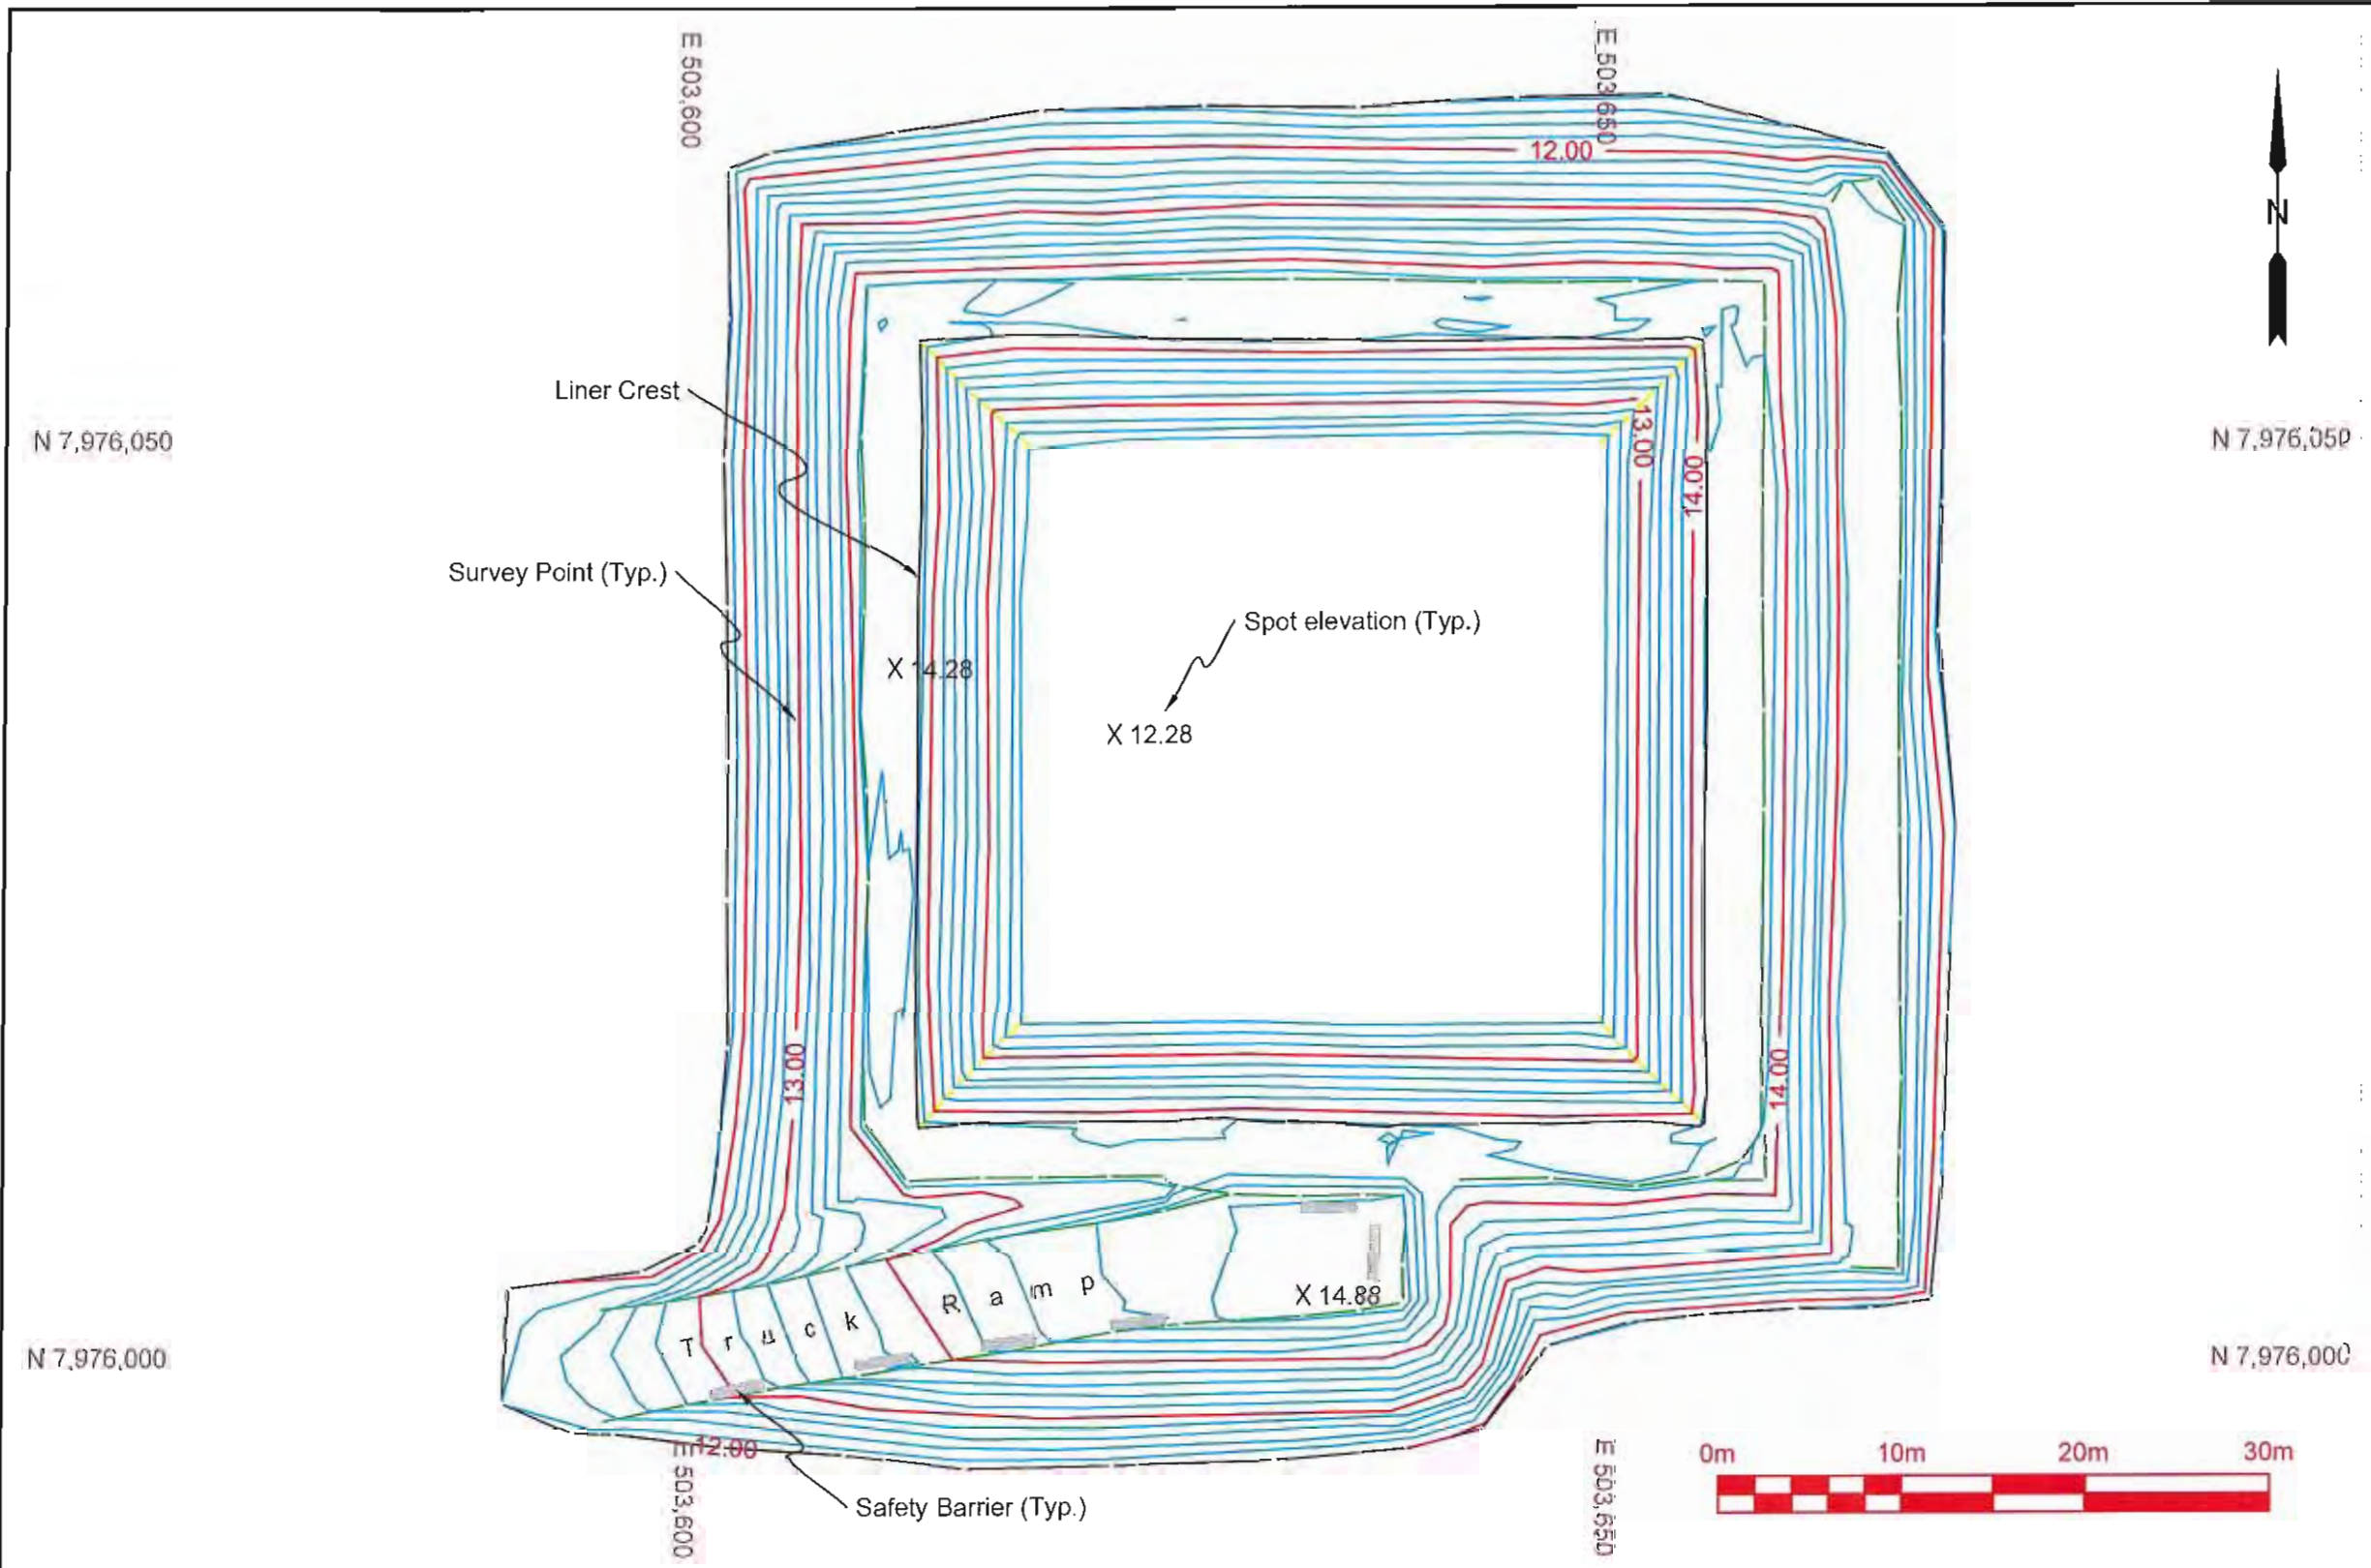
| NOTES: | CLIENT:<br>Baffinland Iron Mines Corporation | PREPARED BY:<br>Nuna East Ltd.<br>9839 - 31 Avenue<br>Edmonton, AB<br>T6N 1C5 | | DRAWING TITLE:<br><b>Final As-built of<br/>Effluent Pond</b> | |

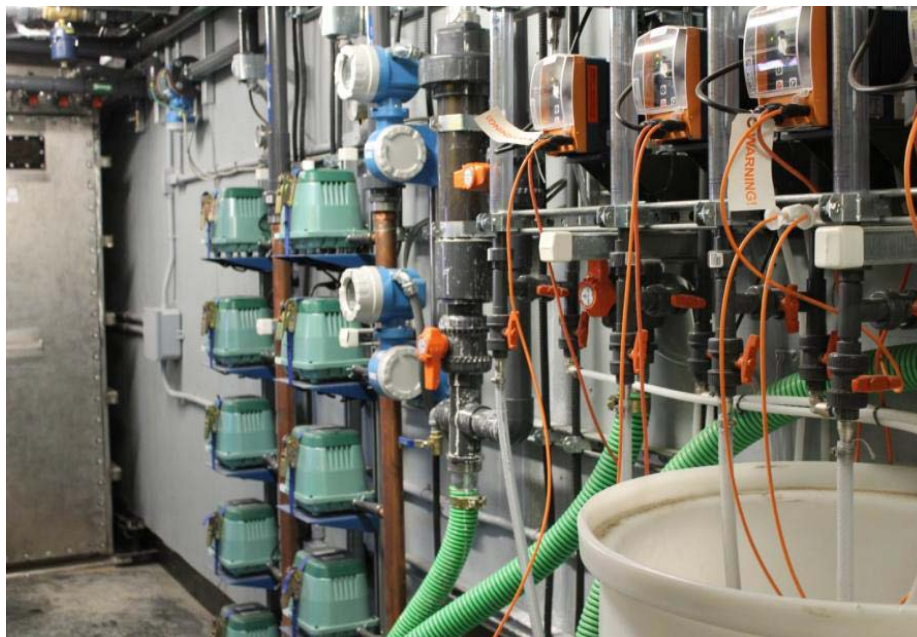
**PHOTO 10** Internal components of the Wastewater Treatment Facility utilizing MBR Technology

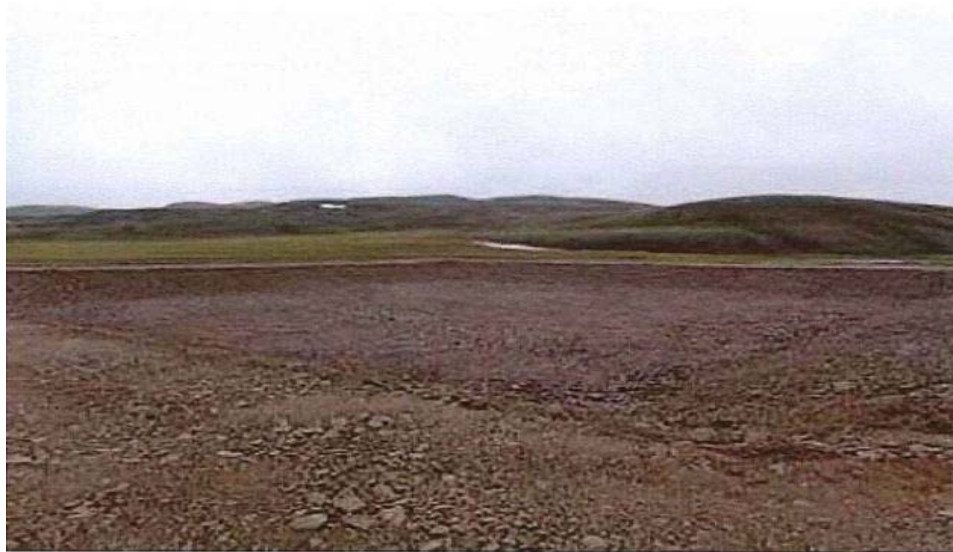
**PHOTO 7** Polishing Waste Stabilization Pond (PWSP) Pad before –sub grade prepared July 2013

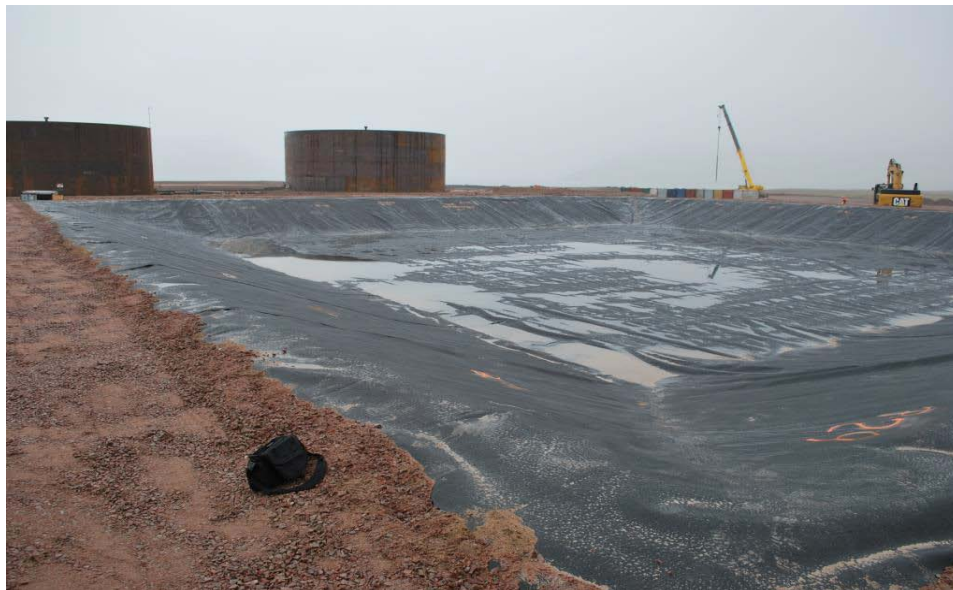
**PHOTO 8** Polishing Waste Stabilization Pond (PWSP) engineered containment structure arctic liner installation July 2013
