PHASE 2 OF THE HOPE BAY PROJECT
DRAFT ENVIRONMENTAL IMPACT STATEMENT

Doris North Gold Mine Project: 2010 Roberts Bay Jetty
Fisheries Authorization Monitoring Report

December 2010
Project #1009-002-19

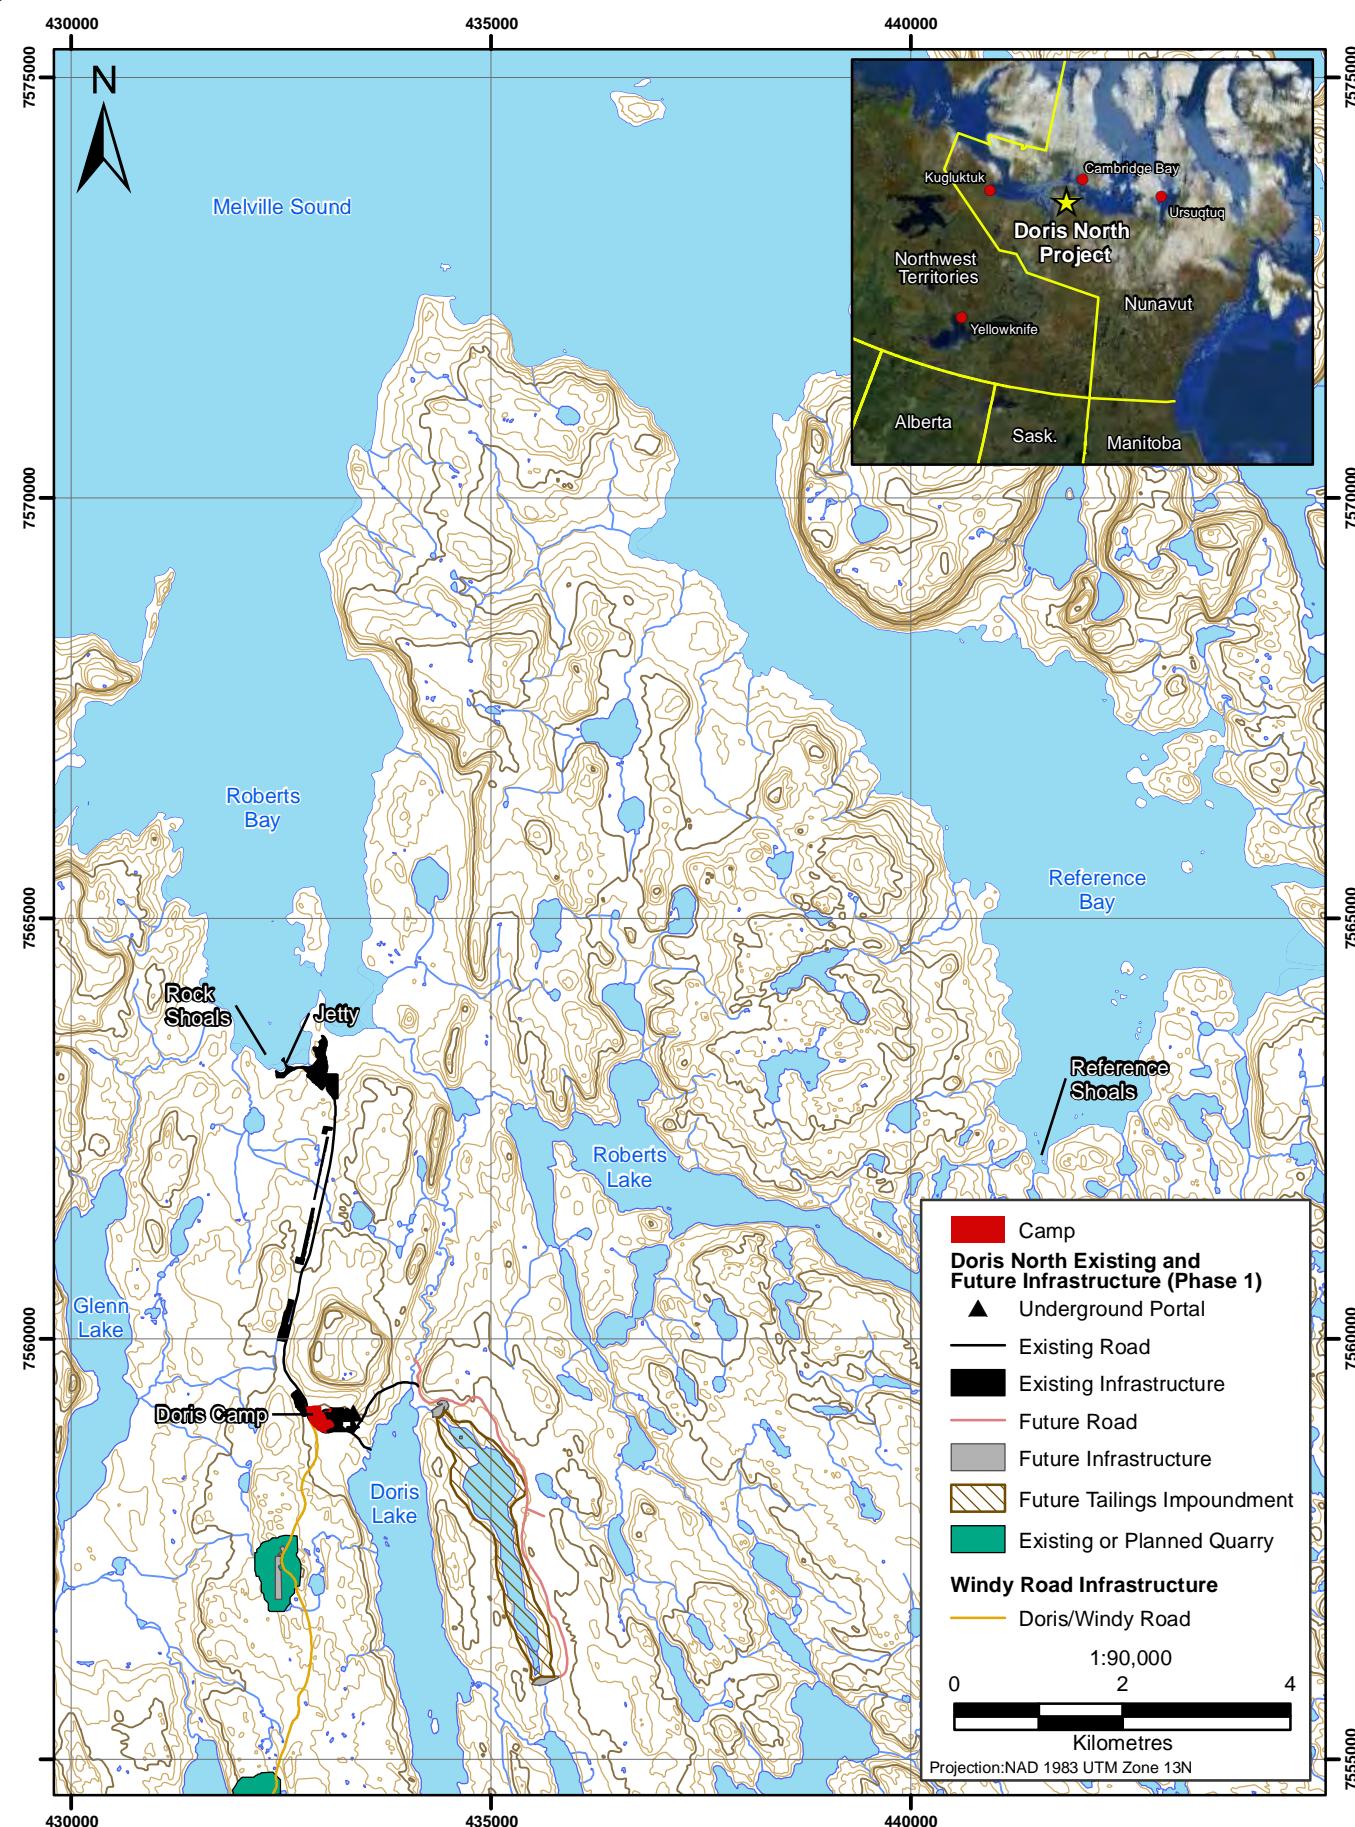
Figure 1.1-1

The Doris North Project is located approximately 125 km southwest of Cambridge Bay, Nunavut, on the south shore of Melville Sound (Figure 1.1-1). As part of the Doris North Mine infrastructure, a rock jetty was constructed at the south end of Roberts Bay for barge loading and off-loading.

classified as the impacted study area (Plate 2.2-1). Meanwhile, a control study site was established in Reference Bay in 2009, based on two conditions; (1) the site was a good representation of the habitat of the jetty and constructed shoals (i.e., similar substrate and depth), and (2) it would not be impacted by future mining activities (Figure 1.1-1; Plate 2.2-2).

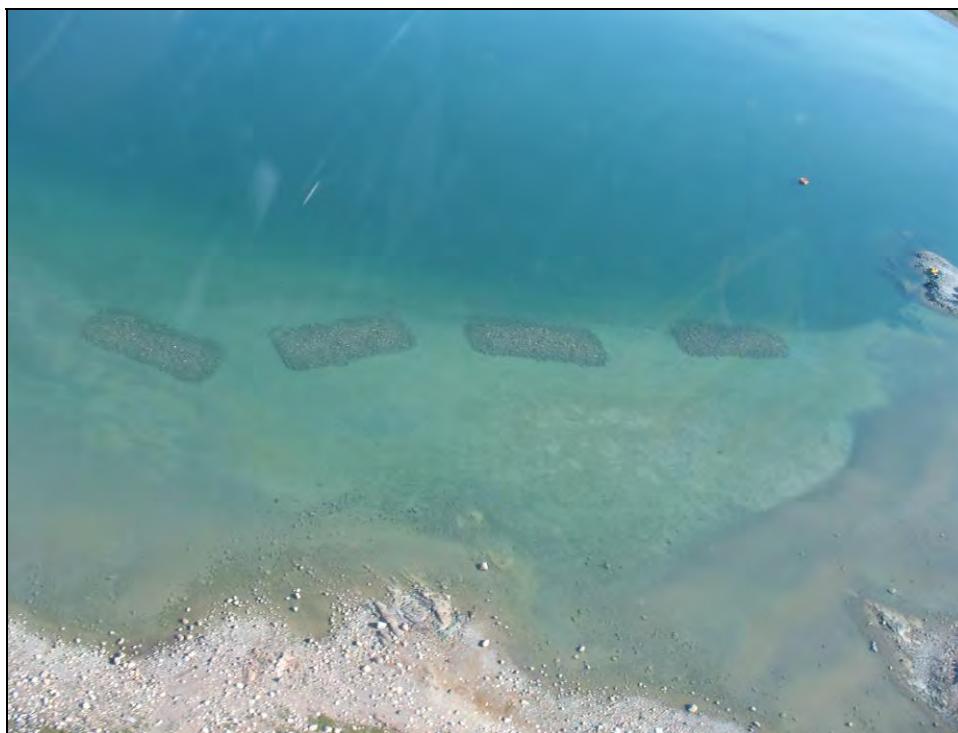
Shoals constructed for fish habitat compensation west of the Doris Jetty were monitored using a Control/Impact design. The constructed shoals and rip-rap along the sideslope of the jetty are

Plate 2.2-1. Aerial view of constructed shoals in Roberts Bay, Doris North Project (2009).

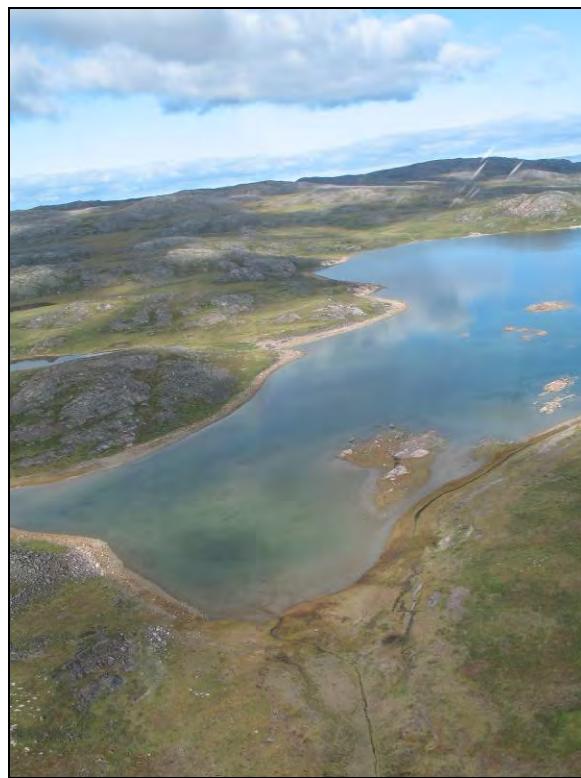
Plate 2.2-2. Aerial view of reference shoals in Reference Bay, Doris North Project (2009).

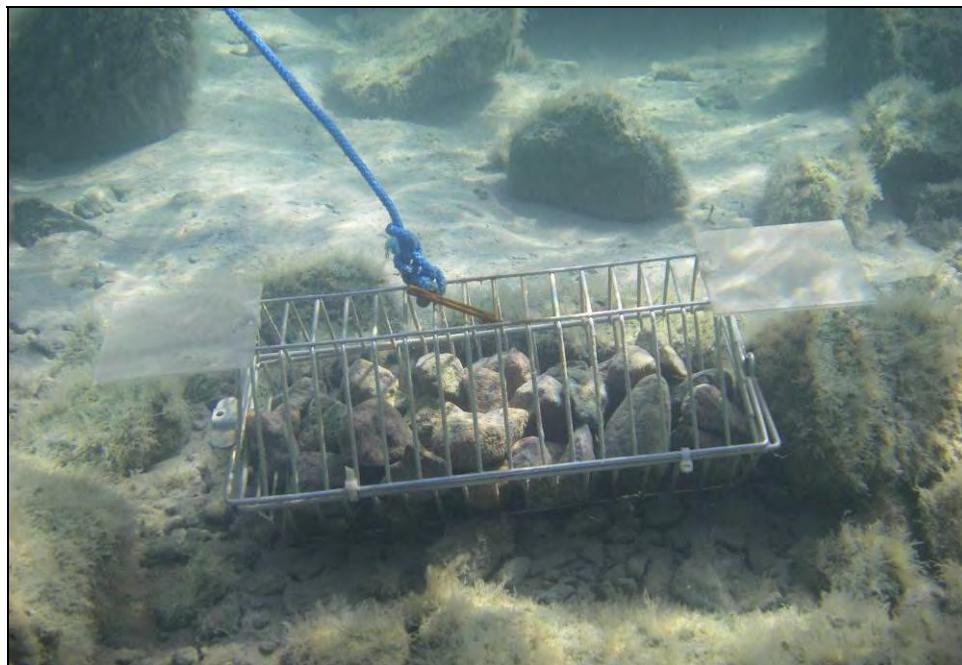
Periphyton samples were obtained using submerged 10 cm x 10 cm Plexiglas plates affixed to an artificial substrate sampler (Plate 2.2-3). Two Plexiglas plates were affixed to each artificial sampler and five replicate samplers were submerged at each of the four compensation shoals and reference shoals (Figures 2.2-1 and 2.2-2). Samplers were immersed for 46 to 51 days. They were deployed between July 11 and 12, 2010, and retrieved between August 26 and 30, 2010.

Plate 2.2-3. Artificial substrate sampler with attached periphyton Plexiglas plates submerged on a shoal in the Reference Bay, Doris North Project (2009).

Benthic macroinvertebrate communities ("benthos") were sampled concurrently with periphyton, using artificial substrate samplers (Plate 2.2-3). The samplers consisted of a cylindrical cage which was 30 cm long and 17 cm in diameter that was approximately 50% filled with rocks of similar size (large gravel and small cobble); therefore, differences in substrate surface size are assumed to be minimal. Rocks used were collected from the shoreline (above the high-tide mark) of the area in which they were deployed. The samplers were placed on the shoals (5 replicates per shoal) in Roberts Bay and at the Reference Bay (Figures 2.2-1 and 2.2-2). Samplers were immersed for 46 to 51 days. They were deployed between July 11 and 12, 2010, and retrieved between August 26 and 30, 2010.

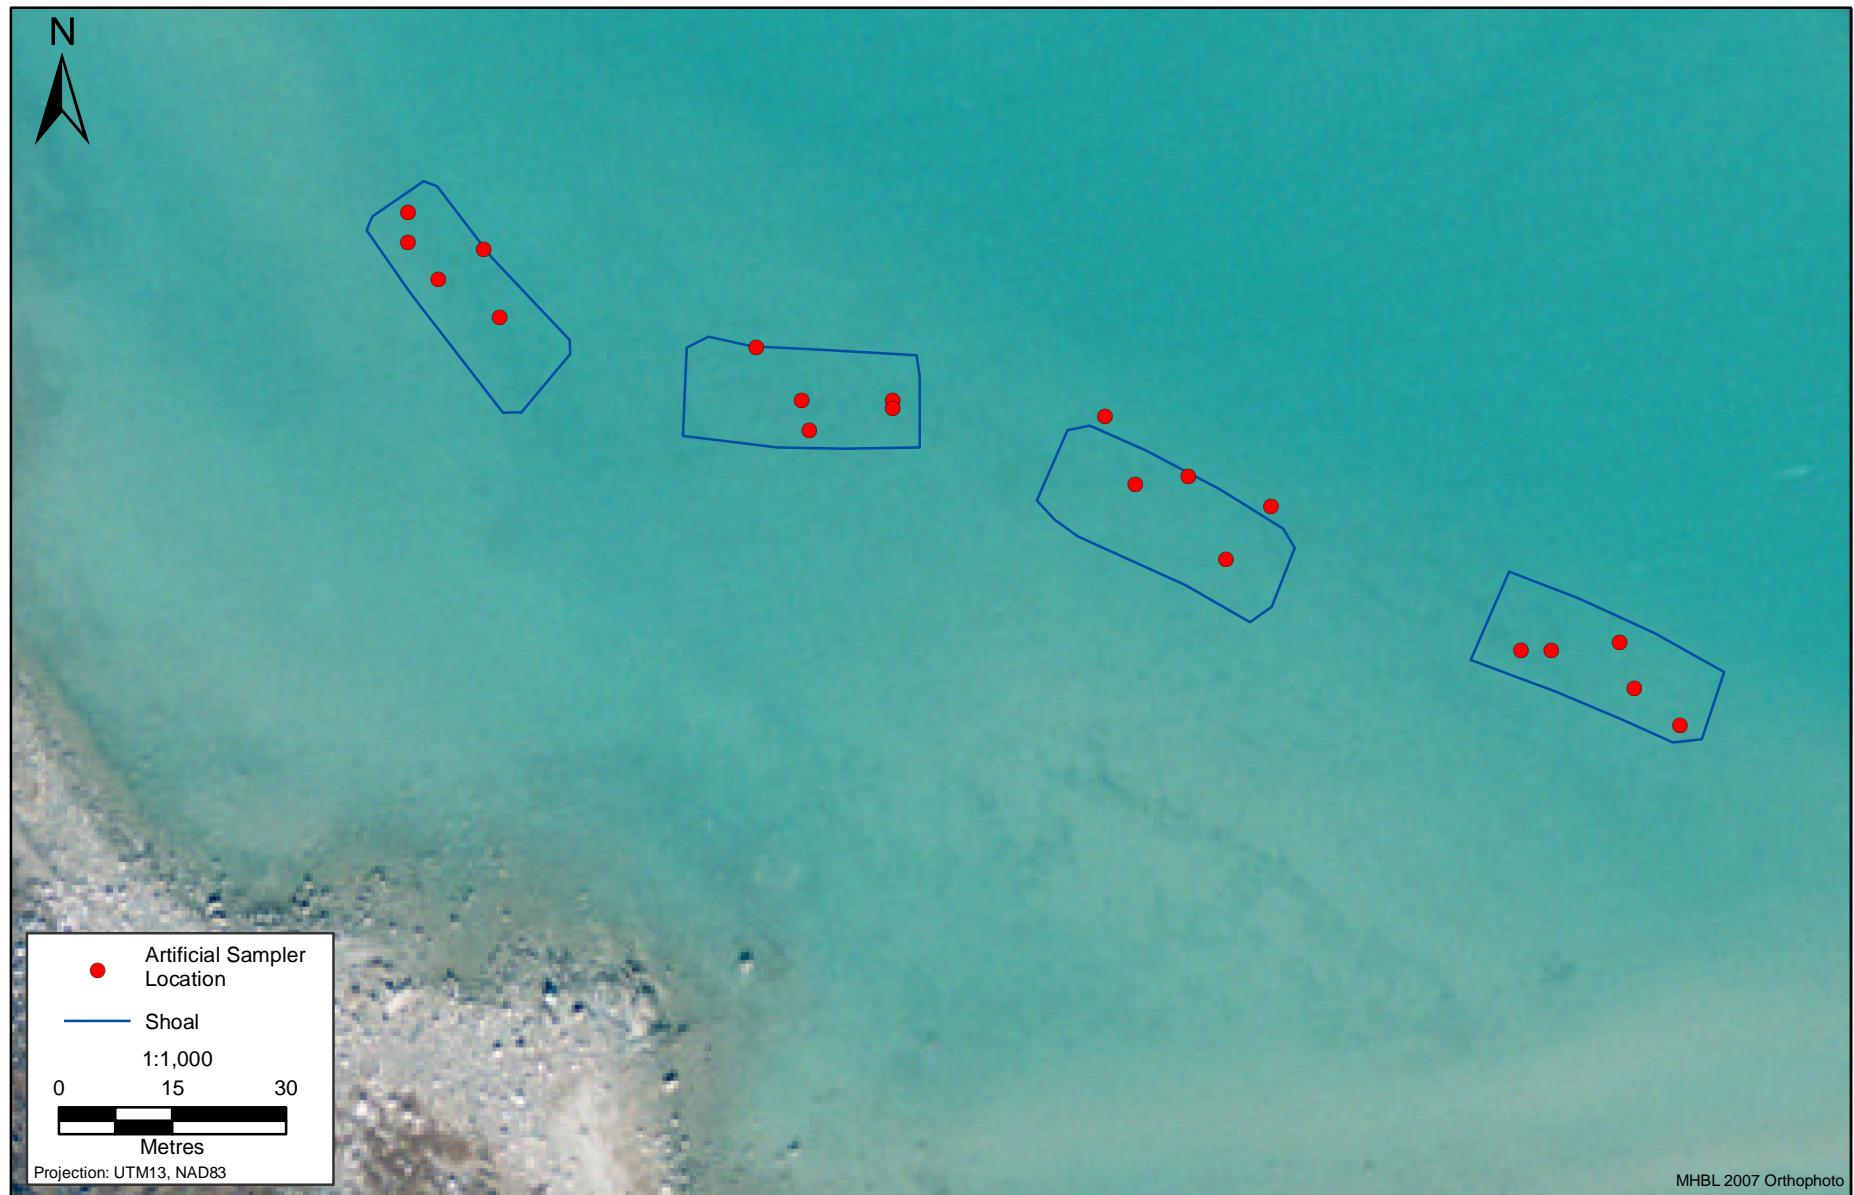
Figure 2.2-1

Periphyton and Benthic Invertebrate Sampling Sites
in Roberts Bay, Doris North Project, 2010
