MADRID-BOSTON PROJECT
FINAL ENVIRONMENTAL IMPACT STATEMENT

Hope Bay Project Water and Ore/Waste Rock
Management Plan for Boston Site

Water and Ore/Waste Rock Management Plan for the Boston Site, Hope Bay Project, Nunavut

SRK Consulting (Canada) Inc.
1CT022.009
January 2017

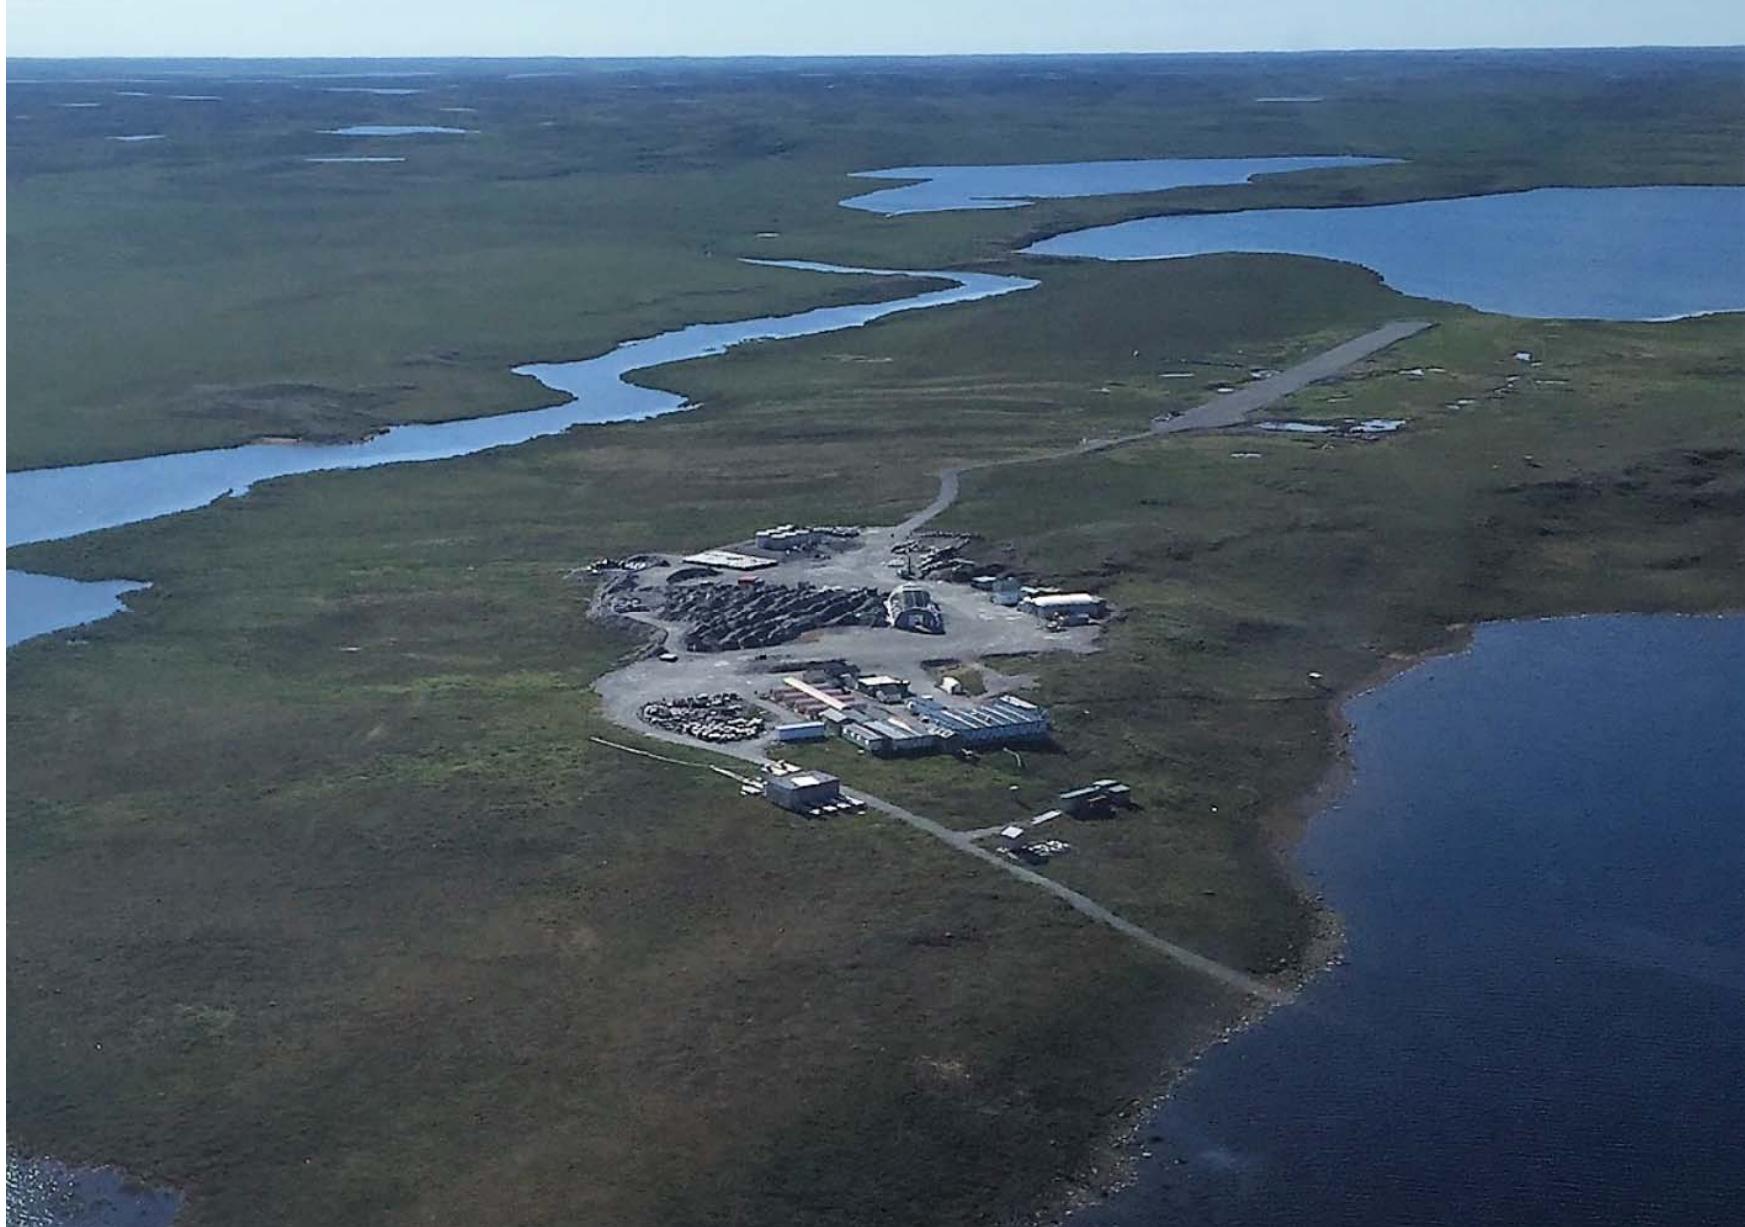
Date: January 2017 Approved: EMR Figure: **2.1**

**Aerial Photograph of
Boston Camp, July 2016**

Aerial photos taken in July 2016 (Figure 2.1) and (Figure 2.2) as well as maps showing the original configuration of the ore stockpiles (Figure 2.3), illustrate the change in stockpiles configuration compared to previous years. A detailed inventory of the ore stockpile area in 2008 indicated the absent stockpiles were mostly ore material from the 1997 campaign (SRK 2009b - Supporting Document A). Volumetric calculations indicate that almost half of ore may have been redistributed to other locations on the site. A substantial portion of this material was used in the construction of the tank farm berm and the remainder has been used as surfacing material.

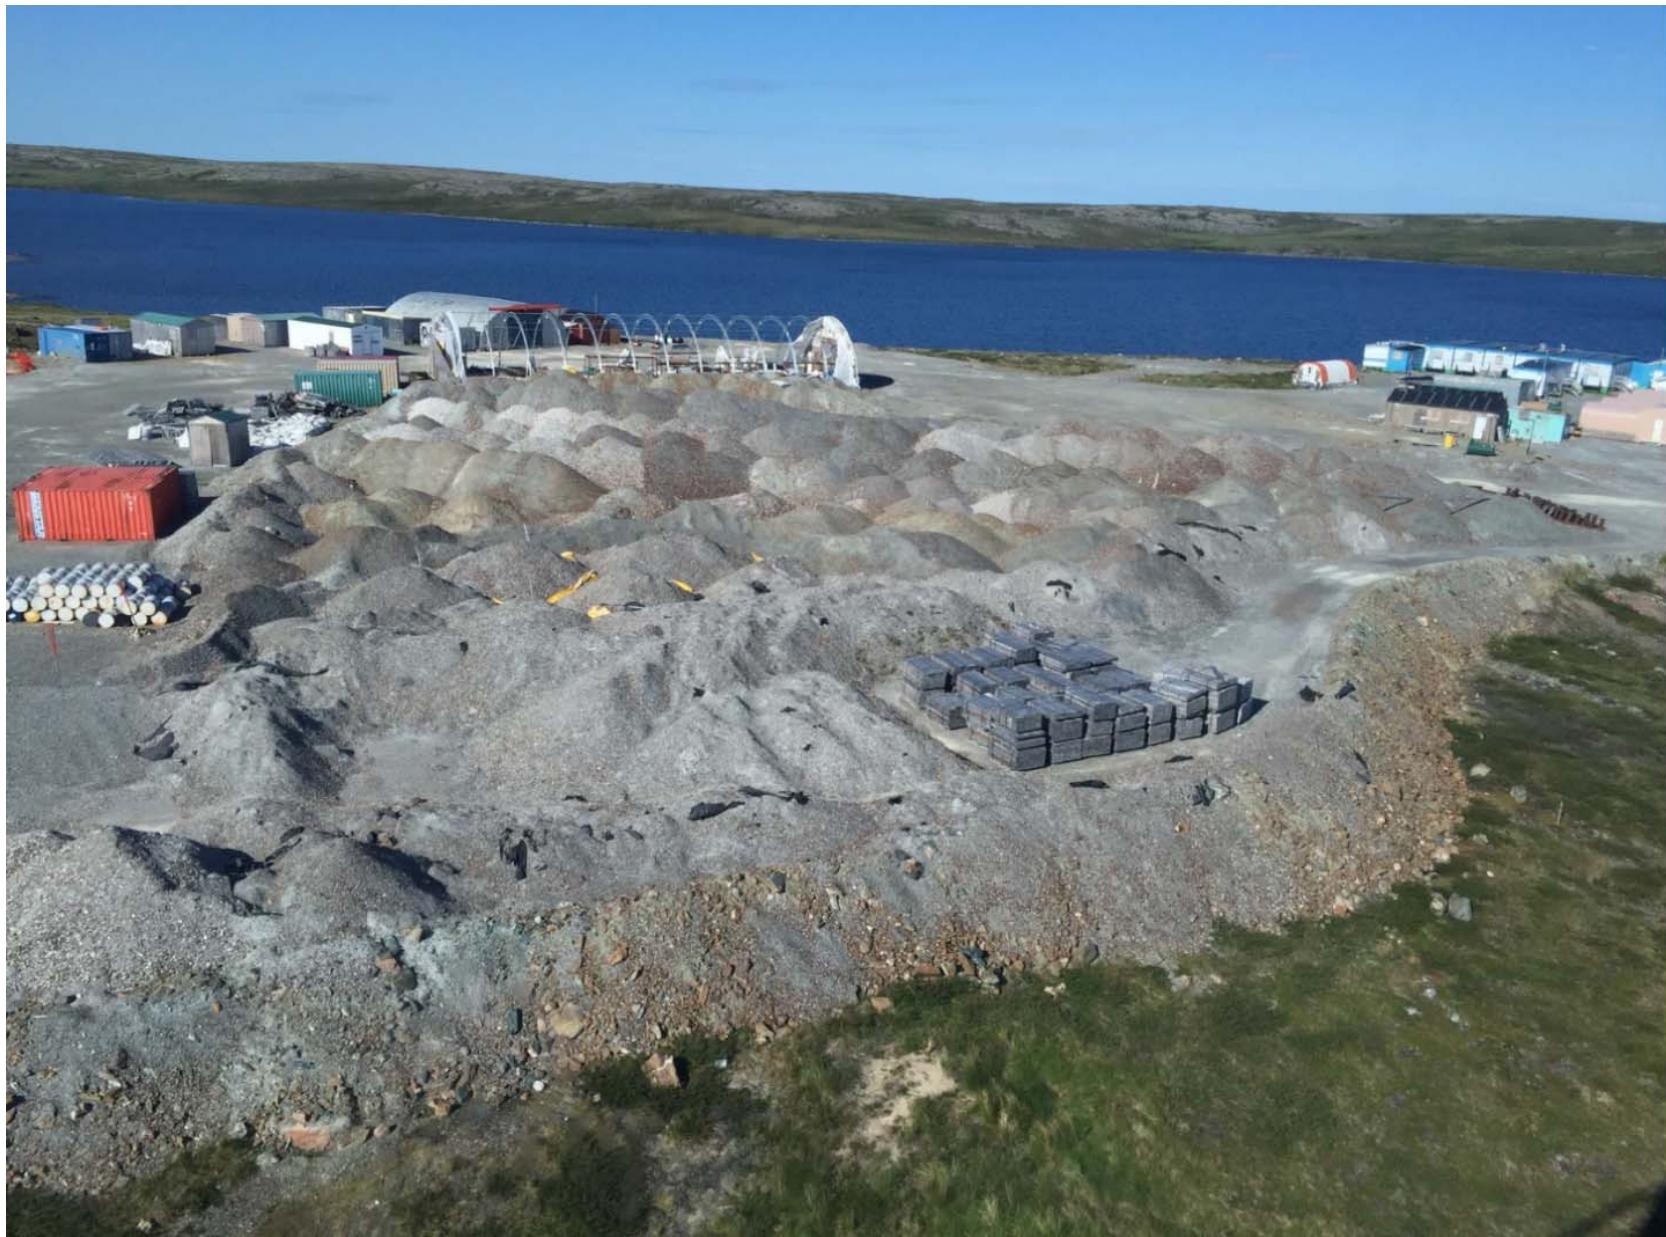
Date: January 2017 | Approved: EMR | Figure: **2.2**

**Aerial Photograph of
Boston Camp ore Piles, July 2016**

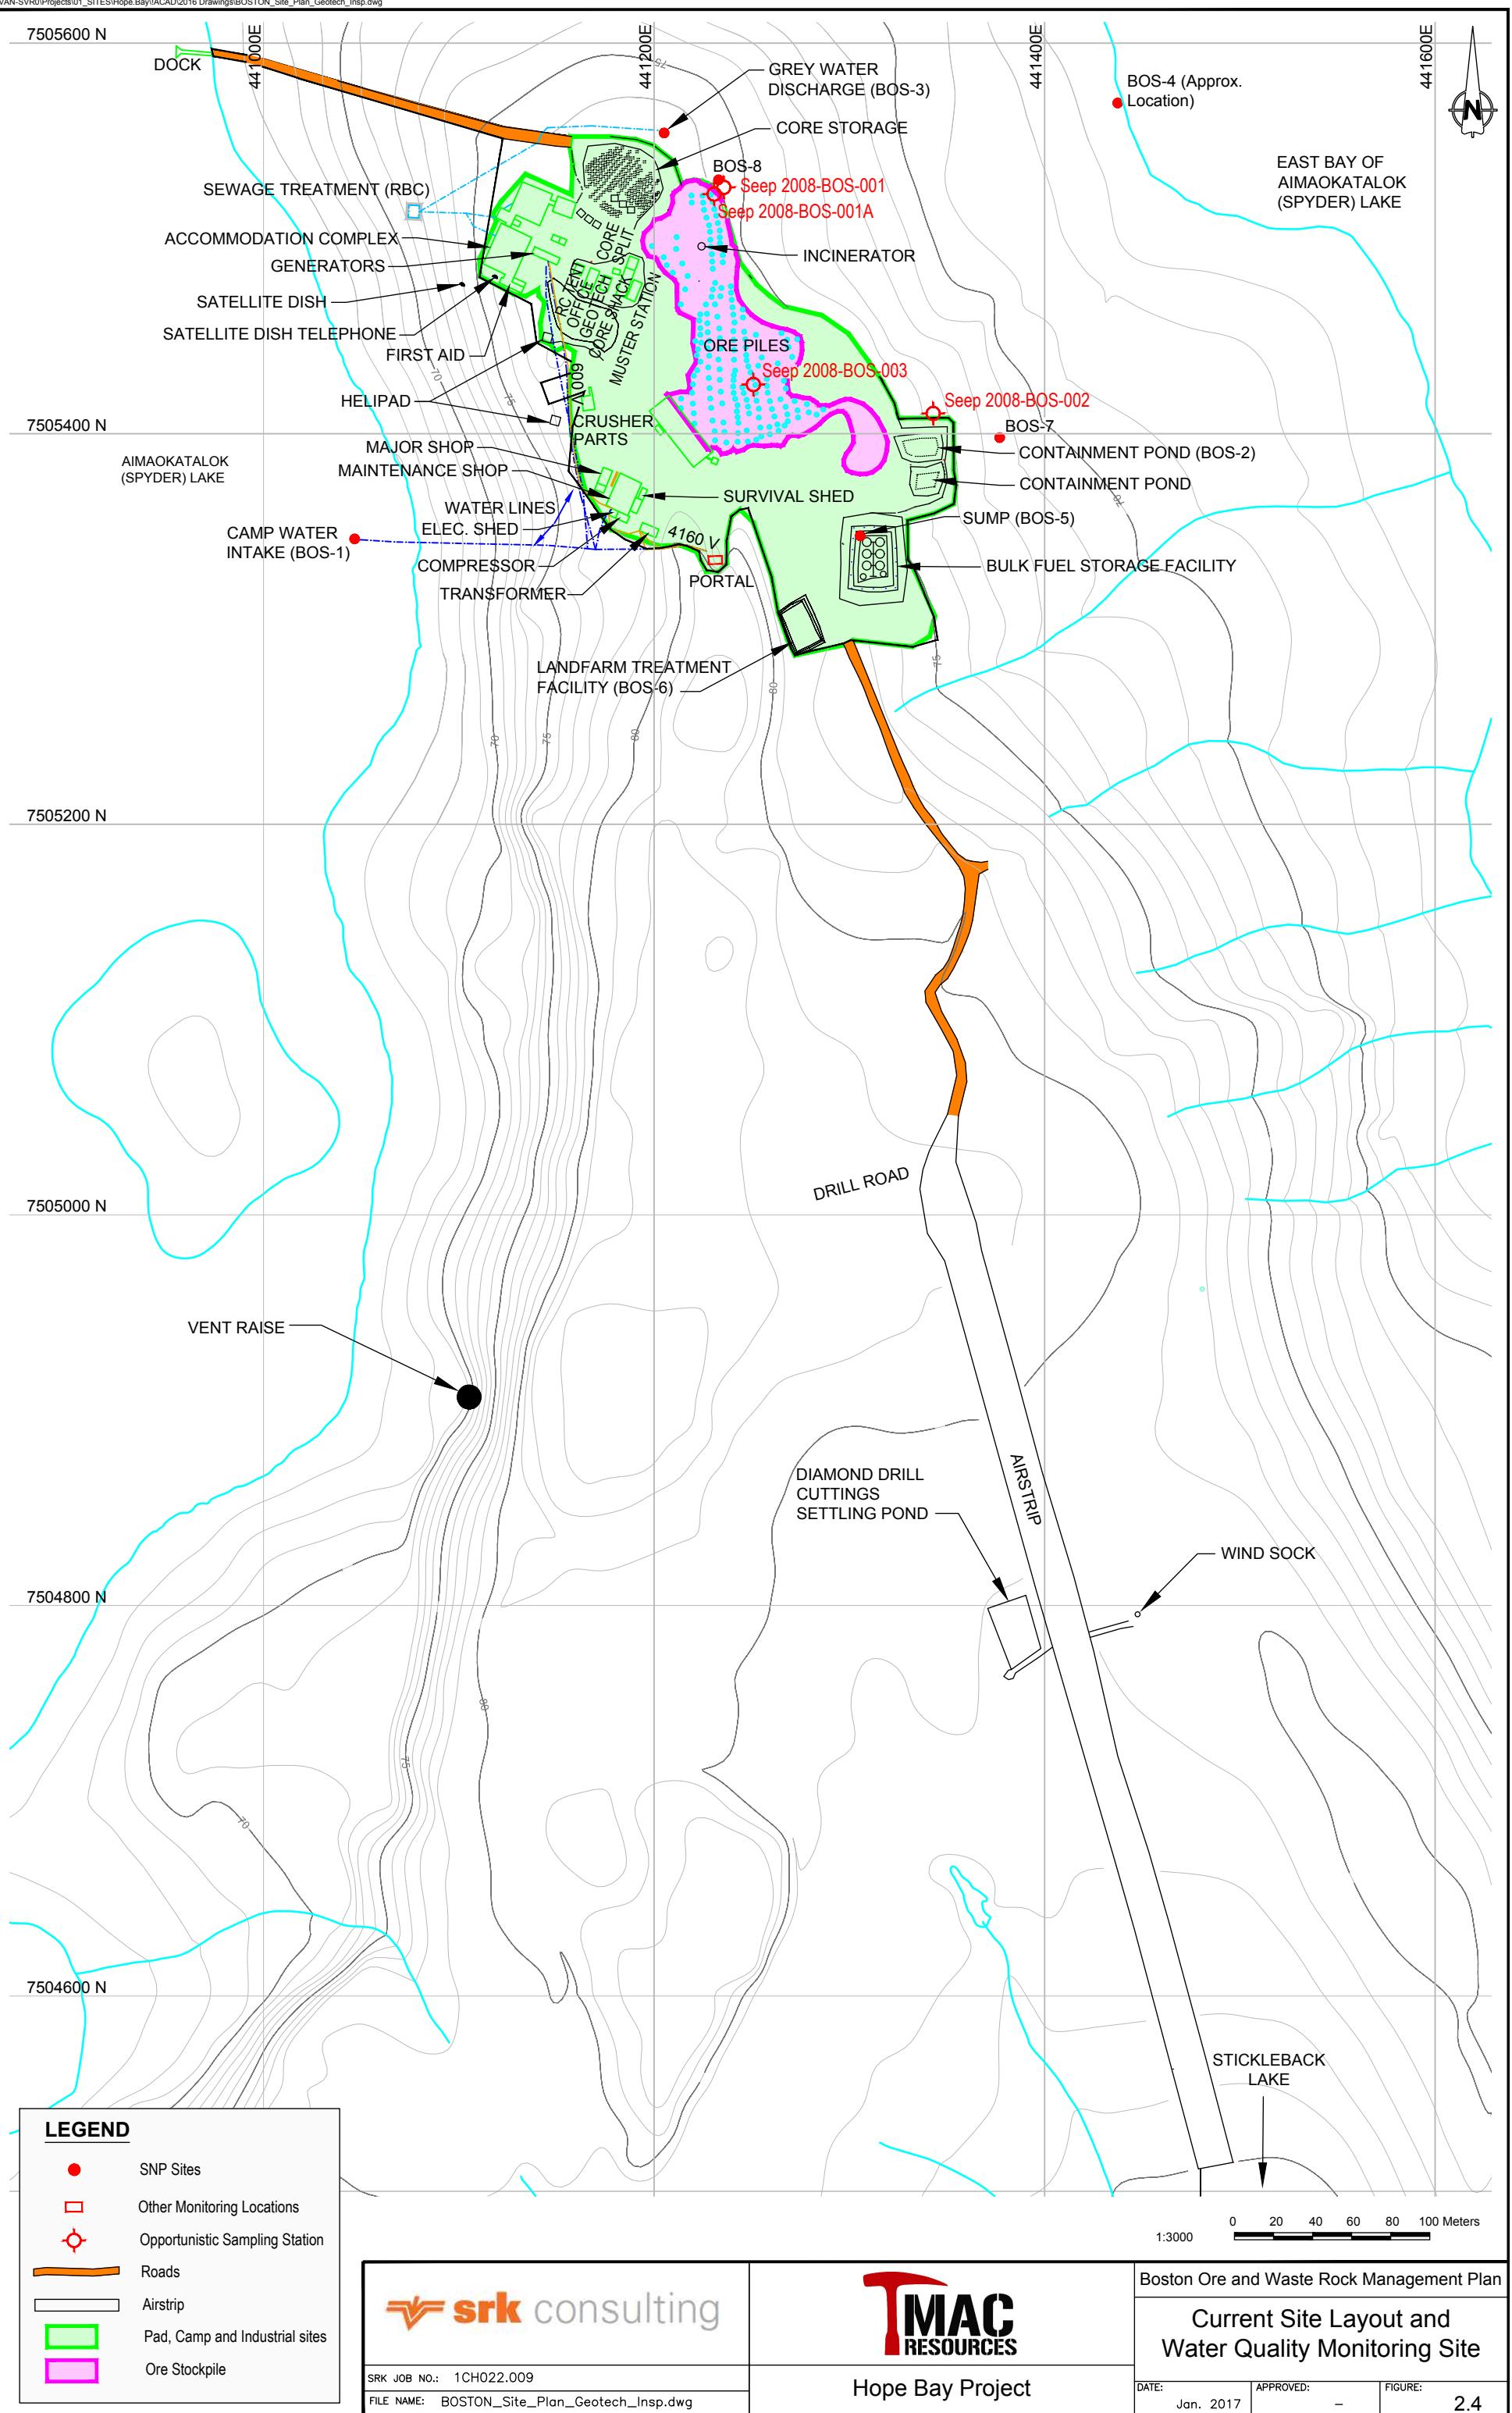
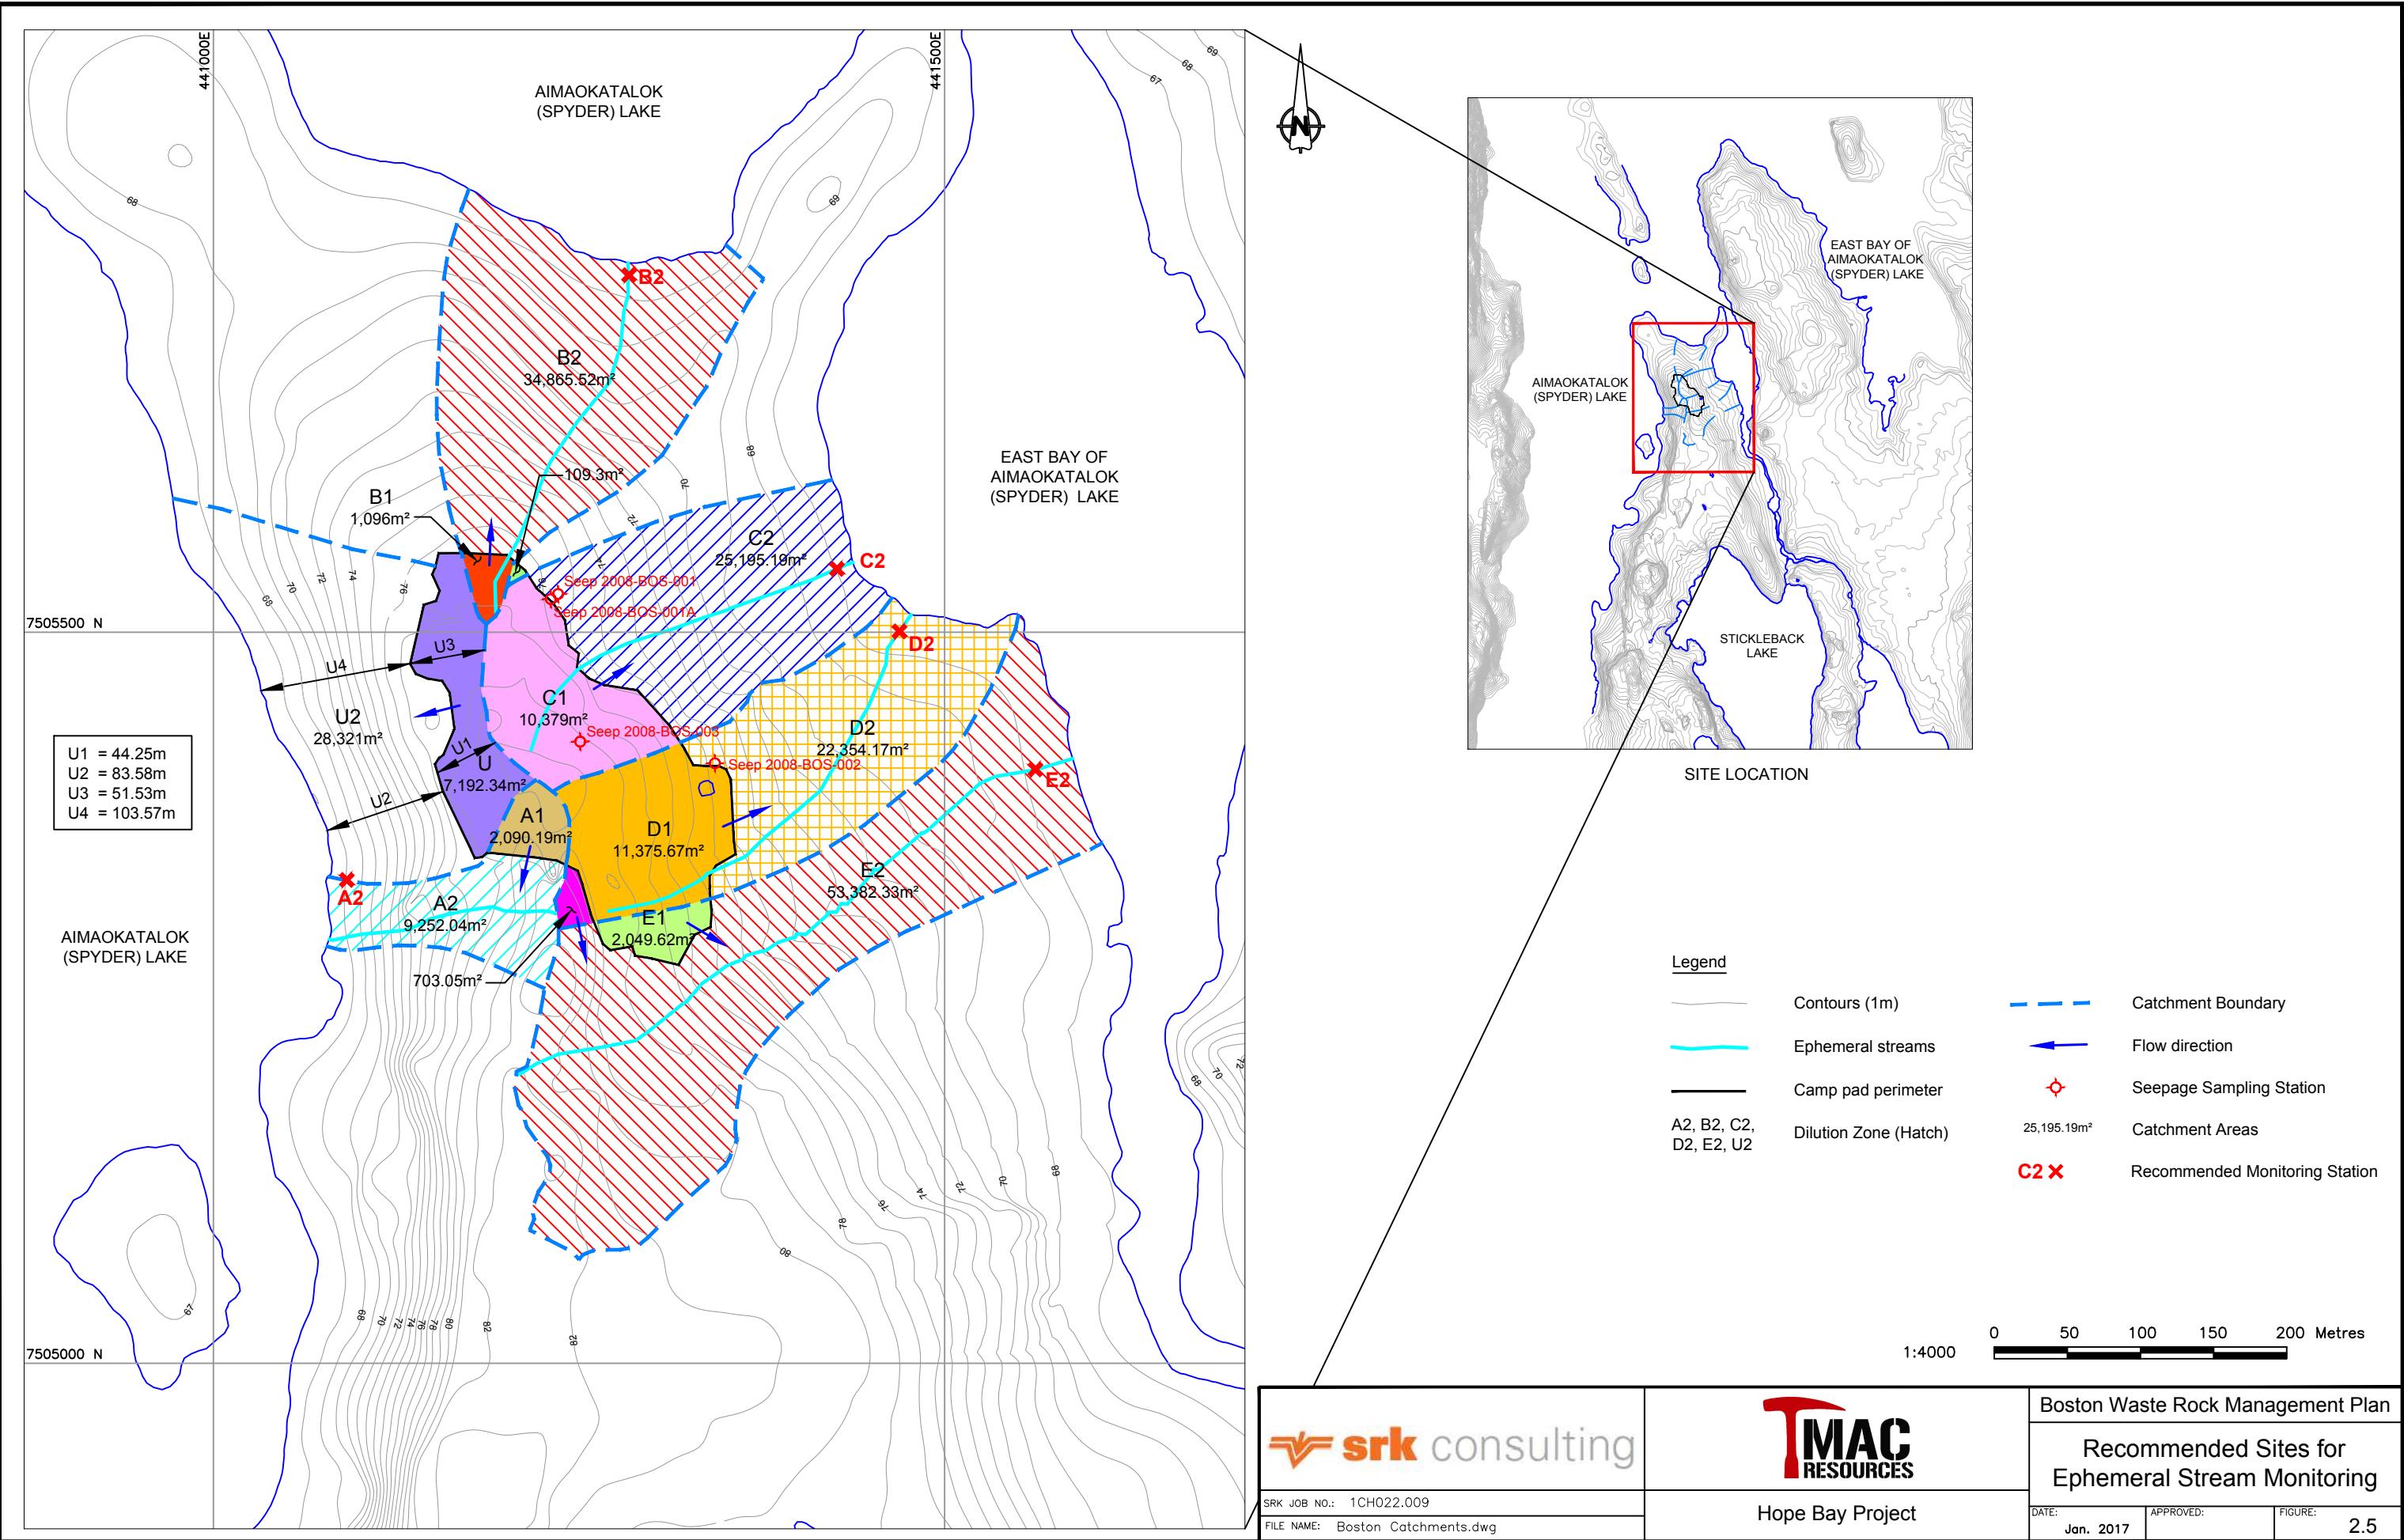
The current site configuration is shown in Figure 2.4. The relative areas of each of the site components are shown in Table 2.2.

The site is situated on a ridge which comprises a peninsula extending northwards into Aimaokatalok (Spyder) Lake, as illustrated on Figure 2.4. The main camp pad spans about 325 m from north to south, and 150 m east to west and was constructed using waste rock from the underground development. The camp pad ranges in thickness from 0.6 m to 3.0 m and slopes generally north at a gradient of about 1%. The majority of the facilities, including the camp and office facilities, industrial site and laydown areas, and ore stockpiles are located on the camp pad. Roads provide access from the camp to an airstrip located south of camp, and from the camp to a boat ramp located northwest of the site. The roads and airstrip were also constructed using waste rock.

Seepage monitoring provides data for the source concentrations from the waste rock and ore. According to Water Licence 2BB-BOS1217, sampling of water quality station BOS-8, and any opportunistic seeps, is required initially during spring thaw and at a minimum frequency of monthly whenever flow is observed (NWB 2012). BOS-7 will also be sampled at the same frequency because this station also monitors seepage from the ore stockpiles and camp pad (Section 2.6). The seep survey will include the north and east sides of the camp pad, and the southern end of the airstrip. Locations of the current SNP seepage monitoring stations and other seeps that have been detected in previous surveys are shown in Figure 2.4.

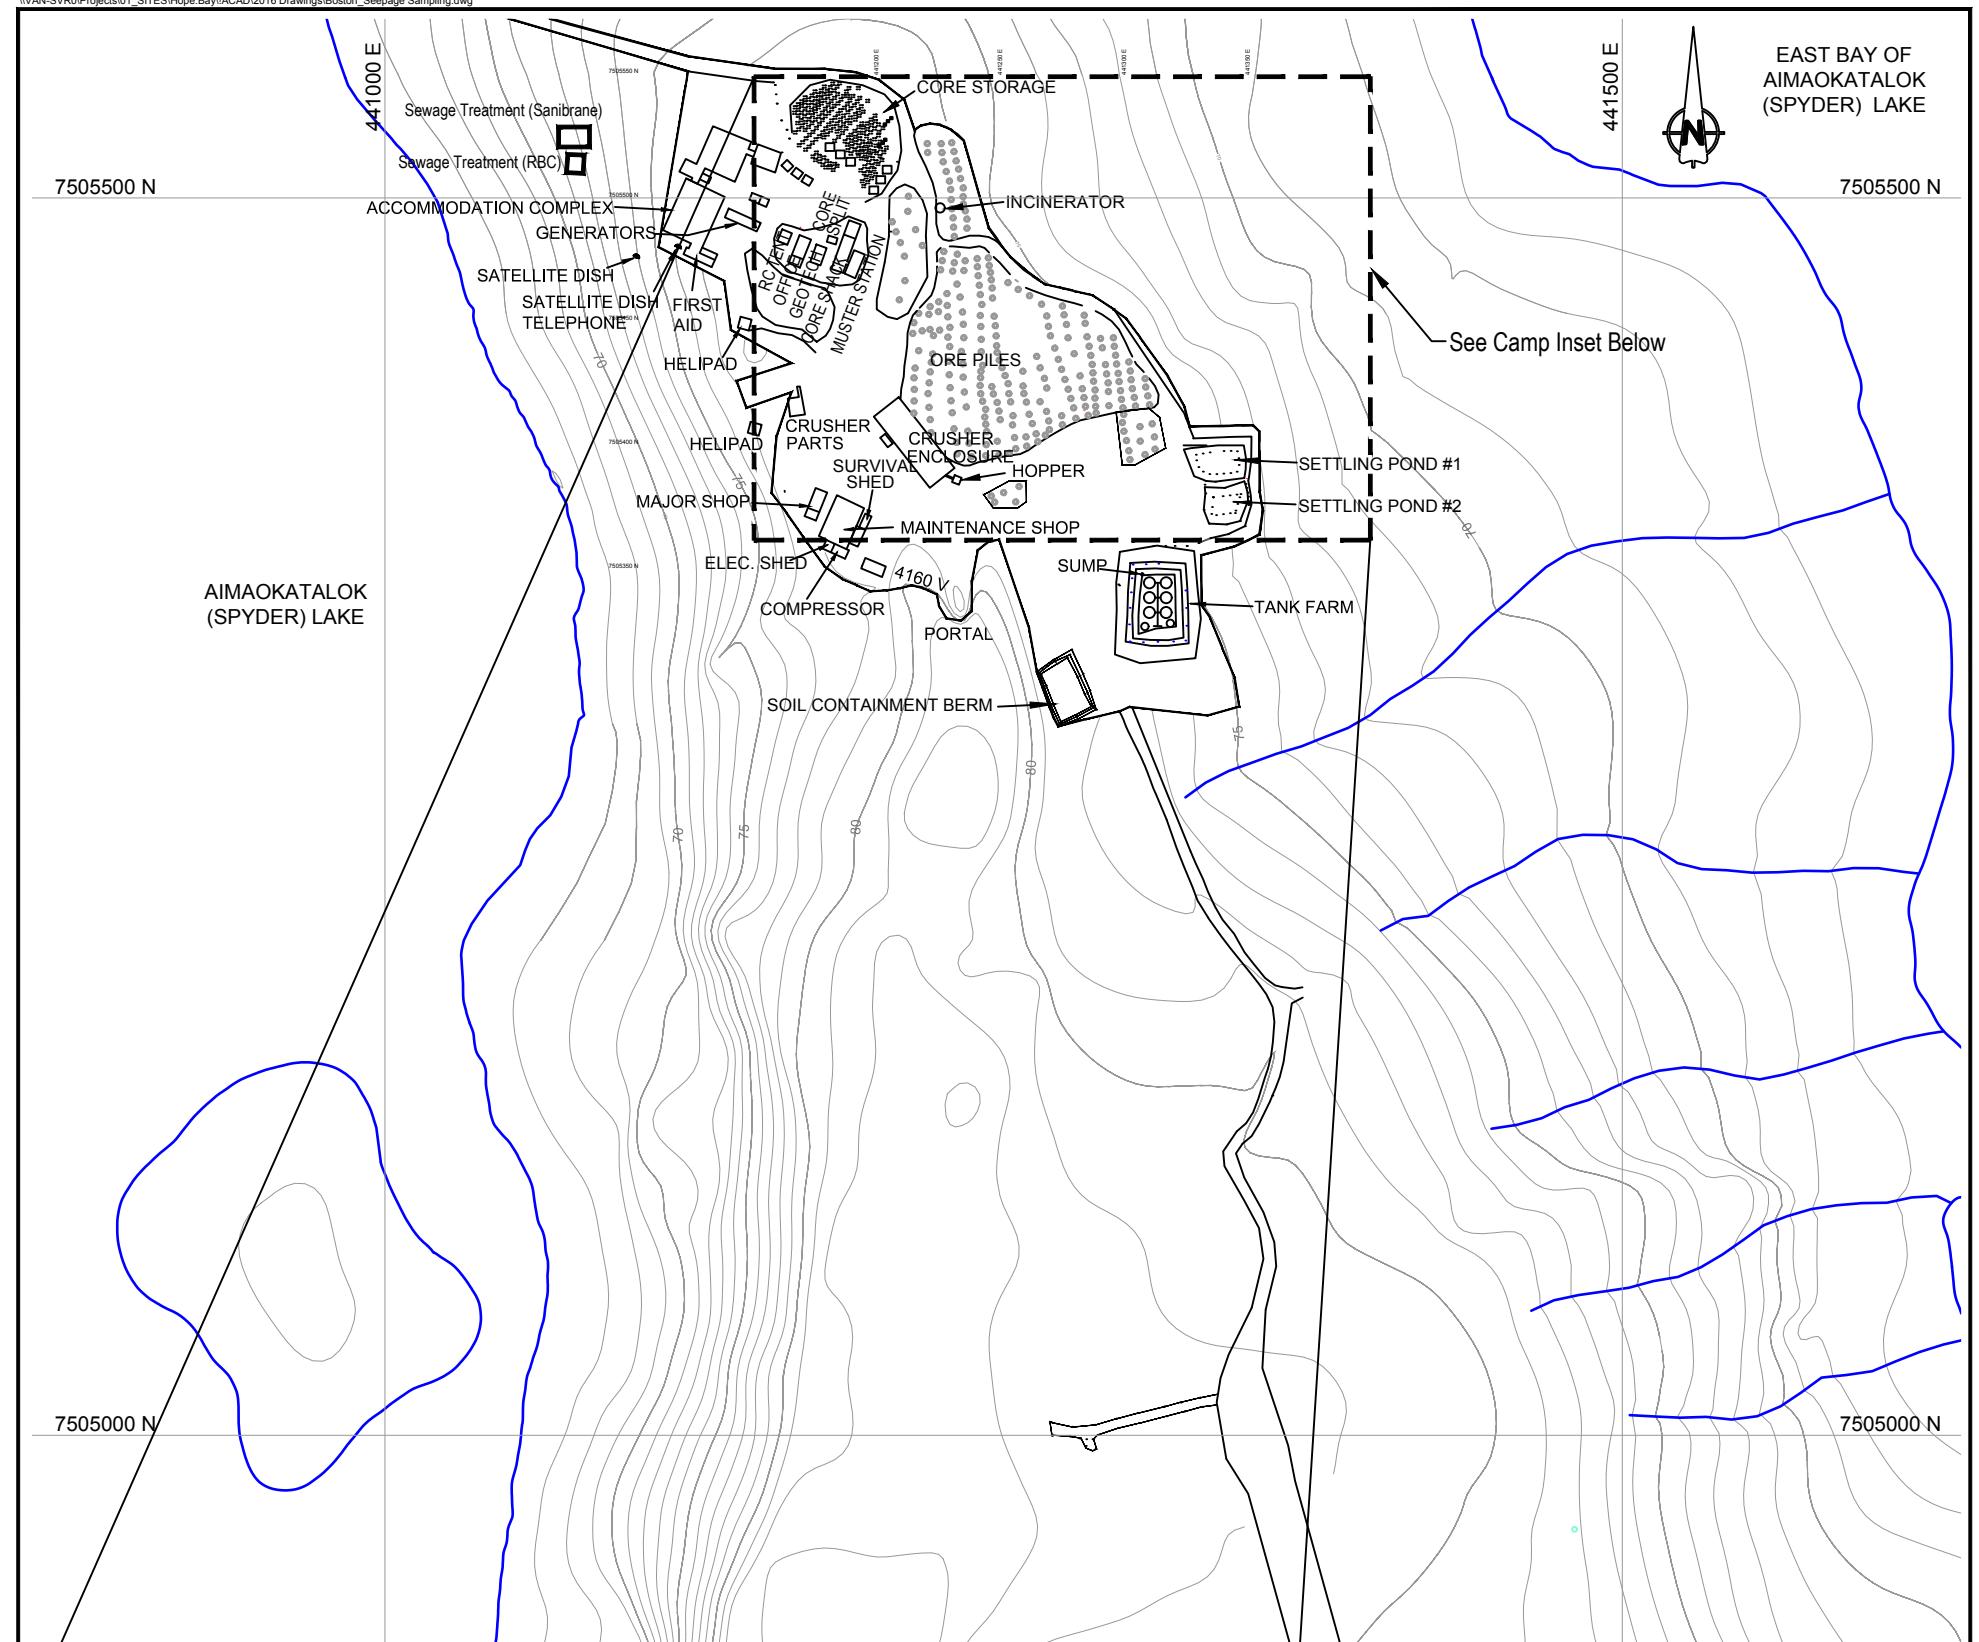
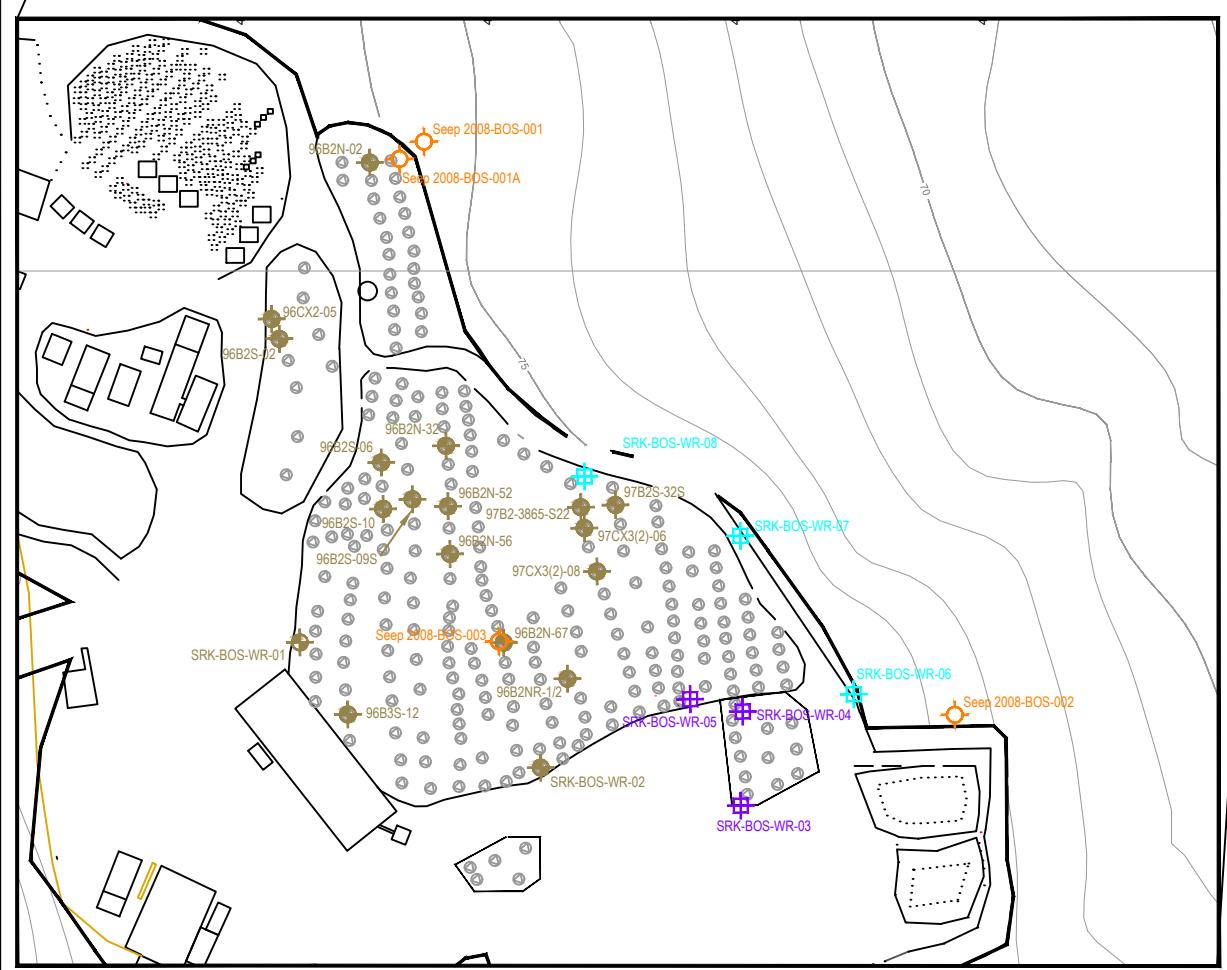
DATE: Jan. 2017 APPROVED: CJ FIGURE: 3.1

Rock Seepage Sampling Locations at
Boston Camp Pad, Ore Stockpiles,
and Airstrip, August 2008

Water sources to the Boston camp include natural precipitation (rain and snow) and raw water sourced from Aimaokatalok Lake during periods of camp activity. Aimaokatalok Lake water is used for camp operations and is discharged via the sewage treatment plant at SNP station BOS-3. Natural precipitation interacts with waste rock and ore and flows to the tundra either as runoff from the surface of the pile or as seepage that has infiltrated through ore and waste rock in the stockpiles and underlying pad. Flowing seeps have been located at a few locations on the east side of the camp (Figure 3.1).

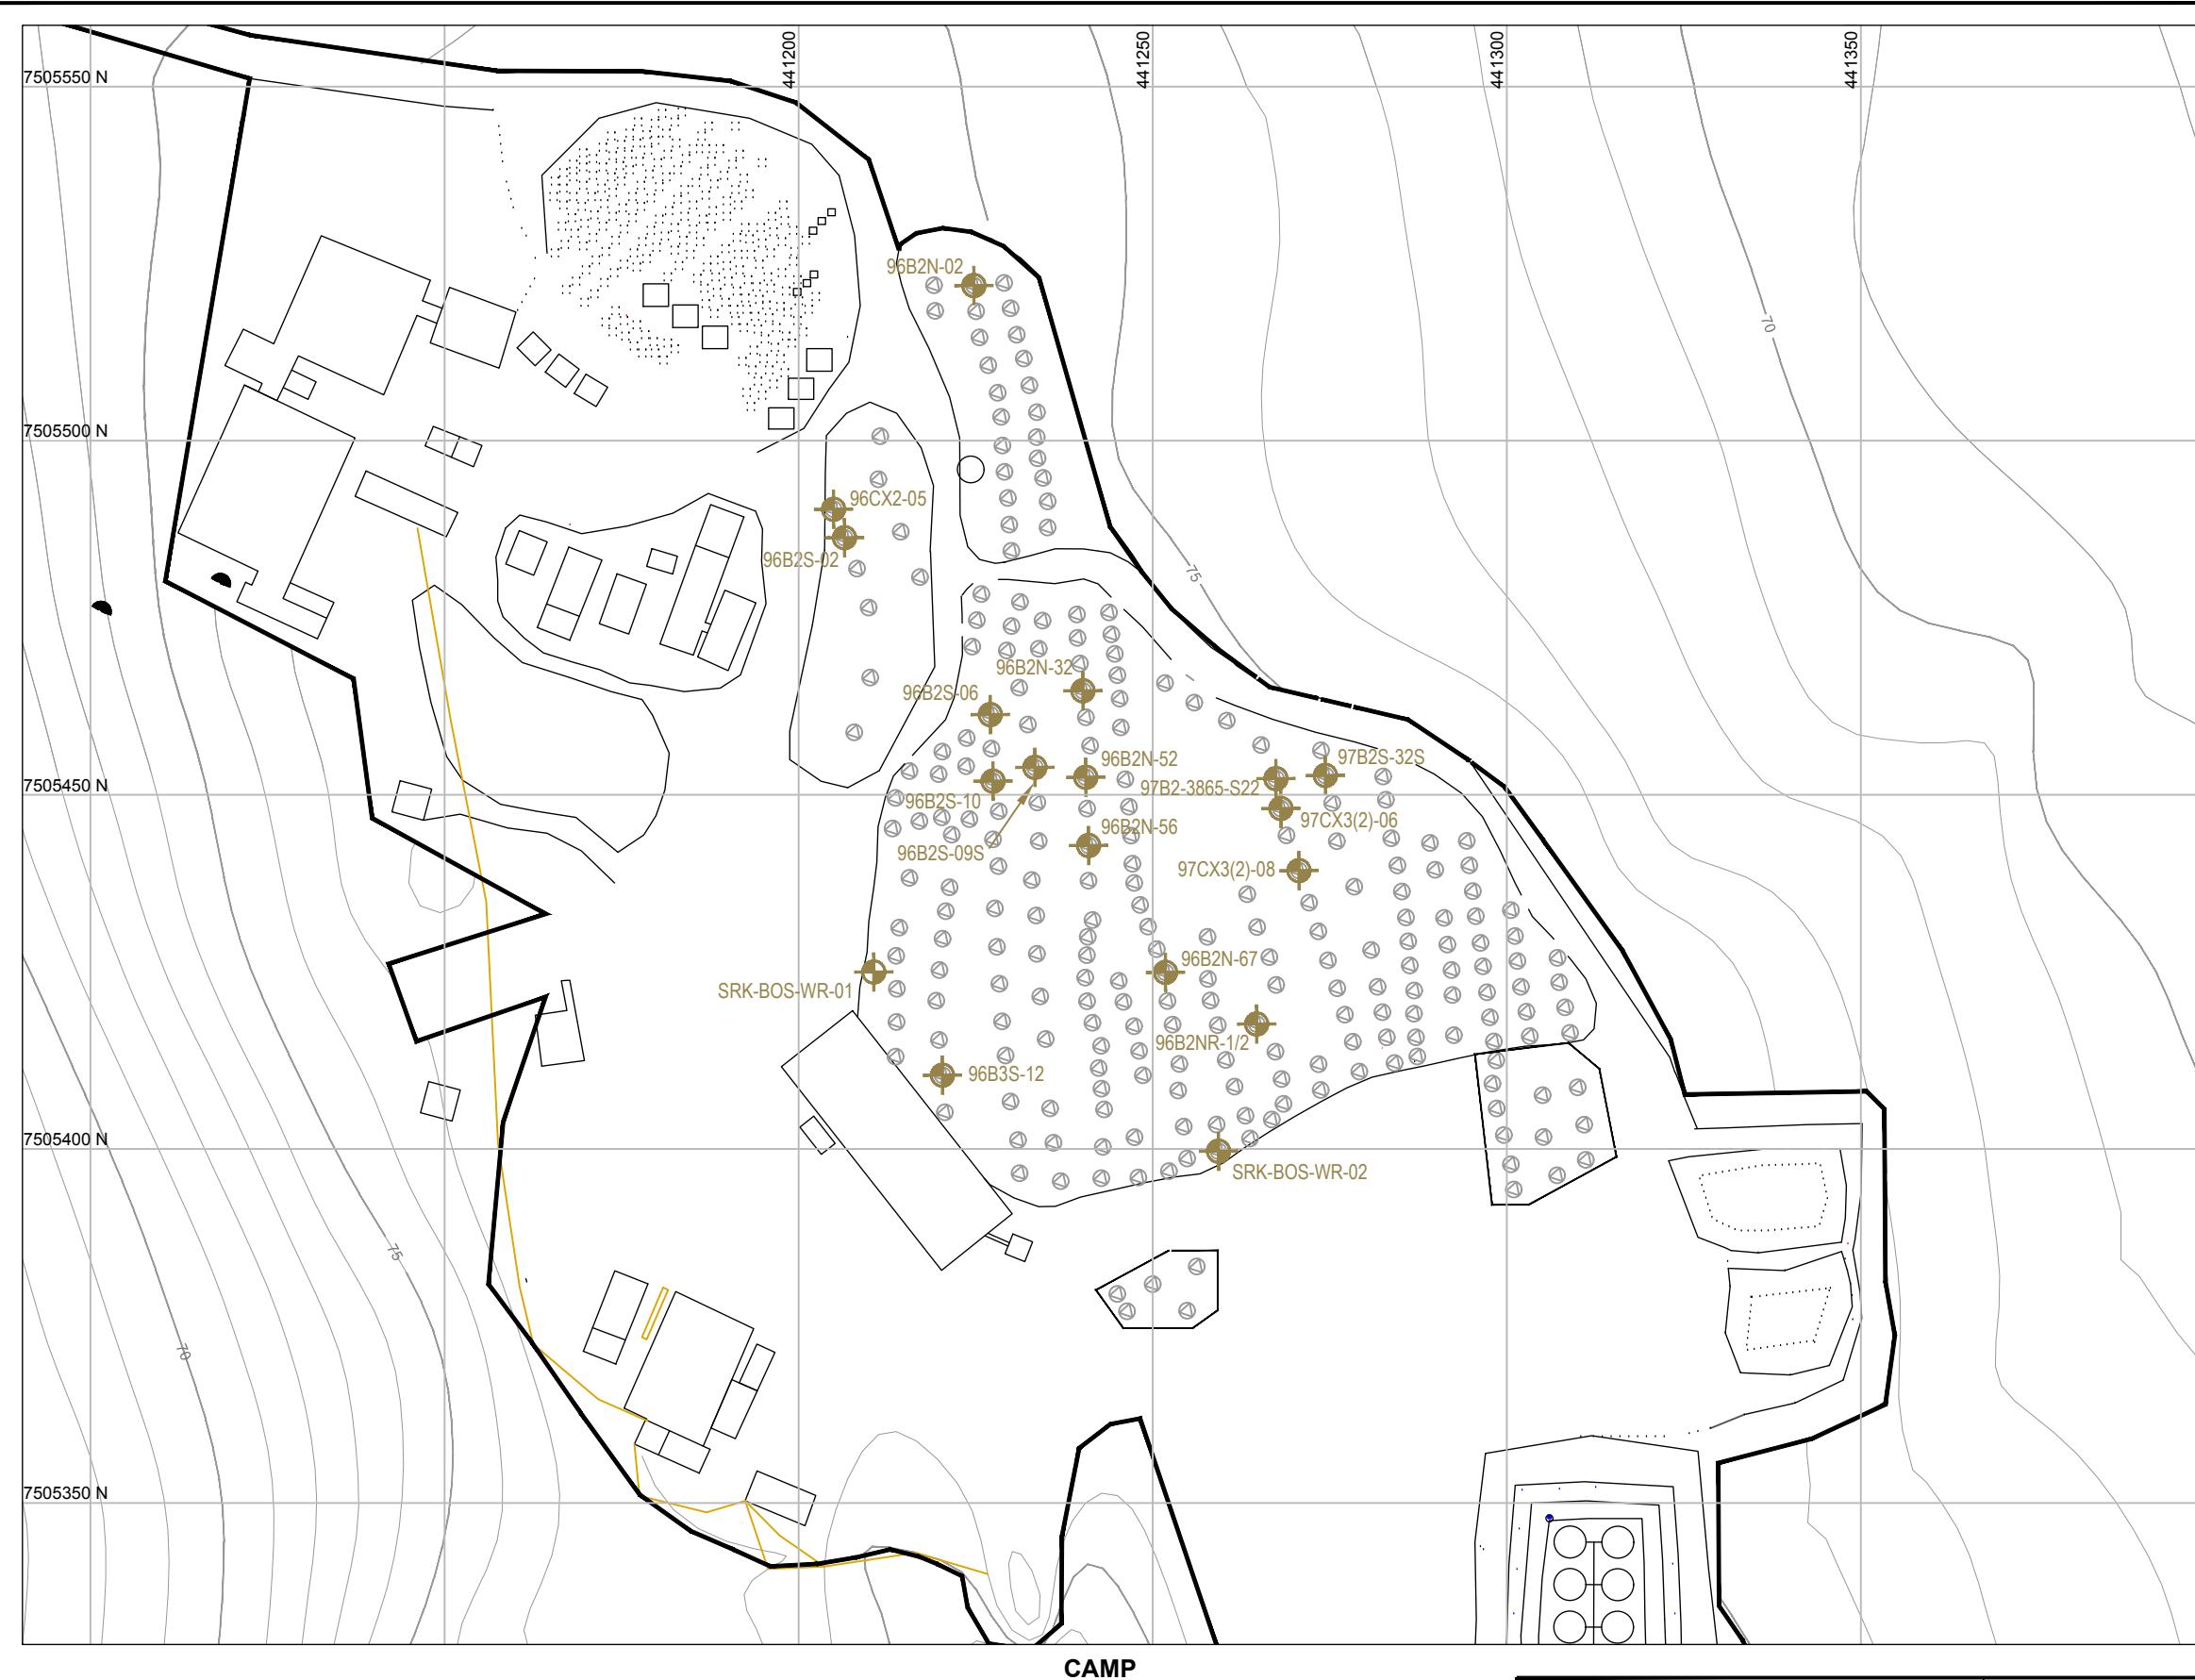
The last rinse pH and conductivity survey was conducted in 2008 (SRK 2009b - Supporting Document A). The next comprehensive rinse pH survey will be conducted in 2018. Ore stockpiles characterized in 2008 would be selected for the survey (Figure 5.1) to allow direct comparison of the results.
